Forensic Case Studies For Civil Engineers

Norbert J. Delatte Jr.,
Ph.D., P.E.

Vaiont Dam Reservoir Slope Stability Failure

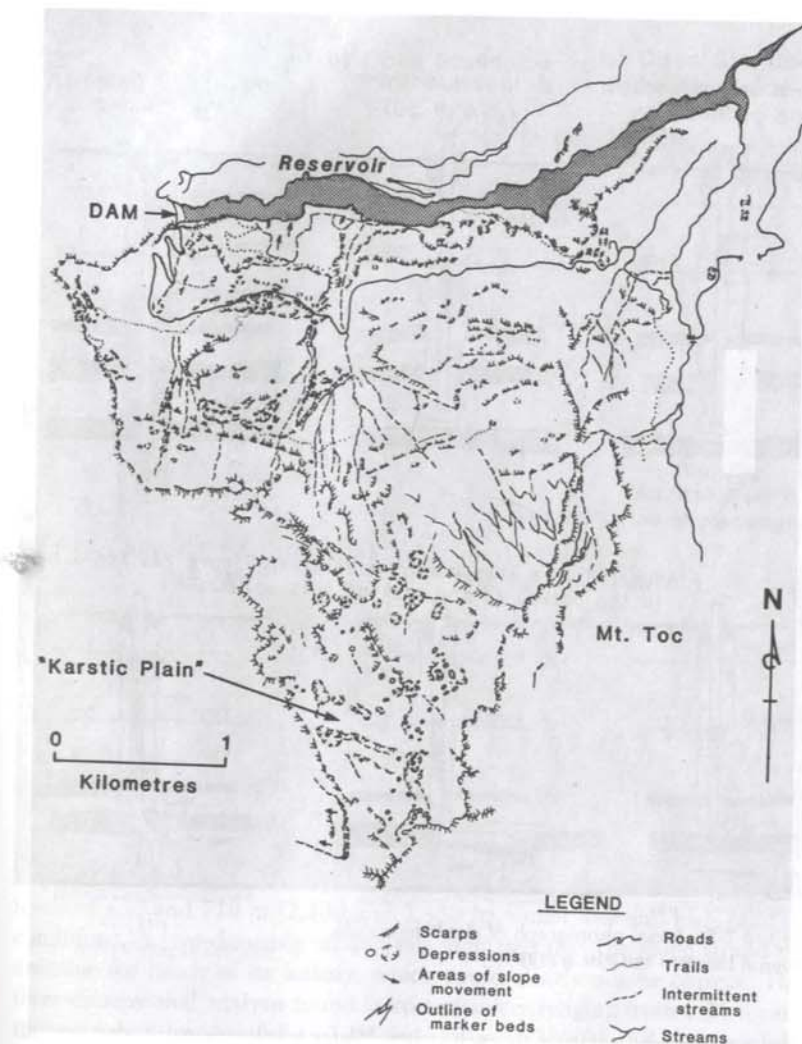
Figure 7-4. Plan view of mass before slide.

The lower, confined aquifer was fed mostly by precipitation on Mt. Toc (Semenza and Ghirotti 2000). Figure 7-4 shows a plan view of the mass that slid to the north. To observers on the opposite side of the valley, it appeared to be M-shaped.

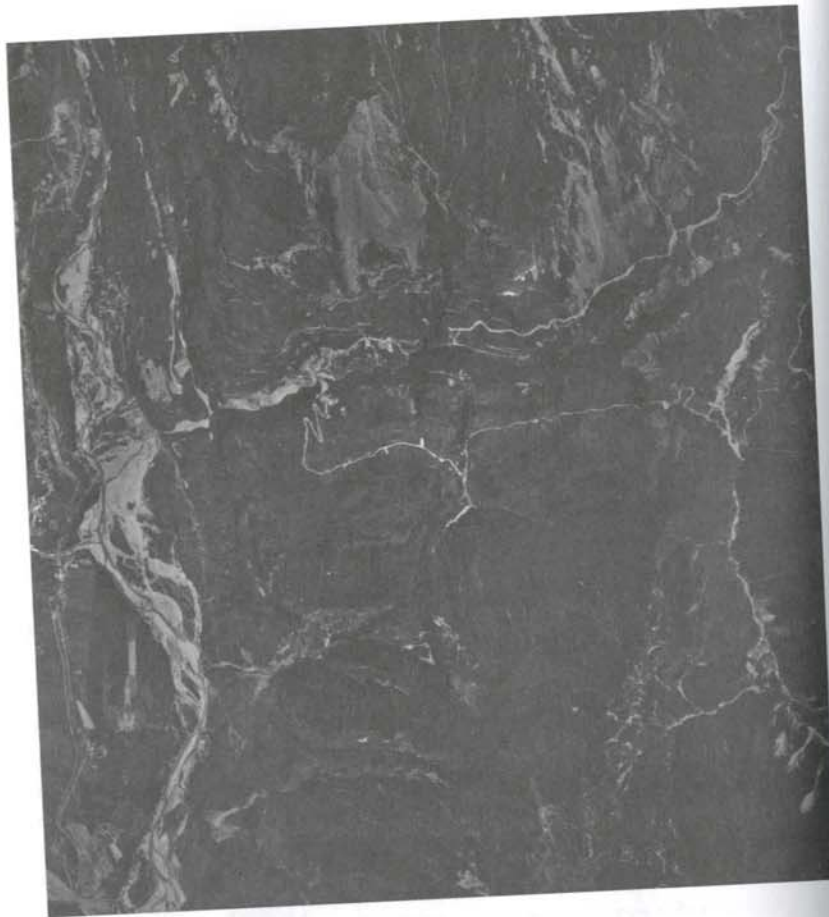
Figure 7-5. Aerial photograph of site before slide.
Source: Hendron and Patton (1985).

Using aerial photographs available at the time, Hendron and Patton (1985, p. 31) identified a pattern of apparent kettles or sinkholes, along with shallow slide areas. These are shown in Fig. 7-5. These features could have been used to identify a possible landslide area for further ground-based investigation.

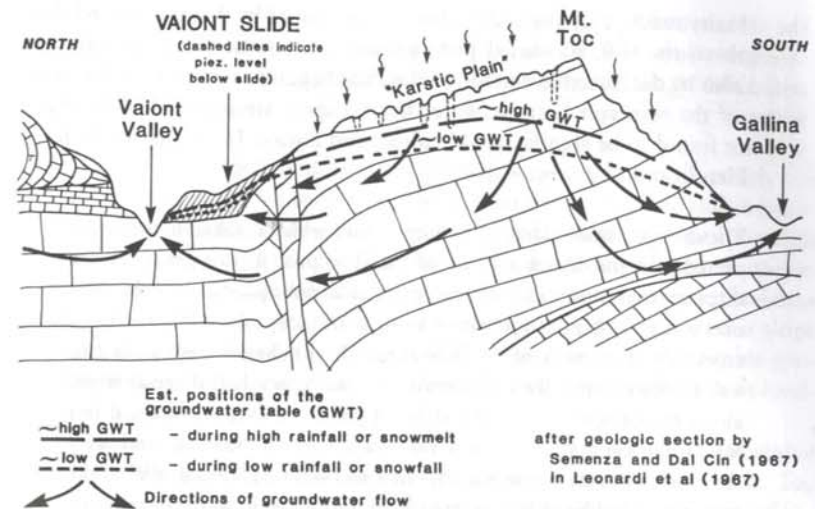
Figure 7-6. Infiltration of water through the mountain.

These sinkholes readily allowed rainwater or snowmelt to infiltrate into Mt. Toc, and to reach the base of the slide as shown in Fig. 7-6. With increasing precipitation, pressure would build behind the clay layer. During his surveys in 1959 and 1960, Edoardo Semenza had observed moist areas and springs below the eventual slide plane, which was consistent with the hydrogeology shown in Fig. 7-6 (Hendron and Patton 1985, pp. 34–35).
