Dam Safety

VOLUME 13 | ISSUE 2 | 2015

REEXAMINATION AND LESSONS LEARNED FROM THE 2004 FAILURE OF BIG BAY DAM, MISSISSIPPI

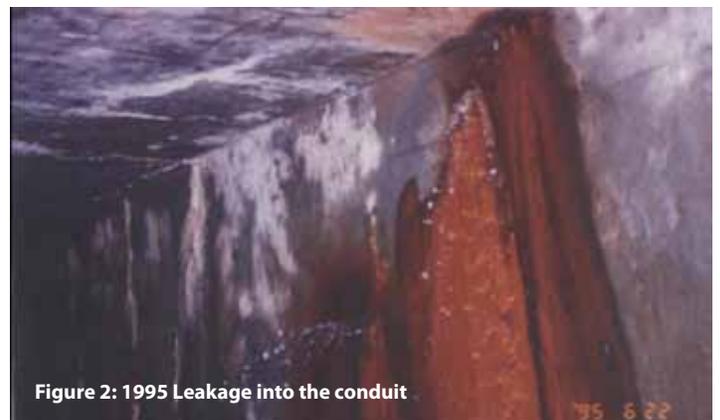
no documentation of the construction and as-built conditions was found in the available records. From the time of first filling of the dam, completed in 1993, until the failure in 2004, the dam exhibited several distress indicators and other warning signs. Substantial leakage into the conduit was observed at multiple locations by the time the reservoir filled, and continued until the dam failed in 2004, with the leakage locations apparently changing over time. Videos from as early as 1995 show substantial leakage into the conduit downstream of the purported core of the dam.

Figure 2: 1995 Leakage into the conduit

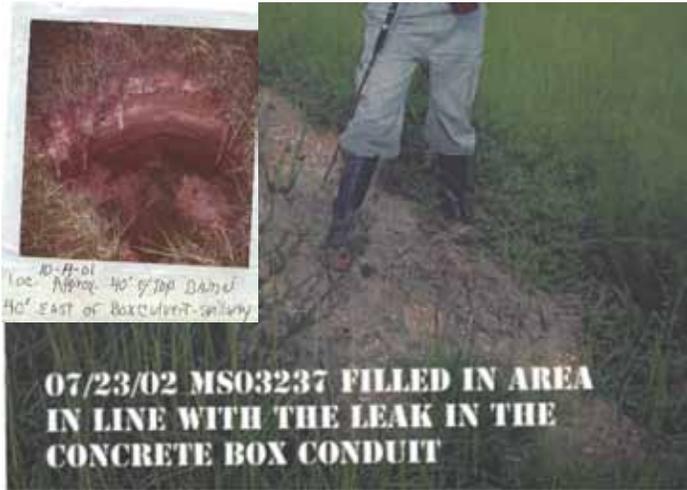
By 2002, a “sinkhole” in the downstream slope had been backfilled (Figure 3). The exact location is not known, and plans for this work were not located, but available records suggest that the sinkhole location was most likely directly above the conduit. In August 2002, the Owner sent the Engineer a letter authorizing studying leaks (Figure 4) and performing annual inspections, and indicating that

Figure 3: Sinkhole near conduit

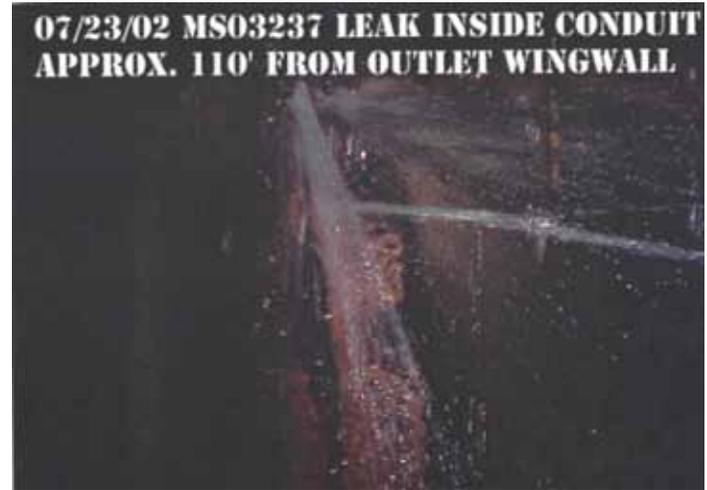
Figure 4: Leakage into the conduit

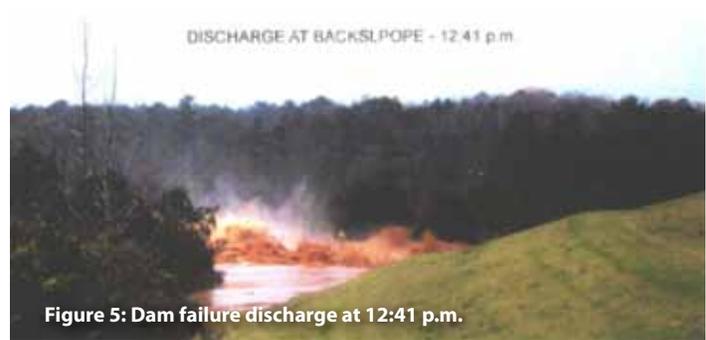
Figure 5: Dam failure discharge at 12:41 p.m.

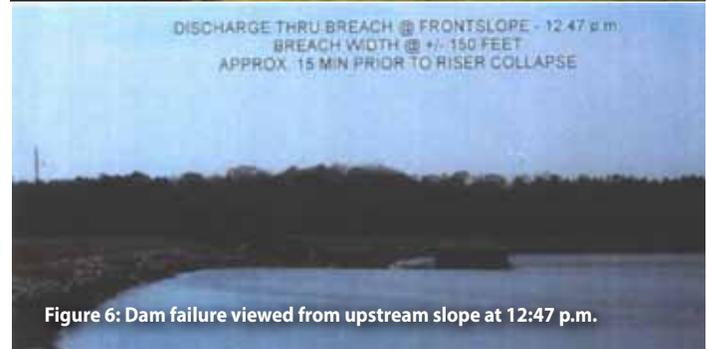
Figure 6: Dam failure viewed from upstream slope at 12:47 p.m.

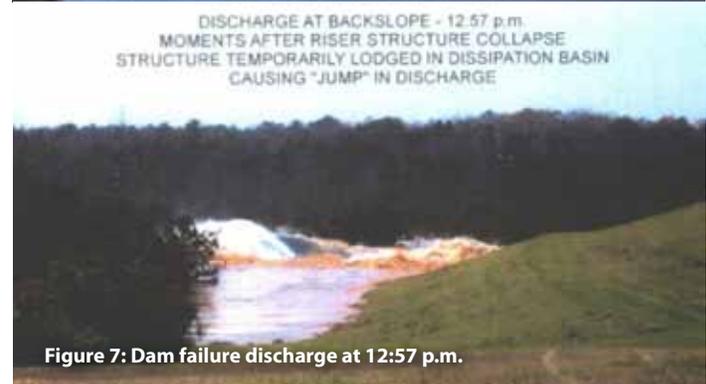
Figure 7: Dam failure discharge at 12:57 p.m.

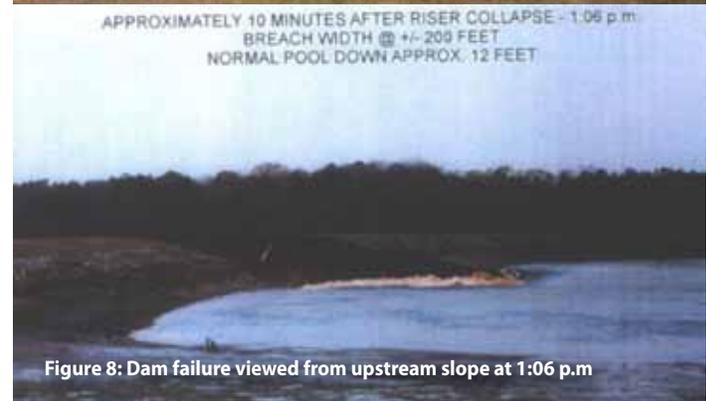
Figure 8: Dam failure viewed from upstream slope at 1:06 p.m.

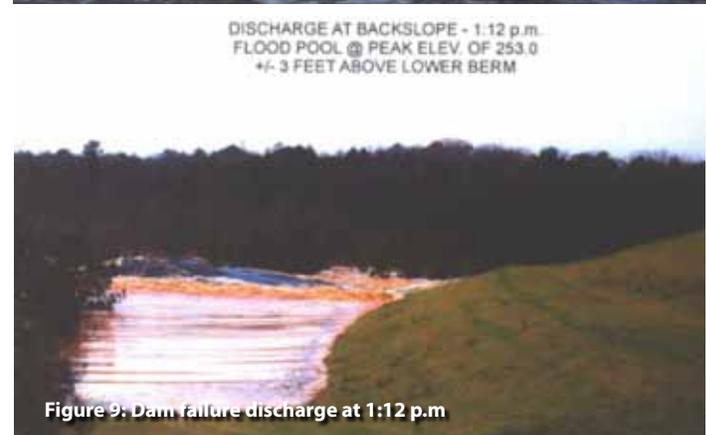
Figure 9: Dam failure discharge at 1:12 p.m.

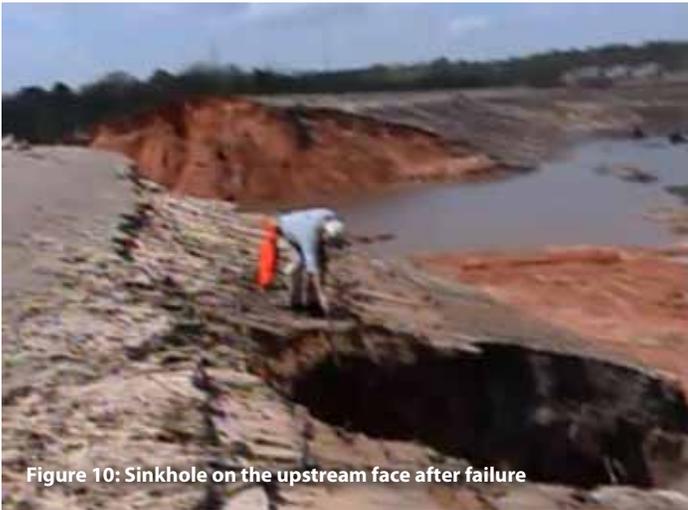
A photo taken after the reservoir drained showed a large sinkhole east of the breach in the upstream face of the dam (Figure 10), below what had been the normal pool elevation.

Figure 10: Sinkhole on the upstream face after failure

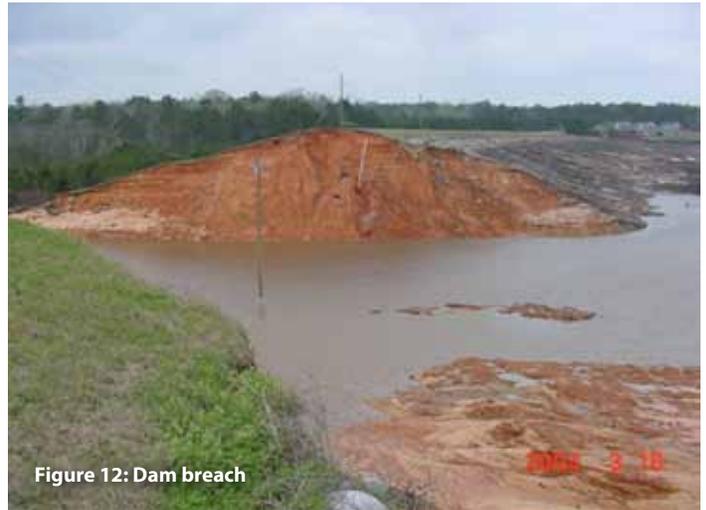
The breach that formed in the dam was in the general vicinity of the outlet conduit and resulted in total failure of the riser, the conduit through the embankment at the foundation contact, and the outlet discharge structure (Figure 12). The distress indicators discussed above are located as shown below on Figure 11.

Figure 12: Dam breach

- The construction inspections performed were apparently insufficient to prevent or correct problems with construction quality, such as defects in the conduit, deficient quality of the toe drain construction, and ineffectiveness of the core/cutoff wall (no core wall is visually apparent in photos of the dam section taken after the breach, e.g. Figure 12).

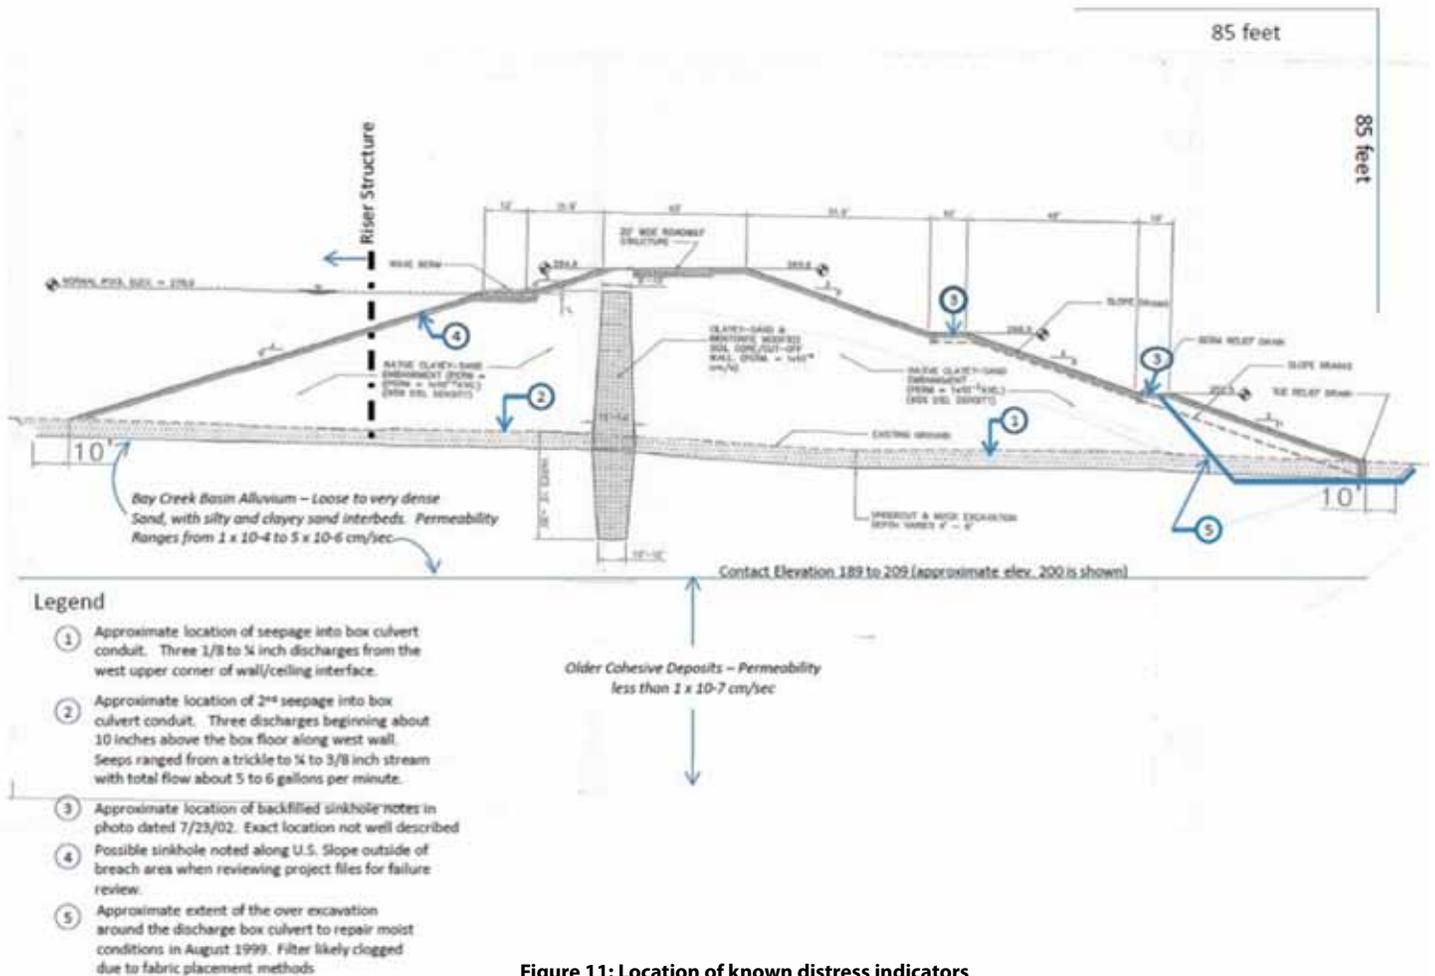
Figure 11: Location of known distress indicators
