RCEM – Reclamation Consequence Estimating Methodology

Dam Failure and Flood Event Case History Compilation

**U.S. Department of the Interior
Bureau of Reclamation**

February 2014

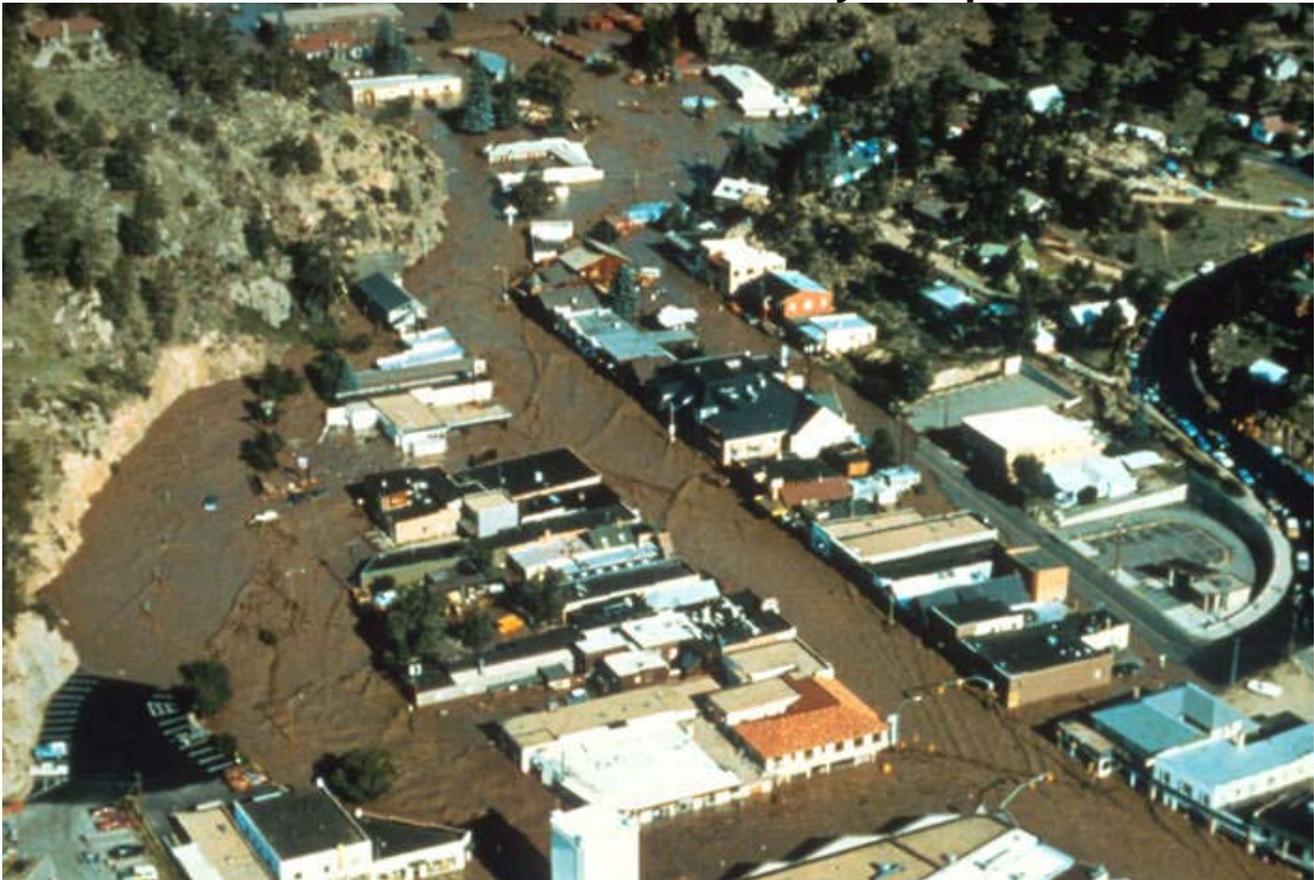
Lawn Lake Dam failure flood in 1982 at Estes Park, CO (Reclamation photograph)

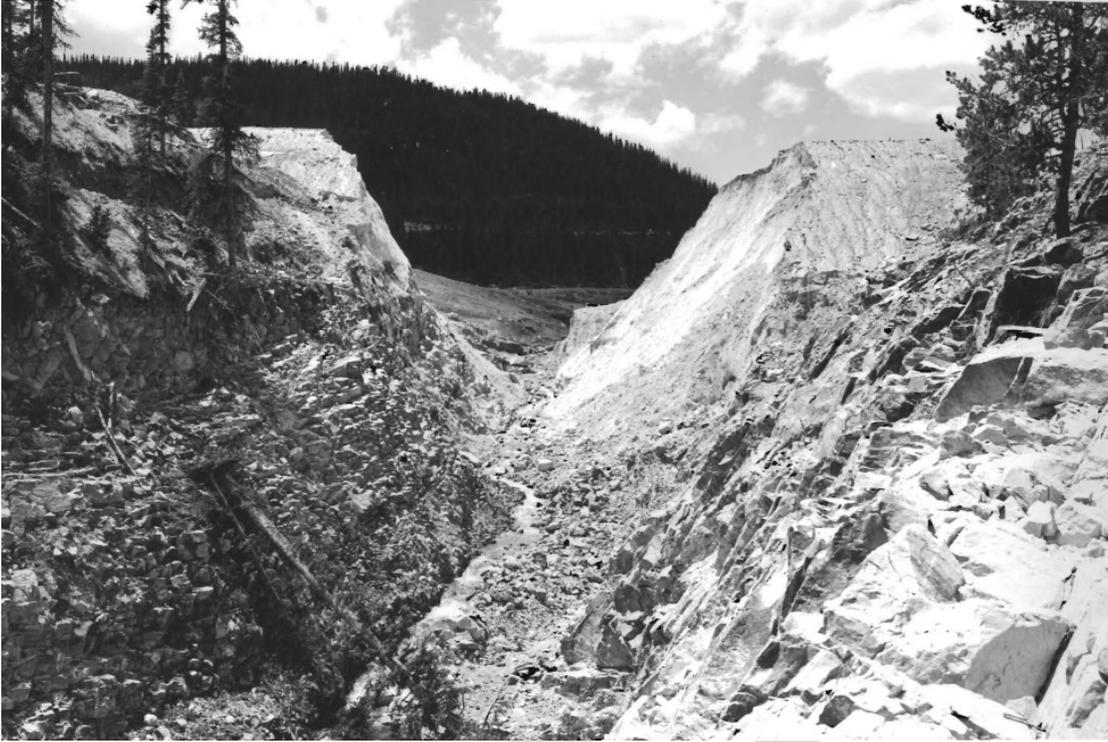
Little Deer Creek Dam, breach in maximum section
Source: Reclamation 1964

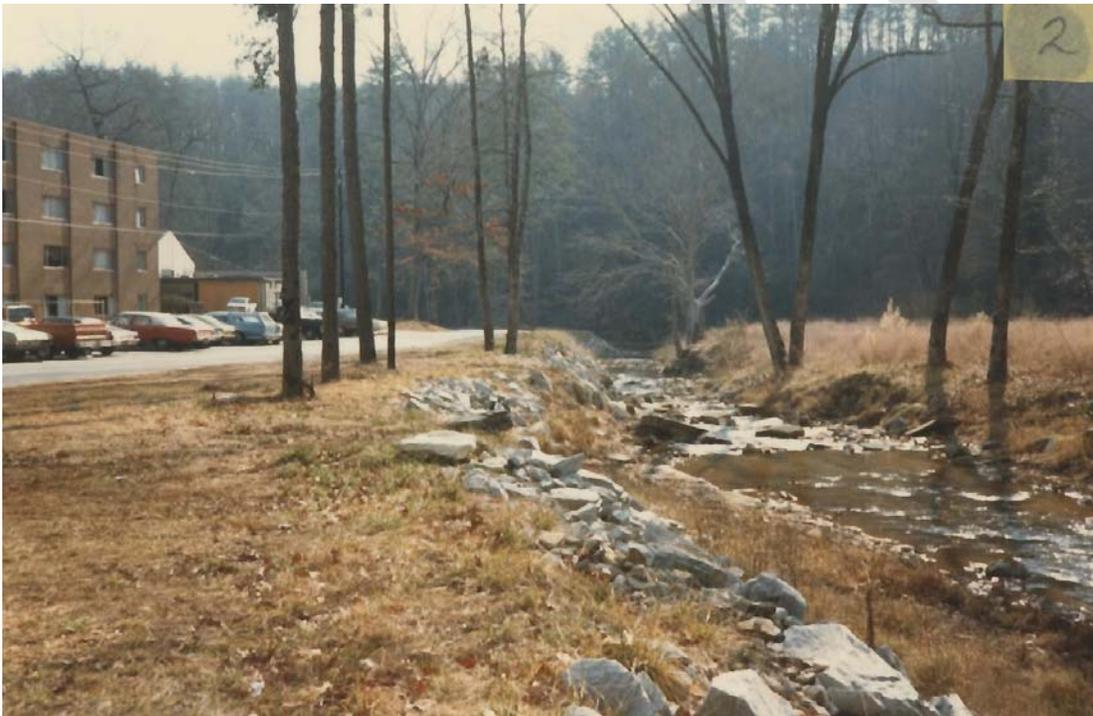
This flood is considered to have been medium severity. Downstream areas on the college campus were severely damaged, but debris and many structures remained after the flood passed. The area was not “swept clean”. Maximum DV at the Forest Hall Dormitory area is estimated to have been 120 ft²/s.

Forest Hall Dormitory on left, Toccoa Creek on right

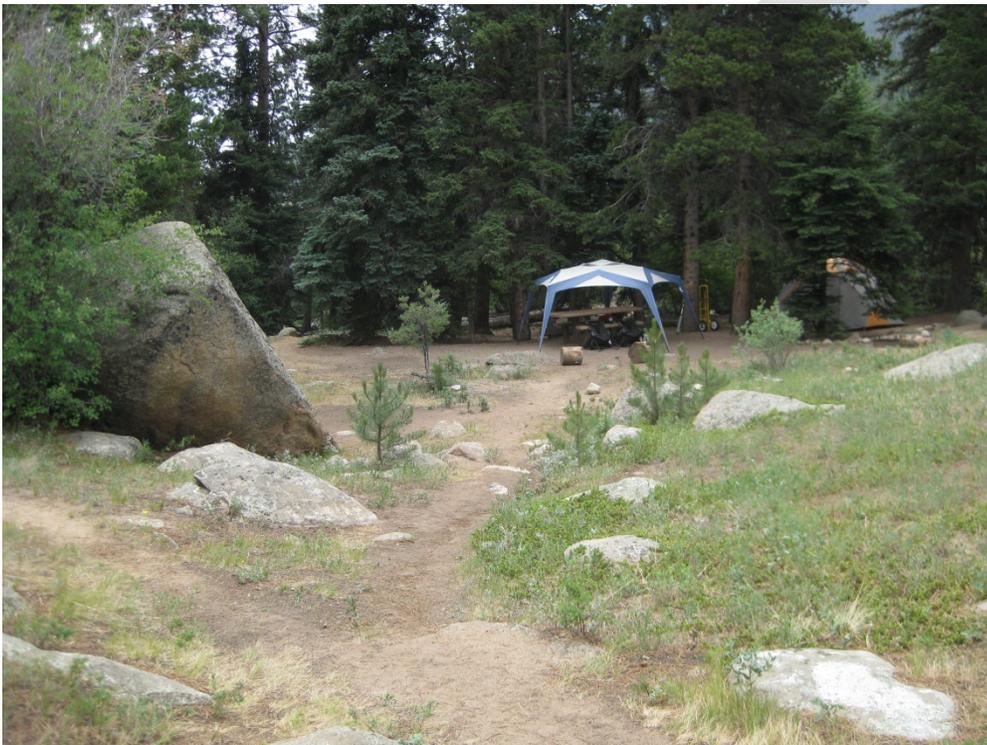
**Aspenglen Campground site near where two fatalities occurred.
Source: Bruce Feinberg, Reclamation, July 2012**

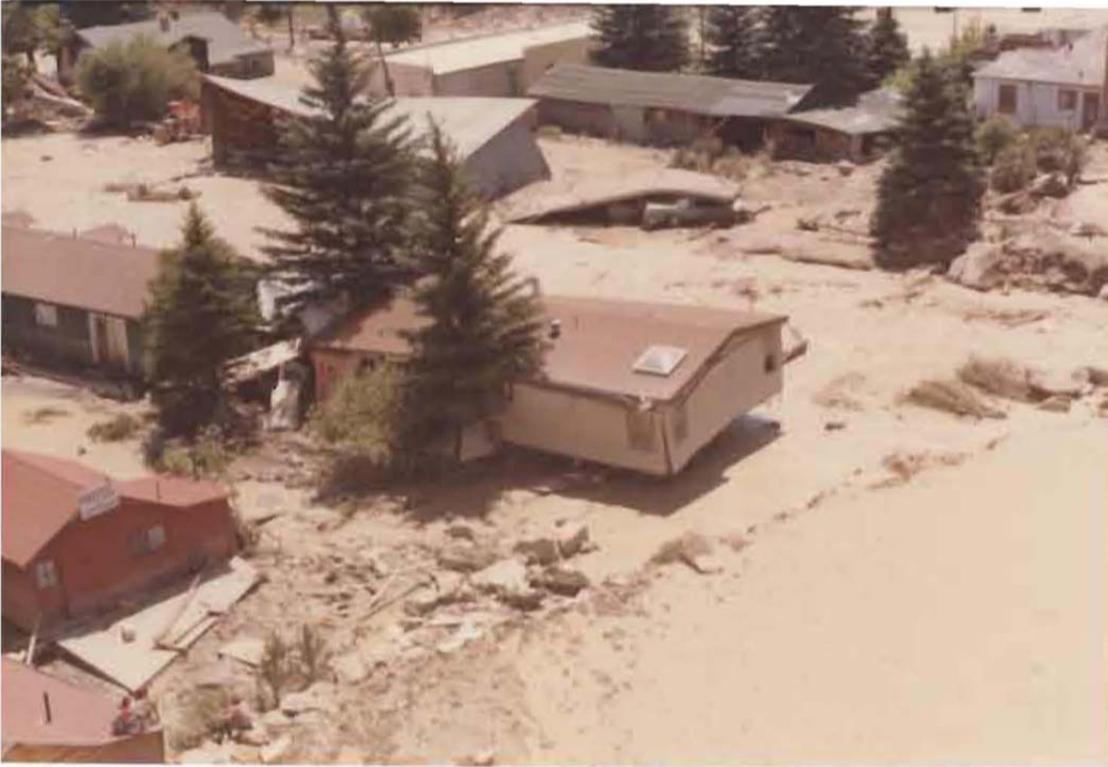
Further downstream along the Fall River Road and in the town of Estes Park, damage was extensive. The warnings in this area were successful though and no additional fatalities occurred. Flooding was fully contained in Lake Estes, the reservoir formed by Reclamation’s Olympus Dam.

Flood damage at Estes Park
Source: Wayne Graham, Reclamation, taken July 15, 1982

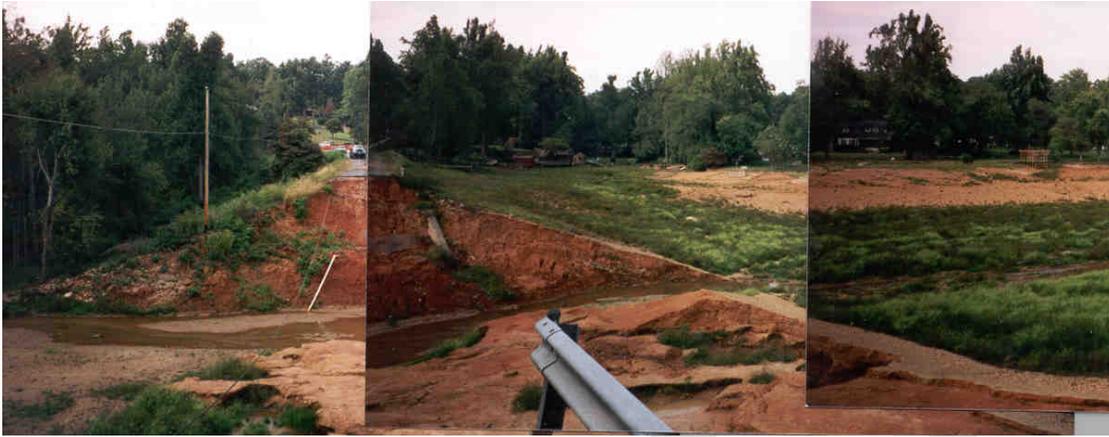
The breached Timberlake Dam
Source: Wayne Graham, Reclamation

Timberlake Dam was rebuilt about one year after its failure.

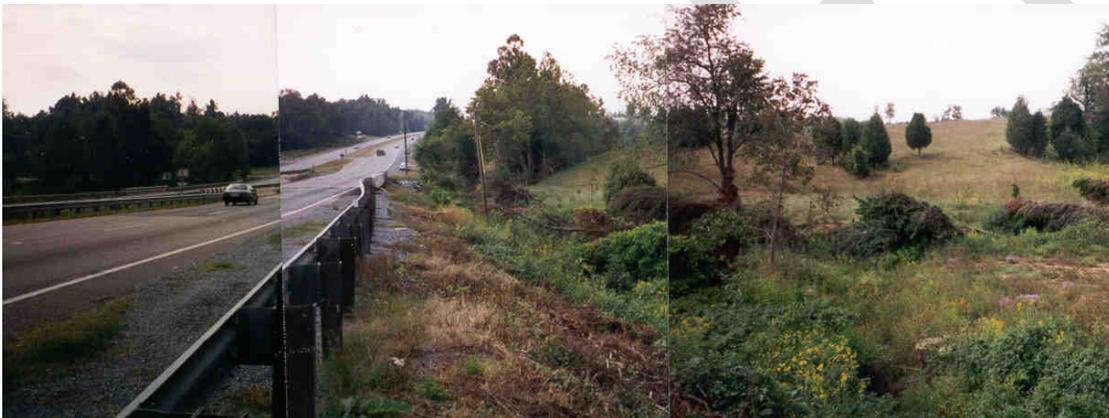
Location where rescue worker was killed
Source: Wayne Graham, Reclamation

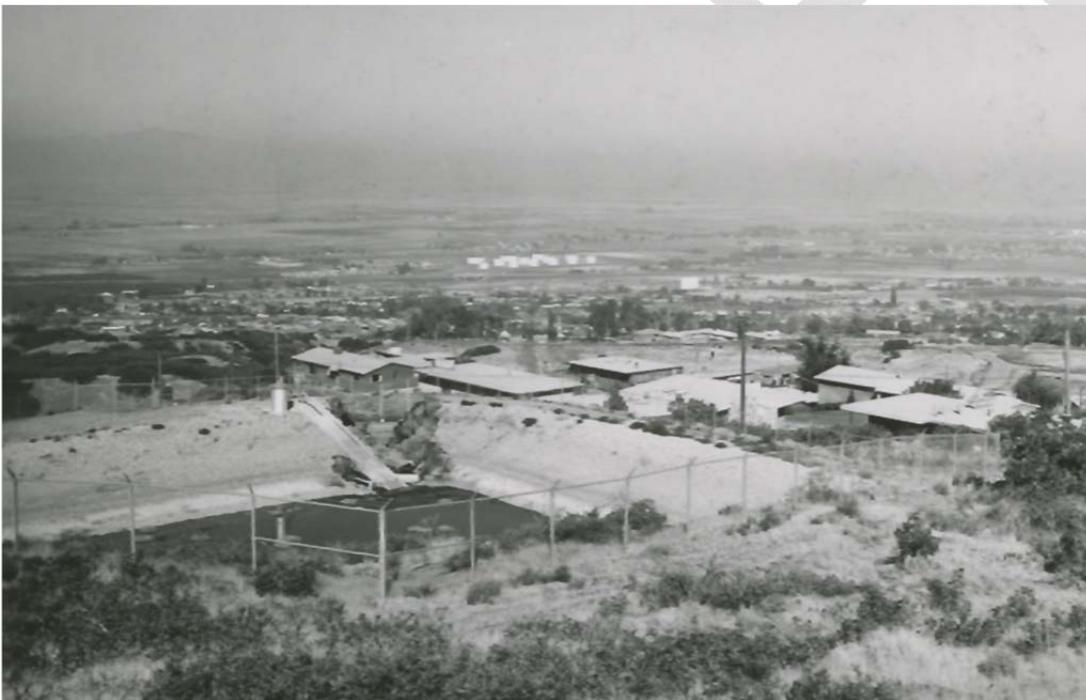
Reservoir No.1, located near Bountiful, Utah, failed on Sunday September 24, 1961 at 4:30 am. The earthen dam, which created a bathtub reservoir, was two years old when it failed from what was thought to be internal erosion. The exact height of the dam is not known, although available photographs indicate the dam height was in the range of about 15 feet. A total of 4.4 acre-feet of storage was reportedly released from the breach and the reservoir emptied in less than fifteen minutes. Failure of the dam was not detected prior to its occurrence and no warning was issued. The flood resulted in damage to about twenty properties which were damaged, but not destroyed, and there was an affected population at risk (PAR) of maybe eighty people. This event did not result in any fatalities.

Breached Reservoir No.1 Dam

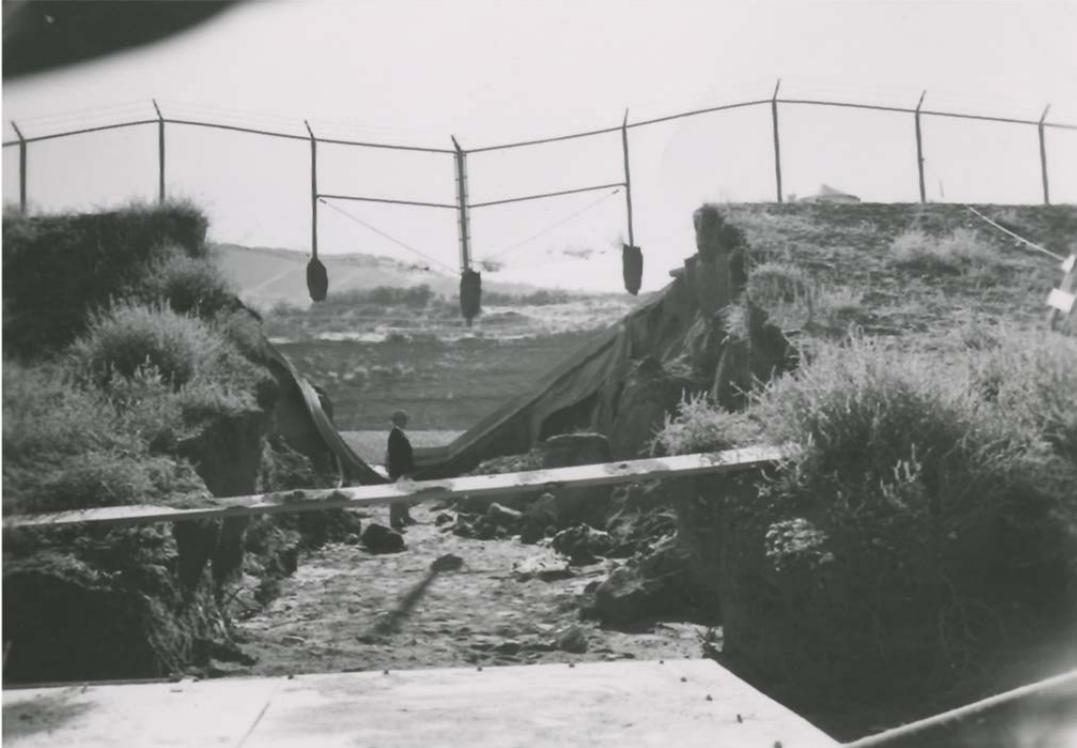
Close up of breach, Reservoir No.1 Dam
Source: Earl Bud Bay, Reclamation, September 25, 1961
