THE WILLIAMSBURG RESERVOIR DAM FAILURE OF 1874

R. Lee Wooten, P.E.¹, Peter L. Spangenberg, P.E.², William C. Salomaa³,
and Michael Misslin⁴

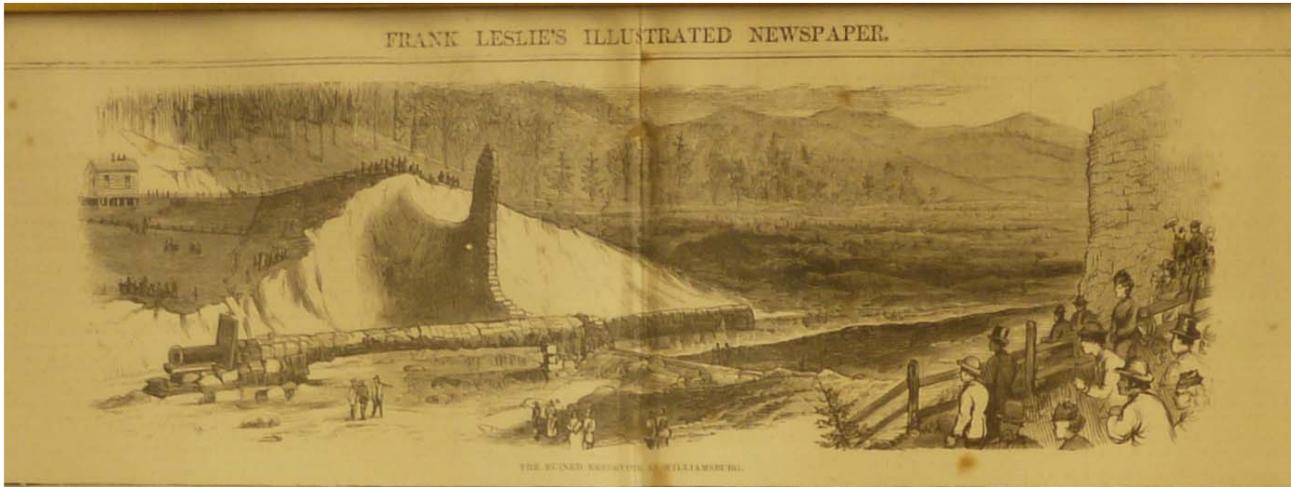
Figure 11. Newspaper Sketch of the Dam Ruins.

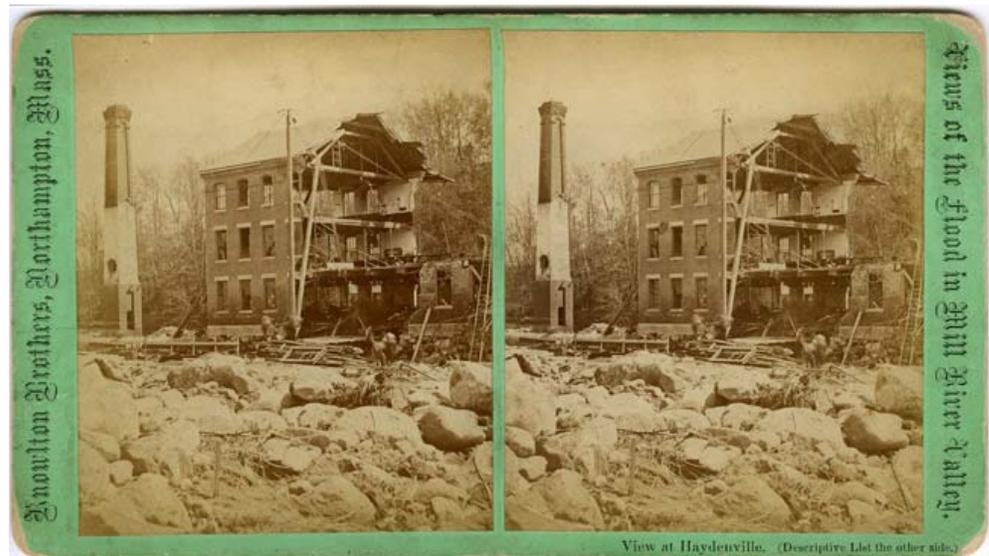
Figure 12. The Hayden Brass Works, Post-Flood.

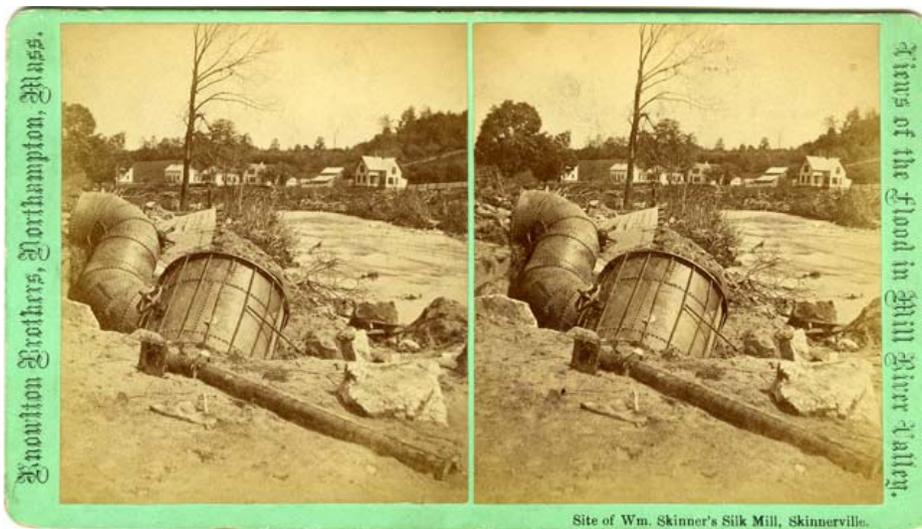
Figure 13. Silk Mill Ruins, Skinnerville.

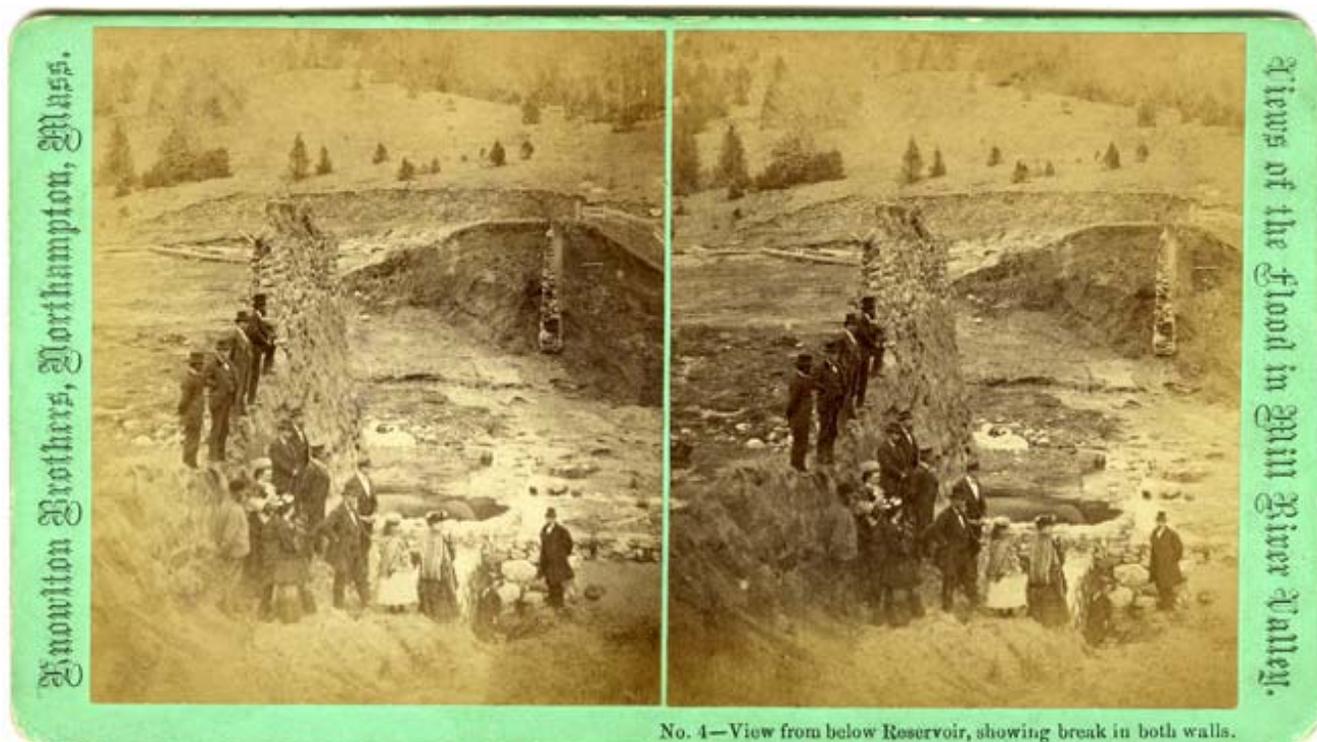
Figure 14. The Dam from the West Abutment, 1874.

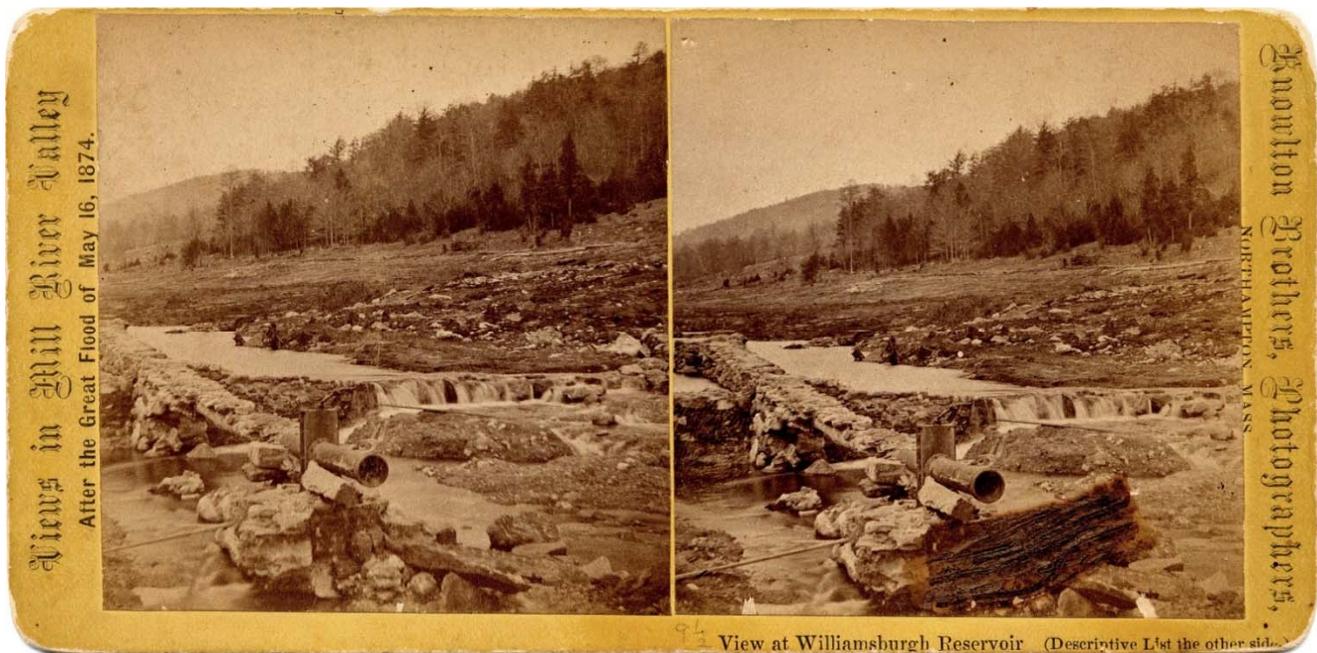
Figure 15. East Side of the Dam from Downstream, 1874

They noted that the exact cause was uncertain but proposed that foundation underseepage on the east side, 100 feet from the outlet, saturated the downstream slope, causing it to slide, leaving the core wall with inadequate support to resist the water load. Their findings were consistent with period photos which showed that the base of the core wall was not washed out by foundation erosion (Figs. 15 and 16). They proposed “a gradual working out of the gravel under and near the wall, and loose places or cavities formed,” that is internal erosion / piping, as the mechanism for the deterioration of the seepage condition and stability.

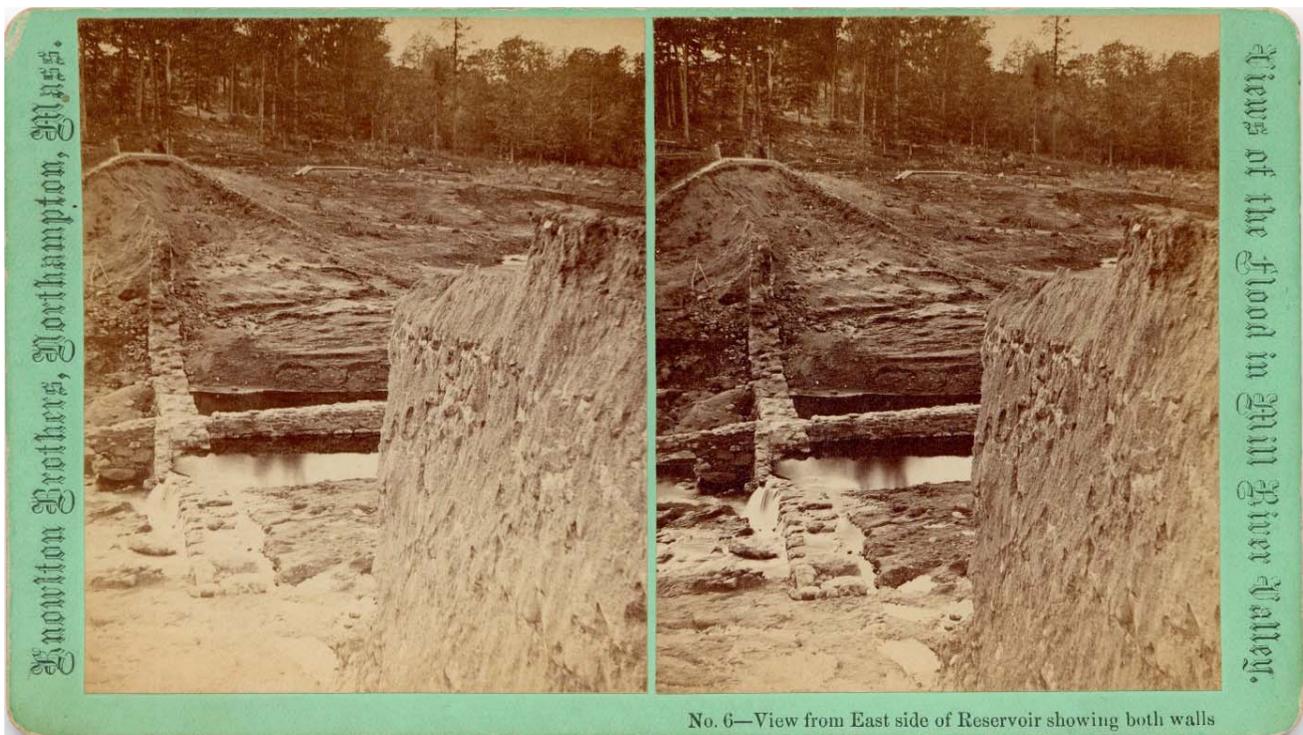
- “There was no sufficient inspection.”
- “The remains of the dam indicate defects of workmanship of the grossest character.”
- The grout quality and workmanship of the core wall was poor such that cavities were not completely filled and the mortar was “some of it, very bad.”

Figure 16. View from East along Core Wall, 1874.

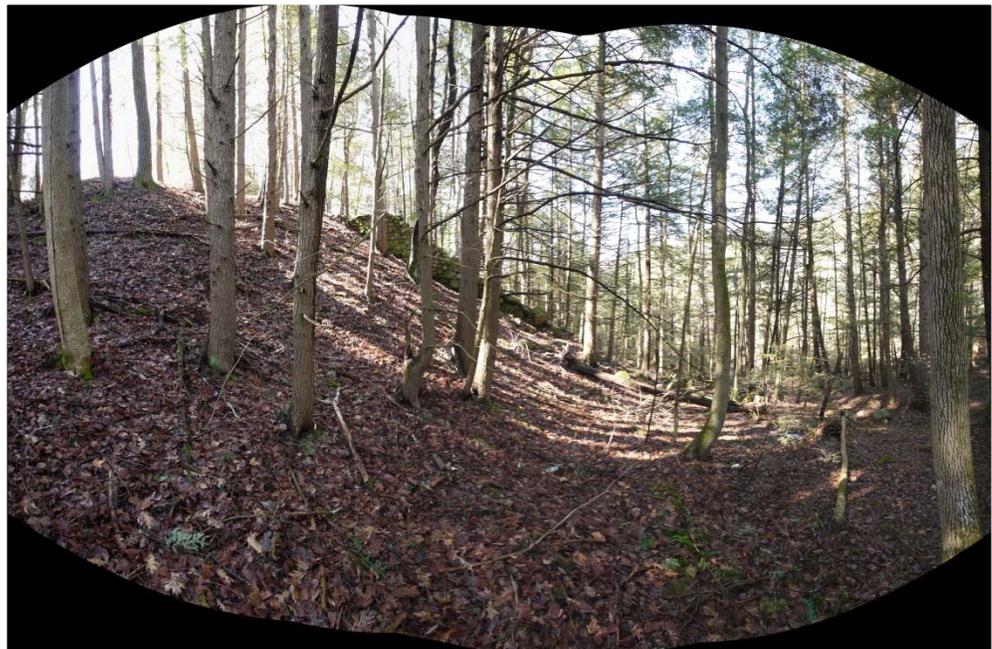
As engineers and dam safety regulators, we have a natural curiosity about the physical and social causes and about lessons from the disaster. Remnants of the core wall (Fig. 17), the outlet pipe foundation, the embankments, and the spillway remain but have melded back into a New England wood. Our best sources of information are the historical accounts and investigations of 1874.

Figure 17. East Abutment and East Side Breach Area, 2014.

formed by internal erosion under or through the dam. However, the preservation of the base of the core wall across the valley indicates that the flow path may have occurred through a section of the wall in the lower part of the dam, but above the wall base.
