80th Anniversary of the Fort Peck Dam Construction Slide

Charles G. Redlinger, P.E., Lead Engineer, U.S Army Corps of Engineers, Risk Management Center;
Keith A. Ferguson, P.E., DWRE, Practice Leader for Dams and Hydraulic Structures, HDR Engineering, Inc. and
Laila M. Berre, P.E., Dam Safety Program Manager, U.S Army Corps of Engineers, Northwestern Division

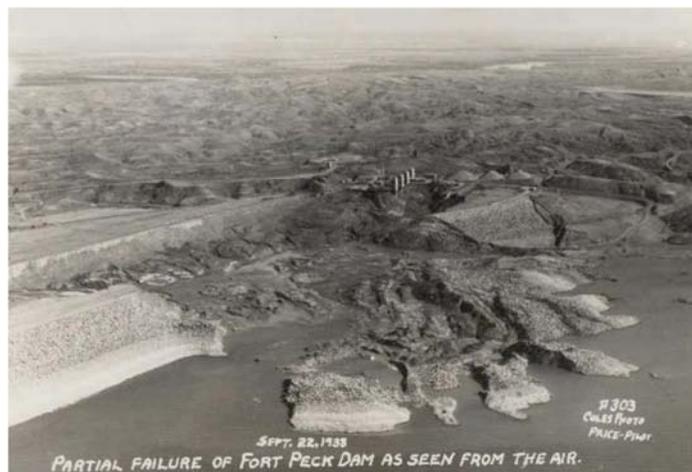
Figure 1: Photograph of the Fort Peck Slide on Sept. 22, 1938

The slide could only be described as enormous. The surface area of the damage was about 160 acres. It was difficult to get perspective of the size from the ground so aerial photographs (see Figure 1) were taken and used to provide a backdrop for some of the forensic explorations and evaluations to come. To put it in perspective the slide volume was more than the entire volume of concrete placed in the Hoover dam and power plant that had been completed two years earlier in 1936. After the sobering search for bodies had ended, the construction of a ring dike and haul roads began to allow re-construction in the damaged area as well as the start of field investigations. The slide area needed to be characterized quickly in order for a design to be developed for the portion of the dam to be founded upon the slide mass. The quickly approaching onset of winter, the enormous surface area and volume of materials needing to be characterized and the complexity of the slide mass left no time to waste.

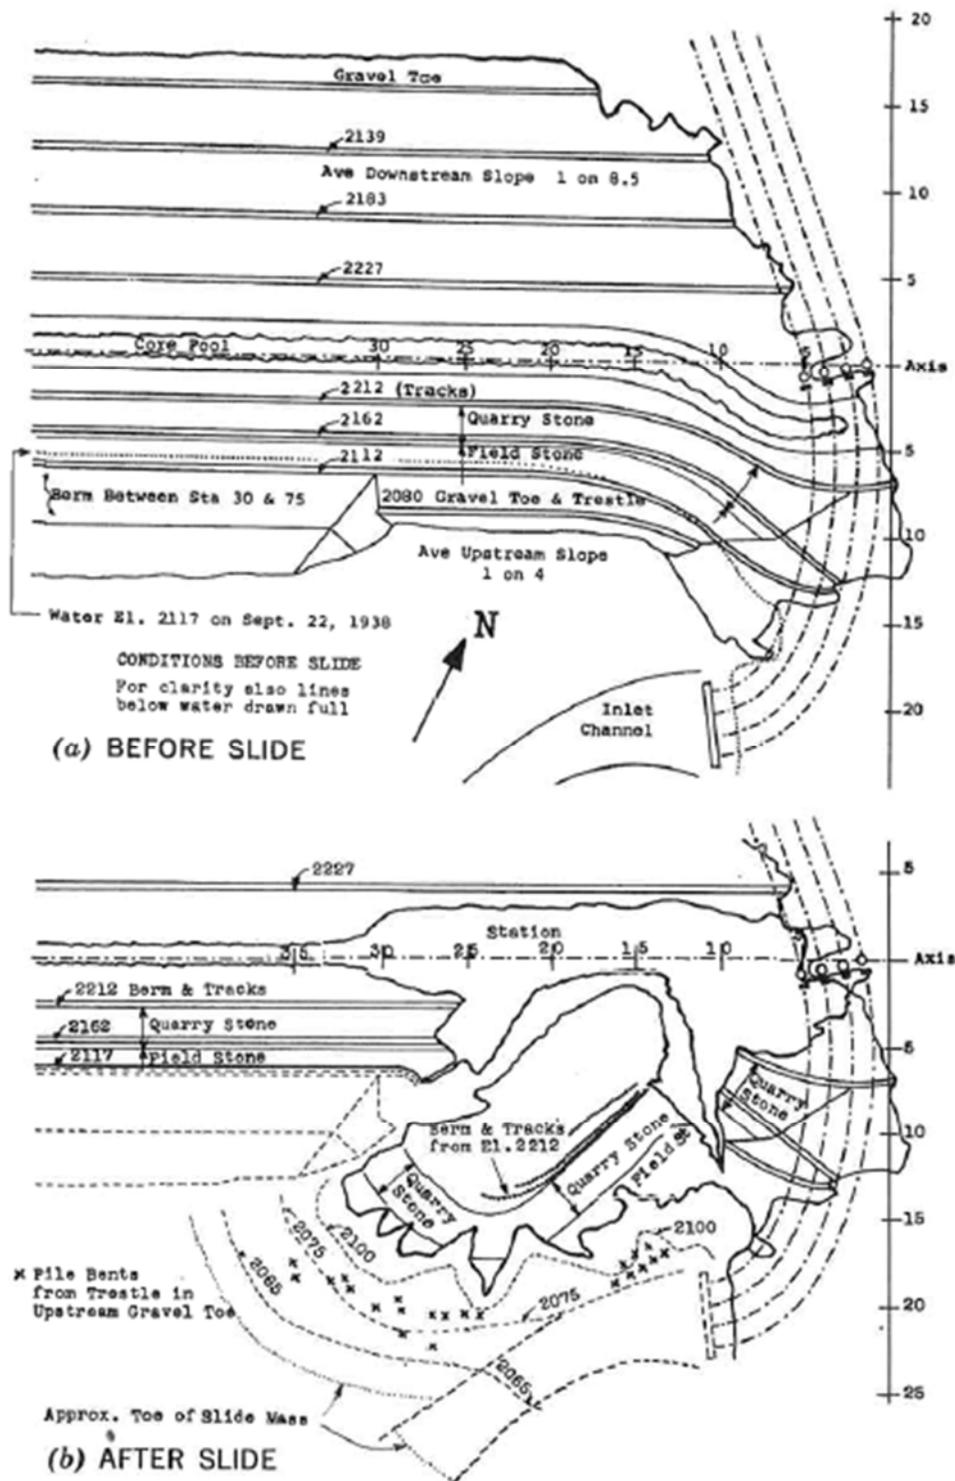
Figure 2 was taken from a 1964 Tezaghi Lecture paper by Arthur Casagrande and shows a plan view of part of the dam before and after the partial failure illustrating the location and extent of the slide. A profile of the dam (looking downstream) showing the relative location of the upstream slide and the foundation conditions along the dam axis is shown on Figure 3. Likewise, Figure 4 contains two cross-sections of the dam at Station 22 drawn at different scales showing the dam configuration both before and just after the slide occurred.

Figure 2. Plan View of Dam near Right Abutment (a) before and (b) after slide

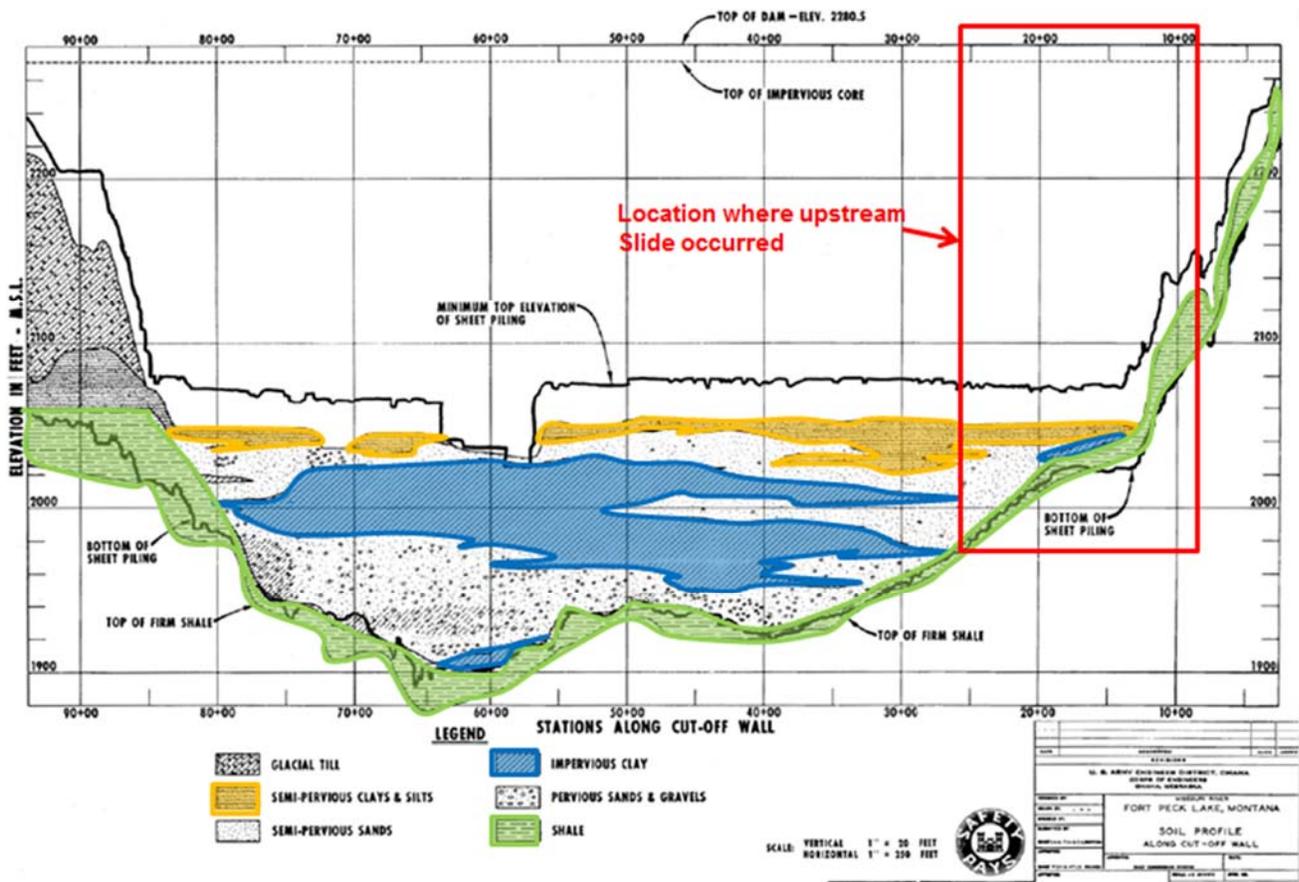
Figure 3: Profile along Dam Axis showing Location of the Fort Peck Dam Slide (Vertical scale exaggerated 12.5 times)

Soil profiles from the Diamond Drill contract are identified as the best source of information on soil conditions beneath the dam, with soil profile drawings generated in 1935 or early 1936. A glimpse of the geotechnical basis of the design is provided in a paper by T.A. Middlebrooks (1936), then an Associate Engineer for the Fort Peck Engineer District located at Fort Peck, Montana. This paper describes a number of the explorations, sampling, testing and analysis methods used to design the closure section of the dam. The designers were particularly concerned about the behavior of the impervious clays within the foundation alluvium that can be seen on Figure 3.

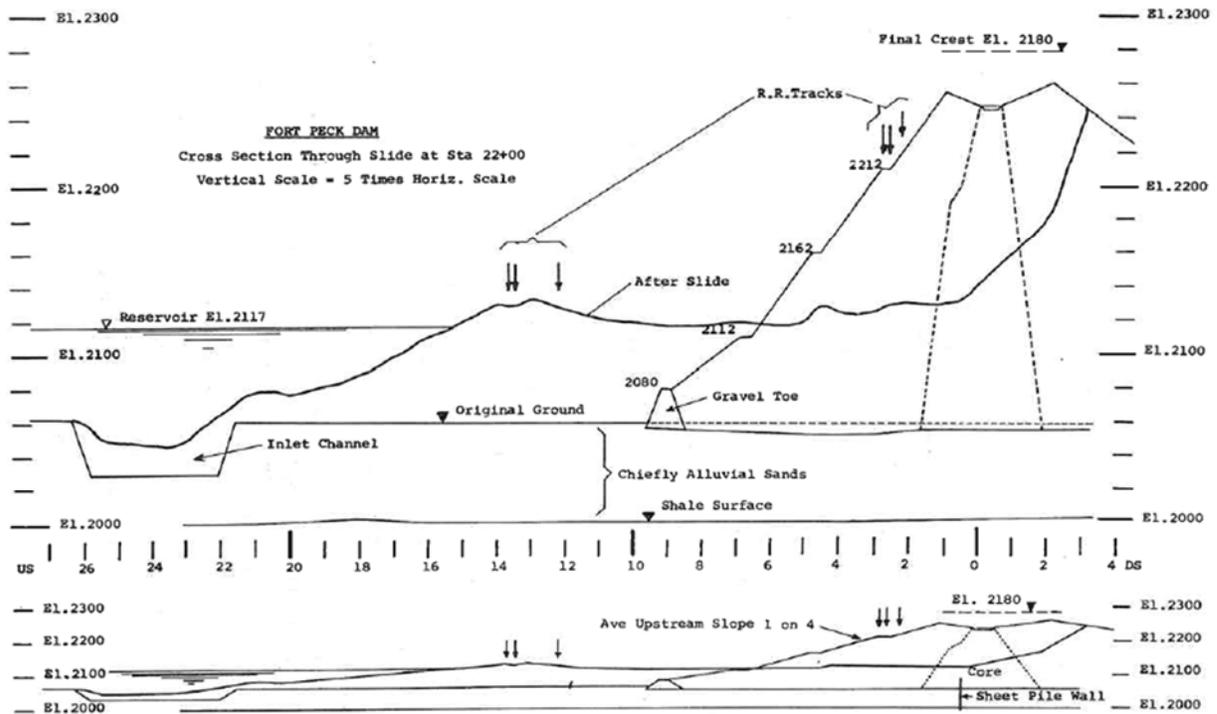
Figure 4. Cross-section of Dam at Station 22+00 before and after the slide at two different scales

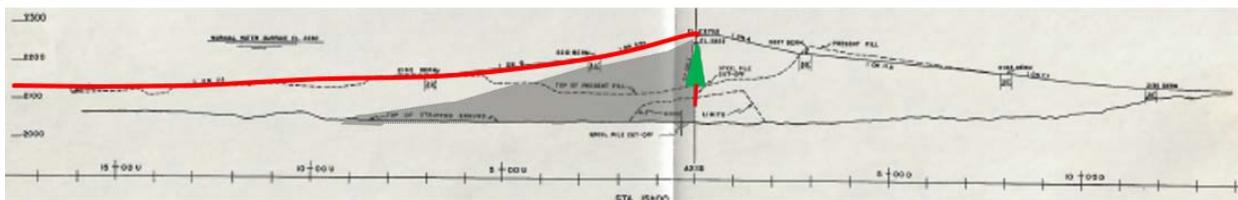
Figure 7. Re-designed slope in red over the original in gray. Green highlights the rolled till core around and above the sheet piles driven into the remnant core materials.

The back analysis of the slide focused on the strength of the bentonite materials as sensitivity studies were performed to determine the strengths to apply in the redesign. The redesigned cross section was simple in concept and even more massive in appearance and more symmetrical when compared to the original as shown on Figure 7.

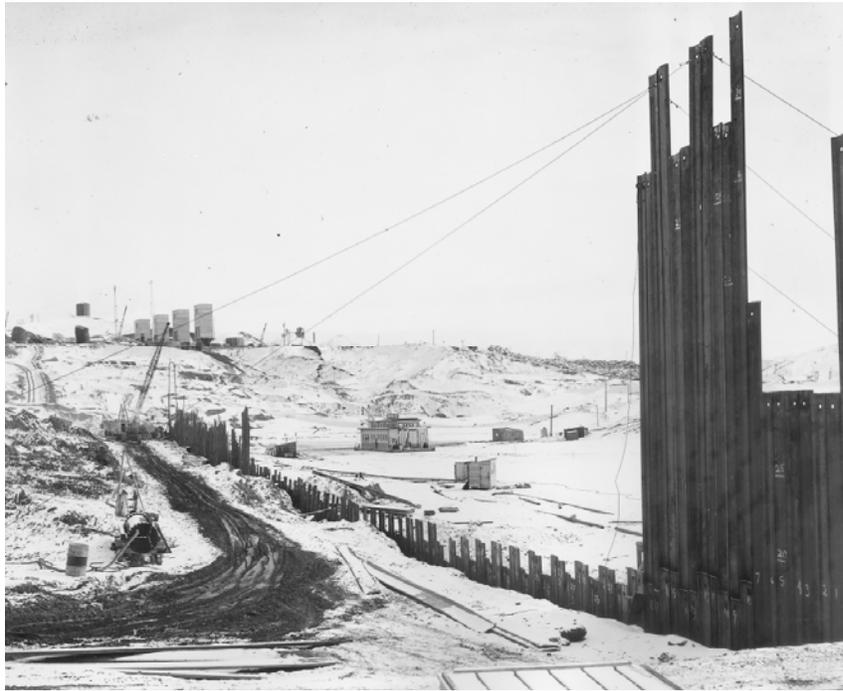
Figure 8. Winter installation of sheet piles into core

The Board of Consultants agreed that the shell of the reconstructed section could be built by either hydraulic fill or rolled-fill methods. The core materials in this area were to be of rolled fill obtained from the glacial till on the left abutment. The Board agreed with the plan for driving a single row of steel sheet piling (Figure 8) through the shell materials that moved in over the original core materials and into the underlying intact core, in effect, tying the three different cores together.

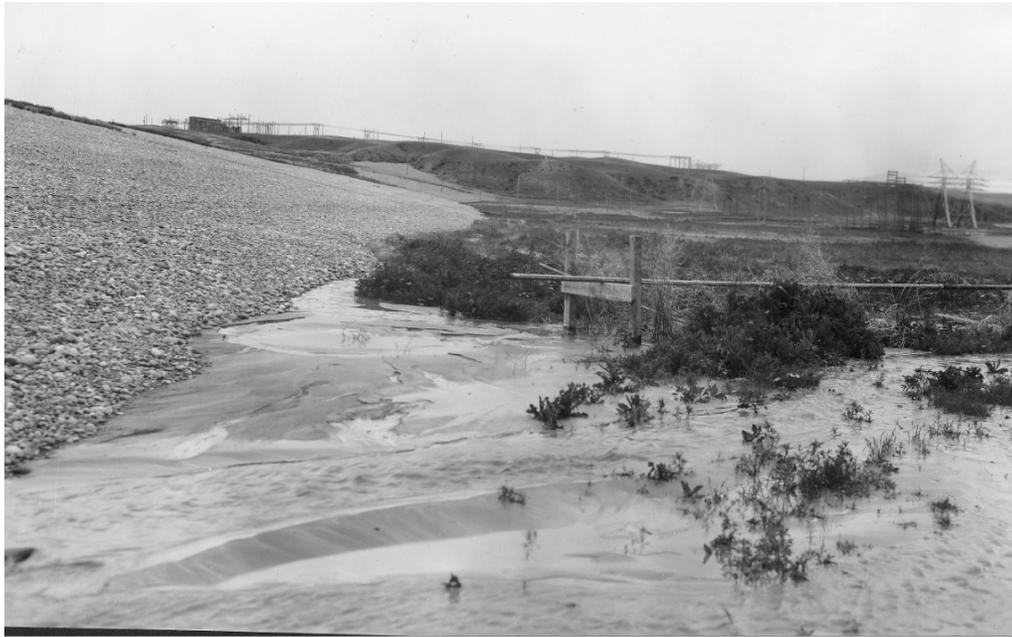
Another design change attributed to post construction operations at Fort Peck is the need to control seepage at dams with soil foundations. As noted previously and shown on the geologic and design cross section the designers were concerned with under seepage and installed a sheet pile cutoff wall to address this concern. A piezometer revealed high uplift pressures deep in the alluvium beneath the clay stratum at the downstream toe in 1942. The head is determined to be 45 feet above the ground surface and the depth to bottom of the clay stratum is about 90 feet at this piezometer. After a short time of high pressure readings, water began to flow up along the outside of the piezometer casing resulting in transportation and deposition of sand at the ground surface as shown in Figure 9.

Figure 9. Sand boils at toe with reservoir partially filled.

This erosion had to be remediated immediately with an inverted filter consisting initially of sand, gravel, and cobbles. More piezometers were installed along the toe and pressures were predicted to rise a maximum of 70 feet above the ground surface at full reservoir. This performance and analysis of data led to the installation of relief wells which were observed to lower the pressures 40 feet to just above the ground surface at a discharge of about 4,000 gallons per minute. The Board was reconvened in the spring of 1943 at which time they agreed the temporary wells were adequate for full reservoir conditions but recommended that a system of more permanent replacement wells be planned as soon as materials were available after the war. The wells were later replaced and new wells were added in 2011 and 2012. The pressures have remained well controlled over the years. This was the first installation of relief wells at a USACE dam.
