# TEMPE TOWN LAKE DAM – ANOTHER BURST BUBBLE

*Gary Brady, PE<sup>1</sup>*  
*George V. Sabol PhD, PE<sup>2</sup>*

## ABSTRACT

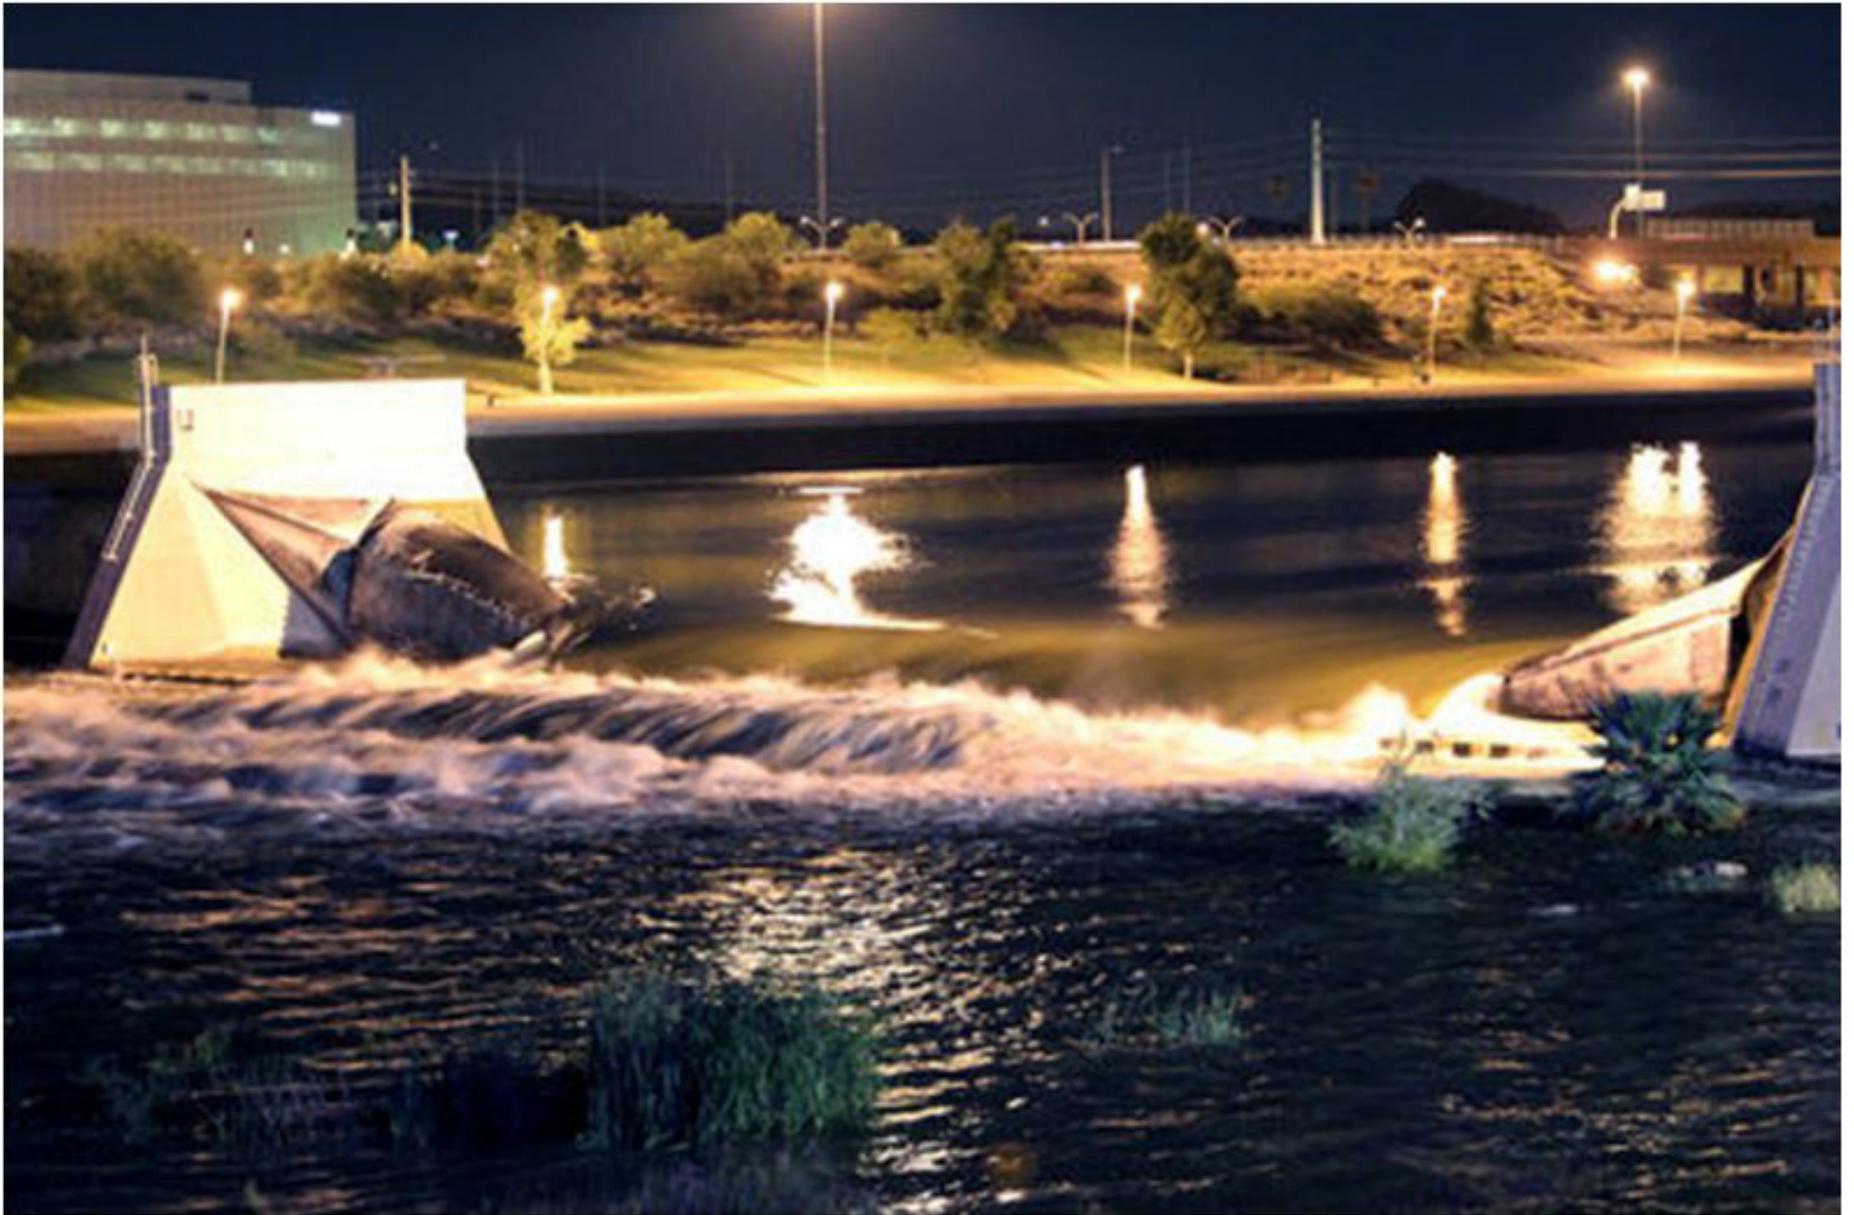
During the day of 20 July 2010, staff of PCL and Stantec were in the Salt River channel downstream of the dam preparing to begin bladder replacement on 21 July. That night at 9:44 pm, one of the four bladders burst, releasing 2,400 acre-feet of water into the Salt River below the dam, see Figure 2. The peak discharge was estimated at 40,000 cfs. Fortunately, there was no loss of life or property damage since the flood wave was contained within the banks of the Salt River. The failure received national news coverage including concern about sabotage or terrorist activity.

**Figure 2.** Rubber bladder failure at Tempe Town Lake Dam on 20 July 2010.

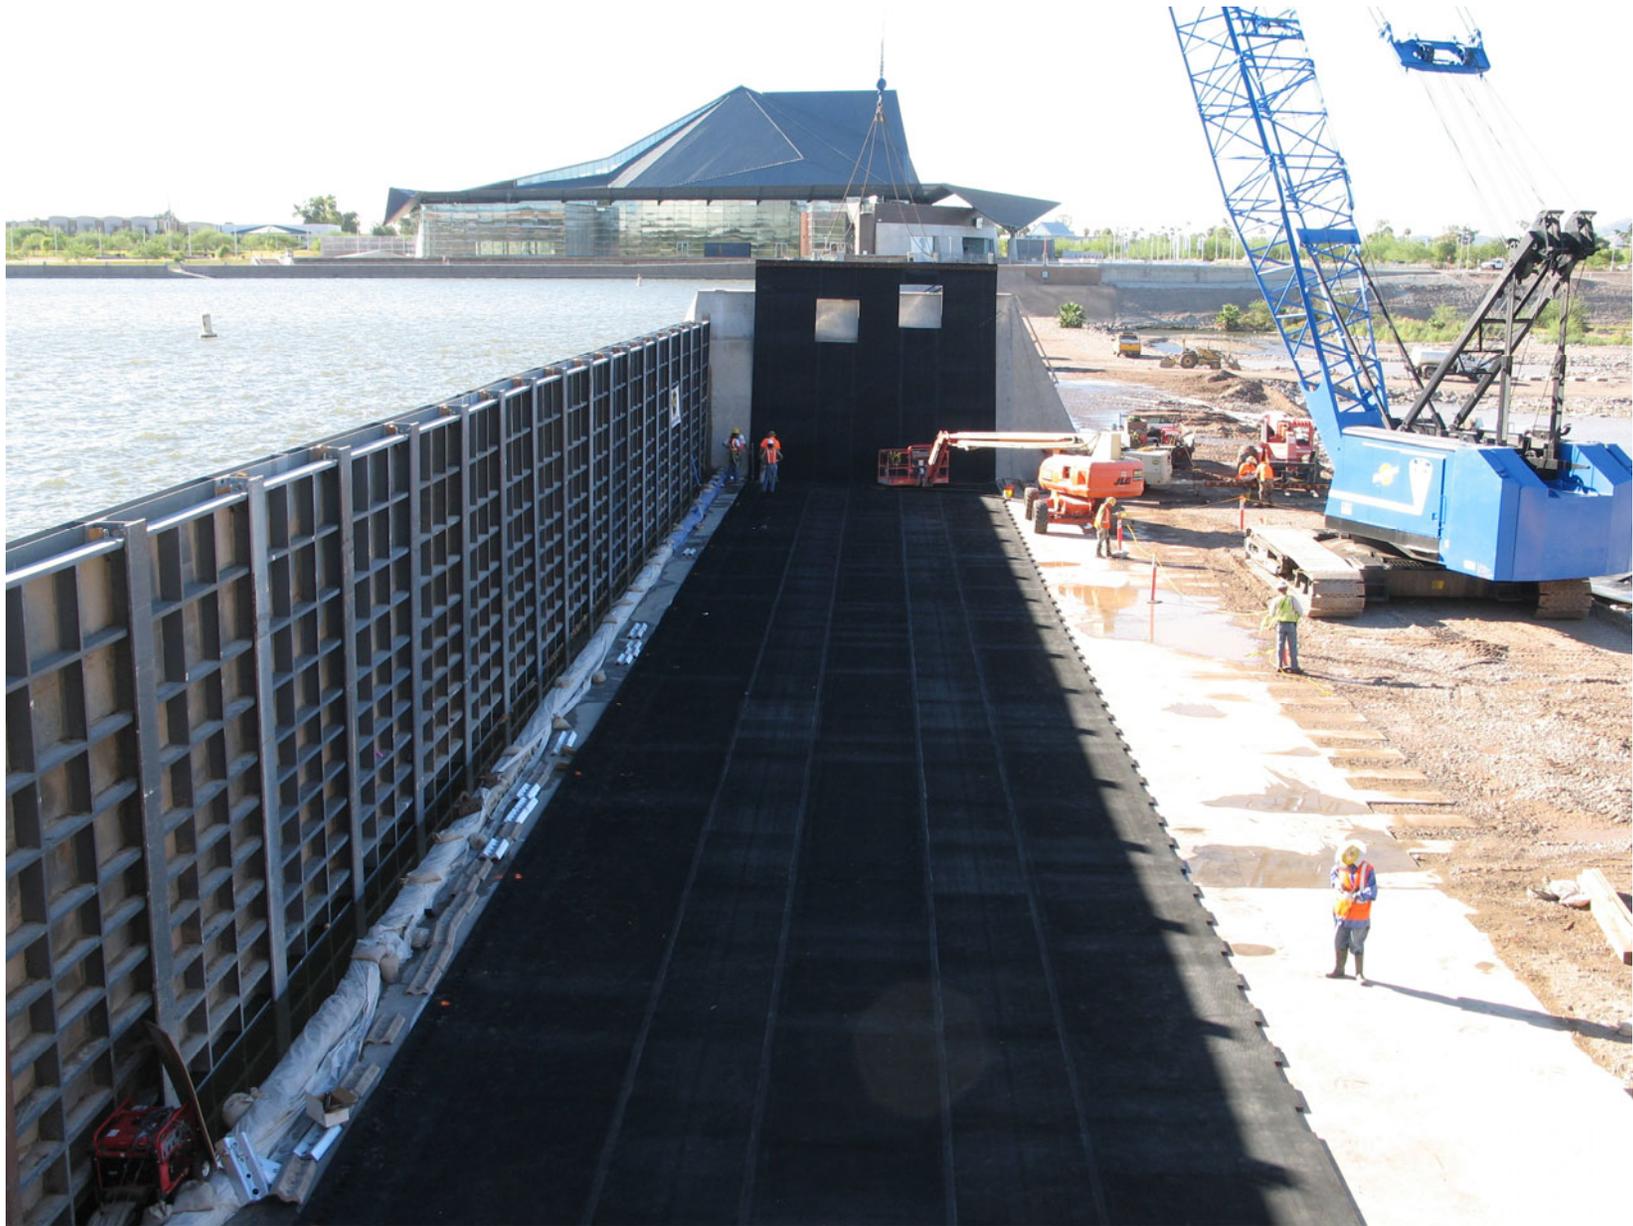
**Figure 3.** Installation of the fourth rubber bladder at Tempe Town Lake Dam with the steel coffer dam in place and the lake filled.

Replacement of the bladders commenced under heightened urgency to restore the lake prior to the fall/winter tourist season. However, Bridgestone could only provide three of the four bladders prior to the date when the lake needed to be filled. The bladder failure and lake draining allowed three of the four bladders to be replaced without the need to install a coffer dam in each bay prior to existing bladder removal. That facilitated bladder replacement significantly for the three bladders, as installation of the coffer dam for each bay requires about two weeks. By October 2010, three bladders were replaced and the steel coffer dam was temporarily placed in the fourth bay so that the lake could be filled, see Figure 3. The final bladder was replaced in November 2010 with the coffer dam in place and a full lake.
