TEMPE TOWN LAKE PROJECT RUBBER DAM DESIGN/CONSTRUCTION/OPERATION/REPAIR

*By John Livingston, PE/CH2M HILL, Basil Boyd, Jr., RG/City of Tempe,
Dave Allard, PE/CH2M HILL, and Chuck Pedri, PE/CH2M HILL*

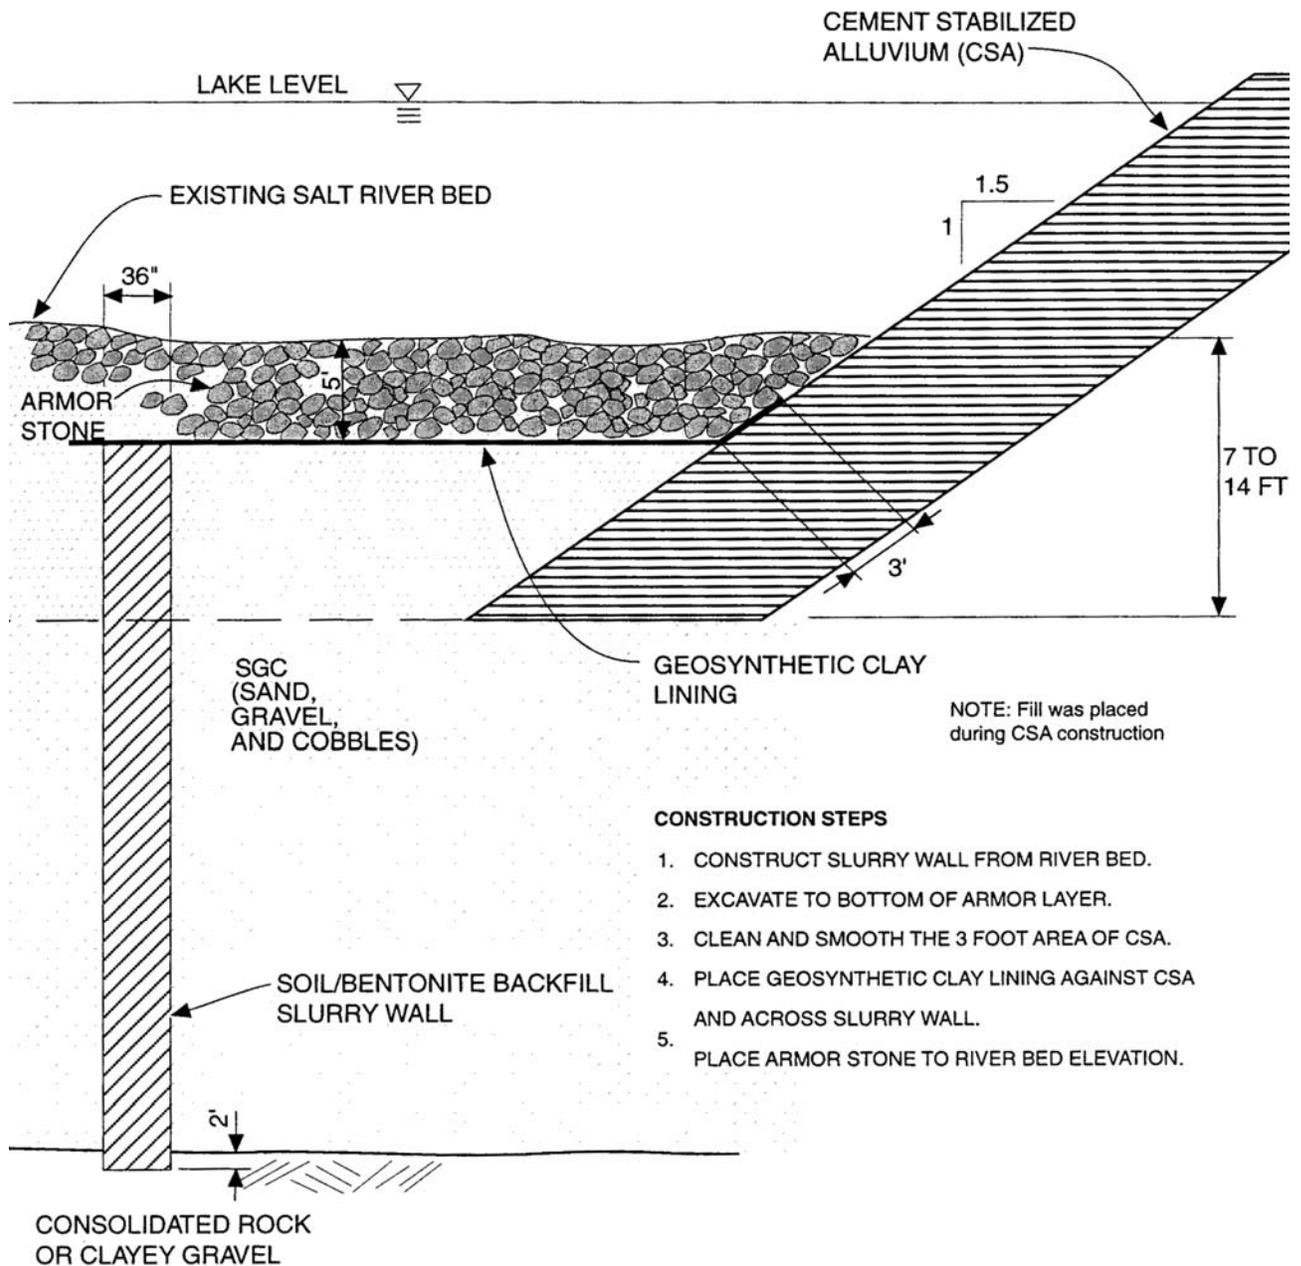
Figure 2. Cut-off Wall Section

about settlement of the hard banking surface during construction, required the cutoff wall to be constructed up to 30 feet from the edge of the river bottom. To control seepage between the cut-off wall and the hard banking a geosynthetic clay lining was placed between the two features. The lining was placed 5 feet below the river bed and covered with large armor stone to protect it during river flow events. A cross section of the slurry wall is shown in Figure 2.

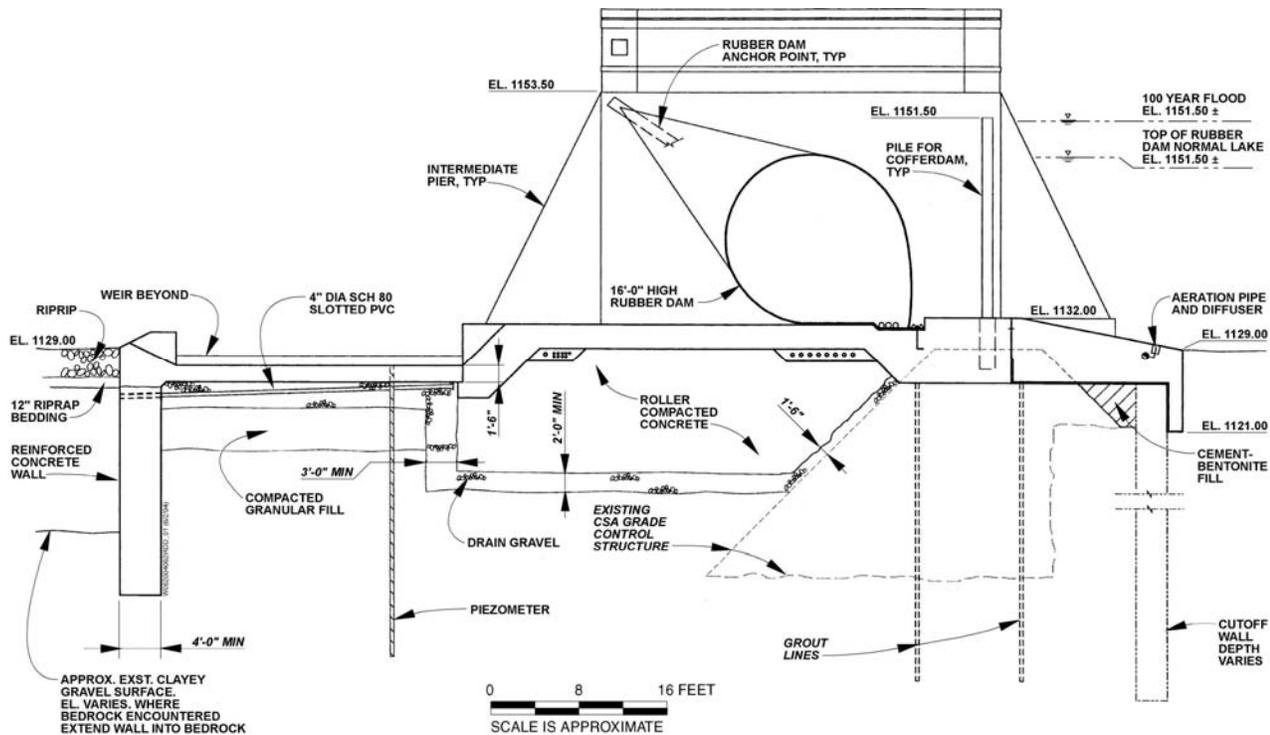
Figure 3. Downstream Dam Cross Section

At approximately 16-feet high, the rubber bladders at the downstream (west) end of the lake are the world's largest by volume and the tallest in North America as of 1999. A cross section of the downstream dam is shown on Figure 3. The words dam, rubber bladder, and rubber dam refer to the elements or combination of elements that provide a hydraulic barrier across the entire river channel.

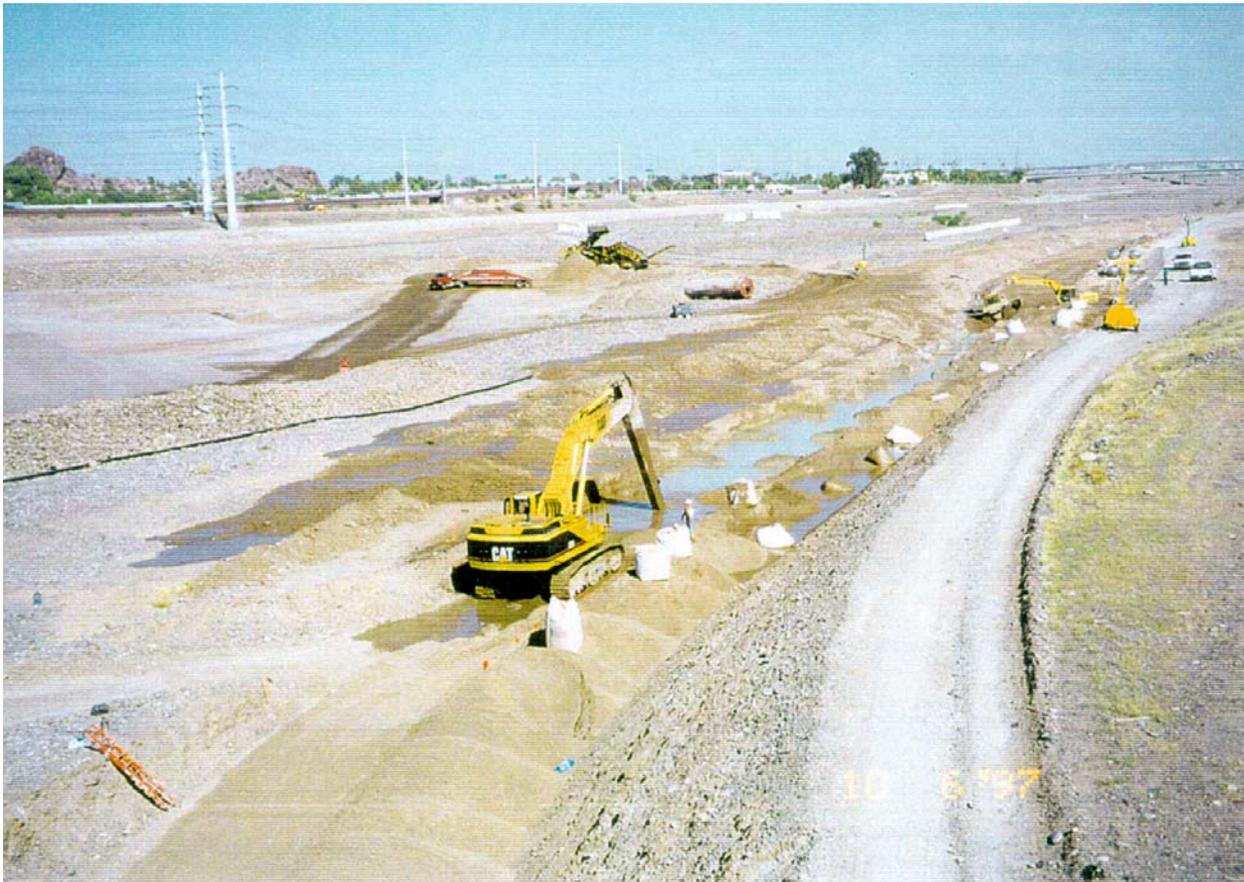
The cut-off wall construction began in September, 1997 with excavation of the armor stone trench to get to the top of wall elevation. The material from this excavation was crushed on-site and placed near the trench for use in the backfill mix. Slurry was mixed in a slurry pond using a high shear mixer, then pumped to the work location through HDPE pipe. The majority of the trench was excavated using a Cat 375 excavator with a standard stick and rock bucket. Backfill was mixed near the trench site using a case 690 excavator and Cat D8 dozer as shown in Figure 4. A custom made long stick (60 foot) was used for the deeper excavations to the east.

Figure 4. Slurry wall construction at toe of shoreline CSA

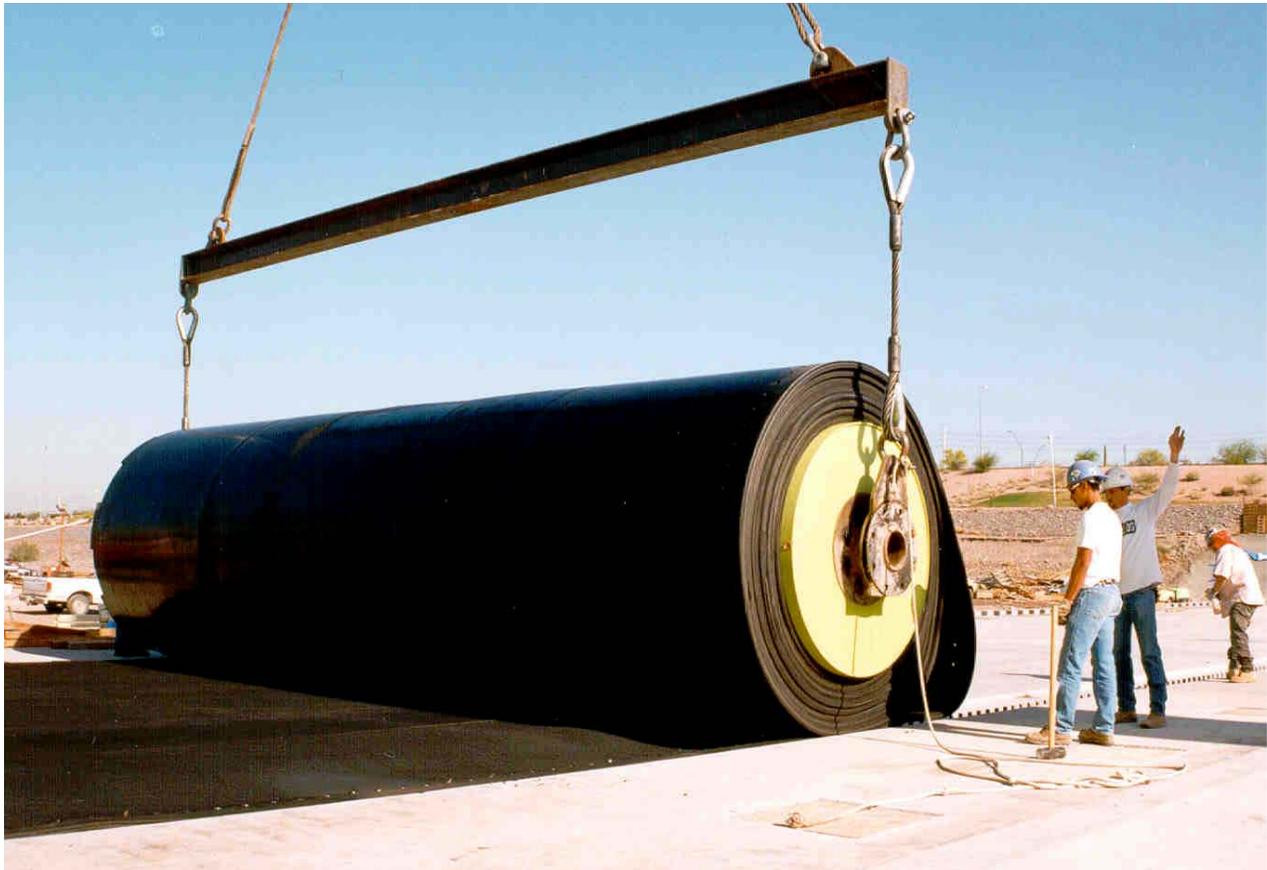
Figure 5. Rubber bladder being positioned on dam foundation

The rubber dam bladders are installed by laying out a flat sheet of the material as shown on Figure 5. Anchor bolts had been cast in the reinforced concrete slab. The sheet is placed over the anchor bolts after holes have been punched at the correct frequency. The sheet is then pulled over itself and the top is aligned, punched, and put over the bolts. A top plate is set over the bolts and nuts torqued. The sloping ends of the bladders are also anchored to the concrete in a similar way. Air piping is attached to the bladder near the anchor plate.
