WATER OPERATION AND MAINTENANCE BULLETIN

No. 202

December 2002

INSTALLATION OF GREASE FITTING BLOCKS FOR AGENCY VALLEY DAM RADIAL GATES

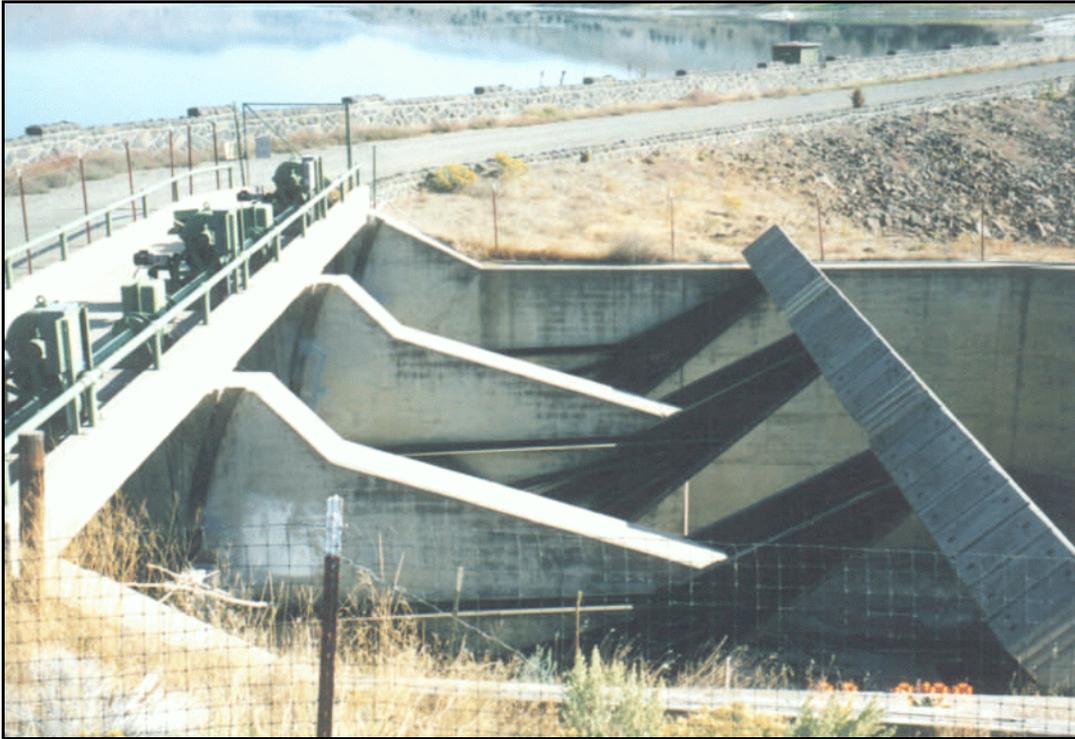
Photograph No. 1.—Radial gates as installed on the right embankment.

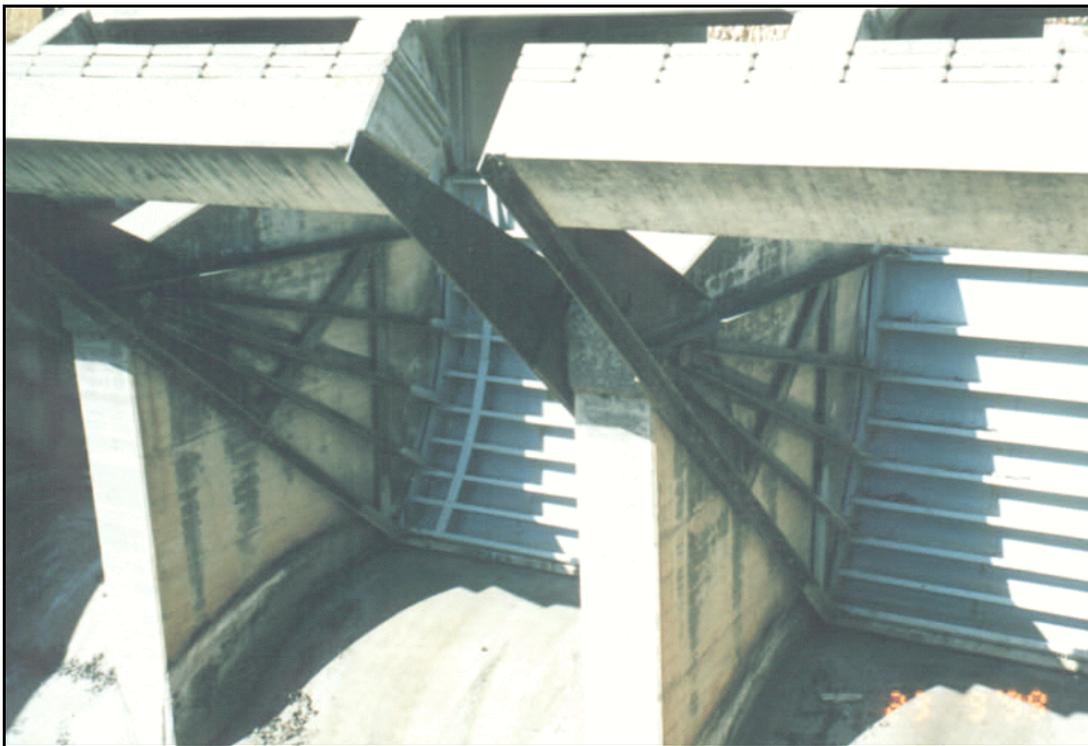
Photograph No. 2.—Back side of radial gates and gate arms.

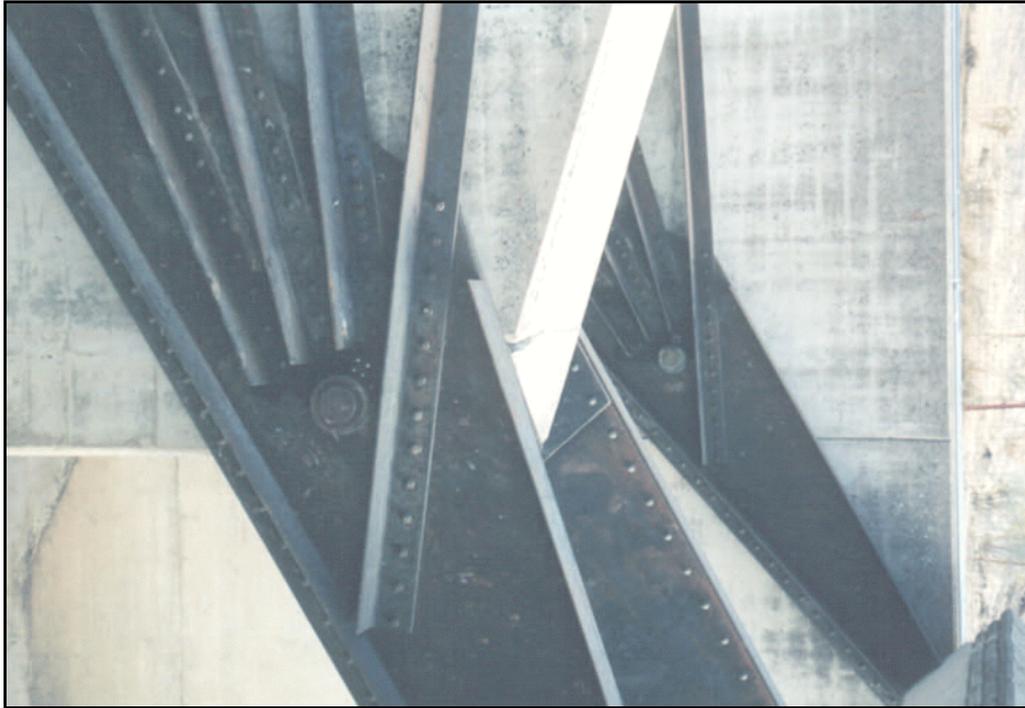
Photograph No. 3.—Spillway radial gate arms and pivot points.

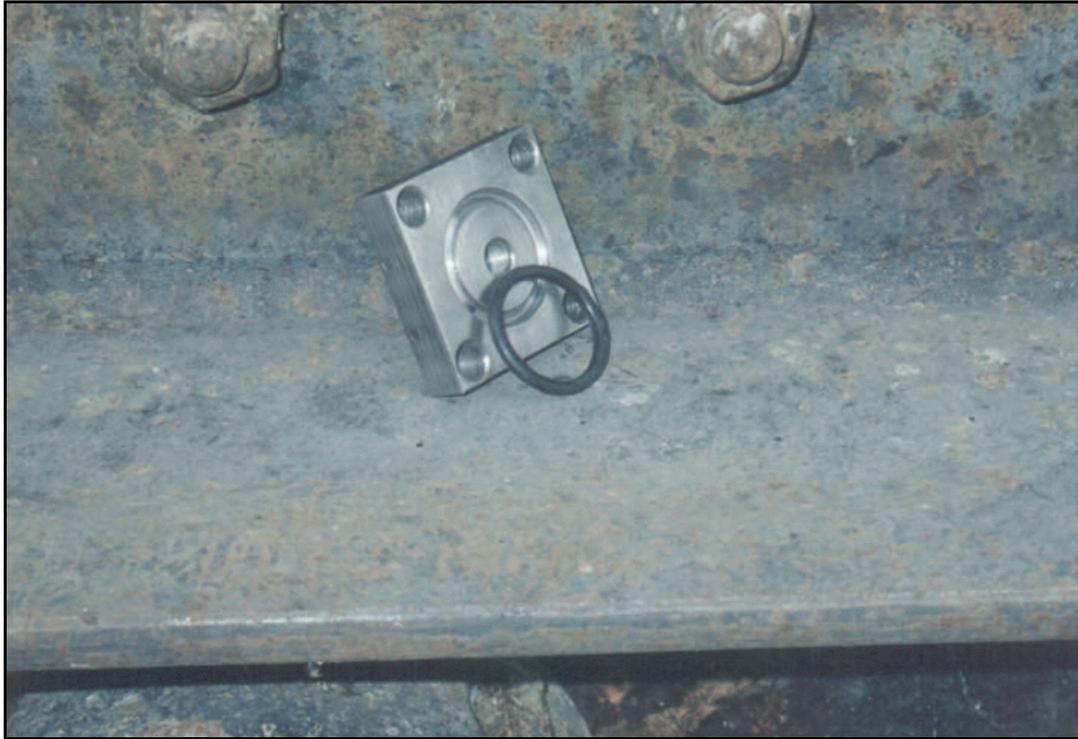
Photograph No. 4.—Back side of a grease block fitting.

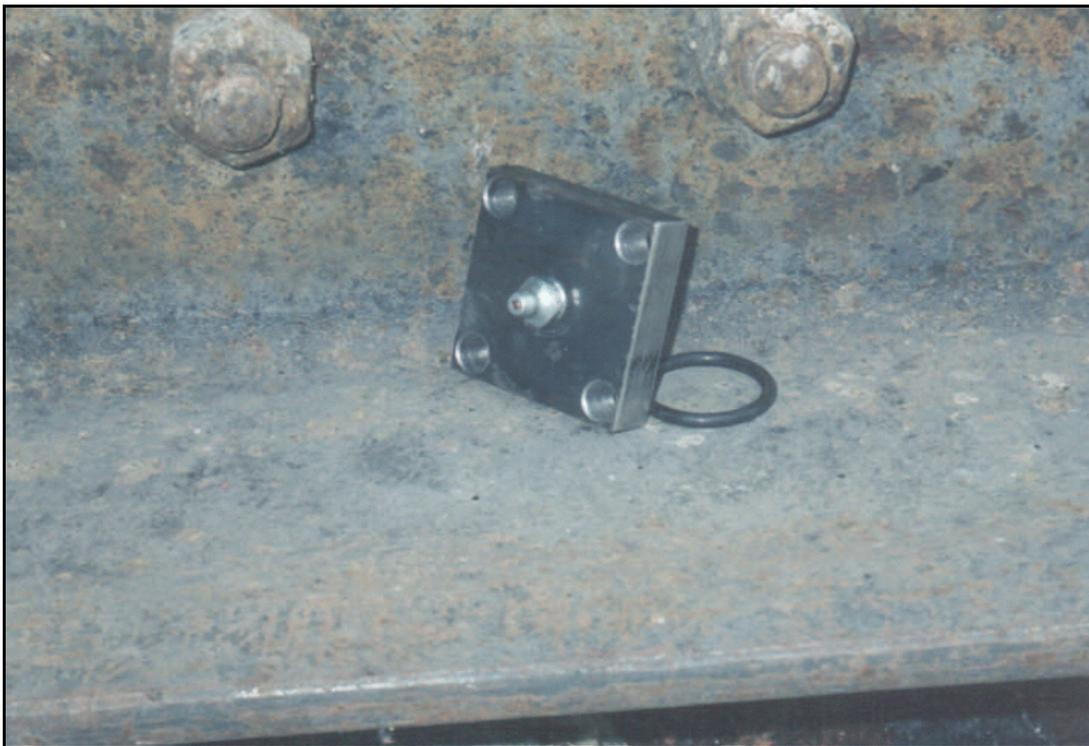
Photograph No. 5.—Front side of a grease block fitting.

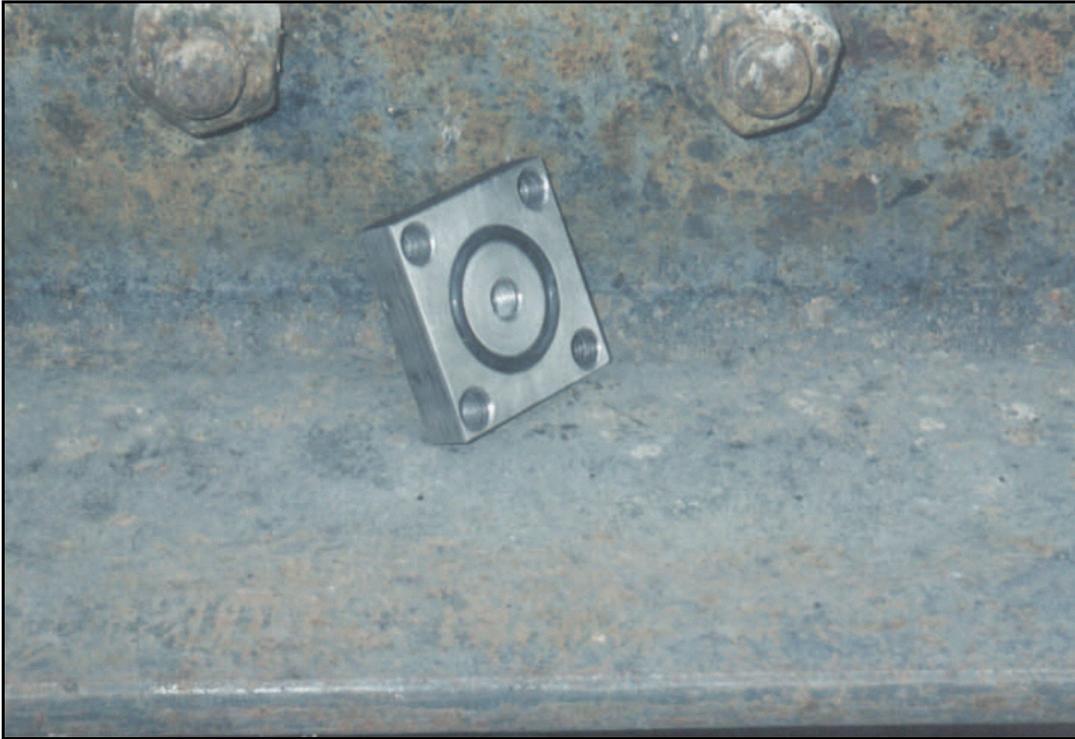
Photograph No. 6.—Grease block fitting with “O” ring installed.

- (9) Ensuring that the rubber "O" ring is in place on the grease block (refer to photograph No. 6), mount grease block fitting onto surface of the radial gate arm using the 5/16-inch x 1-inch bolts. Use 5/16-inch lock washers to keep the bolts from vibrating loose.

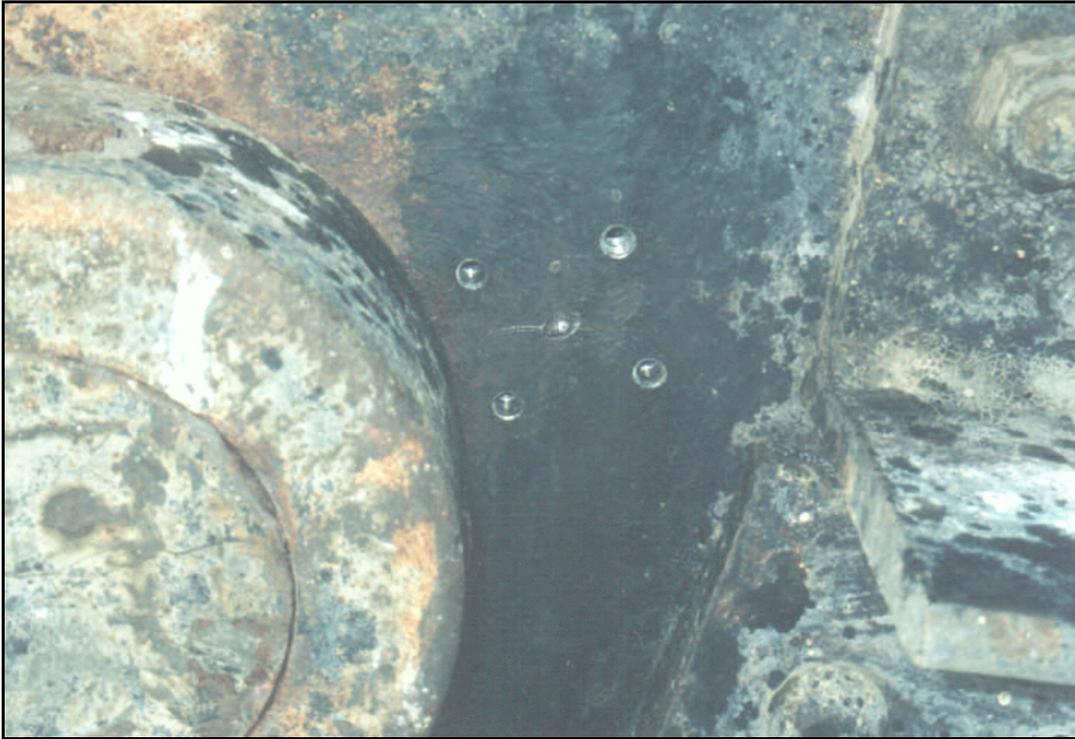
Photograph No. 7.—Grease block fitting mounting and grease channel hole placement on radial gate arm.

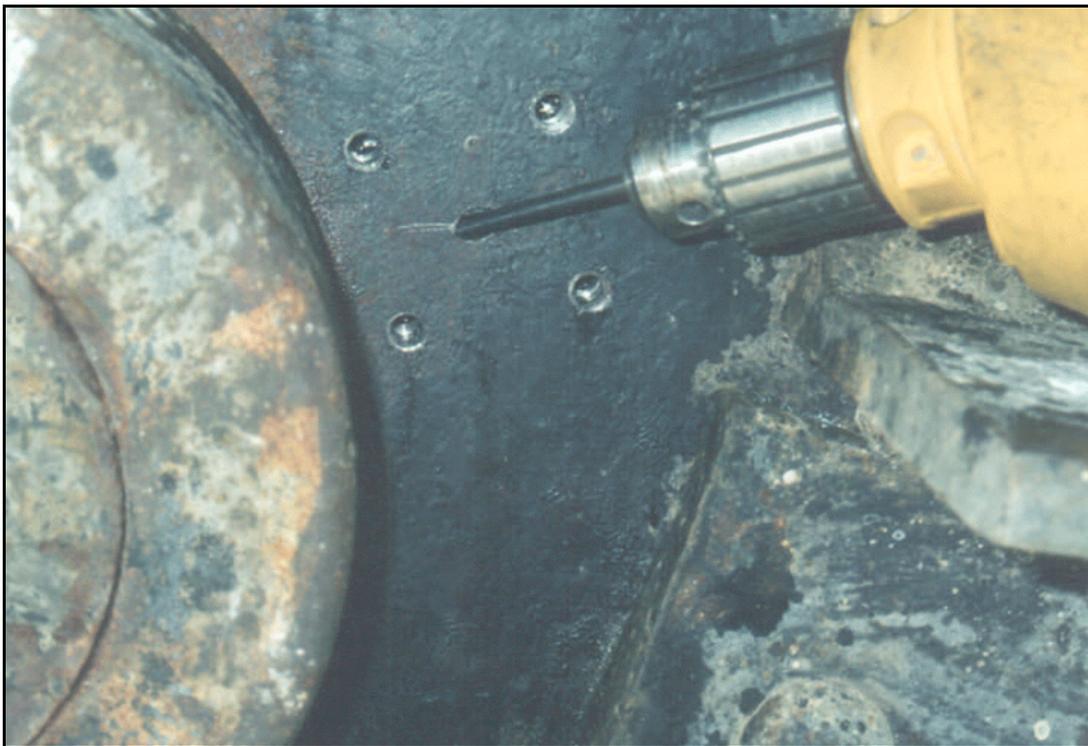
Photograph No. 8.—The 3/16-inch extra length drill bit position for drilling to trunnion pin.

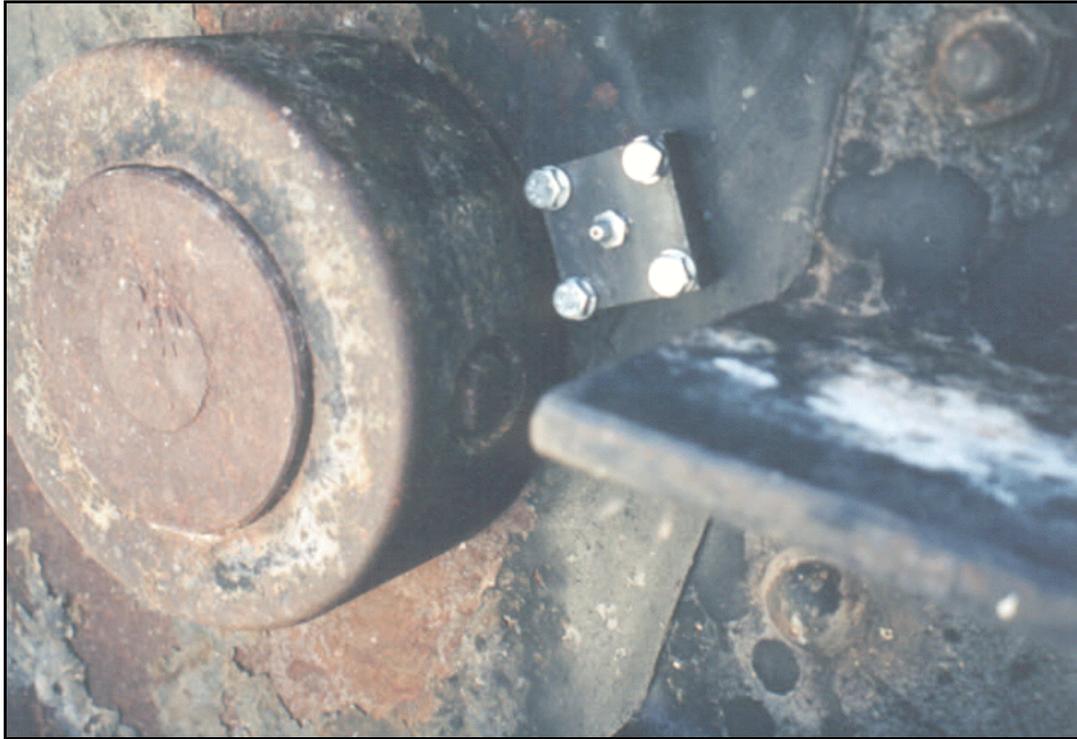
Photograph No. 9.—Installed grease block fitting on radial gate arm.

- (10) Screw the 1/4-inch x 18 pipe thread grease fitting onto the grease block (refer to photograph No. 9).
 - (11) While operating the radial gates, pump grease into the installed grease-fitting block and watch for grease to appear around trunnion pin. At Agency Valley we used a long feeler gage to check for grease behind the safety collar or between the radial gate arm and the cast steel bearing.
-
