# The 1911 Bayless Dam Failure: Physical and Human Factors

Robert A. Kline, Jr., P.E., Gannett Fleming, Inc.  
Irfan A. Alvi, P.E., Alvi Associates, Inc.  
Greg Richards, P.E., CFM, Gannett Fleming, Inc.

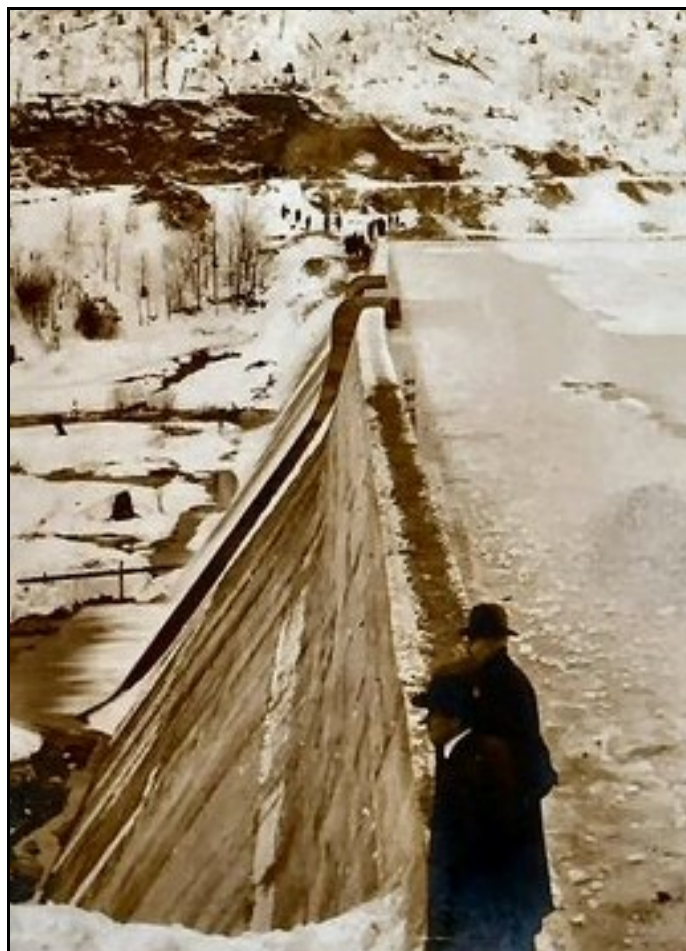
In mid-January 1910, an unseasonably warm period combined with some rain caused rapid snowmelt runoff within the watershed. Within a period of three days the reservoir was filled and the spillway was activated for the first time. On Sunday afternoon, January 22nd, the first signs of trouble appeared, including a large landslide at the left abutment on the downstream side of the dam. Seepage flow, estimated to total about 600 gallons per minute, was present within the slide as well as at various locations along the toe of the dam. On Monday, the dam slid downstream with a maximum deflection of 18 inches at the toe and 31 inches at the crest. As a result of the movement, the dam fractured into six or seven distinct sections each bounded by large cracks that were pinched closed at the upstream face. This movement reportedly occurred over a period of eight hours. In response to this partial failure, the paper mill staff used dynamite to blast an opening in the upper portion of the dam near the right abutment as well as blast the wooden cap free from the downstream end of the outlet pipe to quickly lower the reservoir level.

In an Engineering News article published on March 17, 1910, dam designer Hatton attributed two main causes to the partial failure as given in the following excerpt: "...the failure of the dam to withstand the flood of Jan. 21 is probably due to two causes. One of these is that the great bulk of concrete which had been hurriedly built, some during freezing weather, and which had been completed but six weeks before the maximum pressure came upon it, had not set up so as to attain its ultimate tensile strength. The most important cause, however, was due to the water getting under the dam. This condition was not anticipated when building the dam, and all precautions which seemed to be necessary at the time were taken to guard against it".[1] He also offered further detail with "From the evidence thus far obtained the outward movement of the center of the dam was due to water getting under the foundation, softening up a stratum of clay or shale lying between two layers of rock, and permitting one layer of rock to slip forward about 18 inches upon the lower layer....The water getting under the dam at a depth of 6 ft. below the concrete base exerted a much greater upward pressure than was anticipated when the cross-section was designed and reduced the factor of safety against sliding to an unsafe limit".[1]

Figure 3. Partial Sliding Failure, January 23, 1910 (Source: Potter County Historical Society).

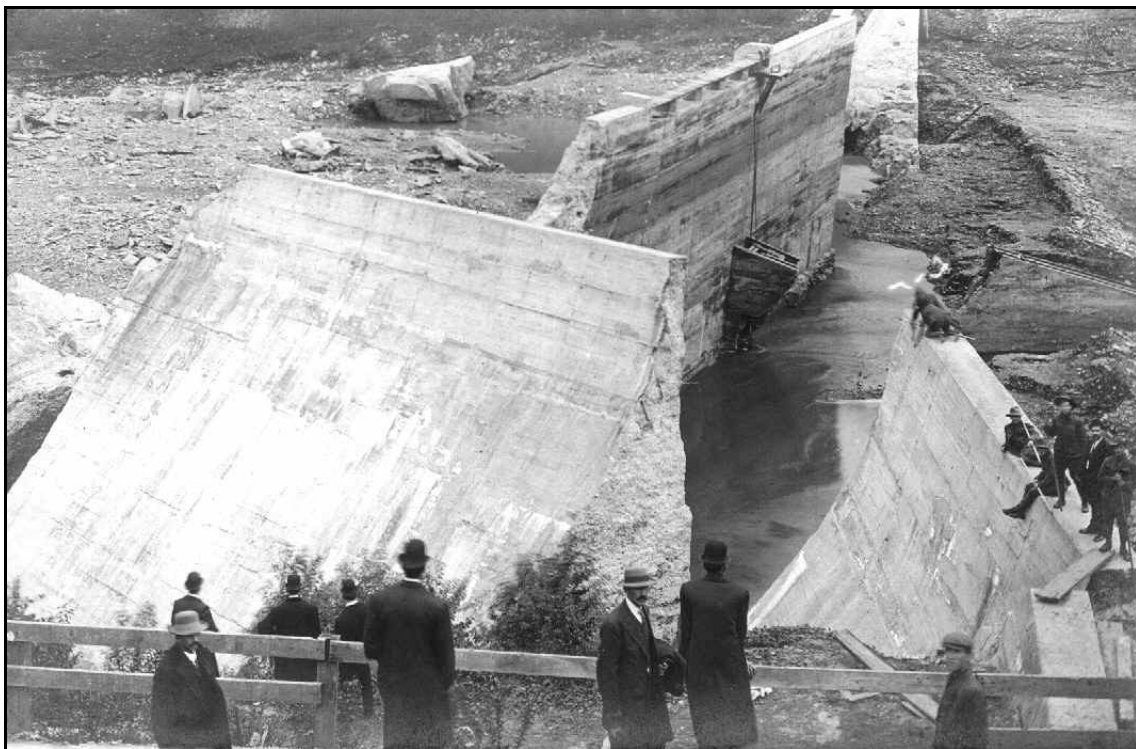
Due to heavy rains during September 15-17, 1911, the reservoir completely refilled to within inches of the spillway crest for the first time since the partial failure occurred in January 1910. By Saturday morning, September 30th, according to several eyewitness accounts, the reservoir level was within a half inch of the spillway crest and leakage both through and under the dam began to increase at an alarming rate. Against the pleas of two mill employees that witnessed the leakage, the mill superintendent refused to allow them to open the outlet works to lower the reservoir nor did he bother to visit the site to observe conditions firsthand. The superintendent's argument was that the reservoir must be kept as full as possible to help meet production demands at the paper mill. Sometime between 2:00 and 2:15 pm in the afternoon, the dam suffered a catastrophic failure as shown in Figure 5.

Figure 5. Catastrophic Collapse, September 30, 1911 (Source: Potter County Historical Society).

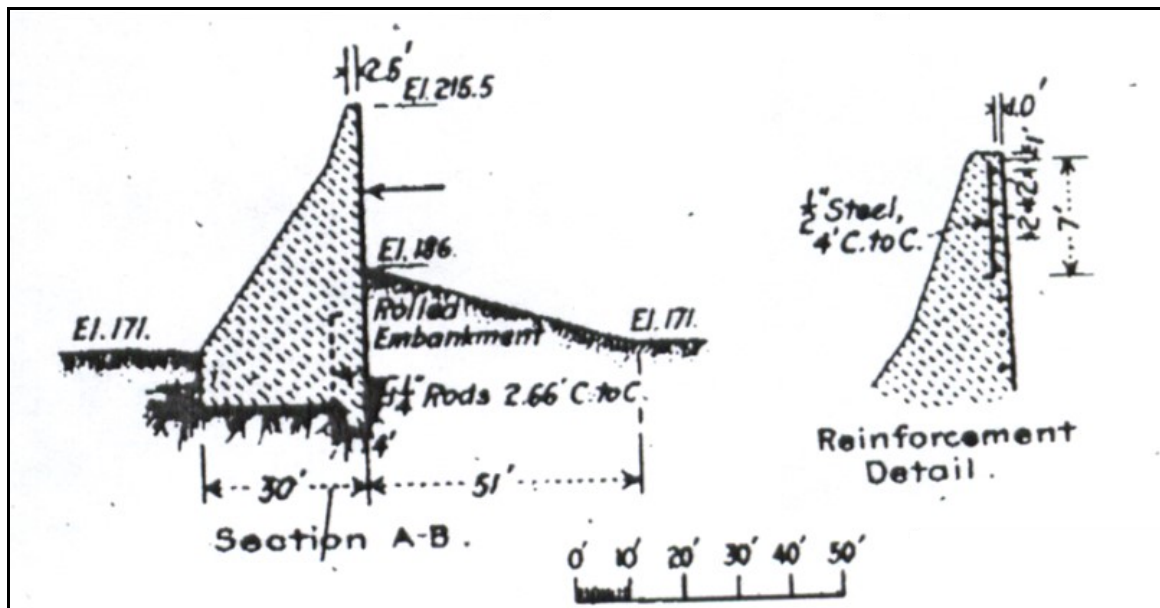
1. **Unconventional Design Features:** Hatton devised some unique unconventional design features to mitigate the reduction in structure mass that was necessary to meet budget requirements. These features consisted of installing 25-foot-long and 1-1/4-inch diameter twisted steel rods on 2.66-foot-centers (see Figure 6) approximately 6 to 8 feet into the foundation rock "to increase the factor of safety against overturning".[6] Again, to further reduce mass, the dam's chimney section had a top width of only 2.5 feet with a very steep downstream slope. To prevent horizontal cracking due to tensile stress in this top portion of the dam, Hatton used 1/2-inch-diameter steel reinforcement spaced 4-feet-vertically and 2-feet-horizontally.

Figure 6. Non-Overflow Section [1].

3. **Uplift Forces Neglected**: Hatton recognized that uplift forces can develop beneath a gravity dam but incorrectly assumed that a rolled embankment (see Figure 6) at the upstream face could provide an impermeable water barrier and essentially eliminate this force. He also incorrectly assumed this embankment would reduce the hydrostatic pressure against the dam, rather than increase the net loading on the dam. Hatton cannot necessarily be entirely faulted for this approach, since many other gravity dams constructed during this era also have this feature, presumably for the same reason.

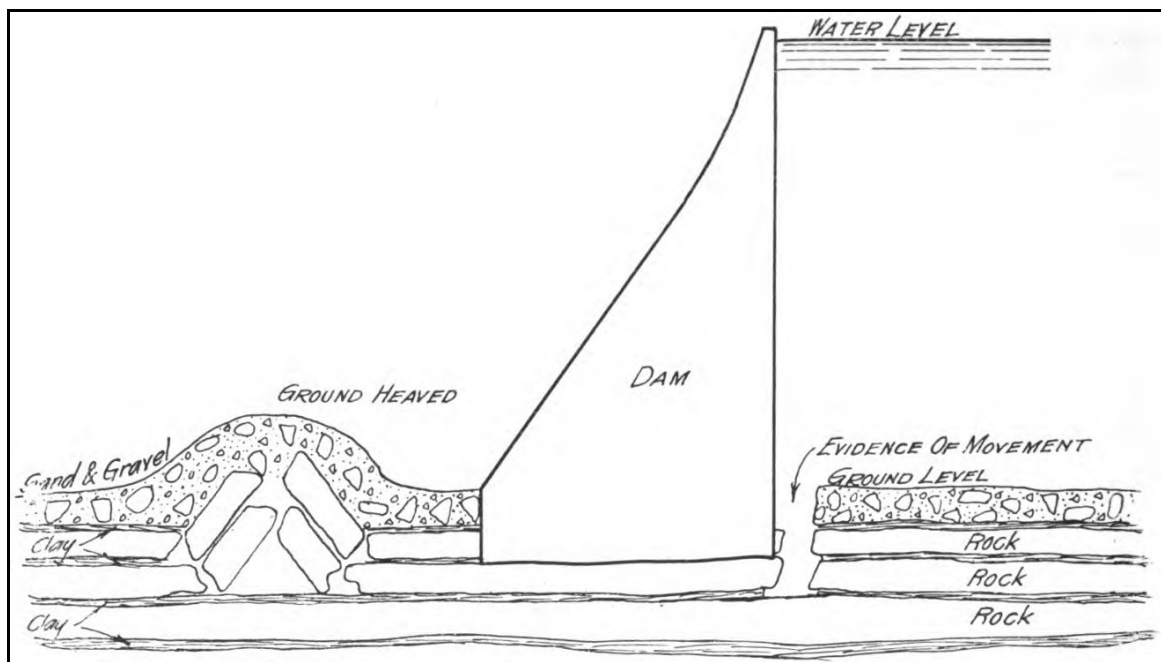
Careful examination of the dam site following the 1911 collapse revealed that the weak plane that precipitated failure of the dam was within the rock foundation at clay-filled bedding joints between sandstone and shale units (see Figure 7). This failure mode was first evidenced during Hatton's inspection of the dam on January 25, 1910 by an 18-inch-wide vertical cleavage in the foundation rock located 12 feet upstream of the upstream face and running parallel to it. Hatton's further details on the failure mode are: "Since January 25, 1910, water has been constantly impounded by this broken concrete wall. The depth of this water has varied from 25 to 52 ft. During this period water has continued to leak through the underlying strata, and this leakage, going on at great pressure, must certainly have washed much of the shale and gravel away, leaving the heavy concrete walls with less and less foundation until the final collapse came on September 30, 1911".[6]

Figure 7. Schematic of Failure Mode – Slip Between Rock Layers [3].

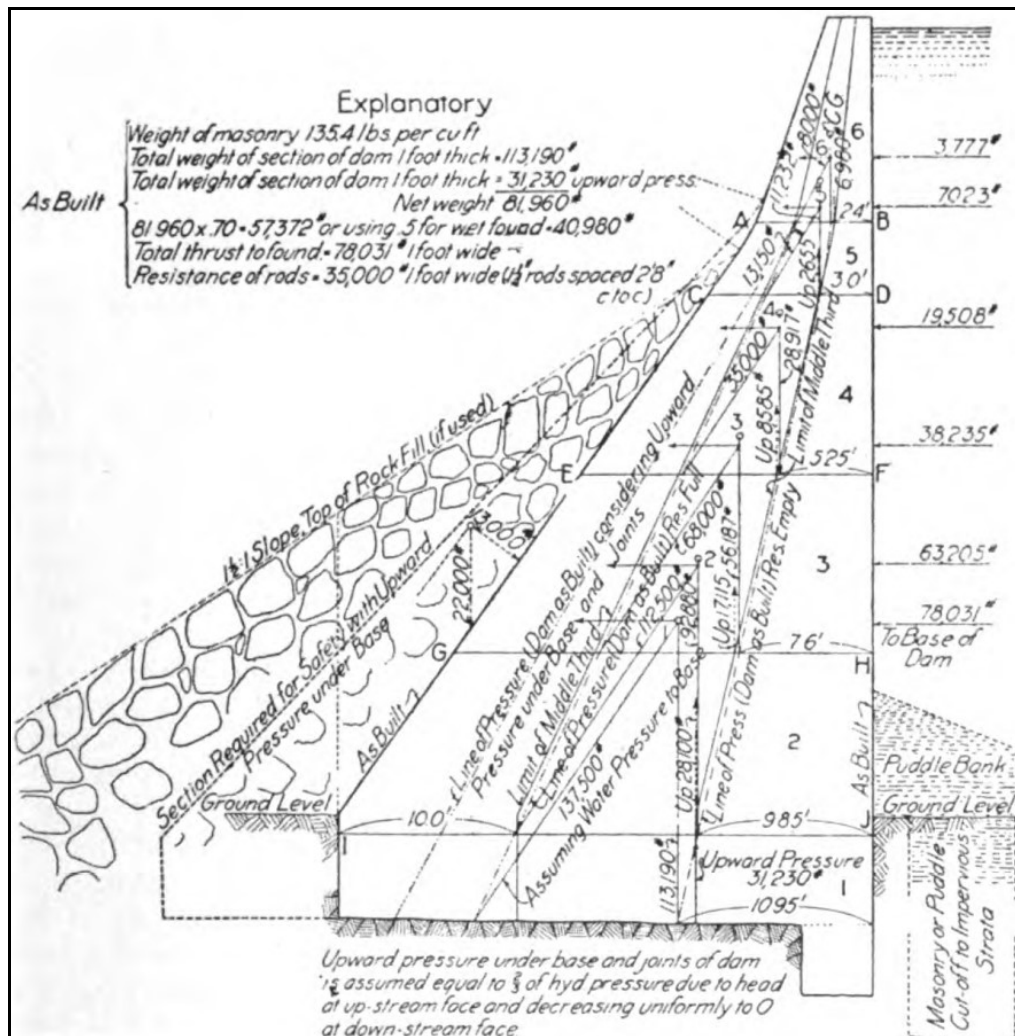
Even though Wegmann was a well-established world-class expert in gravity dams, he was also limited by the profession's knowledge base at that time. In examining the schematic that illustrates his proposed repair scheme, it can be noted that, even though the foundation rock is comprised of thinly-bedded sedimentary rock, Wegmann neglected to consider a more conservative and very plausible uplift pressure condition. The note shown in the schematic at the dam's base reads "Upward pressure under base and joints of dam is assumed equal to 2/3 of hyd pressure due to head at up-stream face and decreasing uniformly to 0 at down-stream face." With the degree of displacement that occurred in the dam and its foundation rock, it is highly possible that preferential seepage paths within the rock joints could have been either partially or fully pinched shut at or beyond the dam's toe. Such a condition could cause full uplift over a higher than normal portion of the dam's base.

- The apparent lack of understanding that the critical weak plane now existed in the slipped surface between bedding joints in the foundation rock and that only residual bedding joint strength was available to resist future loading;
- The likely lack of effectiveness of the proposed seepage cutoff feature at the heel;
- The lack of any type of drainage system to relieve foundation uplift pressure;
- Neglecting to buttress the relatively-thin chimney section;
- Neglecting to account for a more appropriate flood pool loading condition; and,
- Neglecting to account for possible dam overtopping during flood events and its potential scour effect on the foundation rock.

Therefore, in the authors' view, this proposed repair scheme may only have delayed the failure of this structure, rather than prevented it. However, it may have reduced the vertical and/or lateral extent (e.g. chimney section only), and possibly even speed, in which failure developed, such that the release of reservoir water may have been less severe than that which resulted from the near-instantaneous and near full-length failure that did occur.

Figure 8. Proposed Repair by Edward Wegmann – February 1910 [2].
