Toddbrook Reservoir Independent Review Report By Professor David Balmforth

10 February 2020

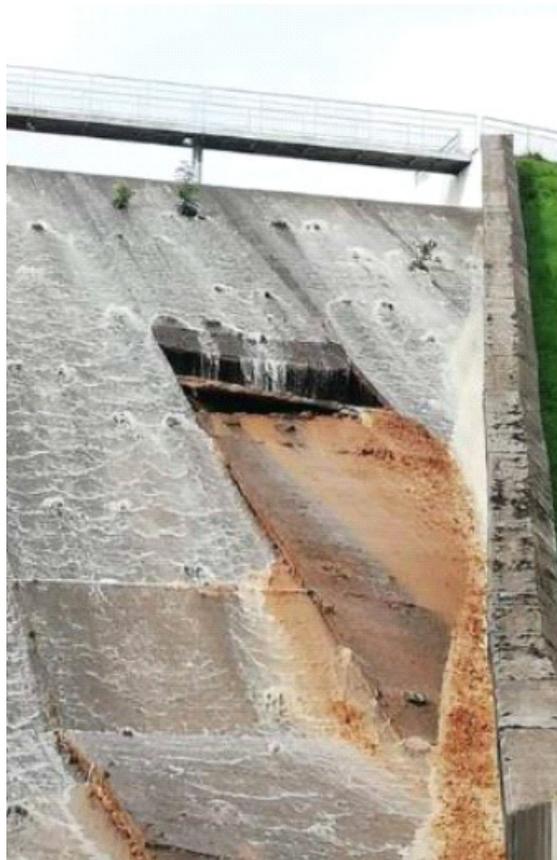
Around 9:00am the first panel is thought to have collapsed (fig 5). This was reported at 9:45am by a second member of the public as a section of concrete about “15ft x 20ft” being broken away and that the “earth bank is starting to wash away”. A void could be seen to have formed beneath the slab. Note that at this stage, discharge down the spillway had significantly reduced.

Figure 5. Collapse of the First Slab into the Void (note the slabs that have been pushed up towards the foot of the spillway chute).

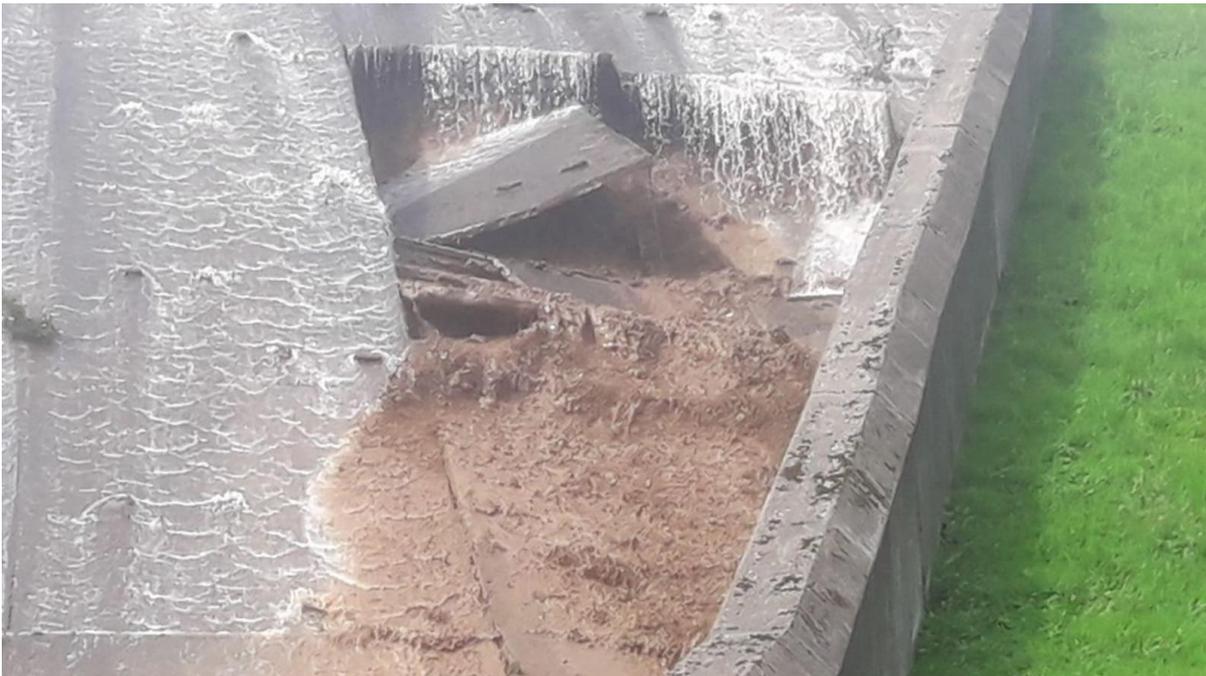
At 10:00am CRT Operations staff arrived on site and opened the draw-off and scour valves. A loud crack was heard. Four panels were observed to have fallen into the void (fig 6). A photograph of the spillway was sent by the CRT Surveillance Operative to senior CRT staff.

Figure 6. Four Sections of Panels Collapsed into the Void

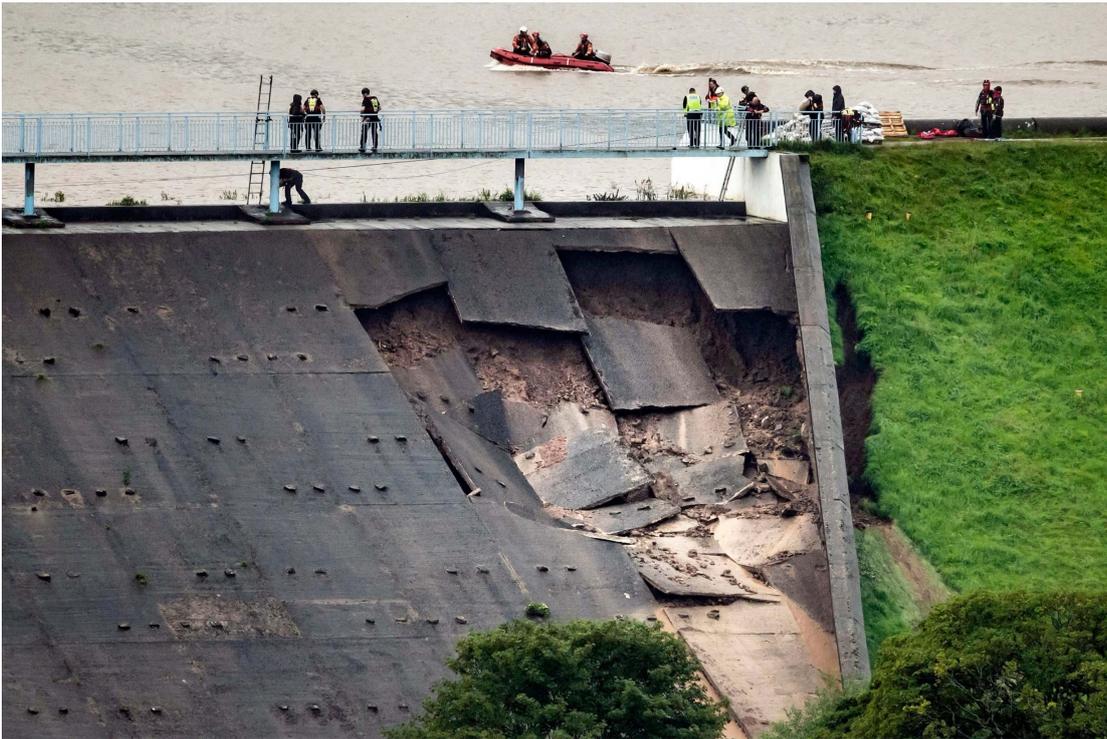
By 2:30pm the next column of panels had collapsed. The top row of panels started to collapse, and the left-hand chute wall was undermined (fig 7).

Figure 7. The Final Stage of Collapse of Panels. Note the undermining of the left-hand chute wall.

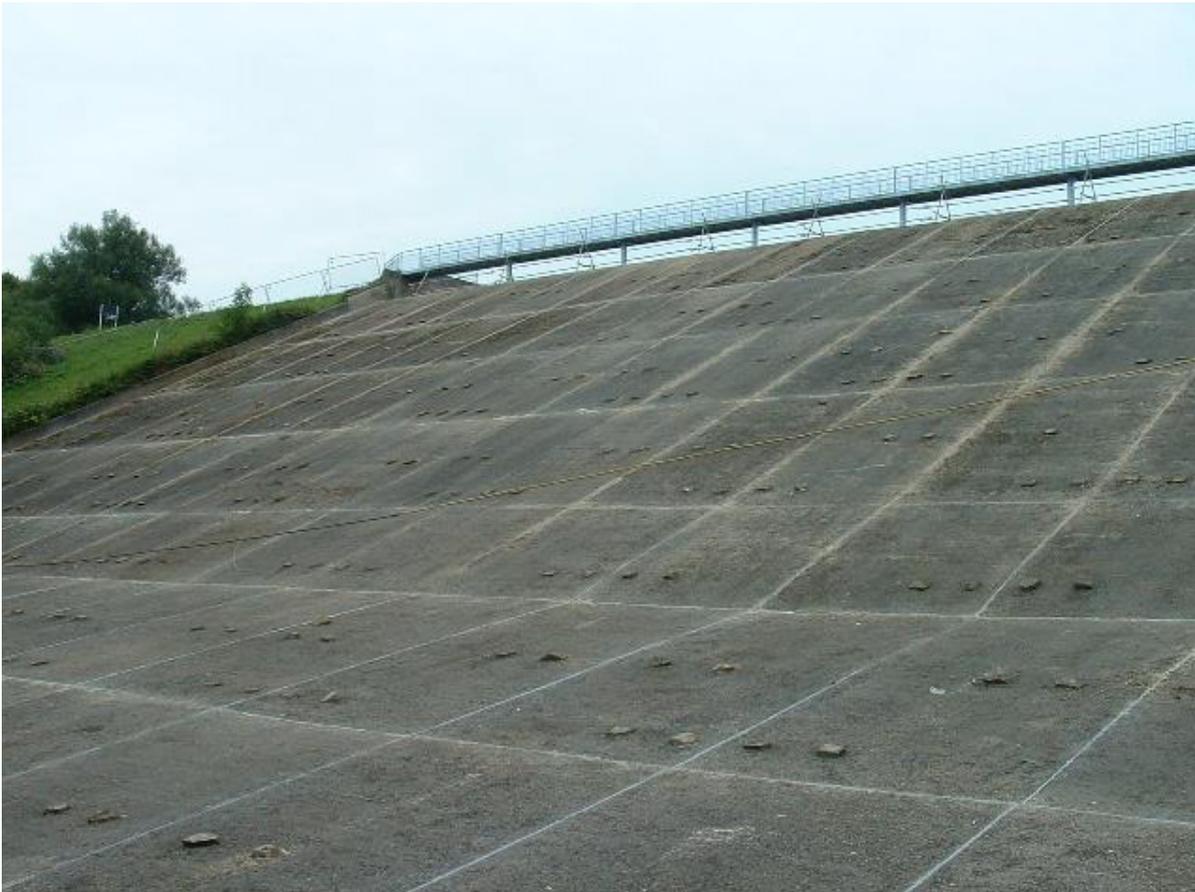
There is a long history of intermittent maintenance of the reservoir. In 2006, the Inspecting Engineer noted that the auxiliary spillway had an appearance of neglect and lack of routine maintenance. He recommended joint sealing and cleaning, removal of vegetation and patch repairs. In the 2010 inspection the Inspecting Engineer noted that the spillway appeared to be in good condition (fig 9).

Figure 9. Evidence of Good Maintenance with Joints cleaned out and Re-sealed, September 2008

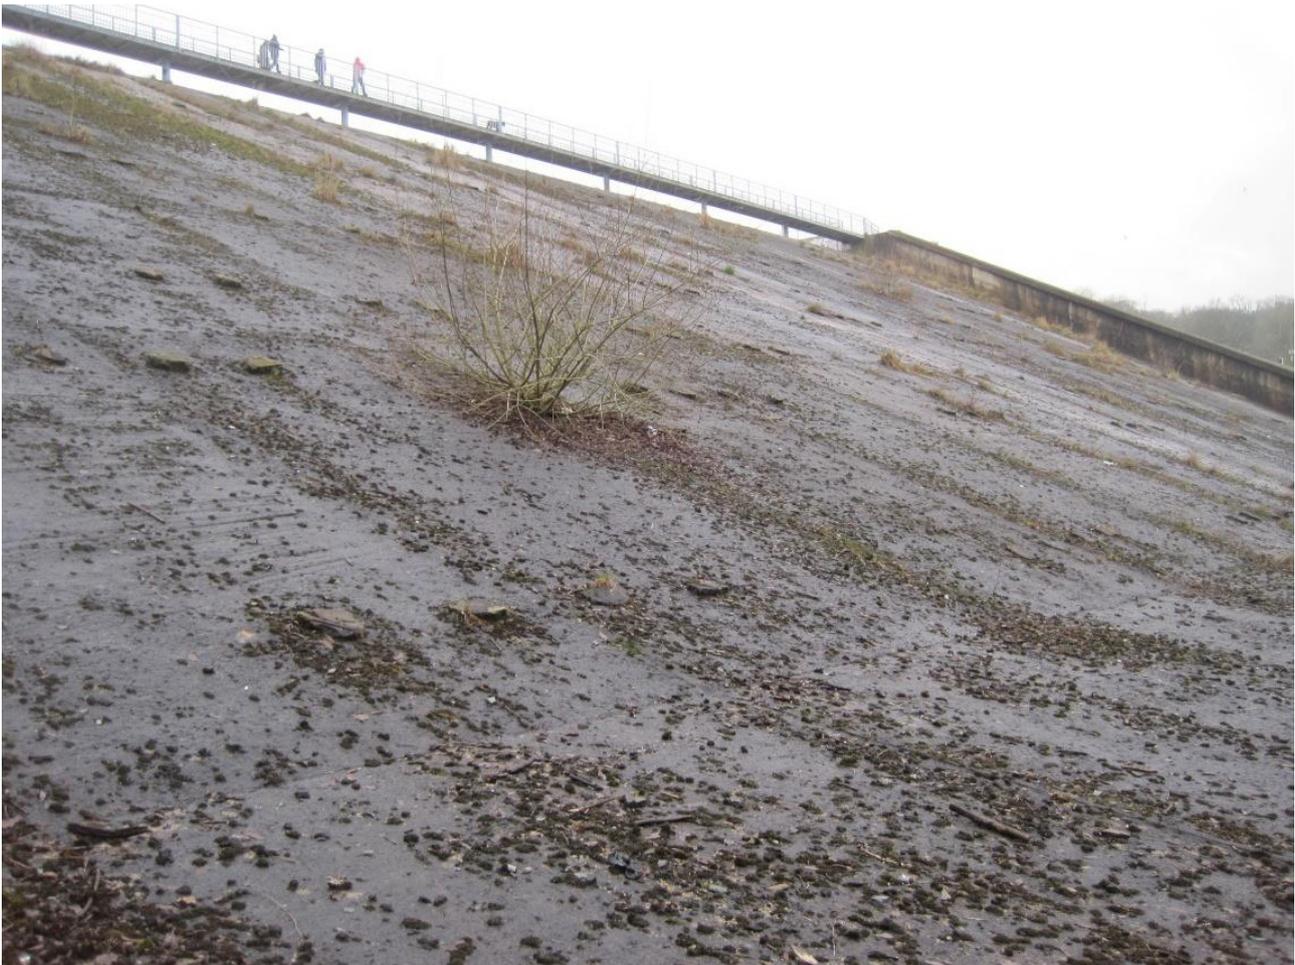
However, from 2015 to 2018 the Supervising Engineer stated, in four separate reports, that vegetation was again apparent on the spillway. There is also photographic evidence to support this (fig 10). The Panel has been provided with documentary evidence on vegetation clearance on the spillway in recent years. However, vegetation clearance is only part of the necessary maintenance. It also needs to include the cleaning out and resealing of joints, and the repair of any cracks.

Figure 10. Evidence of Poor Maintenance with Vegetation and Saplings Growing in Joints, January 2018

15.1 recommend that Owners⁷ ensure that their organisational structure provides a clear path of responsibility for routine and required maintenance. For single owners⁷, clubs and small companies the owner or equivalent should be directly responsible for maintenance

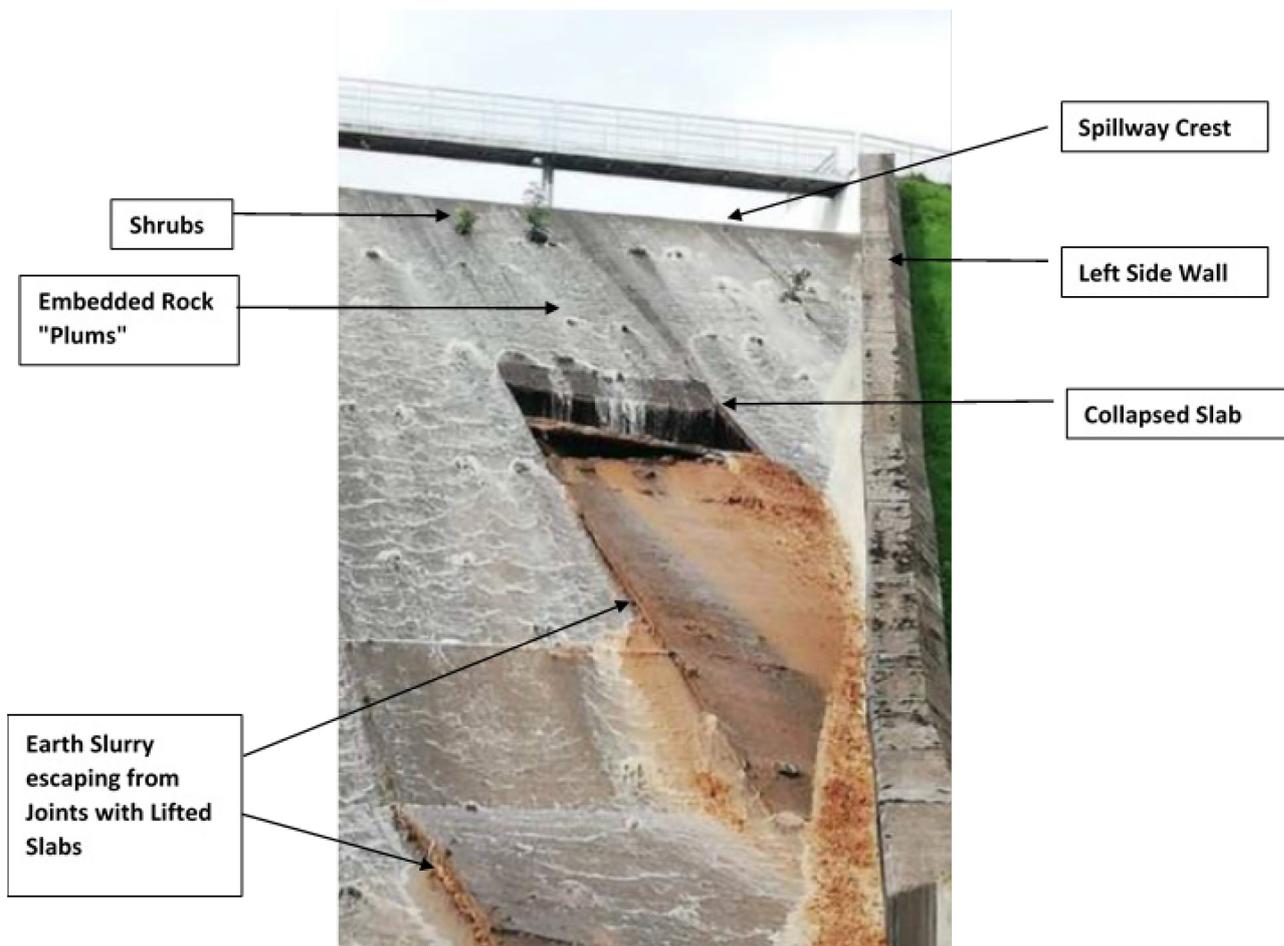
On the morning of 1 August some residual flow continued over the spillway chute. At 08.30 a member of the public reported seeing silty water coming from lower joints in the spillway (assumed to be from the sides of lifted panels rather than through joints as such). At 09.45 a hole is reported in one of the upper parts of the chute (fig B2).

Figure. B2 The initial slab collapse

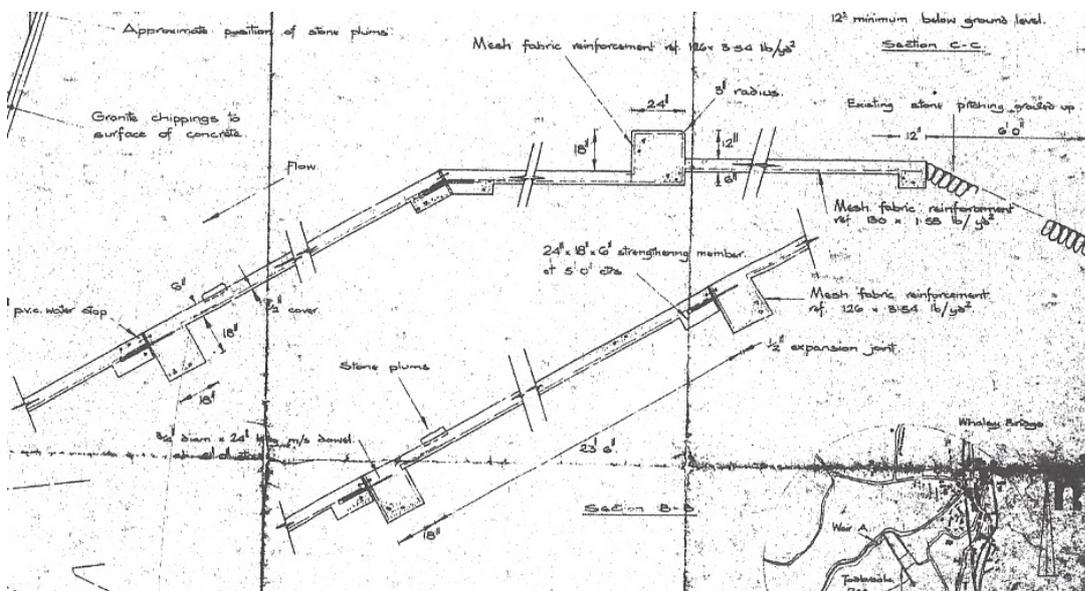
would have carried with it an implicit assumed design life of 60 years. However, the auxiliary spillway at Toddbrook is deficient by even that standard. For example, the concrete cover to the embedded reinforcement in the lower face of the slabs at Toddbrook was recorded on drawings to be ½" (12.5mm) whereas Clause 307 of CP114 requires that where such reinforcement in slabs is in contact with earth, the cover should be 1½" (37.5mm). Indeed, it is not clear what function the embedded wire mesh in the Toddbrook chute slabs was expected to fulfil. The ⅛" (3mm) diameter bars at 150mm centres would not be considered as designed reinforcement by standards in 1969/70. In particular there was no "anti-crack" steel provided in the upper surface of the slabs. Modern requirements would be for designed reinforcement in both upper and lower surfaces of such slabs.

The chute concrete at the Toddbrook Auxiliary spillway is shown on record drawings to have been a 1:2:4 mix. This was a standard "design" mix at the time with 1:2:4 referring to the volumetric proportions of cement, sand and gravel. The nominal 28 days strength of such a mix would be assumed to be 3000 psi (approx. 20.5 MPa). This would be considered low by current standards for spillways, but in fact the Toddbrook concrete would have continued to gain strength well beyond 28 days, possibly reaching 30 MPa or more, eventually. Typical chute details are shown on figure B3 which is taken from a record drawing of the auxiliary chute. The drawing did not give any details for the longitudinal chute joints. It would also seem that a joint shown located on the downstream side of the weir upstand was relocated upstream of the weir on site. Such a joint location would allow water ponded upstream of the crest upstand to penetrate the slab if no water bar was incorporated in it.

Figure. B3 Typical details of the auxiliary chute taken from a record drawing

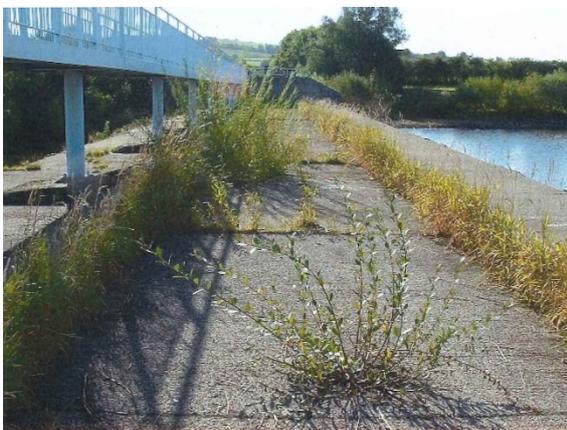
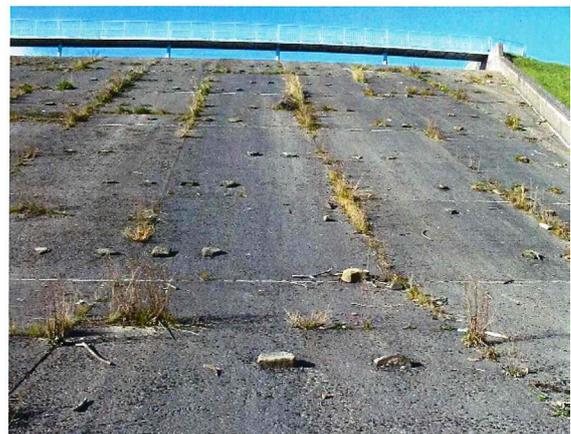
Figure. B4 Well established vegetation on the crest slabs and on the chute in 2007

Interestingly one photograph dated September 2007 shows lines of extensive weed growth laterally across the chute immediately above the slab which initially failed (fig. B4). One of these vegetation lines may be located in a joint between slab panels but at least one other does not line up with the chute joints and so was certainly in a significant crack. The fact

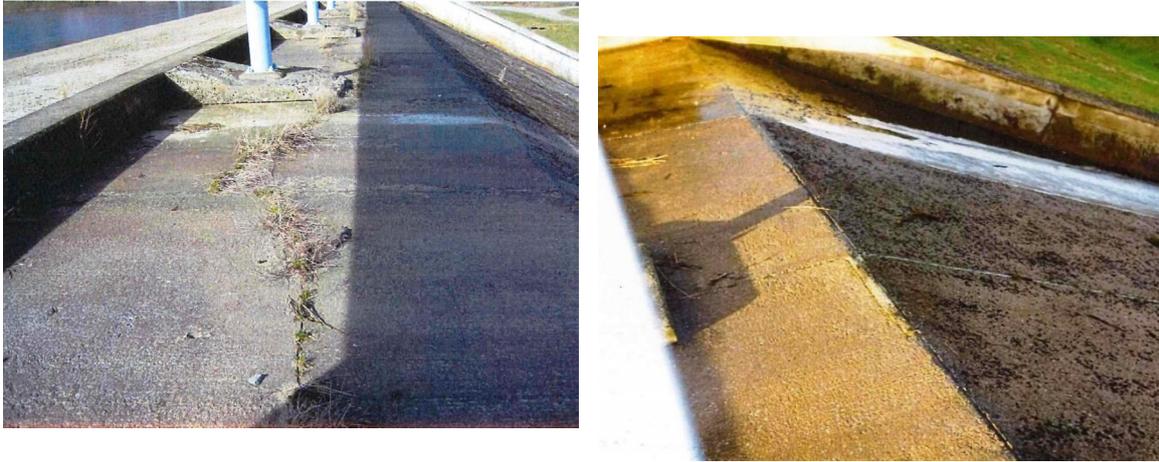
All these features would allow water to ingress at times of chute flow, and some indeed even at times when the water was high but not actually at auxiliary weir crest level. There is evidence of this occurring at a number of places on the crest, including at both left and right ends and the centre, but more prominently on the left (fig B5).

Figure. B5 Historic crest cracking and isolated seepages on the left side on the chute

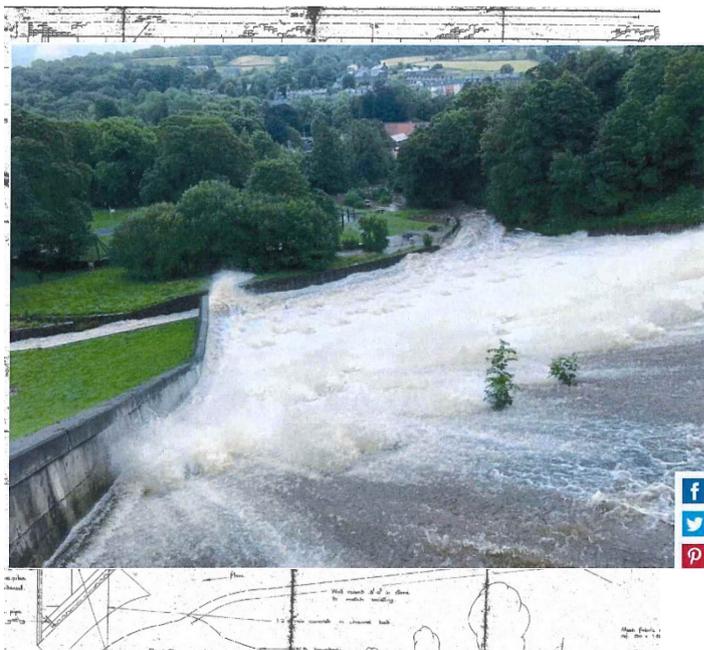
Although the left hand wall tends to increase the local flow depths and turbulence along its length (fig B7), it would not appear to have had any particular influence on the nature of the slab collapse which occurred some distance away from it and away from the turbulence that the wall creates. The view of the Panel is that the scour initially originated at the third row of panels in from the left and that it spread laterally, eventually undermining the wall foundations, causing them to collapse inwards rather than being eroded outwards. This also reflects the thoughts of the engineering staff on site at the time who witnessed events as they unfolded.

Figure. B7 Plan of the auxiliary chute and photo of flows impacting against the oblique left side wall

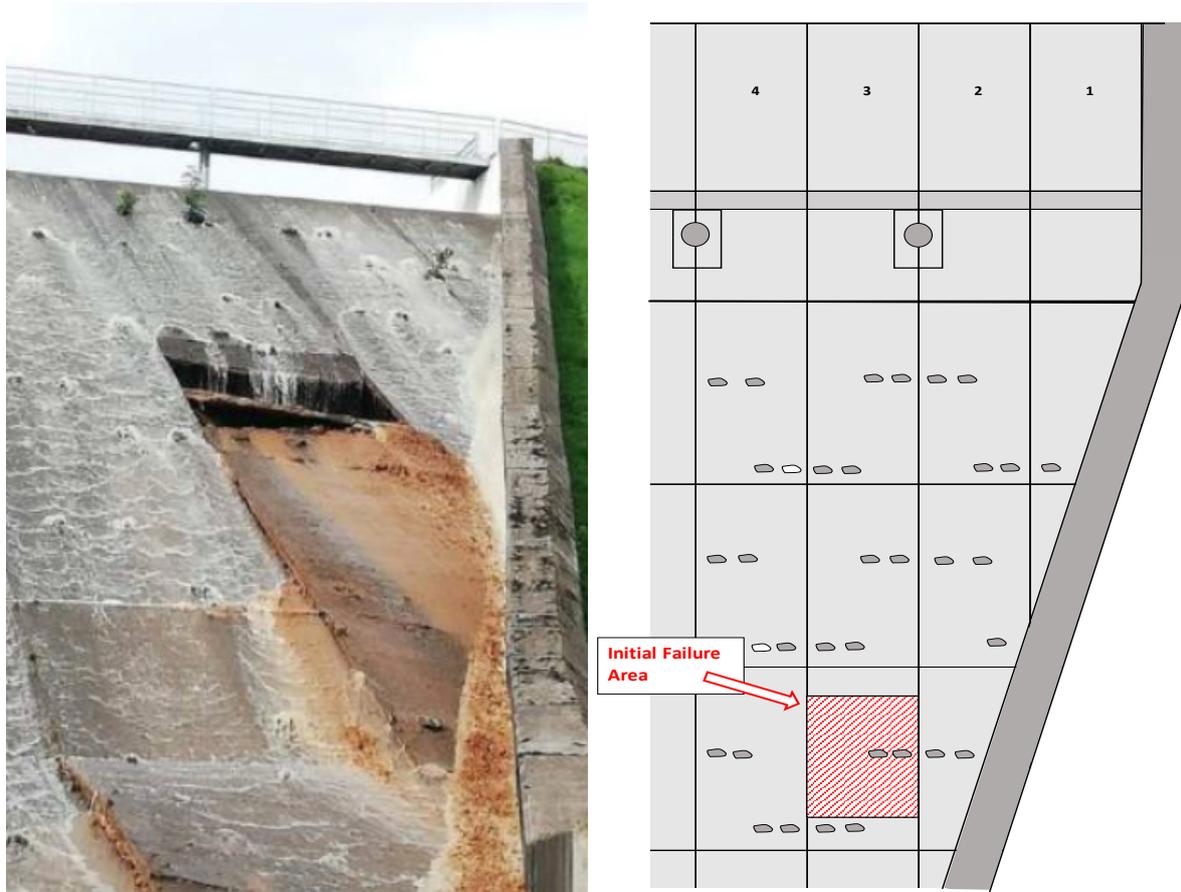
Earth slurry in the form of what appears to be silt, clay and sand can be seen exiting through open joints due to raised slabs, further down the chute. It has clearly “flowed” from the scour hole above implying a fluidization of the fill in the area of the scour hole. This in turn implies that considerable volumes of water had reached the scoured area during the course of the earlier flows down the chute. The earlier descriptions of events and of silty flows leaving the chute during the flood, see above, indicates that this process had been going on for most, if not all of the preceding day, during the main flood event.

Figure. B8 Location of initial slab failure

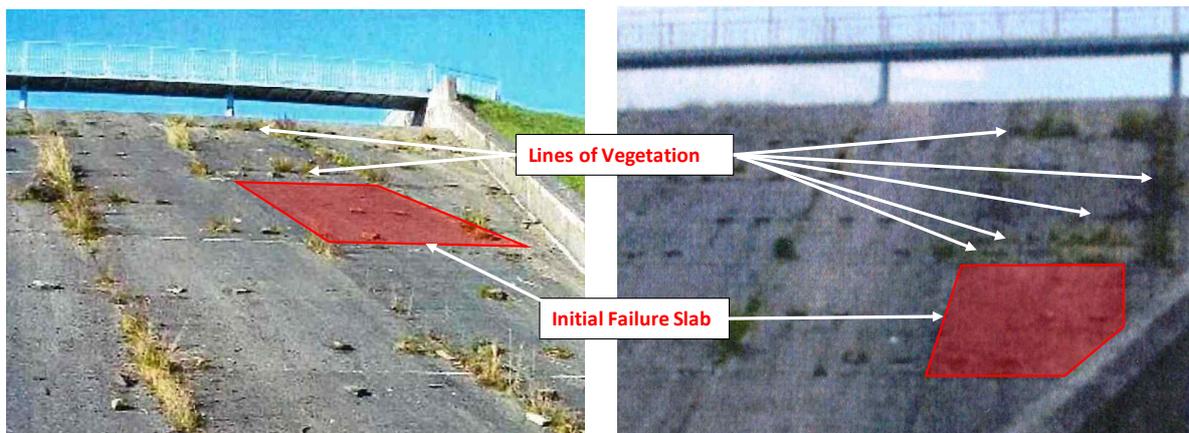
It should be stressed that these values are not definitive as the slabs in question are no longer either intact or available for inspection. However, it is clear from historic photographs showing lines of established vegetation, that at least three such cracks and/or joints existed across the panels immediately above the panel which initially failed (fig. B11). The mechanism demonstrates a means by which water would have potentially been available during spillway flows, to target exactly the foundation area concerned and in sufficient quantities to accomplish much of the substantial erosion and soil liquefaction which occurred on the day. It would also explain why large amounts of silt/earth colouring was apparent in the spillway flow but not in prior drain outlets and other seepages when the spillway was inactive.

Figure. B11 Lines of vegetation in 2007 and 2016, implying open cracks/joints immediately above the slab which failed initially
