REVIEW OF THE
TESTALINDEN DAM
FAILURE

JULY 2010

This report is an independent review of the context leading up the failure of the Testalinden Dam, the circumstances of the event itself, the response and recovery efforts, and a review of dam safety oversight in British Columbia.

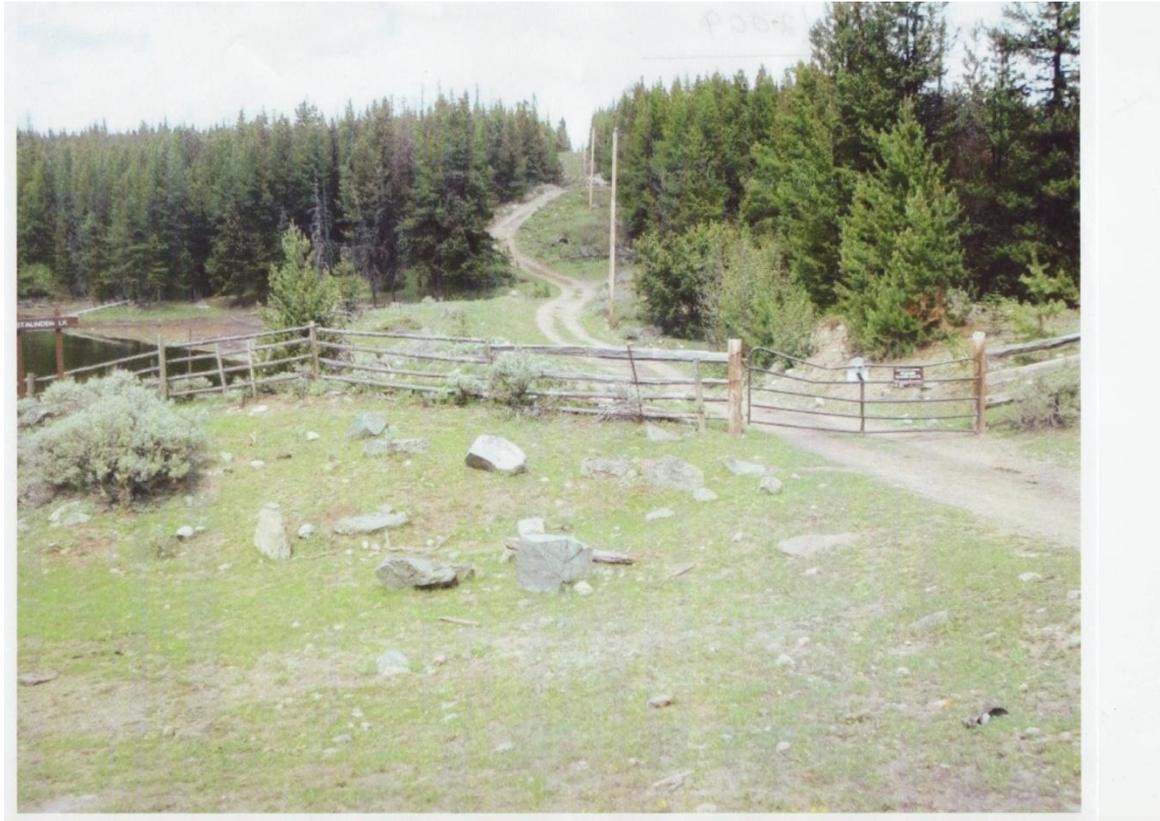
Testalinden Lake and Dam, June 2009
