Report of Findings on the Overtopping and Embankment
Breach of the Upper Dam - Taum Sauk Pumped Storage
Project, FERC No. 2277

FERC Taum Sauk Investigation Team

April 28 2006

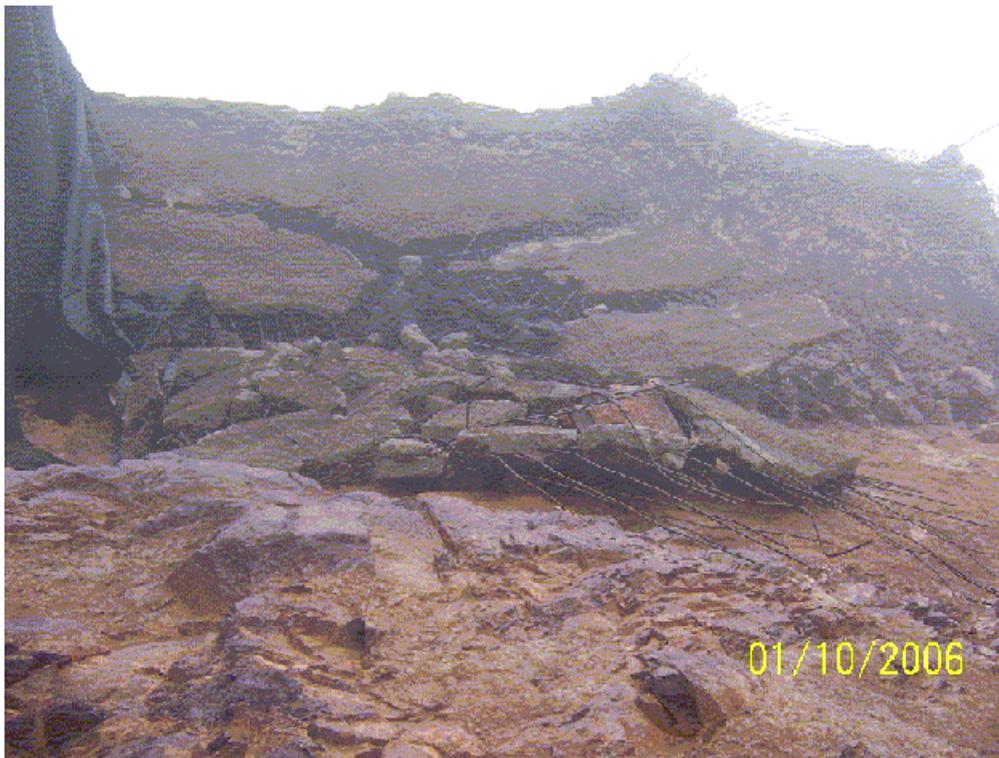
**Figure 2.4 - View of bedrock immediately below failed embankment section.
Note weathered clay in lower portions of the exposure.**

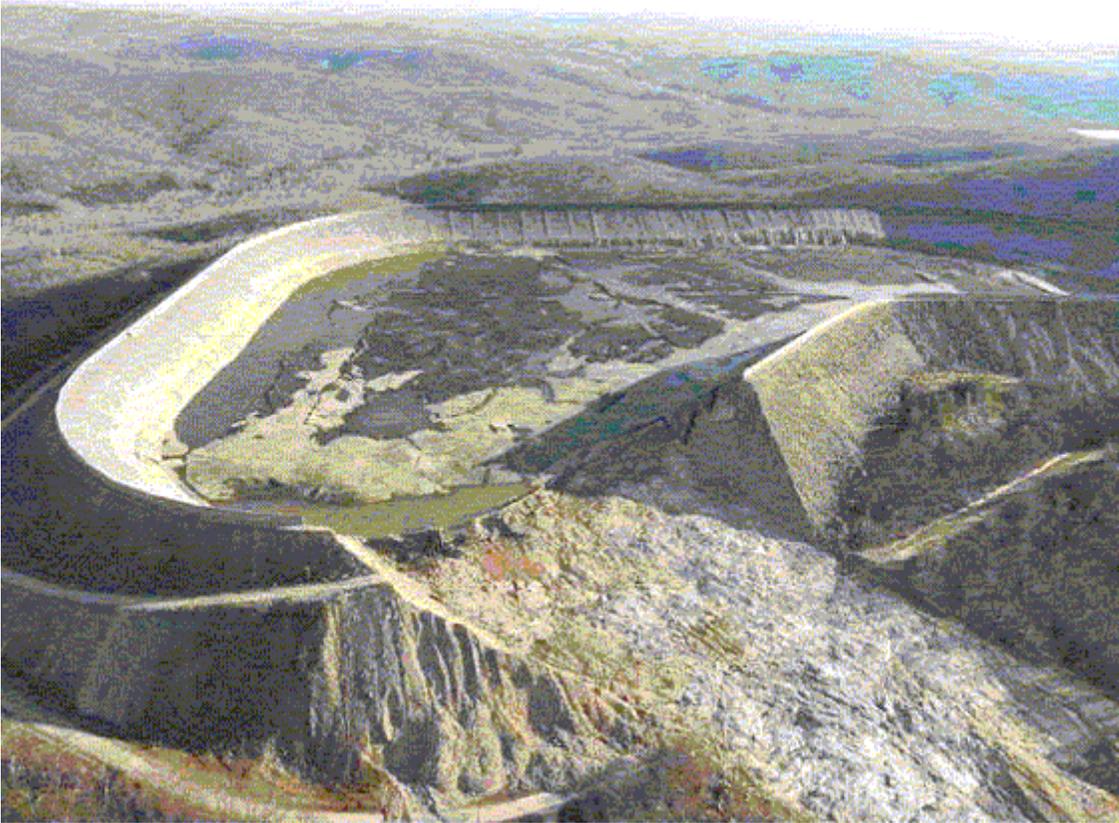
Figure 2.5 - View of bedrock within, and immediately below failed embankment section. Note distribution of weathered rock (red-brown color) and topsoil (green-brown color). The “fish-pond” area contains water and is immediately upstream of the breach.

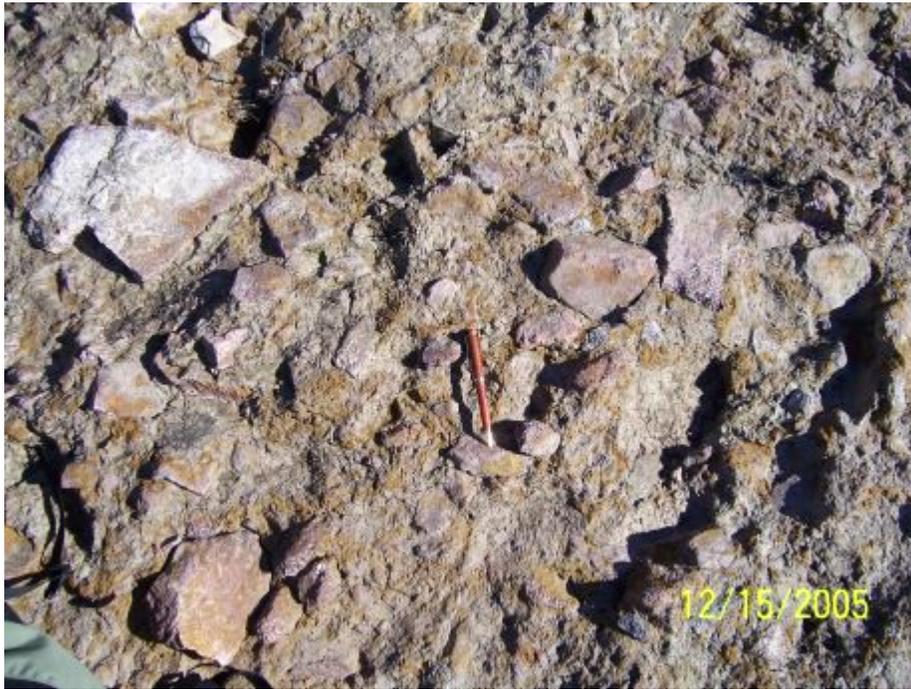
Figure 2.6 - Foundation area composed of weathered rhyolite with some clay, located in breach area.

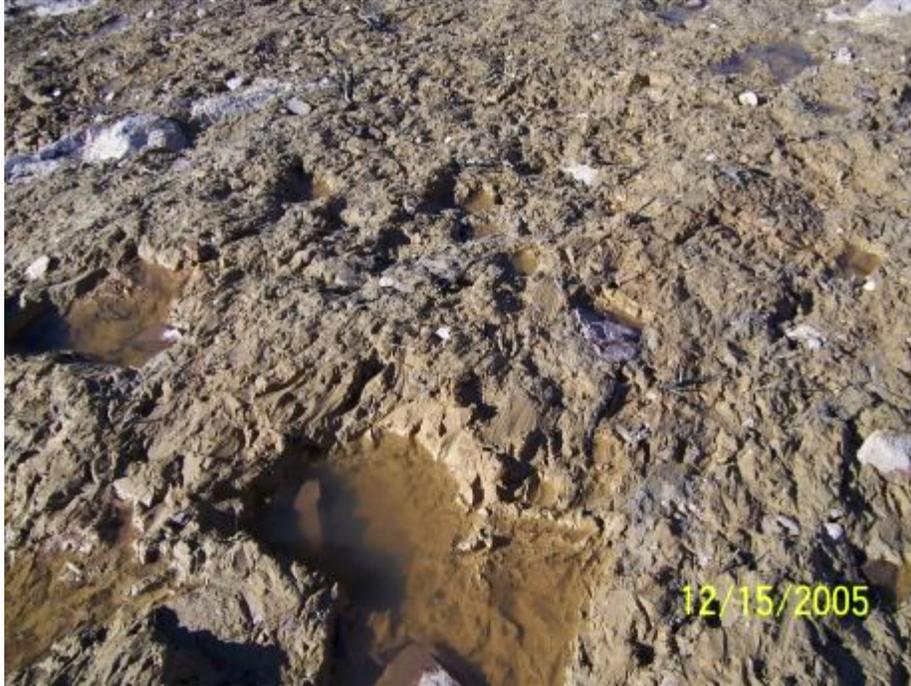
Figure 2.7 - Grooves cut into an area of clay-seam foundation by the floodwaters. This area is located immediately downstream and in the center of the breach.

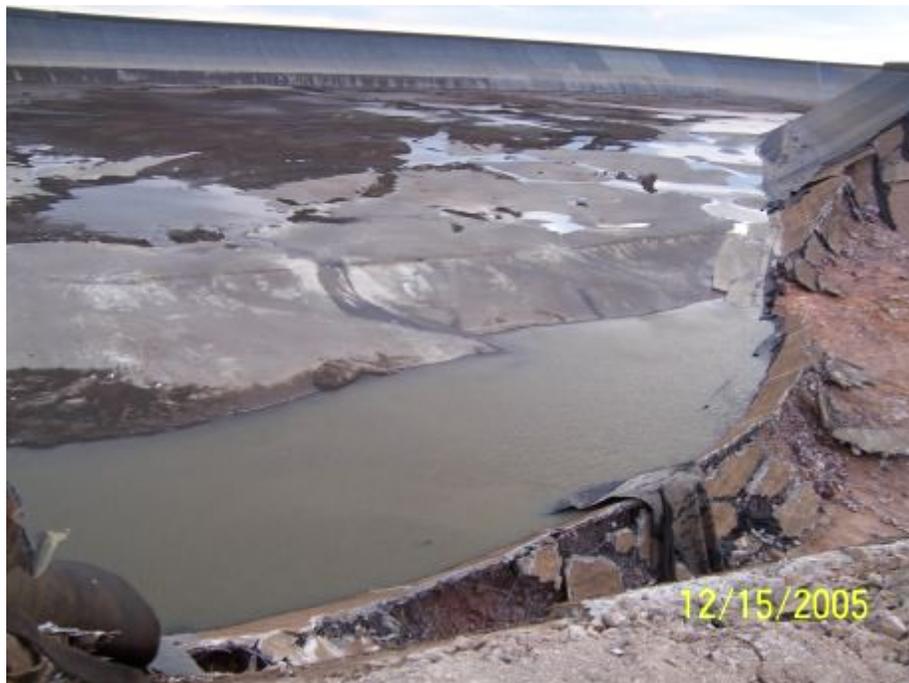
An area of the foundation in the breach section contained clay with low-moderate plasticity and weathered rock in the area just beneath the breach. The clay and weathered rock zone could have provided a failure surface for embankment sliding. The clay appears to be a residual weathering product of the bedrock (Figure 2.6), and in areas, relict bedrock structure can be observed in partially and completely decomposed clay remnants. No records were made available that indicate the extent of clay that was left in the breach area. However it could be conjectured that the settlement of the parapet wall in this area may have been accentuated due to consolidation of this clay deposit if it was of substantial thickness. The clay appeared saturated and contained groove marks from debris (Figures 2.7-2.9). This area was over-excavated in the footprint of the reservoir due to the clay foundation conditions, forming the “fish-pond” area of the

Figure 2.10 - Breached area. Note “fish pond” area immediately upstream of the breach. This area was over-excavated during original construction due to poor foundation conditions.

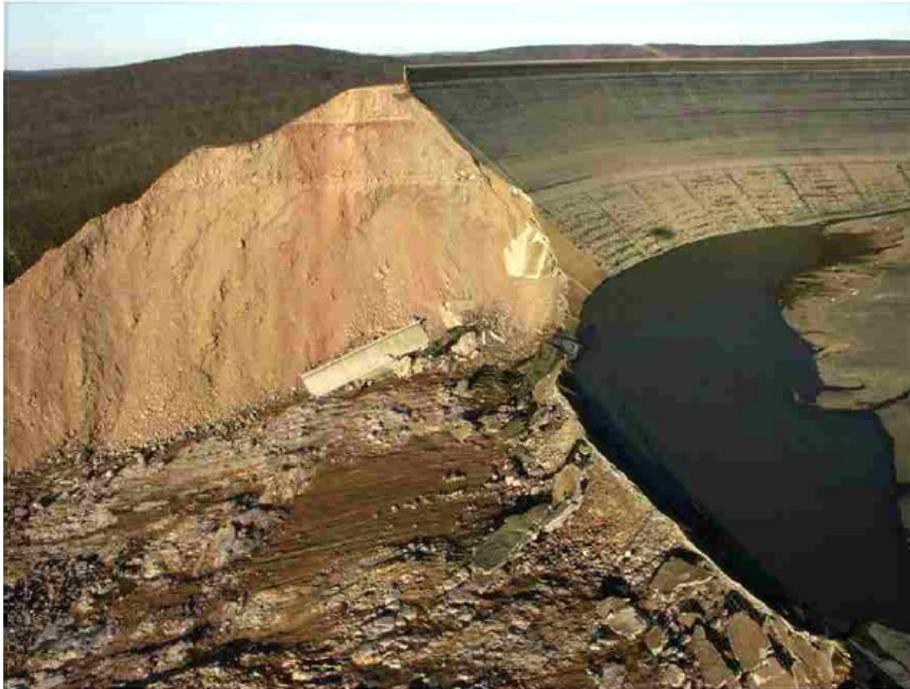
Figure 2.11 - Weathered rock and discontinuous clay seam foundation just downstream of fish-pond area.

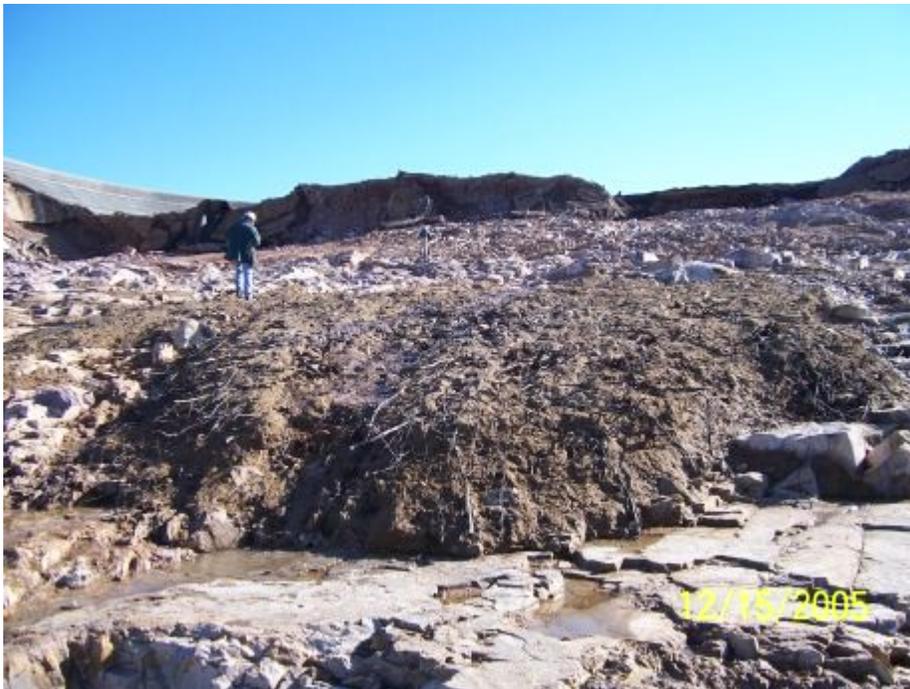
Figure 2.12 - Root-laden remnant native soil in breach area, resting on fresh rhyolite.

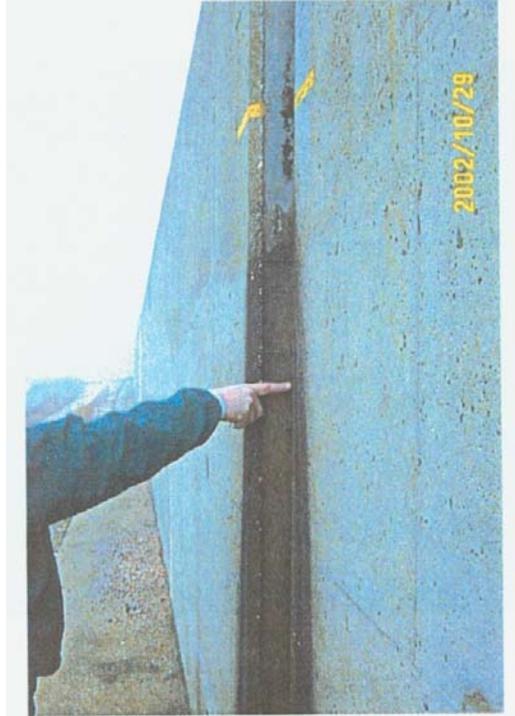
"The maximum horizontal movement observed was at joints 89/90 and 106/107, with about 4-5 inches of translation and rotational movement. Photograph 3 (*of the report – see below Figure 3.4*) shows panel 90 having moved downstream relative to panel 89. The copper waterstop was visible in the joint. This magnitude of movement is likely sufficient to tear the waterstop, but probably does not affect the wall stability."

Figure 3.4- Movement at Upper Dam Parapet Wall at Joint 89/90 from 2003 Eighth Part 12D Report

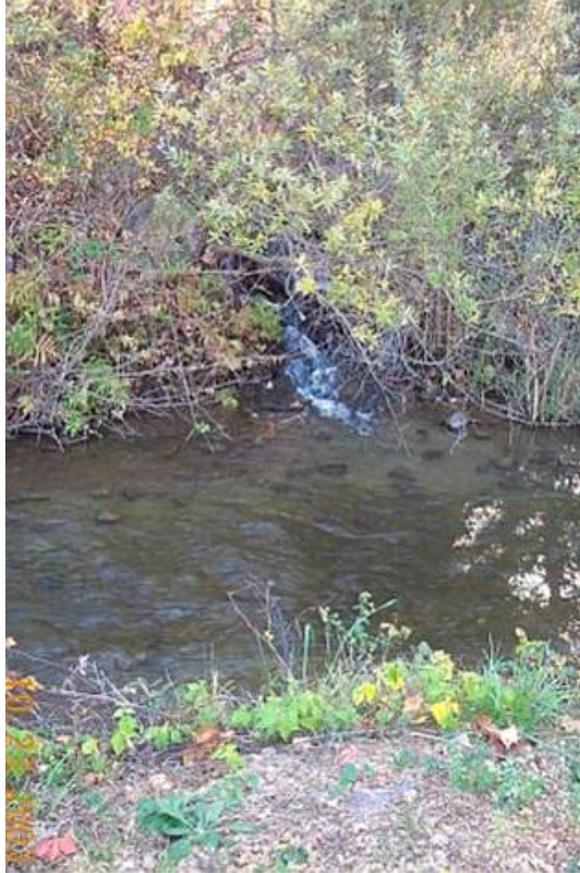
**Figure 3.7 - Concentrated Seep Before liner installation
(2003 FERC Operation Inspection Report)**

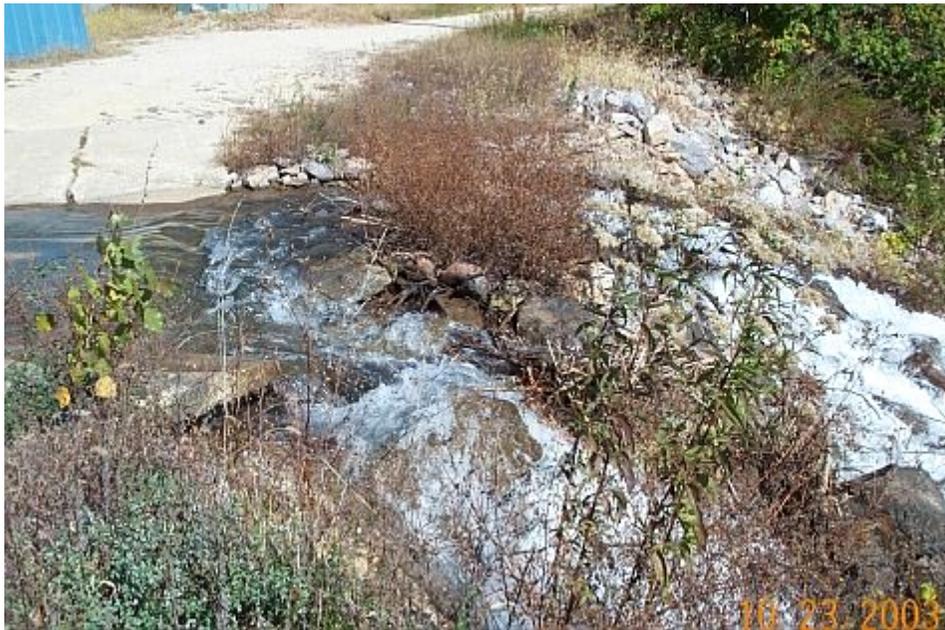
**Figure 3.8 - Overflow of the seepage collection Pond before liner installation
(2003 FERC Operation Inspection Report)**

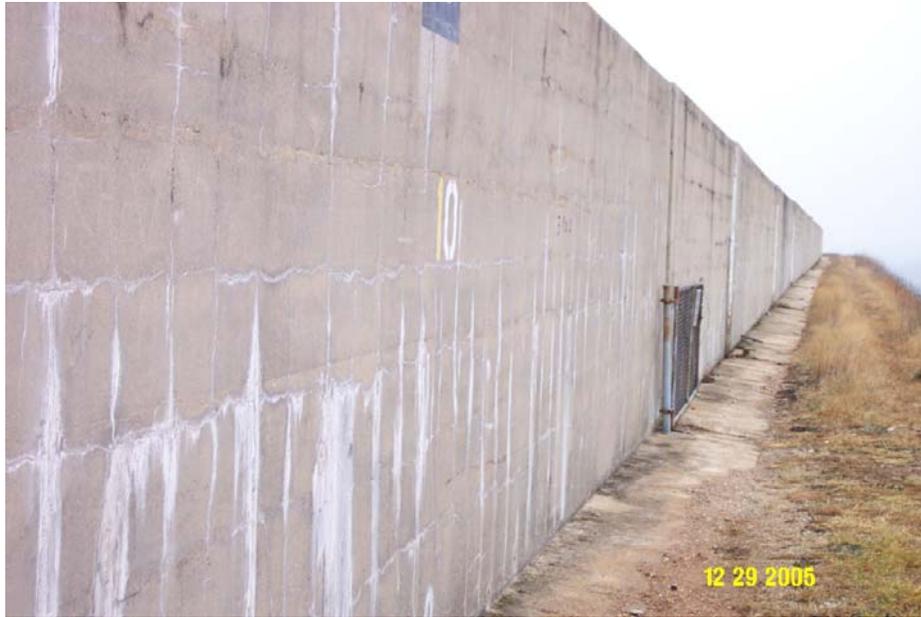
Figure 4.2 - Panel 10
Note grass is lain over near footing
Damage from overtopping was judged as Minimal
Estimate 0.1 ft. of overtopping

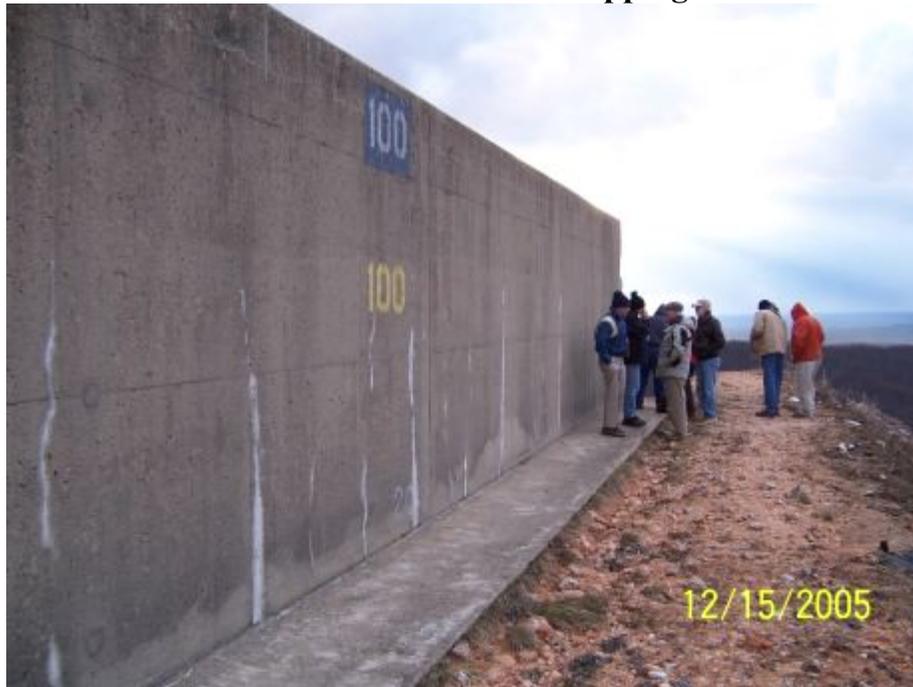
Figure 4.3 - Panel 100
Adjacent to the right side of the Breach
Note erosion at toe of parapet wall footing
Damage which was judged as moderate to significant

The elevations of Panels 100 and 101 were measured between elevations 1597.67 and 1597.82 ft (Figure 4.3). The damage at Panel 100 and 101, which was judged as moderate to severe, does not appear to agree with the estimates of the peak reservoir estimates occurring on December 14, 2005. However, wind-induced waves could have overtopped these walls by several inches on December 14, 2005. Damage may have been the result of the December 14, 2005 event and/or the September 25, 2005 wave overtopping event.

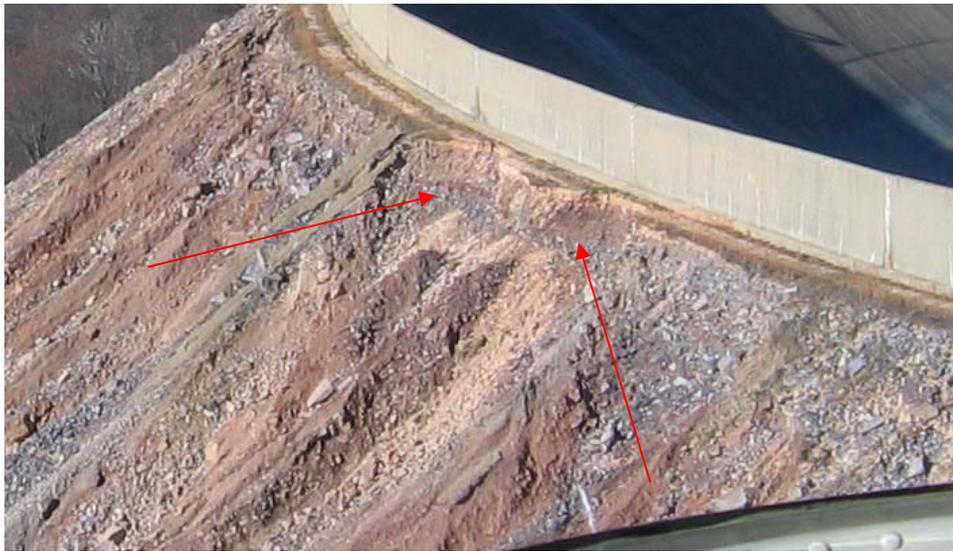
Figure 4.4 - Erosion Panel 48/49

Damage judged as significant

Estimate 0.5 ft of overtopping

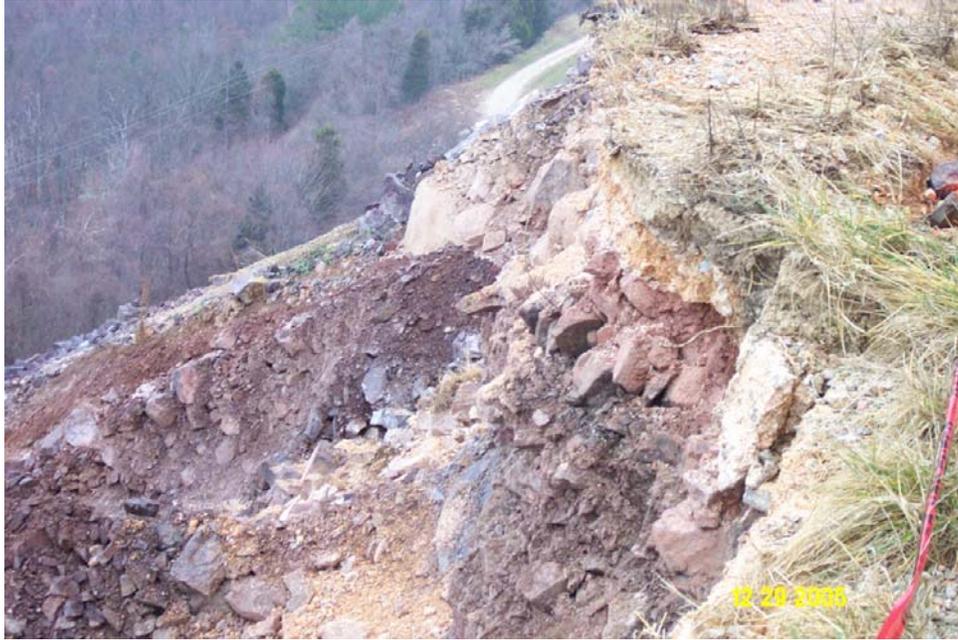
**Figure 4.5 - Panels 48 and 49
Scarp near toe of parapet wall footing**

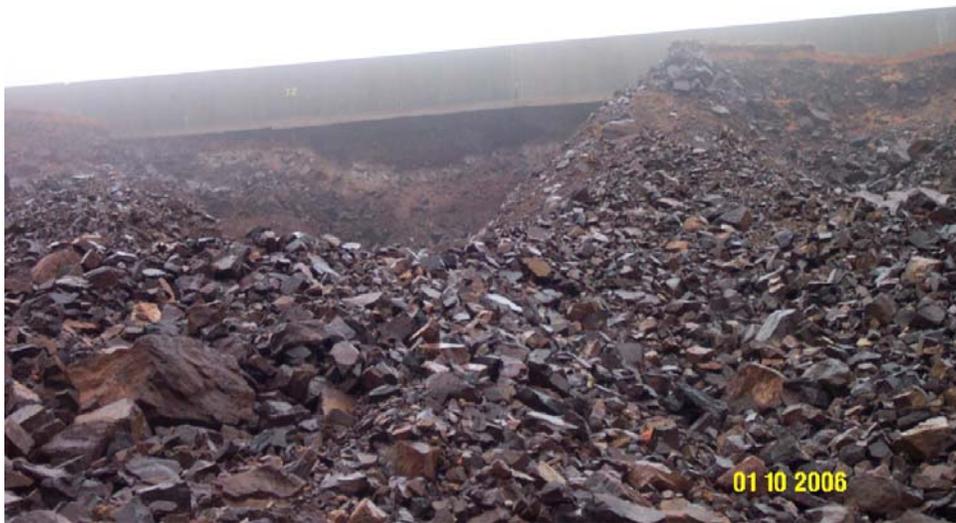
Figure 4.7 - Panel 72
Note erosion deep beneath the parapet wall
Damage judged as significant
Estimate 0.7 ft of overtopping

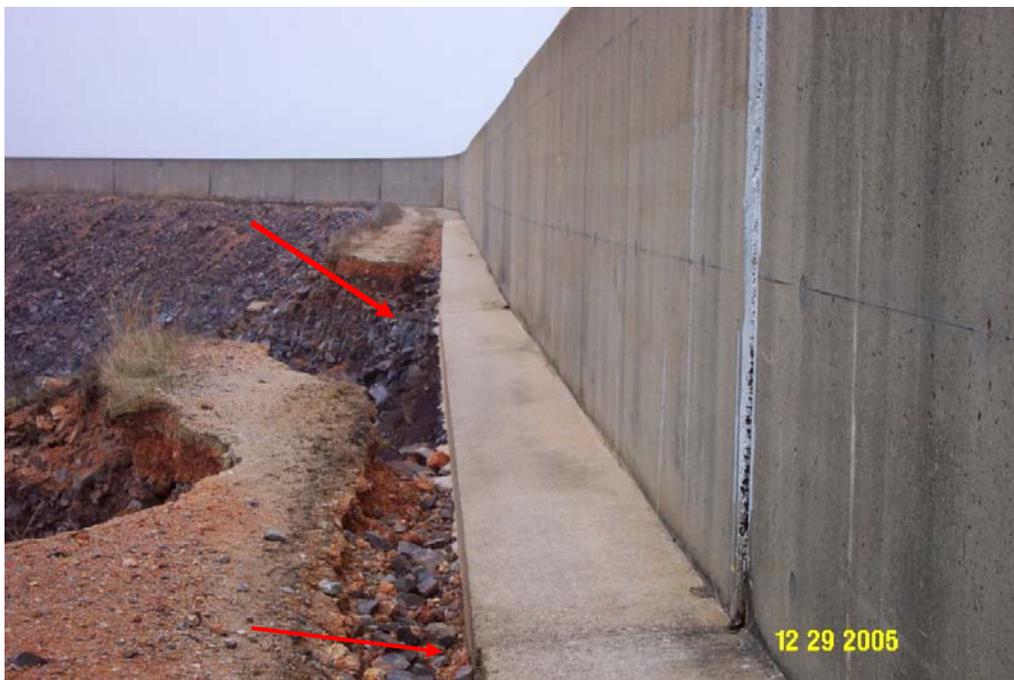
Figure 4.8 - Erosion at Panel 71 footing
Note the horizontal displacement between Panel 70 and 71 (foreground) and
bowing at the joint between Panels 71 and 72. Erosion at the footing is
similar to that described during the September 25, 2005 wave overtopping.

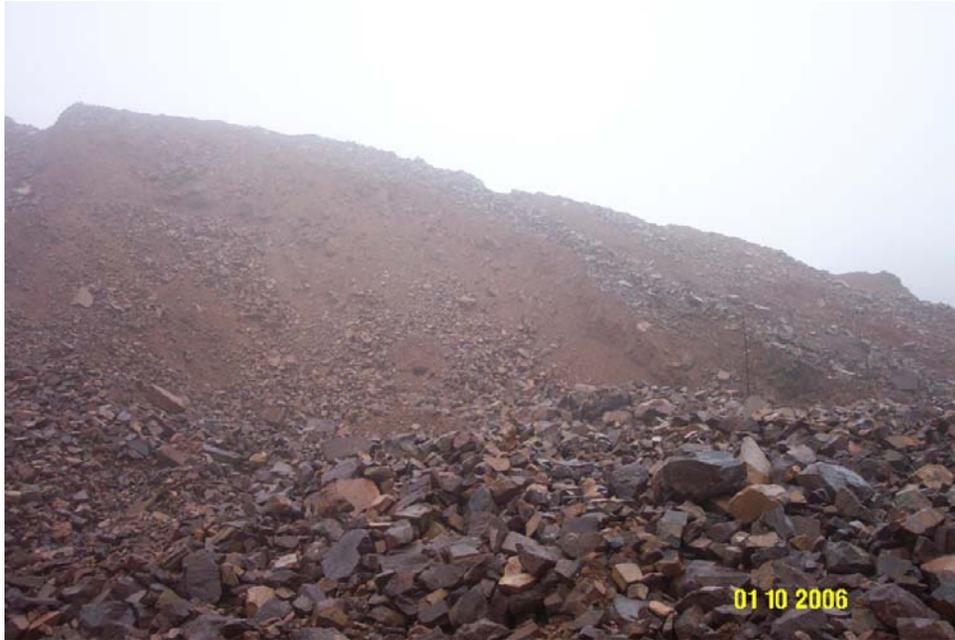
Figure 4.9 - Possible slope failure between Panel 100 and the full breach section

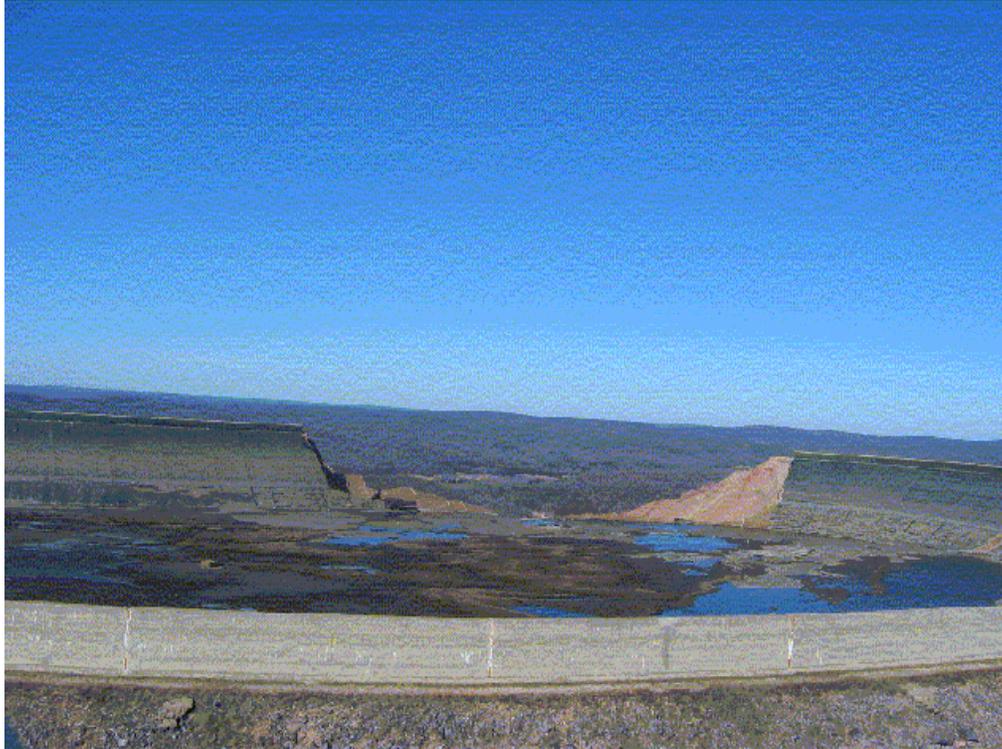
**Figure 4.10 – Breach Panels 88 - 99 removed during the event
Estimate 0.2 -0.3 ft. of overtopping. (Missouri DNR Photo)**

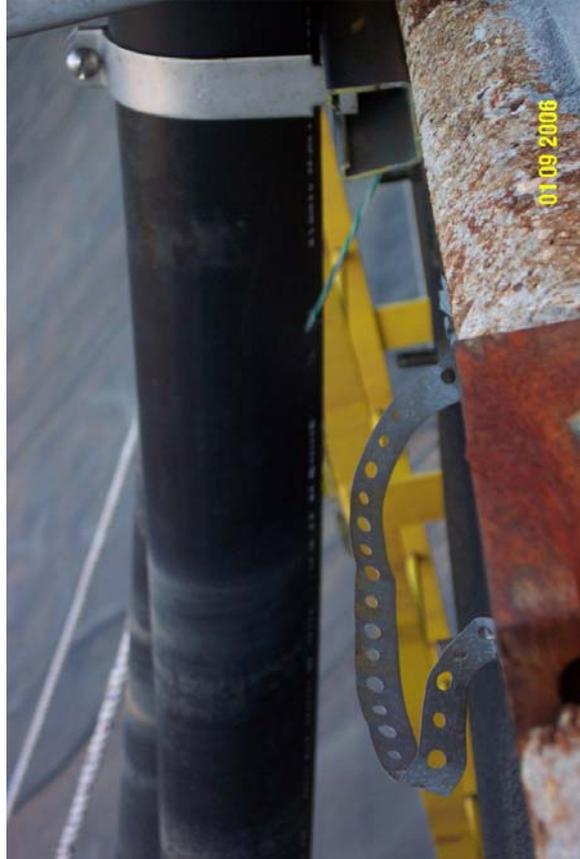
Evidence of the monitoring system not operating as designed was found at the gage house with water marks noted on the HDPE pipes. The elevation of the watermarks indicates the peak reservoir level may have been routinely above elevation 1596 ft. Figures 5.6 and 5.7 are a photograph and schematic of the high water marks, respectively.

Figure 5.6 - High Water marks on HDPE Tubes

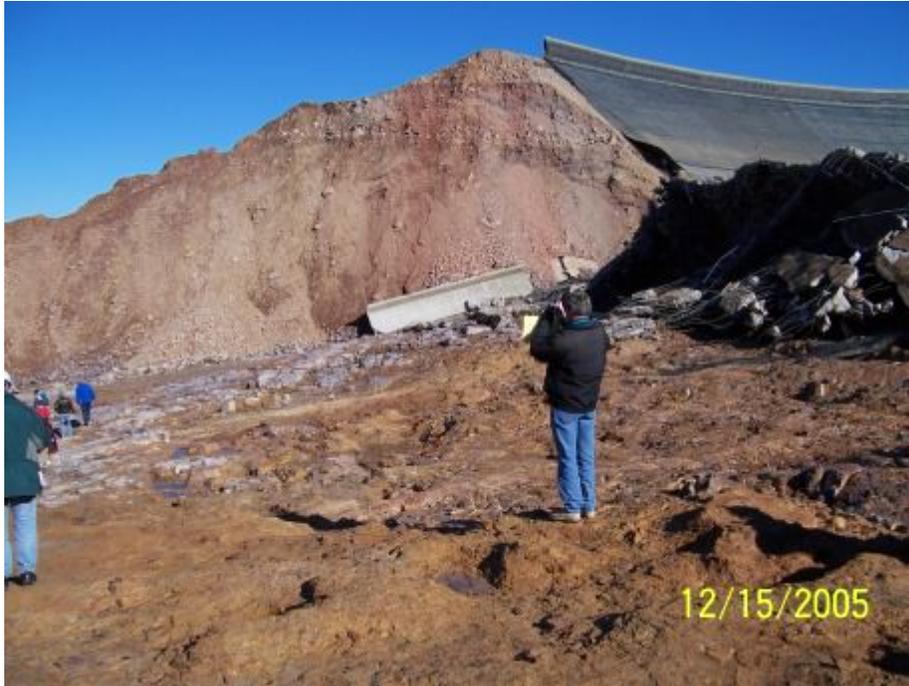
There is no evidence to support a conclusion that the weathered rock or clay layer extended beneath the entire footprint of the breach area. However, it was assumed in the stability analysis that there was a layer of weak material resting on top of bedrock throughout the area that was stripped by the discharge through the breach. Both the clay layer and weathered bedrock were treated as having the same shear strength. This assumed continuous layer of weak material results in more conservative (lower) factors of safety than would have existed if the rock fill had been placed directly on top of bedrock. This should give a lower-bound estimate for stability of the rock fill in the breach area. The foundation was divided into two components; 1) sound rock and, 2) weathered rock/topsoil.

Figure 9.2 - Area of weathered rhyolite, which is in-line with the “fish pond” depression in the reservoir (background).

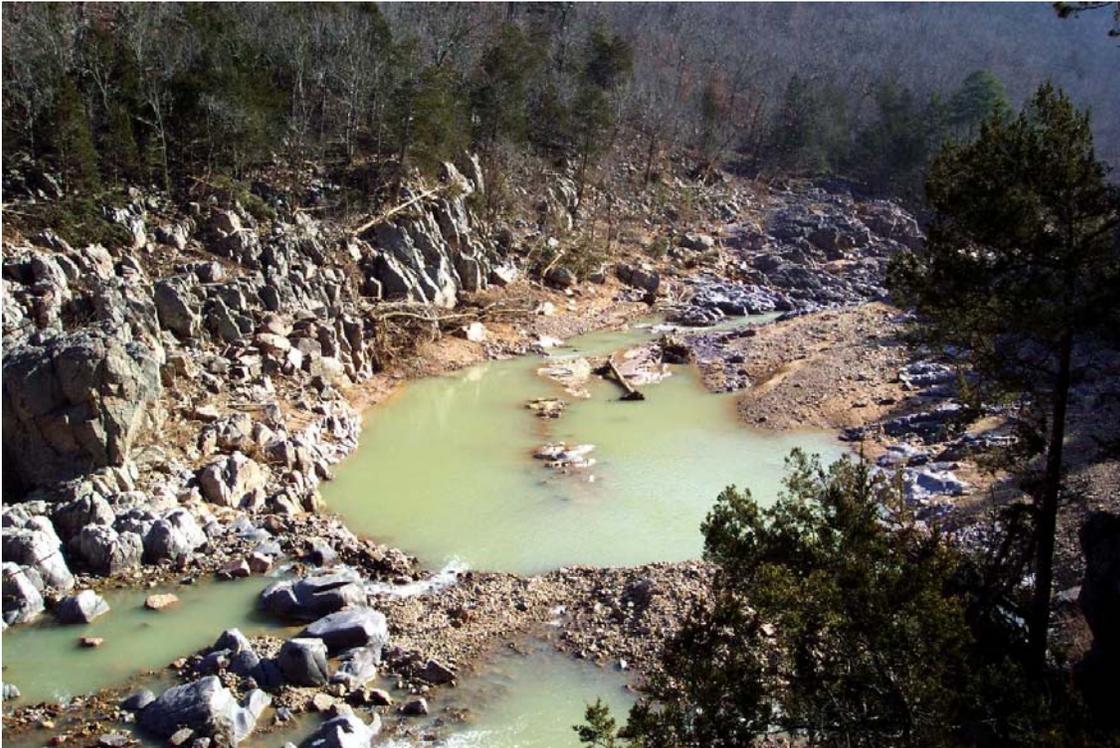
Figure 11.5 – Turbidity at Johnson’s Shut-ins (Source: Staff, 12/22/05)

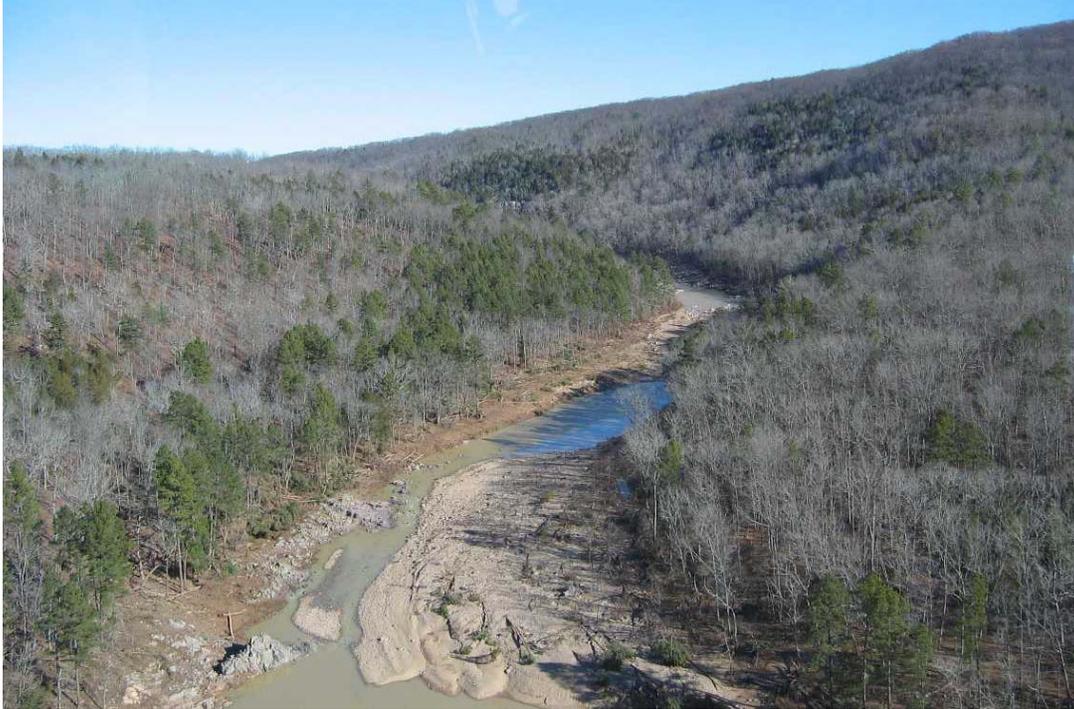
Figure 11.14 - Deforested riparian vegetation below Shut-Ins area of state park. (Source: MDC)
