What Happens Downstream Stays Downstream, or Does It?

Potential Failure Modes from Spillway Exit Flows

Gregory Richards, P.E., CFM, Gannett Fleming, Inc.
Paul Schweiger, P.E., CFM, Gannett Fleming, Inc.
Benjamin Israel, P.E. CFM, Gannett Fleming, Inc.

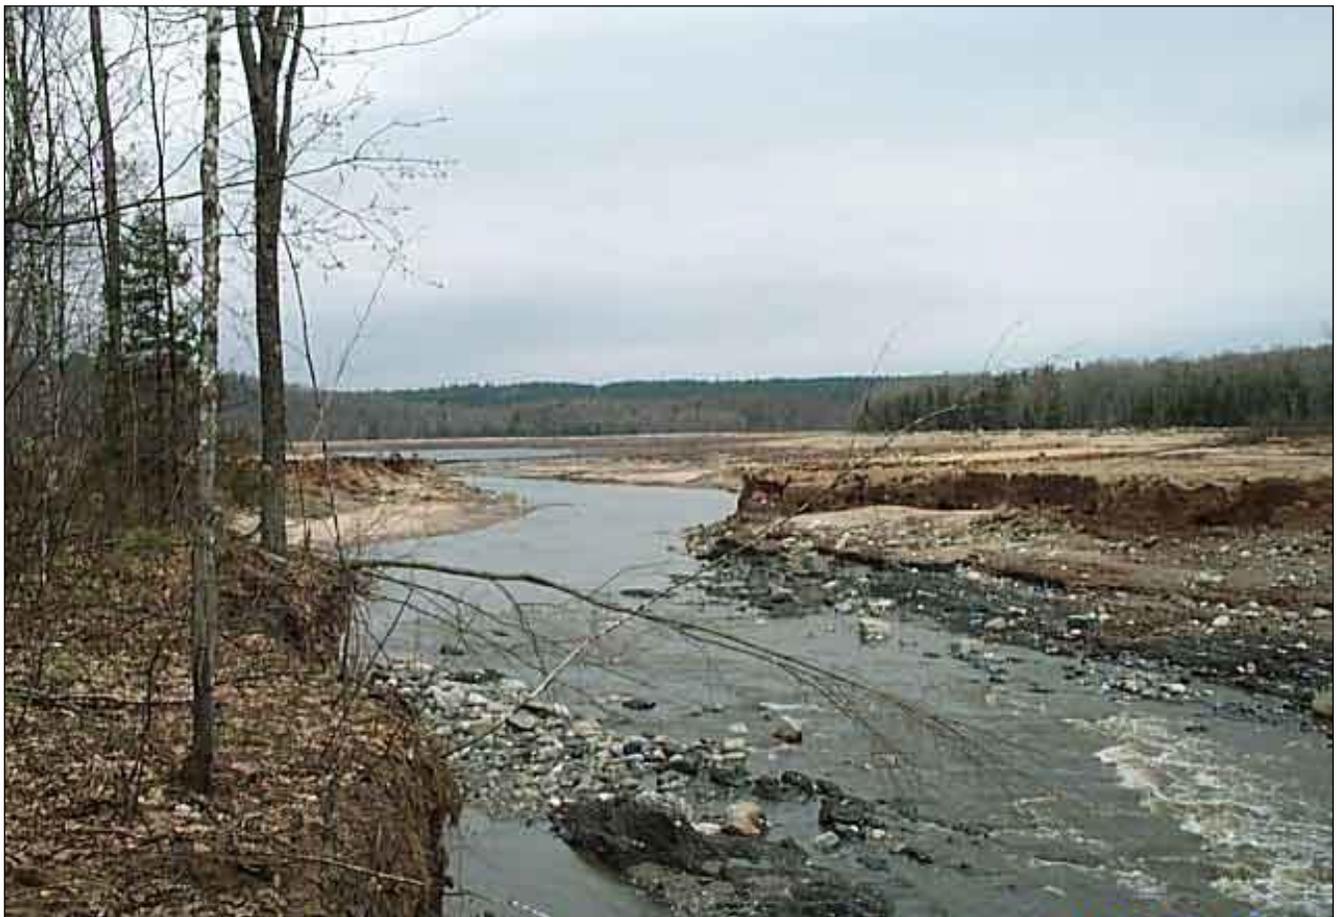
Silver Lake Dam was originally constructed in 1896. It is a 1,500-foot-long, 30-foot-high embankment dam used for water storage for downstream hydroelectric facilities. Upgrades were completed to the dam in 2002 in order to increase the spillway capacity to be able to pass the Probable Maximum Flood. These upgrades consisted of installing 5.5-foot-high fuse plugs in the emergency spillway and raising the dam embankment. On May 14, 2003, a 5- to 10-year recurrence interval flood occurred at the dam which activated the fuse plug emergency spillway. Rather than simply eroding the fuse plugs as intended, the channel downstream of the emergency spillway experienced significant erosion that progressed up through the spillway and into the reservoir. The final eroded spillway breach depth was 25 feet below the foundation of the fuse plugs. Outflows from the failed spillway caused evacuation of 1,700 people and more than \$100 million in damages. Because an Emergency Action Plan was in place and promptly executed, no fatalities occurred.

Figure 1. Channel cut through the Silver Lake Dam emergency spillway, looking upstream (Photo courtesy of FERC)

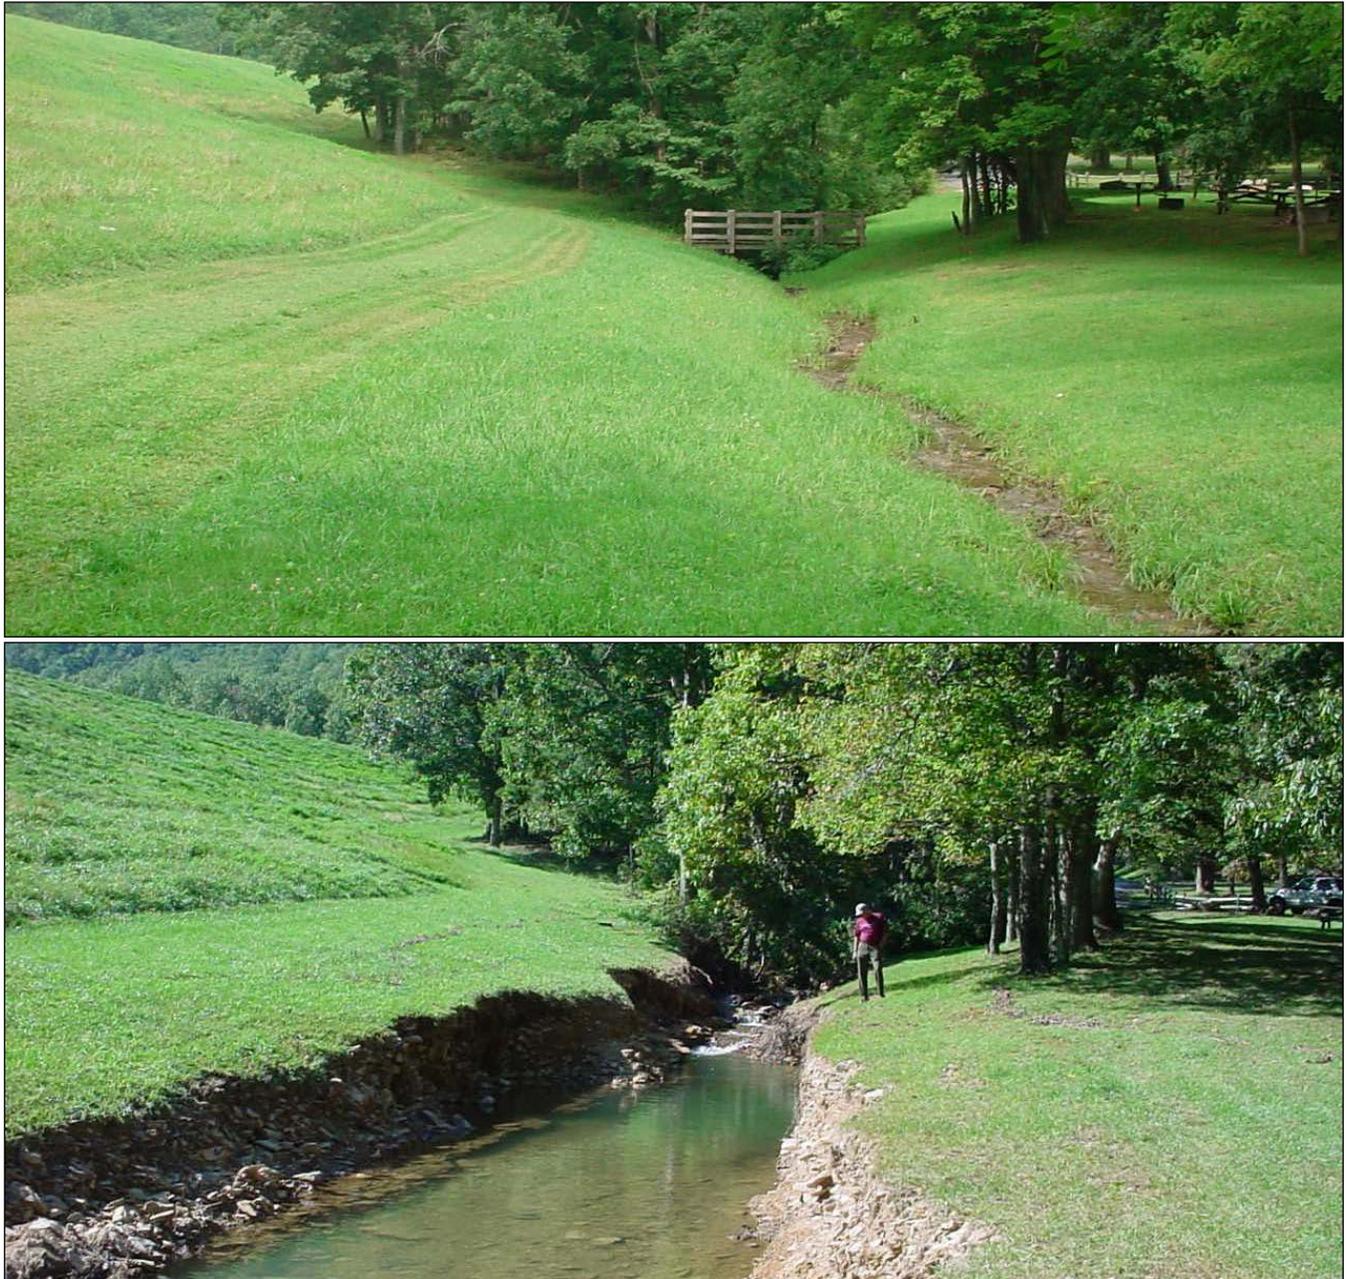
Upper Sherando Dam was constructed by the Soil Conservation Service in 1958 for flood control purposes. In 1961, ownership of the dam was transferred to the U.S. Forest Service. On September 19, 2003, remnants of Hurricane Isabel caused significant flooding in the area of the dam. The auxiliary spillway, which had never previously been activated, experienced flow that was only a few inches deep. As a result of this flow through the spillway, the downstream exit channel which runs along the toe of the dam embankment experienced significant erosion with depths extending more than 20 feet in some places. Had flows continued or been greater in magnitude, significant erosion and failure of the embankment could have been possible.

Figure 2. Auxiliary spillway discharge channel before (TOP) and after (BOTTOM) initial activation of the spillway, looking upstream (Photos courtesy of Tom Roberts, VA DCR)

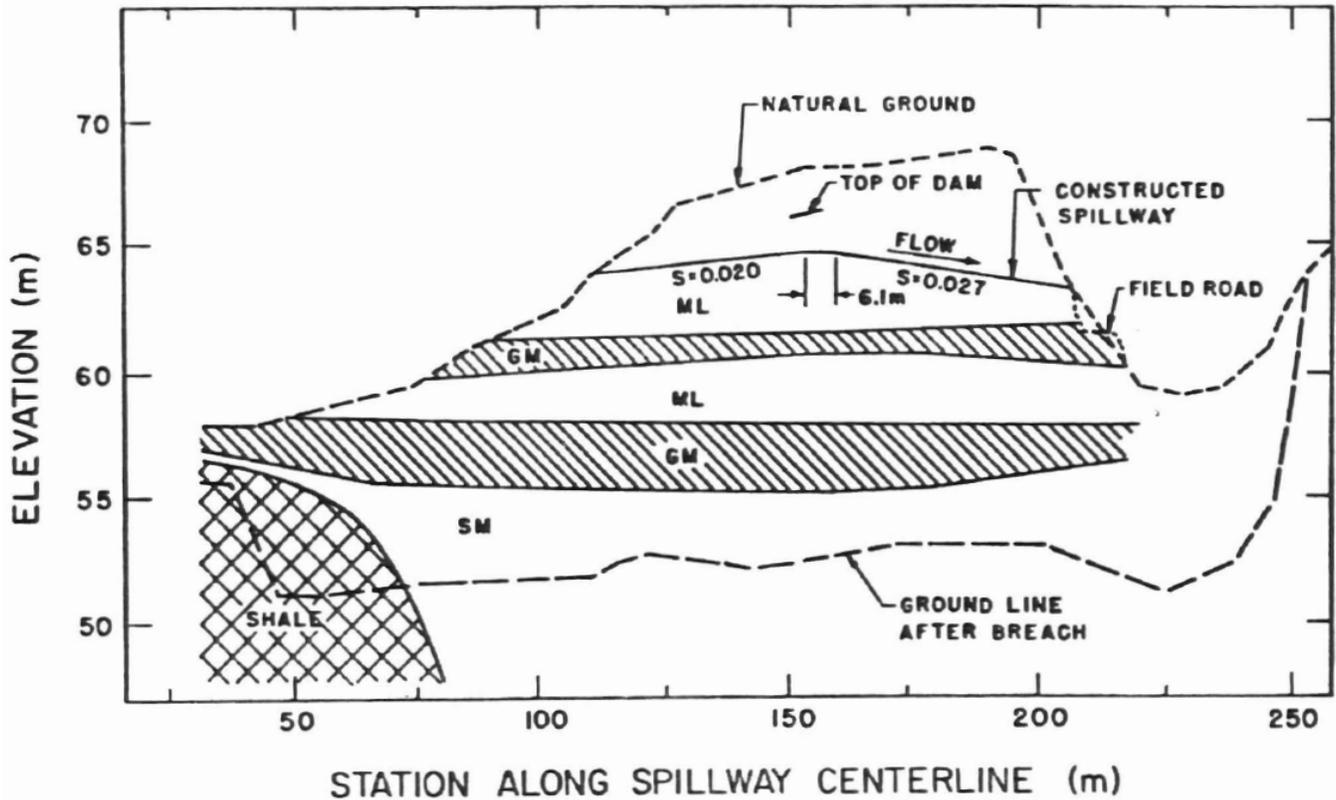
Black Creek Dam is an NRCS flood control structure located in Holmes County, Mississippi. In May 1983, 14 inches of rain fell in the dam's watershed resulting in significant flows through the earth cut auxiliary spillway. At the time of the flood, the spillway was vegetated with grass that was in good condition, and no major discontinuities existed within the spillway. As-built profiles of the spillway indicate that a field road crossed the spillway exit channel perpendicular to the flow, forming two sharp drops (See Figure 3). These drops were determined to be the points of primary attack and initial headcut formation. The spillway, which was originally 5 feet deep and 100 feet wide, eroded to a depth of 40 feet and 160 feet wide. In all, about 4,500 acre-feet of water was released from the reservoir, and 187,000 cubic yards of material was eroded and deposited in the downstream river reach. Downstream roadways were severely damaged, but no loss of life occurred.

Figure 3. As-built profile of the auxiliary spillway at Black Creek No. 53 Dam. Note the “field road” excavated into the exit slope of the spillway (Figure courtesy of Darrell Temple).

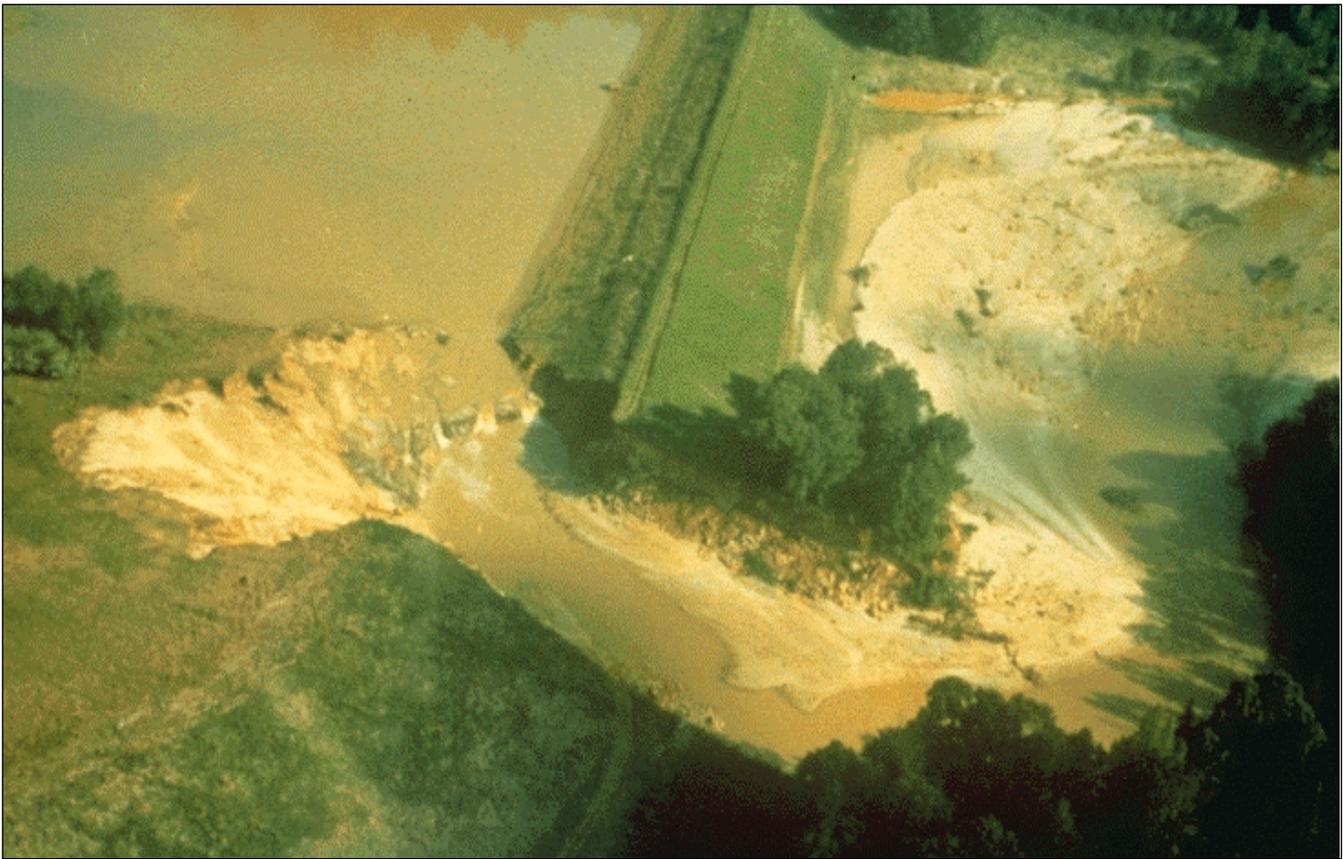
Figure 4. Overview of the failed auxiliary spillway at Black Creek No. 53 Dam (Photo courtesy of Darrell Temple).

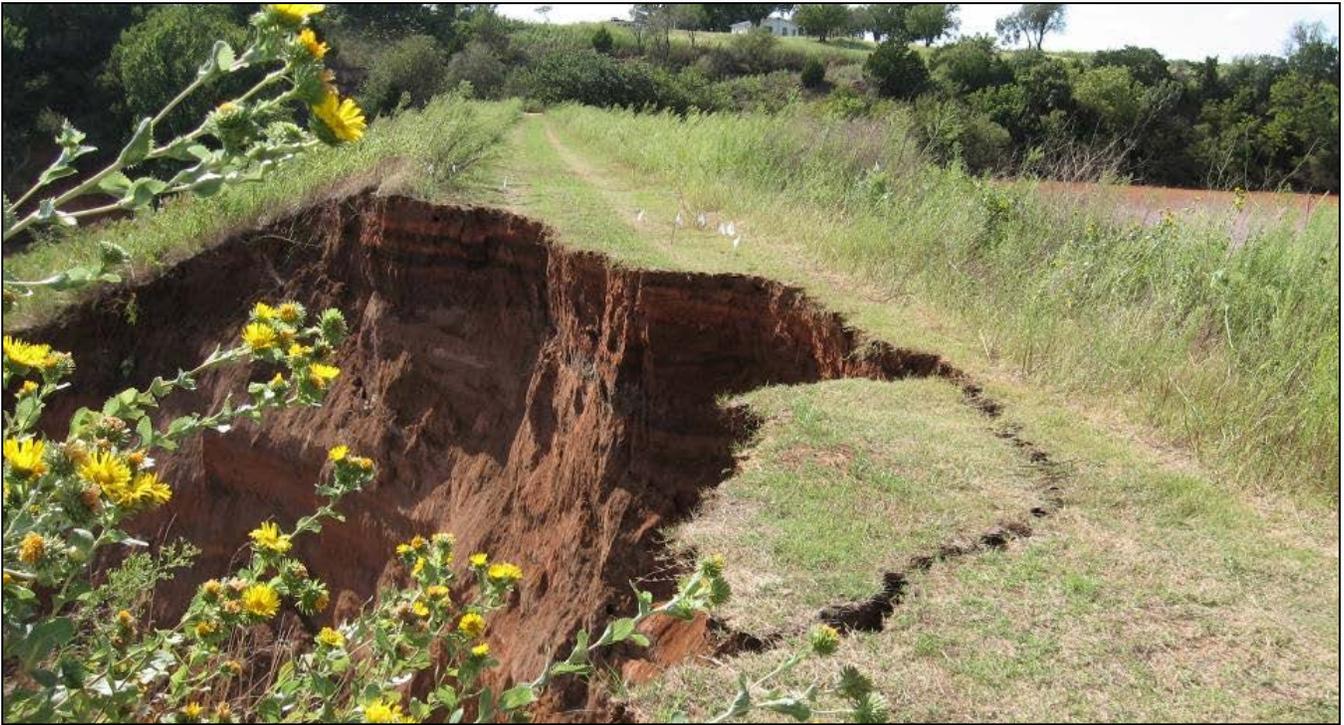
On the weekend of August 18-19, 2007, tropical depression Erin swept across Oklahoma. Rainfall amounts fell in parts of Caddo County that greatly exceeded that of a 100-year frequency storm. Preliminary measurements of the rainfall in the drainage area above Sugar Creek Dam L-44 indicate that over eight inches of rain fell in less than 12 hours and activated the auxiliary spillway. Flows from the auxiliary spillway were discharged beyond the toe of the earth embankment, but returned after encountering the Highway 81 road embankment to erode the downstream slope of the dam and nearly breach the dam. Backwater from debris plugging the culvert under Highway 81 may have contributed to the unusual flow conditions. Ultimately, the erosion advanced through more than half of the width of the dam embankment crest. Had spillway flows continued much longer, the dam would have failed due to erosion and instability of the remaining embankment material.

Figure 5. Photograph showing the erosion in the downstream slope of Sugar Creek Dam in Caddo County, Oklahoma (Photo courtesy of Danny McCook).

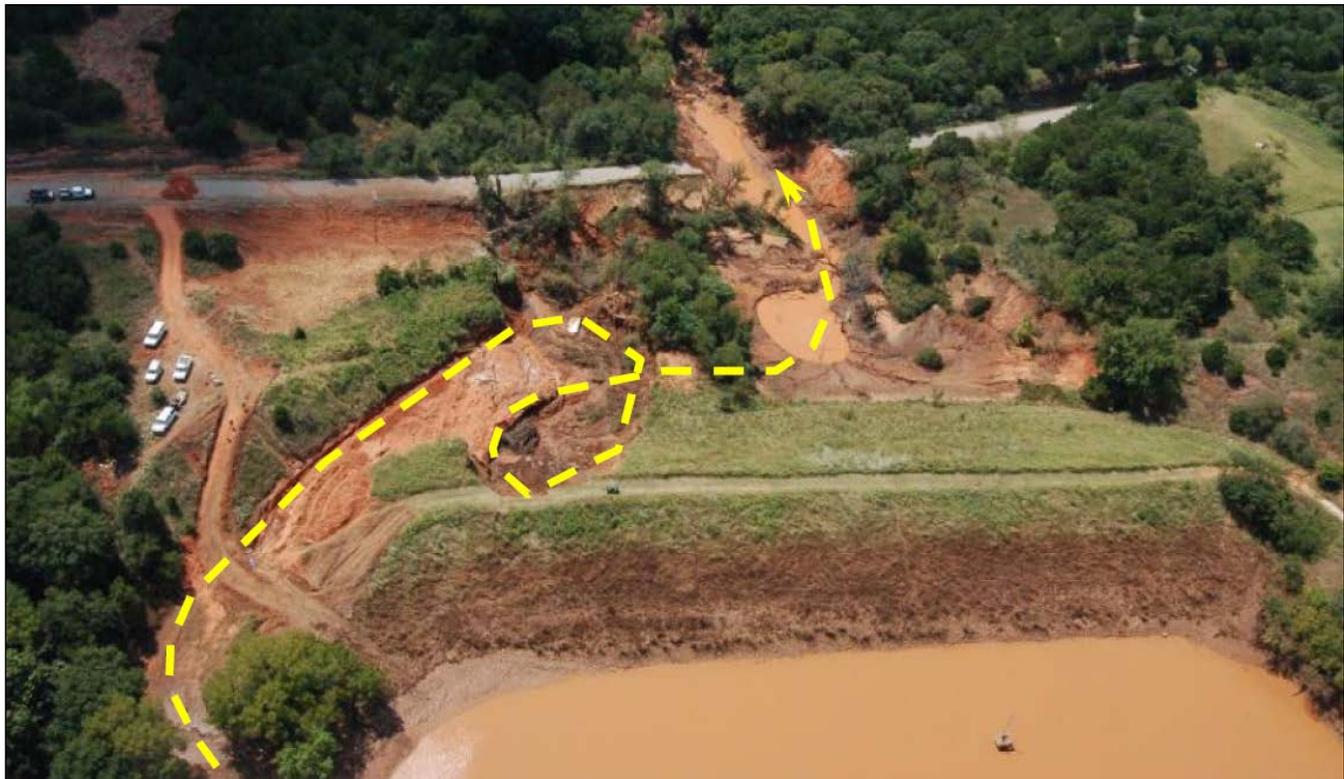
Figure 6. Photograph showing the flow path and erosion in the downstream slope of Sugar Creek Dam in Caddo County, Oklahoma (Photo courtesy of Danny McCook).

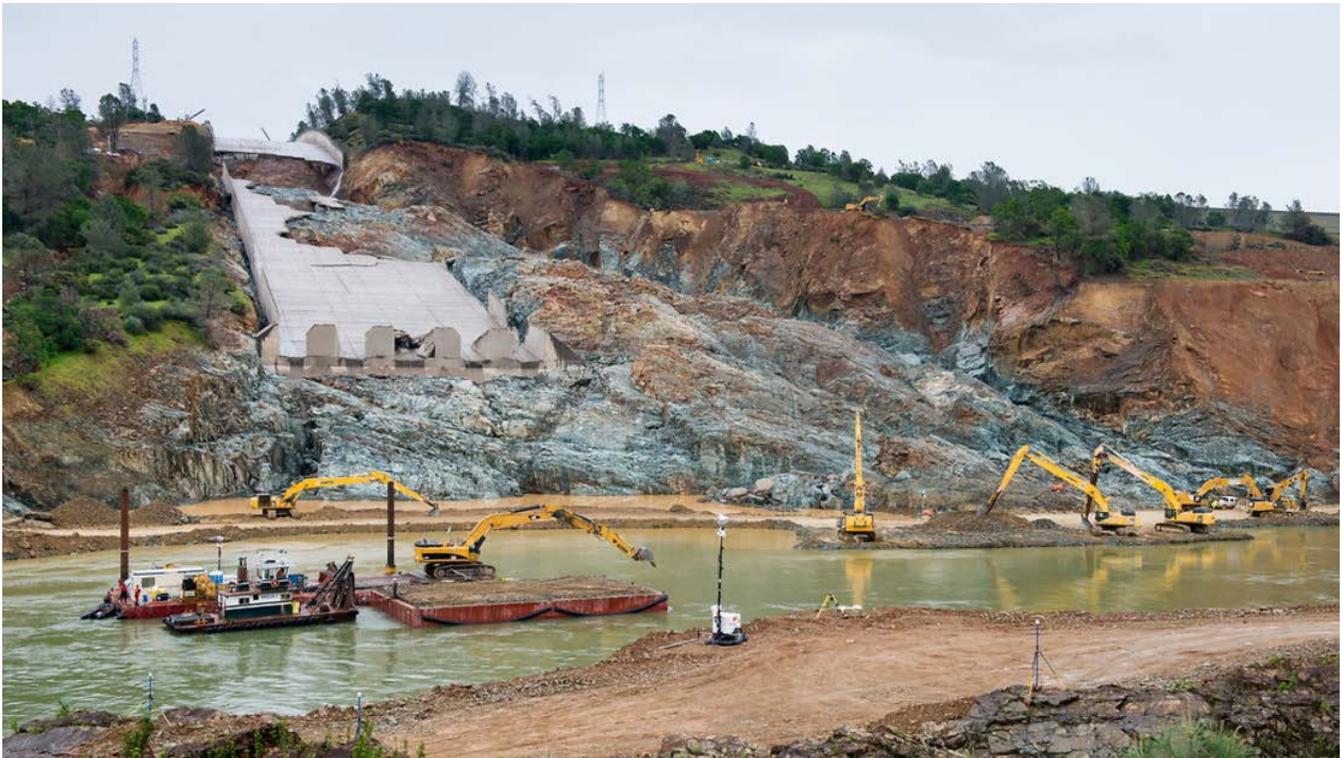
Oroville Dam is a hydroelectric dam constructed in the 1960's. At 770 feet tall, it is the tallest dam in the United States. The concrete main spillway chute at Oroville Dam experienced failure during a period of heavy rainfall and runoff in February 2017. Subsequent flows through the damaged main spillway and the activation of the emergency spillway resulted in significant erosion and deposition of more than 1.7 million cubic yards of material in the Thermalito Diversion Pool and the downstream reach of the Feather River. These deposits created a significant tailwater condition at the tailrace of the Hyatt Powerplant, Oroville Dam's hydroelectric generation facility, rendering the powerplant inoperable. Although the crisis was averted by diverting flows through the damaged main spillway, it is important to note that the three primary means of diverting flow through or around the dam were simultaneously damaged or rendered inoperable. When runoff subsided and the main spillway was able to be closed, crews worked around the clock to clear a path through the material obstructing the downstream channel. This was done in order to lower the tailwater at the Hyatt Powerplant rendering it usable once again.

Figure 7. Debris removal in the diversion pool below Oroville Dam with the damaged principal spillway in the background. (Photo courtesy of CA DWR).
