A SUCCESSFUL FAILURE – NOT APOLLO 13, A DAM INCIDENT AT SUGAR CREEK SITE L-44.

J. Chris Stoner, Oklahoma NRCS, State Conservation Engineer
Robert Toole, Oklahoma Conservation Commission, Director of Conservation
Operations

For Paper and Poster Presentation at the Dam Safety 2008 ASDSO Annual Conference
Indian Wells, CA
September 2008

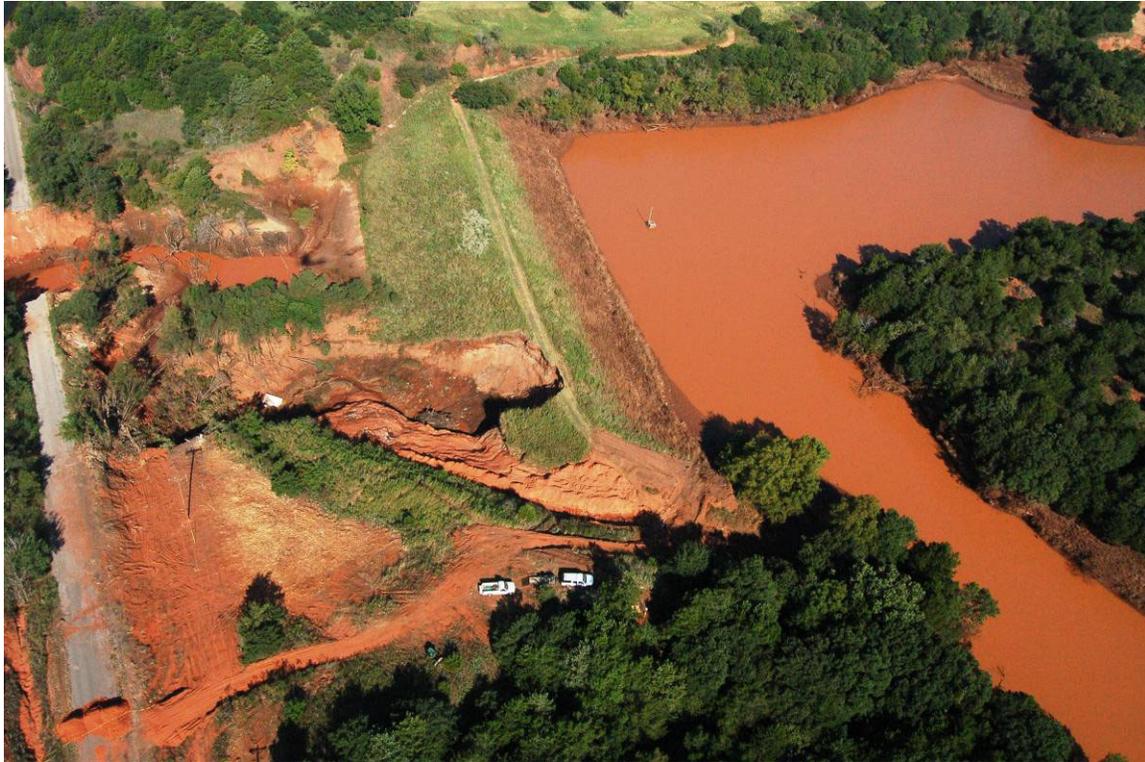
The eroded embankment continued to collapse towards the upstream crest of the top of the dam. By the evening of August 22, the eroded area was within 4 to 5 feet of the upstream crest of the dam. Oklahoma NRCS and Agricultural Research Service

(ARS) Hydraulic Engineering Unit personnel had discussed a possible “controlled breach” and where to locate a breach in the dam to lower the water level and reduce the risk of inundation of downstream homes. A manufactured breach in the dam was planned near the right abutment due to the presence of competent sandstone in the abutment, but this breach was not performed.

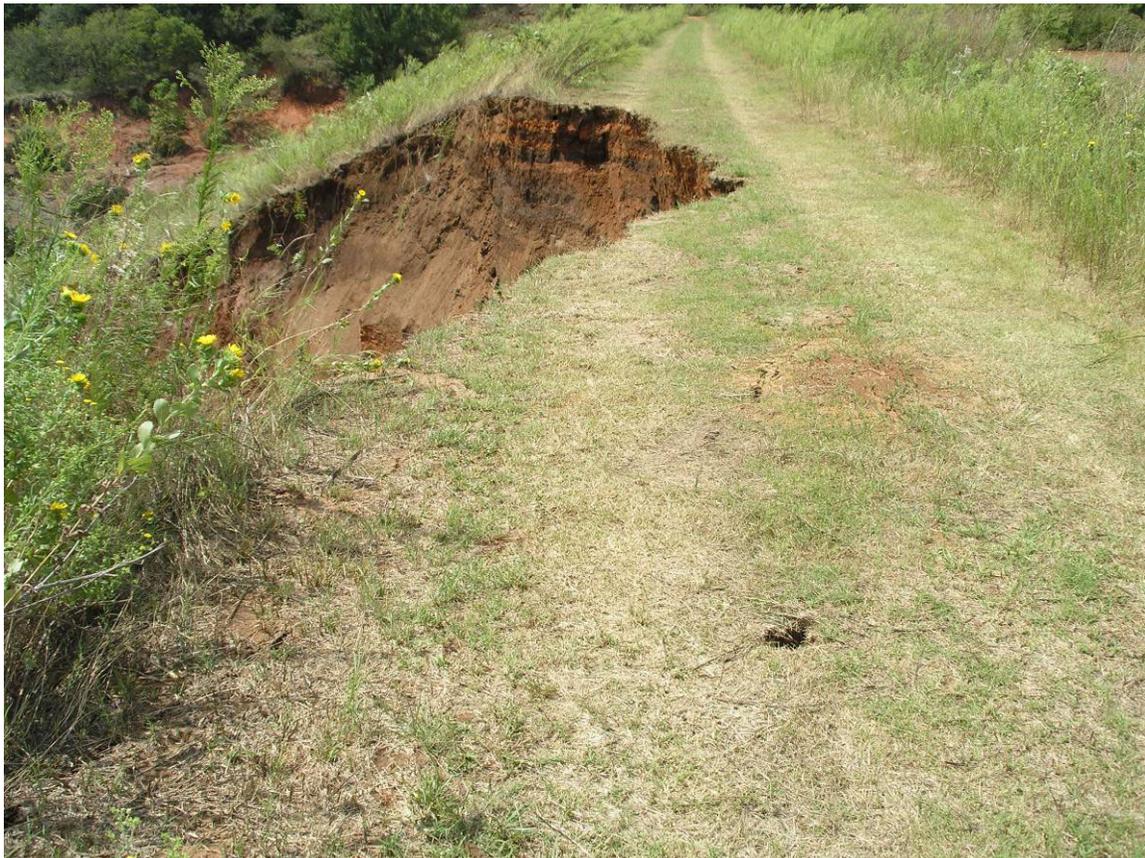
By mid-afternoon, the engineers had evaluated the situation as critical. Large cracks are found along the crest of the dam which indicated more sloughing is eminent. Minor sloughing continues. It is determined that the site is too unstable to try dumping rock into the void to help stabilize it. The next alternative is to get the water out as quickly as possible. The engineers on-site (the Project Engineer and the Resource

Engineer who arrived at 3:00 PM) along with the OCC Watershed Technician devised a plan for a track hoe to dig a trench into the sandstone rock on the outside perimeter of the auxiliary spillway as deep as possible to provide for additional overflow thereby providing more immediate relief. They determined that they will be able to lower the water approximately 5 feet. The NRCS State Conservation Engineer had concerns about such drastic measures and how this would impact the repair of the site, but the Project Engineer stated that if we don't do something to get the water down, we won't have a dam left to repair. It was agreed by all parties to proceed with the trench. Work began to cut the trench around 4:00 PM and was completed around 6:00 PM. The Project Engineer supervised the construction of the AS notch (lowered the water level about 3 feet on his first pass) and the discharge as water began to flow and the OCC Watershed Technician remained on site as well. Most of the flow was exiting the auxiliary spillway away from the dam and sloughing area. Cracking and sloughing continued throughout the afternoon and evening. The principal spillway (PS) is flowing at full capacity with the pool elevated about 16 feet above the inlet. The sponsors are bringing in pumps to expedite the drawdown. The gate is operational but will only be effective once the PS flow is no longer at full pipe.

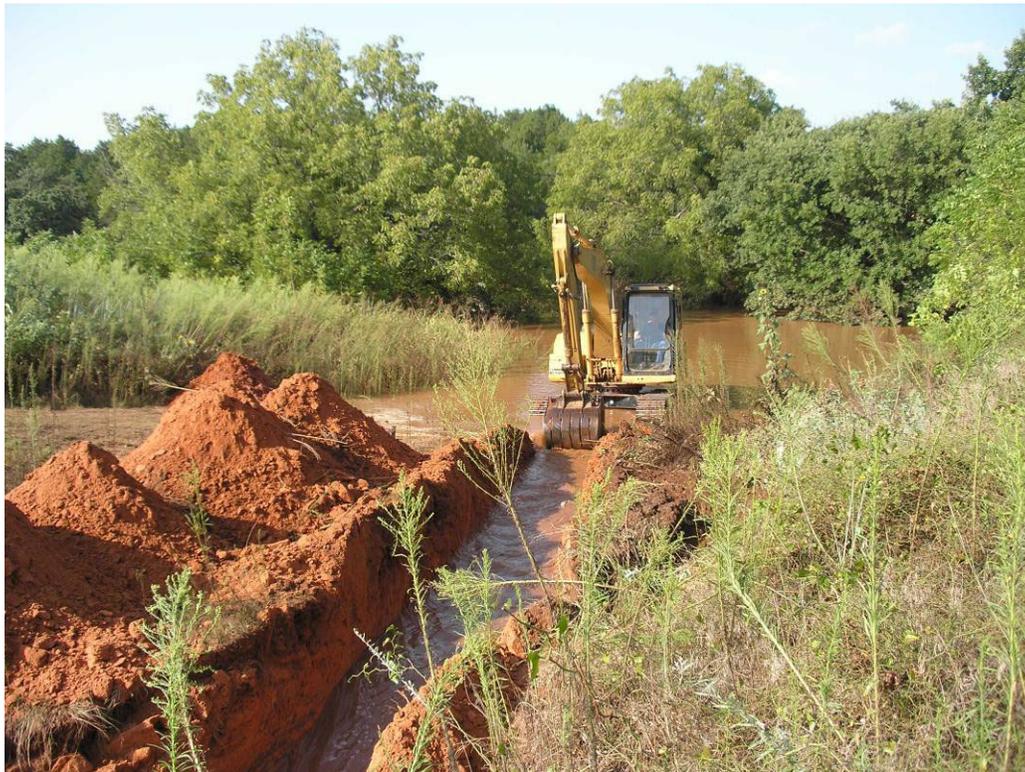
By morning (Tuesday, August 21), the water level was down to the notch that was cut in the AS (approximately Elev. 1302). By 10:00 AM, the Project Engineer and the OCC Watershed Technician determined that additional relief could be made by deepening the notch in the AS. A cut of an additional estimated 2 feet is made. By mid-afternoon, the slough has seemed to stabilize, but the danger is far from over and the Project Engineer recommends continuing to keep people out of their homes and away from the downstream area. The site is monitored throughout the day.

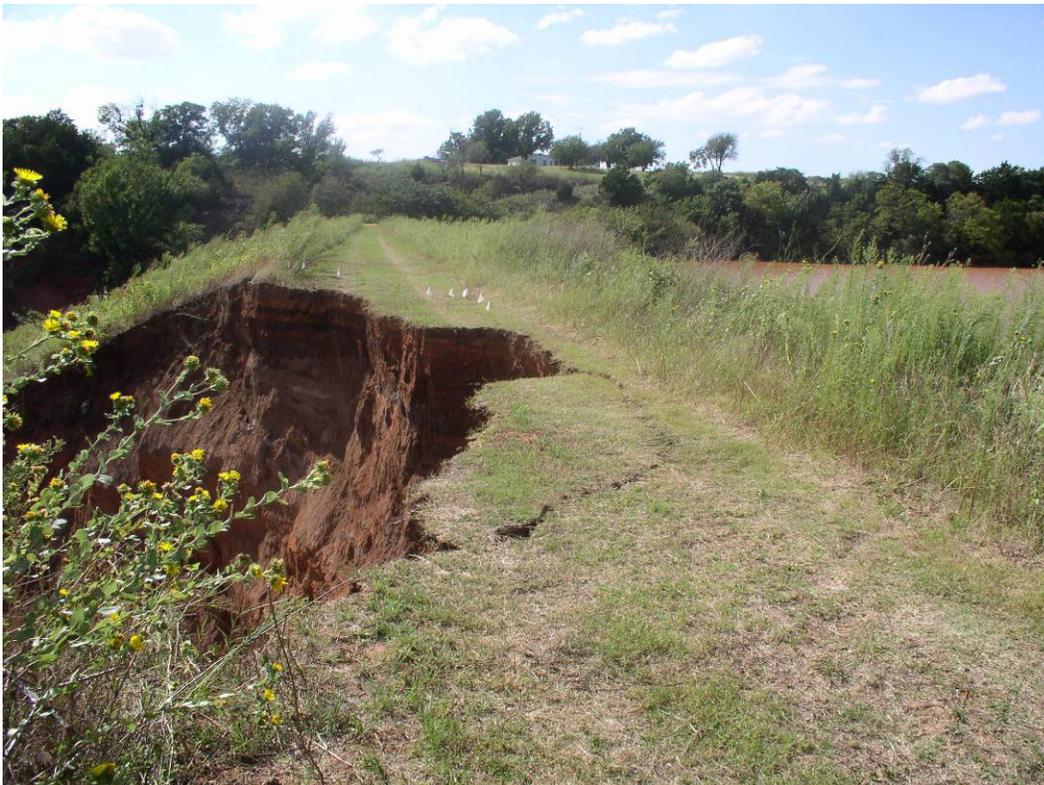
Wednesday (August 22) morning reveals a large crack along the top of the dam. If the present crack sloughs, the top width of the dam will be reduced to about 4 feet. (Currently it is at 6 feet approximately) Around 10:00 AM the crack breaks off, and plans begin immediately for the NRCS State Conservation Engineer and the NRCS Head Design Engineer, Oklahoma to visit the site. In addition, contacts are made with the ARS Hydraulics Research Unit Leader (ARS) and the National Design and Soil Mechanics Center in Ft. Worth. A Design Engineer from the Center also leaves Texas for the site. The Director of Conservation Operations for OCC proceeds to the site and orders the three Watershed Technicians and the two 3000 GPM pumps be dispatched to the location.

Upon arrival, the slough was past the center line of the dam and vertical for about 35 feet. Additional cracking was evident. Discussions begin to possibly perform a “controlled breach” as a last alternative to protect downstream interests. The NRCS State Conservation Engineer and the ARS Hydraulics Research Unit Leader discussed possible breach scenarios. They determined based on the downstream soils and topography that the best location would be near the right abutment. The ARS Hydraulics Research Unit Leader estimated under controlled conditions that the breach would be fully-involved in about 2 hours, compared to about 30 minutes if a major slough caused an uncontrolled breach.

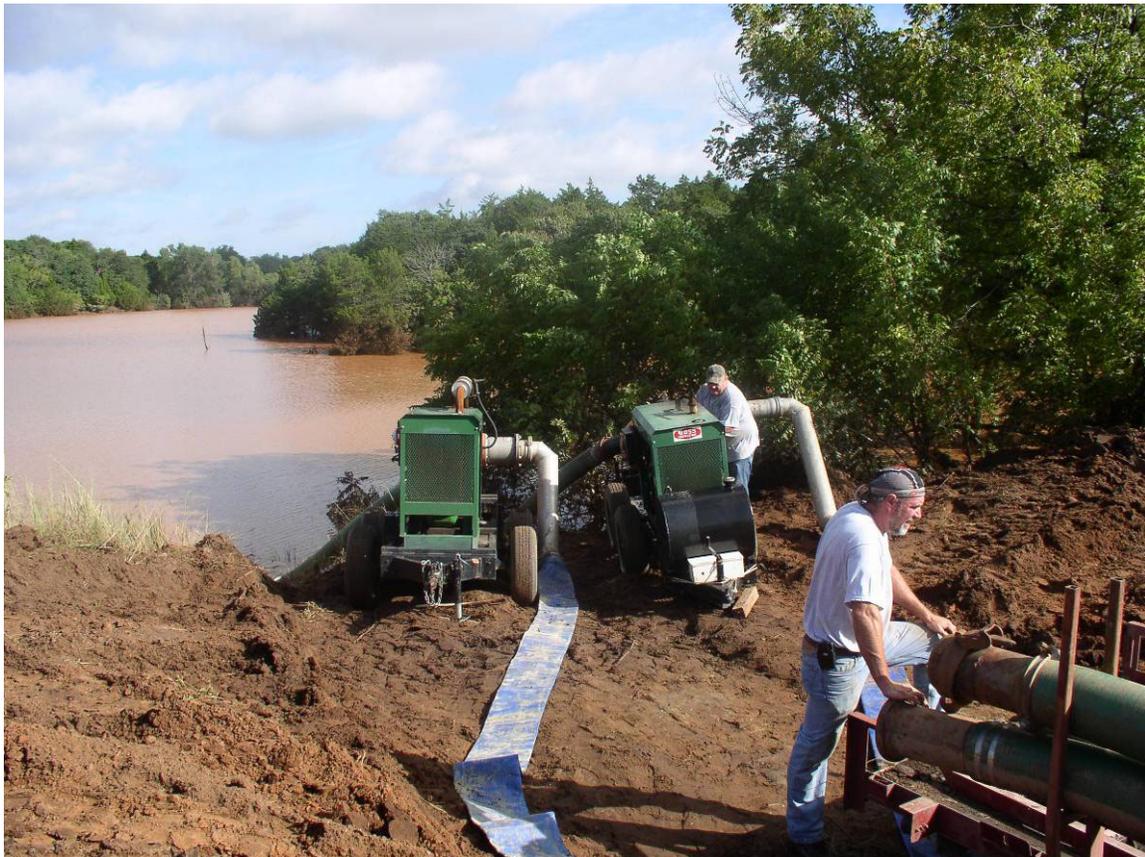
No additional cuts can safely be made in the auxiliary spillway and the only option available to get more water out of the site is to pump. Access to the pool area with the large OCC pumps is limited. A road had to be constructed by OCC and the

South Caddo Conservation District from the county road, over a high bluff and to the AS forebay. The pumps are positioned and placed in operation.

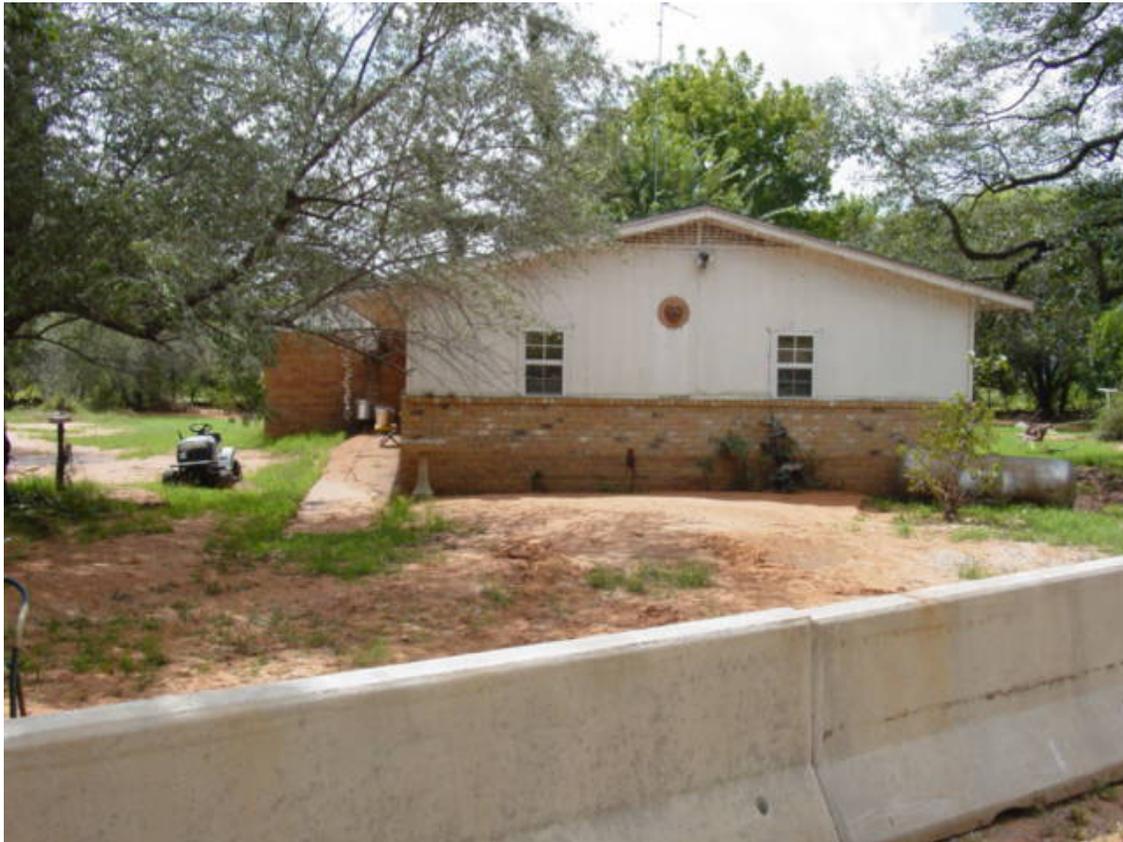
By Thursday (August 23), parts of the major crack had sloughed, but not all. It was noted that previous sloughing had created somewhat of a toe at the base of the slough and was helping to stabilize some areas. Some parts were still vertical for about 35 feet. NRCS employees from the planning, design, and watershed construction (surveying) staffs arrived on site to begin planning and design for the rehabilitation. The site had been tentatively approved for rehabilitation and was on a fast-track for planning and design. This was a significant step and aided in the decision making process for how to stabilize the dam.

By the time plans were finalized for the Jersey Walls, things seemed to be stabilizing at the dam site. However as a measure of safety, installation began on the Jersey Walls around 7:30 PM Thursday and was completed around noon on Friday.

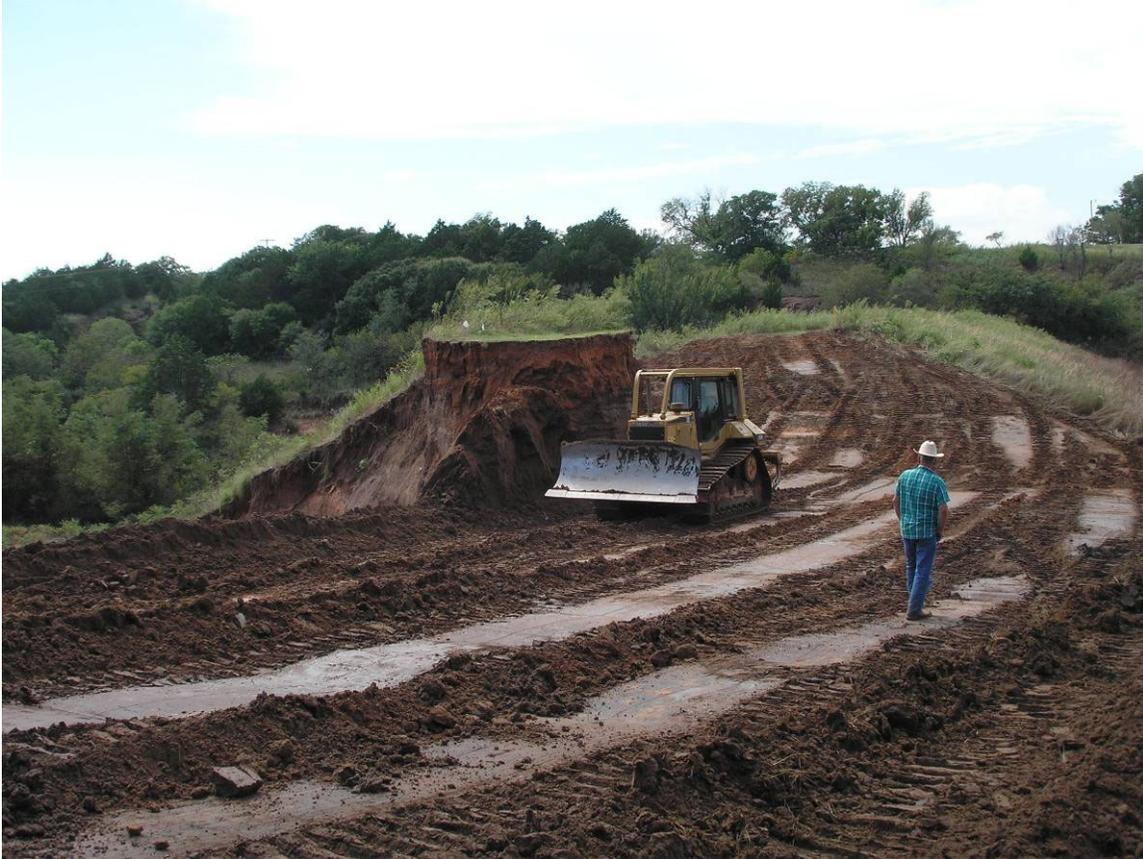
Flow was still somewhat restricted due to the size of the gate opening. Plans were developed to cut additional notches in the tower to provide more capacity. This work requires a dry stable work area and could not start until the water completely receded.

Pumping and monitoring continued through the weekend. In addition, the NRCS staff also formulated plans to begin notching the dam. The notch would not be a breach, but a cut through the embankment, stopping 1.5 feet above the water level. Since it would take considerable time to excavate to the desired elevation, the work was ordered to begin prior to the determination of the final elevation of the notch. As the water level drops, the notch would be cut lower until an elevation was reached that would provide some minimal flood protection, but would not be a breach hazard. The NRCS Hydraulic Engineer in Stillwater worked on determining the desired elevation. The notch was to be located at the slough area. This would allow excavated material to be used to fill in the slough and there was more disposal areas along the left abutment. Salvaging fill was a prime concern for the eventual rehabilitation of the site. Excavation was to be on a 2:1 slope with a top width of around 200 feet. This would allow for a 10 foot bottom at the maximum cut elevation. If less cut was needed, the bottom width would be wider. At no time was the cut to be closer than 1.5 feet from the water level. Work on the notch began on Tuesday afternoon, August 28 (9 days after the event

began). This was viewed as an extreme option, but one that would eliminate the threat downstream allowing people to return to their homes and leave the site in a somewhat stable state until rehabilitation could begin. If rehabilitation of the site was not an option, plans would have likely been different.
