The Little Deer Creek Dam Failure

A Forensic Review of a Fatality

Utah Dam Safety

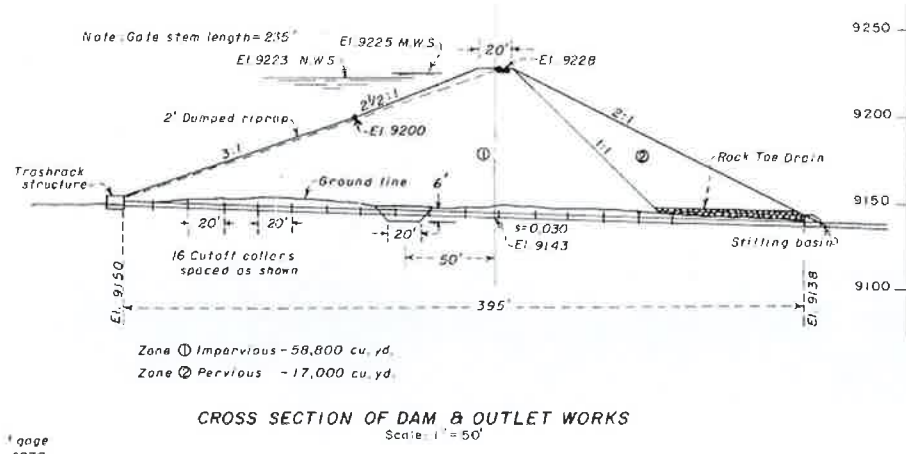
Figure 3: Profile of Maximum Section of Dam by Utah Water and Power Board Design Drawing (1961). Note: Actual Section Built was a Homogeneous Section

The autumn of that year was especially inclement and the contractors worked in difficult, wet and cold, early winter conditions. The construction log made many references to the freezing weather, the wet fill, the jointed and fractured condition of the rock on the right abutment, the probability that it could seep and pipe, the inadequate cutoff (bedrock was 17 feet deep) and the lack of structural integrity of the outlet pipe. The US Soil Conservation Service, in their review of the dam, made several comments about the design and recommended a drainage system on the seep area on the right abutment (Figure 3). During the first construction season, water was noted flowing from the right abutment

The Fuhrman and Rollins Engineering Company prepared a report on the failure in November of 1963. This report cited seepage, through the unsealed and unfiltered right abutment, as the probable cause of failure. Attorney’s briefs concerning the case also noted the wet weather, wet fill, insufficient cutoff, large boulders in the fill, insufficient bedrock preparation and a change in the specification from a zoned embankment to a homogeneous

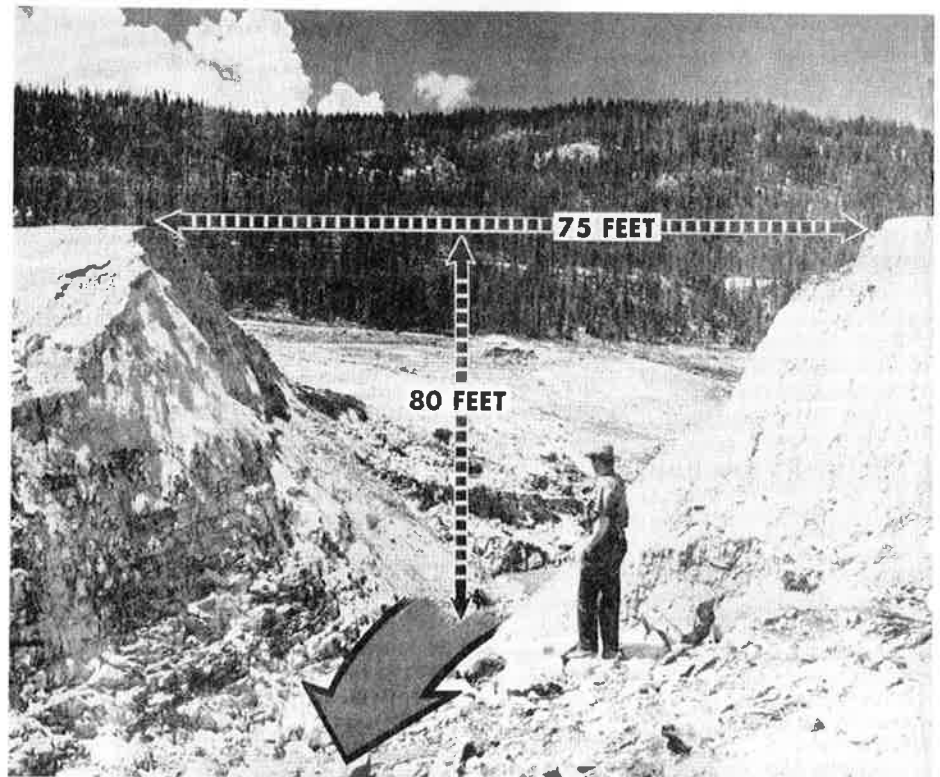
Figure 4: Breach Opening. Salt Lake tribune, June 18, 1963.

14,000 and 17,000 c.f.s. The final breach was 80 feet deep and 75 feet wide and extended below the dam to bedrock 17 feet below (Figure 4). Downstream damage was extensive and is still visible today. There was a scouring of the immediate downstream toe area, followed by several acres of deposition above a grade control rock out-crop where pieces of the outlet remain. Downstream of this grade break, is another steep, scoured channel that dumps into the much flatter Duchesne River, downstream of the diversion dam for the Duchesne Tunnel. There is a huge debris deposit at the confluence that backs up a small lake/wetland area to the base of the diversion dam. After the dam failed the flood waters took 5 hours to reach the towns of Hanna and Tabiona, 15 miles away, and roughly 12 hours to reach the town of Duchesne, 45 miles away. It was reported that 10 out of 11 bridge crossings on the Duchesne River were washed away with the flood and there was also minor damage to farms next to the river. It also inundated the small Ashley National Forest campground on the Duchesne River. The bridge repairs were estimated at \$190,000, the Browns filed a claim for \$31,000; additional claims totaled \$96,000. No civil suits or criminal charges were ever filed and no licenses were reviewed or revoked on account of this failure. There have been several other catastrophic dam failures in the state of Utah, with two other related

A raging torrent of water which took the life of a young boy and did extensive damage in Duchesne County poured through this gap in the Little Deer Creek Dam which is checked by District Forest Ranger Larry Colton. The earth-filled dam was completed during the past year.

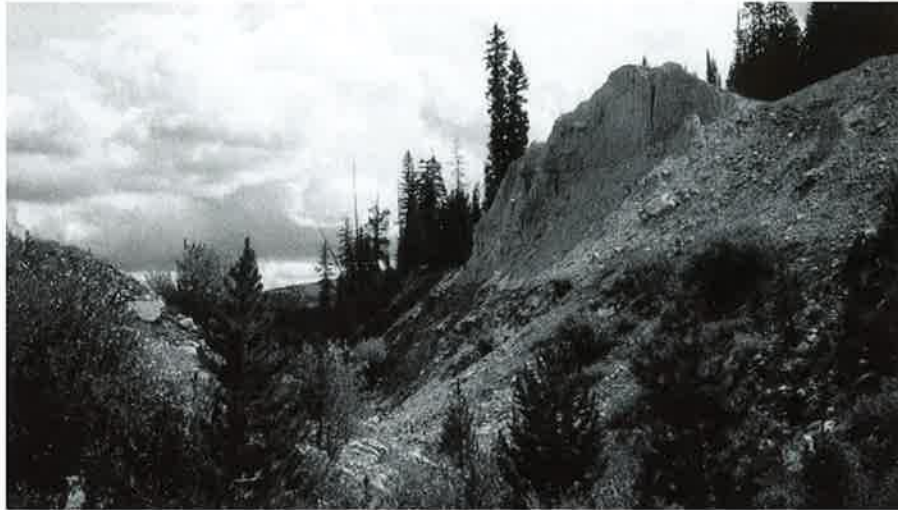
*Figure 5: Remnants of Dam in 2002 Looking Upstream
Note: Left Abutment Spillway Channel at Top Right in Photo*

Today, the remnant of the Little Deer Creek Lake has a small, natural grade control at the outlet and supports a healthy lake, wetland and littoral area (Figure 5). Moose were feeding in the lake as I performed the forensic reconnaissance in August 2002. The clearing originally done for the lake was evidenced only by the age of the younger trees growing below the old high water line. The stream flowing from the right abutment near the outlet intake was flowing 1 c.f.s. and an adjacent spring was flowing 5 - 10 g.p.m. during the latest visit. A complete section of the dam

embankment, with a vertical face, remains on the right abutment but the left side of the dam has been completely removed. The most striking features of the small piece of the old embankment are the sandy gravel matrix with very little minus No. 200 sieve, excessive amounts of 3 - 6 inch cobbles and boulders as big as 3 - 10 feet in diameter. There is a slump on the right side of the remaining crest over the right abutment. The maroon quartzite, visible on the right abutment, is highly fractured and jointed with intermediate green siltstone layers every 8 - 12 inches. The main open joint patterns trend steeply downstream at approximately the slope

of the stream and appear to be at a favorable piping orientation. A piece of the old spillway structure remains high and dry on the left abutment, with a “Utah State Engineer” survey monument embedded in the concrete. A 72-foot section of the storage gage remains on the upstream left abutment; the borrow pit of the right abutment still contains an old culvert and plow blades.
