Department of Water Resources

INVESTIGATION OF FAILURE
BALDWIN HILLS RESERVOIR

APRIL 1964

Baldwin Hills Reservoir Failure Consulting Board Report

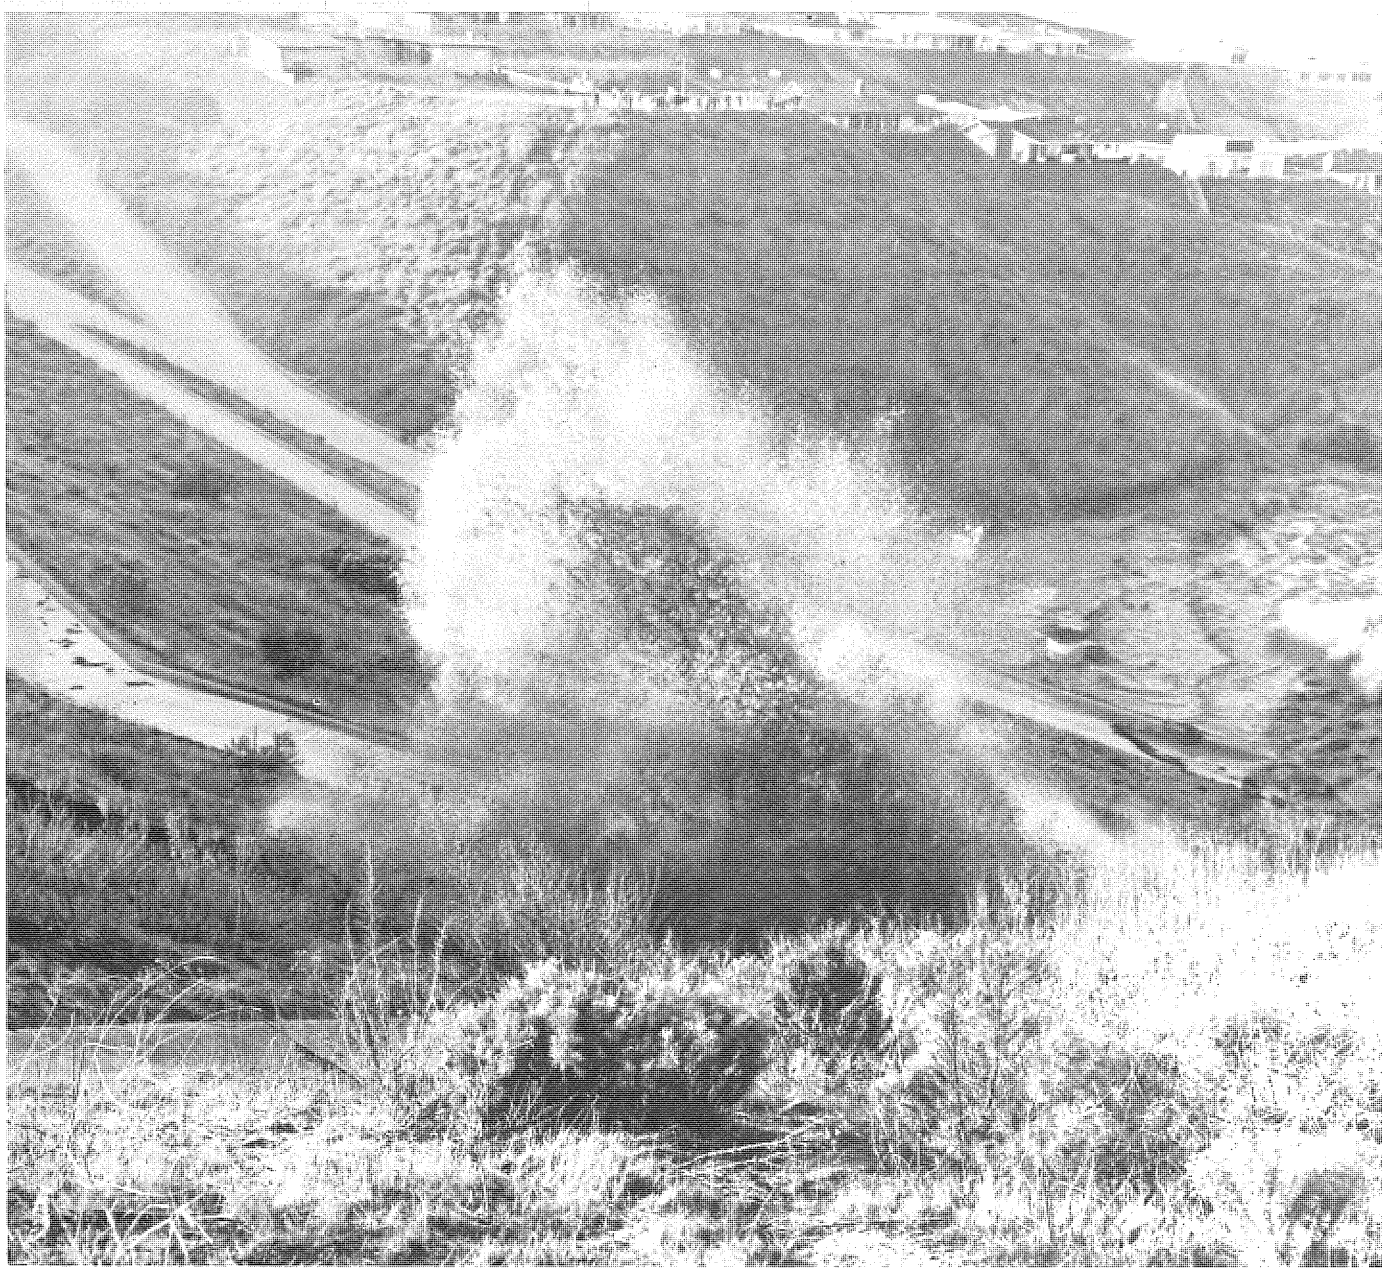
PHOTO 4. Flow through breach during final stage of failure, at about 4:00 p.m. Spray caused by material falling into flow.

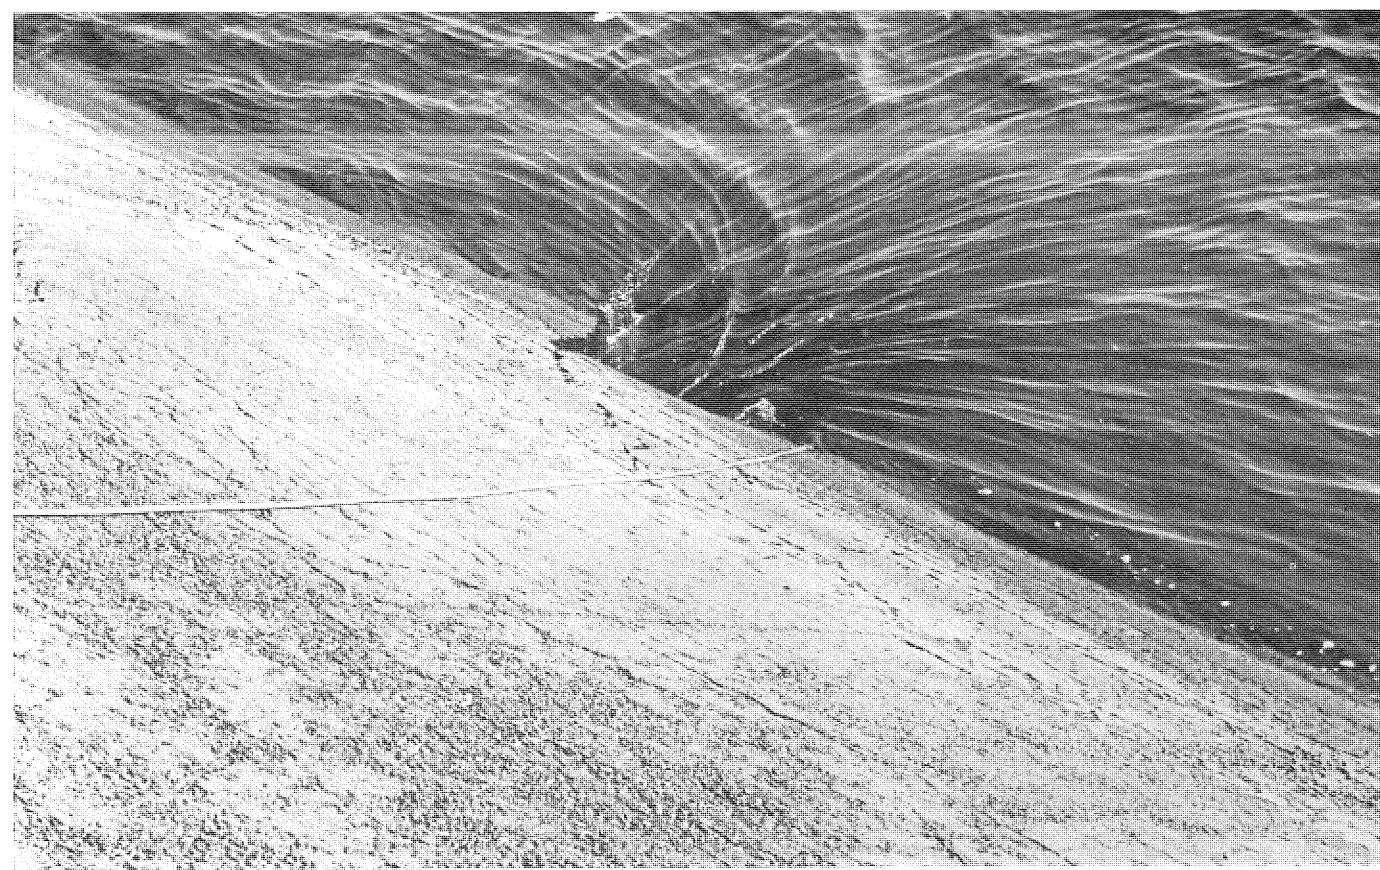
PHOTO 5. Discovery of hole on face of main dam at approximately 2:20 p m.

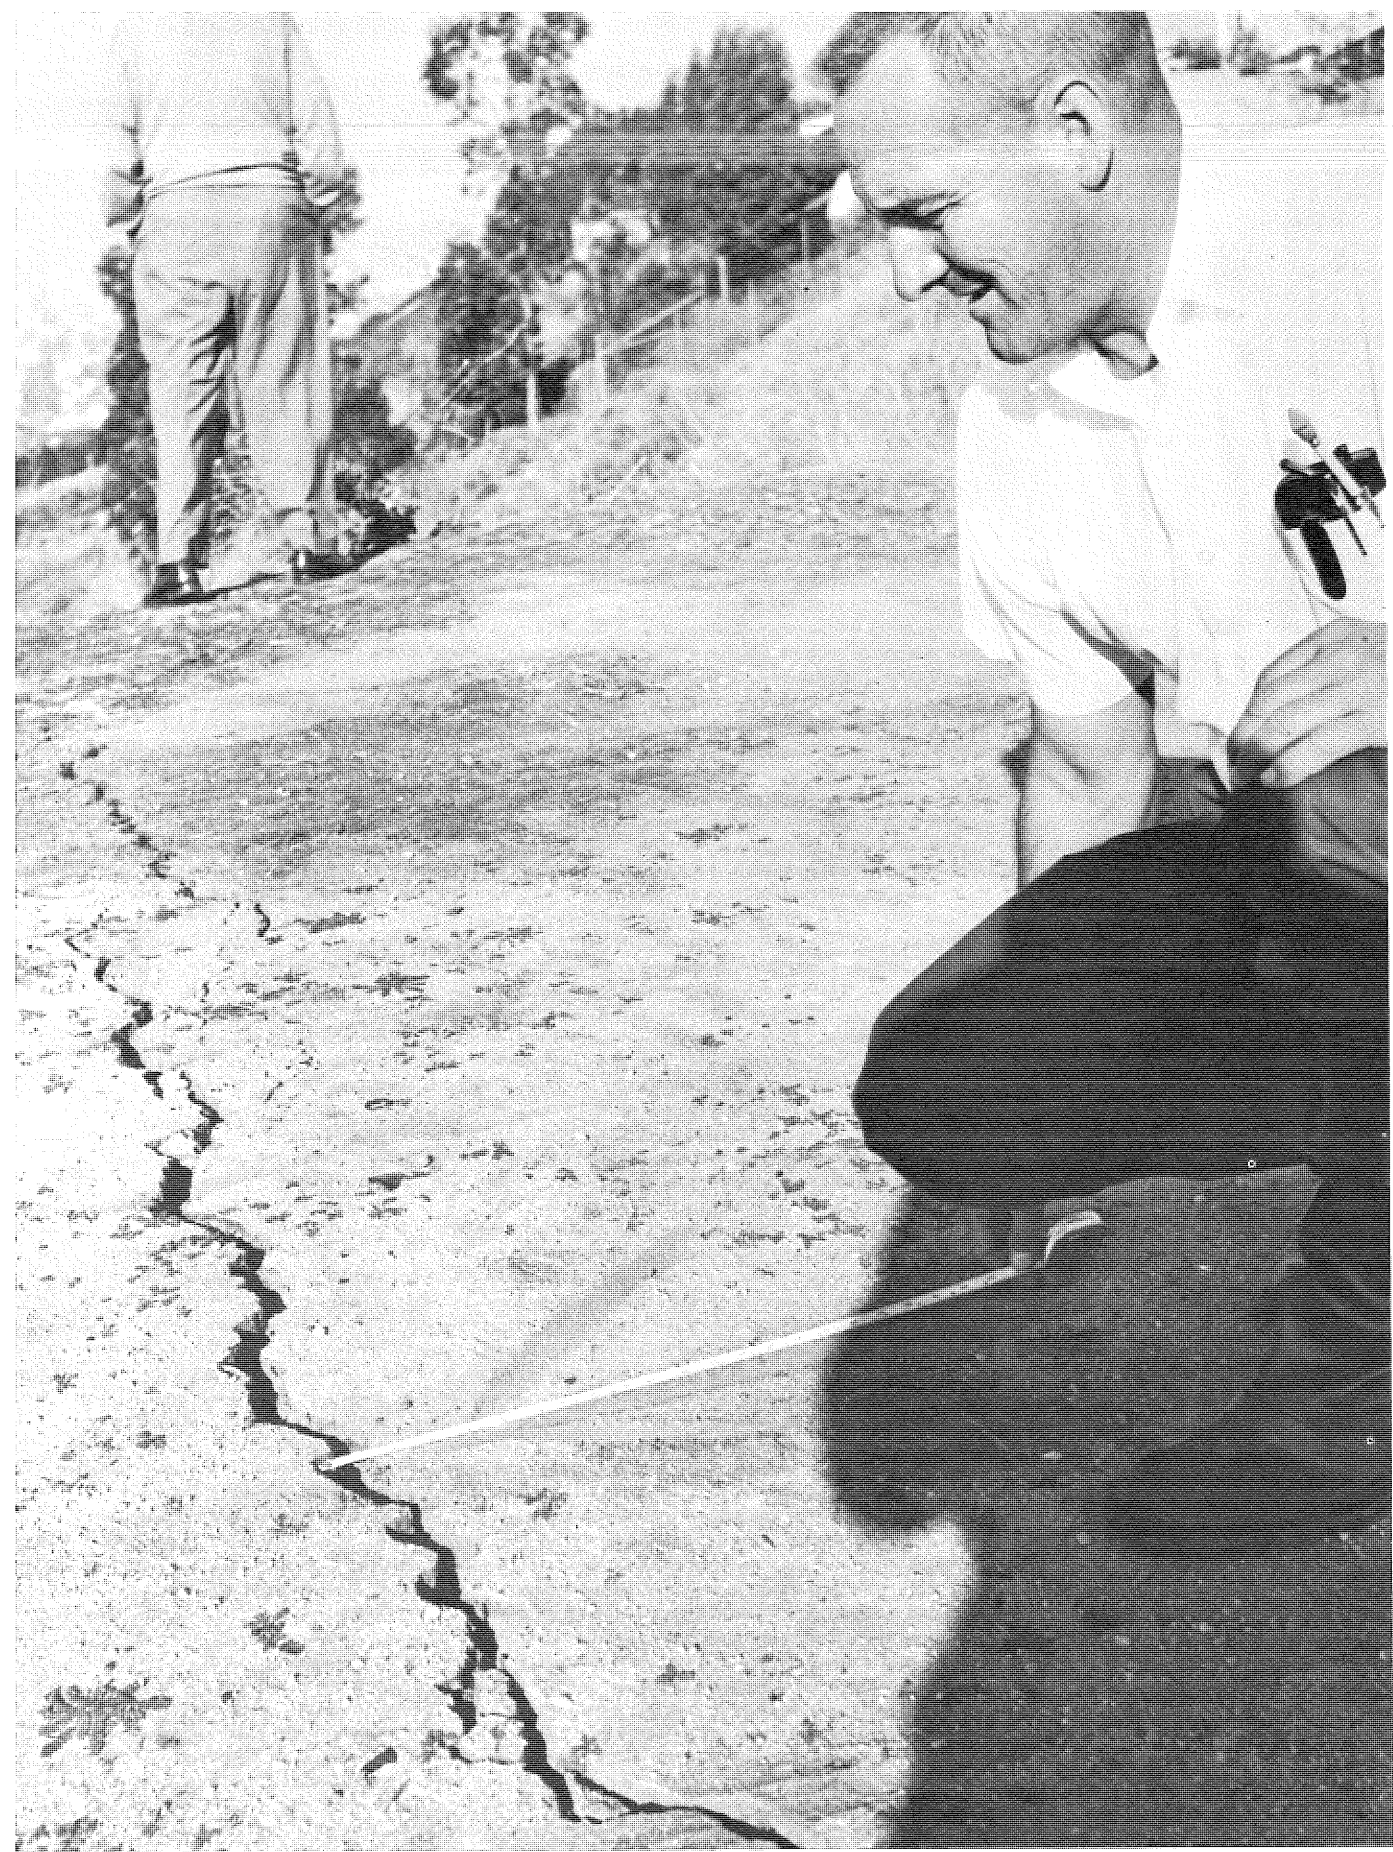
PHOTO 13. Crack at crest of main dam near east abutment.

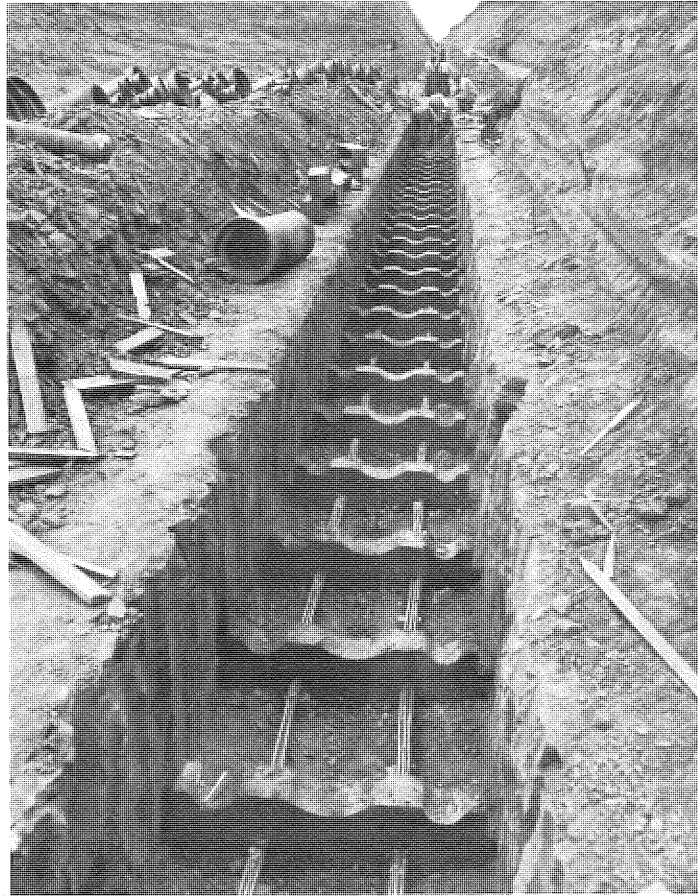
PHOTO 24. Foundation drainage details—Cradles for 4-inch and 12-inch tile and copper tubing for settlement measuring devices.

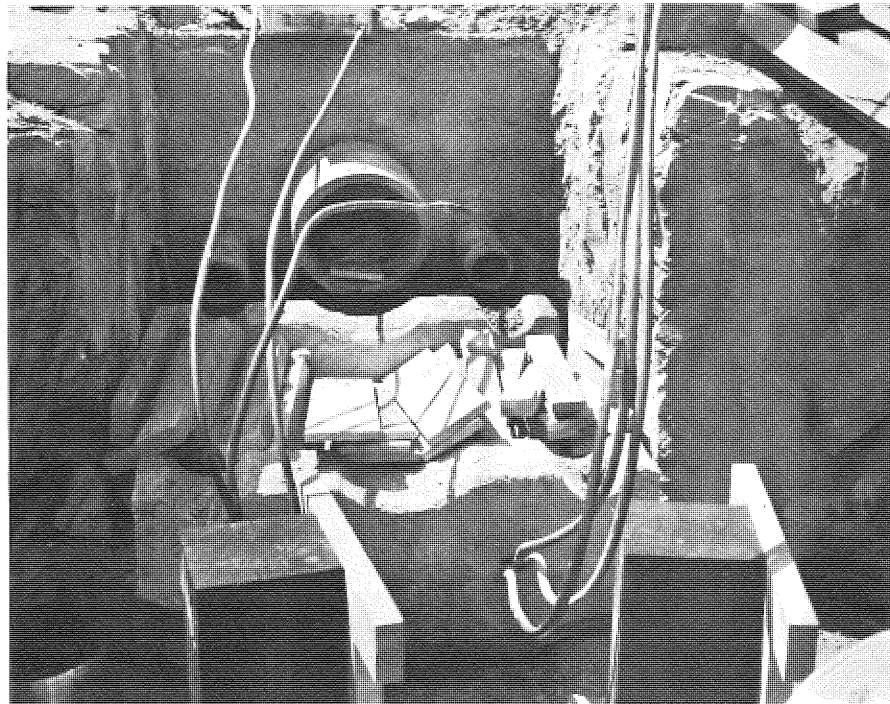
PHOTO 25. Looking upstream from Manhole A, showing 12-inch and 4-inch tile drains and copper tubing.

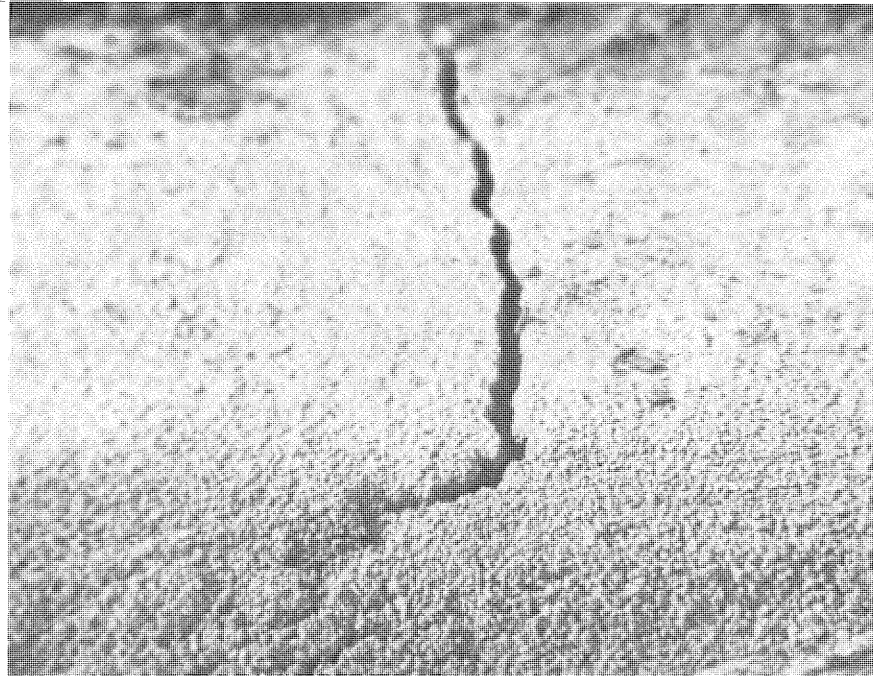
PHOTO 40. Crack in 4-inch cemented pea gravel discovered during construction.

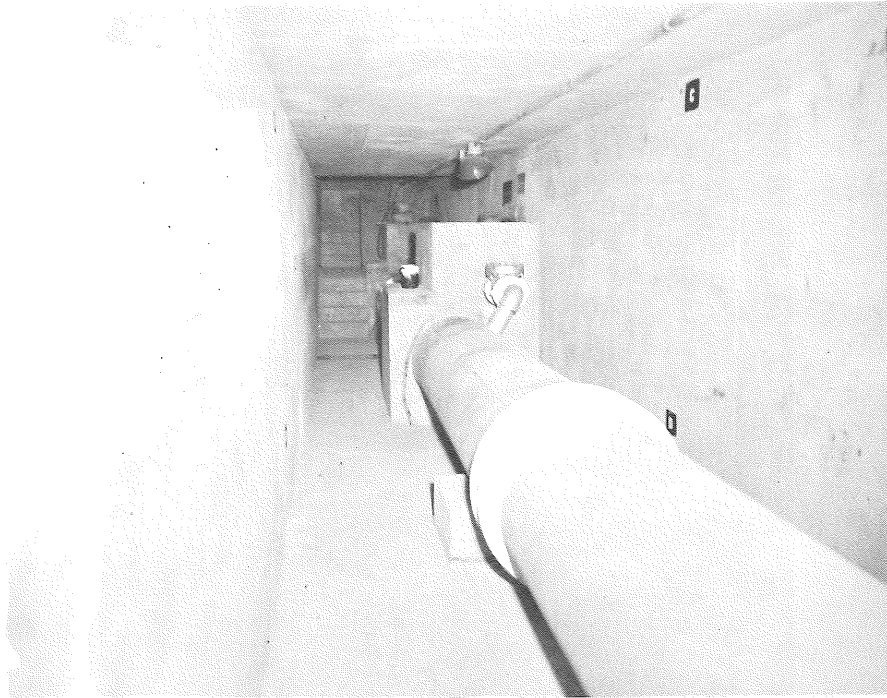
PHOTO 47. Drainage inspection chamber, January 10, 1952, showing 24-inch blowoff pipe in foreground and weir box for southeast toe, northeast toe, and fault drains in rear. Labels C and D on south wall locate crack at Station 0+70.3.

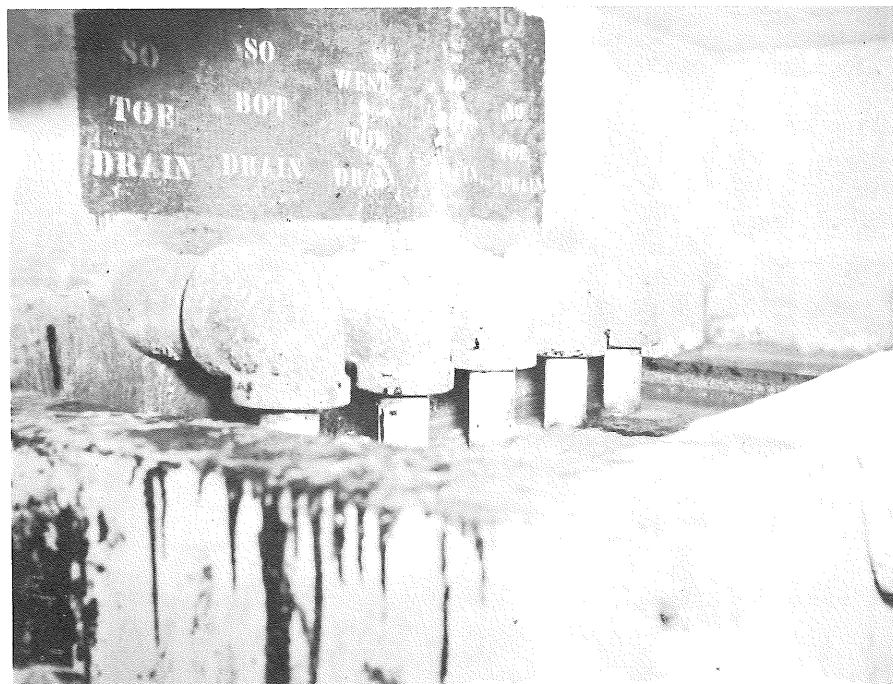
PHOTO 48. Drains at west end of drainage inspection chamber, January 10, 1952. Note evidence of asphalt discharge.

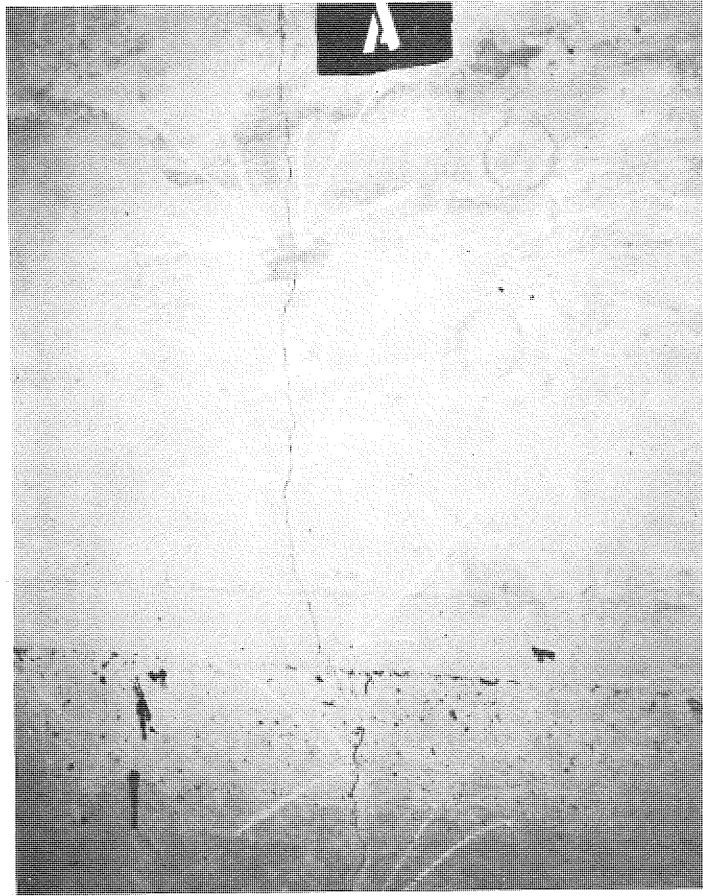
PHOTO 51. Crack in drainage inspection chamber at Station 0+70.3, January 10, 1952.

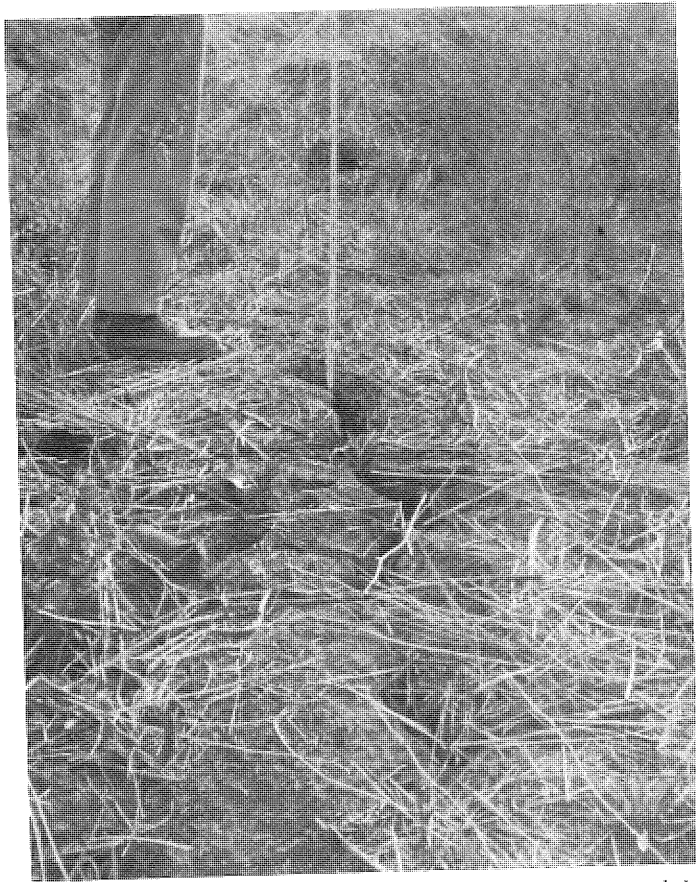
PHOTO 55. Earthcrack 4 near La Brea Avenue. A typical open crack in undeveloped field.

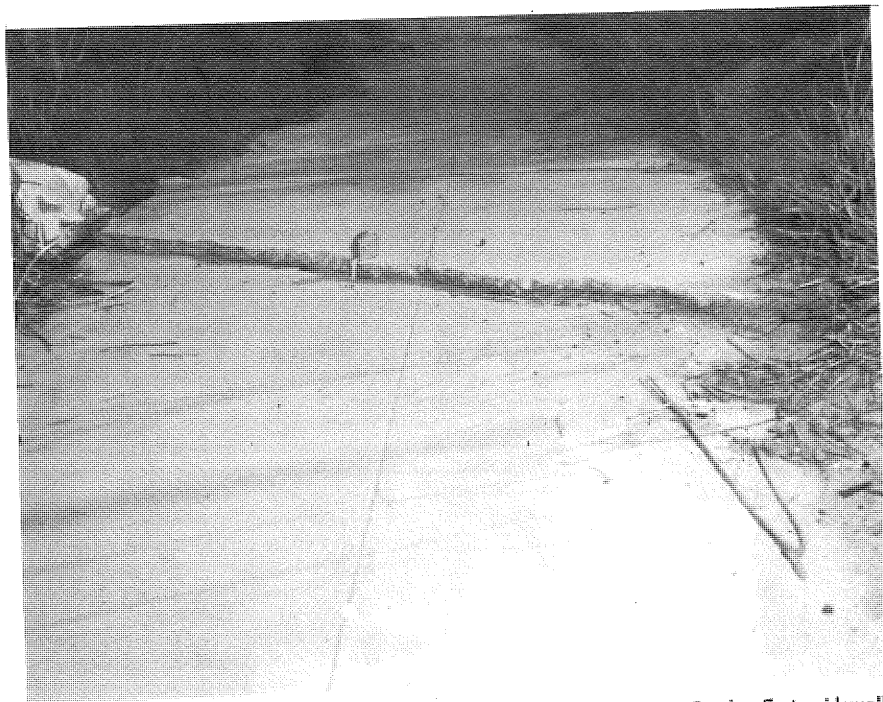
PHOTO 56. Earthcrack 6 near Don Miguel and Don Lorenzo Drives. Crack offsets sidewalk about 1 inch.

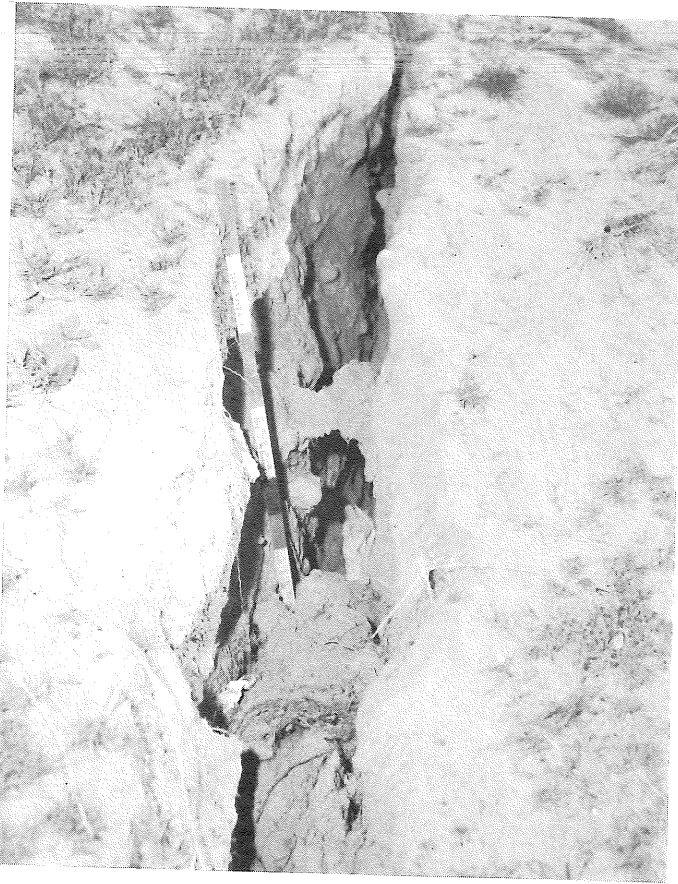
PHOTO 57. Earthcrack 9. Looking north showing open crack near base of slope northwest of detention basin and south of Cloverdale Avenue.

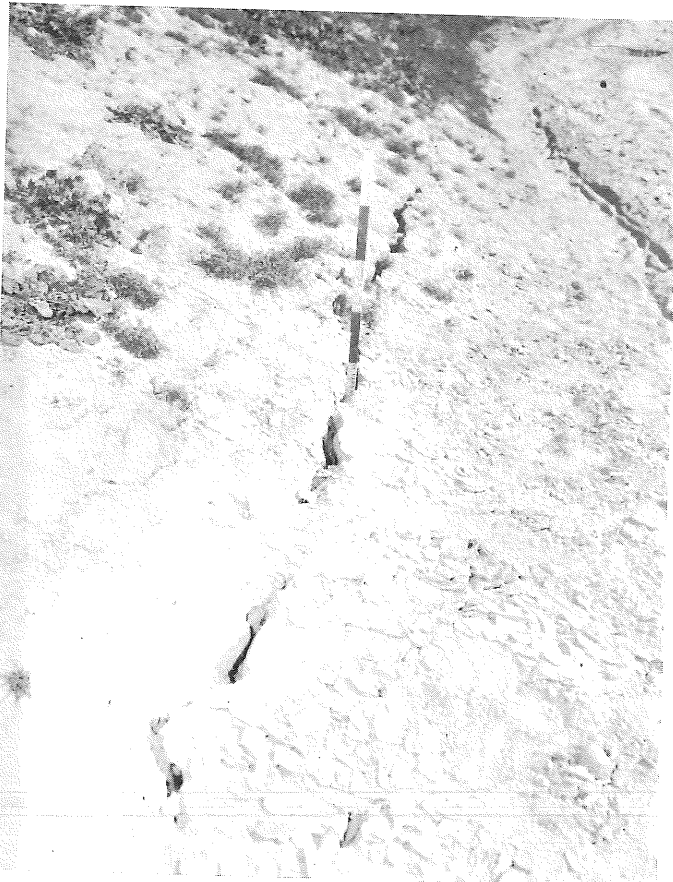
PHOTO 58. Earthcrack 10. Looking north at open eroded crack in south bank of Cloverdale Avenue.

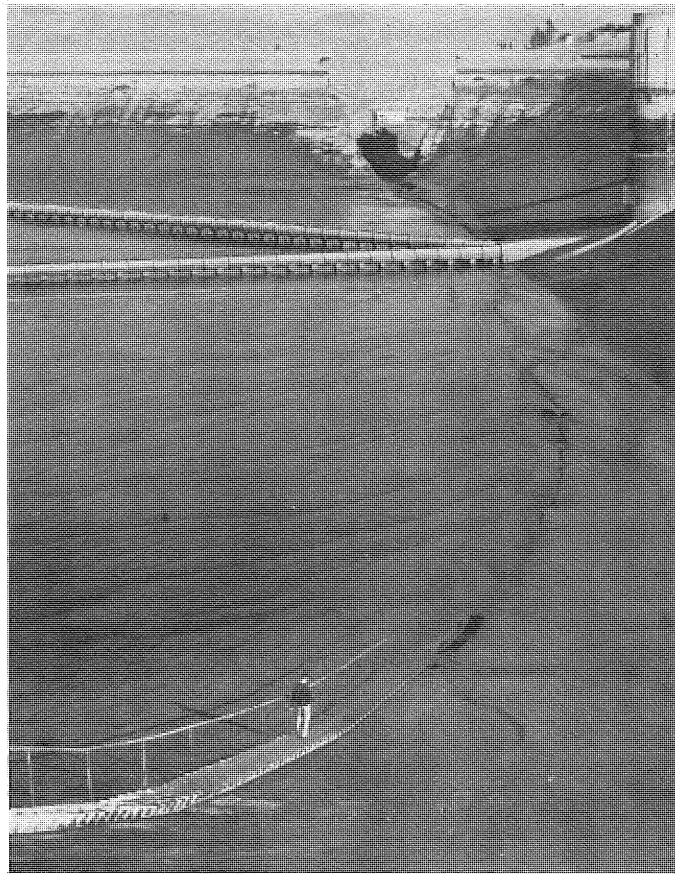
PHOTO 59. Ruptured reservoir lining and breach in main dam, December 15, 1963.

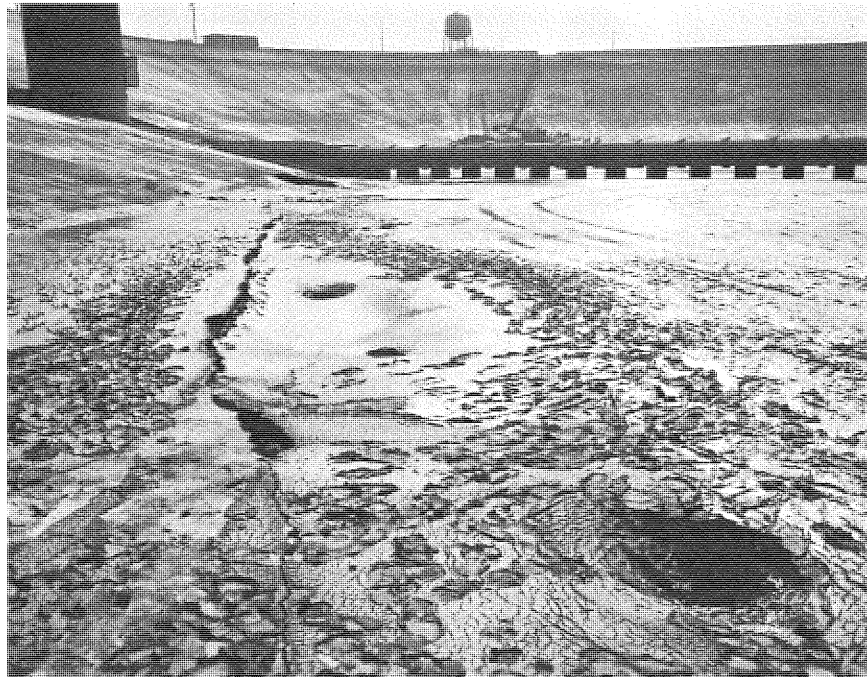
PHOTO 64. Sink holes and collapse features west of surface expression of Fault 1 along east side of reservoir.

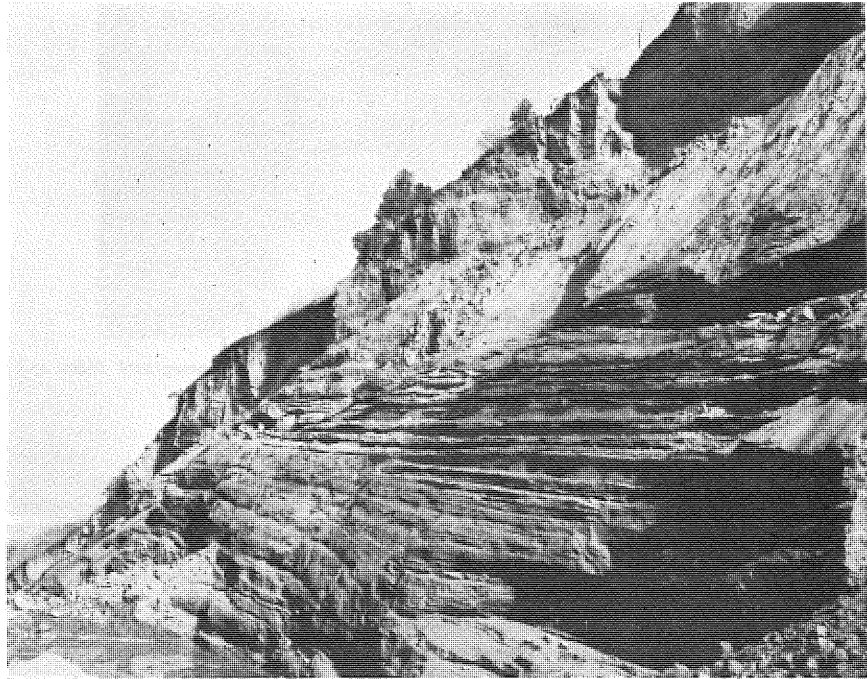
PHOTO 67. Effects of water erosion on foundation strata on east face of breach, December 22, 1963.

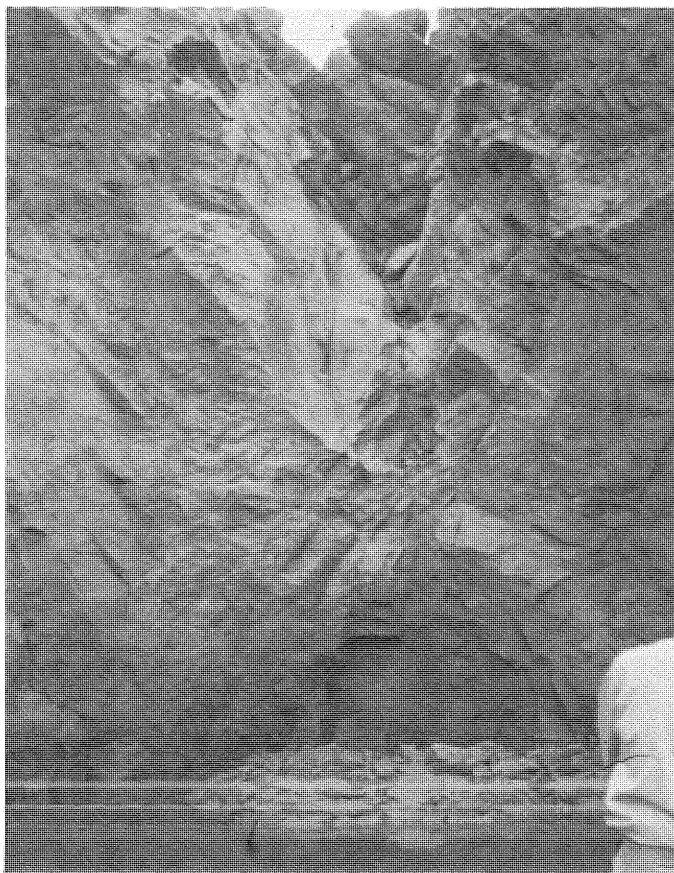
PHOTO 69. Looking upstream at faulted Pico formation in lower end of breach, December 16, 1963.

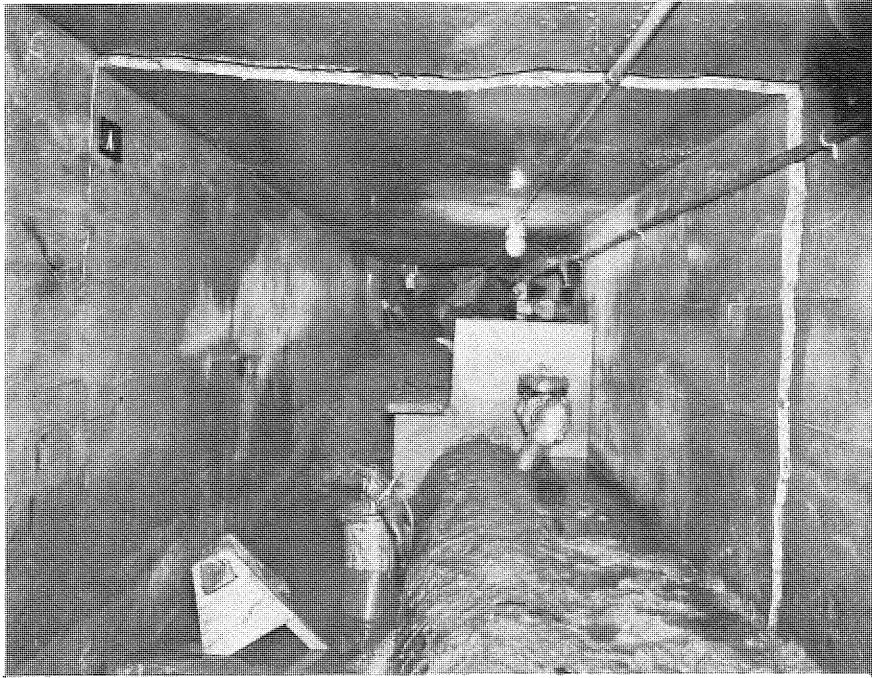
PHOTO 72. Drainage inspection chamber, showing crack at Station 0+70.3, December 20, 1963.

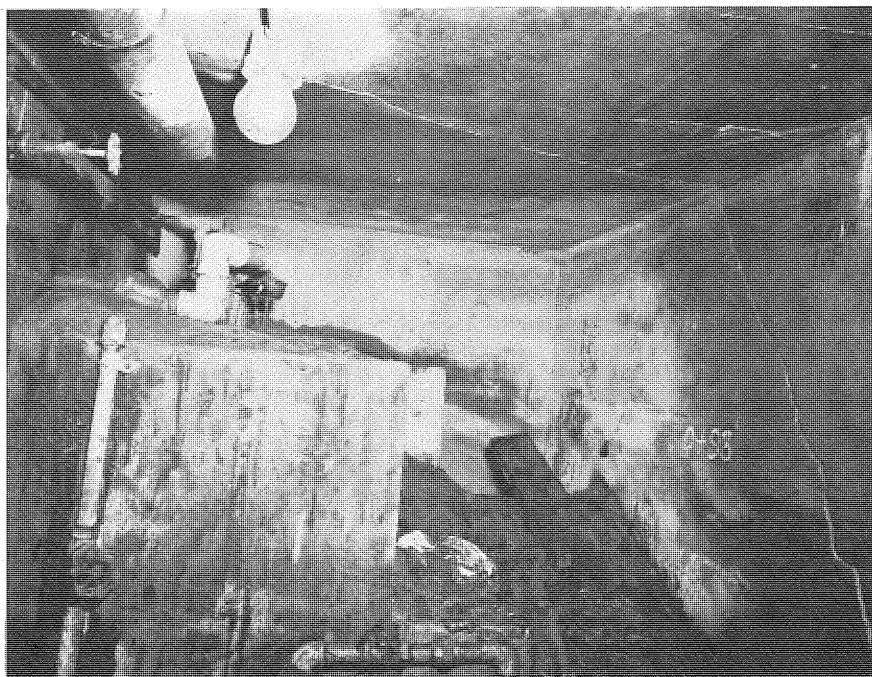
PHOTO 73. West end of drainage inspection chamber, showing crack at Station 0+89, drains, and weir box, December 20, 1963

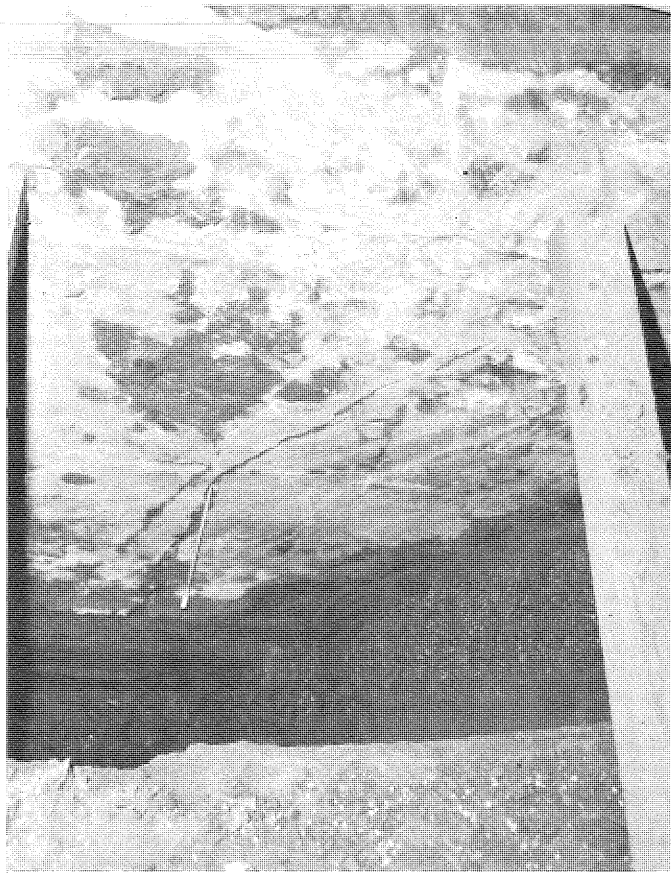
PHOTO 79. Break in north wall of drainage inspection chamber at Station 0+89 as exposed in Excavation No. 7B. Break closes to hairline crack at top.

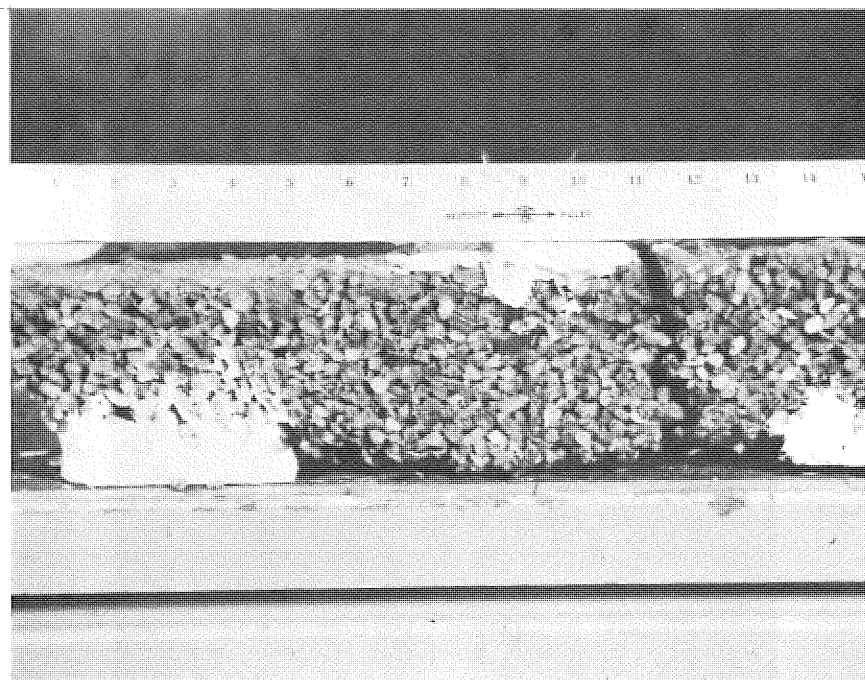
PHOTO 82. Pea-gravel drain Flexure Test Specimen B1 after testing. Failure occurred with a concentrated load of 270 pounds, indicating a modulus of rupture of 91 psi.

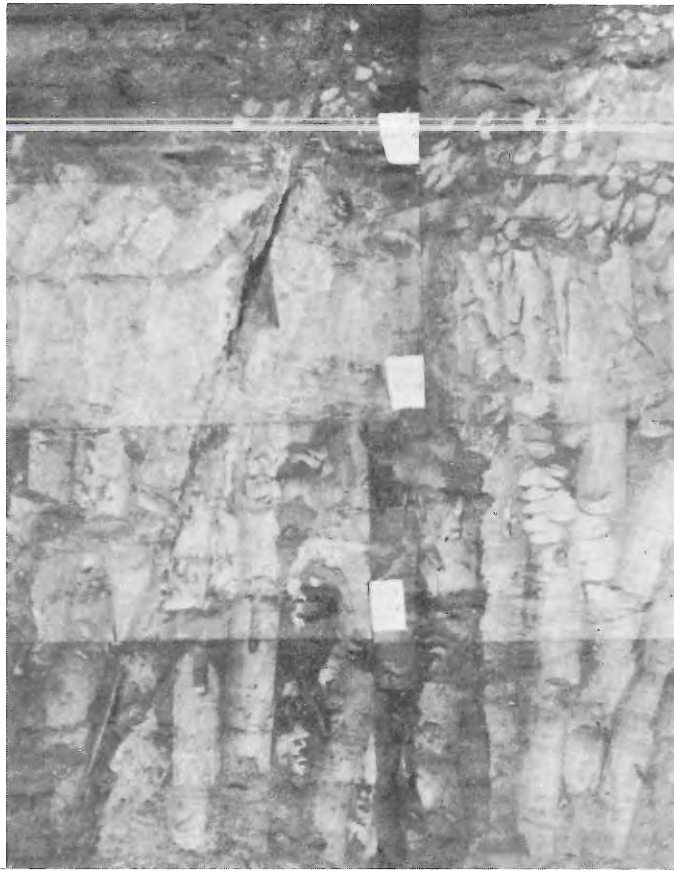
PHOTO 88. Mosaic showing fault plane at Station 0+16 in Excavation No. 9, a point directly beneath south toe of main dam. Fault is partially filled with loose silt. A cavity appears in upper half of photo.

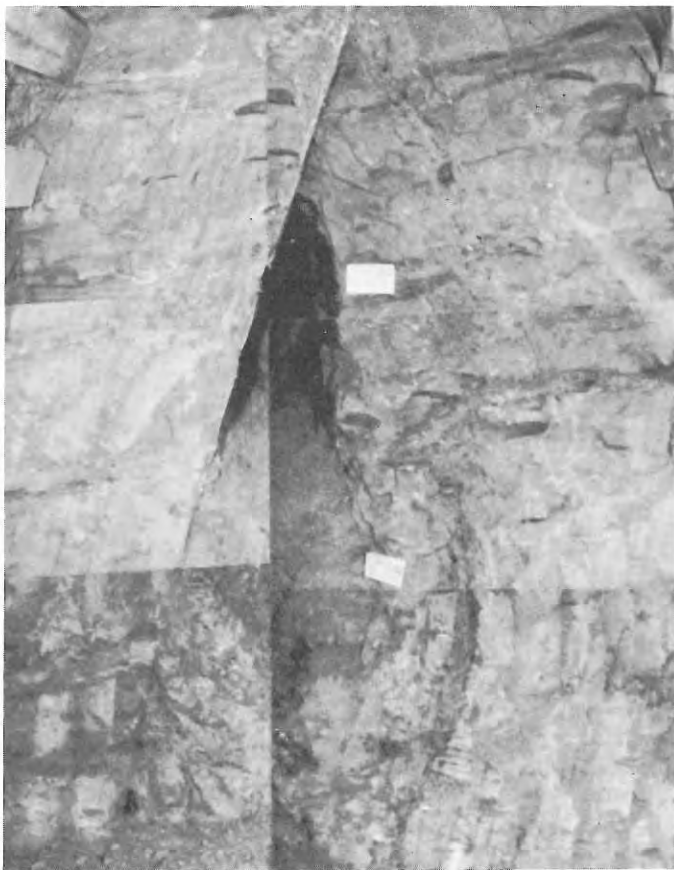
PHOTO 89. Mosaic showing cavity along Fault I at Station 0+62 in Excavation No. 9. Cavity extends beyond face to distance of 4.5 feet.

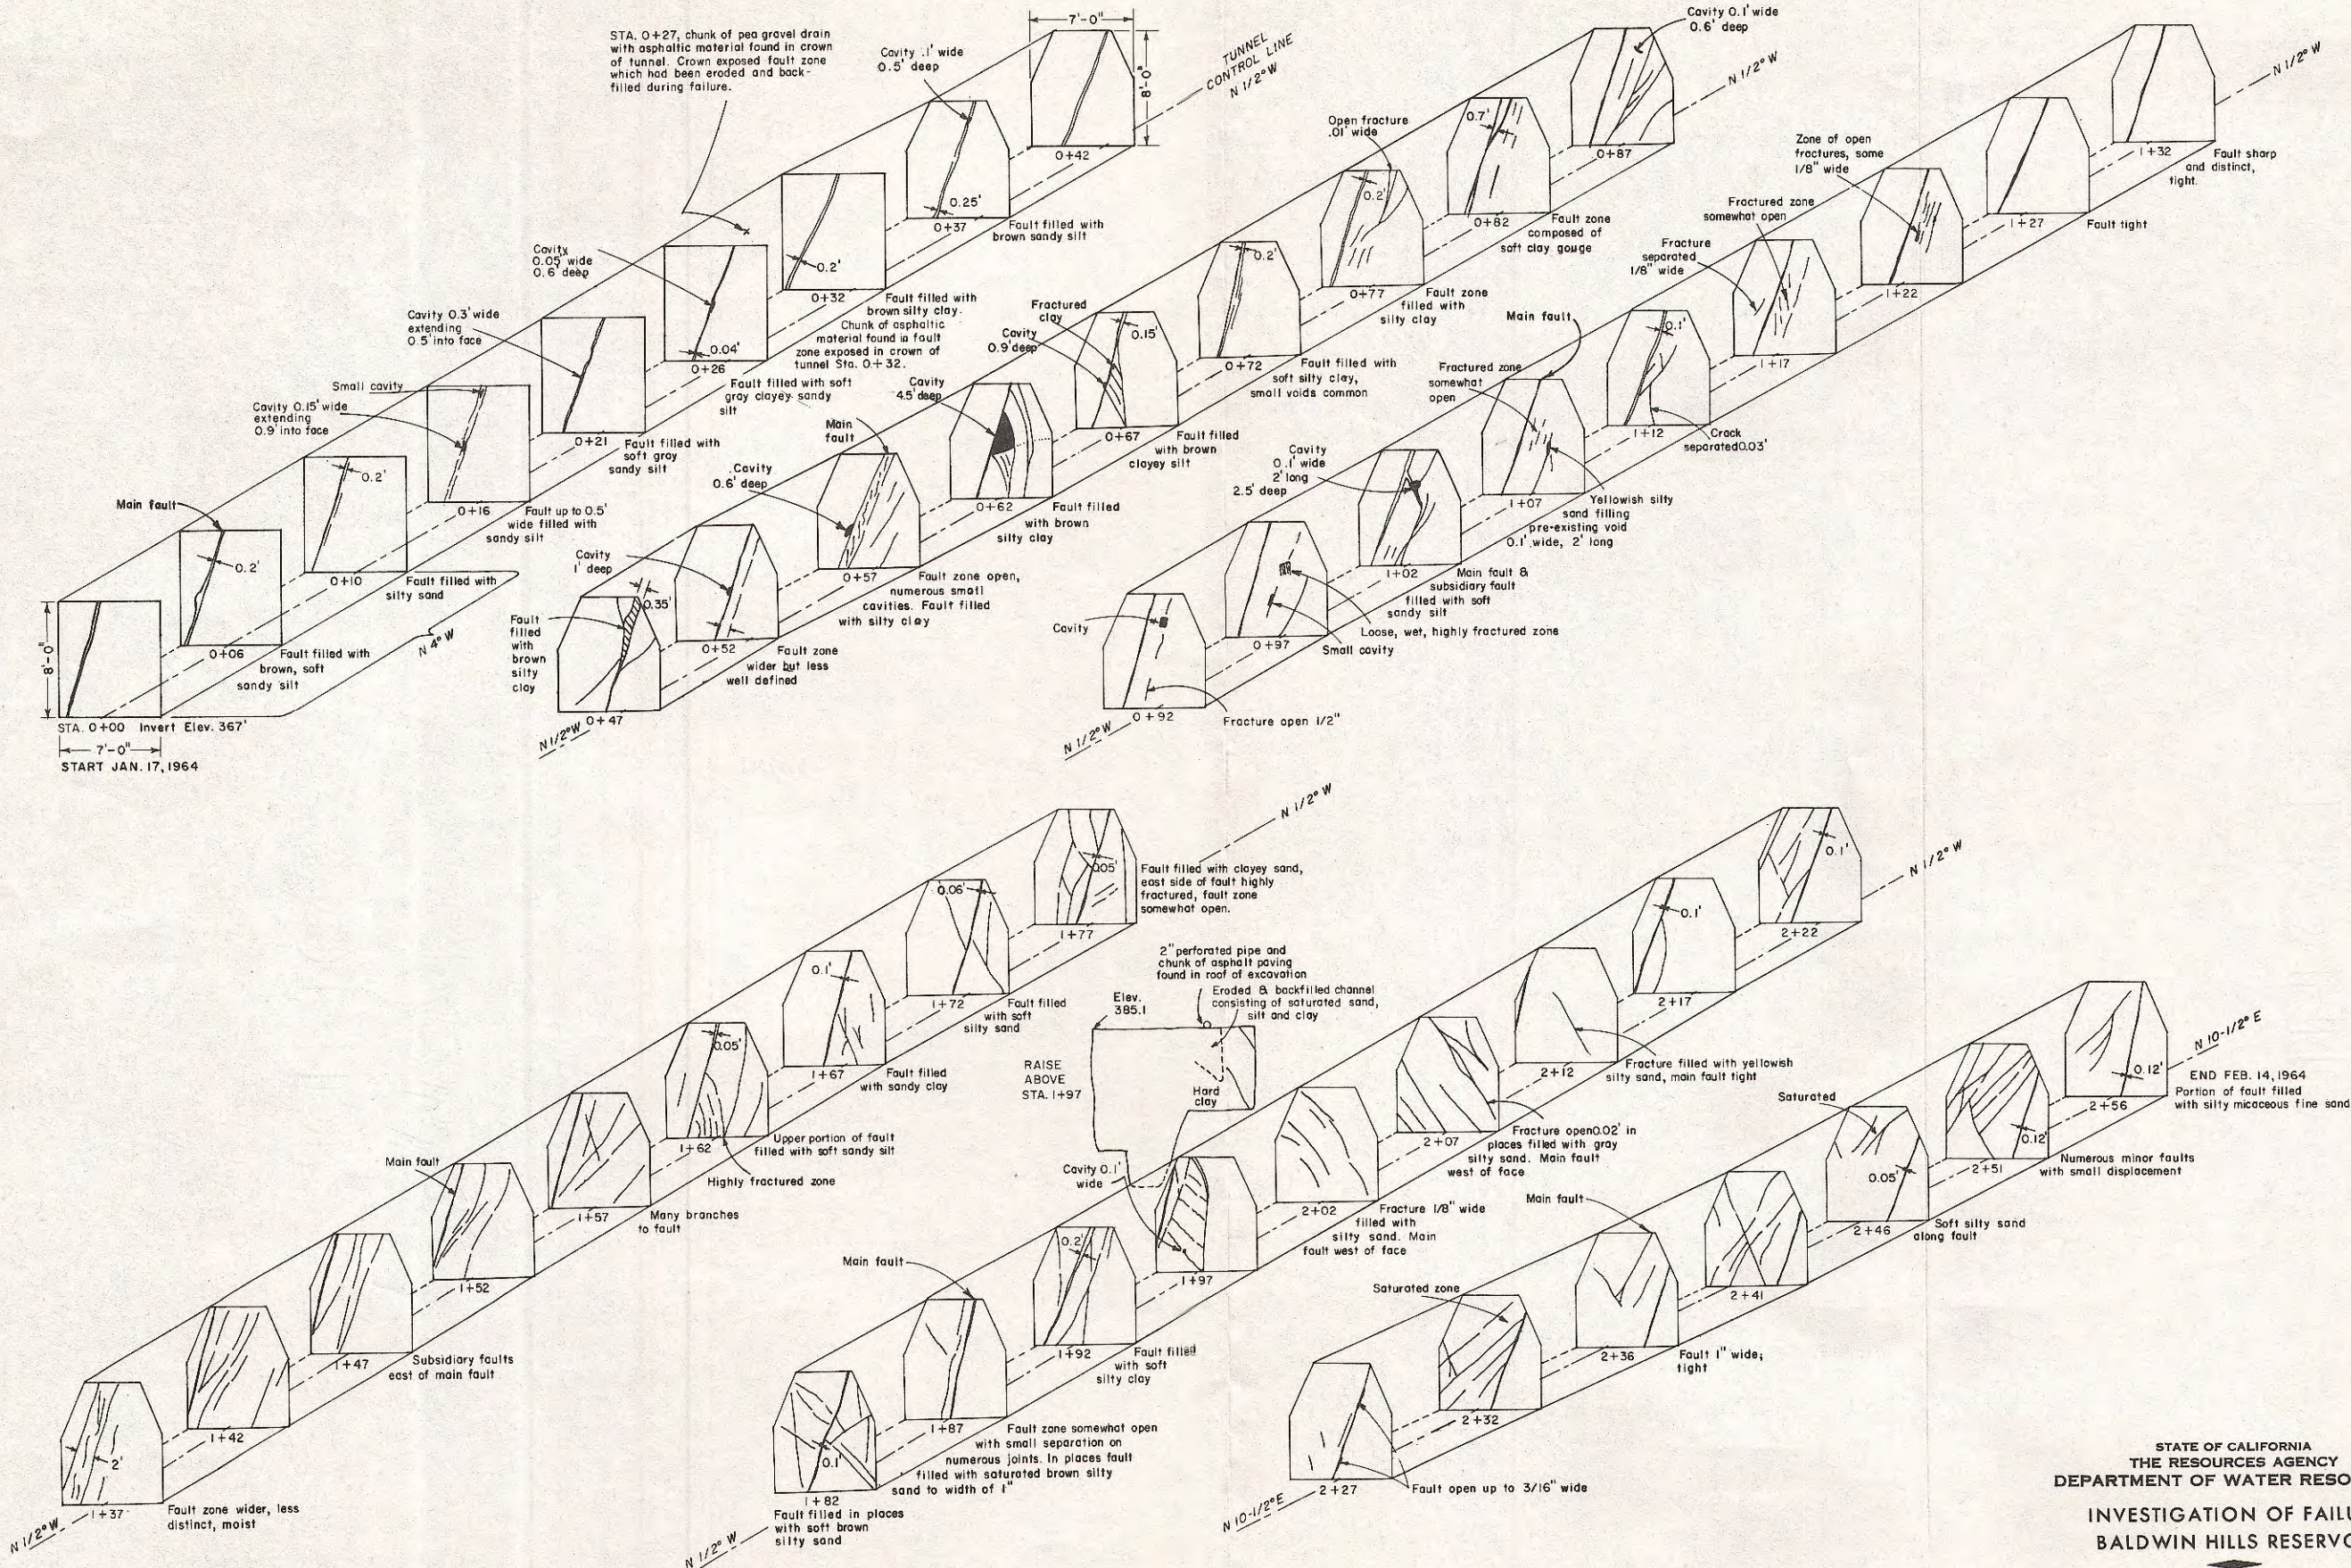
STATE OF CALIFORNIA
THE RESOURCES AGENCY
DEPARTMENT OF WATER RESOURCES
INVESTIGATION OF FAILURE
BALDWIN HILLS RESERVOIR
LOG OF EXCAVATION No. 9

STA. 0+27, chunk of pea gravel drain with asphaltic material found in crown of tunnel. Crown exposed fault zone which had been eroded and back-filled during failure.
