Bonasa Breaks Ranch Dam

Dam Failure and Hydrologic Report

Asotin County, Washington

August 2017

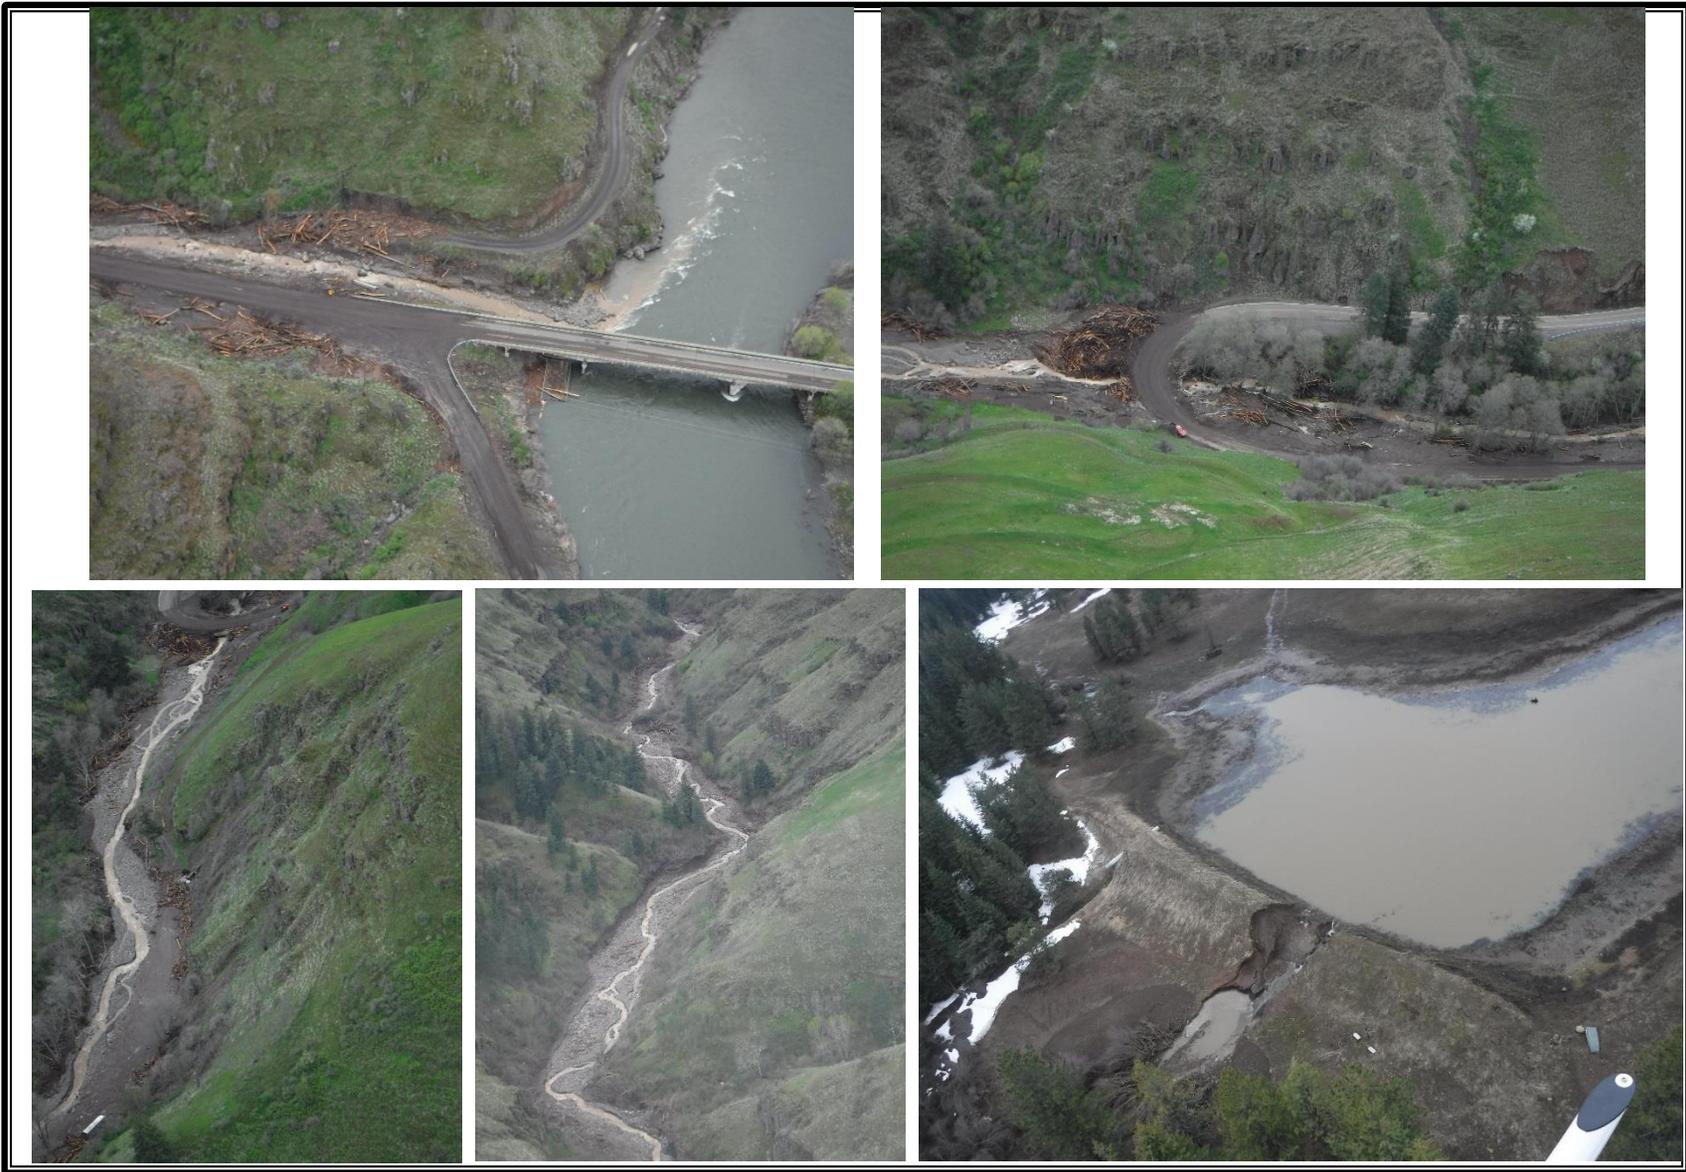
Figure 3. Remnants of the debris flow on Rattlesnake Creek and State Highway 129 from Bonasa Breaks Ranch Dam breach

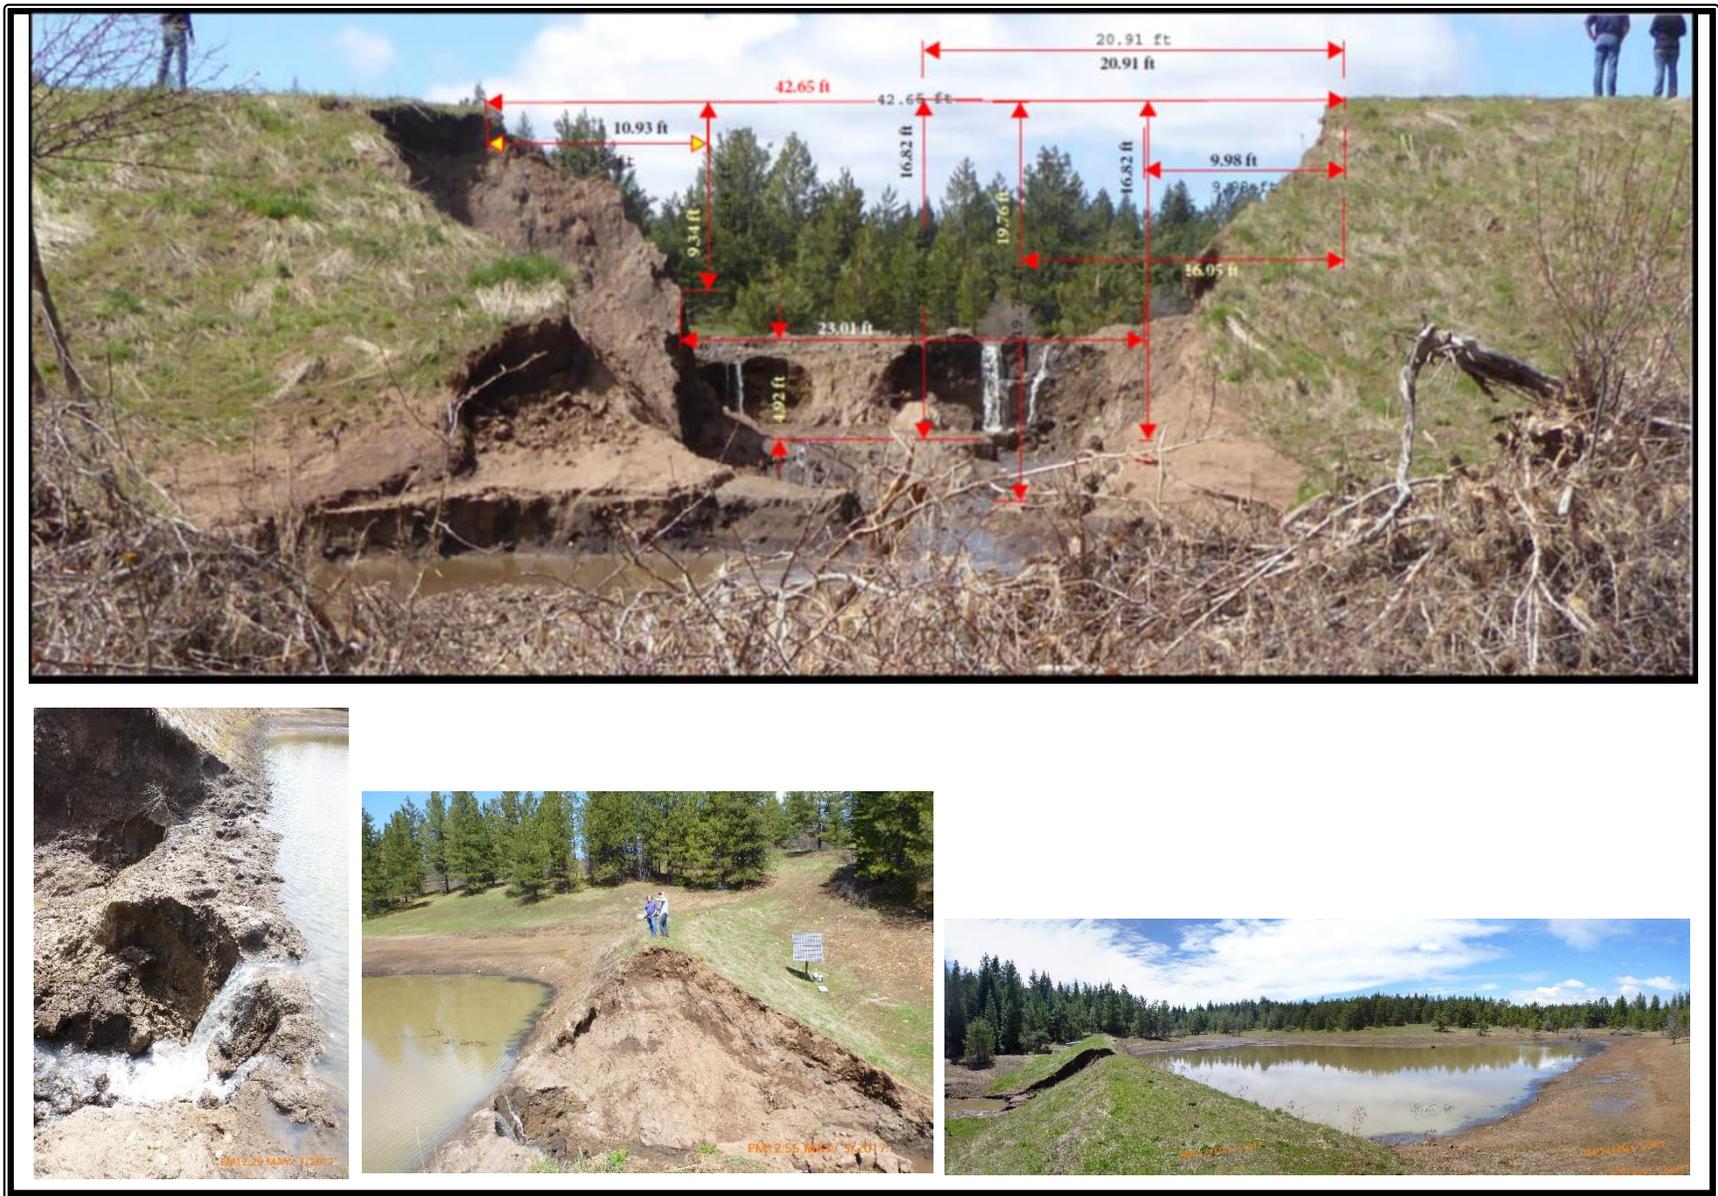
Figure 4. Bonasa Breaks Ranch Dam breach and reservoir remnant characteristics

The breached section of the dam is located approximately 125 feet from the north abutment. A cross section of the breach has approximate dimensions of 42.7 feet across the top and 23.1 feet across the bottom, a maximum breach depth at the center of the embankment of 19.8 feet, with approximate left and right side slopes (looking downstream) of 0.60 H:1V and 0.65 H:1V, respectively. A narrow remnant of the embankment, approximately 3.5 feet in height, continues to impound a remnant reservoir, estimated to have a volume of between 4.9 and 7.1 acre-feet, depending on the remnant surface area assumed.

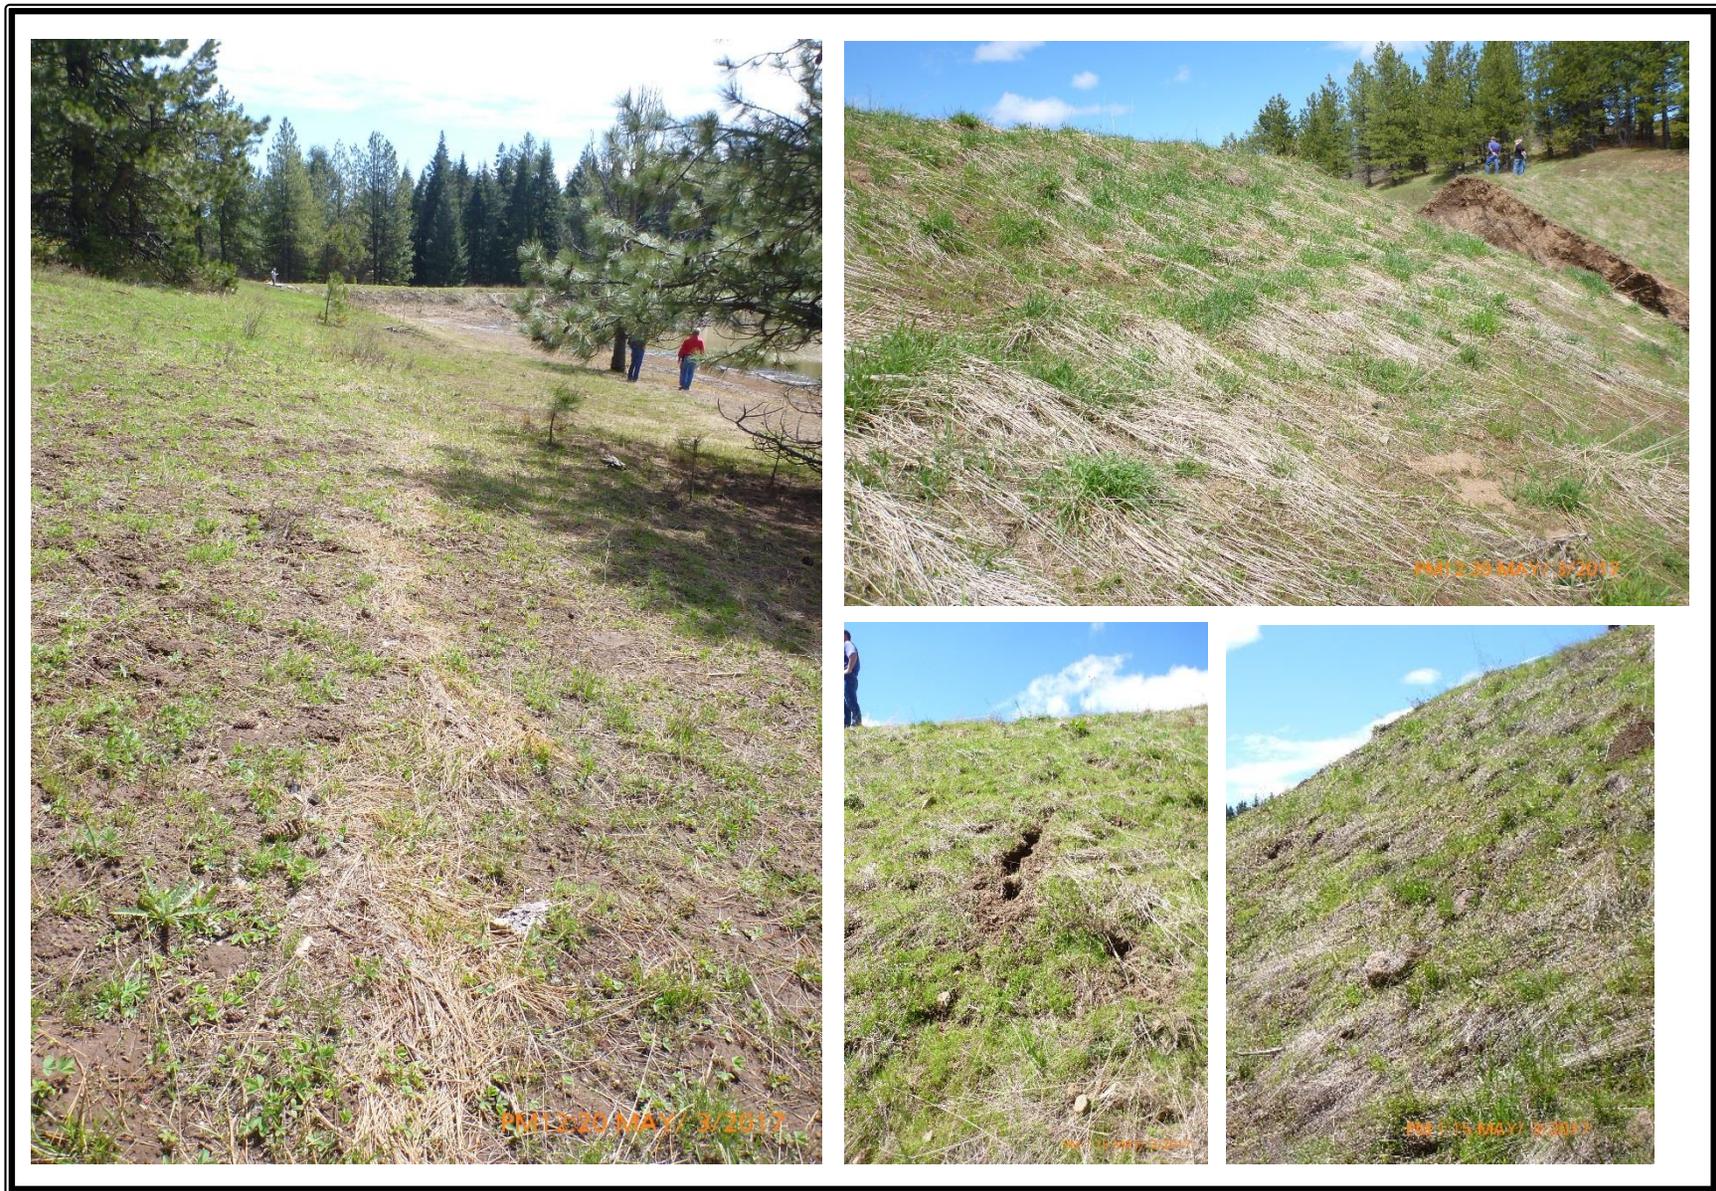
- Erosion features, vegetation that appeared to be laid down flat and spotty sediment accumulations on the downstream face likely resulting from water sheeting down the embankment strongly suggest that the dam may have been overtopped (Figure 6). Overtopping could have led to an erosion failure of the embankment and a sudden release of the reservoir's contents.

- A debris line observed along the rim of the reservoir indicating that the reservoir was particularly high prior to the breach event. DSO surveyed a few locations along the north side of the reservoir and estimated that the debris line was at an approximate elevation of 3959.0 feet, i.e. approximately 0.72 feet below the lowest surveyed crest elevation measured along the dam crest. Although the debris line appeared to be below the lowest crest elevation, other observations indicate that the reservoir water appeared to have flowed over the embankment crest and downstream slope before the breach. It should be noted that drawdown action during the breach event may have swept the observed debris line below its highest elevation before the breach and that the elevation on the crest in the vicinity of the breach may have been lower than the surveyed minimum.

Figure 6. Bonasa Breaks Ranch Dam Inspection: debris line, grasses lying flat on the embankment, and erosion features.

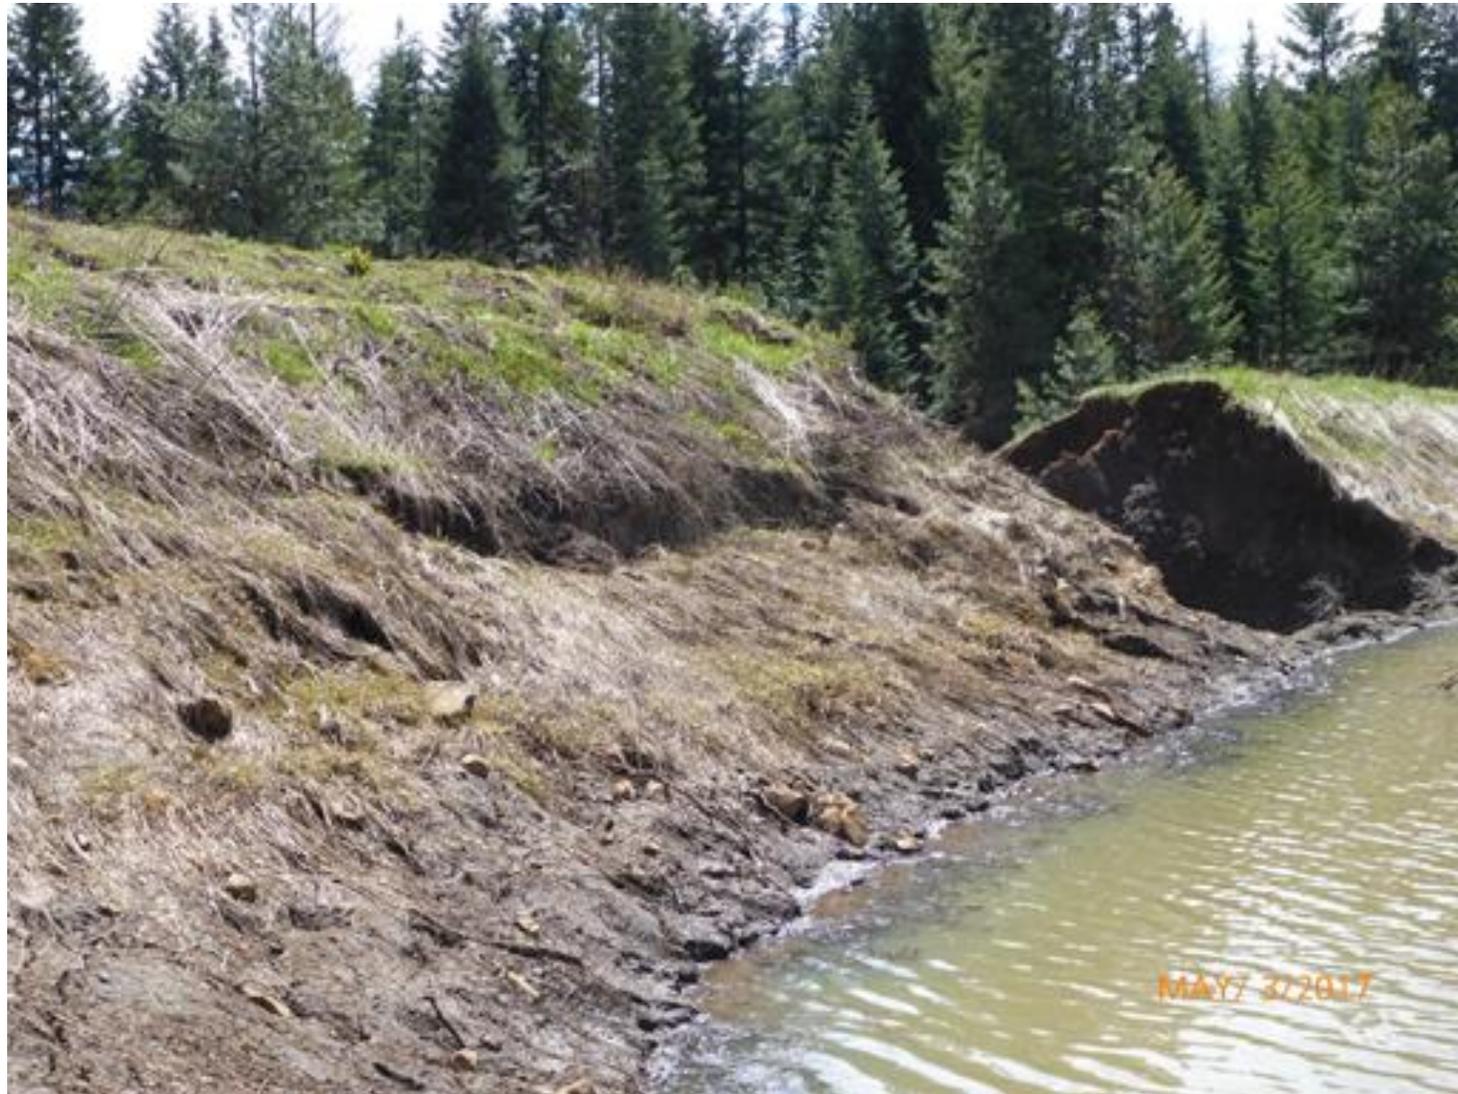
- Signs of a rapid drawdown failure (slumping) on the upstream slope of the dam were visible along the northern side of the breached section (Figure 7). We also observed some cracking on the upper section of the upstream slope along the embankment section near the overflow spillway pipe (Figure 8).

Figure 7. Bonasa Breaks Ranch Dam: soil movement likely induced by rapid drawdown failure on the upstream slope

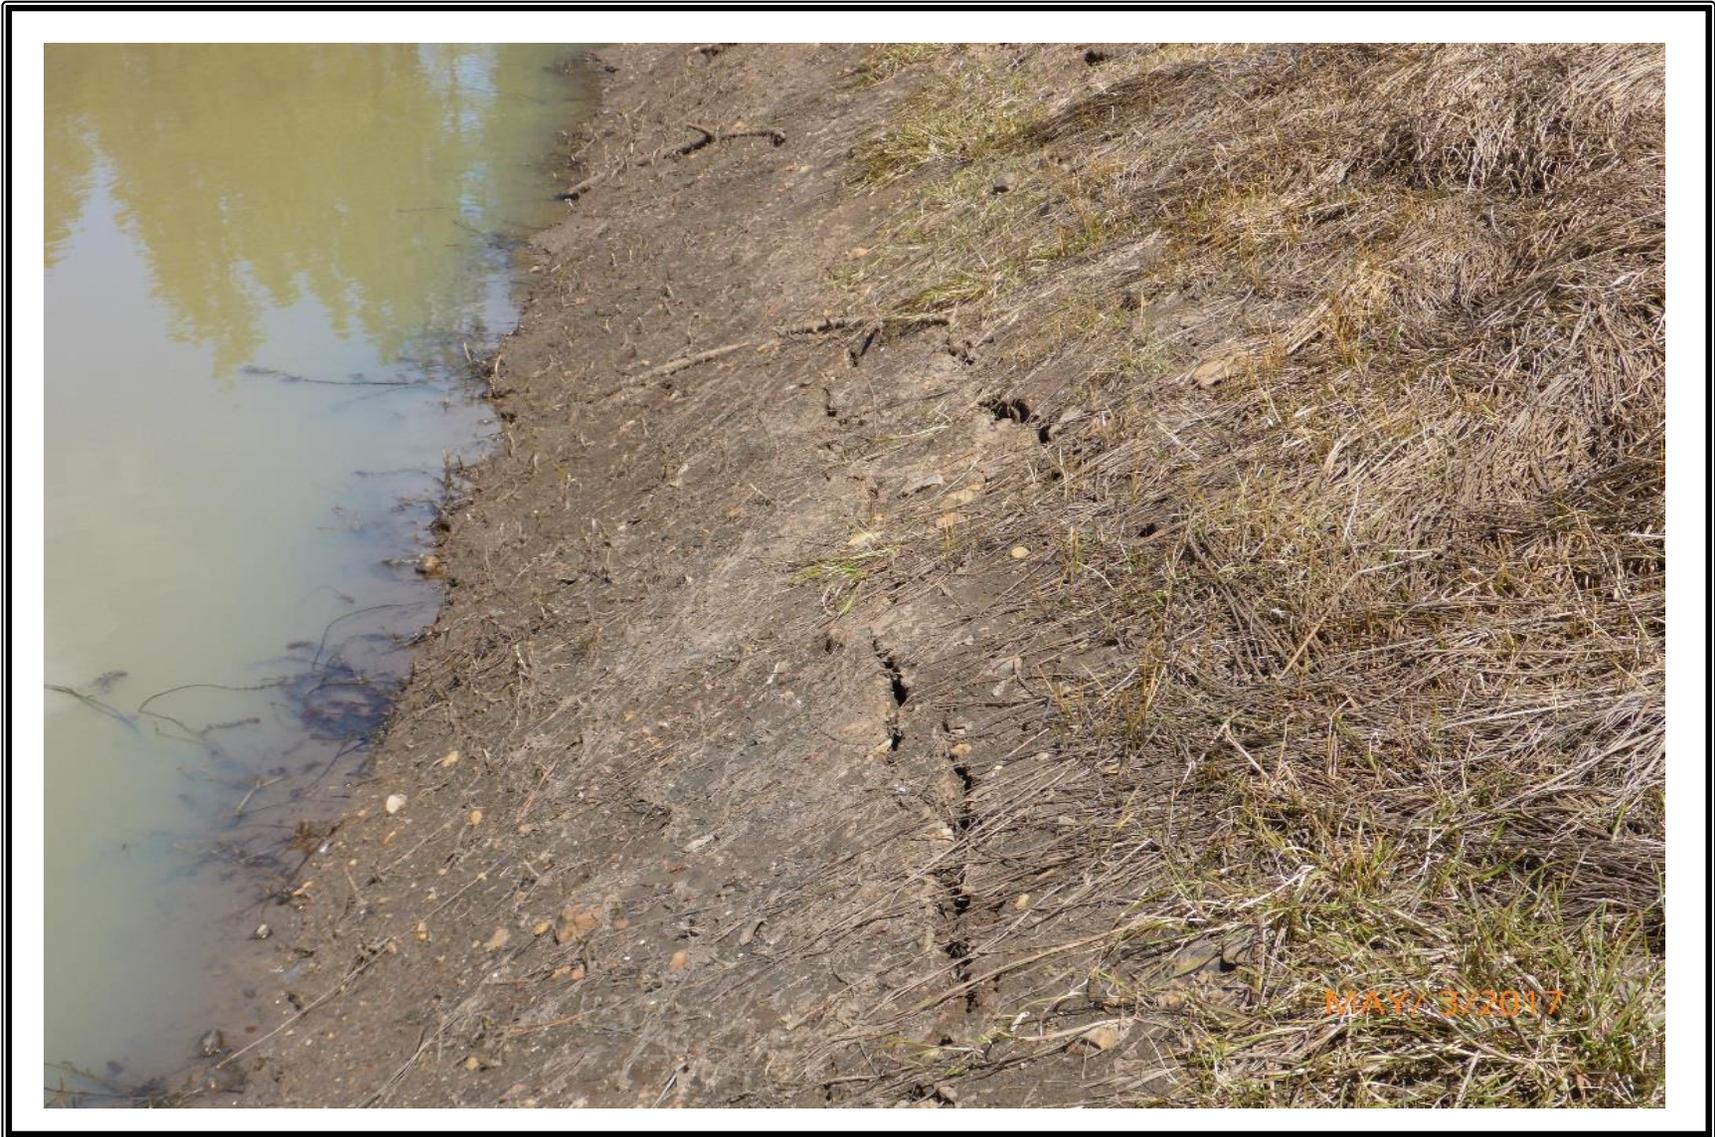
Figure 8. Bonasa Breaks Ranch breach: cracking on upstream slope along southern embankment section

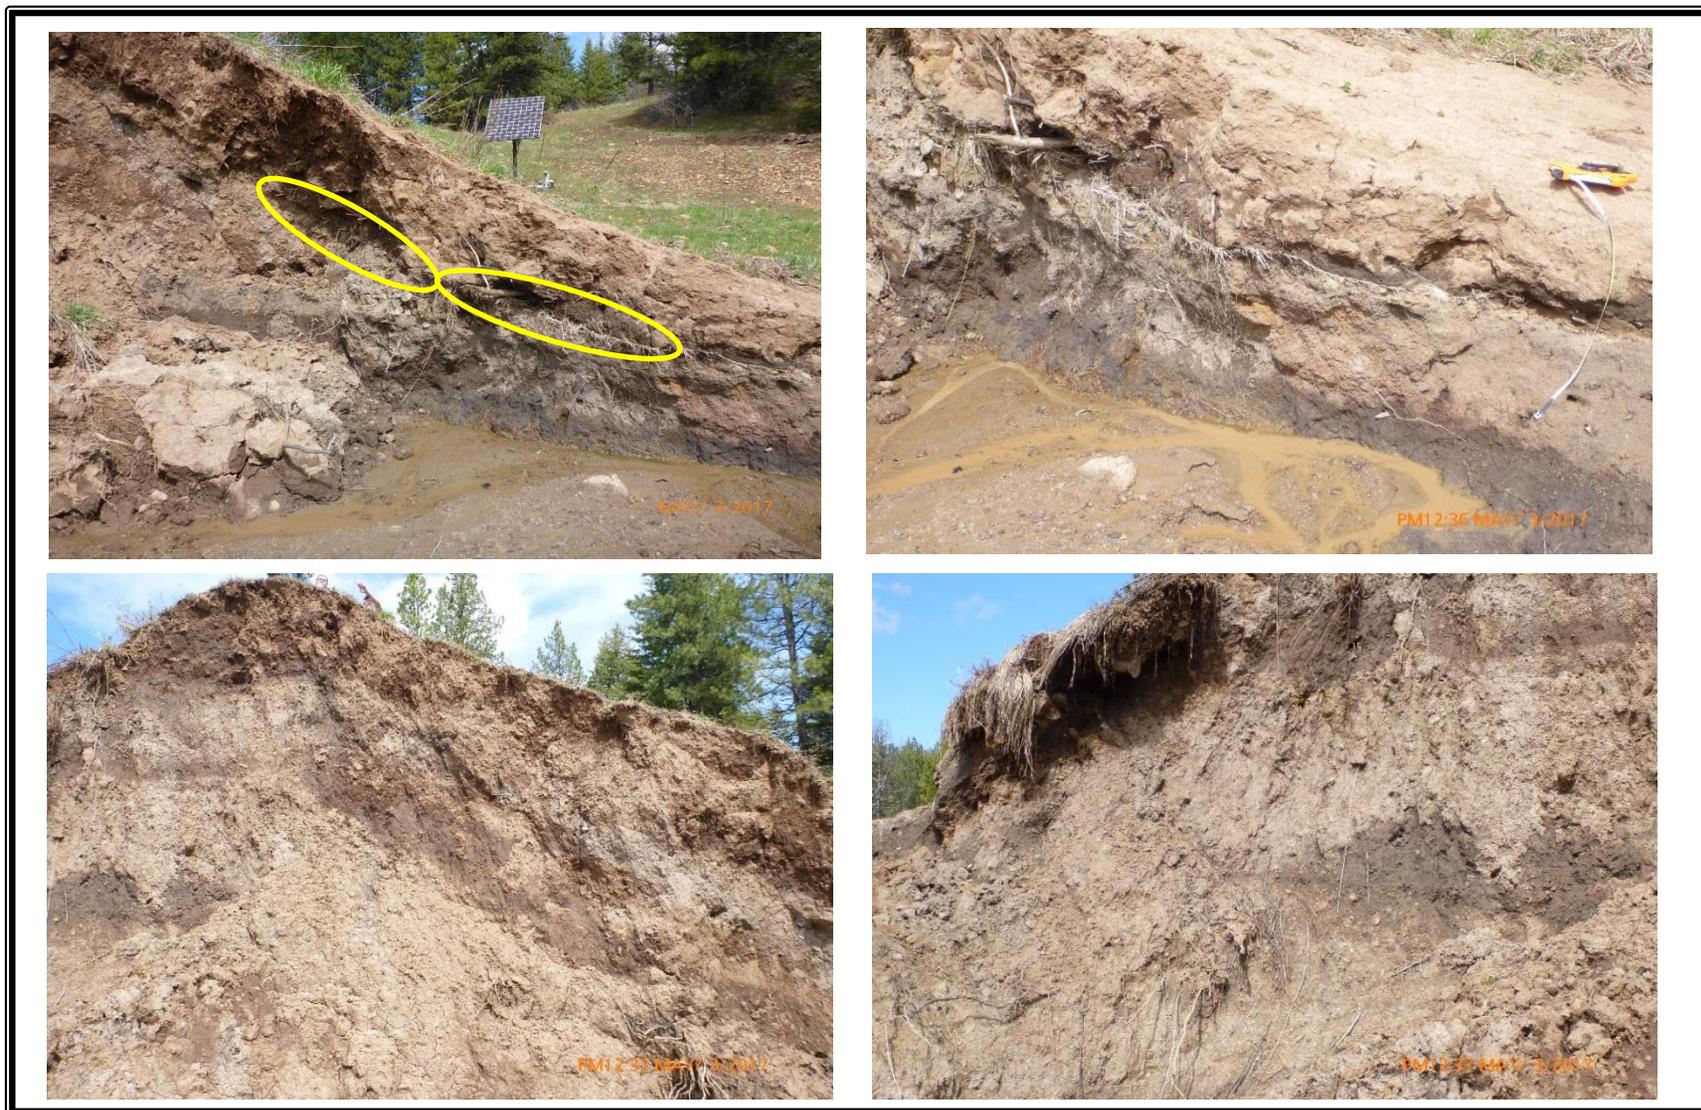
- A layer of organic material was observed 1-2 feet below the surface of the downstream slope on the northern sidewall of the breach (Figure 9). This layer was visible from the downstream toe up to approximately halfway up the downstream slope, and its alignment was parallel to the slope face.

This organic layer may be considered a “weak” plane parallel to the slope which may adversely affect the stability of the downstream slope. It is noted that there were no visible signs of movement along the remaining embankment sections.

Figure 9. Bonasa Breaks Ranch downstream toe section. Notice the organic layer below the light brown top layer.

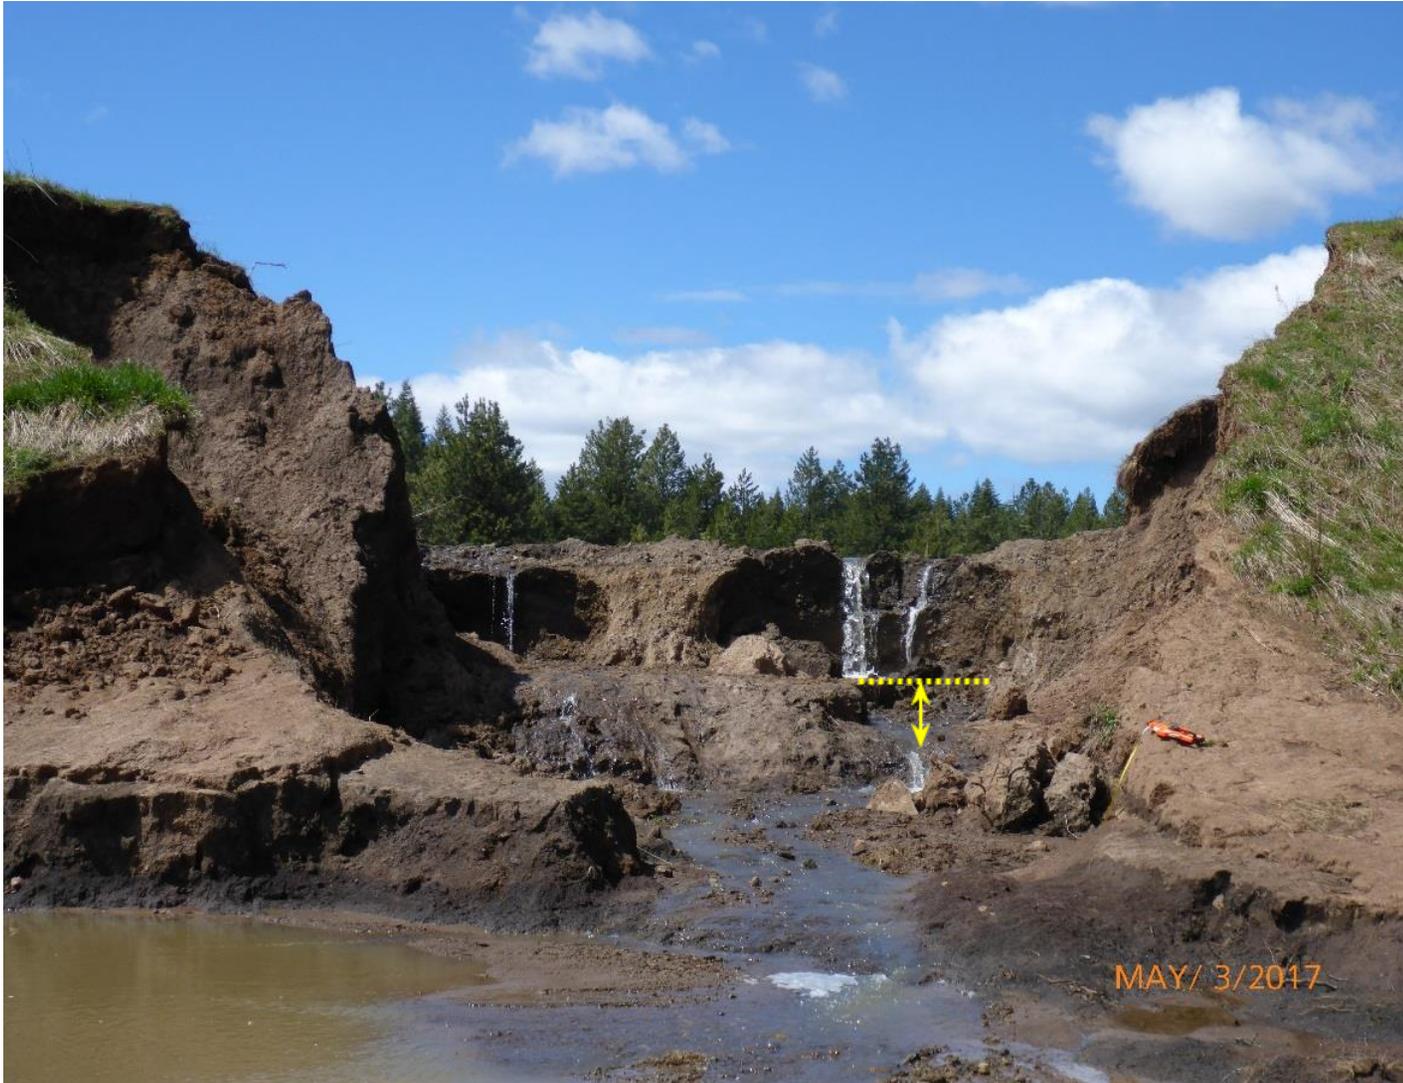
- The foundation of the breached section appeared to be formed by a hard, rock-like material. The north side of the foundation exposed at the breach was at an elevation lower than the southern section (Figure 10). This specific zone appeared not to have been properly prepared during original construction of the dam in order to prevent stress concentrations and differential settlement within the embankment. This may lead to vertical cracking which may cause leakage related problems. This failure mode may be compounded if the embankment materials were not properly compacted.

Typically, a cutoff trench would also be required to block or intercept any seepage along the interface between the structural fill and the foundation material. There were no visible signs that such a cutoff trench was provided for the original embankment.

Figure 10. Bonasa Breaks Ranch breach section: Notice the difference in elevation at foundation level.

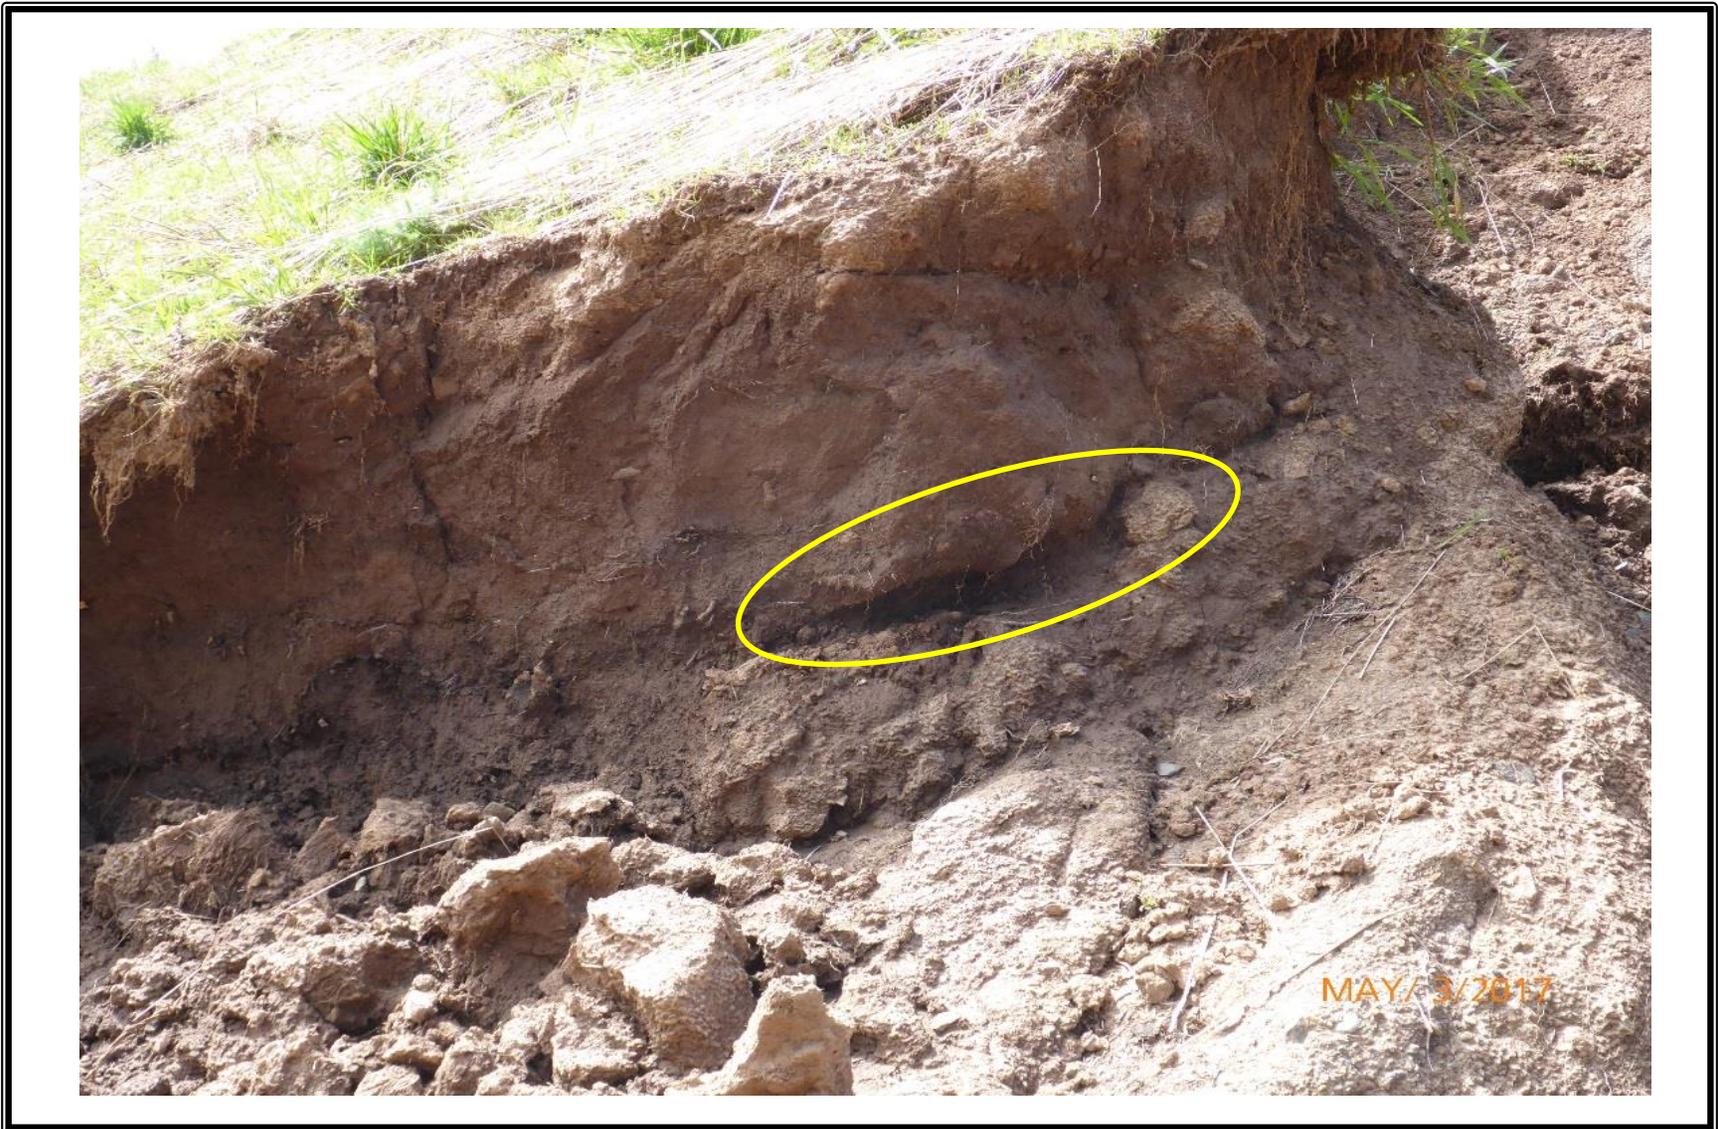
- A “tube-like” feature was observed on the northern sidewall of the breached section (Figure 11). Features like this are typically associated with piping of embankment materials. There were no visible signs on the sidewall that this feature extended towards the downstream toe or that it may have been hydraulically connected to the reservoir. On the other hand, these features may have been washed away by the dam breach flood waters. It may be noted, that no visible signs of piping (seepage, saturated soils, voids, etc.) were observed on the remaining embankment sections, although this may not pertain to the section that did fail.

Figure 11. "Tube-like" feature on southern sidewall of breached section

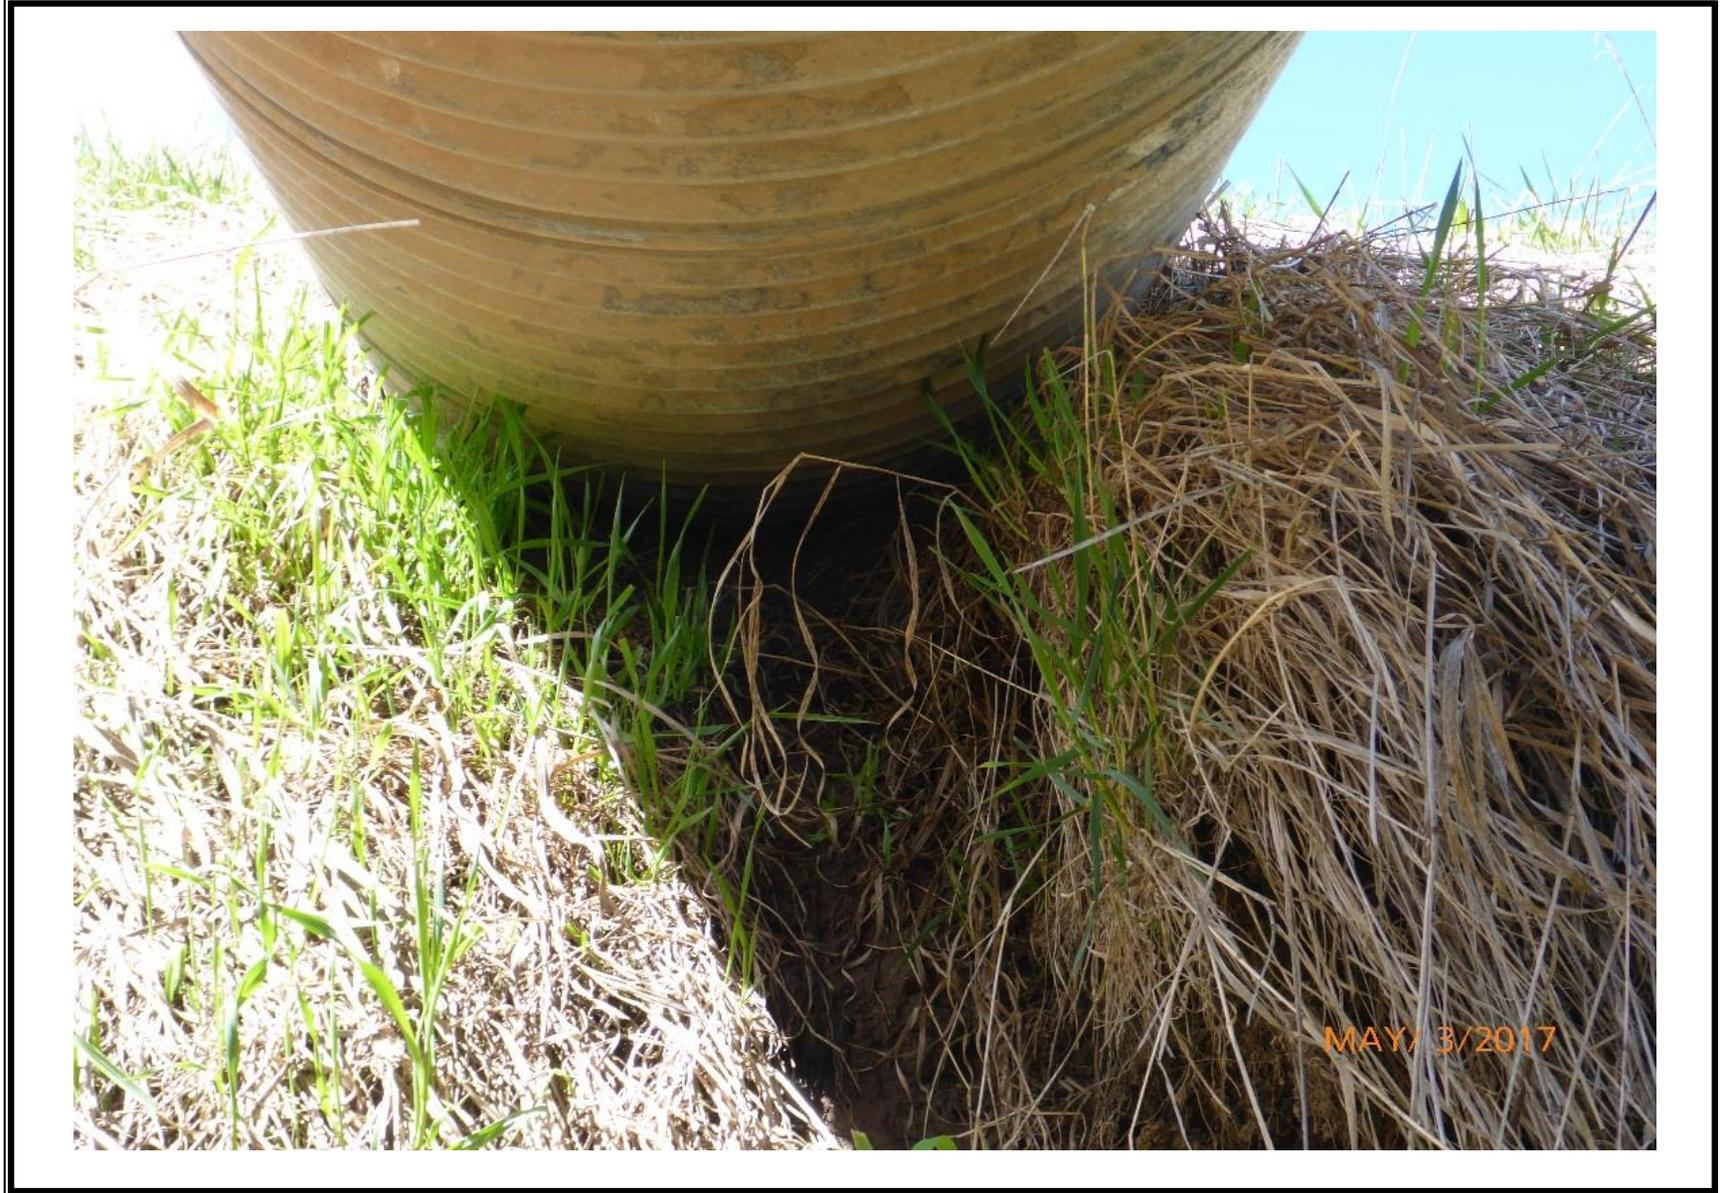
- A 3-foot diameter corrugated metal pipe was installed on the upper section of the embankment, approximately 120 feet from the southwest abutment. Installation of this type of conduit requires careful construction practices, as it is difficult to achieve acceptable compaction levels of the backfill material, especially under the pipe. It appears that compaction of the backfill material was not adequate as it was observed that a void had developed under the pipe at both the upstream and downstream side of the dam (Figure 12). It is our opinion that this void was likely created by water seeping along the alignment of the pipe.

Figure 12. Downstream side of overflow conduit

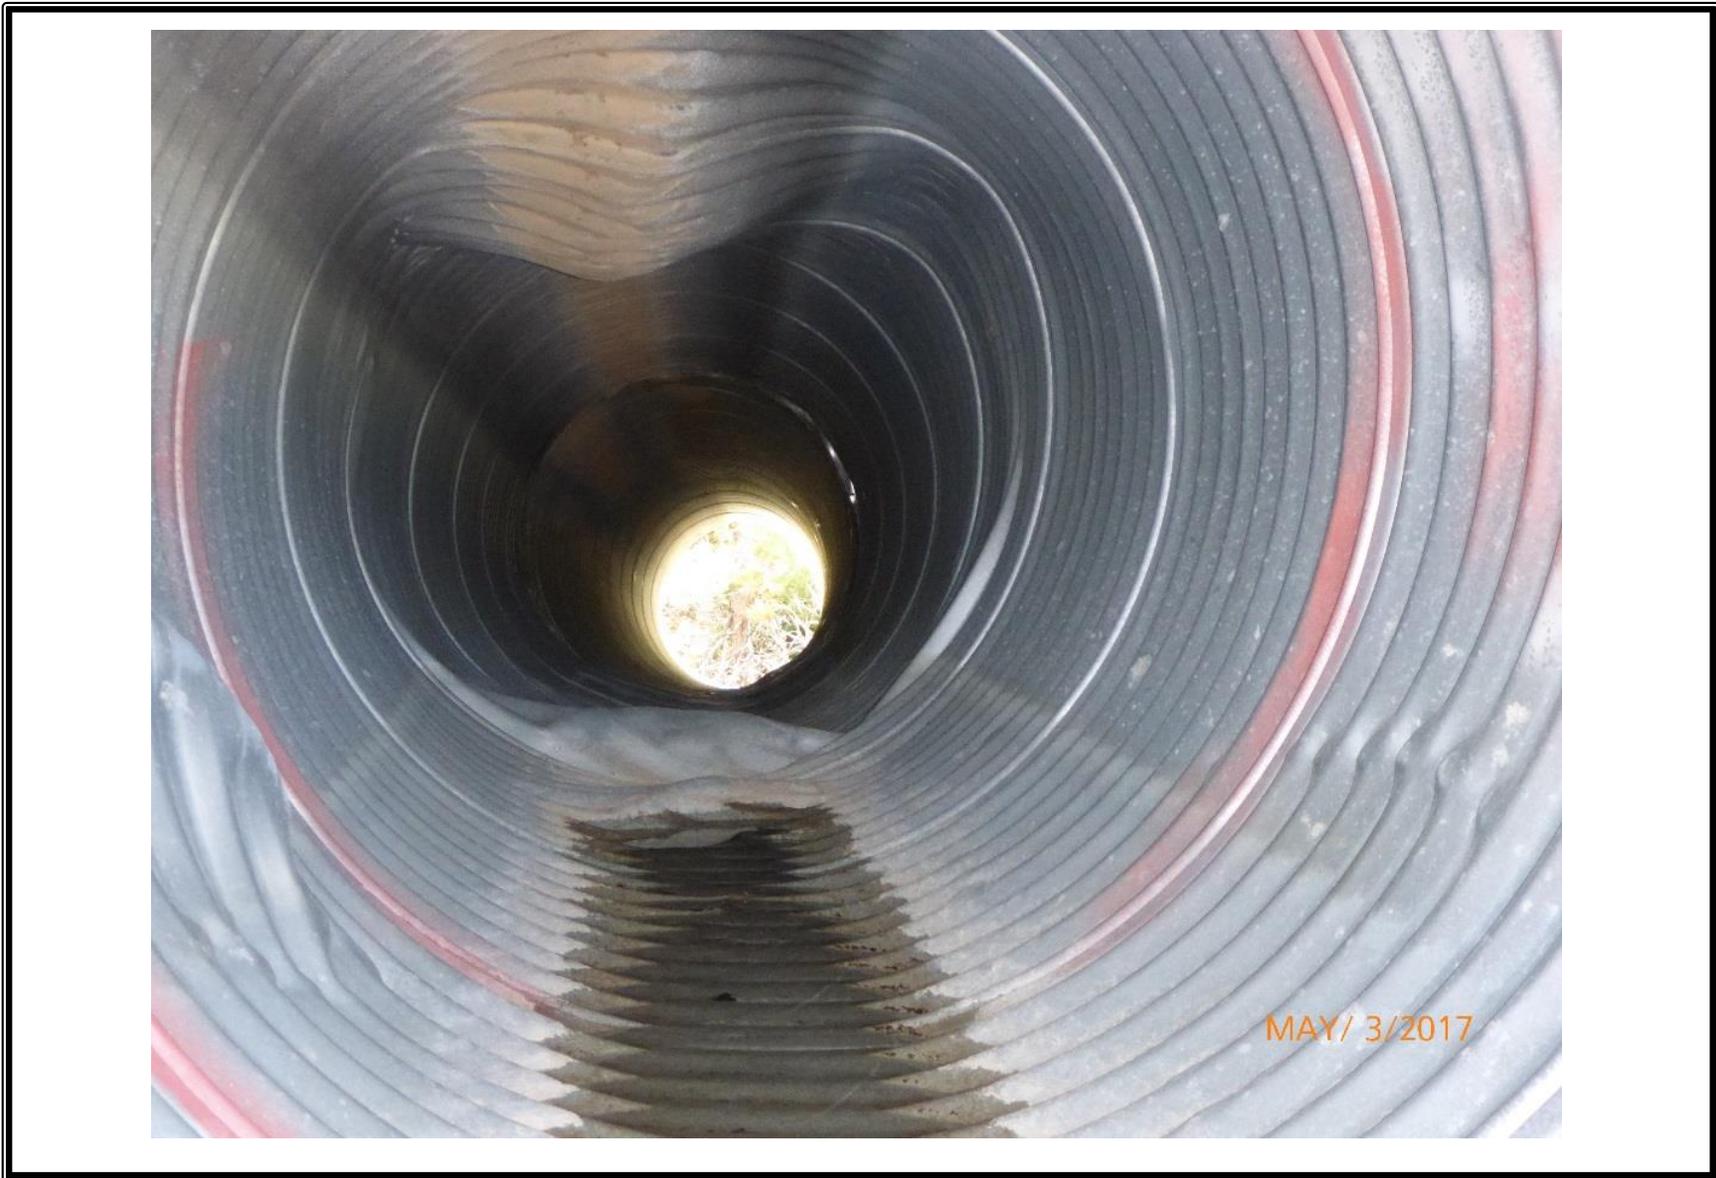
A visual inspection of the pipe interior revealed some damage along the crown of the pipe (Figure 13), which the DSO believes was caused by vehicular traffic on the embankment compounded by an inadequate amount of cover material above the pipe. There was also damage on the bottom of the pipe; however, it is not clear what may have caused it. Hence,

Figure 13. Interior of overflow conduit

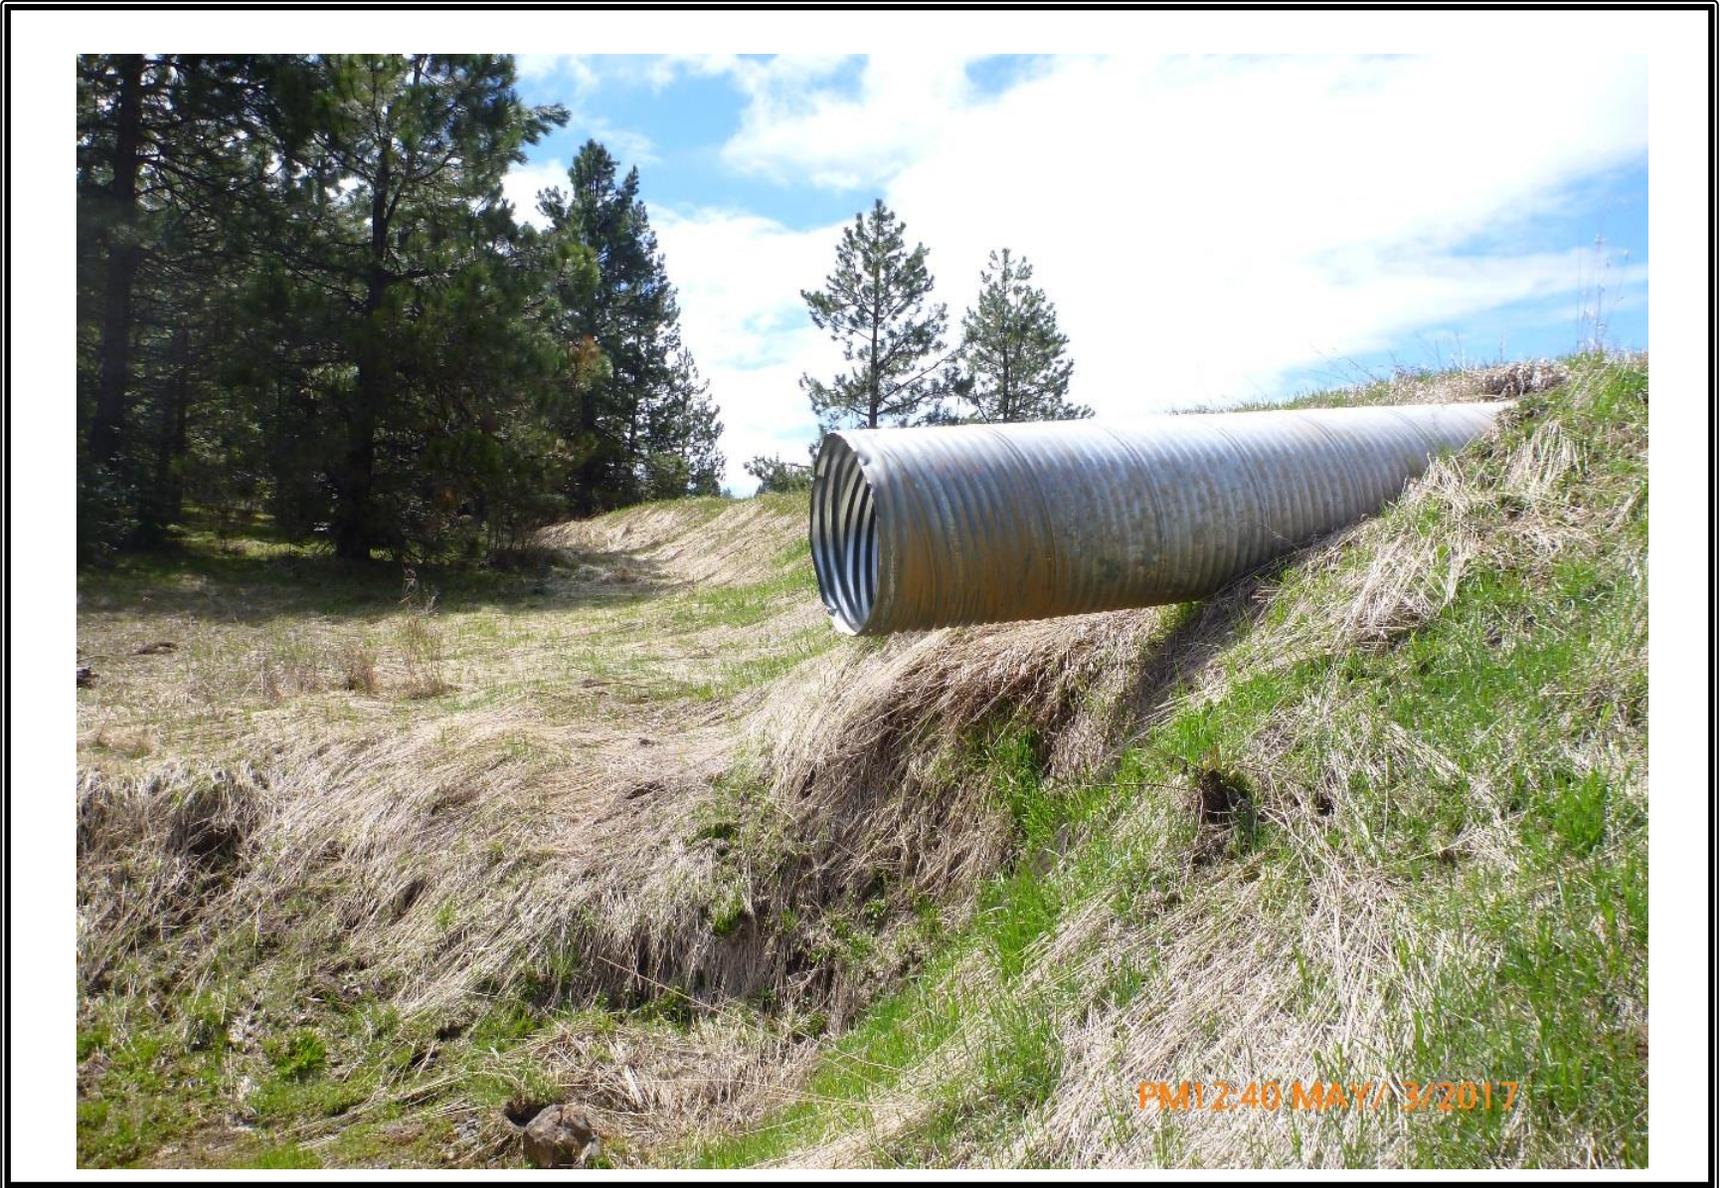
It was also observed that an energy stilling basin was not provided at the downstream foundation area where the flows from the pipe discharged. Some erosion of embankment material was observed directly below the section of the conduit on the downstream slope (Figure 14). At minimum, some kind of erosion resistant layer should have been provided in this area to prevent erosion of the foundation and embankment materials.

Figure 14. Downstream toe area at overflow spillway conduit. Notice erosion damage on slope
