Initial Report of Findings

FERC Investigation of Activation of Fuse Plug Spillway  
May 14, 2003

Silver Lake Basin  
Dead River Project No. 10855  
Marquette County, MI  
Upper Peninsula Power Company

Draft: July 24, 2003

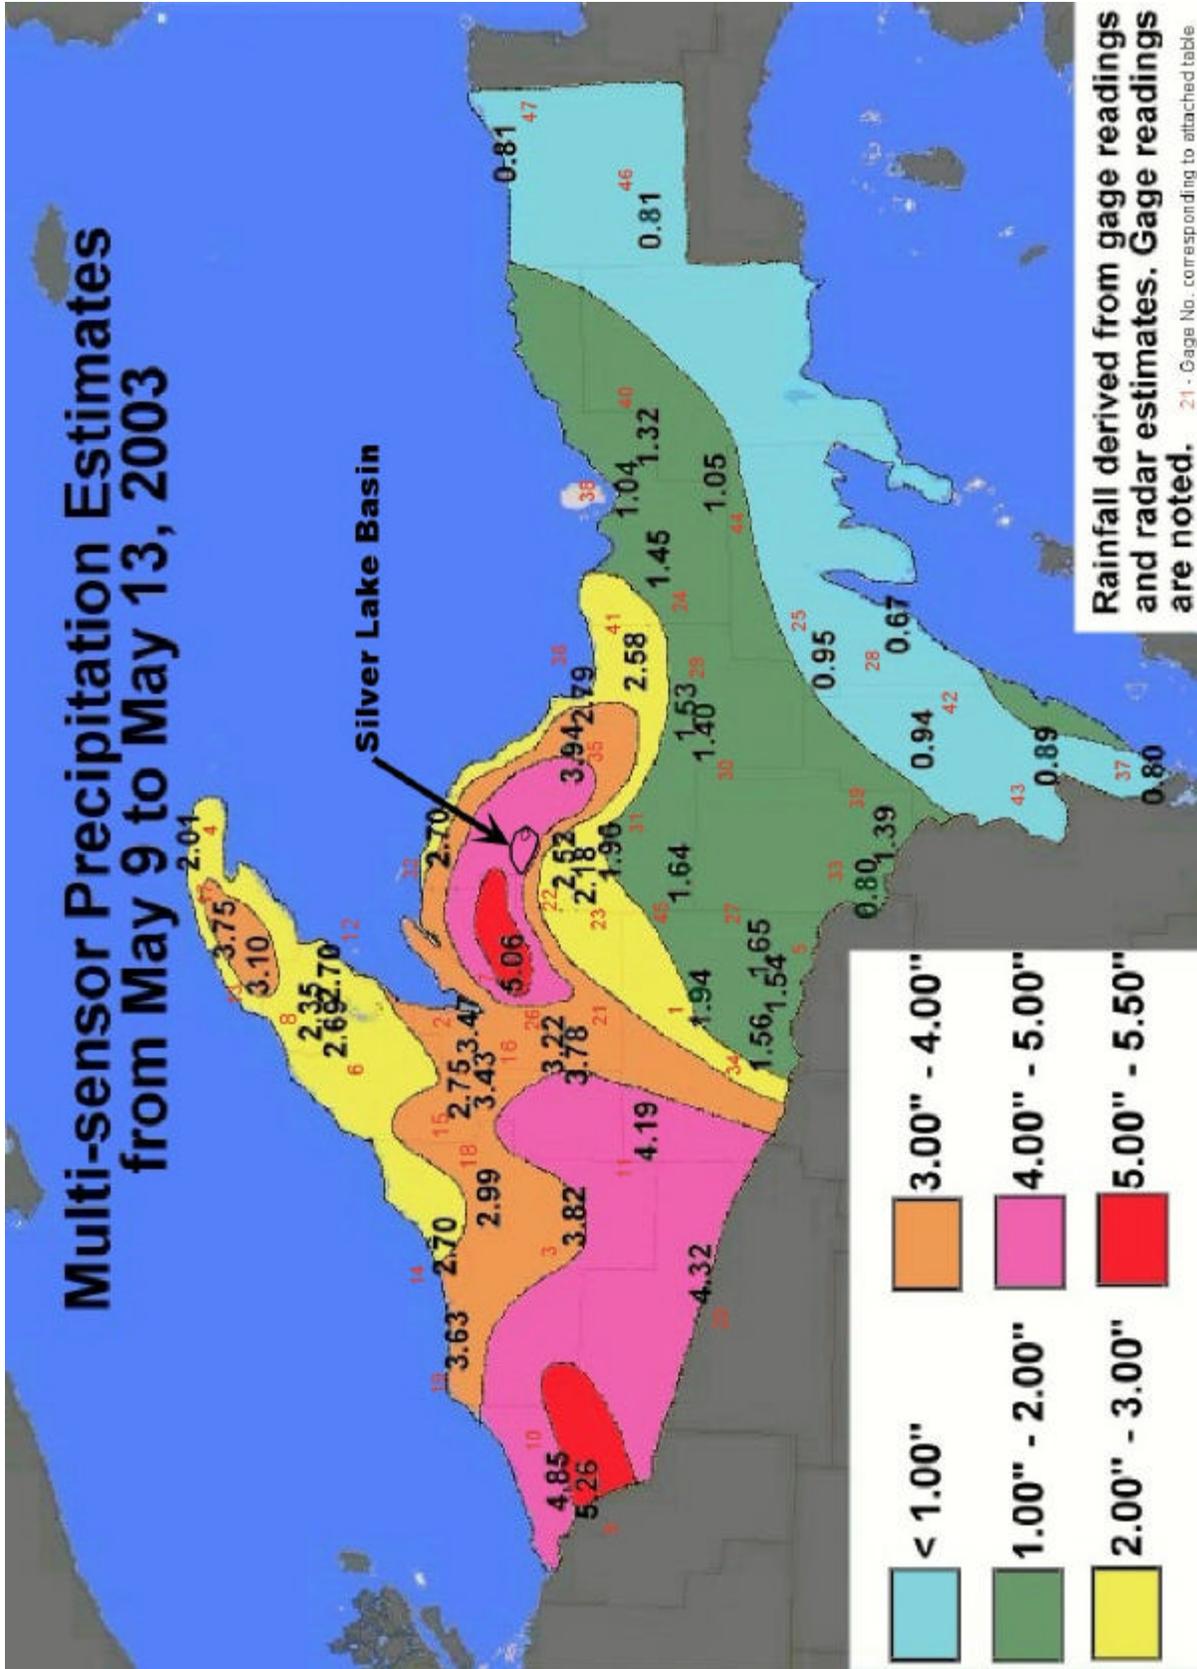
A review of the NWS rainfall map indicates there are no rain gages located in or near the Silver Lake basin. However, based on the rainfall patterns shown on the map, it appears that 4 to 5 inches of rain occurred within the basin during this rainfall event. A review of the Herman, Champion 4E, Champion/Clarksburg, Humbolt, Huron Mtn Club, Marquette NWS, and Marquette WWTP precipitation gages listed on Table 1 indicates most of the rain fell during the 48-hour period from 8 a.m. May 10<sup>th</sup> to 8 a.m. May 12<sup>th</sup>, 2003.

Figure 1. May 9-13, 2003 Rainfall Estimates and Precipitation Gage Totals

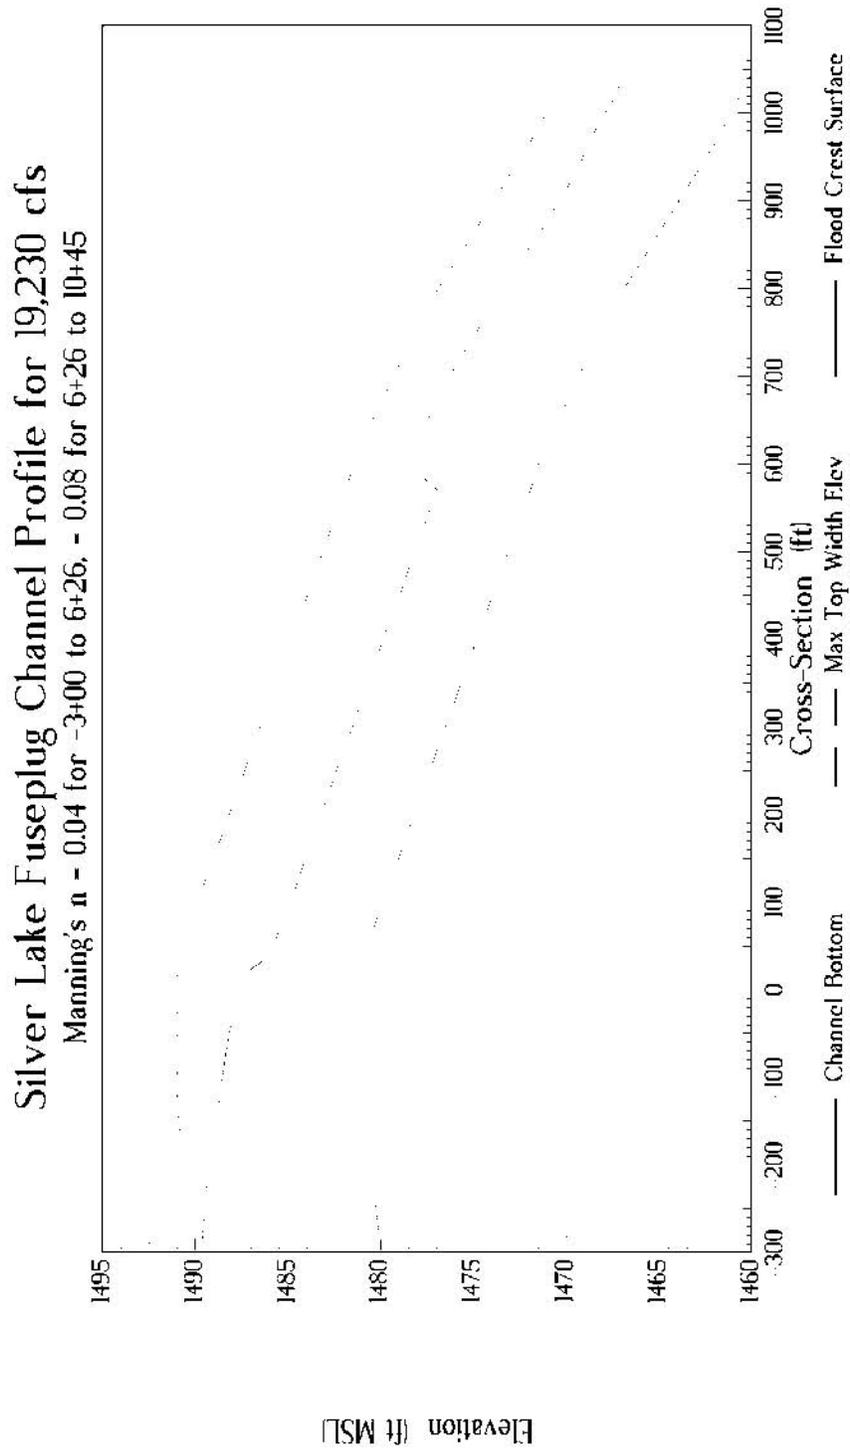
We also performed an open channel analysis using the same model to approximately match the water surface elevation at the entrance channel entrance to the high water mark of 1485.60 feet observed on the upstream side of the overflow spillway. Through trial and error, we determined that a flow of about 8,000 cfs was needed to match the water surface elevation at Station -3+00 to the high watermark. For this scenario, the velocity in the sloped section of the exit channel was computed to be equal to about 10 fps.

Figure 2. Slope Profile of the Fuseplug Channel during the PMF.

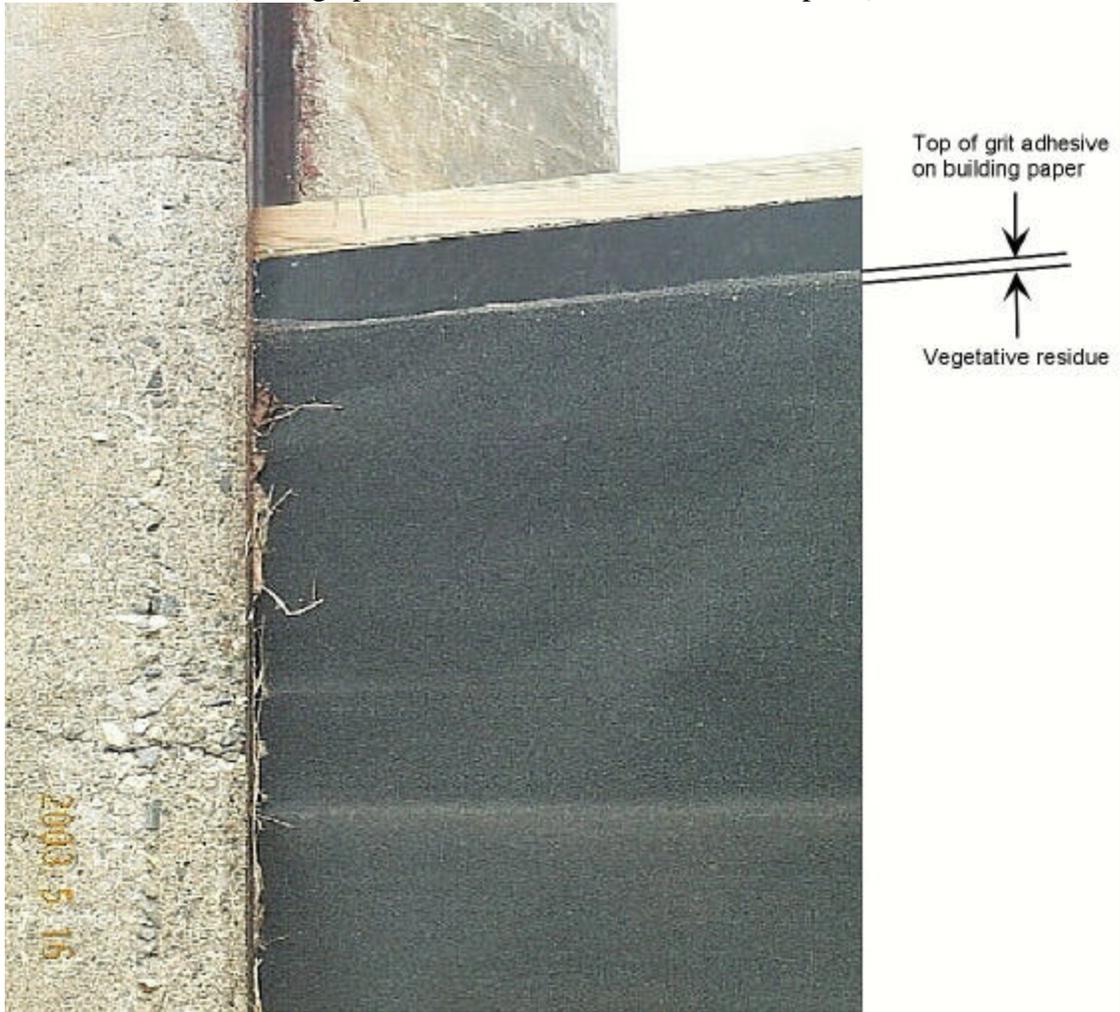
Photograph 1. Downstream right side of the stoplog bay of the overflow spillway at Silver Lake. Photograph taken on May 16, 2003. Note the vegetative debris in the slot and small debris on the felt paper indicative of a watermark near the top of the felt paper.

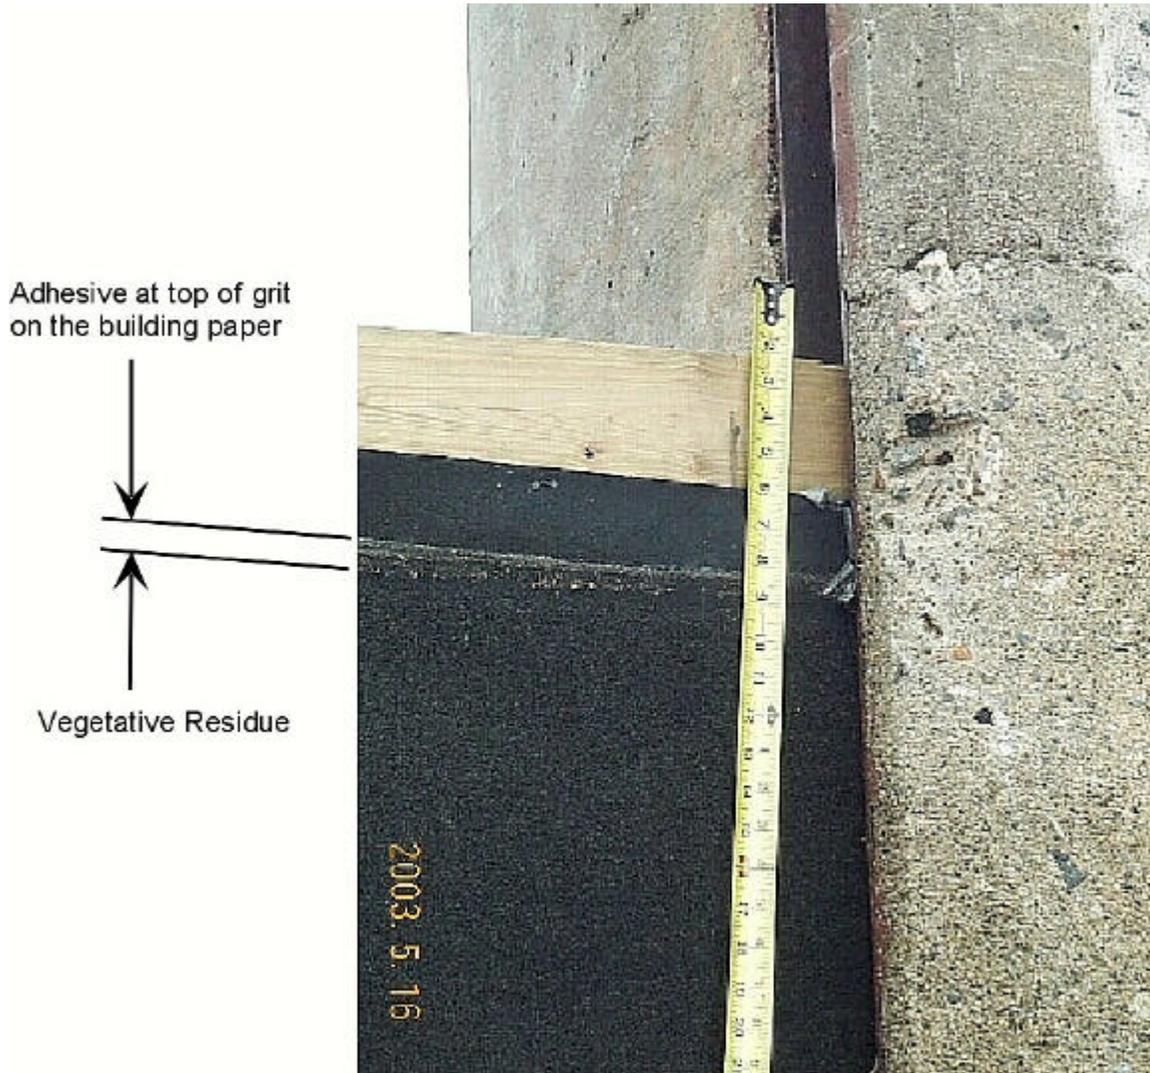
Photograph 2. Downstream left side of the stoplog bay of the overflow spillway at Silver Lake. Photograph taken on May 16, 2003. Note the small debris on the felt paper indicative of a watermark near the top of the felt paper.

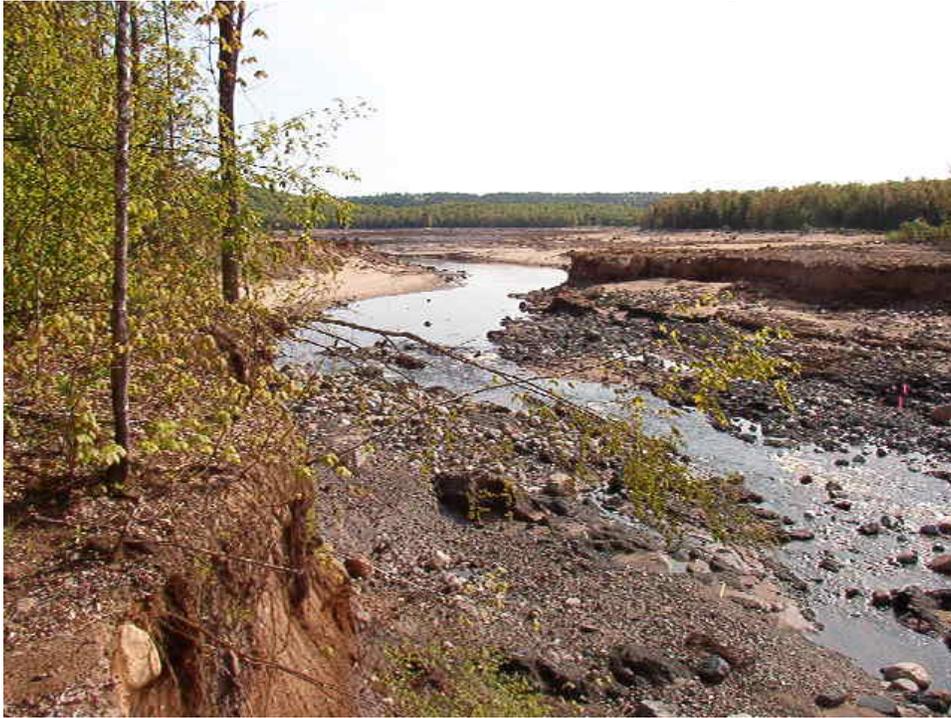
The licensee hired STS Consultants to survey the breached channel. Their results were included with the licensee's June 12, 2003 letter. Photographs 3-7 show the channel as observed during our June 3, 2003 site visit. The breach scoured the entire entrance and exit channels and further

Photograph 3. Silver Lake channel entrance as viewed from the right abutment near Station 0+35. Photograph taken on June 3, 2003.

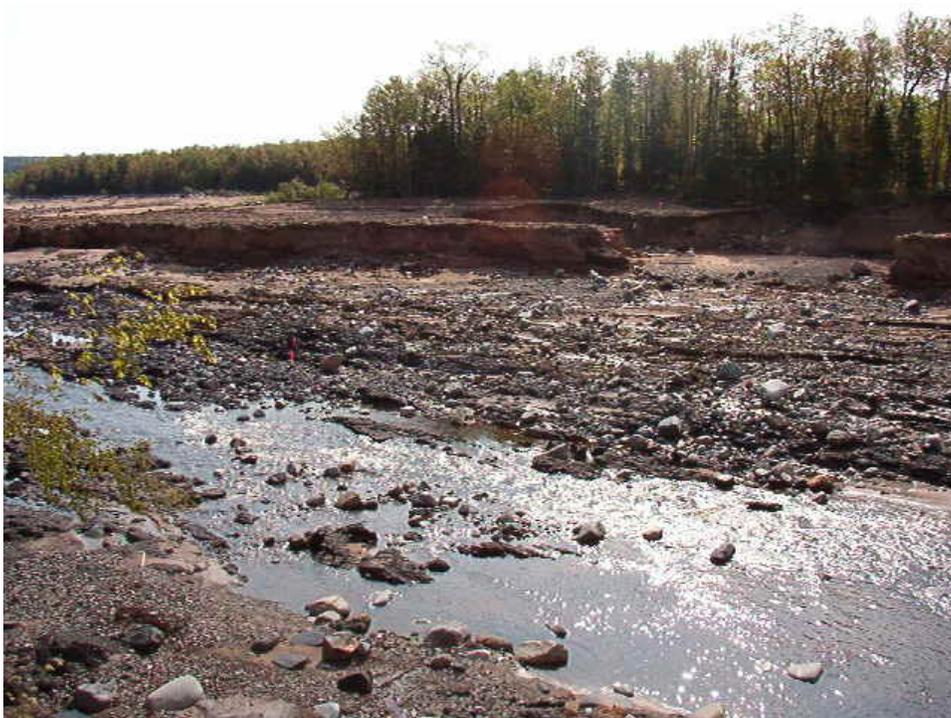
Photograph 4. View of the upstream portion of the channel as viewed from the right abutment near Station 0+35. Photograph taken on June 3, 2003.

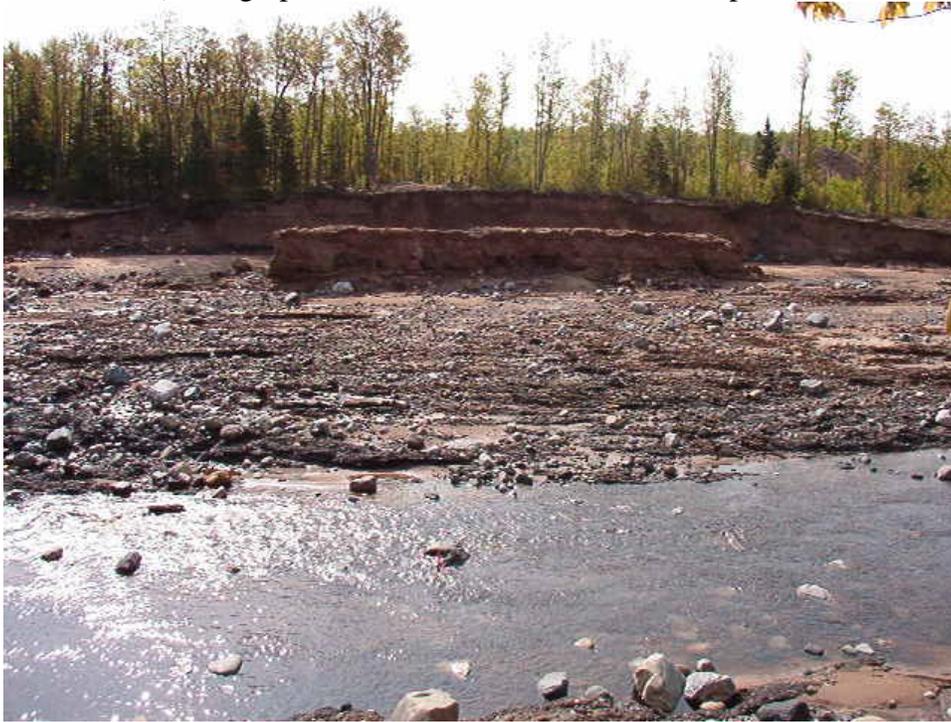
According to the STS survey, the channel scoured the foundation of the fuseplug to elevation 1453 feet at its lowest point, which is 28 feet below the constructed channel invert at 1481.0 feet. Most of the breach channel invert is between elevation 1458 and 1468 feet. A 20-foot wide remnant of the channel remains near the left abutment which still has its top elevation at 1481.0 feet. The breach scoured the sides of the channel to a width of about 335 feet at the location of the fuseplug.

Photograph 5. The left abutment at Station 0+35 where the fuseplug dike was located. According to the STS survey, the top of the remnant section is at elevation 1481 feet. Photograph taken on June 3, 2003.

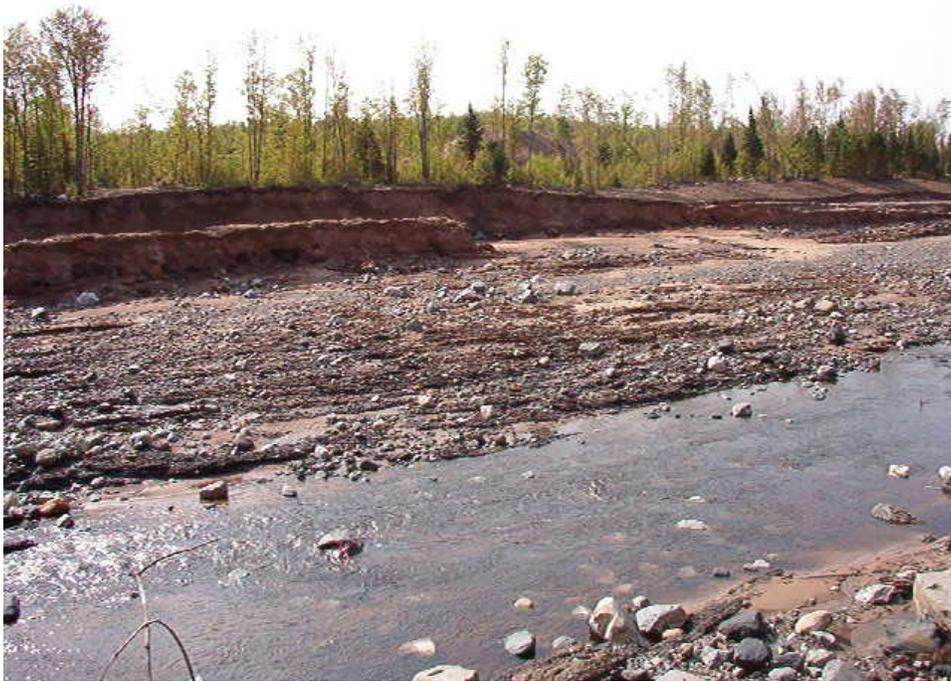
Photograph 6. Downstream portion of the channel as viewed from the right abutment near Station -0+60. Photograph taken on June 3, 2003.

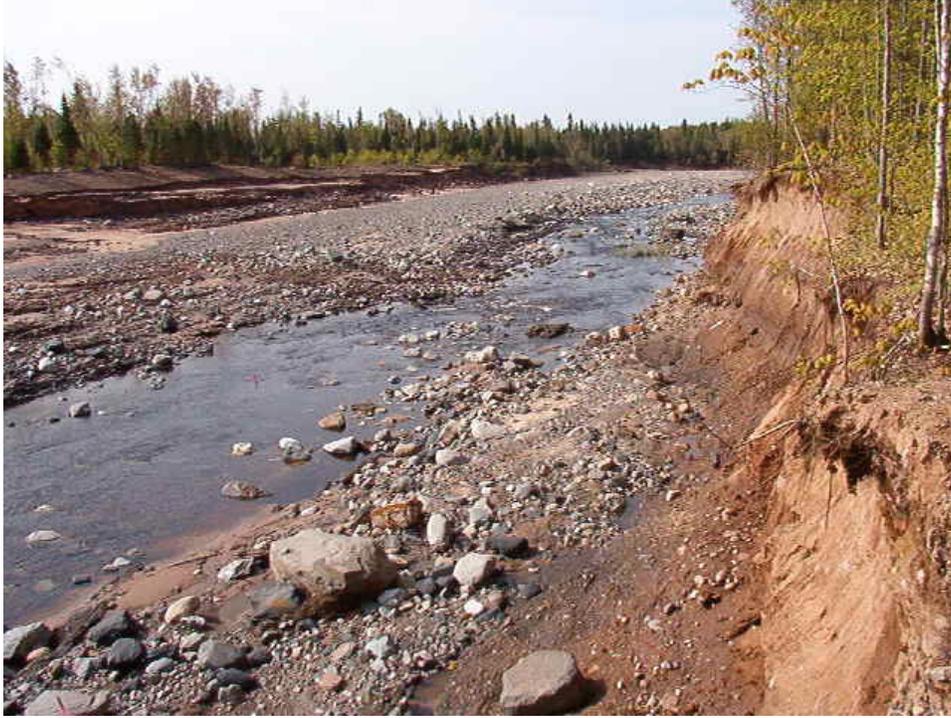
Photograph 7. Downstream channel as viewed from the right abutment near Station -0+60. Photograph taken on June 3, 2003.
