VIII. Fuse Plug Design, Construction and Activation

B. Fuse Plug Construction.

a) Surficial Geology along the Silver Lake Fuse Plug (Dike No.2) Channel

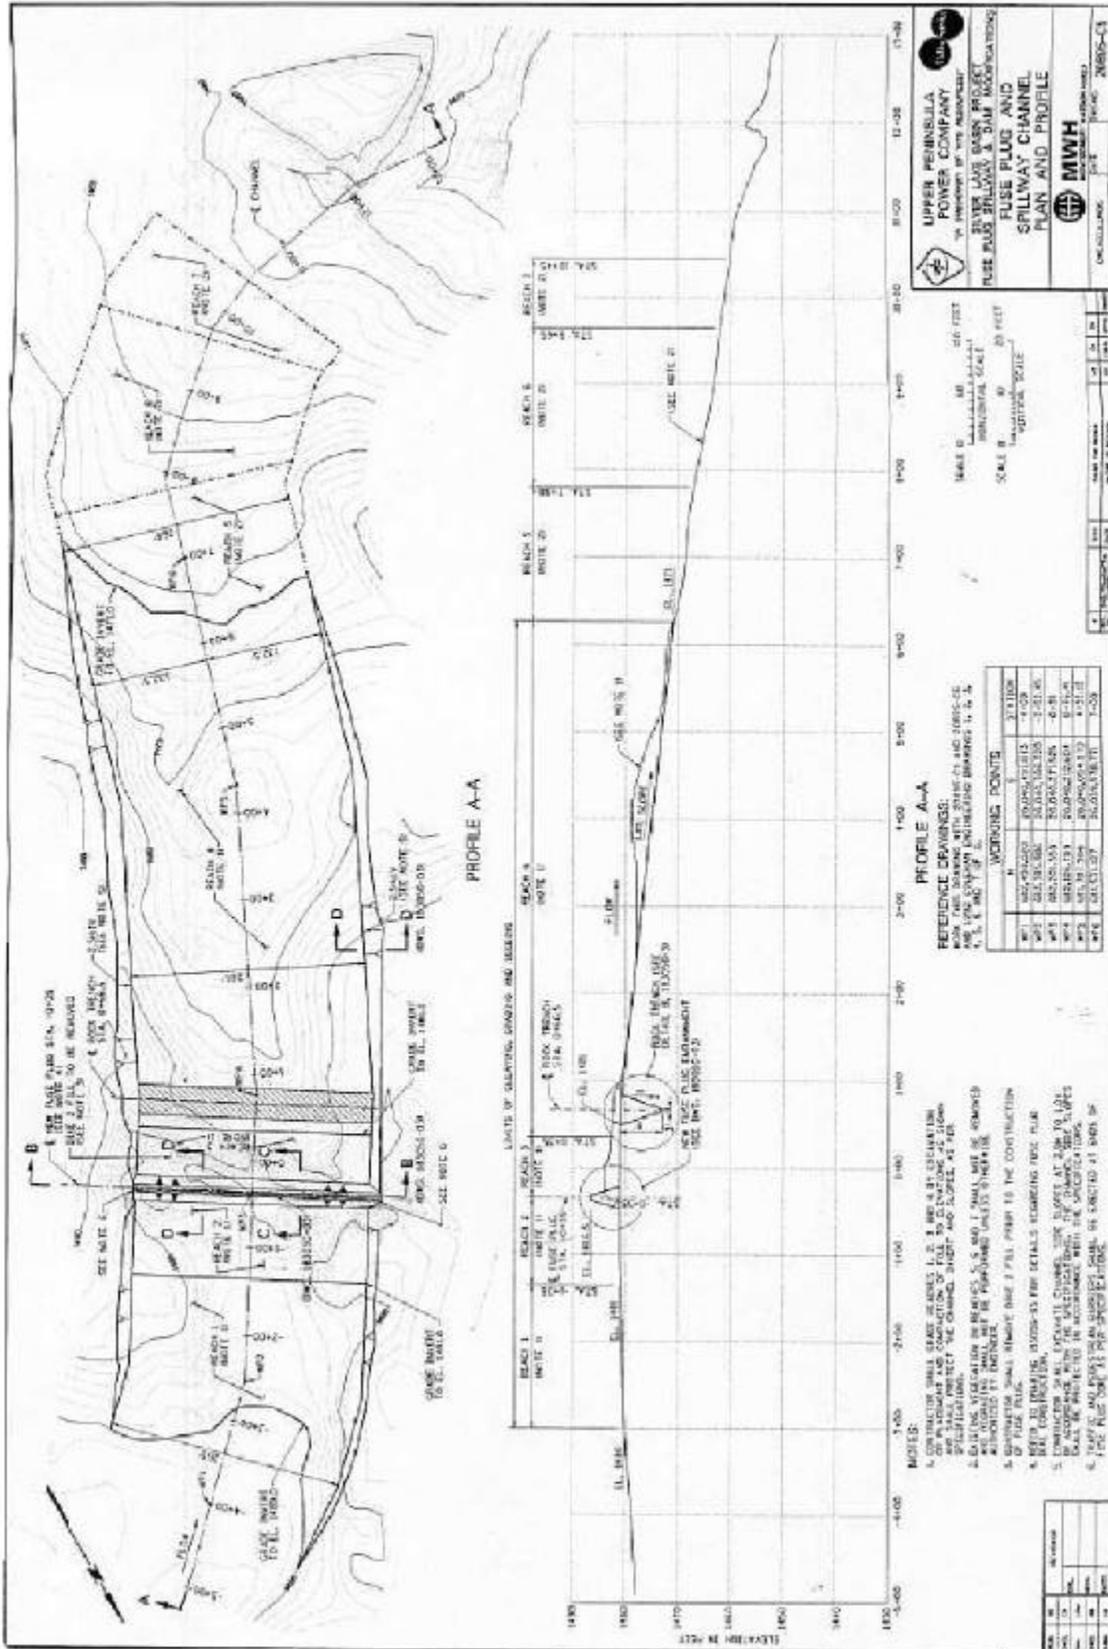
DATE: 01/11/2010
 DRAWN BY: MWH
 CHECKED BY: MWH
 PROJECT NO: 20895-C5

The design plan of the fuse plug, its spillway channel, and profile are shown in MWH drawing 20895-C5. The design cross section of the fuse plug and rock trench section are in MWH drawing 20895-C6.

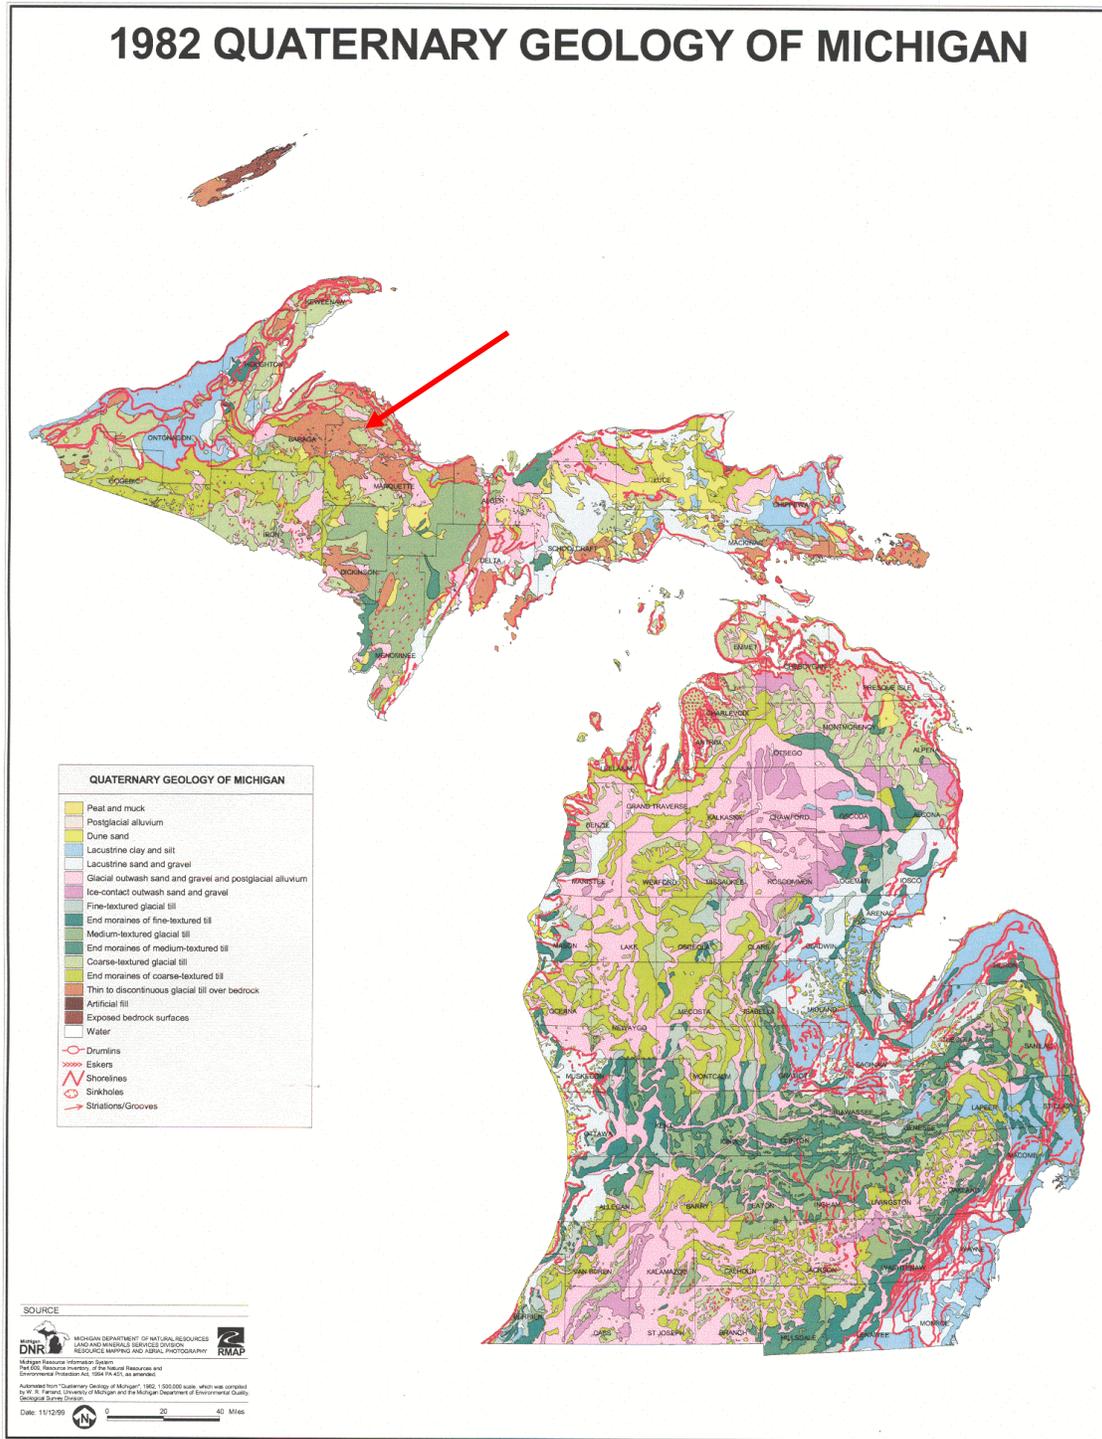
As indicated by the brief glacial history cited above, the surficial deposits in the channel area have a complex and varied origin. Figure 1 is a glacial map of Michigan from the Michigan Department of Natural Resources. As shown in Figure 1, the glacial deposits in Marquette County (red arrow) are predominantly "thin to discontinuous glacial till over bedrock" (light brown unit). Aligned from the northwest to the southeast are glacial deposits indicated as "glacial outwash sand and gravel and postglacial alluvium" (pink) and "coarse-textured glacial till" (olive green). The Silver Lake Reservoir lies immediately to the NNW of a deposit of this "coarse-textured glacial till" (red arrow point of Figure 1). This deposit forms the channel outlet along the Fuse Plug spillway channel. These coarse deposits may likely be associated with the Au Train-Whitefish Channel that drained proto Lake Superior to proto Lake Michigan, as discussed above. As such, these deposits likely constitute a higher-energy depositional environment than that of a typical glacial till. Three glacial units were observed along the channel area during the authors' reconnaissance and are described below from youngest to oldest.

Figure 1 Glacial Map of Michigan. Red arrow points to "Coarse-textured glacial till" (olive-green oval deposit). Silver Lake lies immediately to the N-NW of this unit (at point of arrow).

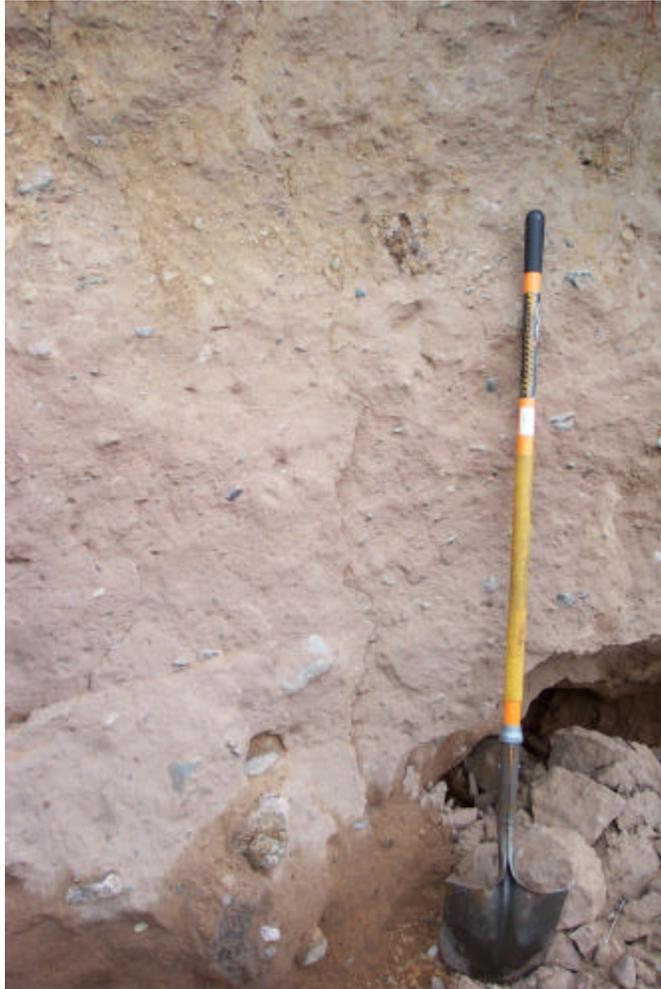
Figure 2 Detail of "Coarse-textured glacial till." This material is generally 90% fine to coarse sand and 10% non-plastic fines (SP-SM), with occasional gravel, cobbles and boulders. Note that some faint stratification is present. The stratification and coarse-grained material point to a higher-energy glacial environment, possibly originating closer toward the ice terminus. View is of left channel downstream of former fuse plug.

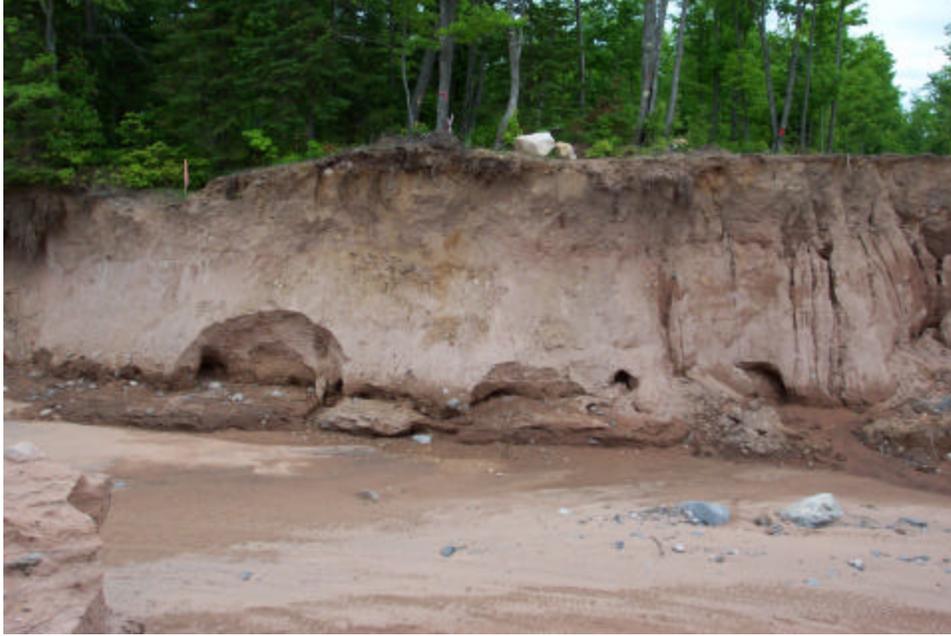
The upper 12- to 18-inches of this deposit is oxidized to a medium to dark brown color, with some organic root material from surface vegetation. The lower 6 feet is unweathered, light tan in color, and is massive to faintly stratified. This material displays an unusual circular erosional characteristic (Figures 2 through 6) at the base of this unit that appears to concentrate immediately above the change in lithology. This erosion may be the result of washing away of silt and/or carbonate cementation.

Figure 3 Overall view of "Coarse-textured glacial till." Note vertical erosional gullies (at right) and circular erosional features near base. Upper horizon is oxidized and contains some roots from surface vegetation. This deposit stands vertically similar to loess. On surface exposures, this material is dry. This unit likely contains weak carbonate cementation, but is a cohesionless soil. View is of left channel downstream of former fuse plug.

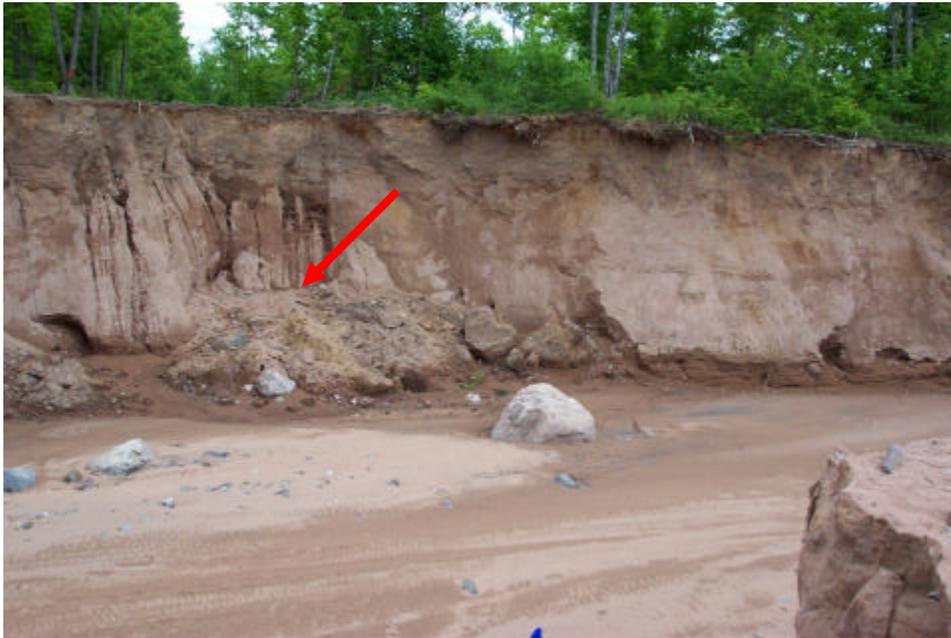
Figure 4 The upper SP-SM unit appears to contain a weak soil structure (weak carbonate cementation?) that when disturbed loses strength and crumbles (pile at arrow). This unit has a low dry strength and is easily broken by light finger pressure. View is of left channel downstream of former fuse plug.

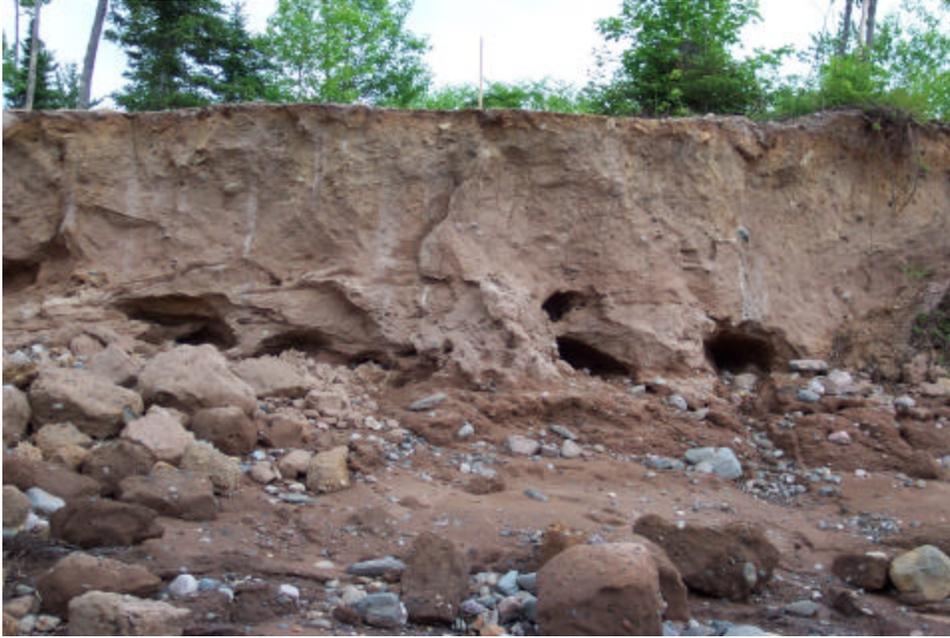
Figure 5 Note the dark brown unit immediately below the circular erosional features. This unit is a fine to medium clean sand (SP), is moist to wet, and contains prominent thin bedding (locally cross-bedded). The circular erosion appears to concentrate immediately above this change in lithology, and may be related to solution of the silt and/or carbonate content of the “coarse-textured glacial till”. View is of left channel downstream of former fuse plug.

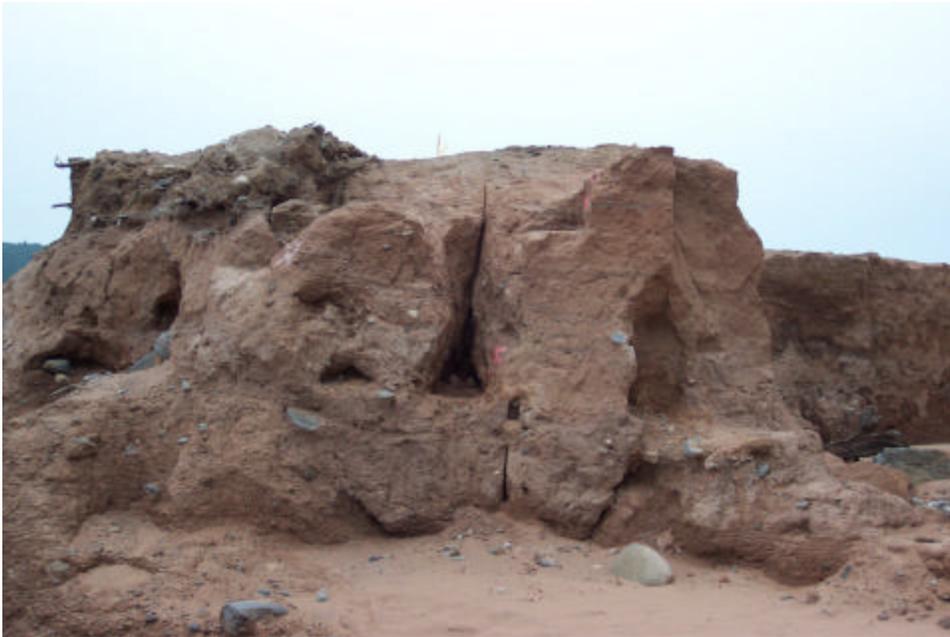
Figure 6 View of similar erosional features as described in Figure 5. Note the association of a vertical fracture with two of these erosional pockets. View is of an “island” remnant downstream of former fuse plug.

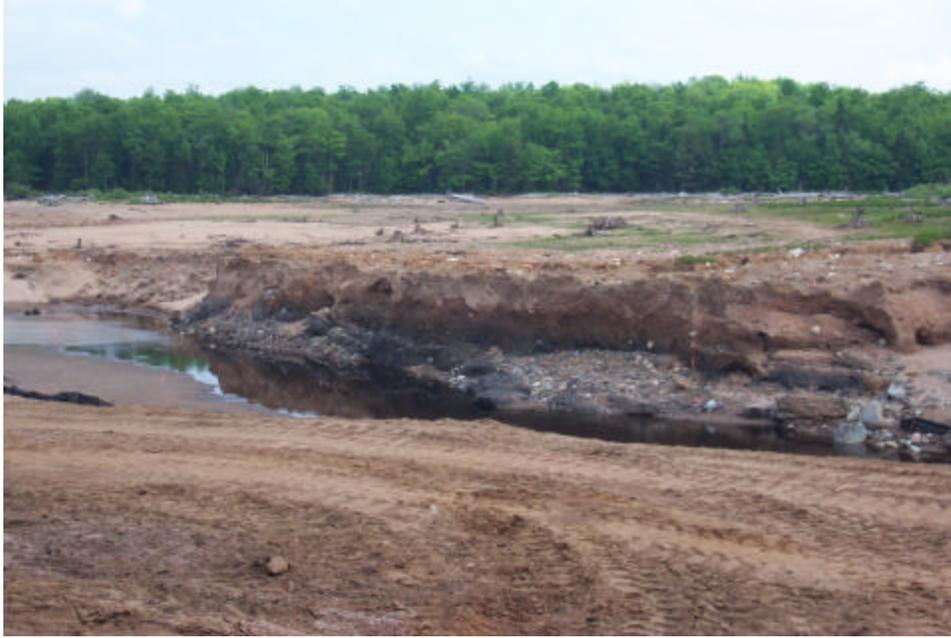
Immediately below the fluvioglacial sands is a dark gray to black deposit that appears to be an organic silt (OL). This unit may represent a swampland or low-lying glacial slough that accumulated large amounts of vegetation during glacial times. Although predominantly fine-grained, it appears to be fibrous, dries rapidly upon exposure to air, and has high to very high dry strength (could not be crushed between fingers and a hard surface). A total exposure of this unit was not observed, but it appears to exceed two feet in thickness. The aerial extent of this deposit is unknown, but it is observed upstream of and along the old alignment of the original Dike No. 2.

Figure 7 Note the dark gray to black unit stratigraphically below the "Coarse-textured glacial till." This deposit appears to be an organic silt (OL) with a very high dry strength and contains a significant fibrous organic content. View is of left channel upstream of former fuse plug.

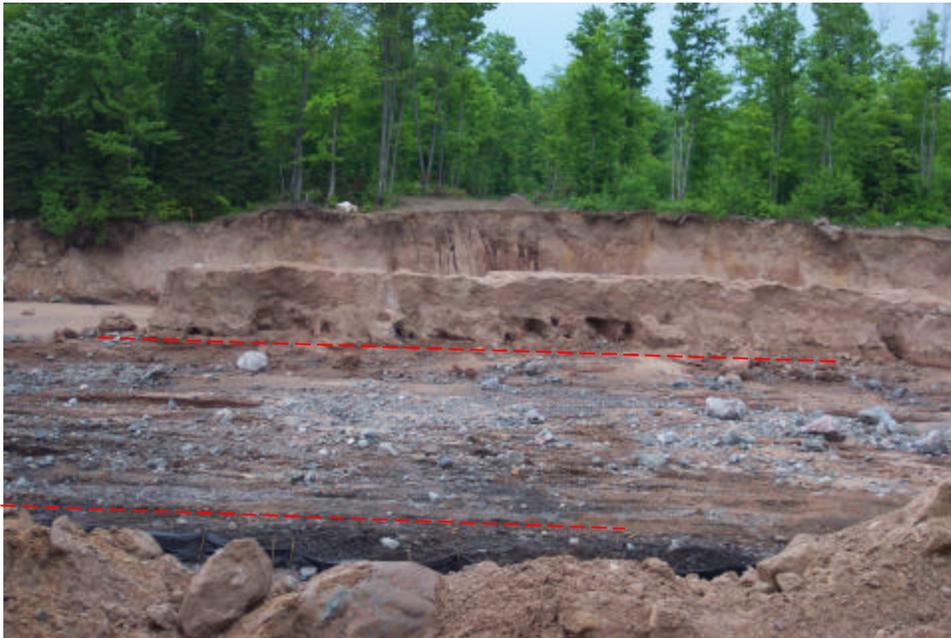
Figure 8 Overall stratigraphy of the area. Note the light-brown, dry SP-SM unit on the far channel wall and erosional remnant within the channel (above upper red line), the dark-brown, moist to wet finely bedded SP unit below the SP-SM unit (between the red lines), and the black organic silt (OL) unit at the base (below lower red line). View is from the right channel wall looking to the left directly along the alignment of the former fuse plug.

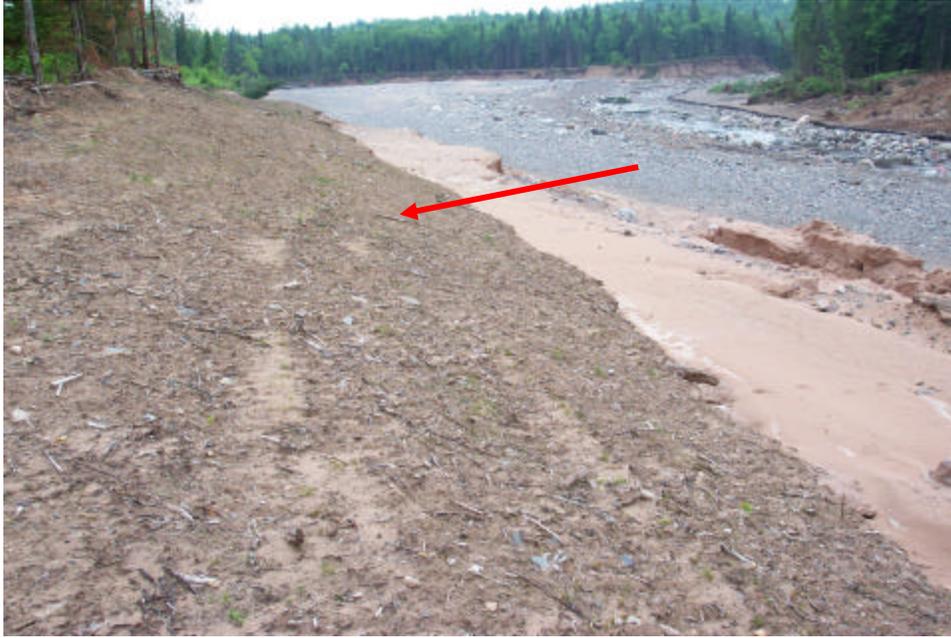
Channel erosion during the Fuse Plug activation cut easily through the un-vegetated coarse-textured glacial till (Figure 9). Much of the sand from this unit appears to have settled out along the inner curve of the Fuse Plug channel, approximately 1,100 feet downstream of the old dike alignment (Figure 10).

Figure 9 Foreground shows the original ground surface of the fuse plug channel. Flood erosion occurred to the right of the line marked by the arrow. Note the coarse-grained cobble and boulder deposition along the channel centerline. View is on left channel downstream of former fuse plug.

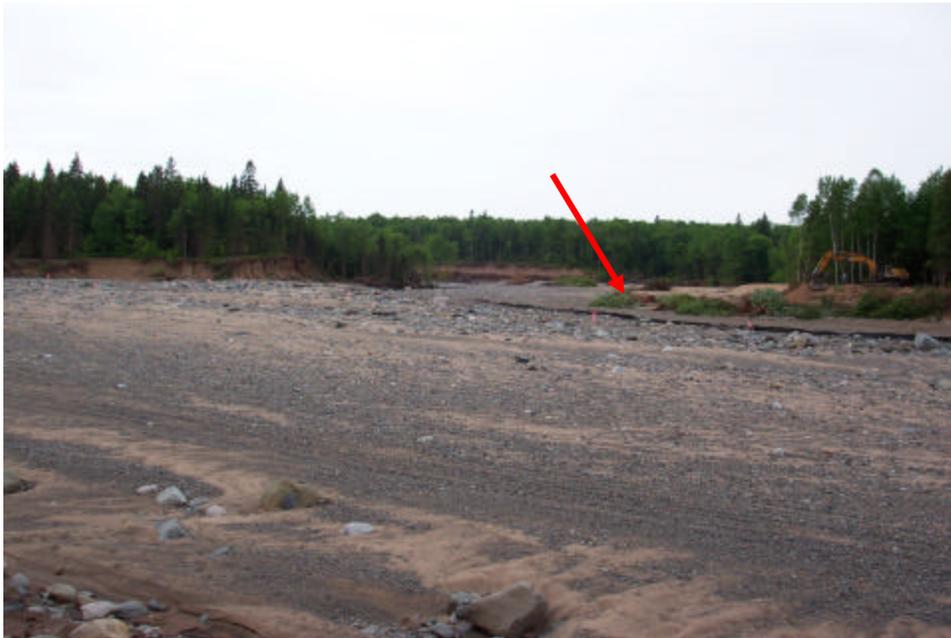
Figure 10 View of channel erosion and flood deposition downstream of former fuse plug. Note the light-colored deposits in the upper right of the photograph (arrow). This shows large amounts of well graded sand that were deposited along an inner bend of the channel alignment, approximately 1,100 feet downstream of the former fuse plug.
