Report of the Expert Panel on the Technical Causes of the Failure of Feijão Dam I

December 12, 2019

EXECUTIVE SUMMARY

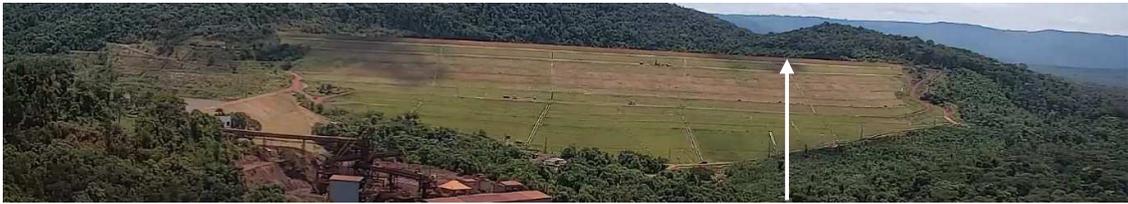
Figure 5: Observed Initial Deformation of the Central Part of Crest

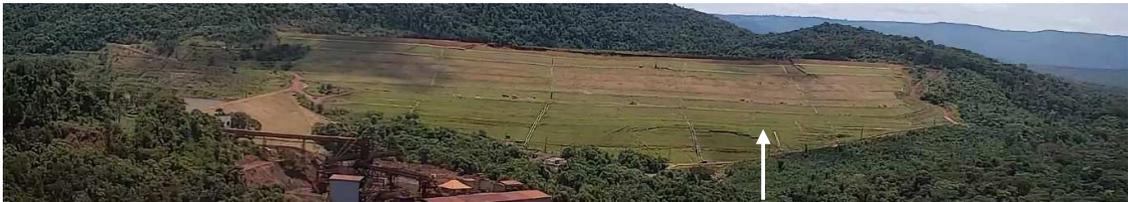
Figure 6: Bulging Above the Toe of the Dam Approximately One-Third in from the Left Abutment (Right Side of Photograph), Initiated About 0.2 s After the First Observed Deformation at Crest

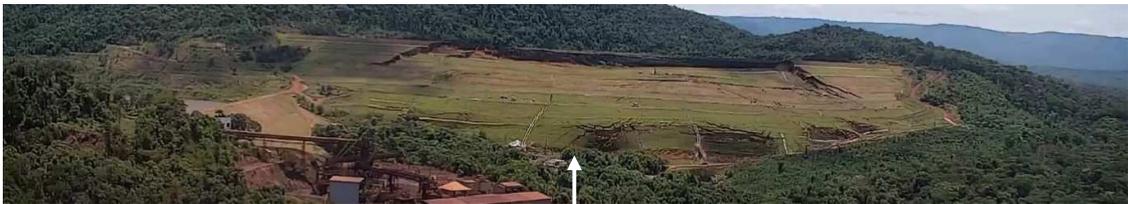
About 5 s after the first observed deformation at the crest, further crest settlement and bulging above the toe occurred and water appears to erupt from the toe region of the dam about one-third in from the right abutment (Figure 7). A second, more turbid, water spout erupted from the toe area, as the surface of the dam in the region of the bulge began to break apart (Figure 8).

Figure 7: Continued Settlement of the Crest and Bulging Above the Toe with Water Erupting Above the Toe Toward the Right Abutment (Left Side of Photograph) About 5.5 s After the First Observed Deformation at Crest

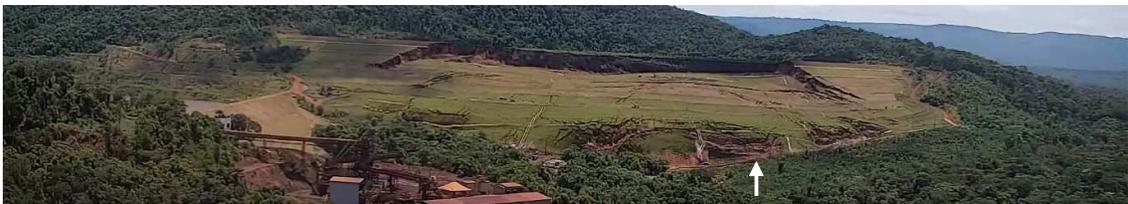
Figure 8: Extensive Settlement of the Crest and Bulging Above Toe with a Second Water Spout in the Region of Bulge About 5.8 s After the First Observed Deformation at Crest

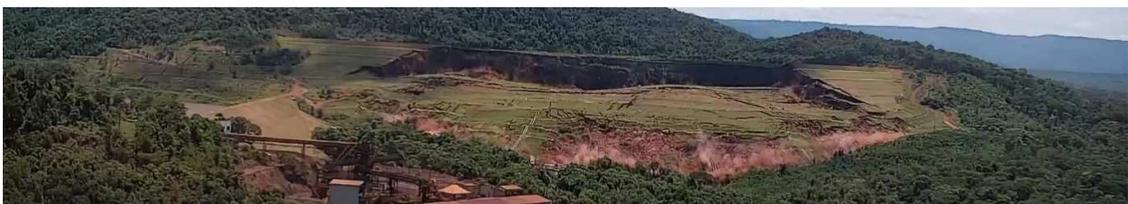
Figure 9: Full Development of Slope Failure with Failed Mass Moving out Beyond the Toe at About 6.7 s After the First Observed Deformation at Crest

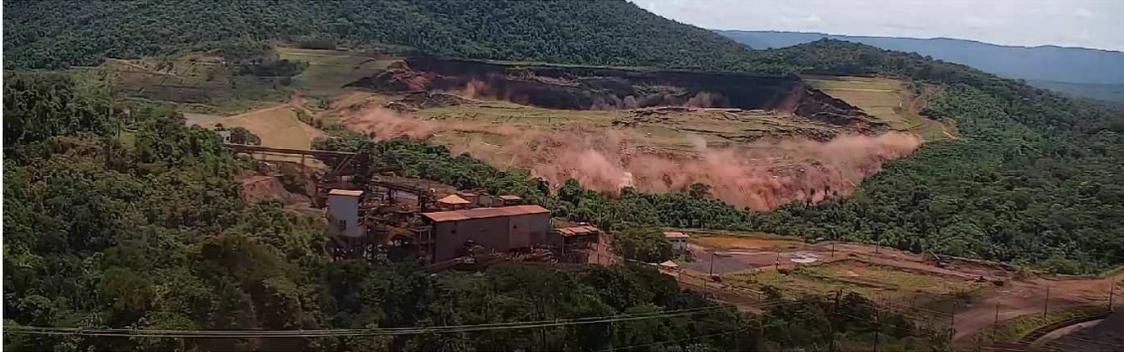
As the failed mass progressed downstream, the failure regressed into the stored tailings as a series of rapid slips, leaving near-vertical back scarps, as shown in Figures 10 through 12. The capture of further progression of the failure by CAM1 became obscured by the dust and mist that rose above the failing mass.

Figure 10: Regression of the Failure 11 s After the First Observed Deformation, as Captured by CAM1

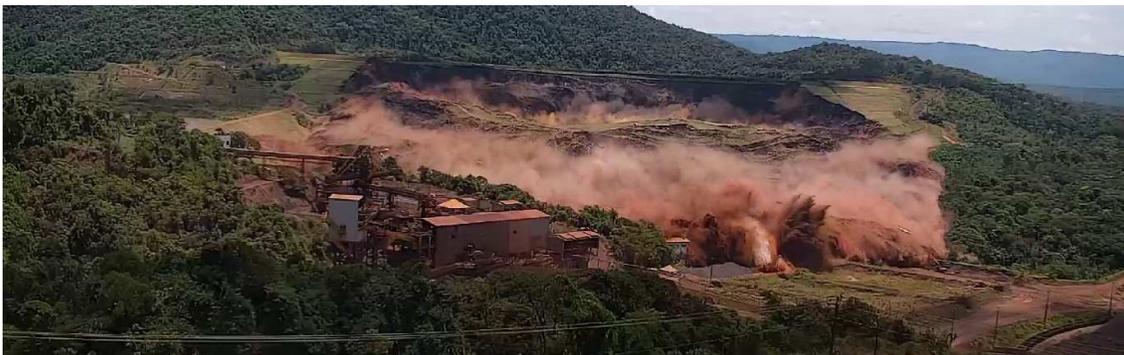
Figure 11: Regression of the Failure 18 s After the First Observed Deformation, as Captured by CAM1

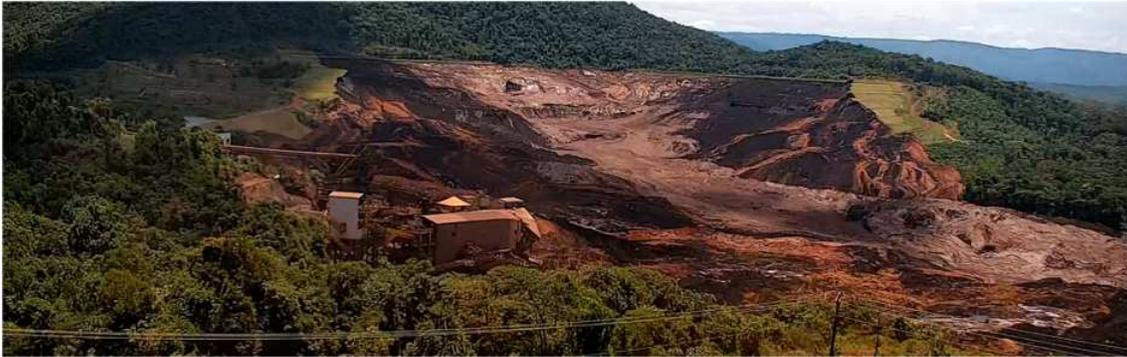
Figure 12: Final Regression of the Failure 6 min and 25 s After the First Observed Deformation, as Captured by CAM1

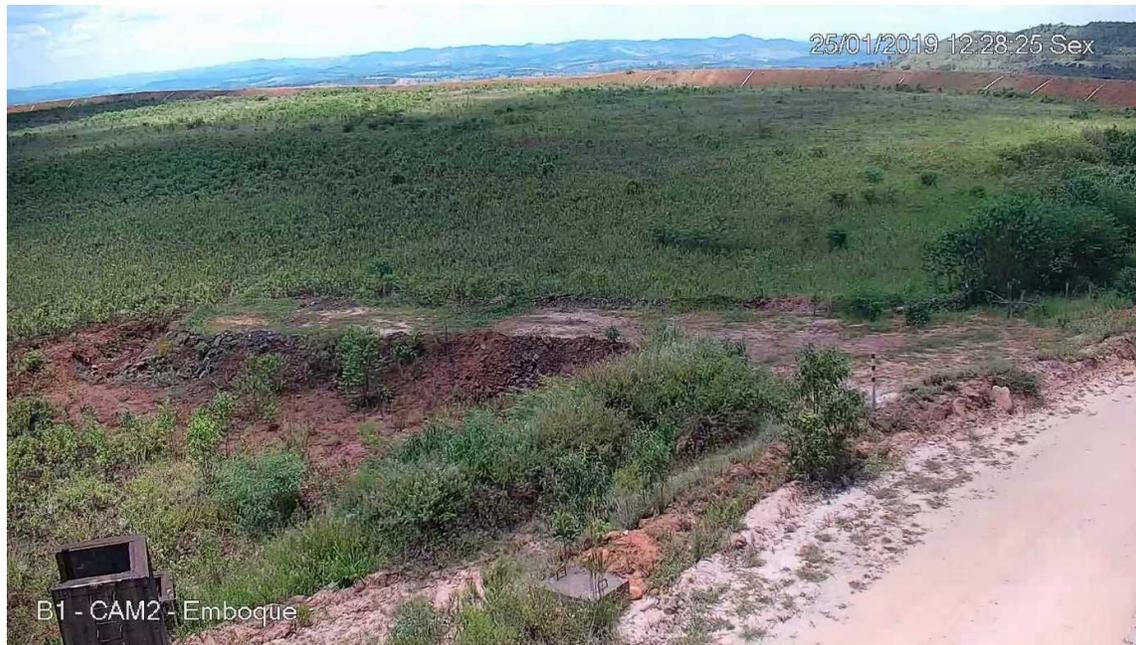
CAM2 confirmed that the initial failure was relatively shallow and started just behind the crest. CAM2 also clearly shows the regression of the failure into the stored tailings, eventually stopping close to natural ground, as seen in Figures 13 through 17. CAM2 also shows that after each failure slice, the failed material appears to become a heavy liquid.

Figure 14: Initial Settlement of the Central Part of Crest, as Captured by CAM2

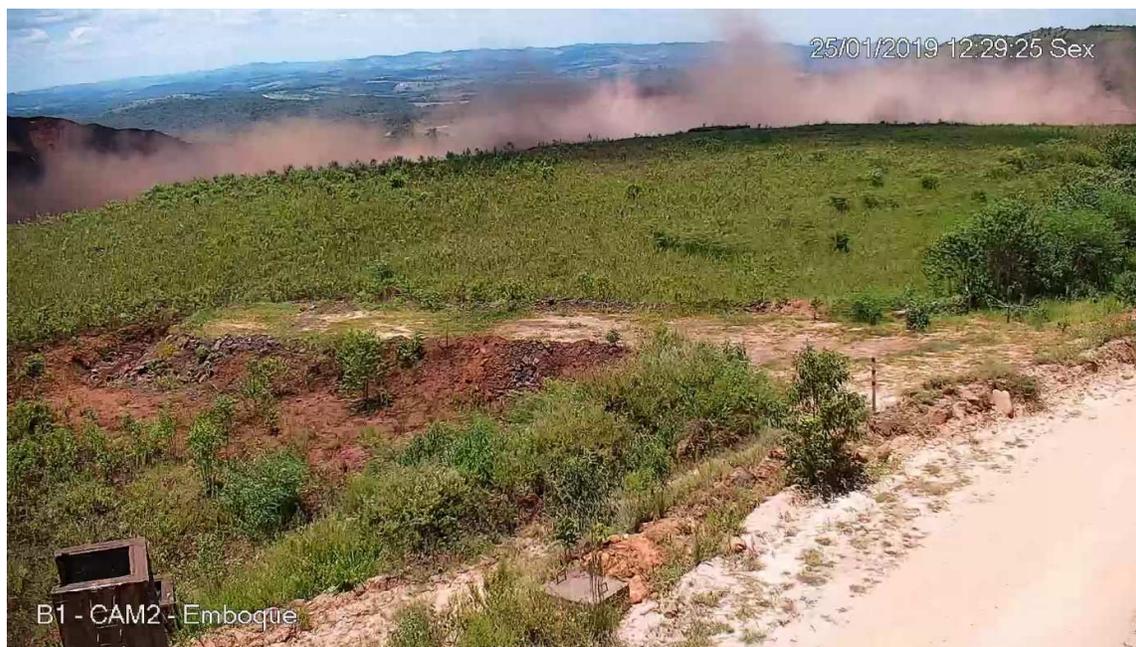
Figure 15: Regression of Liquefaction Failure at 60 s After the First Observed Deformation, as Captured by CAM2

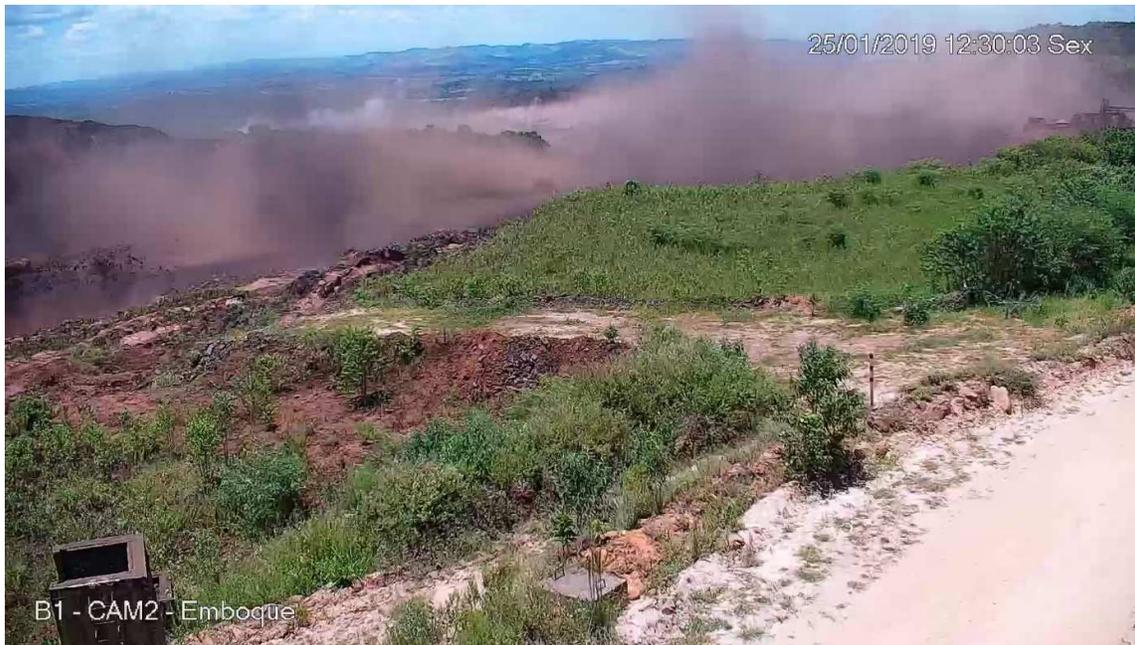
Figure 16: Regression of Liquefaction Failure at 98 s After the First Observed Deformation at the Crest, as Captured by CAM2

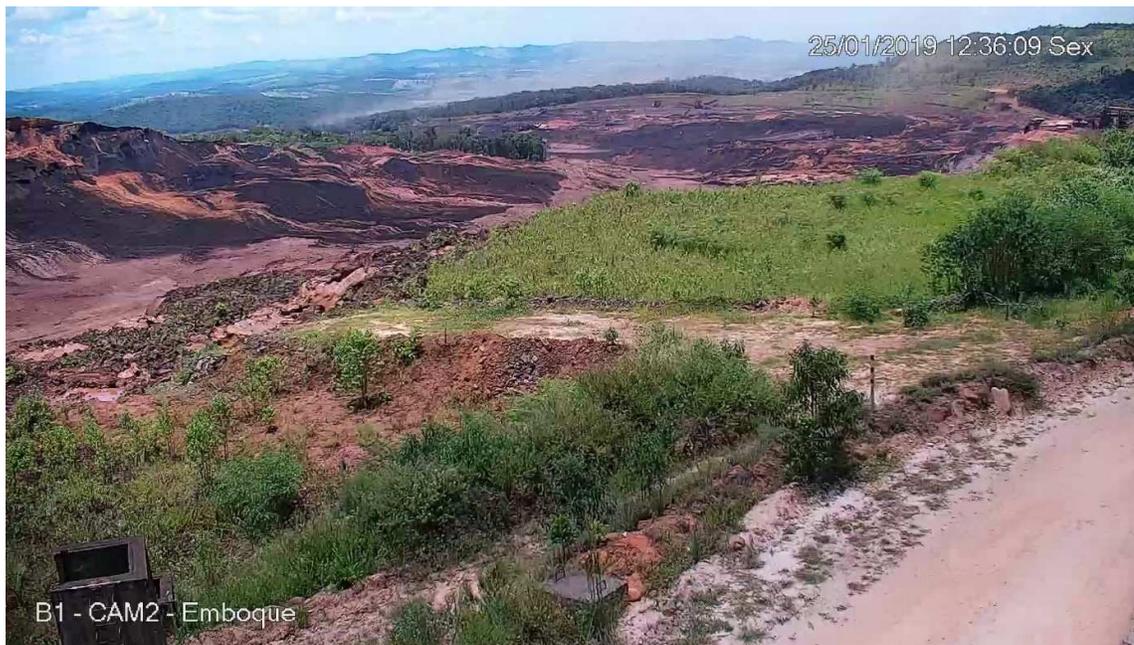
Figure 17: Final Regression of Liquefaction Failure 7 min and 44 s After the First Observed Deformation Initiation of Failure, as Captured by CAM2

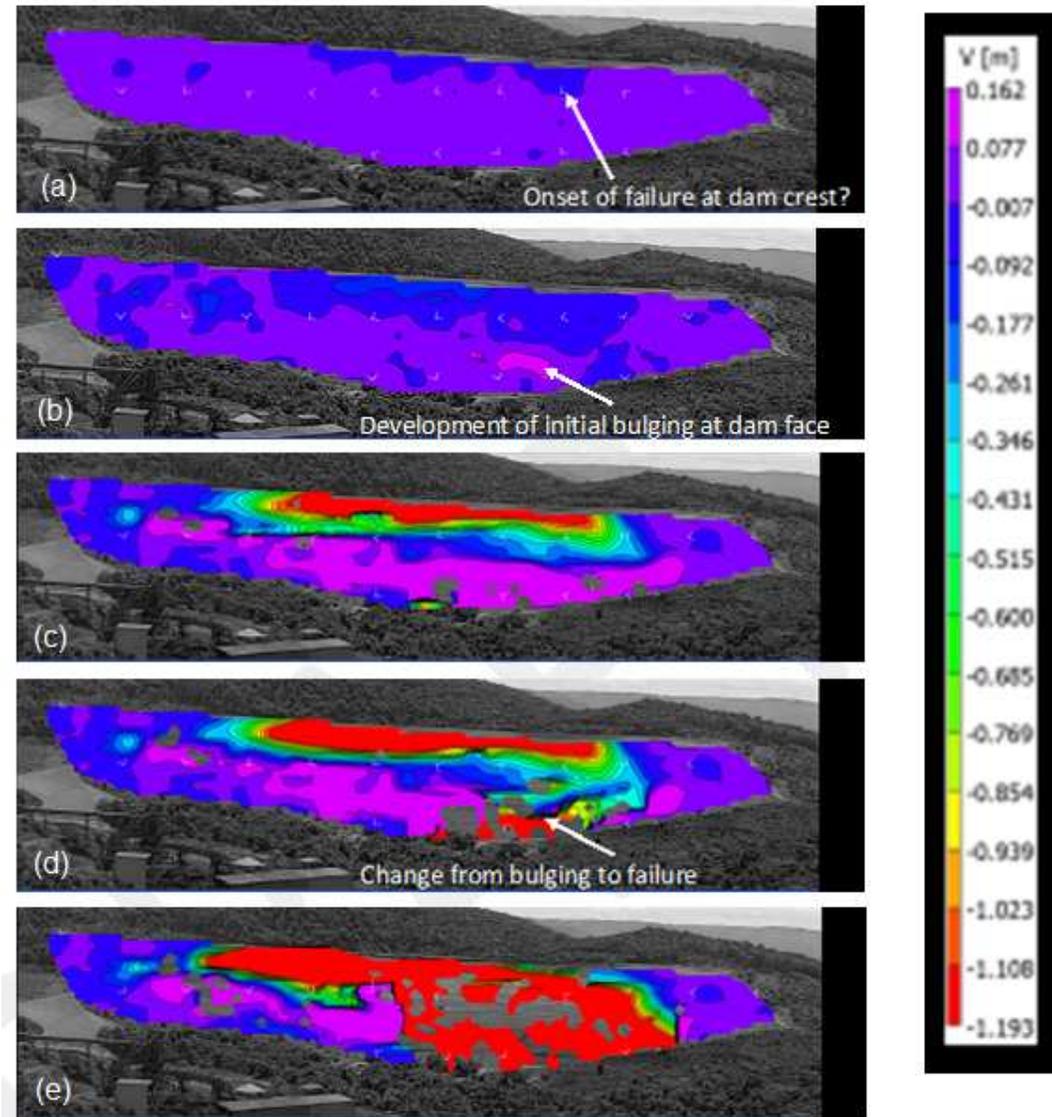
by initially upward deformation of the area just above the toe that rapidly changed to downward deformation as the crest continued to drop vertically. The slope shows signs of complete failure after about 4 s.

Figure 18: Failure of Dam I: (a) Observed Initiation at the Center of the Crest; (b) 0.2 s After the Observed Initiation, Showing Initial Bulging of the Face; (c) 1.4 s After the Observed Initiation, Showing Escalation; (d) 2.4 s After the Observed Initiation, Showing the Widening Collapse of the Crest and Increased Bulging of the Face; (e) 2.6 s After Observed Initiation; and (f) 3.6 s After Observed Initiation When the Crest and Bulging Join in Failure

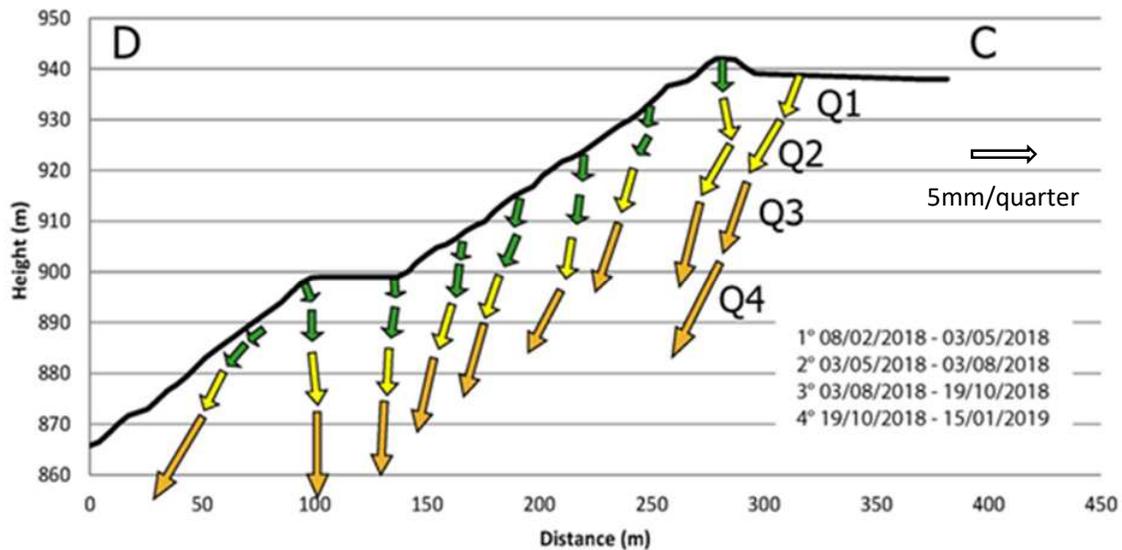
The Panel obtained and used InSAR data to evaluate deformations of the dam and impounded tailings in the one-year period prior to failure. The InSAR images provide about an order of magnitude higher precision than the ground-based radar, since the radar wavelength used for InSAR is longer, making the results less sensitive to moisture, and hence generating less noise. The analysis of the InSAR data indicates small downward deformations near the crest and mid-height of the dam of no more than 30 mm/year. In the lower parts of the dam in the central region, the analysis indicates small deformations of up to 36 mm/year, mostly in the downward direction. Figure 20 shows the quarterly velocities of deformation in the 12 months before the failure in the central region of the dam. It also shows that the deformations near the crest are mostly vertical, while closer to the toe of the dam the deformations have a slight horizontal outwards component. The horizontal deformations (in the east-west (E-W) direction) near the toe of the dam were mostly less than 10 mm/year over that period, but included some small areas with up to 30 mm/year. The deformation vectors inferred from InSAR do not include the north-south (N-S) component since the LOS of both ascending and descending orbits were almost perpendicular to that direction and, hence, likely to be an unreliable estimate of the actual deformations. A comparison between the InSAR and rainfall data indicates a correlation where deformations tend to increase slightly during the wet season. The observed deformations from the InSAR were too small and slow to be reliably detected by the survey, inclinometers, and ground-based radar methods used. The CPTu data show that the tailings within the dam were fully consolidated. Hence, such deformations in the dam are consistent with slow, long-term settlement of the dam, likely the result of ongoing internal creep, and are not indicative of a precursor to failure.

Figure 20: Cross-section Showing Deformation Vectors for the Four Quarters Prior to Failure

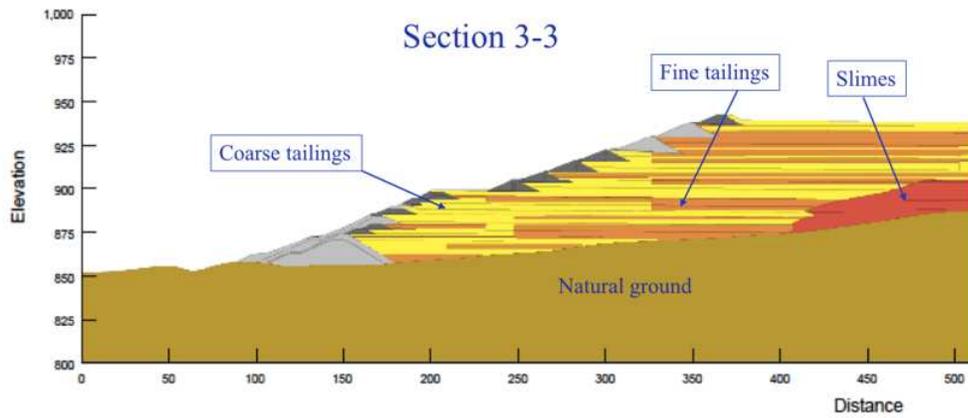
Figure 24 shows an example of a recreated cross-section for the steepest and highest section of the dam (cross-section 3-3). Figure 24 shows that the predominate material under the dam was coarse tailings (shown in yellow) with thin layers of fine tailings (shown in orange). In general, the tailings become more fine-grained with depth, reflecting the increasing distance from past crest elevations during the upstream construction. The slimes (shown in red) are generally farthest from the Dam.

Figure 24: Recreated Cross-section 3-3 Based on Historical Data, Expanded to Show Details Under the Dam

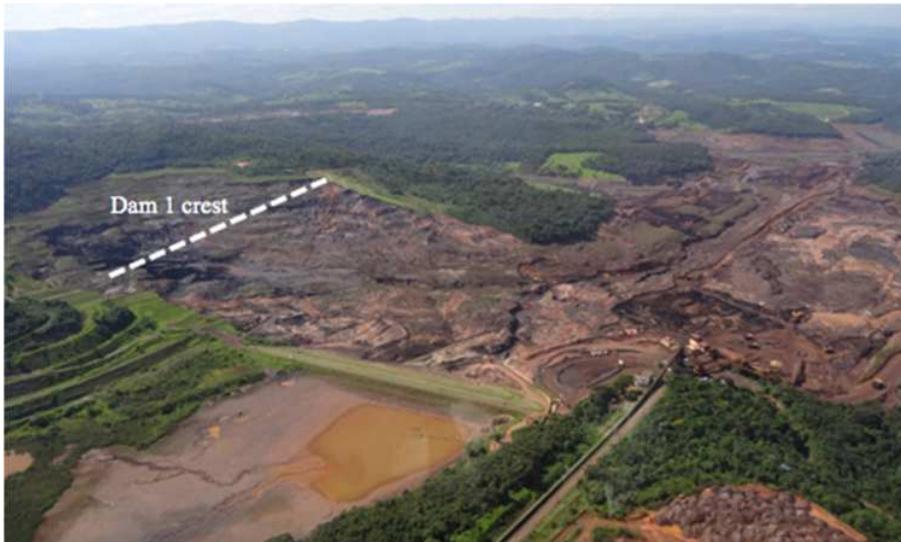
Figure 25: Aerial View of Failed Dam I, Looking Approximately South-East, Photographed on March 28, 2019

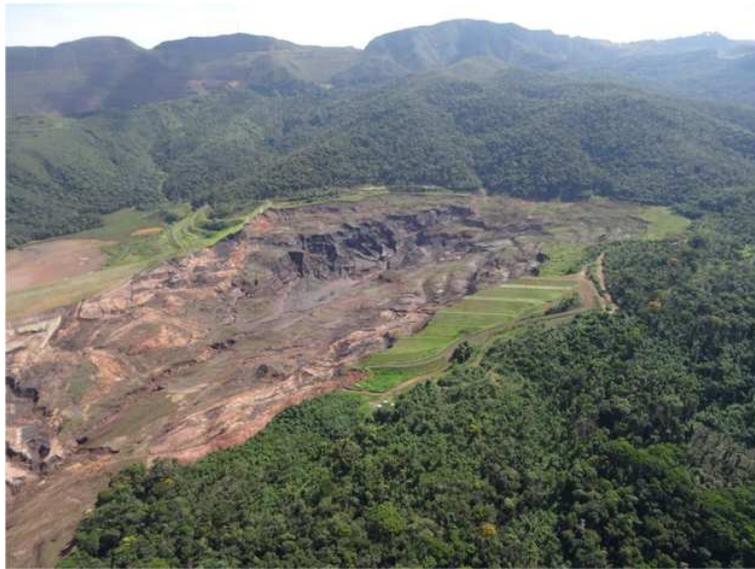
Figure 26: Aerial View of Failed Dam I, Looking North, Photographed on March 28, 2019

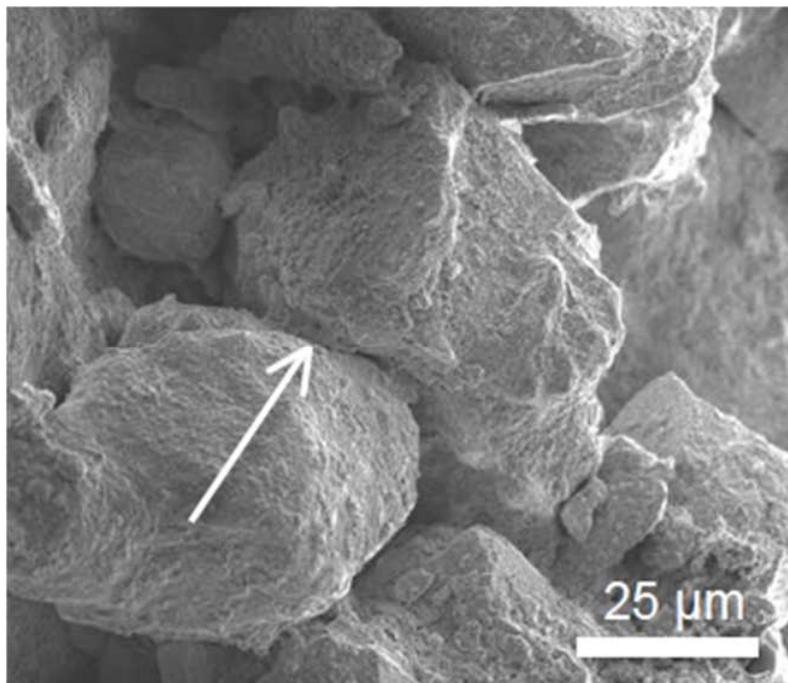
Scanning electron microscope (SEM) images were taken of samples of coarse tailings and slimes from the June 2019 field program to qualitatively assess particle structure, angularity, and other parameters at the microscopic level. Example images are shown in Figures 31 (coarse tailings) and 32 (slimes). The SEM images confirm the high iron content and show that the particle shape is similar for both materials and that the grains are typically sub-angular to angular with rough, often pitted surfaces. Additional SEM images were taken to study the interaction between particles and showed evidence of bonding between particles, shown in Figures 33 and 34. The nodules shown in Figure 33, and highlighted in Figure 34, are composed of iron oxide. The bonding appears to be derived from clay-size iron oxide. It appears that oxidation of the iron produces bonding between particles.

Figure 34: SEM Image of Coarse Tailings (Detail of Box Shown in Figure 33).
Region Highlighted with Arrow Shows Bonding Between Particles

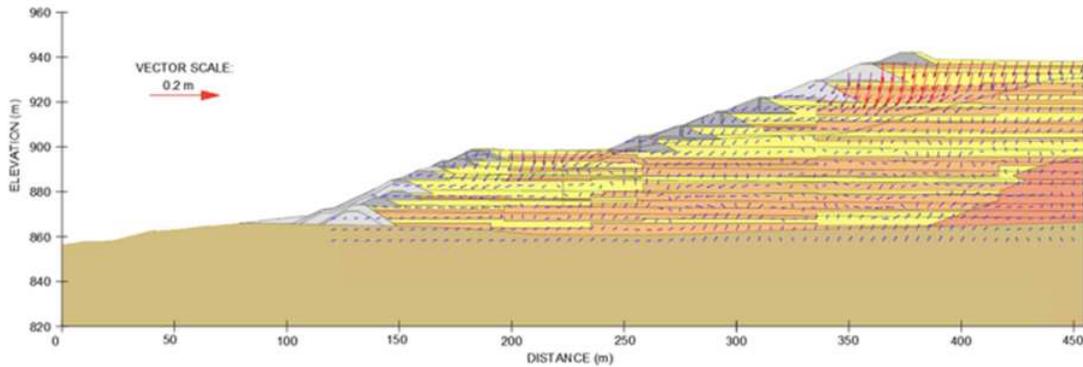
Figure 50: Cross-section 3-3 Showing Calculated Pre-failure Deformations Due to Creep Combined With a 15 kPa Strength Reduction From Loss of Suction from 3D Computer Simulations

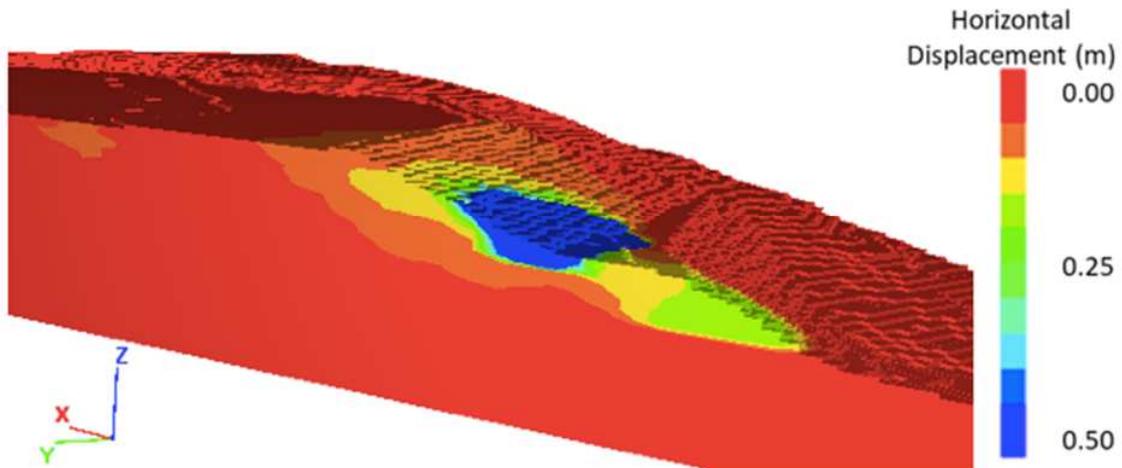
Figure 51: Cross-section 3-3 Showing Calculated Deformations at Failure Due to Creep Combined With a 15 kPa Strength Reduction From Loss of Suction from 3D Computer Simulations
