# **Dam Safety Incident Report**

## **Benson Creek Rainfall-Runoff Model Results**

### **Benson Creek Flood, August 2014**

### **Okanogan County near Twisp, WA**

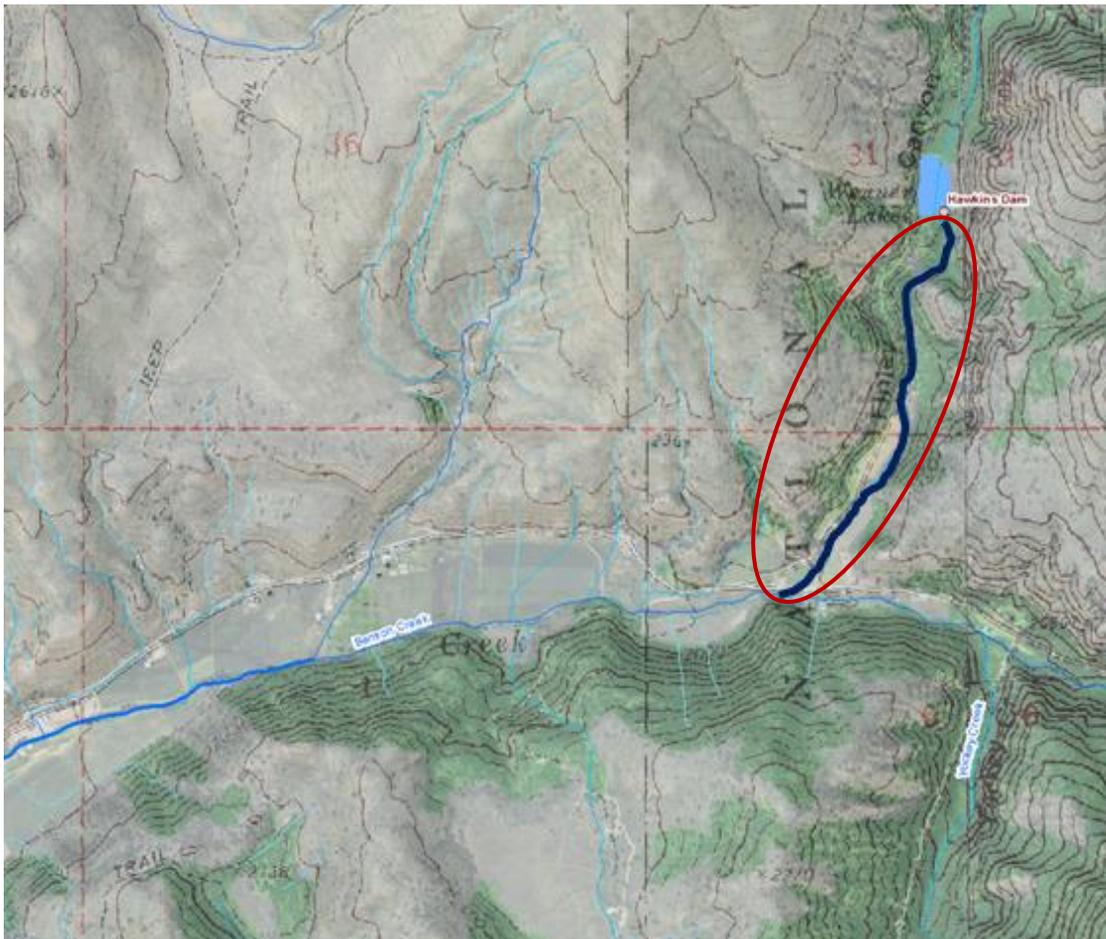
Lower Finley Canyon below Hawkins Dam

For Lower Finley Canyon below Hawkins Dam, without the spillway breach, model predictions are that the peak flow at the mouth of the canyon would have been 410 cfs. With the spillway breach, model predictions are that the peak flow at this location was 647 cfs. This peak flow is 58% higher than the non-failure scenario.

side slopes averaging 15 H:1V. Comparison of these flows with a stage-discharge curve for the valley cross-section estimated flow depths of 2.1 feet for 410 cfs and 2.6 feet for 647 cfs. The increased flow depth is about 5 inches higher than the non-failure scenario. On a relative basis, the increased depth is about 20% higher than the non-failure scenario.

- At a location 3200 feet downstream from the dam and 1600 feet upstream from the confluence with Benson Creek, the valley cross-section is roughly trapezoidal in shape and about 264 feet wide. Comparison of these flows with a stage-discharge curve for the valley cross-section estimated flow depths of 0.4 feet for 410 cfs and 0.6 feet for 647 cfs. The increased flow depth is about 2 inches higher than the non-failure scenario. On a relative basis, the increased depth is about 35% higher than the non-failure scenario.

- At a location 4200 feet downstream from the dam and 600 feet upstream from the confluence with Benson Creek, the valley cross-section is roughly triangular in shape with side slopes averaging 9.6 H:1V. Comparison of these flows with a stage-discharge curve for the valley cross-section estimated flow depths of 2.6 feet for 410 cfs and 3.1 feet for 647 cfs. The increased flow depth is about 6 inches higher than the non-failure scenario. On a relative basis, the increased depth is about 20% higher than the non-failure scenario.

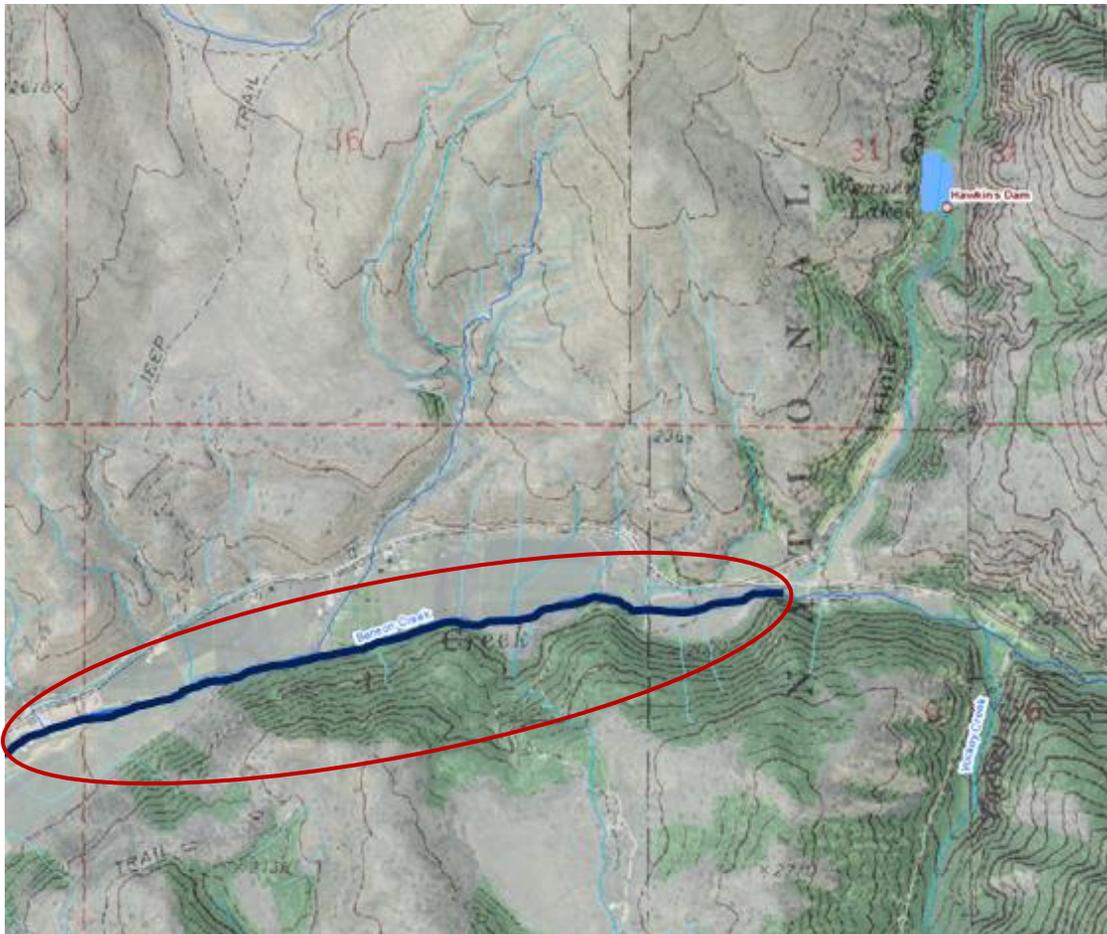
Lower Benson Creek below Finley Canyon

For Lower Benson Creek just below the confluence of Lower Finley Canyon and Upper Benson Creek, without the spillway breach, model predictions are that the peak flow into Lower Benson Creek would have been 1059 cfs. With the spillway breach, model predictions are that the peak flow at this location was 1291 cfs. This peak flow is 22% higher than the non-failure scenario.

- At a location 0.12 miles (600 feet) downstream from Finley Canyon, the valley cross-section is roughly triangular in shape with side slopes averaging 12.6 H:1V. Comparison of these flows with a stage-discharge curve for the valley cross-section estimated flow depths of 3.4 feet for 1059 cfs and 3.7 feet for 1291 cfs. The increased flow depth is about 3 inches higher than the non-failure scenario. On a relative basis, the increased depth is about 8% higher than the non-failure scenario.

- At a location 0.45 miles (2400 feet) downstream from Finley Canyon, the valley cross-section is roughly triangular in shape with side slopes averaging 28 H:1V. Comparison of these flows with a stage-discharge curve for the valley cross-section estimated flow depths of 2.5 feet for 1059 cfs and 2.7 feet for 1291 cfs. The increased flow depth is about 2½ inches higher than the non-failure scenario. On a relative basis, the increased depth is about 8% higher than the non-failure scenario.

- At a location 0.92 miles (4900 feet) downstream from Finley Canyon, the valley cross-section is roughly triangular in shape with side slopes averaging 10.3 H:1V. Comparison of these flows with a stage-discharge curve for the valley cross-section estimated flow depths of 3.7 feet for 1059 cfs and 4.0 feet for 1291 cfs. The increased flow depth is about 3½ inches higher than the non-failure scenario. On a relative basis, the increased depth is about 8% higher than the non-failure scenario.

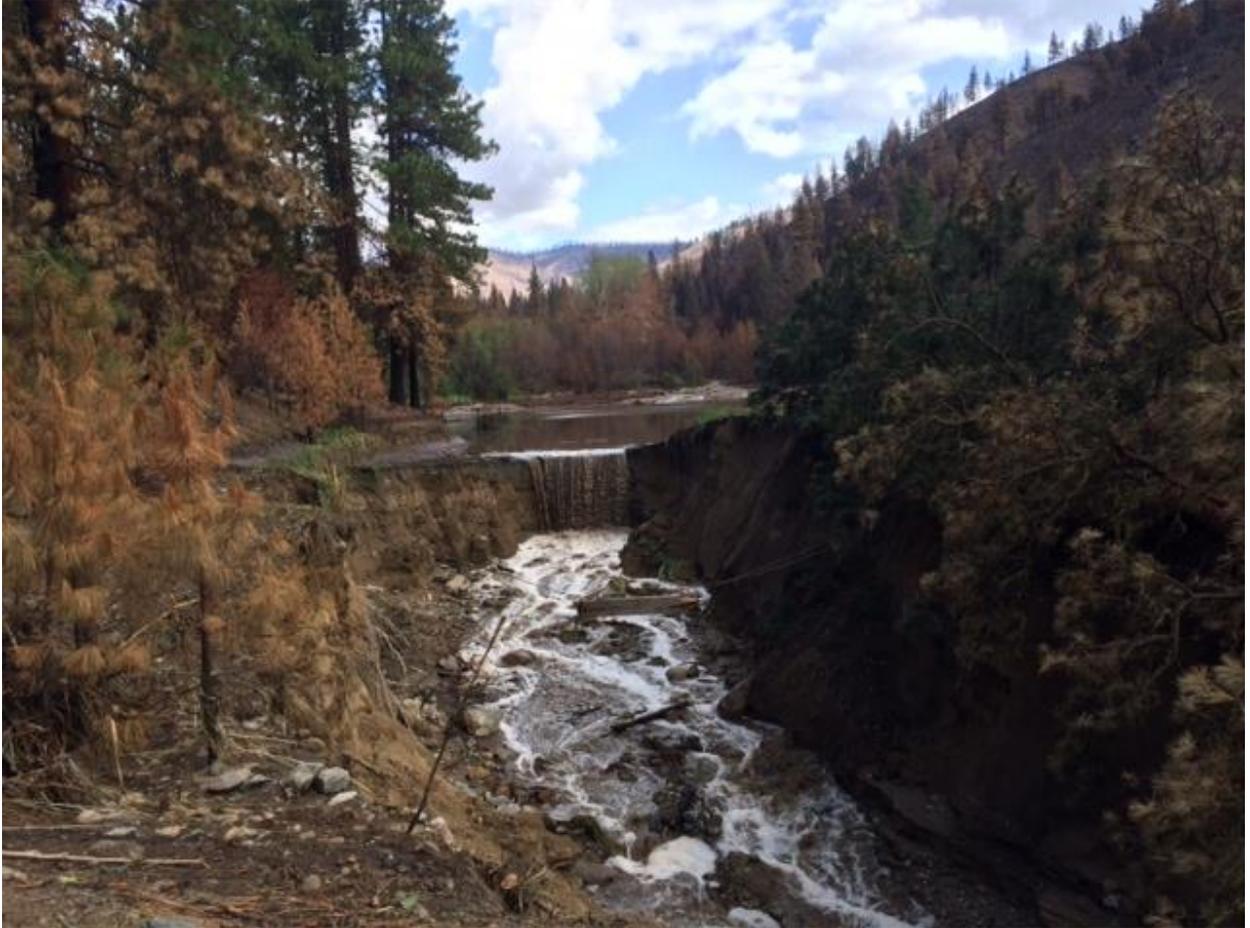
As measured on August 28<sup>th</sup> by engineers from the Department of Ecology's Dam Safety Office (DSO), eroded dimensions averaged 13.4 feet deep and 36.5 feet wide. From photos taken mid-day on August 22<sup>nd</sup>, there was still a large drop from the reservoir into the eroded spillway, and a significant volume of water still in pond. The overflow elevation from the reservoir into the eroded spillway appears to be about half of the eroded spillway depth, or about 6.7 feet deep.

Photos of the spillway breach also show a somewhat curved overflow from the reservoir into the eroded spillway, similar to that observed in studies by the USDA Agricultural Research Service and others (Hanson et al, 2005, ASDSO Journal of Dam Safety). For the Hawkins spillway, a 50% increase in rim overflow length is estimated compared to the eroded width of the spillway, for a total overflow length (breach width) of about 55 feet.

5. Hawkins Dam (Wenner Lake No.5) spillway, mid-day on August 22<sup>nd</sup>.

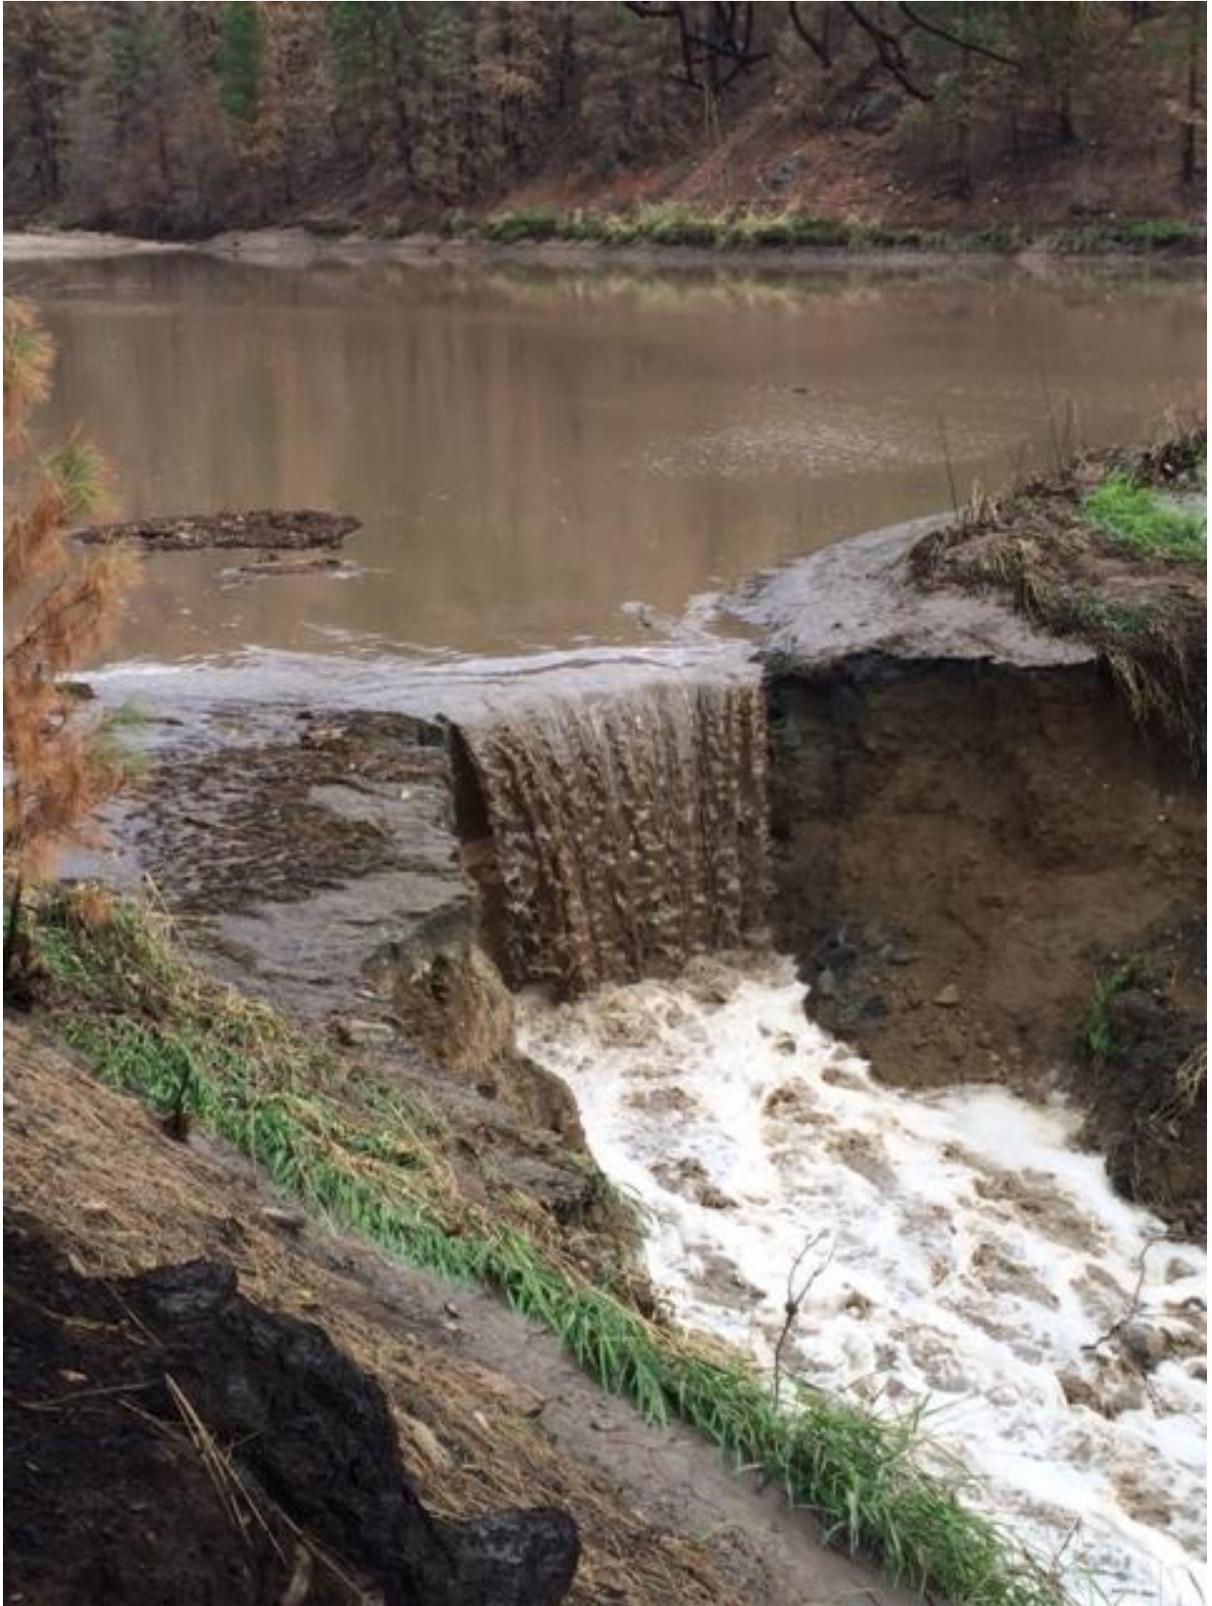
The spillway at Hawkins Dam probably eroded over a time period of 2½ to 3 hours. The stored volume of 22 acre-feet released by the spillway breach represents 17% of the total flood runoff at the dam that occurred within the first 6 hours of the storm. In Benson Creek below the Finley Canyon outfall, this 22 acre-feet released by the breach represents 7.1% of the total flood runoff that occurred within the first 6 hours of the storm.

6. Hawkins Dam (Wenner Lake No.5) spillway, mid-day on August 22<sup>nd</sup>.
