Hurricane Matthew in North Carolina Dam Risk Management Assessment Report

FEMAP-1090 / DR-4285-NC / May 2017

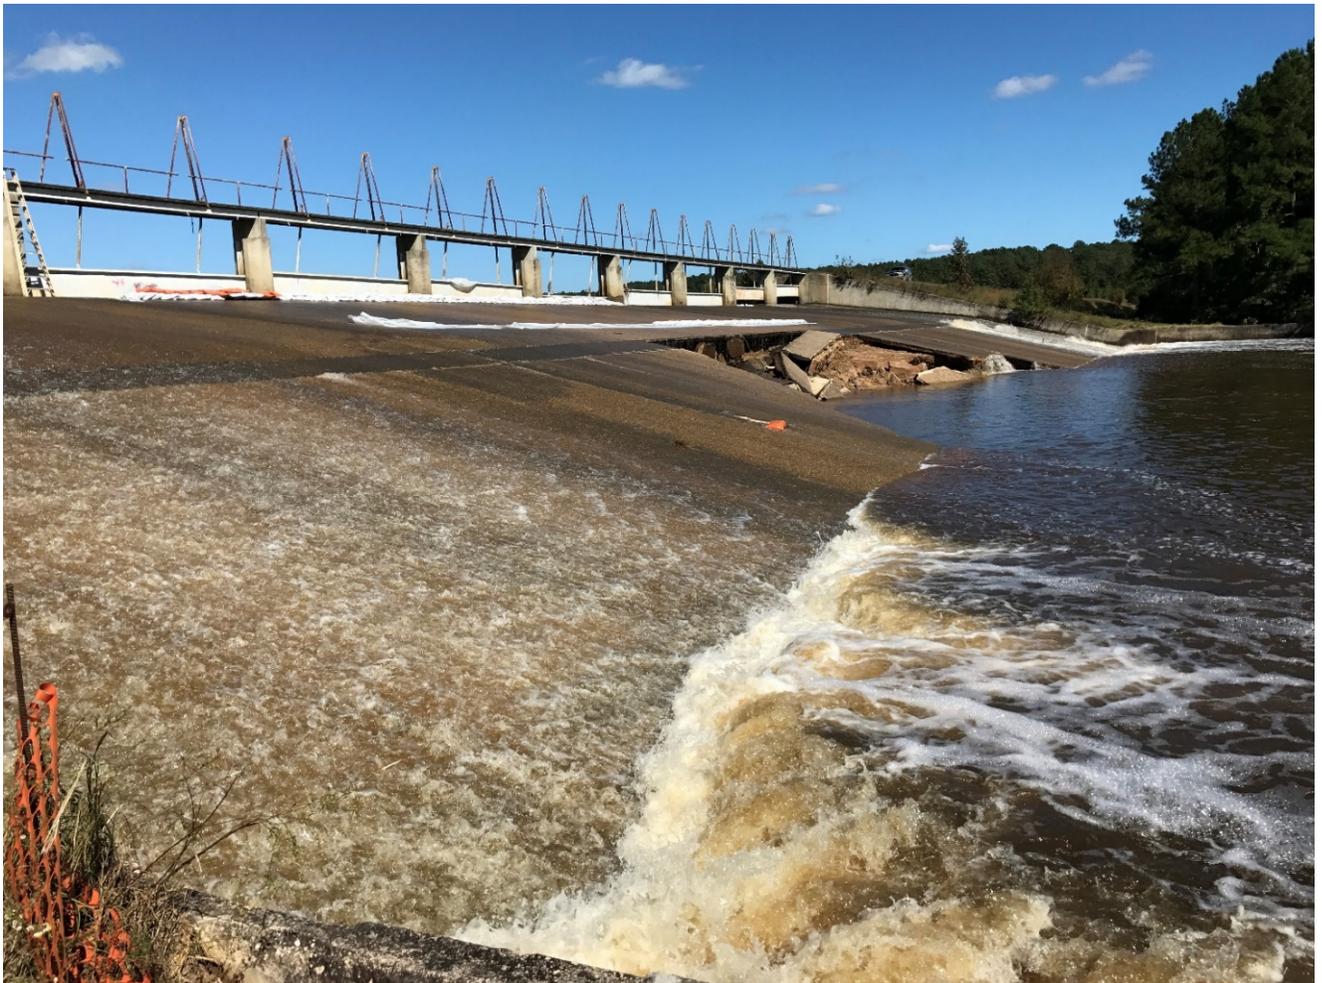
Woodlake Dam (Moore County) post-flooding event;

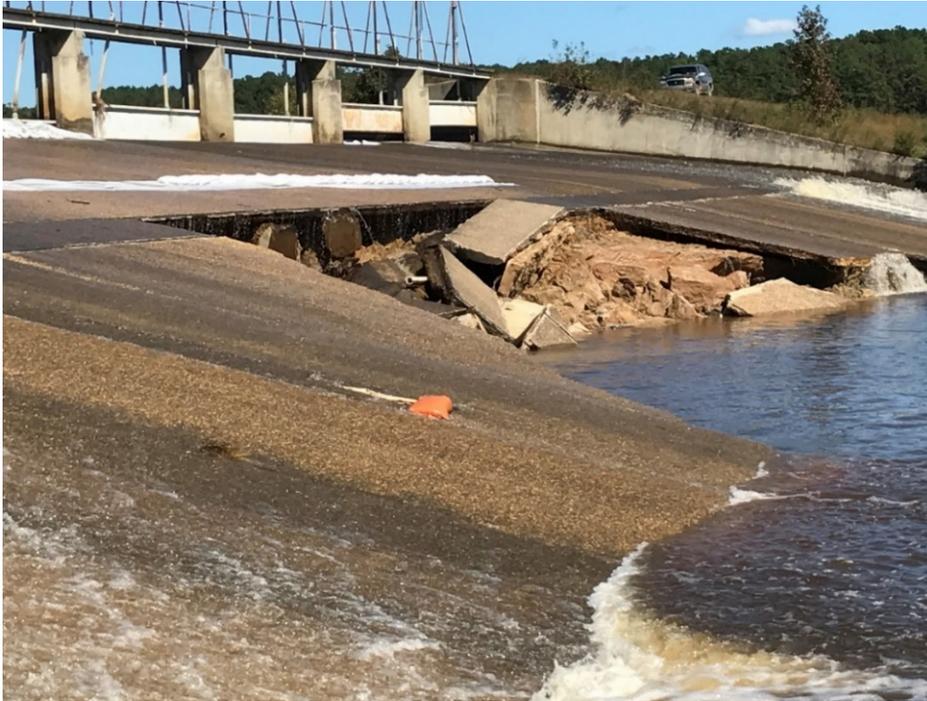
Figure 8.1 Damaged concrete spillway at Woodlake Dam Credit: NC DEMLR

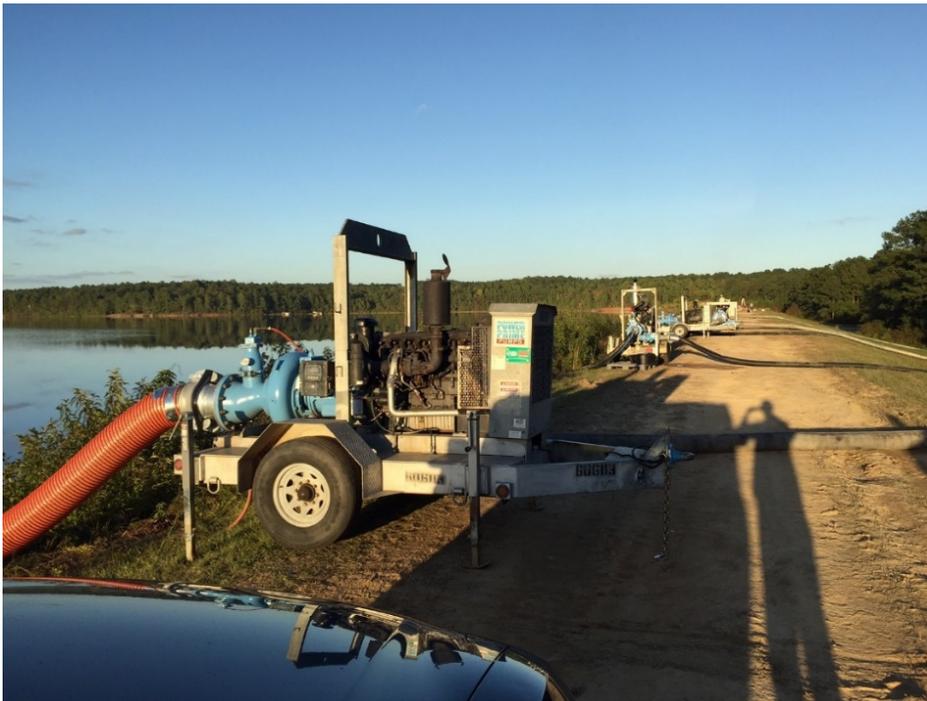
Figure 8.2 Pumps on Woodlake Dam Crest;

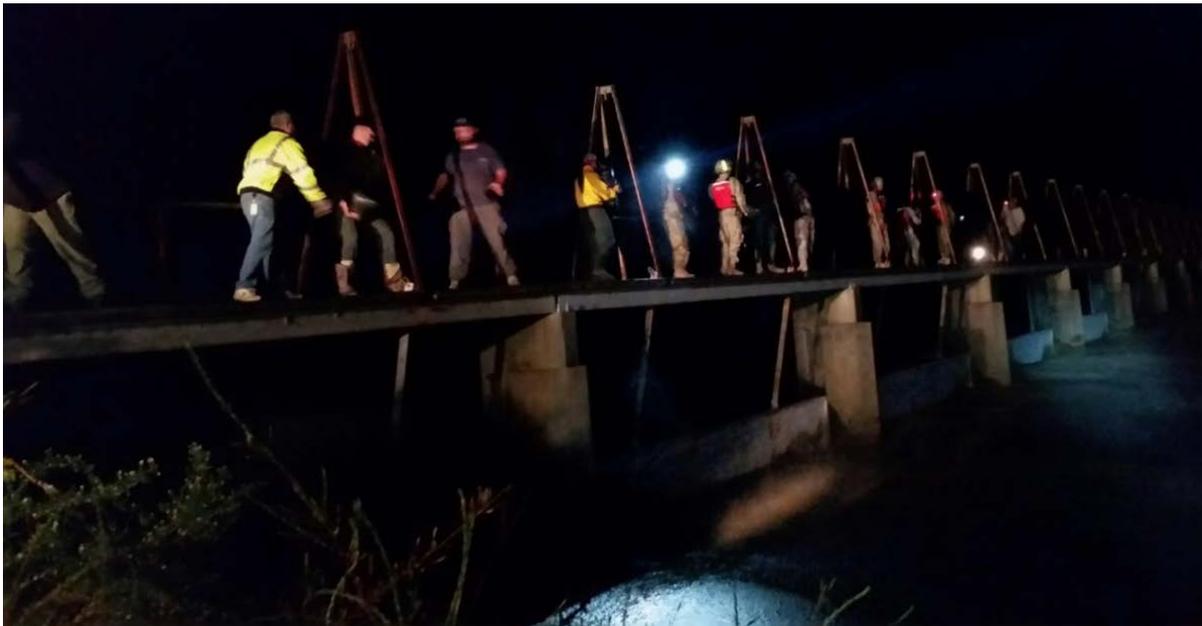
Figure 8.3 National Guard and others placing sandbags at Woodlake Dam Credit: NC DEMLR

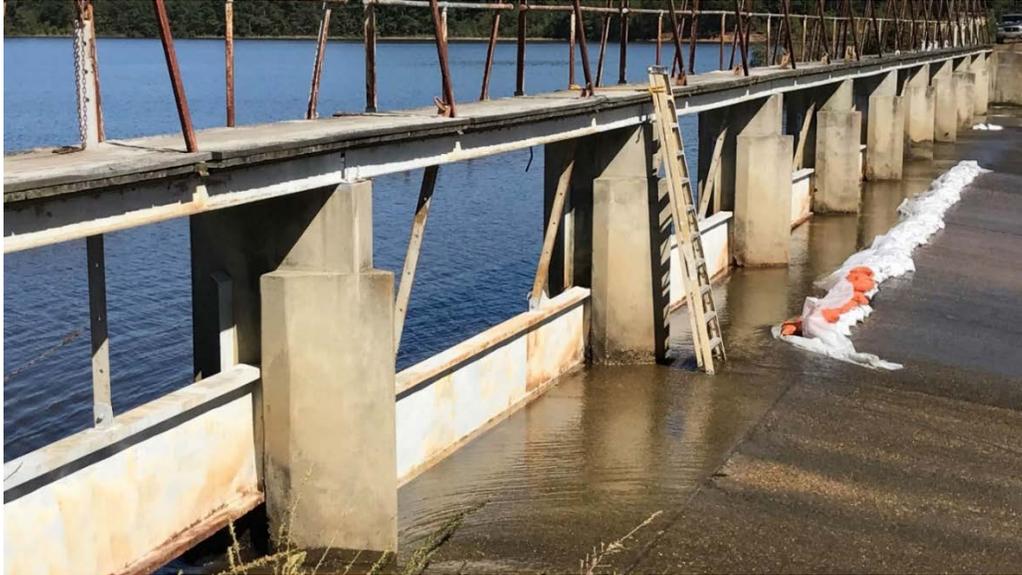
Figure 8.4 Sandbags in center above damaged spillway area; Credit: NC DEMLR

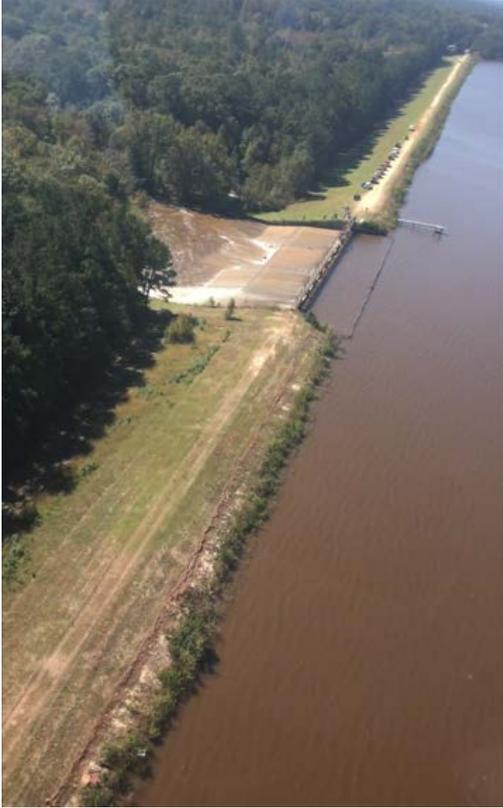
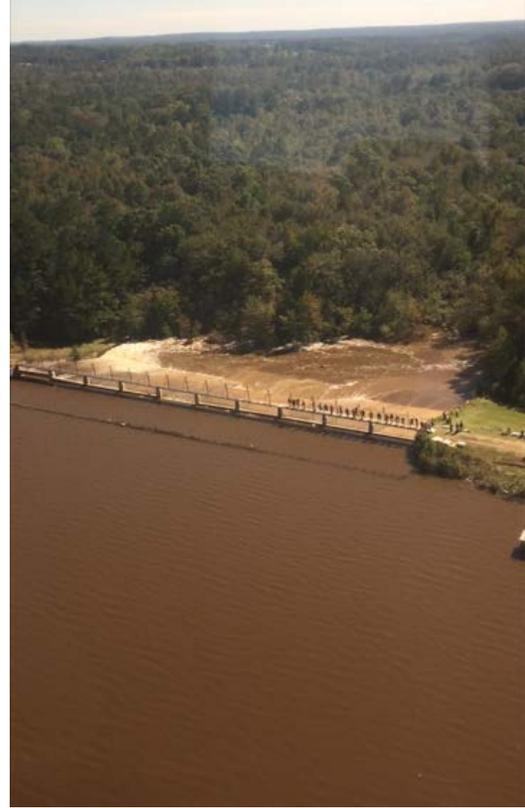
Figures 8.5 and 8.6 Woodlake Dam Fly-over October 2016 mid response operations; Credit: NC DEMLR

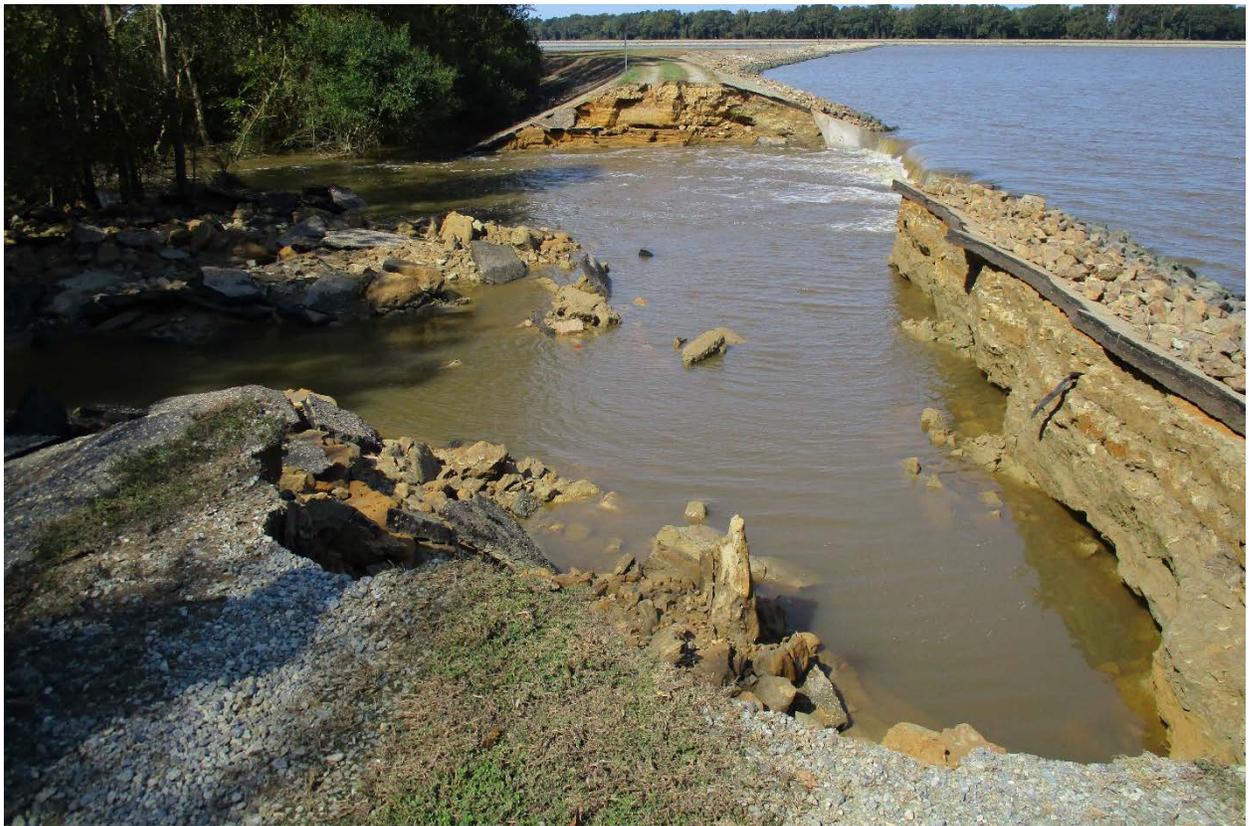
The owners of H.F. Lee cooling pond activated their EAP due to concerns of a potential overtopping from the rising Neuse River. The cooling pond dam did overtop due to the rise of the Neuse River located directly adjacent to the dam. Water first flowed backward over the dam's spillway from the river and subsequently over earthen portions of the dam. The partial breach occurred as the flood waters receded and water flowed over the saturated embankment back to the river side, causing a slough on the downstream slope and erosion through the dam's crest. More details on H.F. Lee can be found in Appendix A due to this partial breach.

Figure 8.8 H.F. Lee Cooling Pond Partial Breach; Credit: NC DEMLR

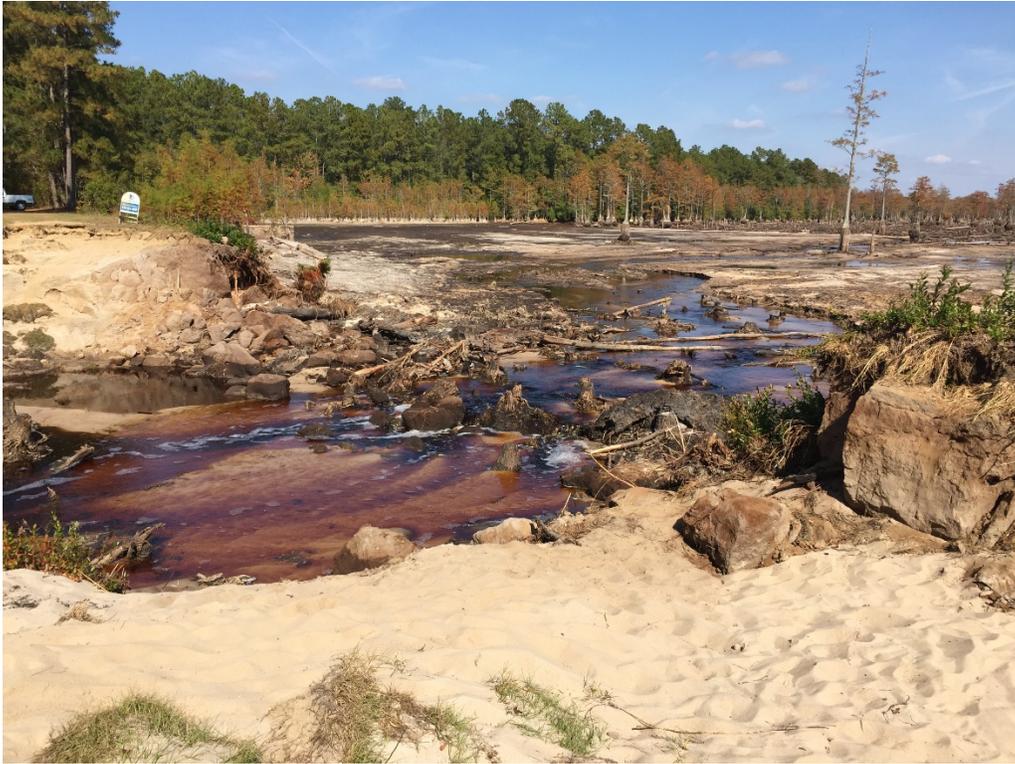
Figure 11.2 Jessup Mill Pond breach (Smith Lake Dam); Credit: FEMA; Plisich

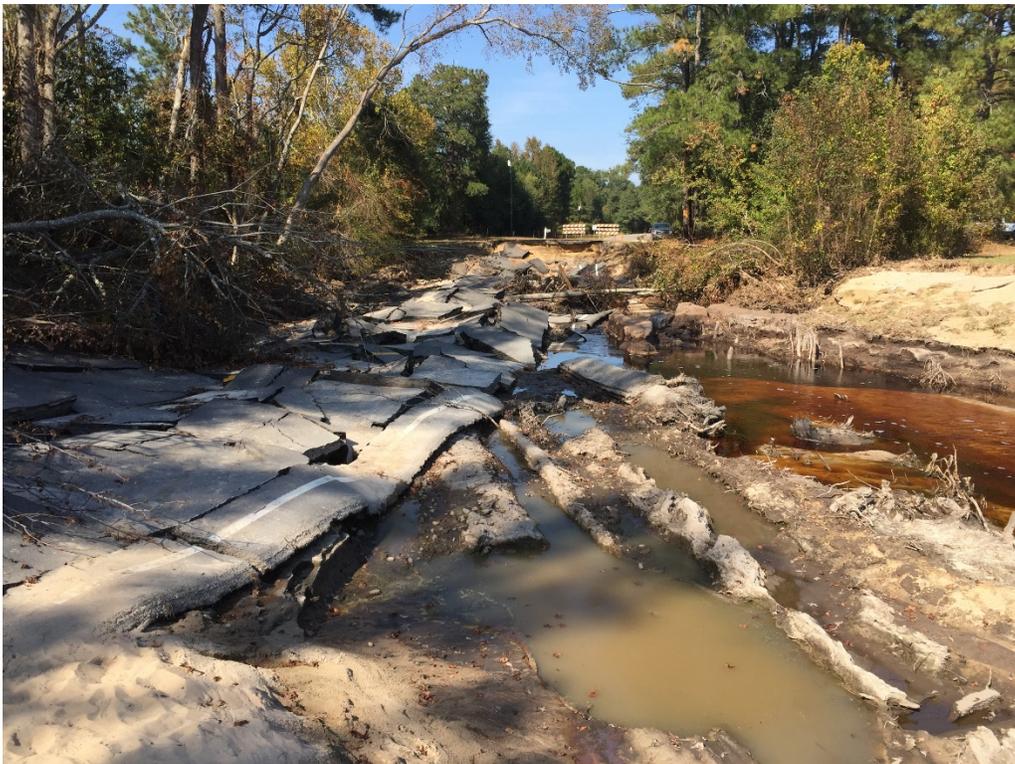
Figure 11.3 State route (NC-53) road washout due to Jessup Mill Pond (Smith Lake Dam) breach; Credit: FEMA; Plisich

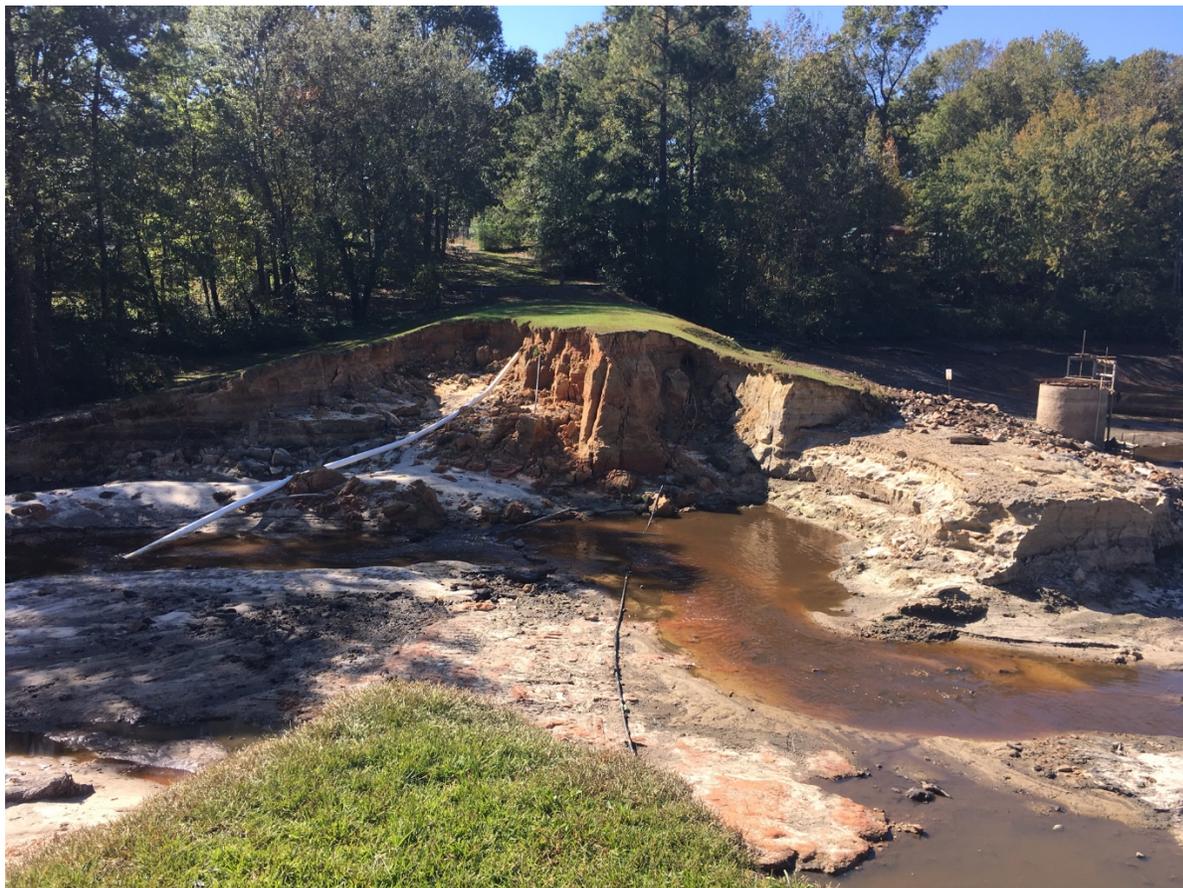
Figure A1.4: Loch Lommond Dam post-event photo;

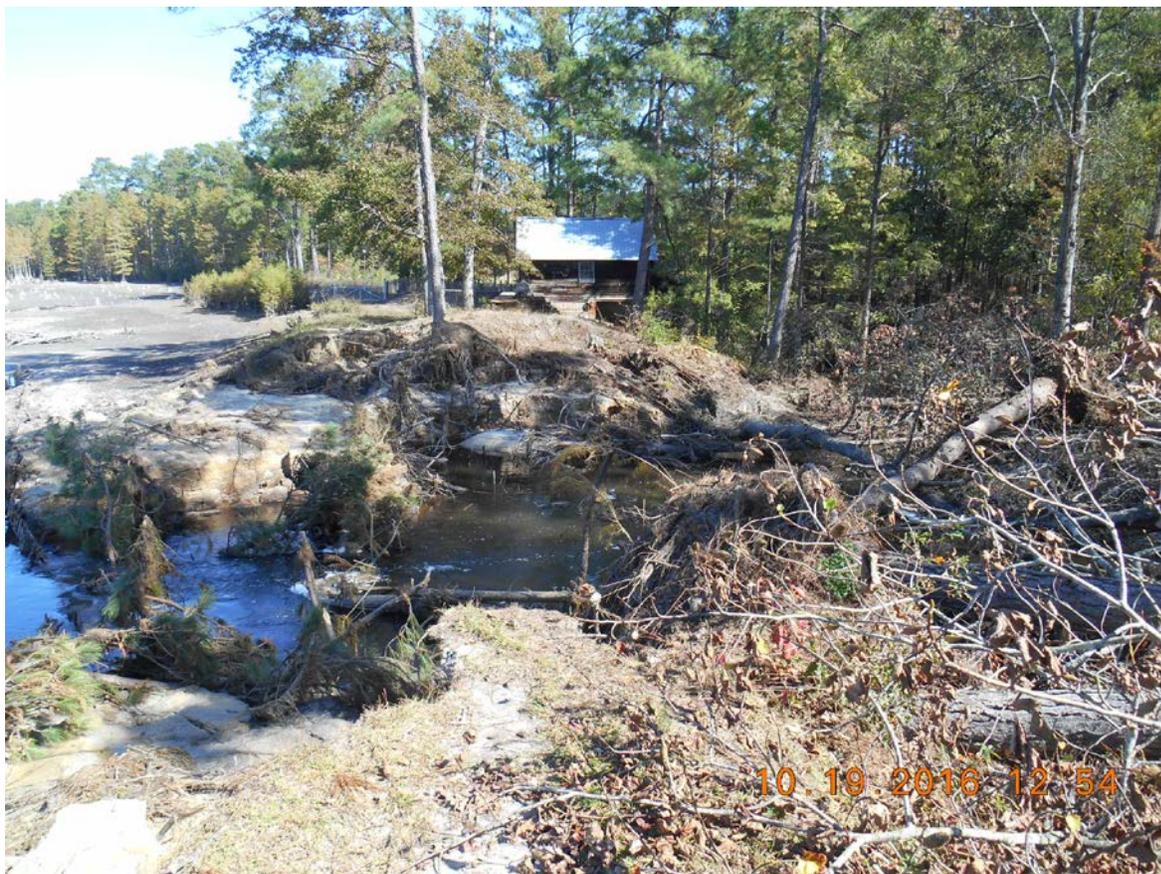
Figure A2.3: Long Valley Dam post-event photo;

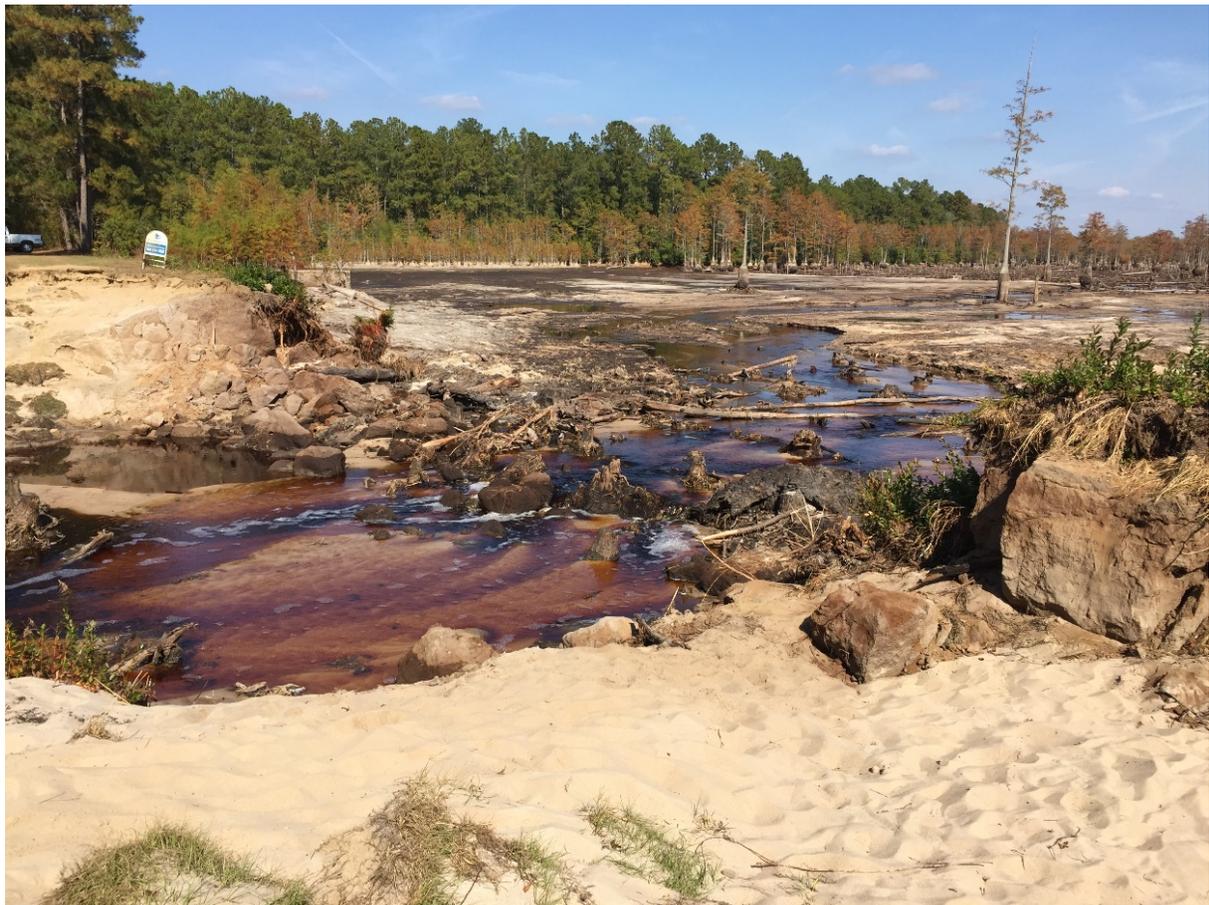
Figure A3.4: Smith Lake Dam post-event photo; Credit:

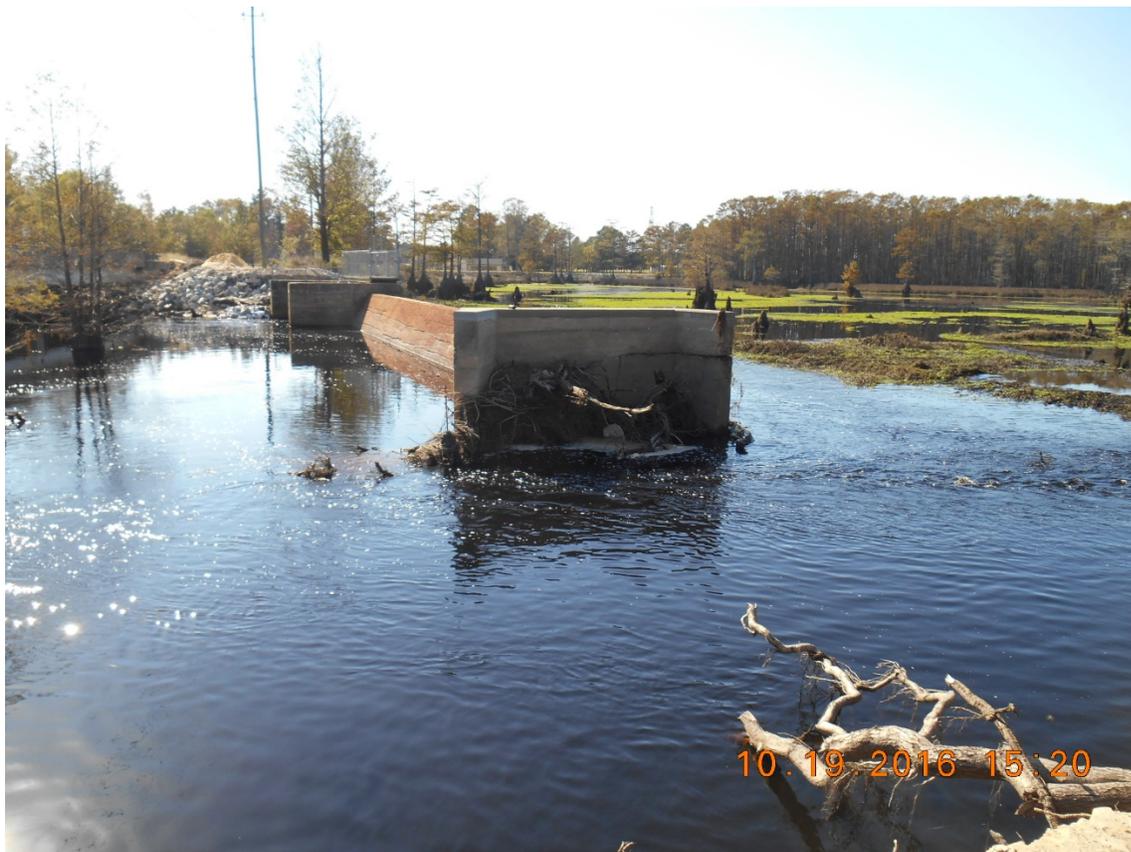
Figure A5.4: Rhodes Lake Dam failed left embankment nearest the spillway post-event photo; Note the root system in foreground in the embankment; October 19, 2016; Credit: NC DEMLR

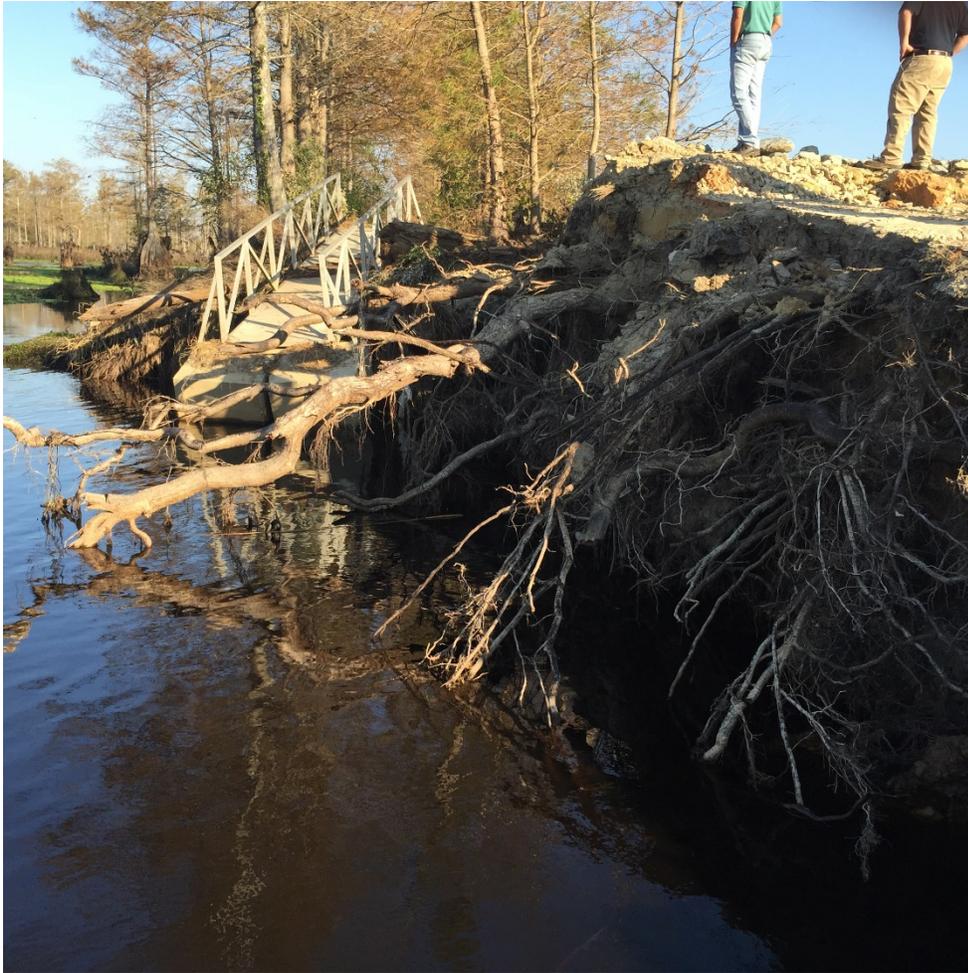
Figure A5.5: Rhodes Lake Dam root system in failed dam embankment left of spillway; same root system seen in Fig A5.4; October 31, 2016
Credit: FEMA; Plisich

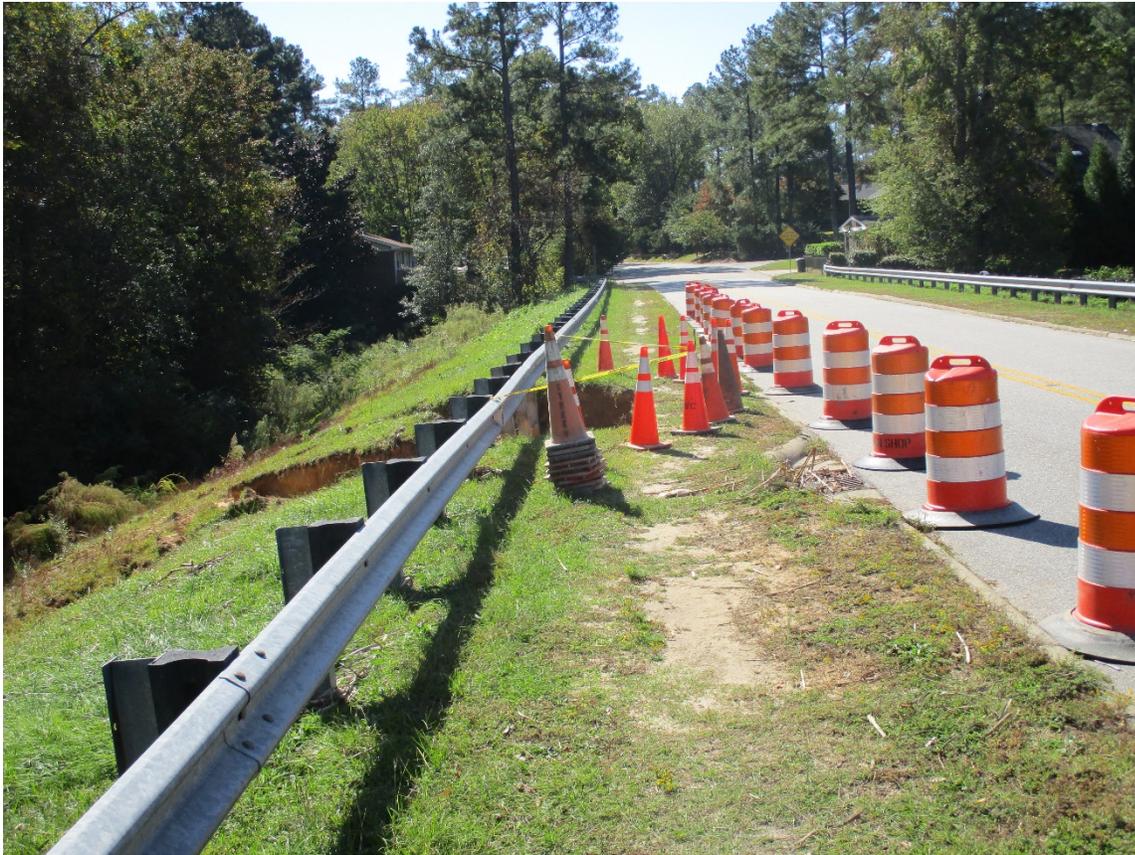
Figure A9.4: Devonwood Lower Dam post-event photo;

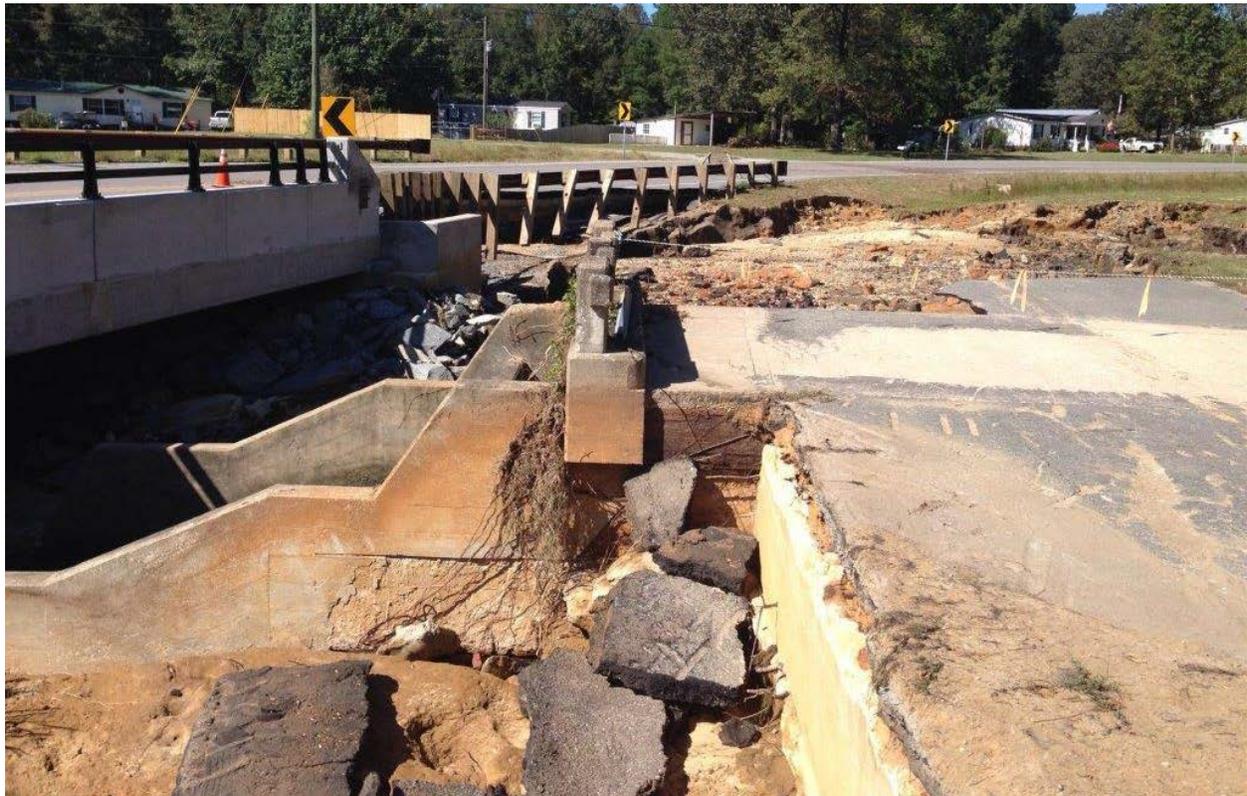
Figure A12.5: Maxwell Mill Pond Dam post-event photo;

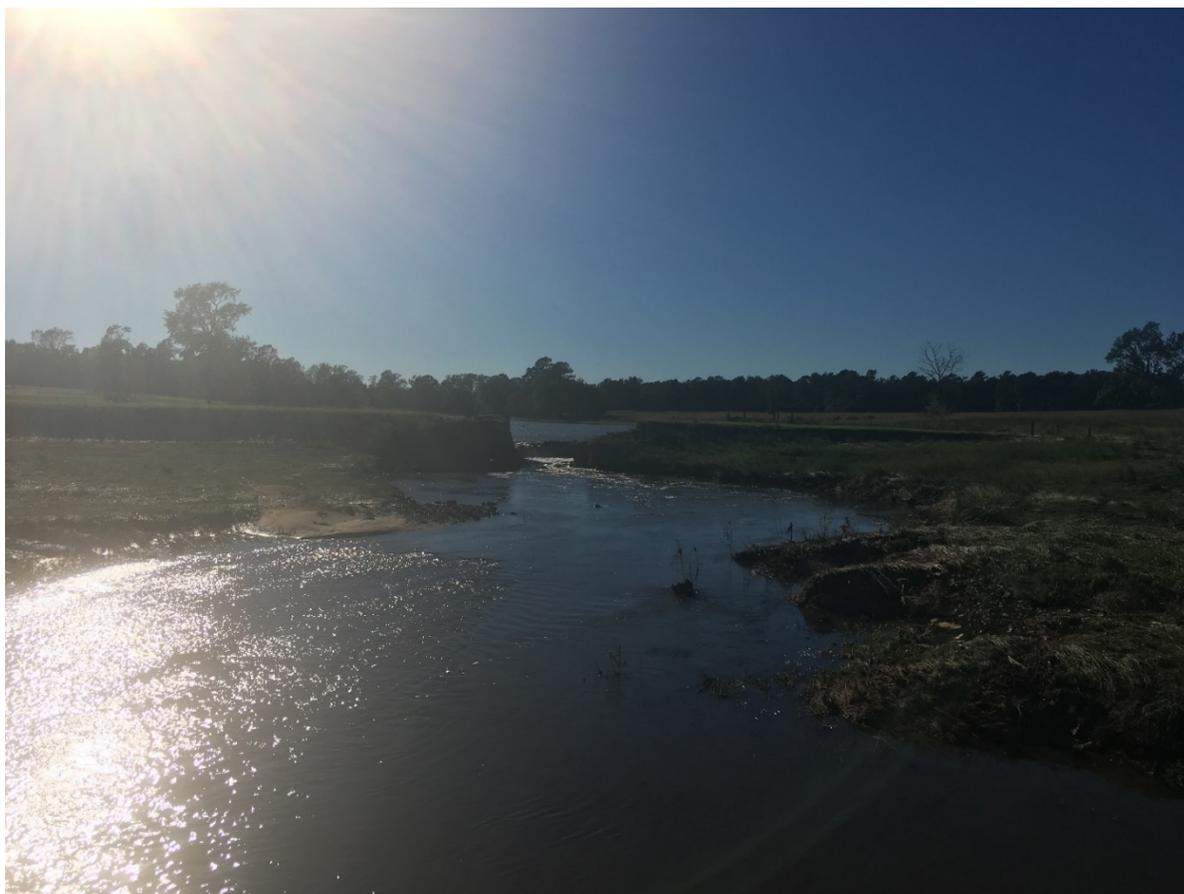
Figure A13.5: Guy Lake Dam post-event photo; Credit: NC DEMLR

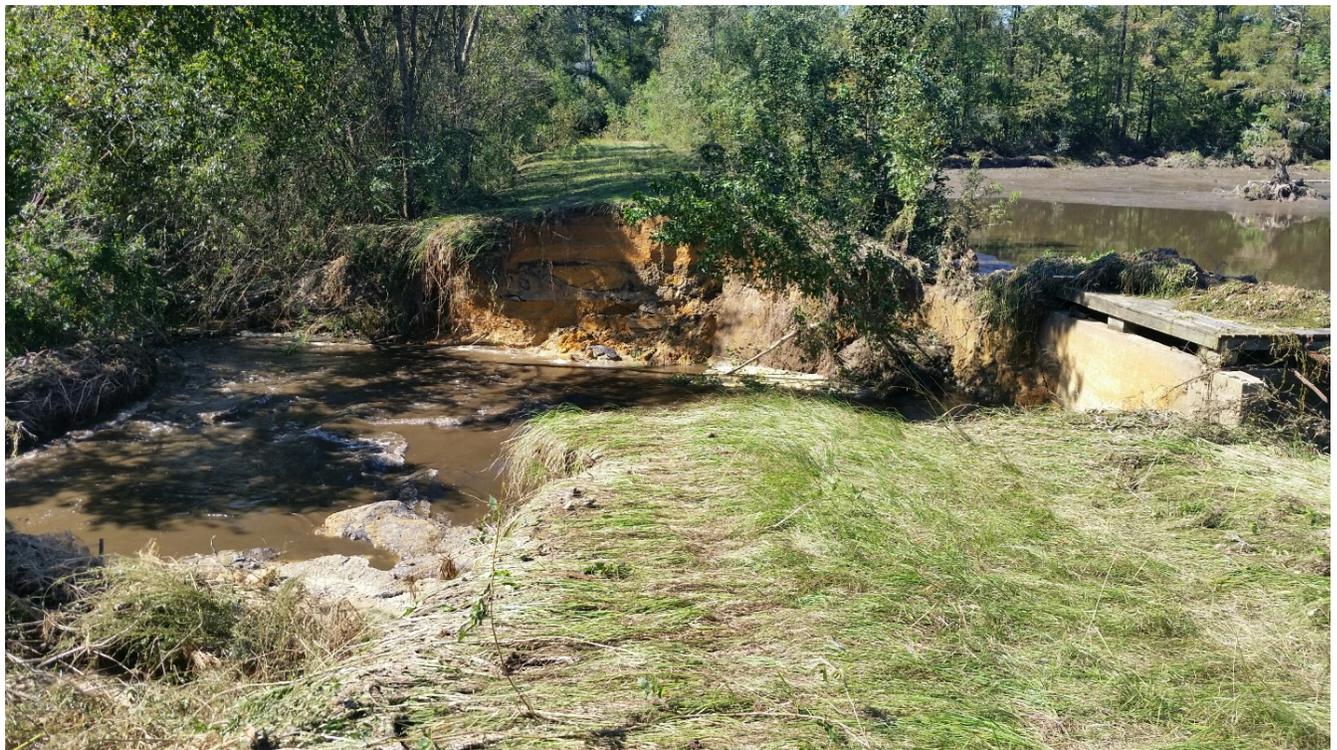
Figure A16.4: Laurel Lake Dam post-event photo;

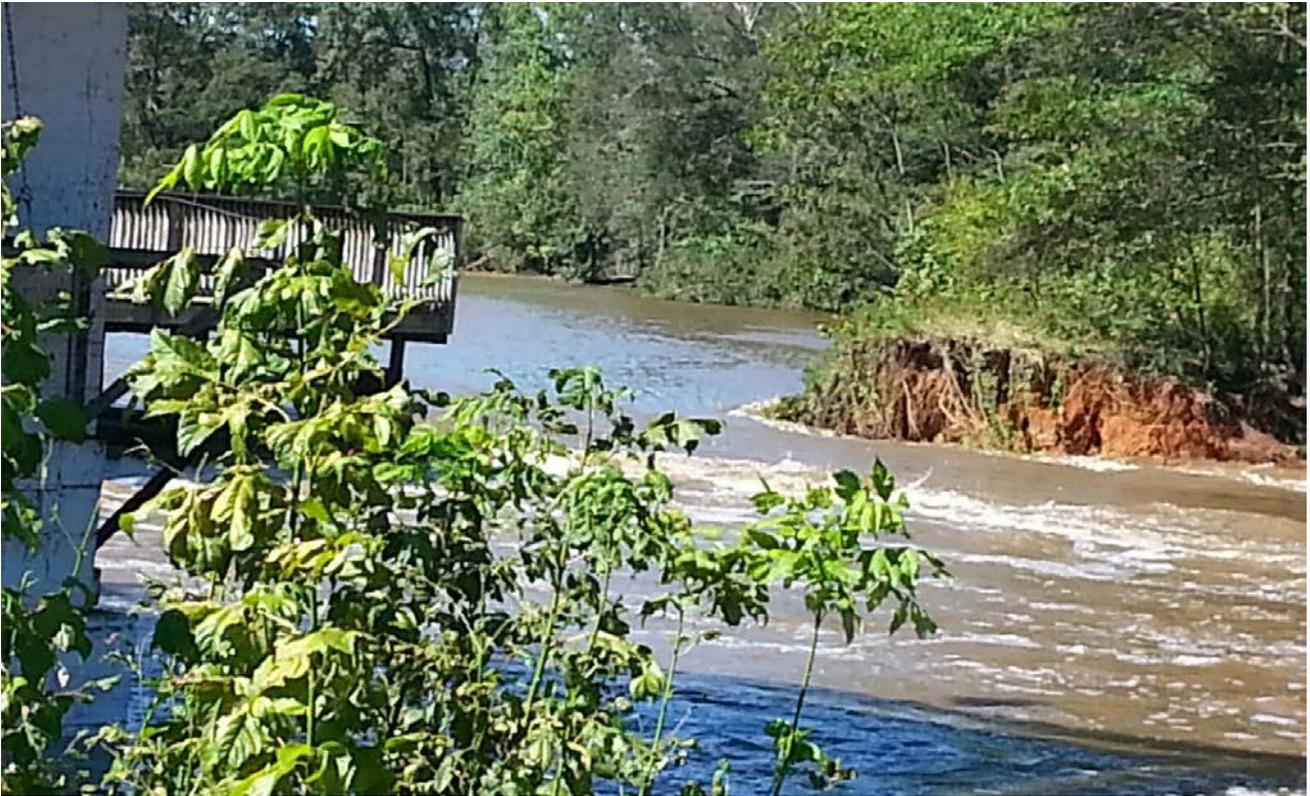
Figure A20.4: Silver Lake Dam post-event photo; Credit: NC DEMLR
