INVESTIGATION OF FAILURES OF EDENVILLE AND SANFORD DAMS

Independent Forensic Team

FINAL REPORT

Investigation of Failures of Edenville and Sanford Dams

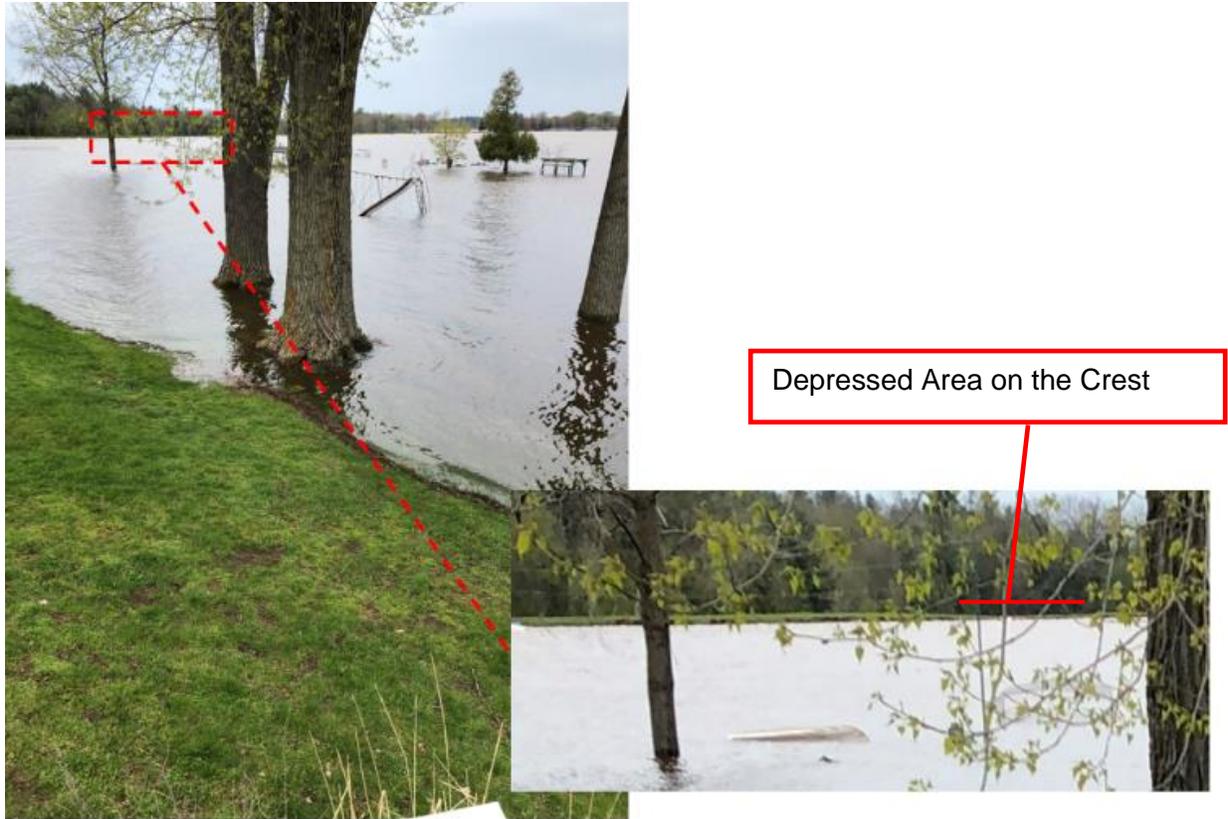
Figure 3 shows a view of the depression in the crest from upstream at 5:33 p.m. The photograph in Figure 3 also shows the erosion that had occurred on the upstream slope of the embankment.

Figure 3-1: Photograph Showing Depression in the Crest of the Edenville Left Embankment at 5:03 P.M., Tuesday, May 19, 2020 (photo courtesy of local resident)

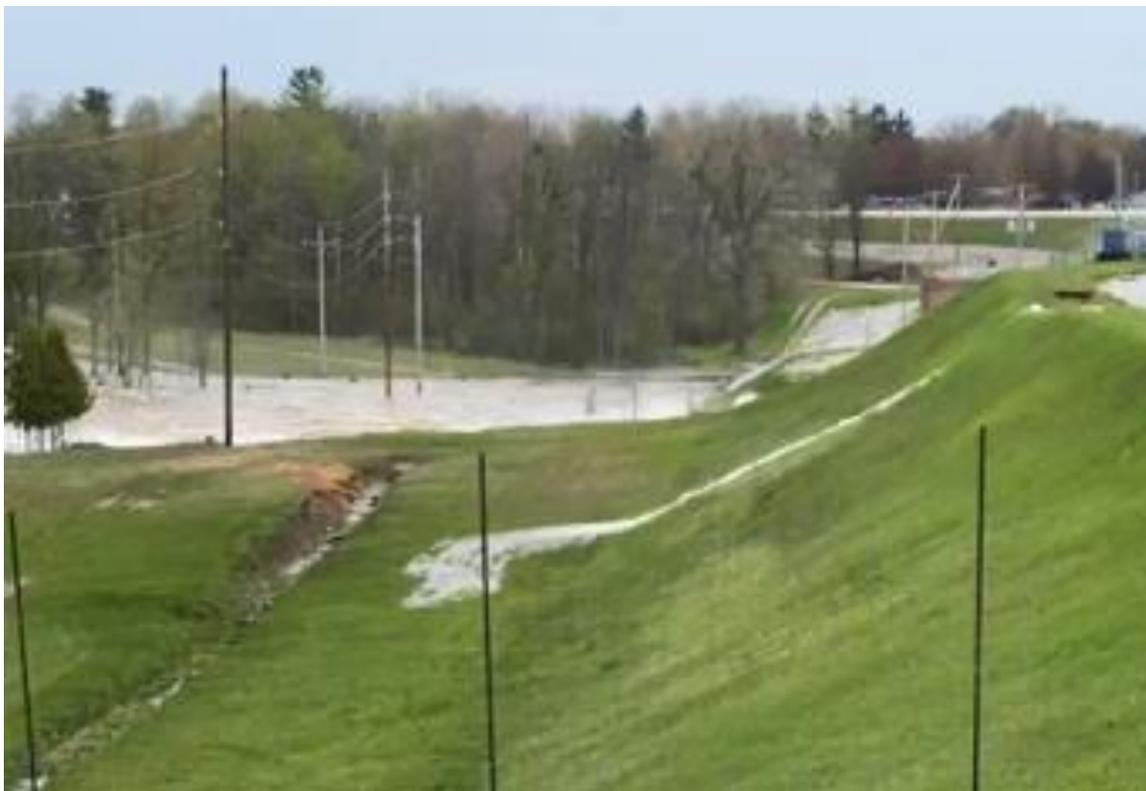
Figure 3-6: Enlarged Still Image from Dam Failure Video at 0 Seconds

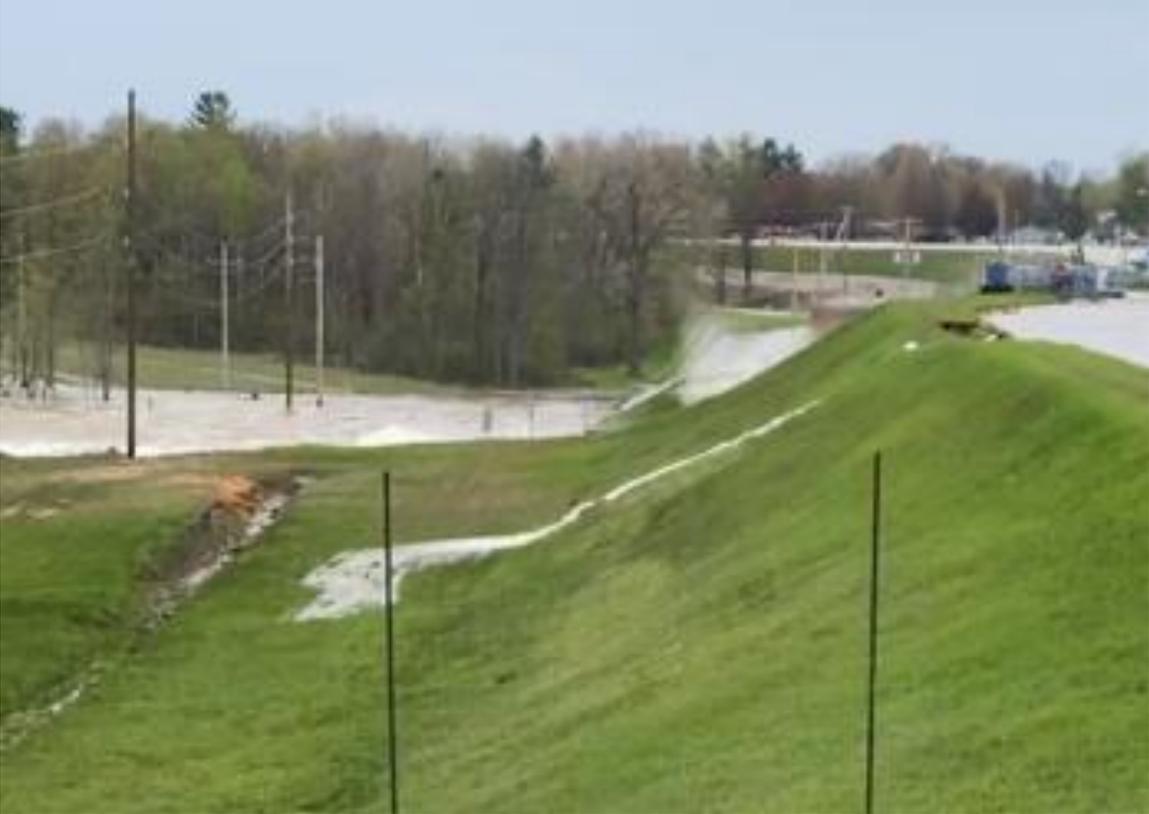
Figure 3-7: Enlarged Still Image from Dam Failure Video at 4 Seconds

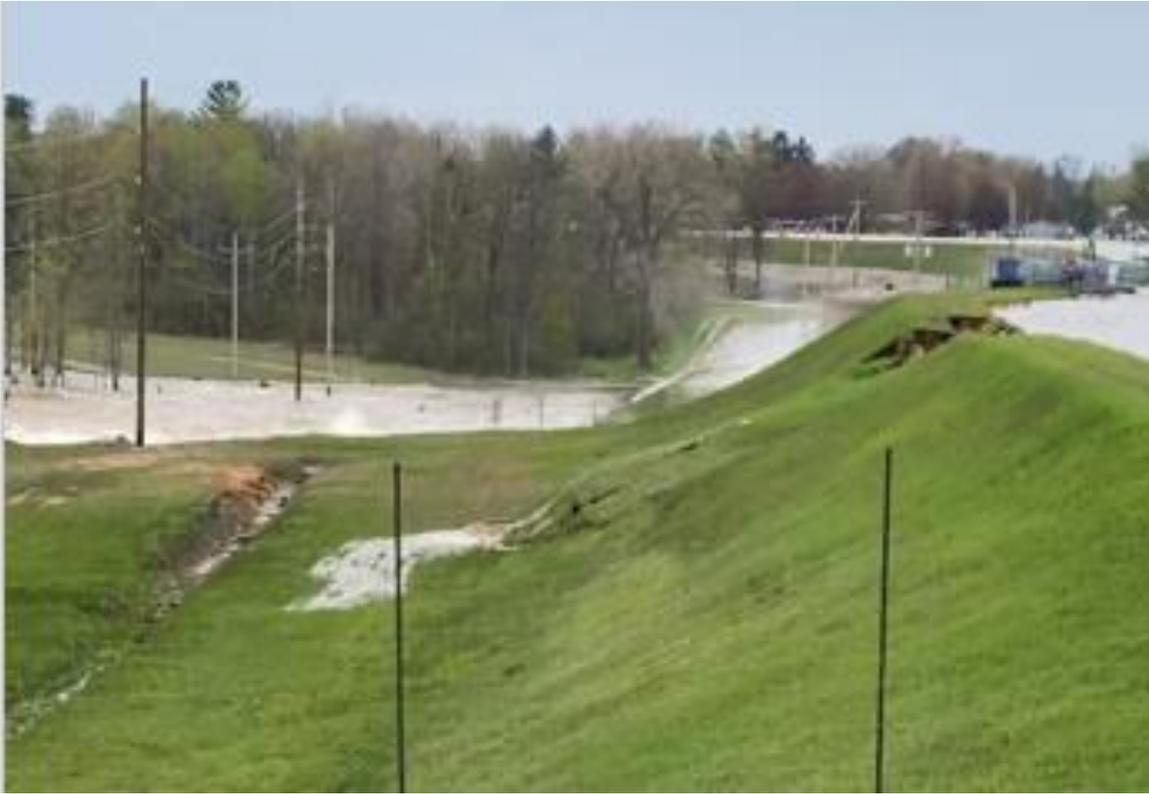
Figure 3-8: Enlarged Still Image from Dam Failure Video at 6 Seconds

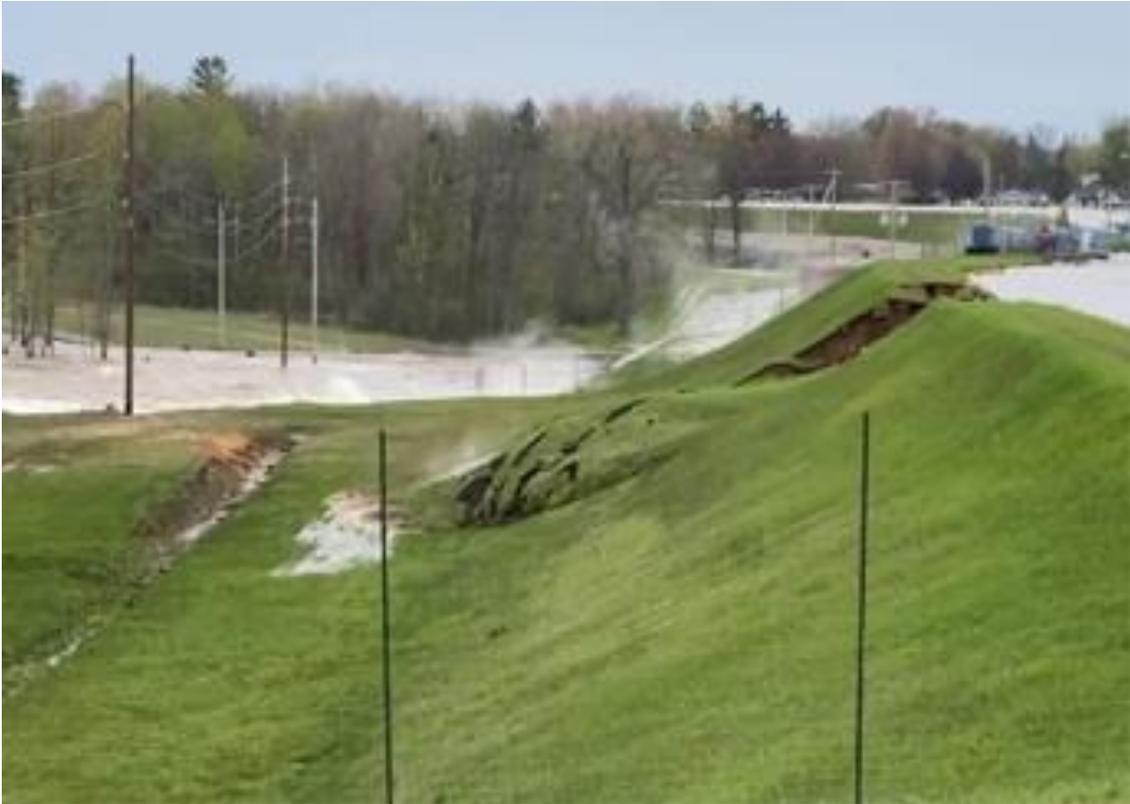
Figure 3-9: Enlarged Still Image from Dam Failure Video at 7 Seconds

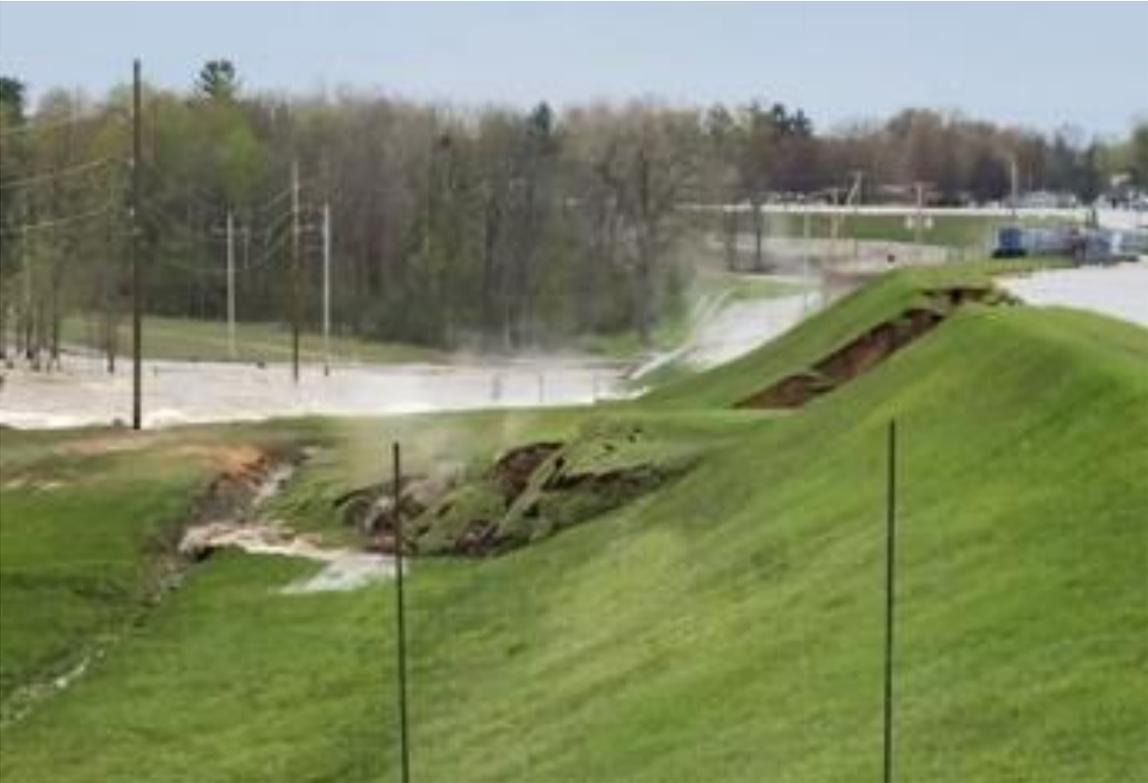
Figure 3-10: Enlarged Still Image from Dam Failure Video at 8 Seconds

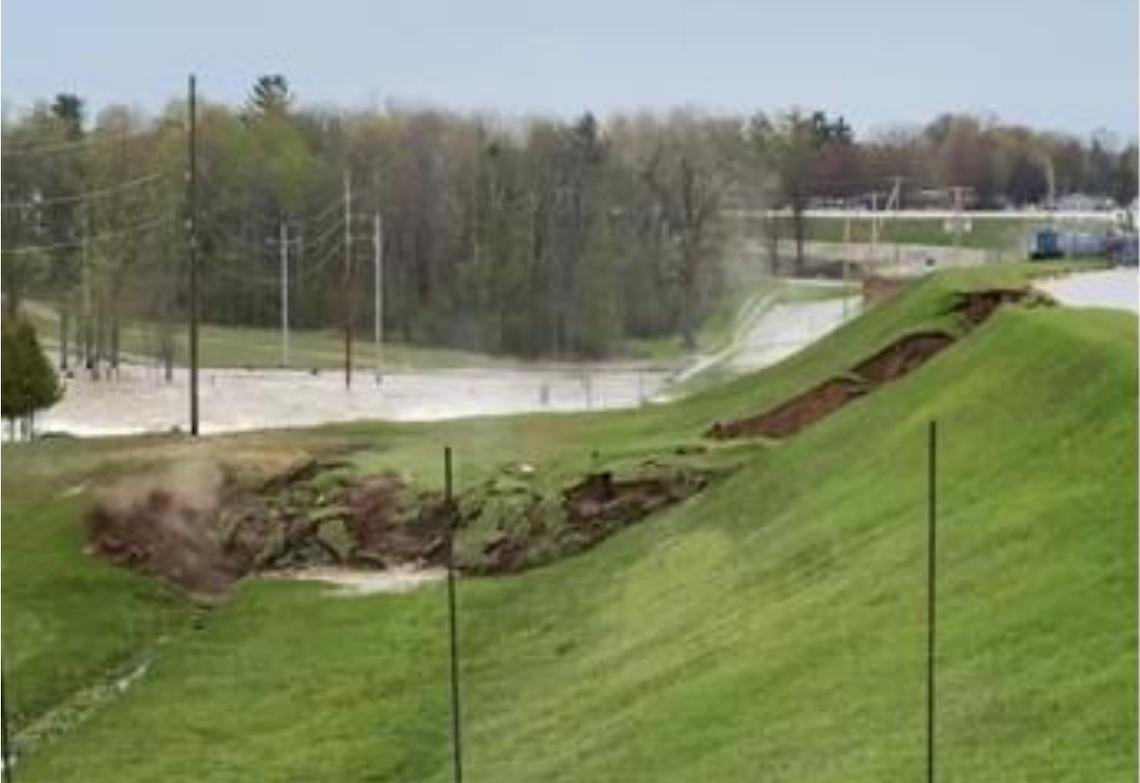
Figure 3-11: Enlarged Still Image from Dam Failure Video at 10 Seconds

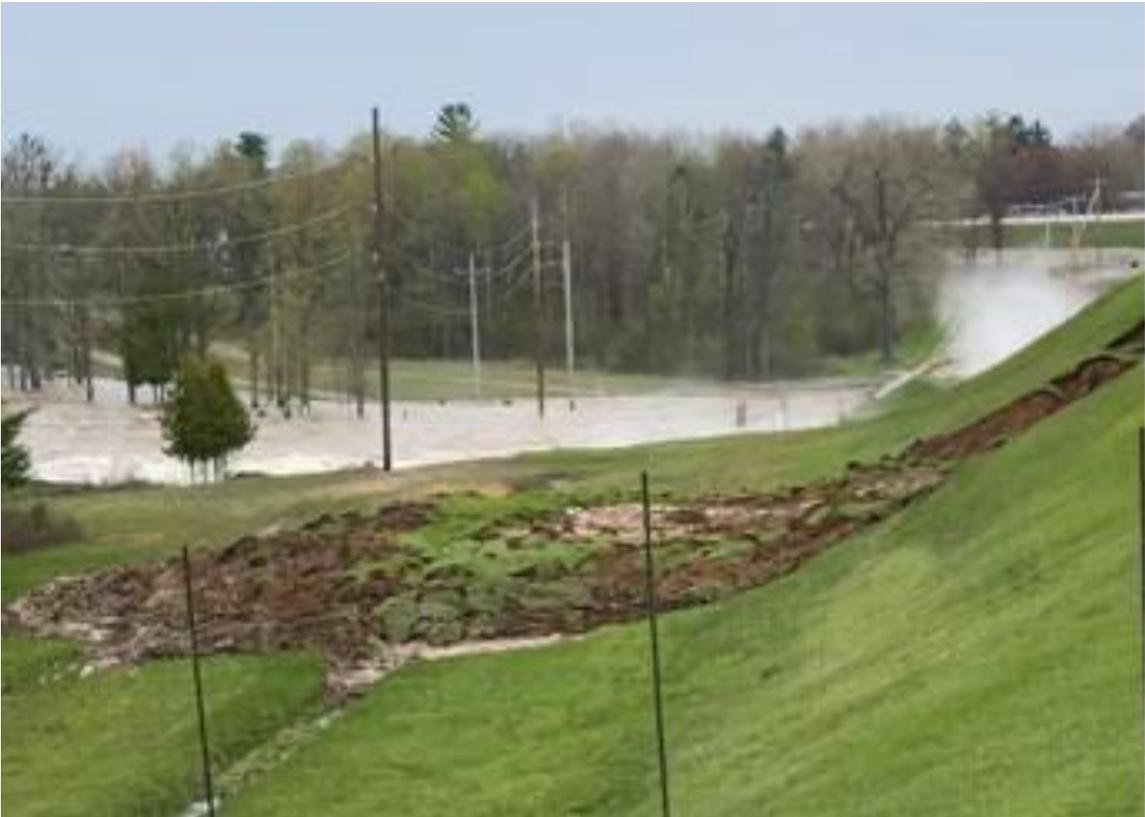
Figure 3-12: Enlarged Still Image from Dam Failure Video at 15 Seconds

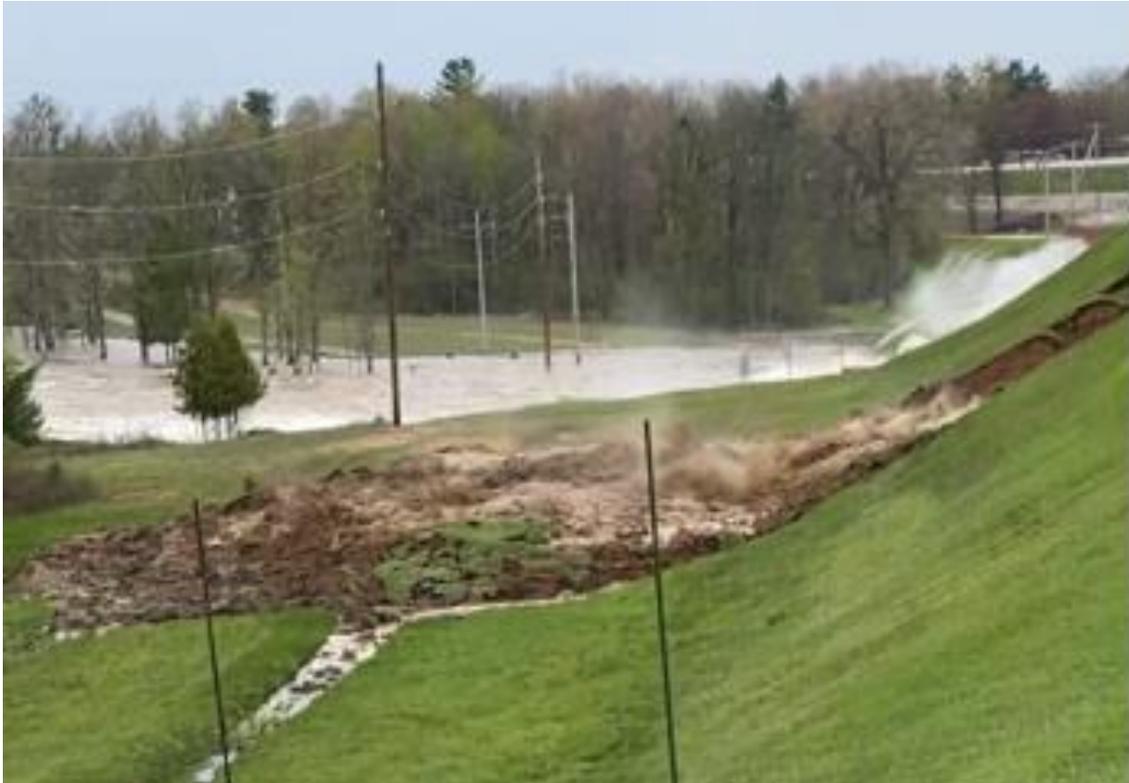
Figure 3-13: Enlarged Still Image from Dam Failure Video at 28 Seconds

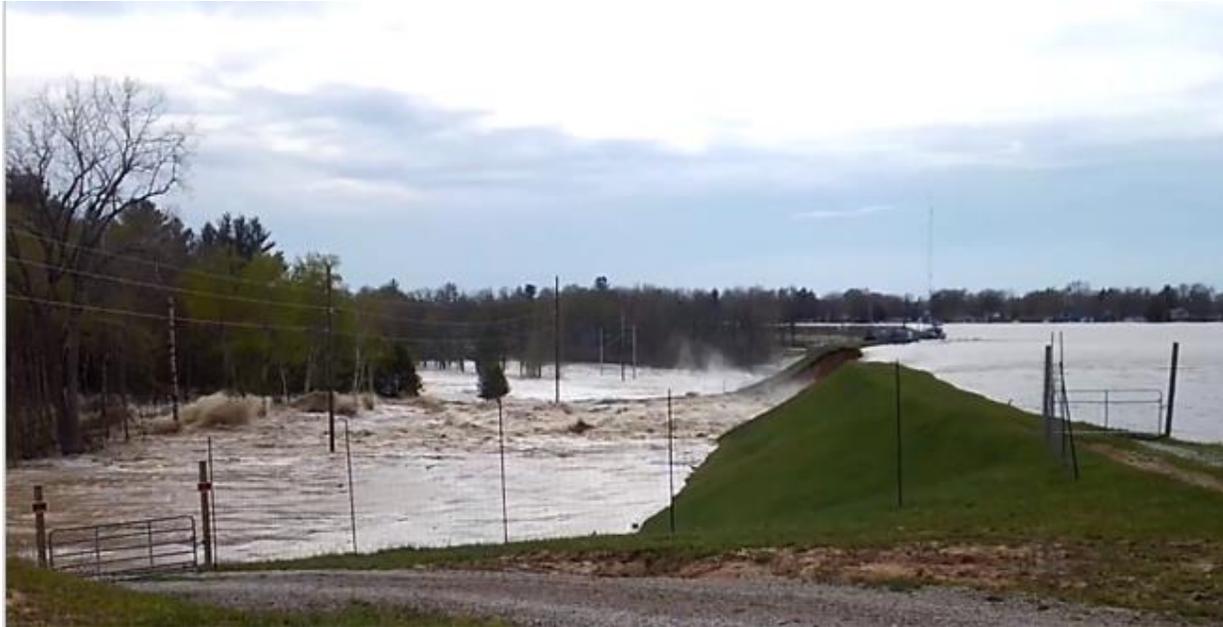
Figure 3-15: Edenville Left Embankment Breach at 6:00 P.M. on Tuesday, May 19, 2020

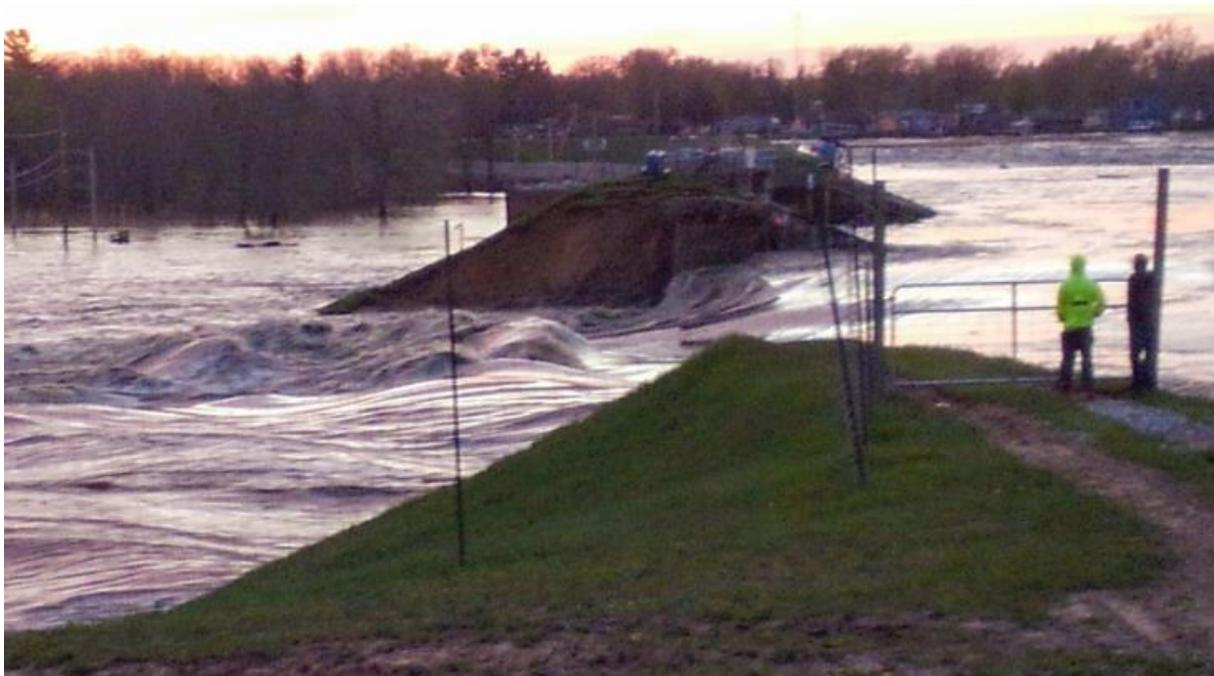
Figure 3-18: Edenville Left Embankment Breach at 9:04 P.M. on Tuesday, May 19, 2020

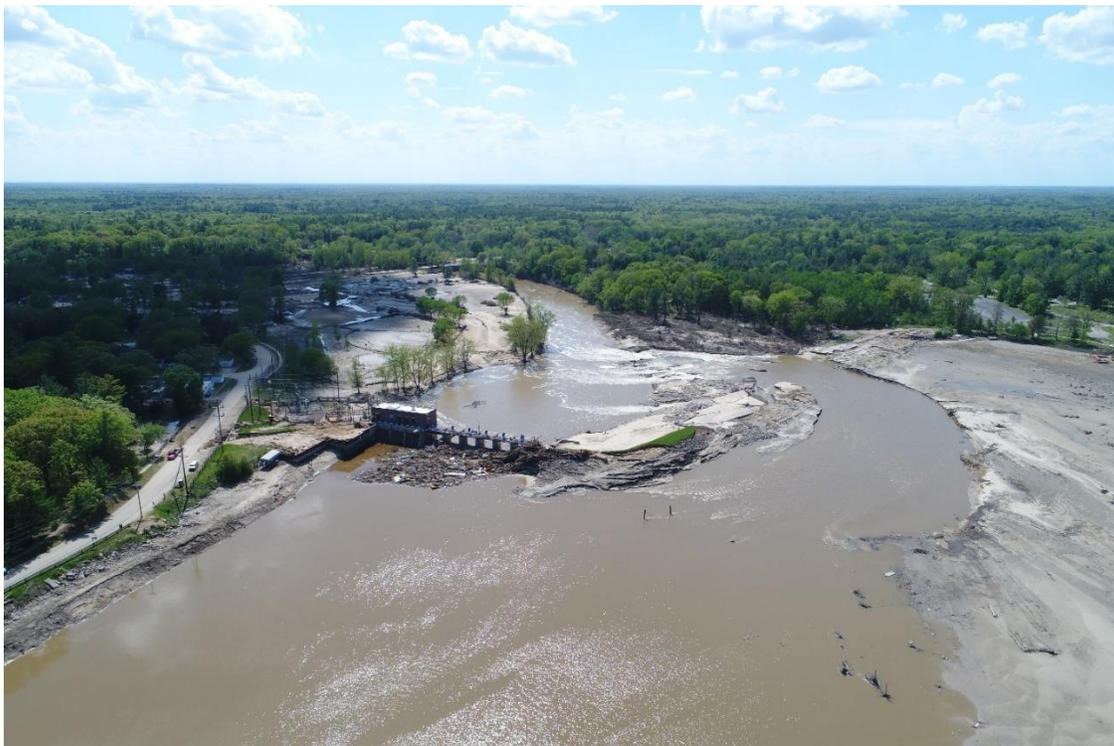
Figure 3-19: Sanford Dam Failure, Viewed from Upstream (photo courtesy of EGLE)

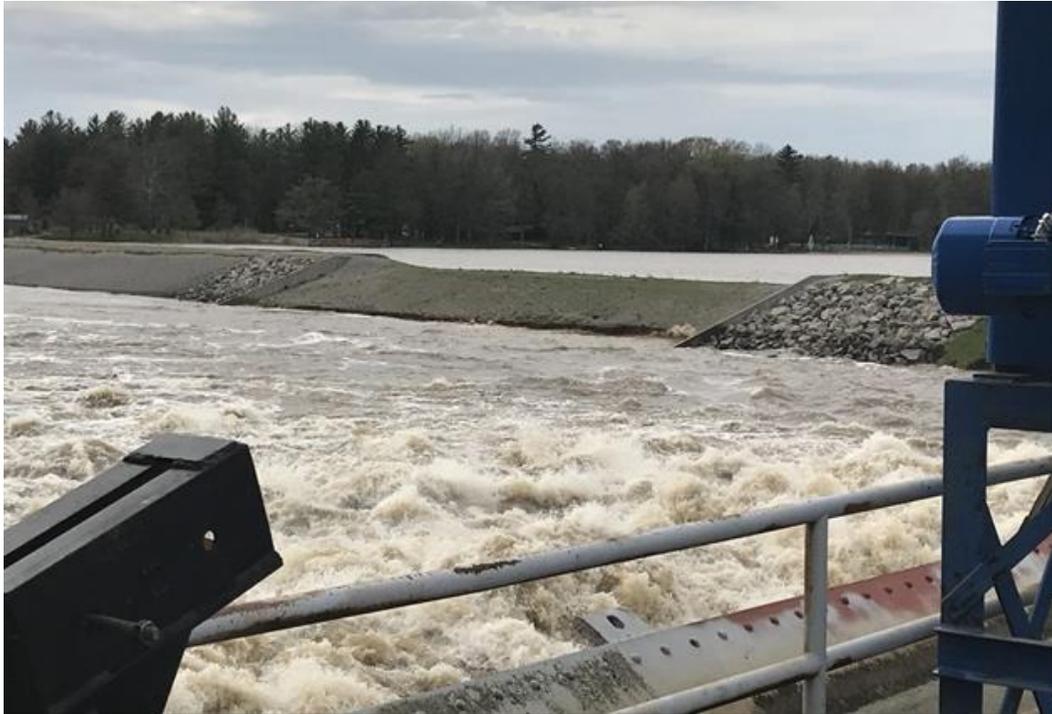
As discussed in Appendix A, the erosion of the fuse plug was likely slowed by the relatively flat downstream slope (4H:1V), the relatively wide fuse plug crest (8 feet), the lack of pilot channels in the crest, possible compaction of the fuse plug crest from vehicle traffic, and vegetation on the fuse plug crest and downstream slope. However, the discharge from the Edenville Dam breach was significantly greater than the combined capacity of both spillways at Sanford Dam. It is the IFT’s opinion that the outcome of the May 2020 event would have been essentially the same even if the fuse plug had eroded more quickly.

Figure 3-20: Erosion along Toe of Fuse Plug Prior to Overtopping (photo courtesy of EGLE)

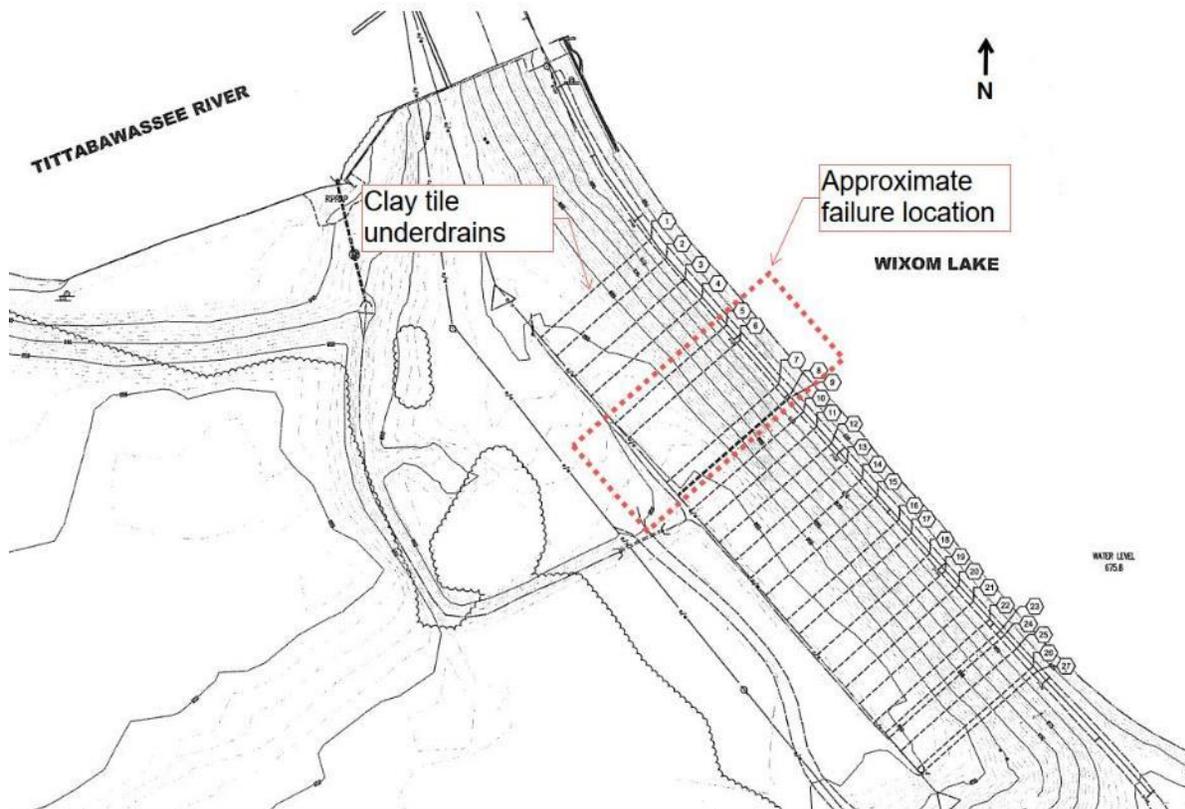
A 2012 investigation of the drains did not identify drains beneath the center of the failure location, as shown in Figure 4, suggesting that the drains at that location either were never installed or subsequently had become buried and ineffective. Since the remainder of the drains along the Edenville left embankment have been observed to consistently flow, they appear to provide some degree of drainage for the embankment. The lack of drains in the center of the failure location could have resulted in higher pore pressures at that location than elsewhere along the embankment.

Figure 4-7: Plan from 2012 Underdrain Survey Showing Lack of Underdrains in the Failure Location

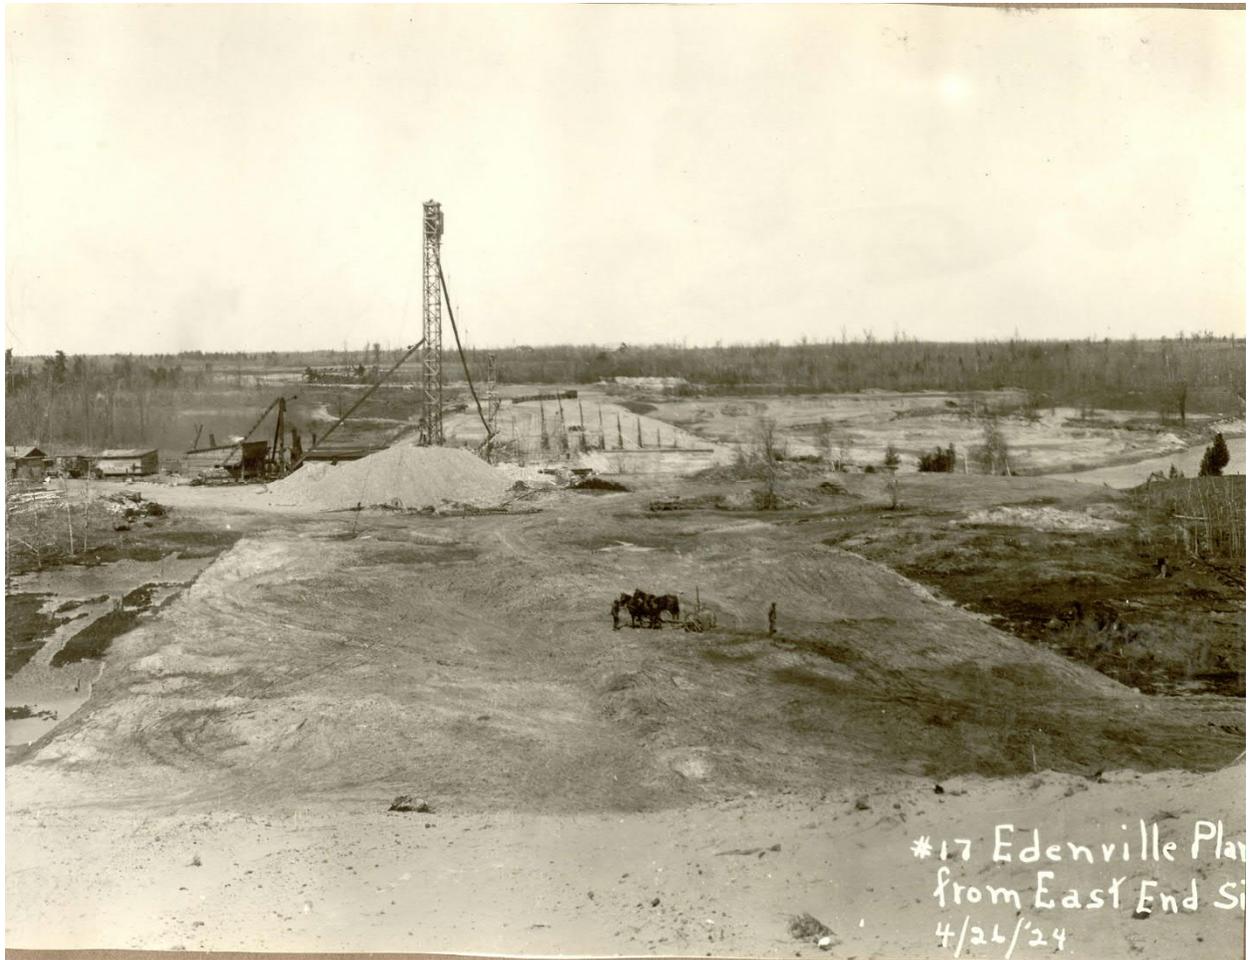
Fill placed near the foundation level of Edenville east (left) embankment. Note stockpile of material in background in downstream portion of the embankment. (April 1924)

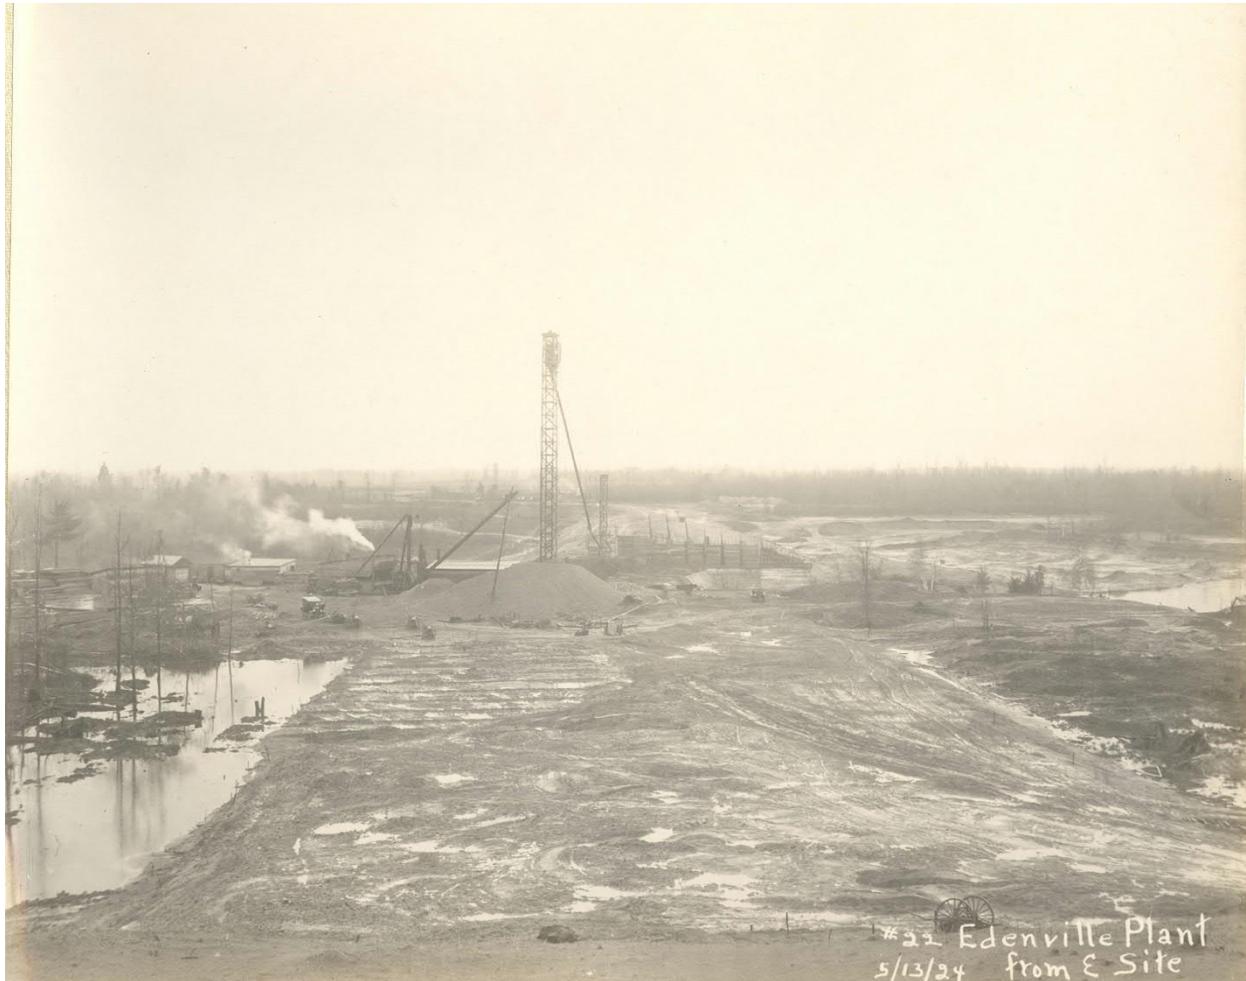
Fill placed near the foundation level of Edenville east (left) embankment. Note stockpile of material in background in downstream portion of the embankment and what appears to be linear alignments of foundation drains. (May 1924)

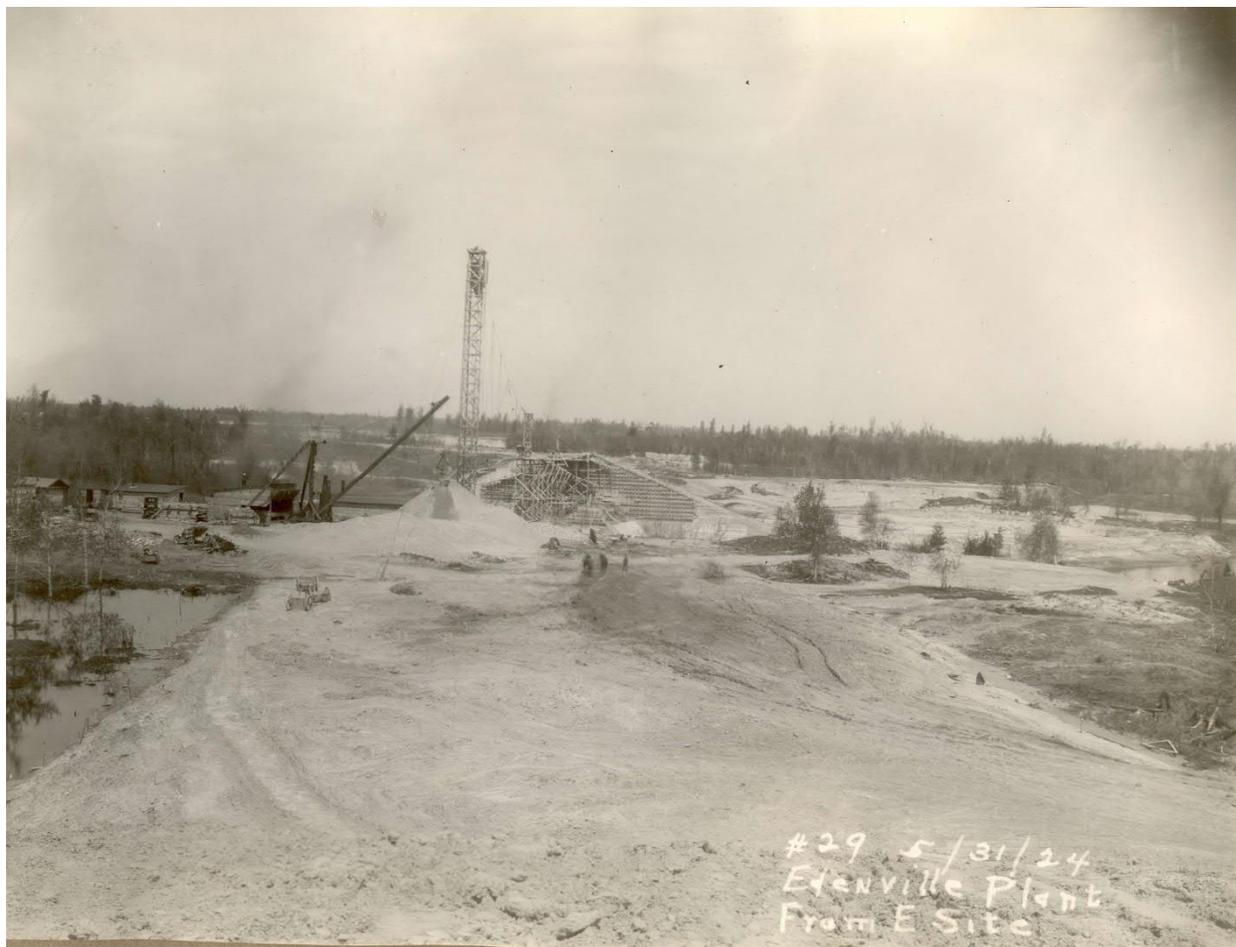
Fill placed in lower portion of Edenville east (left) embankment. Note material in background being stockpiled with clam-shell bucket in downstream portion of the embankment. Foundation drain pipes are visible along the downstream toe. Note the apparent color variation between upstream and downstream areas of the embankment. (May 1924)

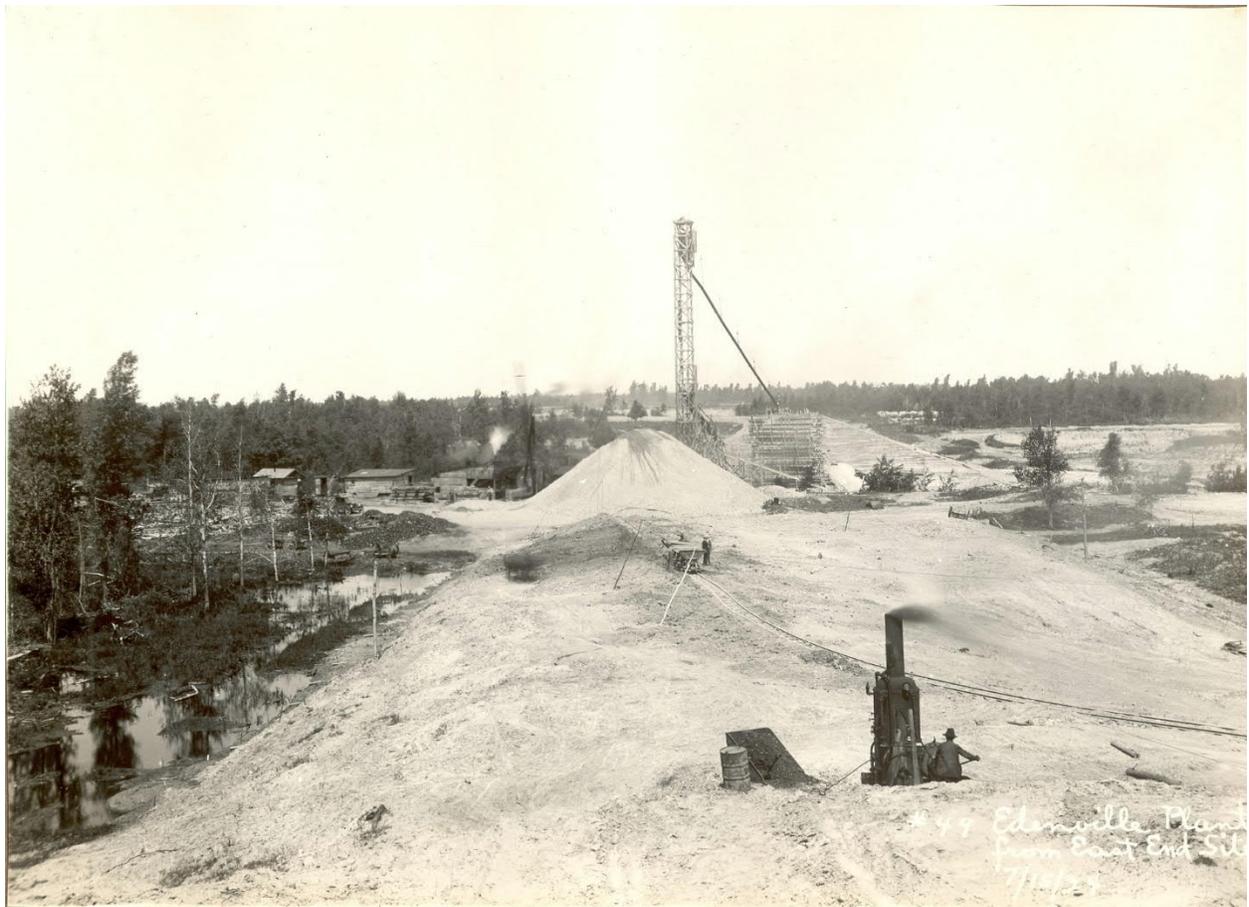
Fill placed in lower portion of Edenville east (left) embankment. Note material in background being stockpiled in downstream portion of the embankment. Note in this photo the rail car from the east is placing fill in the downstream area and the apparent color variation in that area. (July 1924)

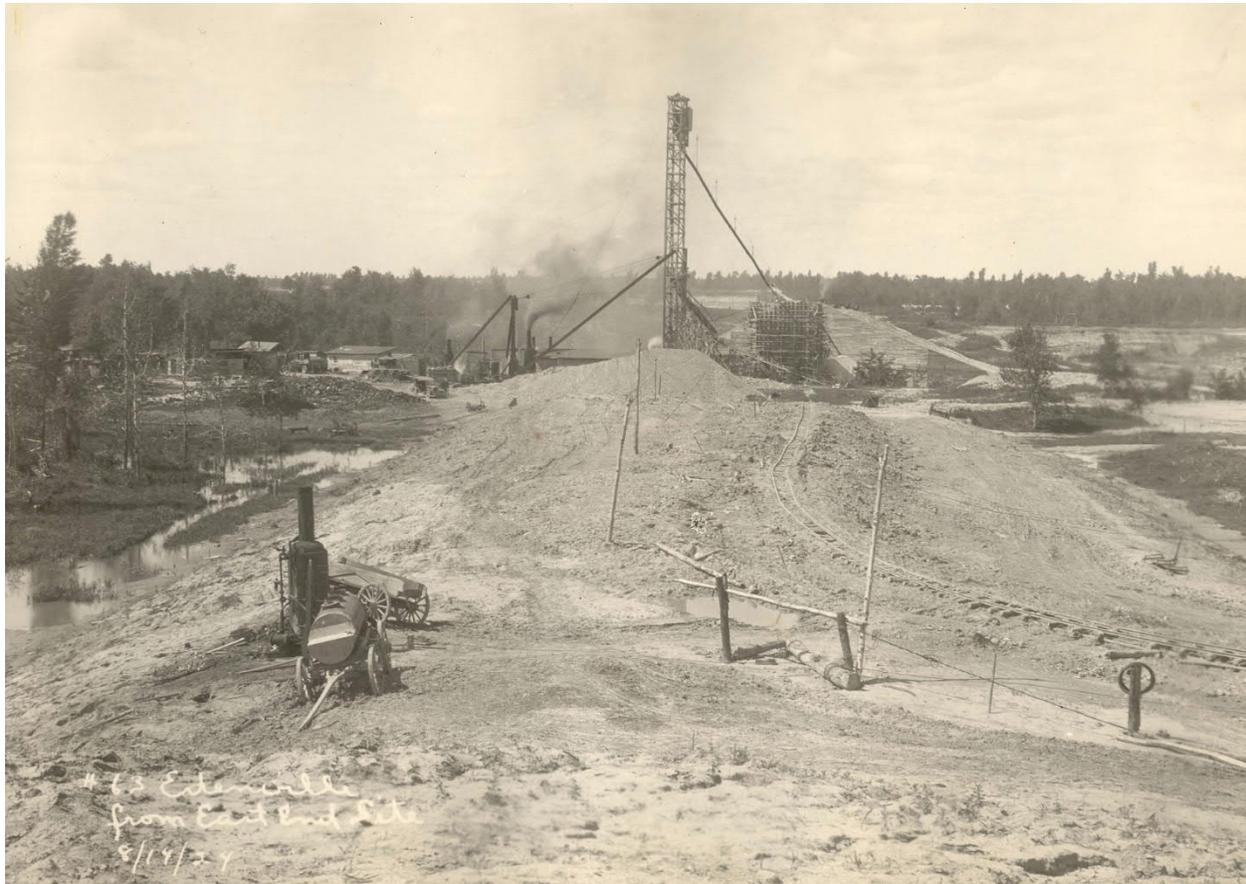
Fill placed in lower portion of Edenville east (left) embankment. Note material in background stockpiled in downstream portion of the embankment. Note the downstream area of the embankment at a slightly higher elevation than the upstream. Aspen poles used for construction utilities are visible [representative of an aspen pole observed in the embankment fill of the remnant right face of the embankment breach] (August 1924)

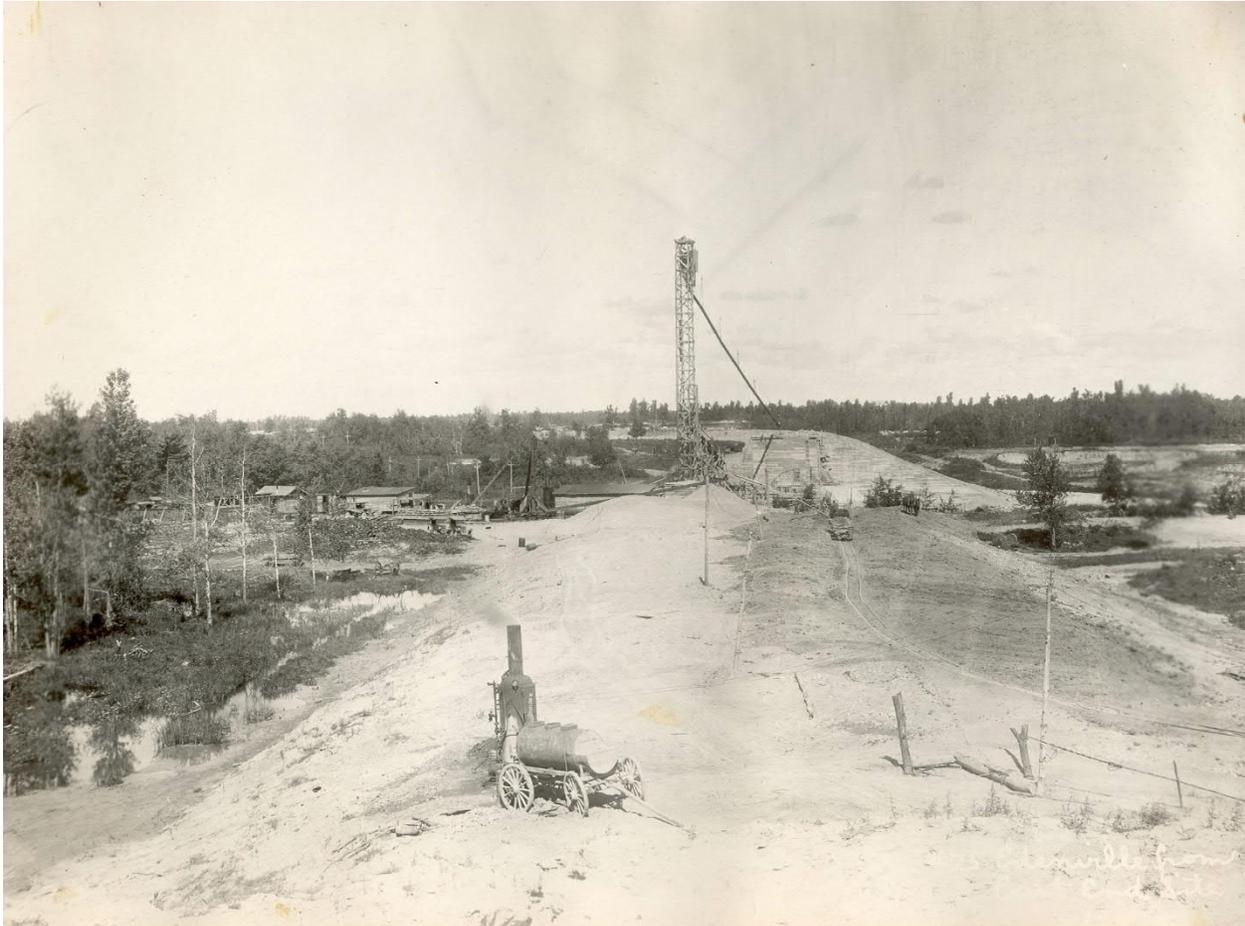
Fill placed in lower portion of Edenville east (left) embankment. Note material in background stockpiled in downstream portion of the embankment. Note the apparent color variation between upstream and downstream areas of the embankment. (no date)

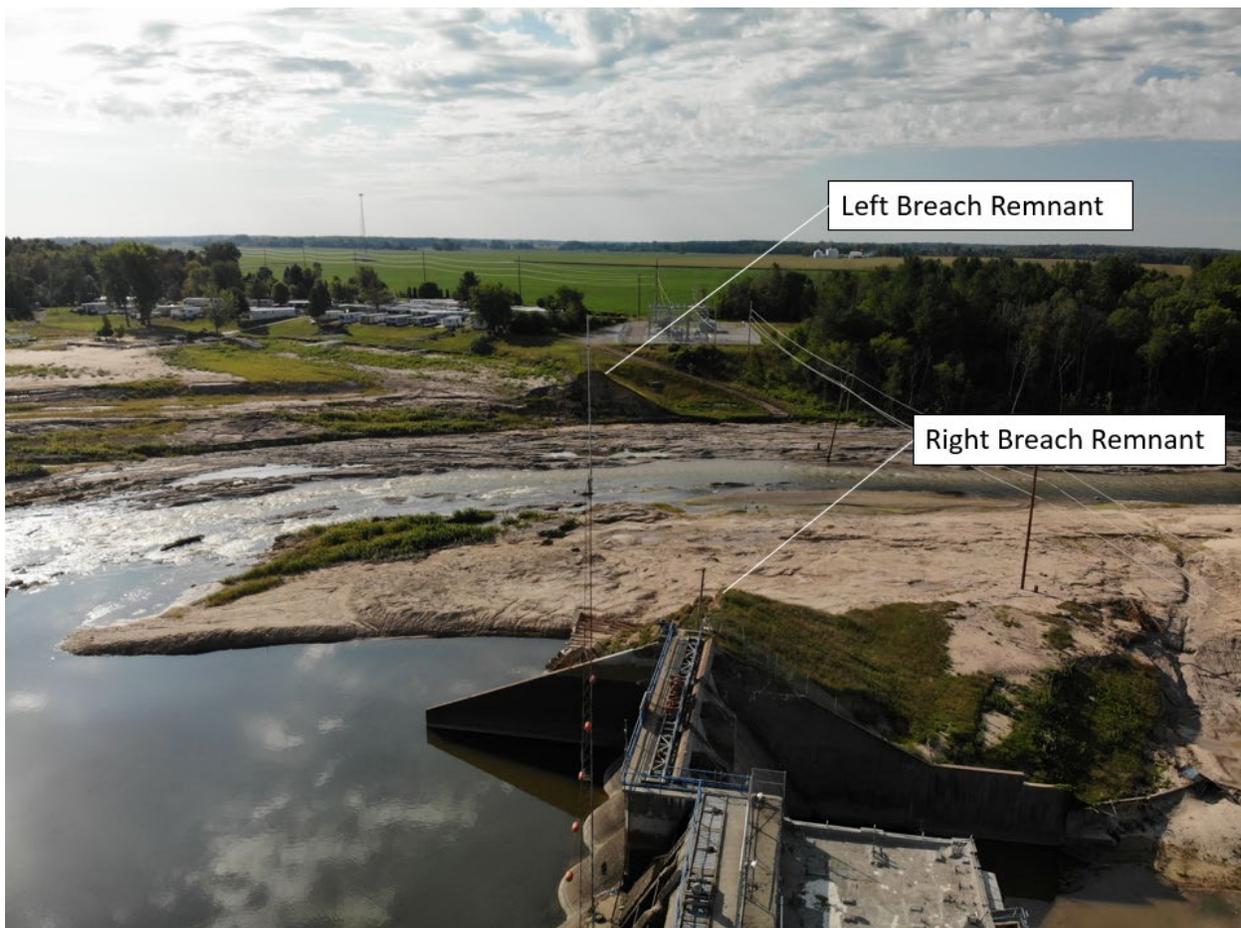
Figure E-1 shows the post-failure breach of the Edenville left embankment and depicts the general conditions at the time of the field investigation.

Figure E-1: View of Edenville Left Embankment, Post Failure (photo courtesy of EGLE)

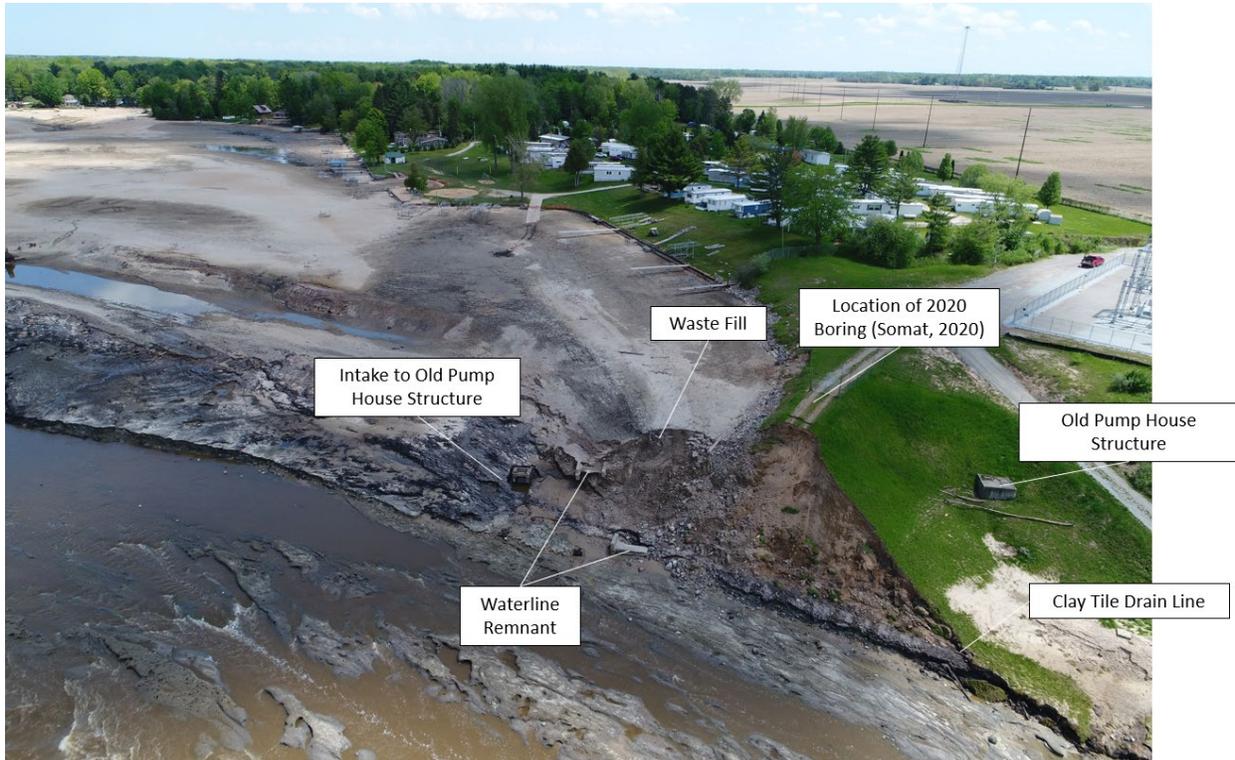
downstream toe. The left abutment (natural foundation) appeared to be exposed near the upstream toe. Waste fill, which included lumber debris, appeared to have been placed upstream of the embankment section on the abutment/foundation contact. Remnants of an old intake and waterline structure, which originally connected to a downstream pump house structure, were exposed near the upstream toe. An aerial image of the left breach remnant is shown in Figure E-2.

Figure E-2: Aerial View of Left Breach Remnant (photo courtesy of EGLE)
