INVESTIGATION OF FAILURES OF EDENVILLE AND SANFORD DAMS

Independent Forensic Team

FINAL REPORT

Investigation of Failures of Edenville and Sanford Dams

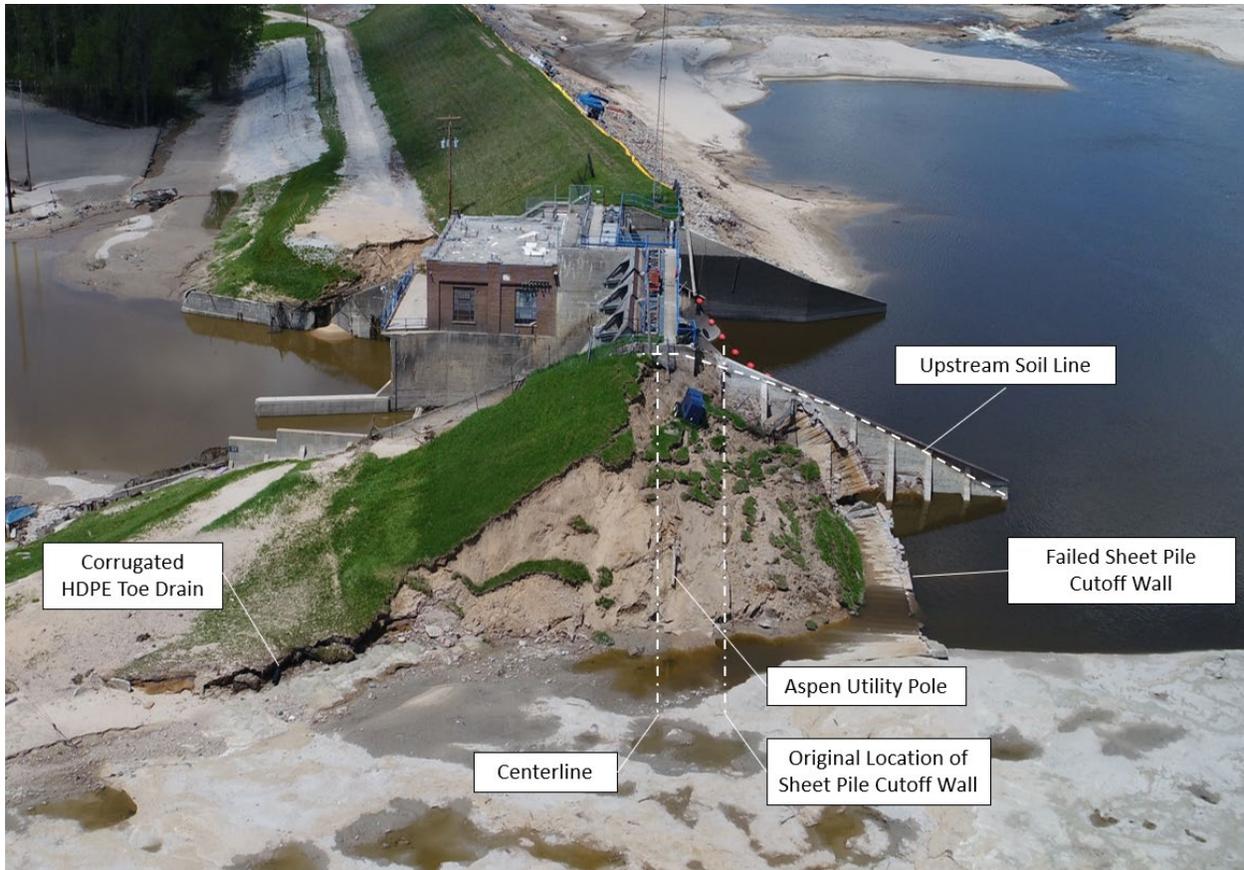
The downstream embankment section of the right breach remnant, from the centerline to the downstream toe, was generally visible and intact, and some loose slough could be seen on the face and at the base of the embankment. Upstream of the centerline, the embankment had slumped/deformed toward the upstream side during the May 2020 event due to the failure of the upstream sheet pile cutoff wall. The upstream toe was submerged and not visible. An aspen pole, likely a temporary utility pole from the original construction, was embedded and protruding from the face of the embankment. An 8-inch corrugated high-density polyethylene (HDPE) pipe, likely an extension from the original clay tile drain pipes, was exposed near the downstream toe. An aerial view of the right breach remnant is shown in Figure E-3.

Figure E-3: Aerial View of Right Breach Remnant (photo courtesy of EGLE)
