REPORT TO  
U.S. DEPARTMENT OF THE INTERIOR AND STATE OF IDAHO  
ON  
**FAILURE OF TETON DAM**

BY  
INDEPENDENT PANEL TO REVIEW CAUSE OF TETON DAM FAILURE

DECEMBER 1976

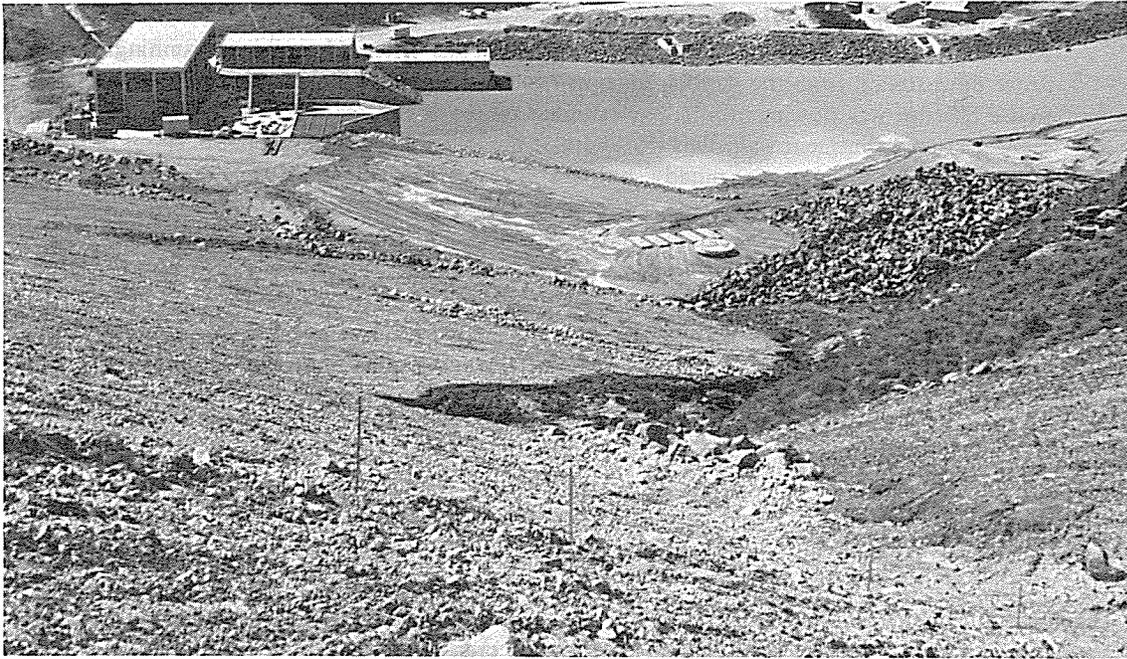
Fig. 2-7. View from top of embankment toward leak at El. 5200 near right abutment. Approximately 10:30 a.m. June 5, 1976.

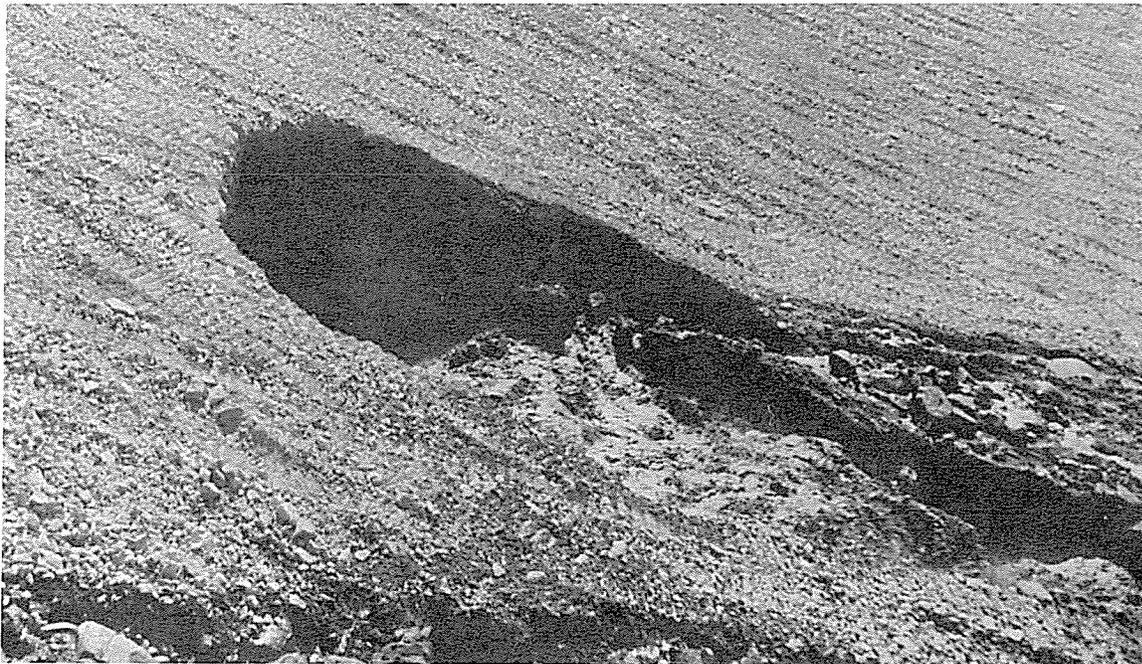
Fig. 2-8. Close-up of leak shown in Fig. 2-7. Turbid flow about 15 cfs. Approximately 10:30 a.m. June 5, 1976.

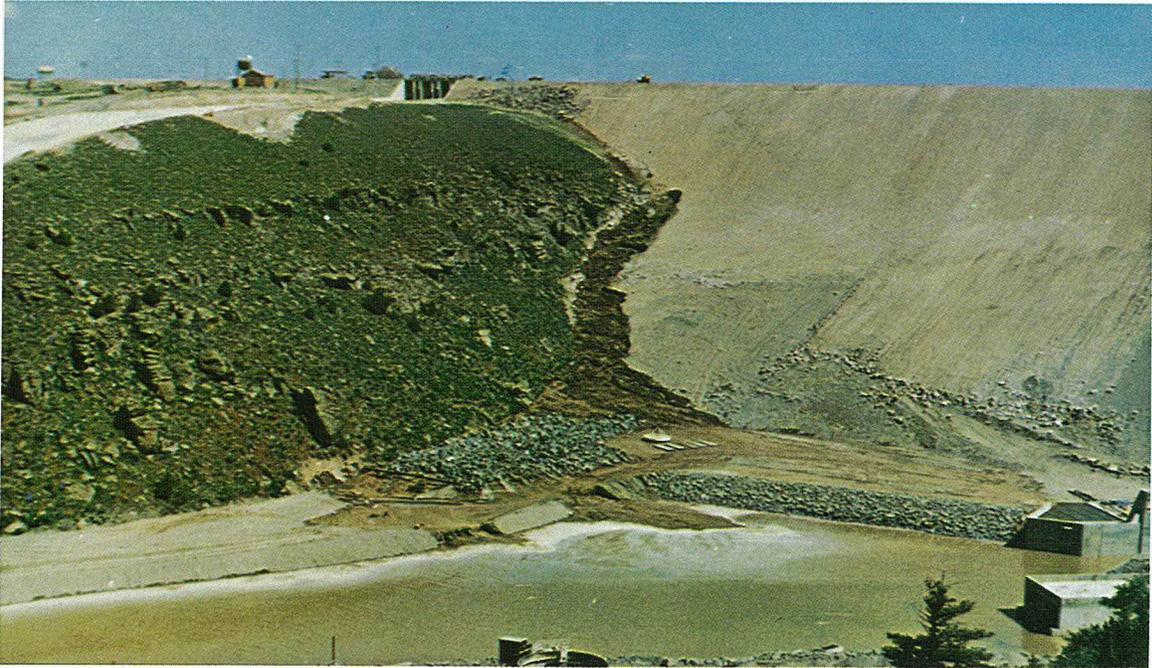
**Fig. 2-9.** Flow increasing. Dozers sent to fill hole at El. 5200. About 10:45 a.m. June 5, 1976.

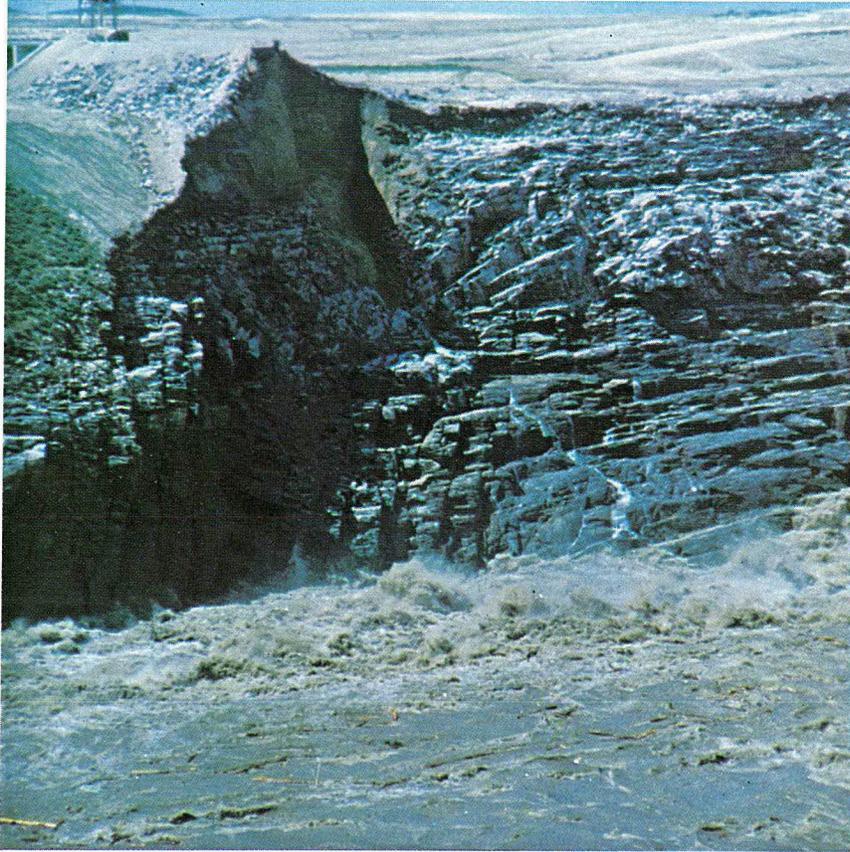
**Fig. 5-8** Showing prevalent horizontal joints upstream and dominating vertical joint system downstream of dam in right wall of canyon (post-failure photo)

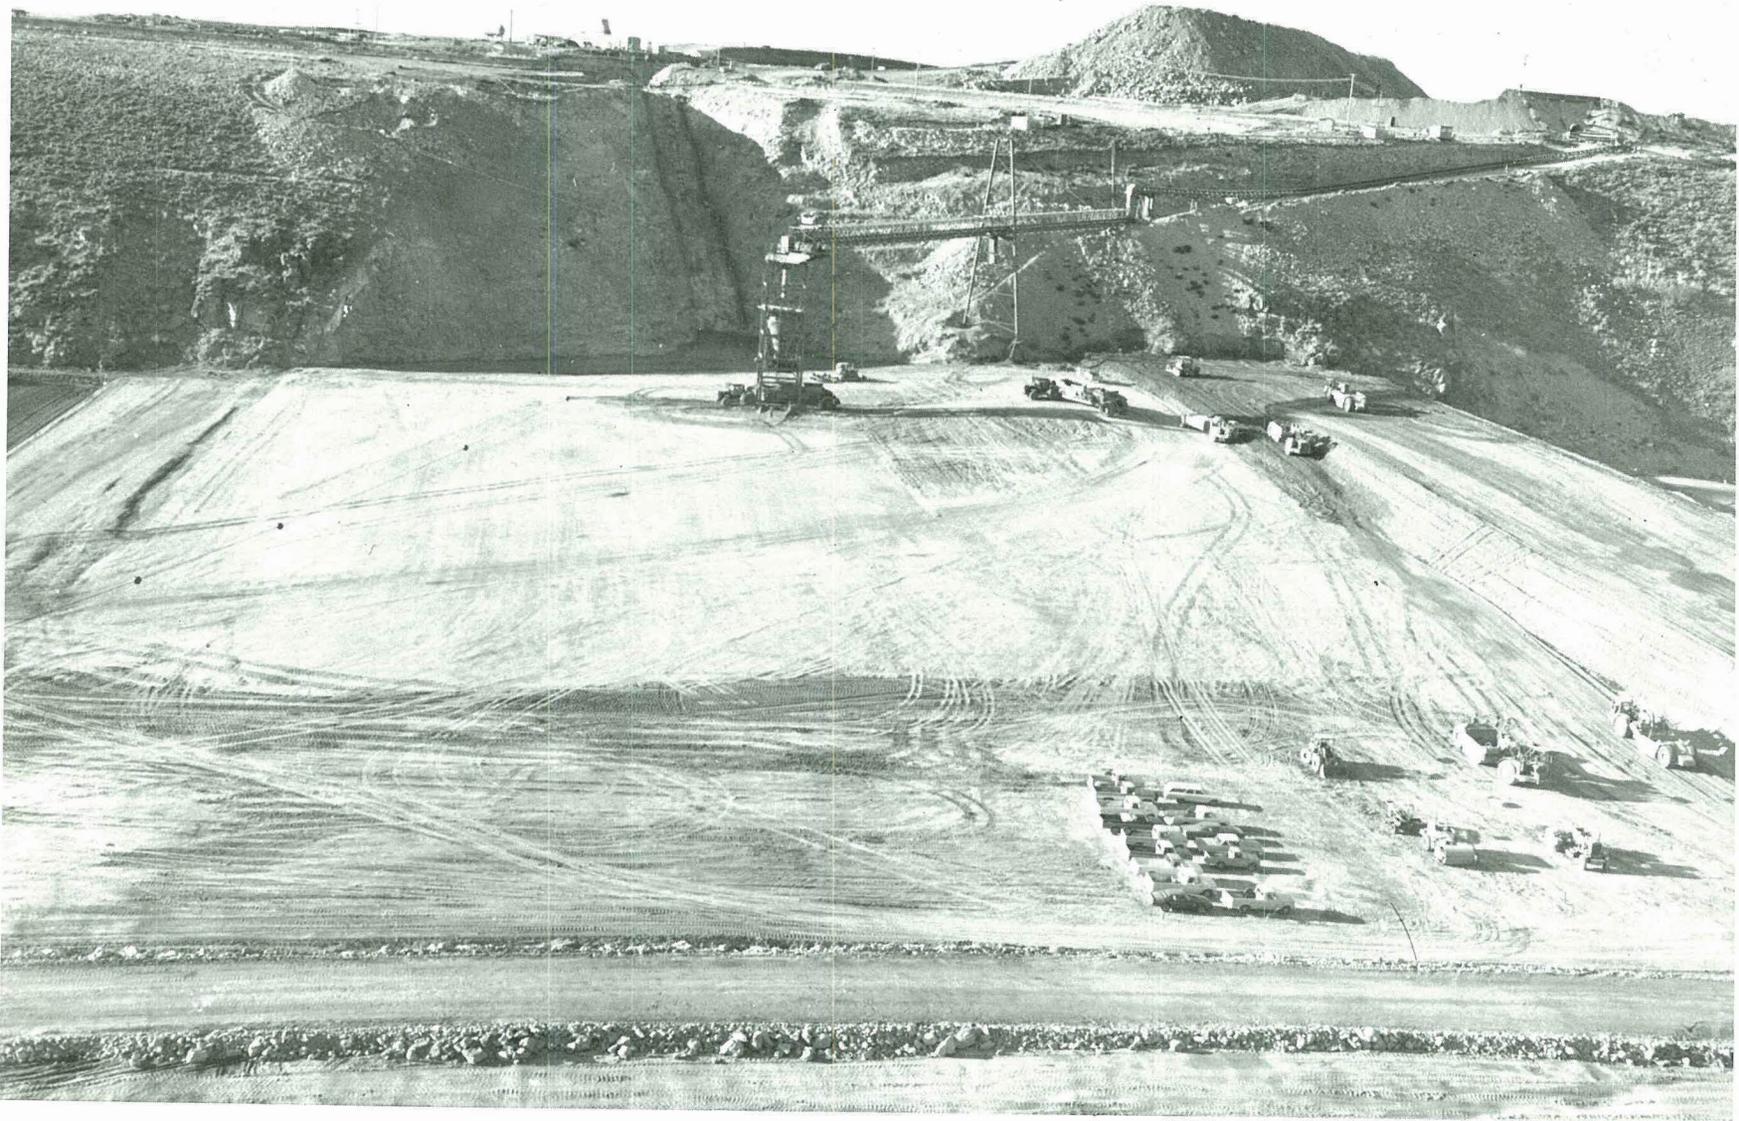
Fig. 9-4 Right abutment excavation showing the variable qualities of foundation for the various embankment zones and for the key-trench invert. Zone 1 is approximately El. 5145.

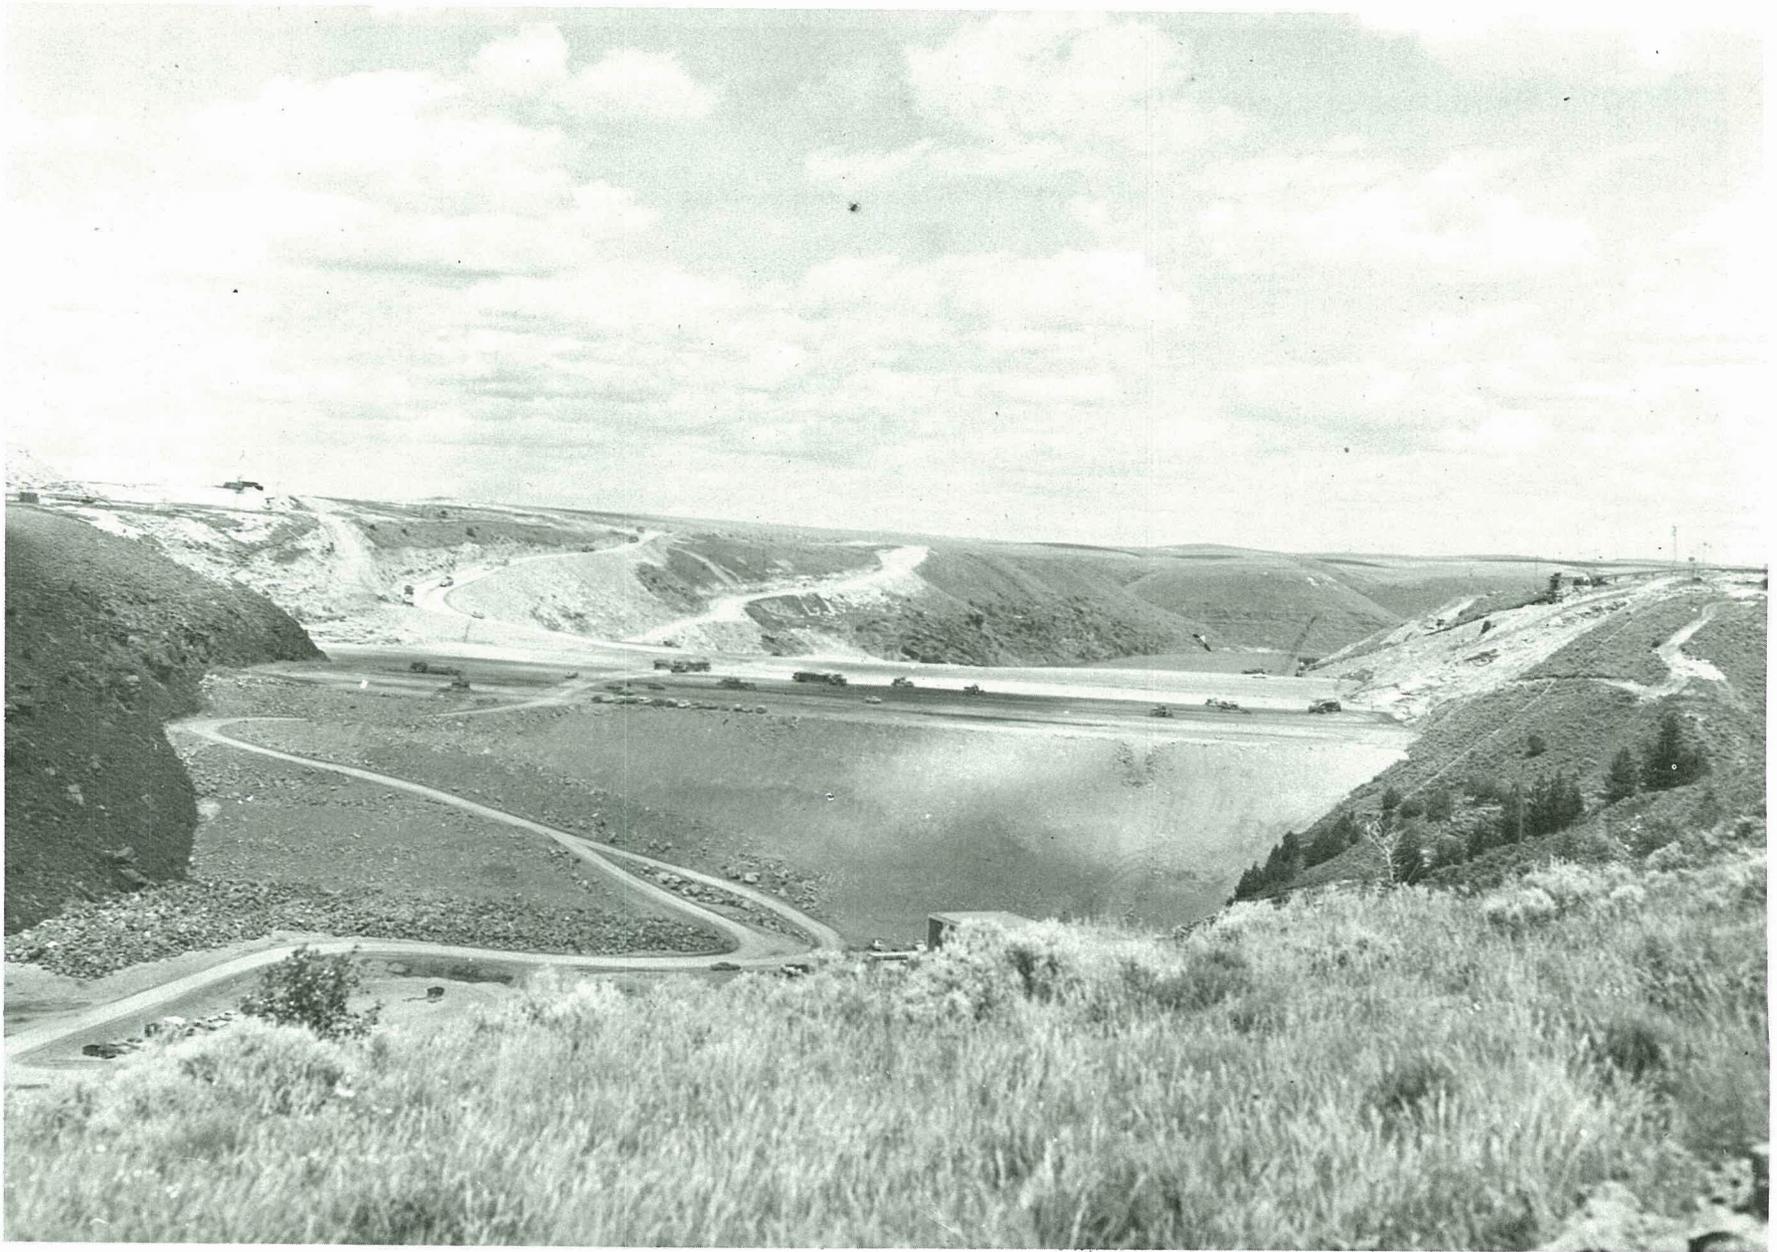
Fig. 9-5 Right abutment (to left in photo) showing minimal stripping (vegetation only) in preparing Zones 2 and 5 foundation. Zone 1 is approximately El. 5170.

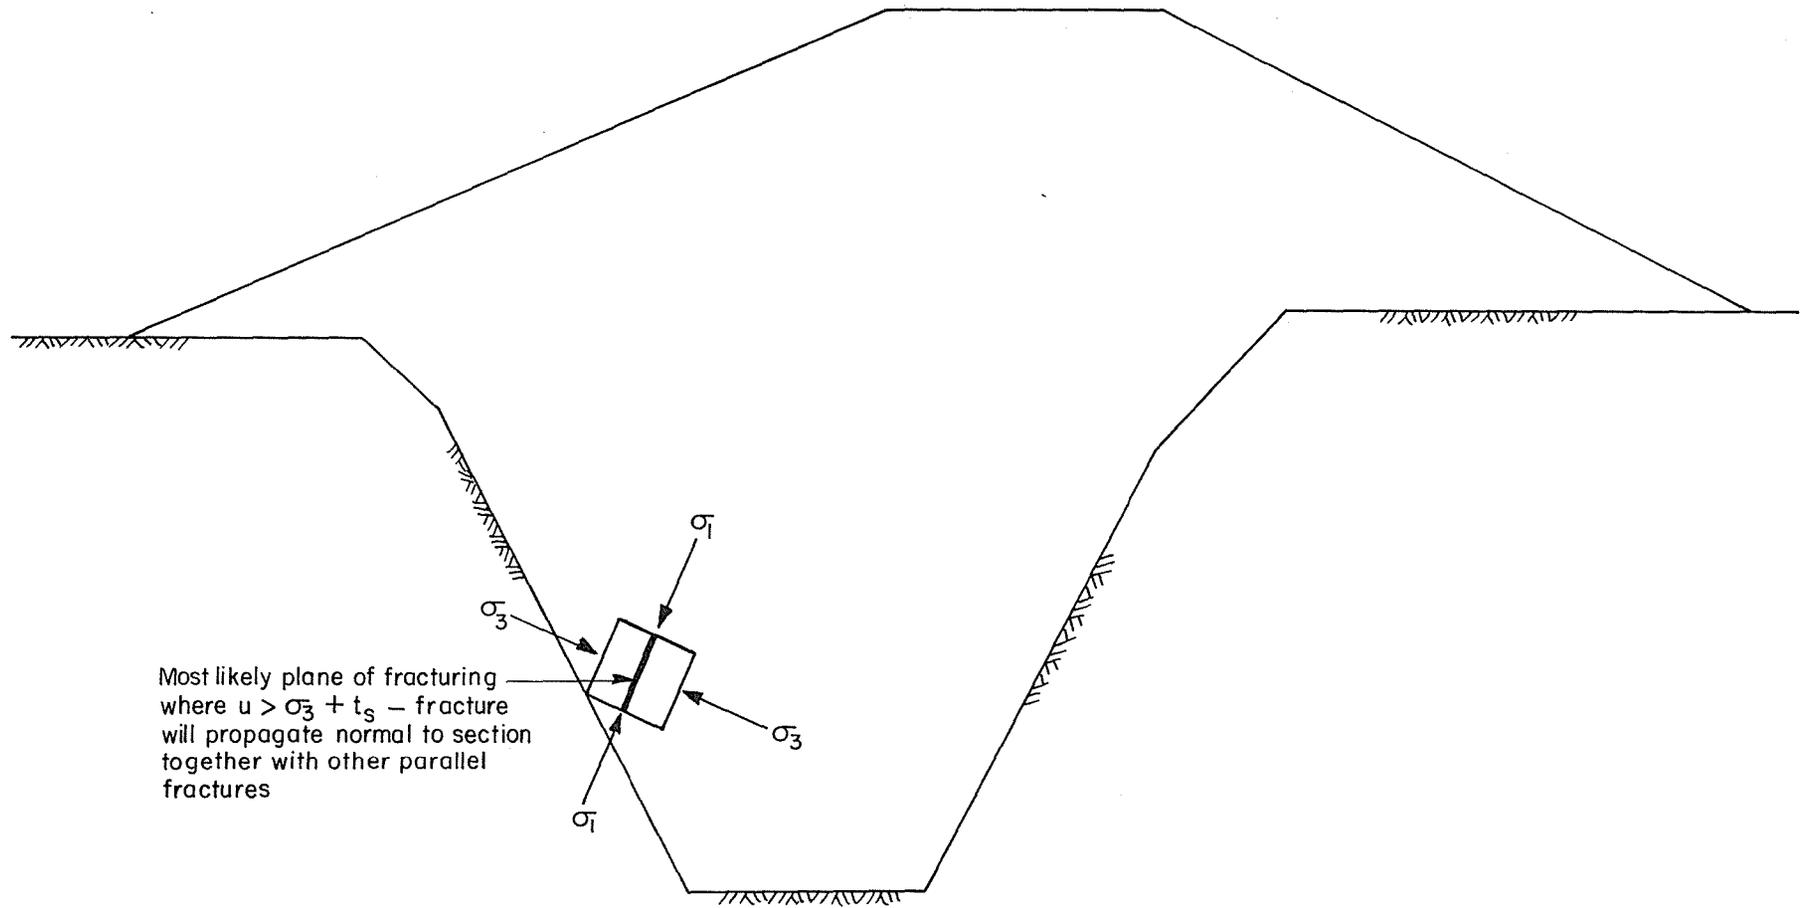
FIG. 12-10

DEVELOPMENT OF LONGITUDINAL FRACTURE PATTERN

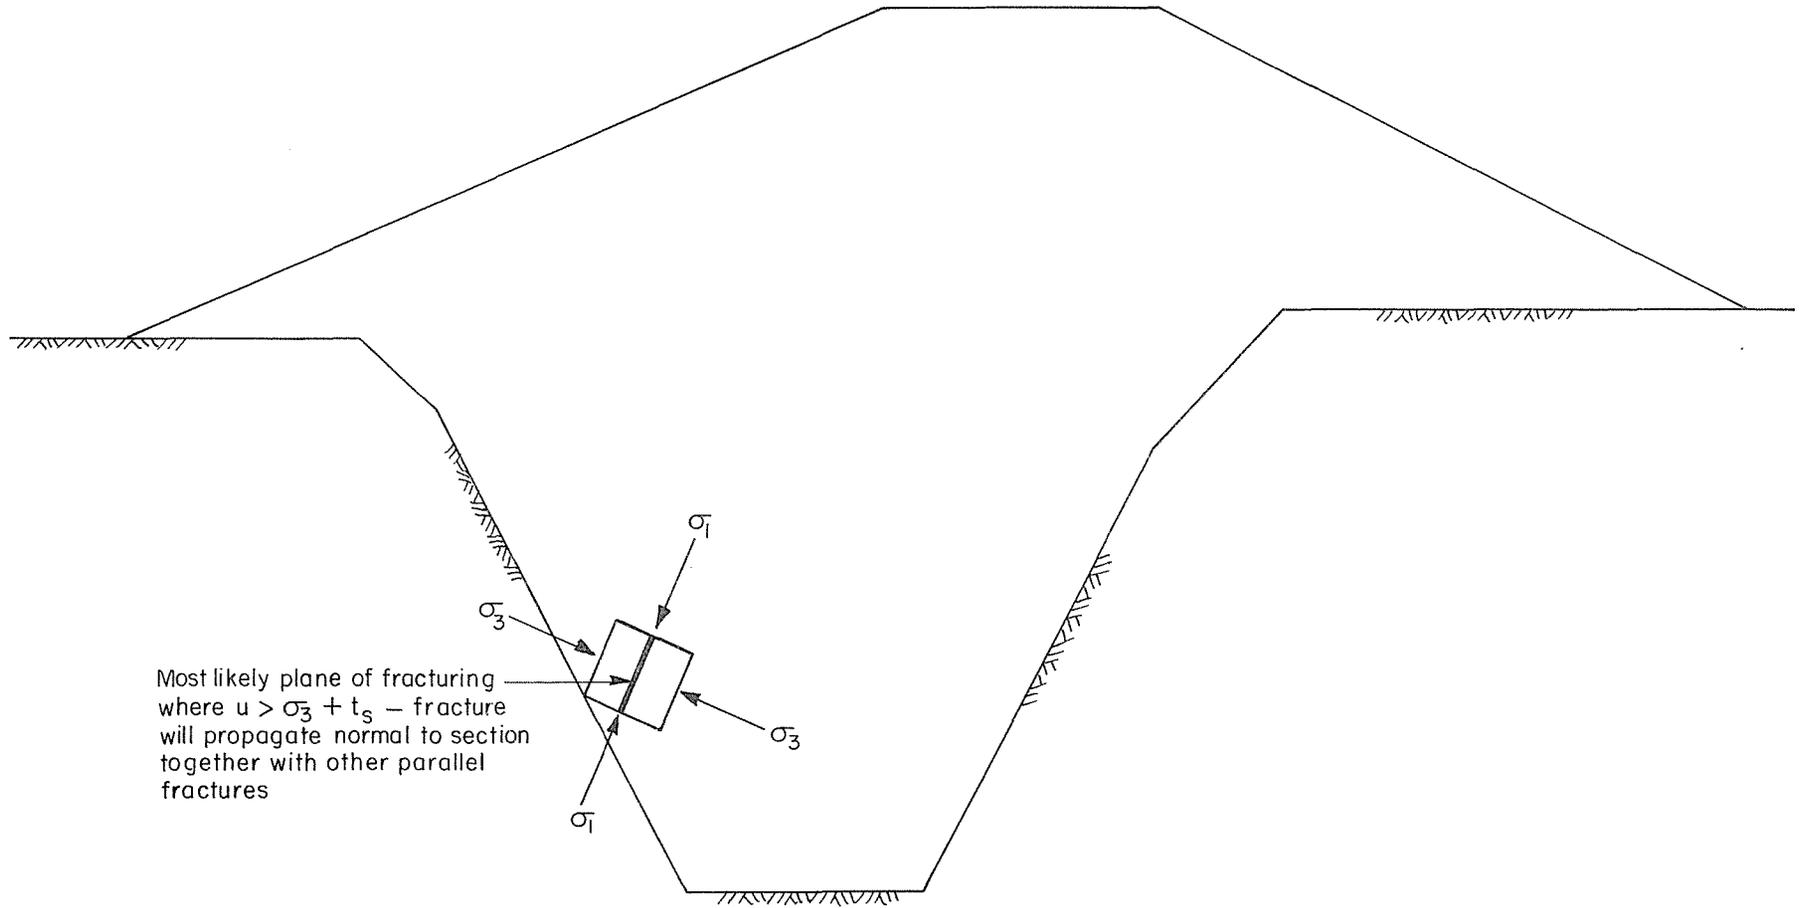
FIG. 8 DEVELOPMENT OF LONGITUDINAL FRACTURE PATTERN

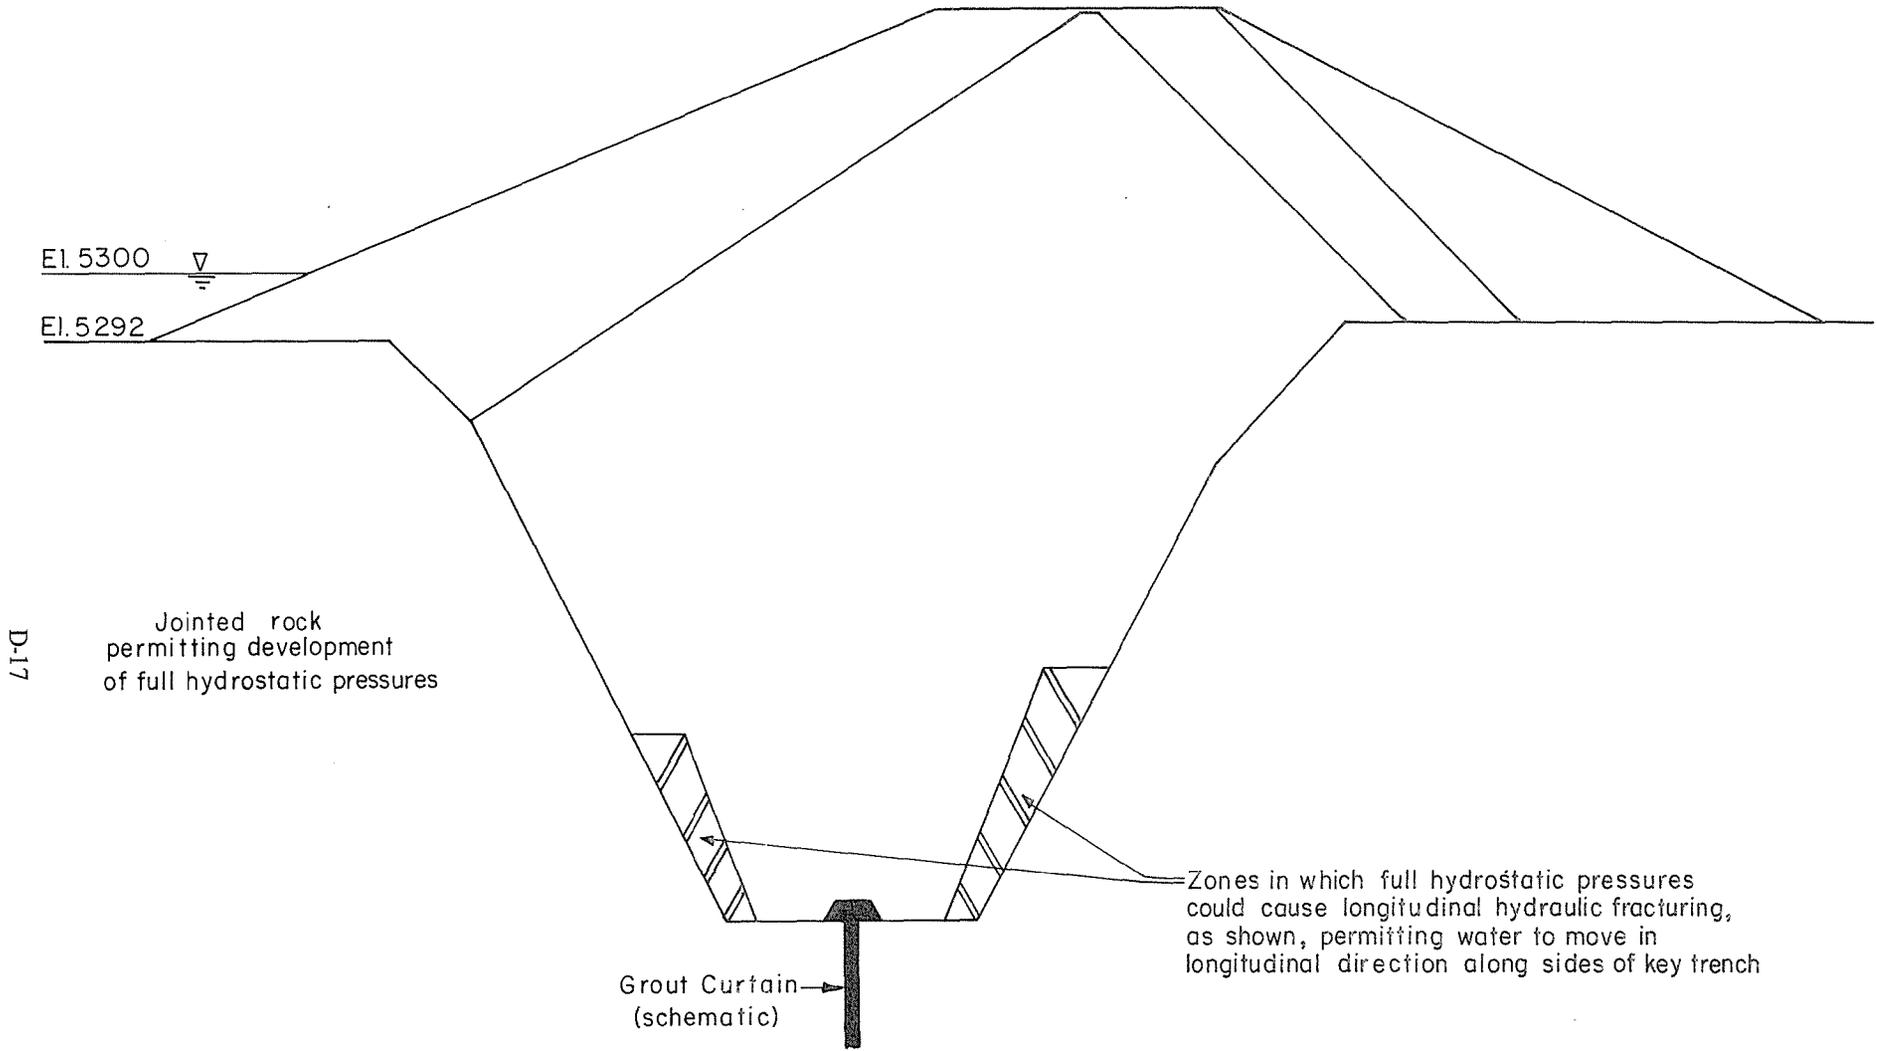
FIG. 9 ZONES OF POTENTIAL LONGITUDINAL FRACTURING AT STA. 12 + 70

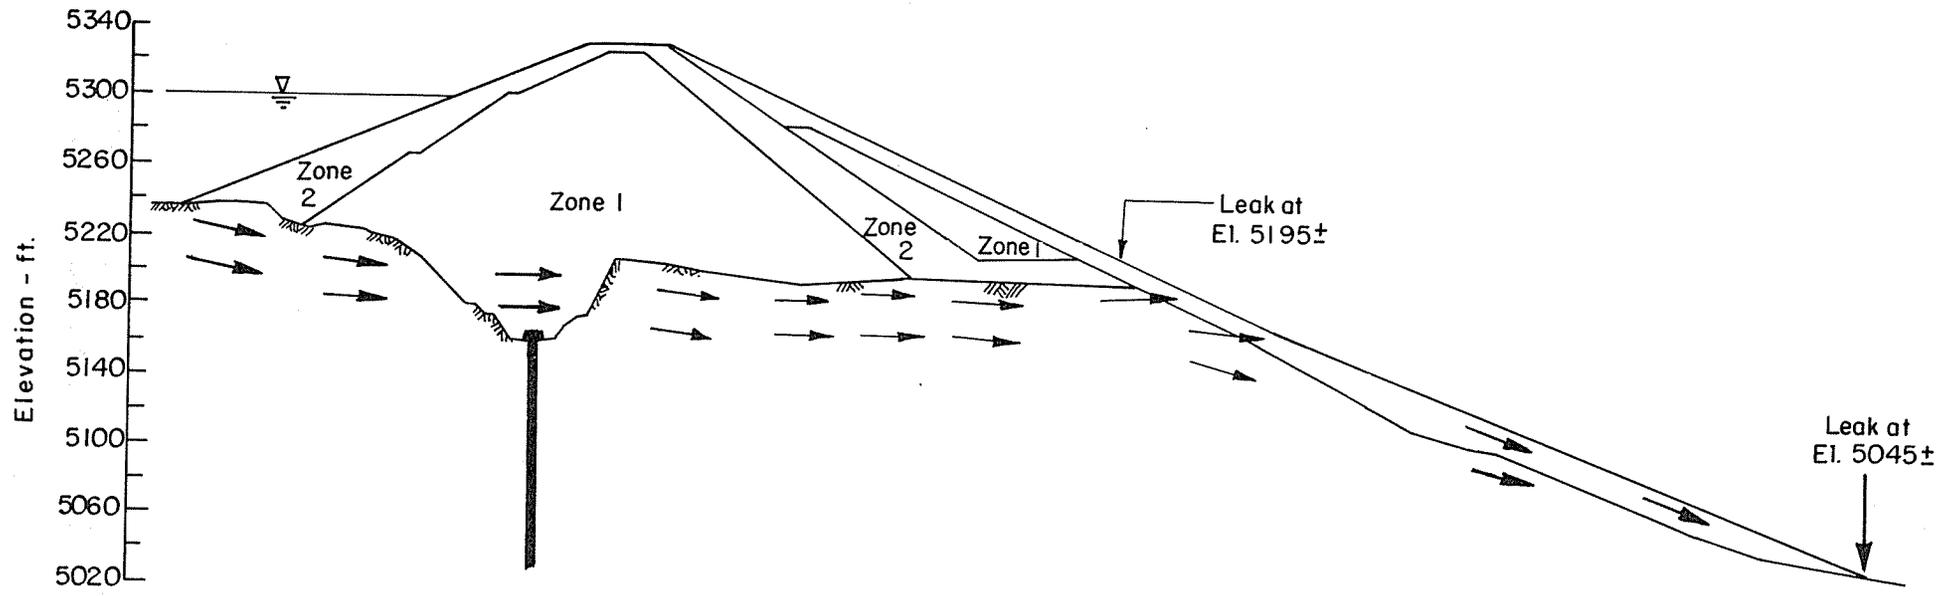
FIG. 22 PROBABLE PATH OF WATER IN EARLY STAGES OF LEAKAGE
