603  
I 1.2'  
T29/2

BOSTON PUBLIC LIBRARY  
3 9999 06317 343 7

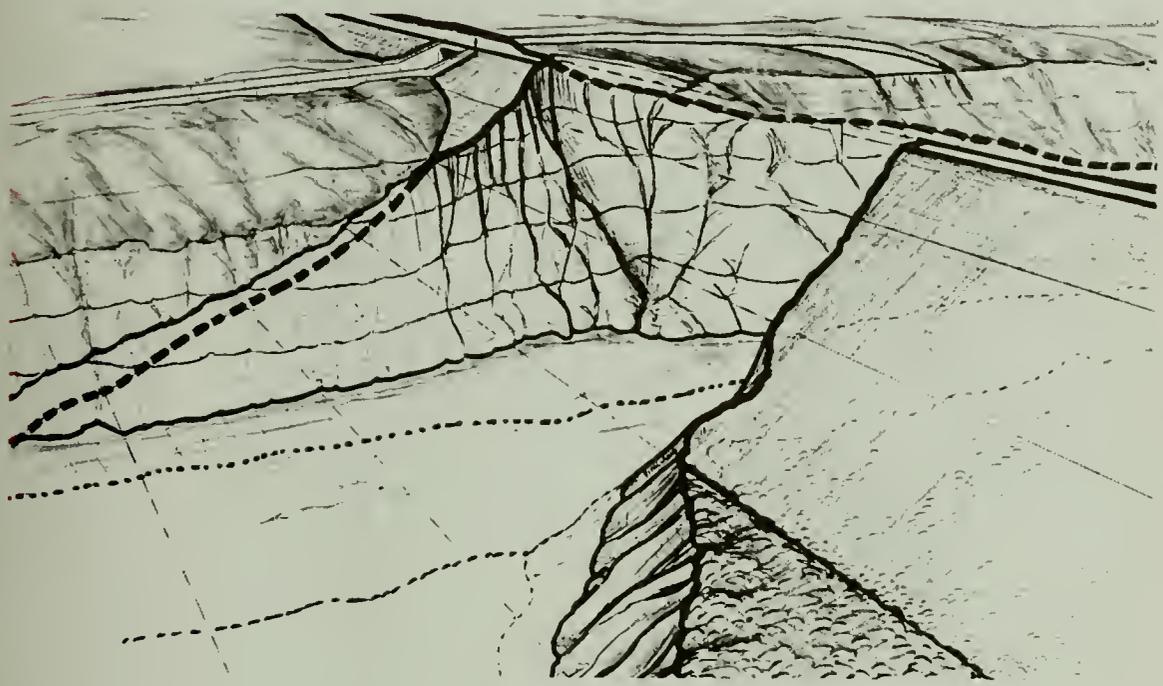
U.S. GOVERNMENT PRINTING OFFICE LIBRARY  
U.S. DEPARTMENT OF THE INTERIOR  
JUN 13 1977

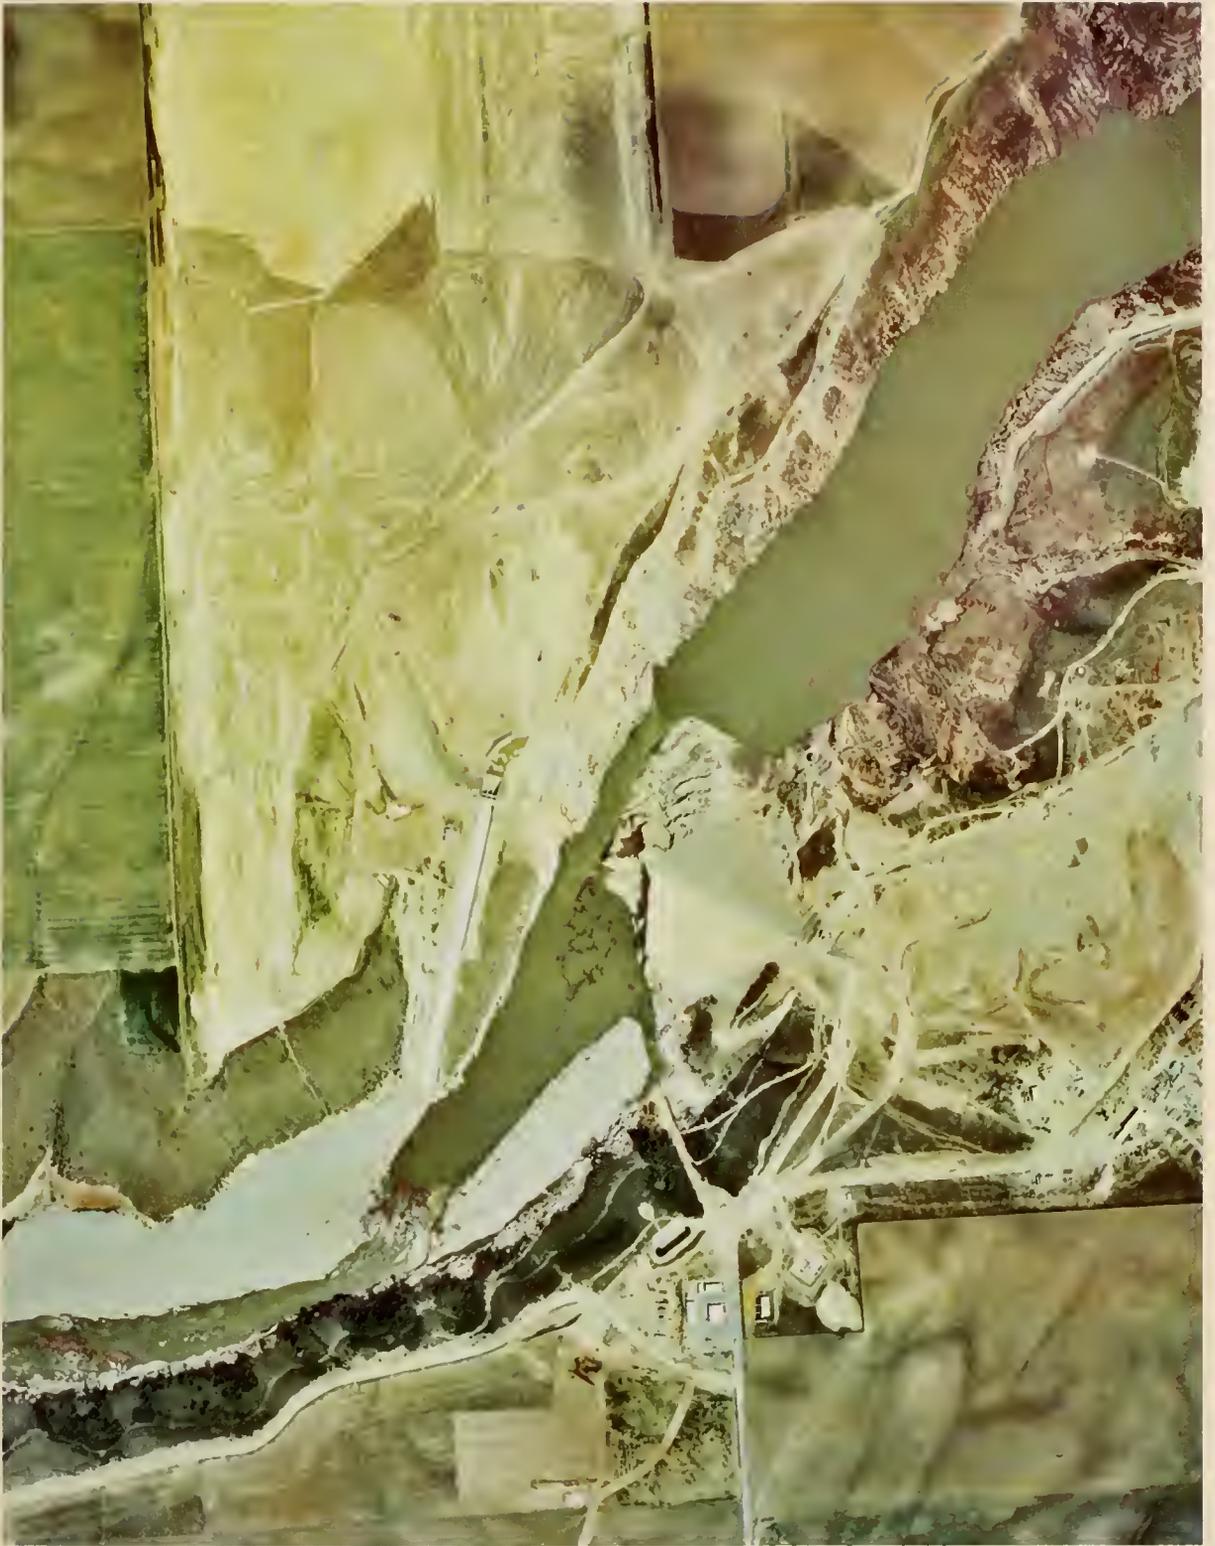
Frontispiece.—Aerial view of Teton damsite after the failure of the dam.

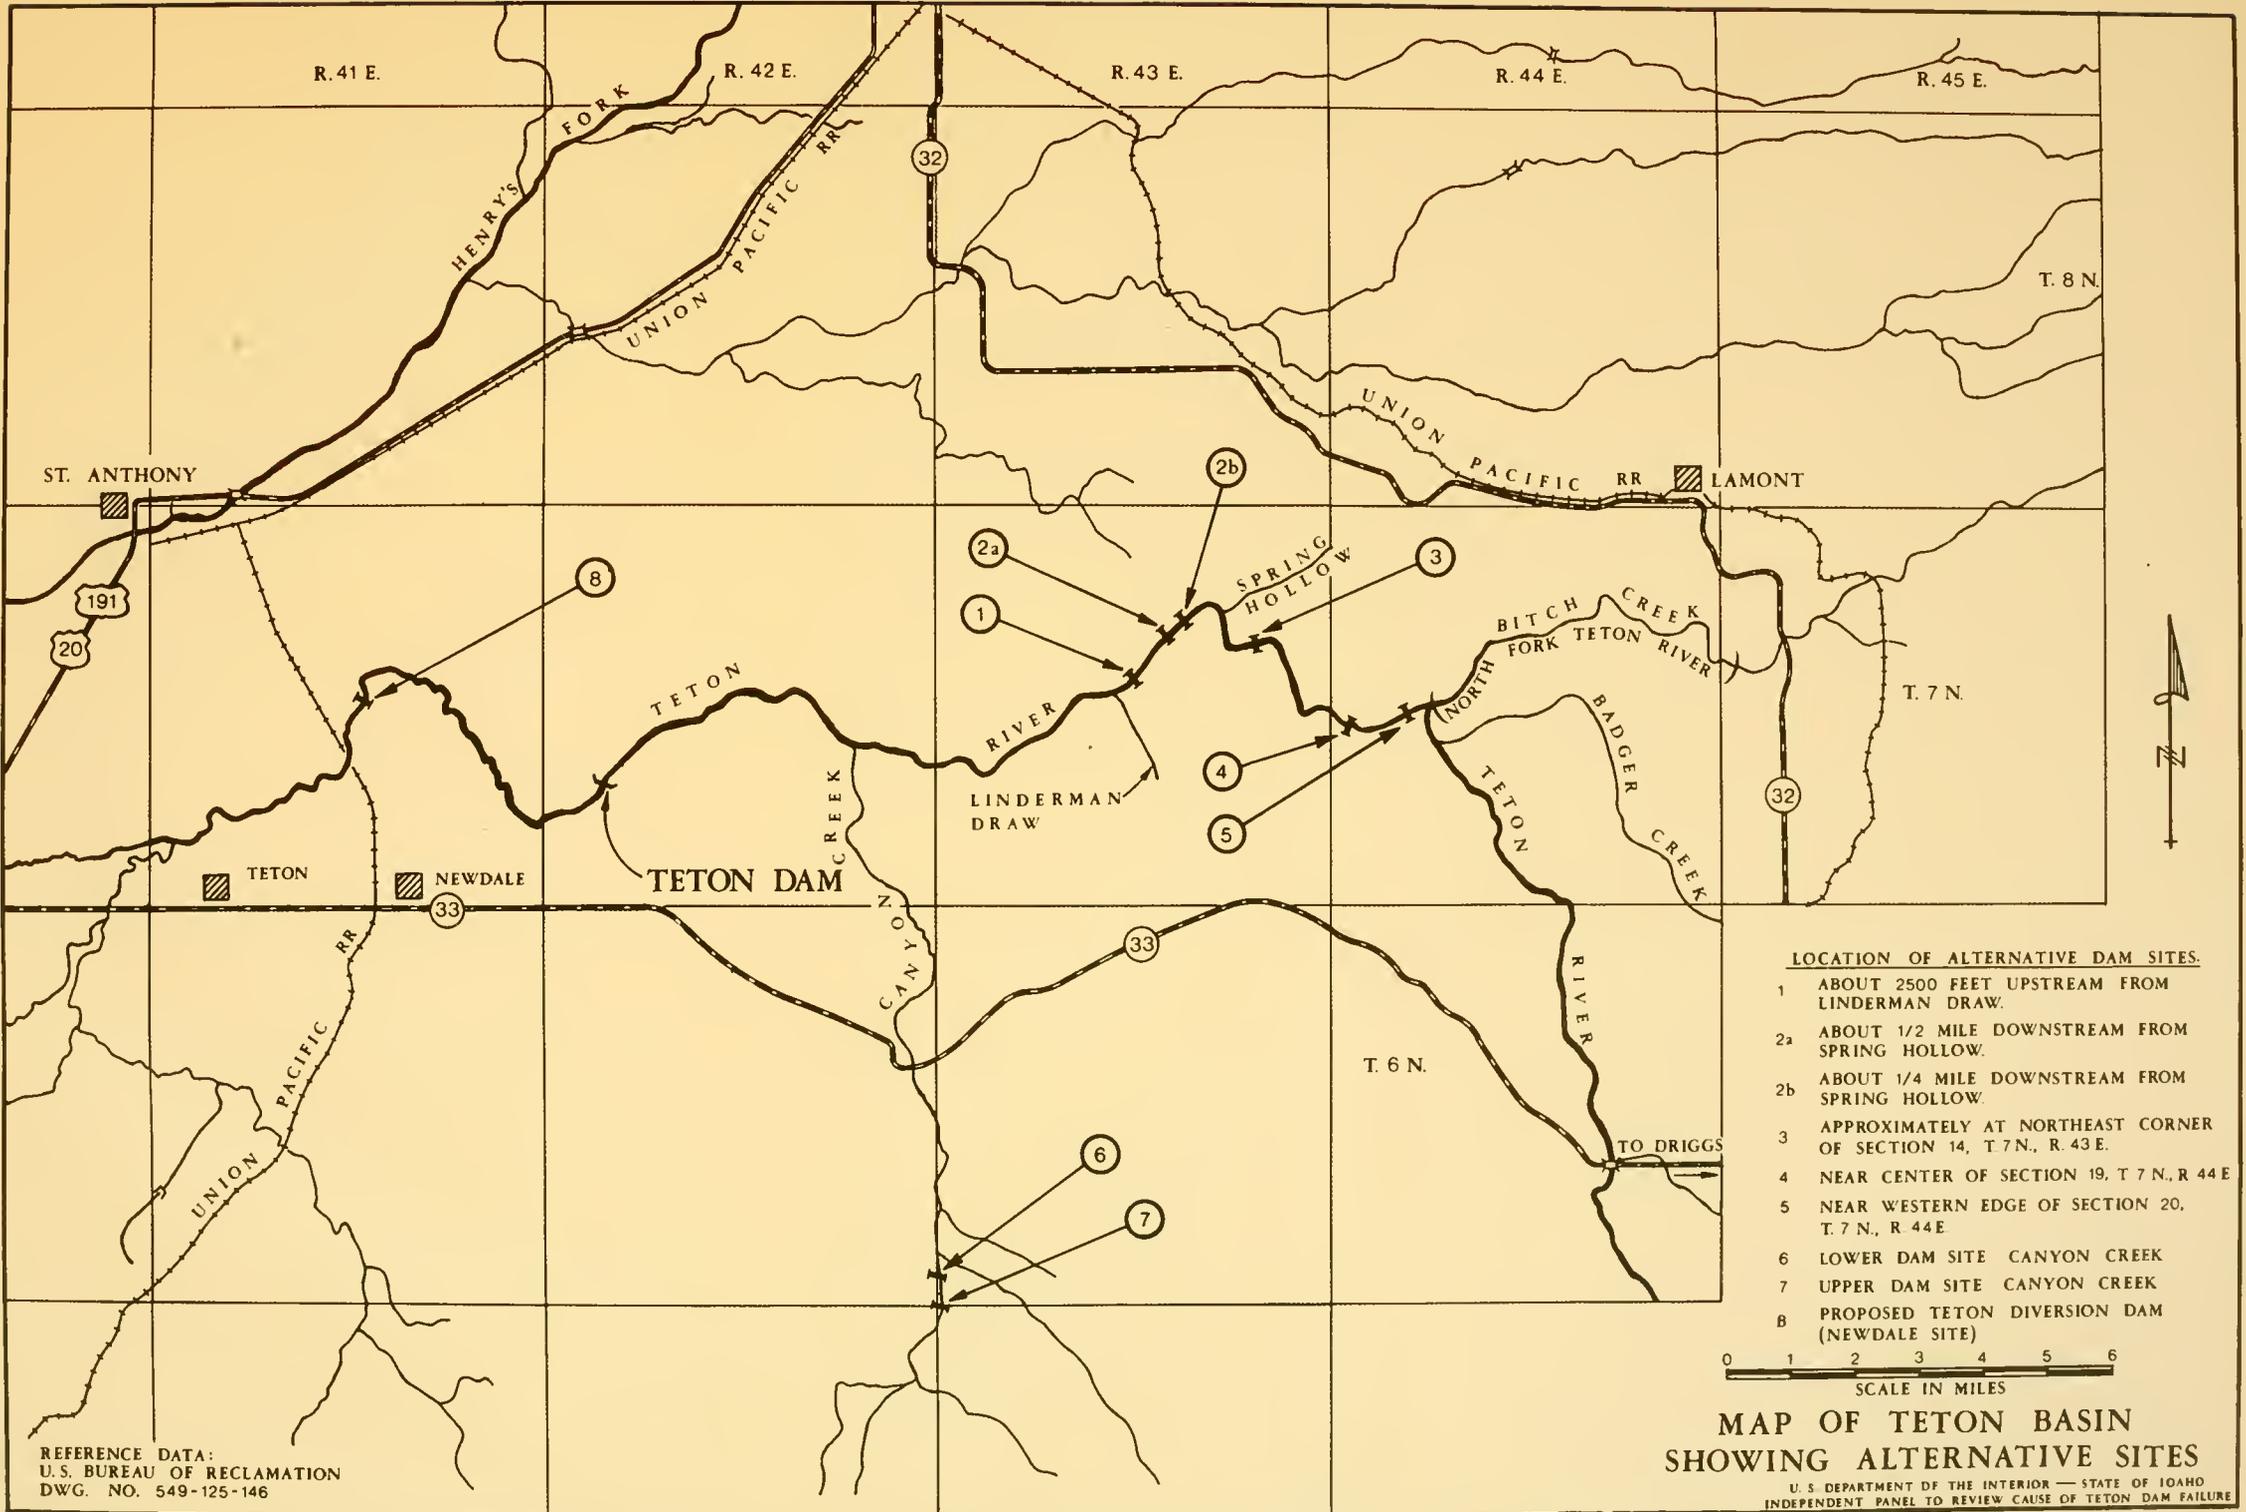
Figure 3.—Location of alternate dam sites

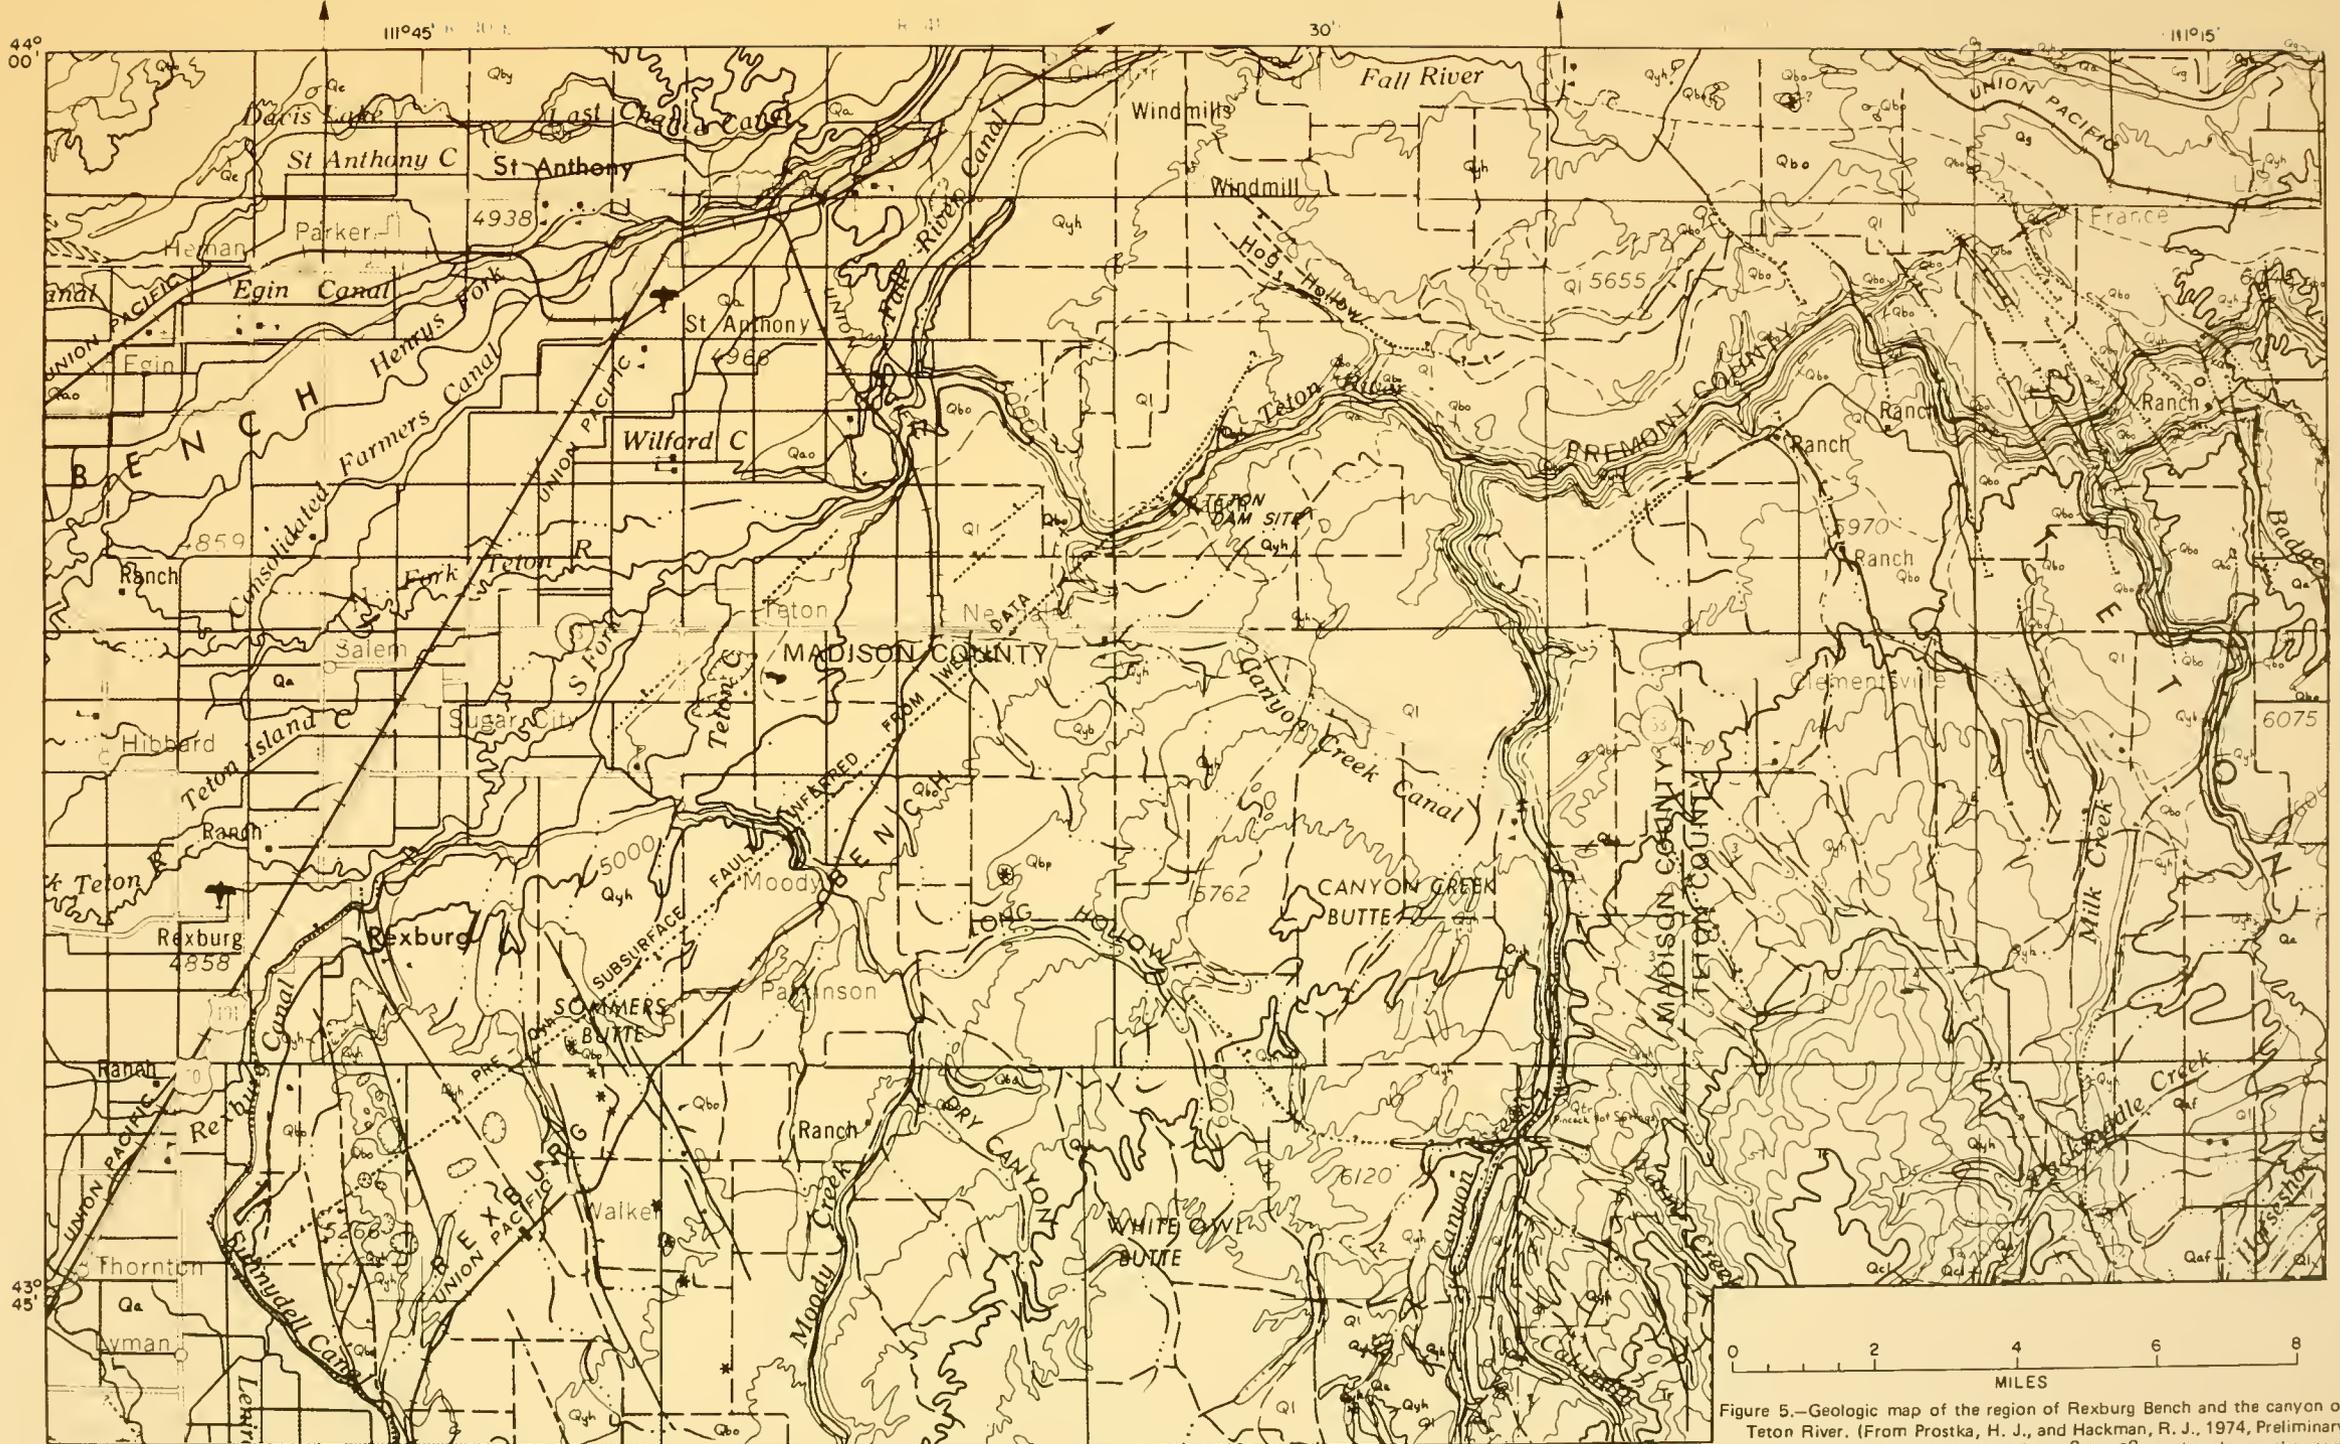
Figure 5.—Geologic map of the region of Rexburg Bench and the canyon of Teton River. (From Prostka, H. J., and Hackman, R. J., 1974, Preliminary geologic map of the NW 1/4 Driggs 1° by 2° quadrangle, southeastern Idaho: U.S. Geol. Survey Open-File Report 74-105.)

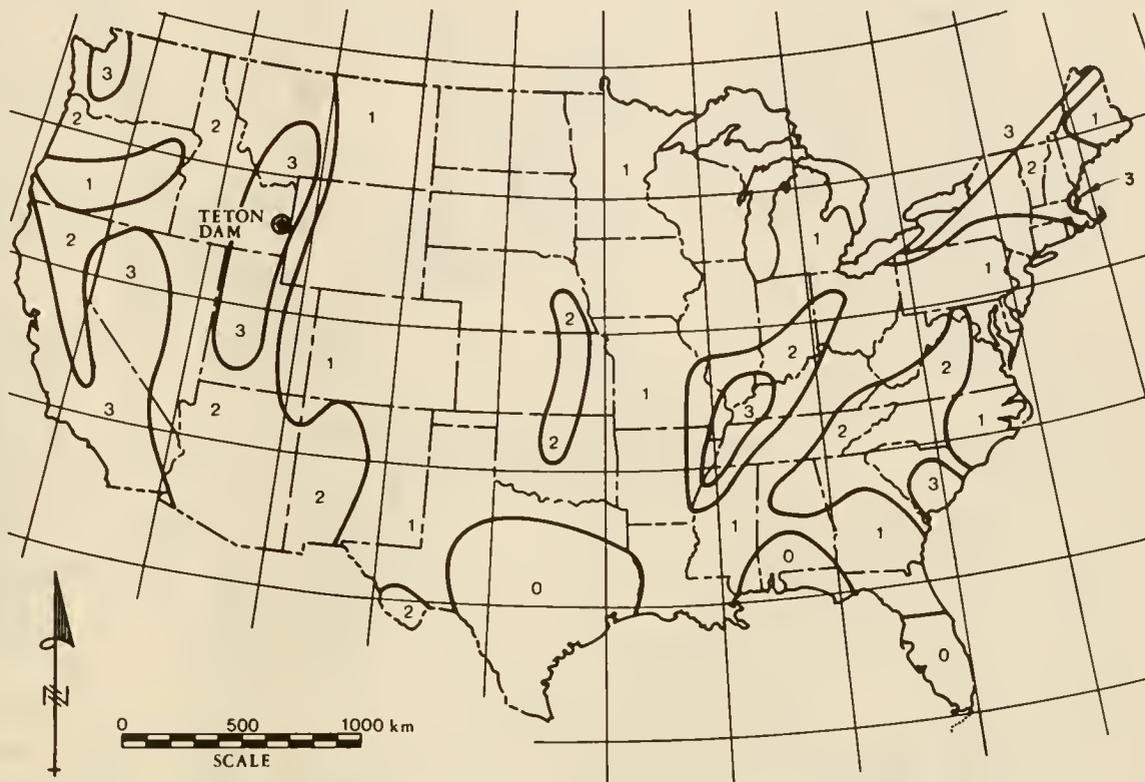
SEISMIC RISK MAP OF THE UNITED STATES

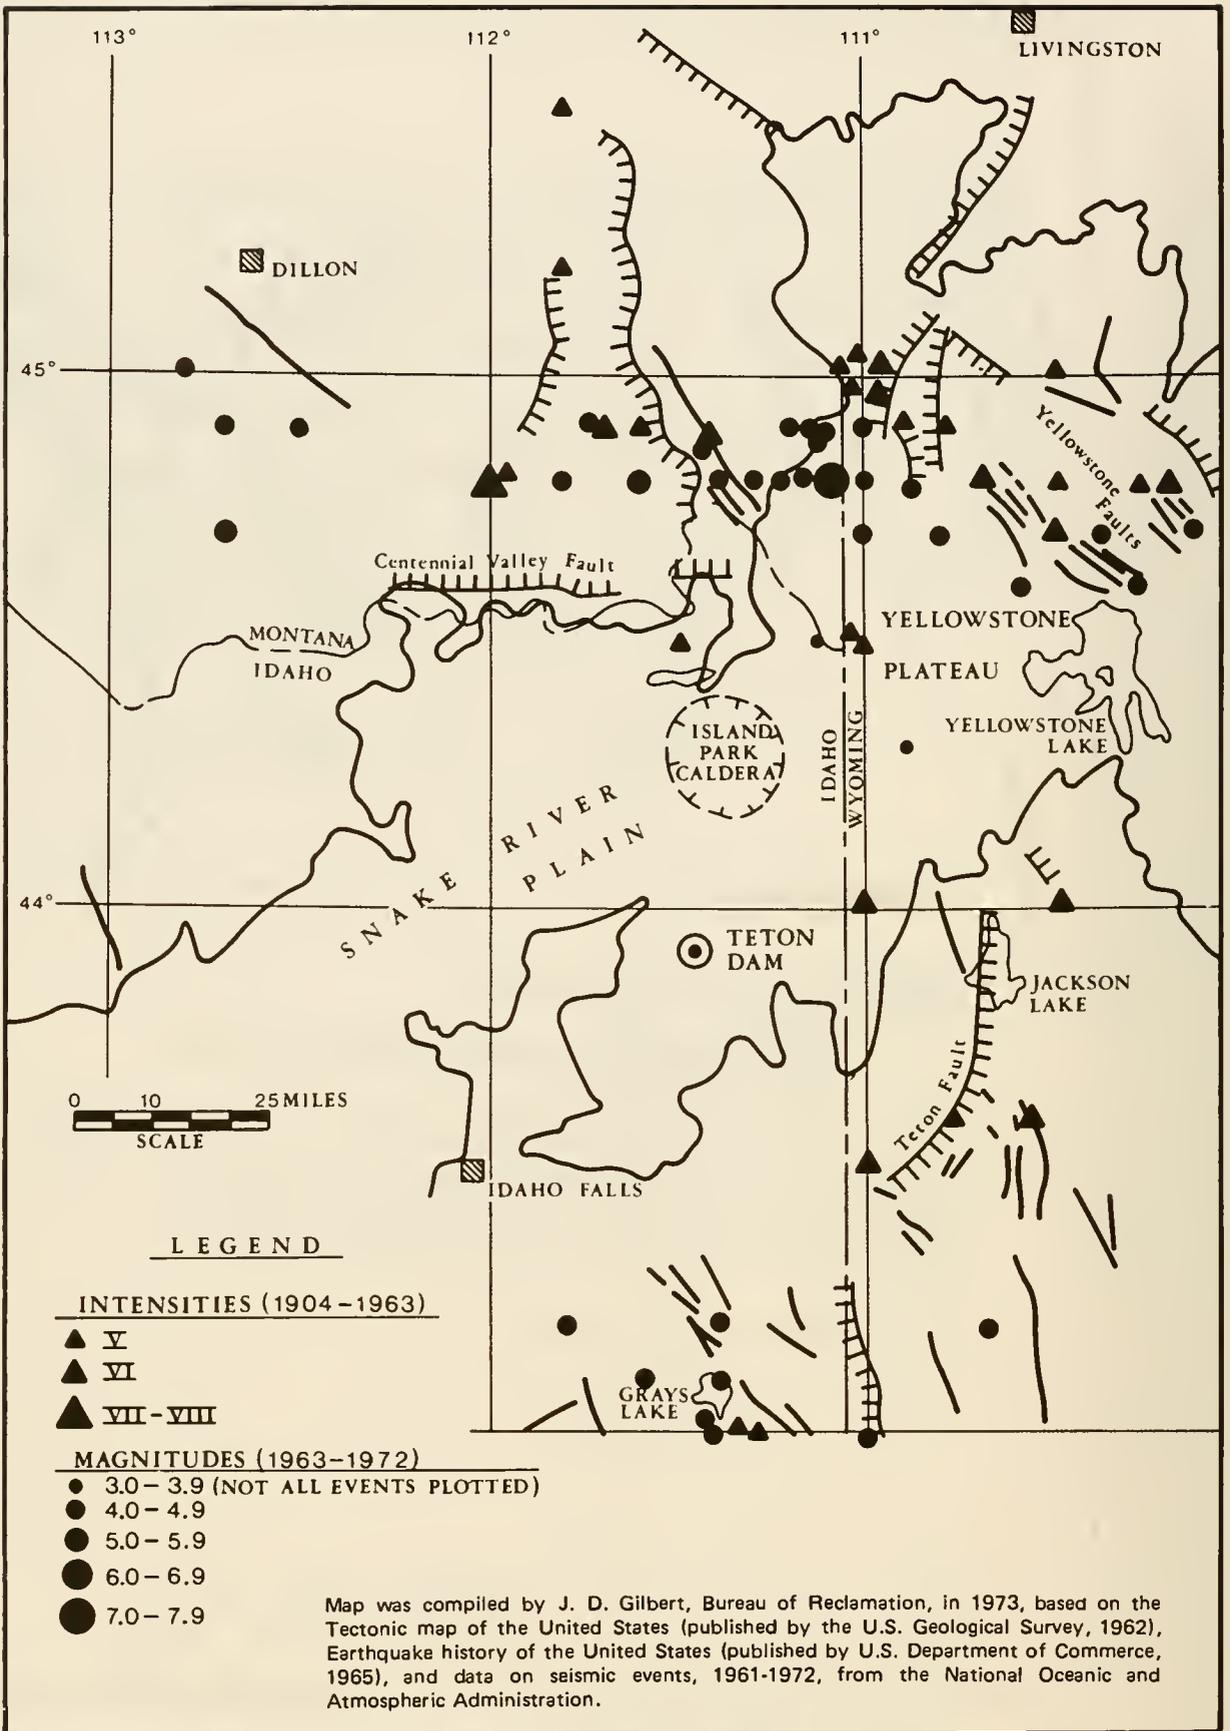
Figure 7.—Earthquake occurrence near the eastern Snake River Plain.

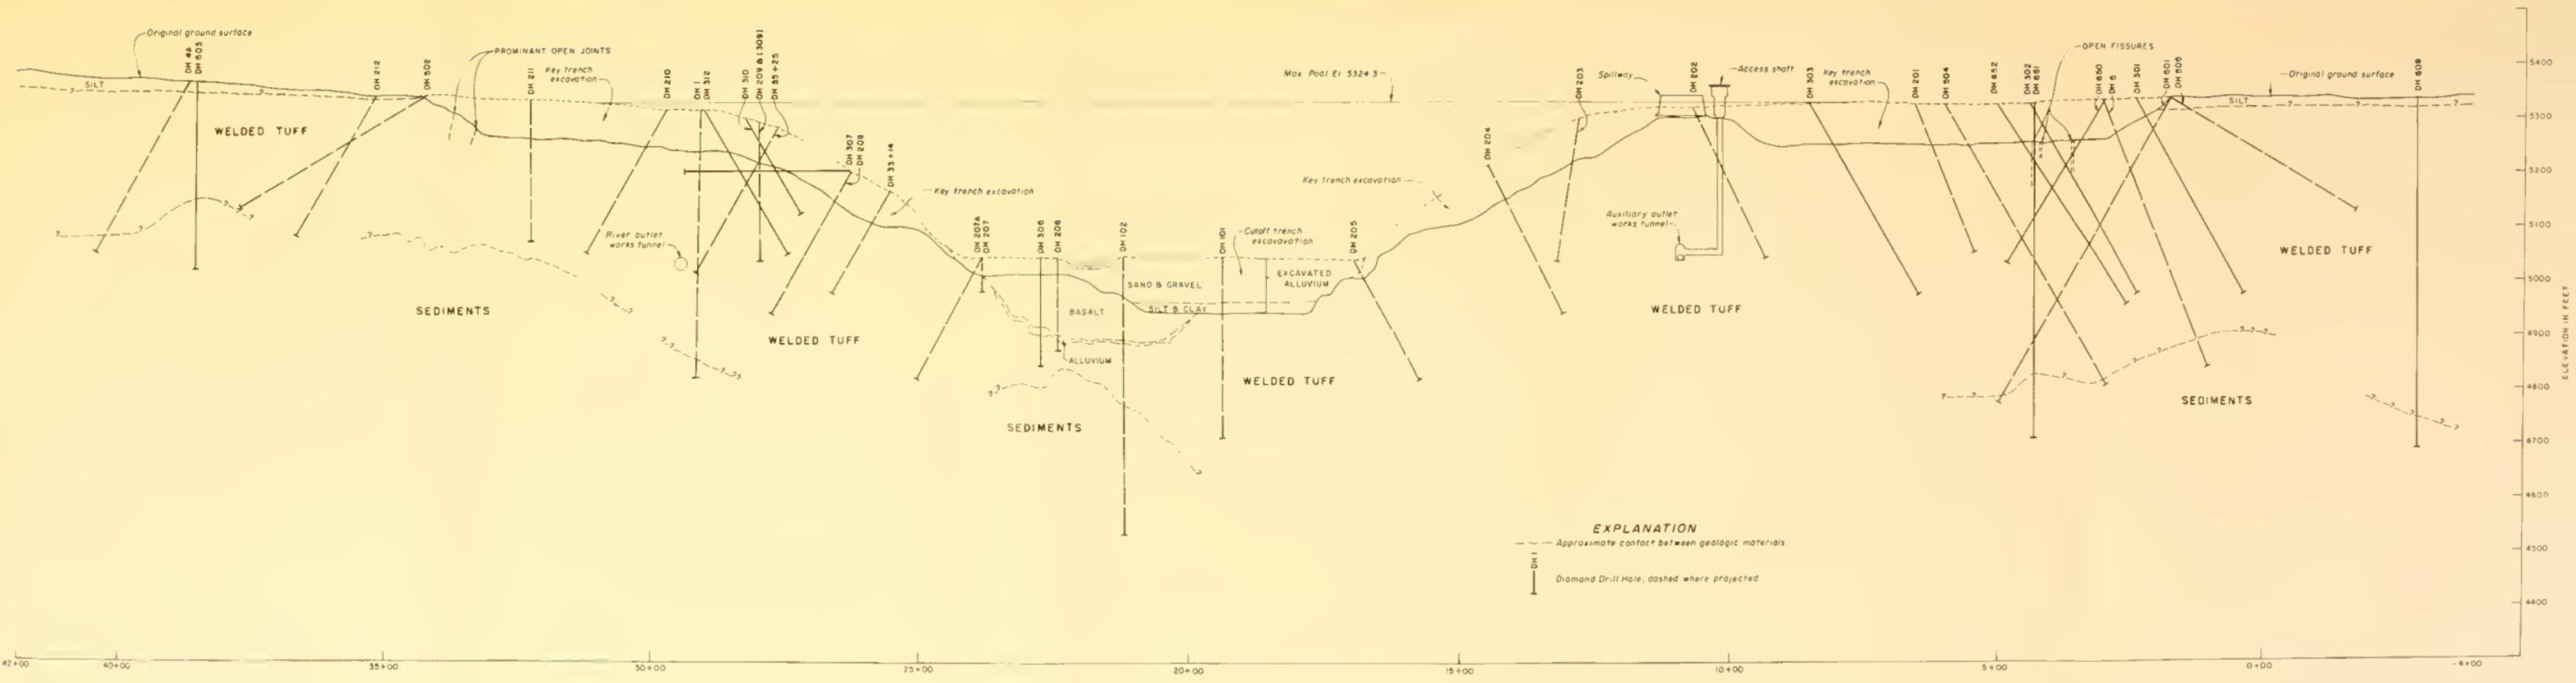
Figure 9 - Teton Dam - geologic profile on dam axis

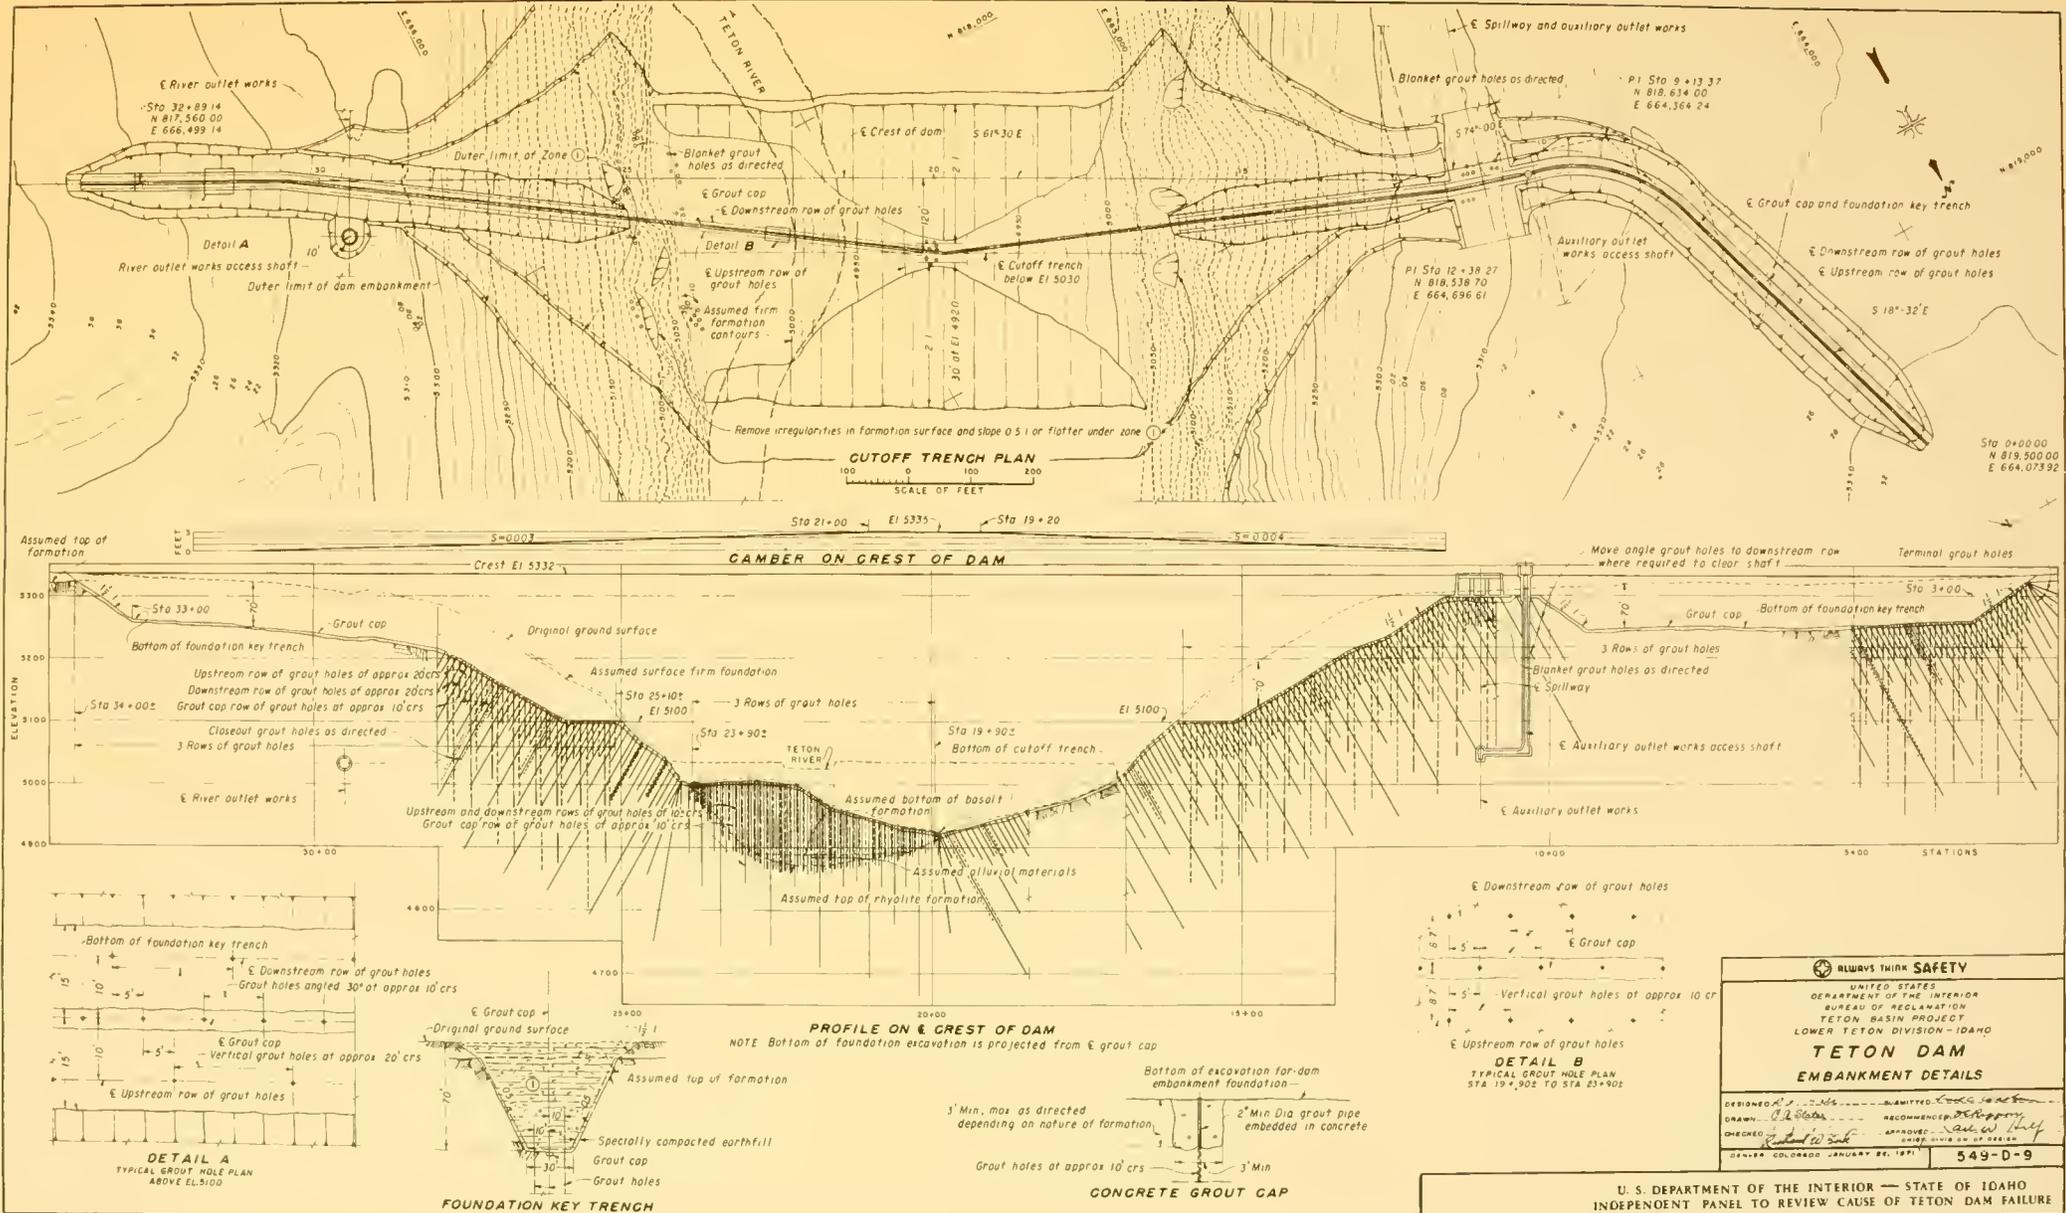
U. S. DEPARTMENT OF THE INTERIOR — STATE OF IDAHO  
INDEPENDENT PANEL TO REVIEW CAUSE OF TETON DAM FAILURE

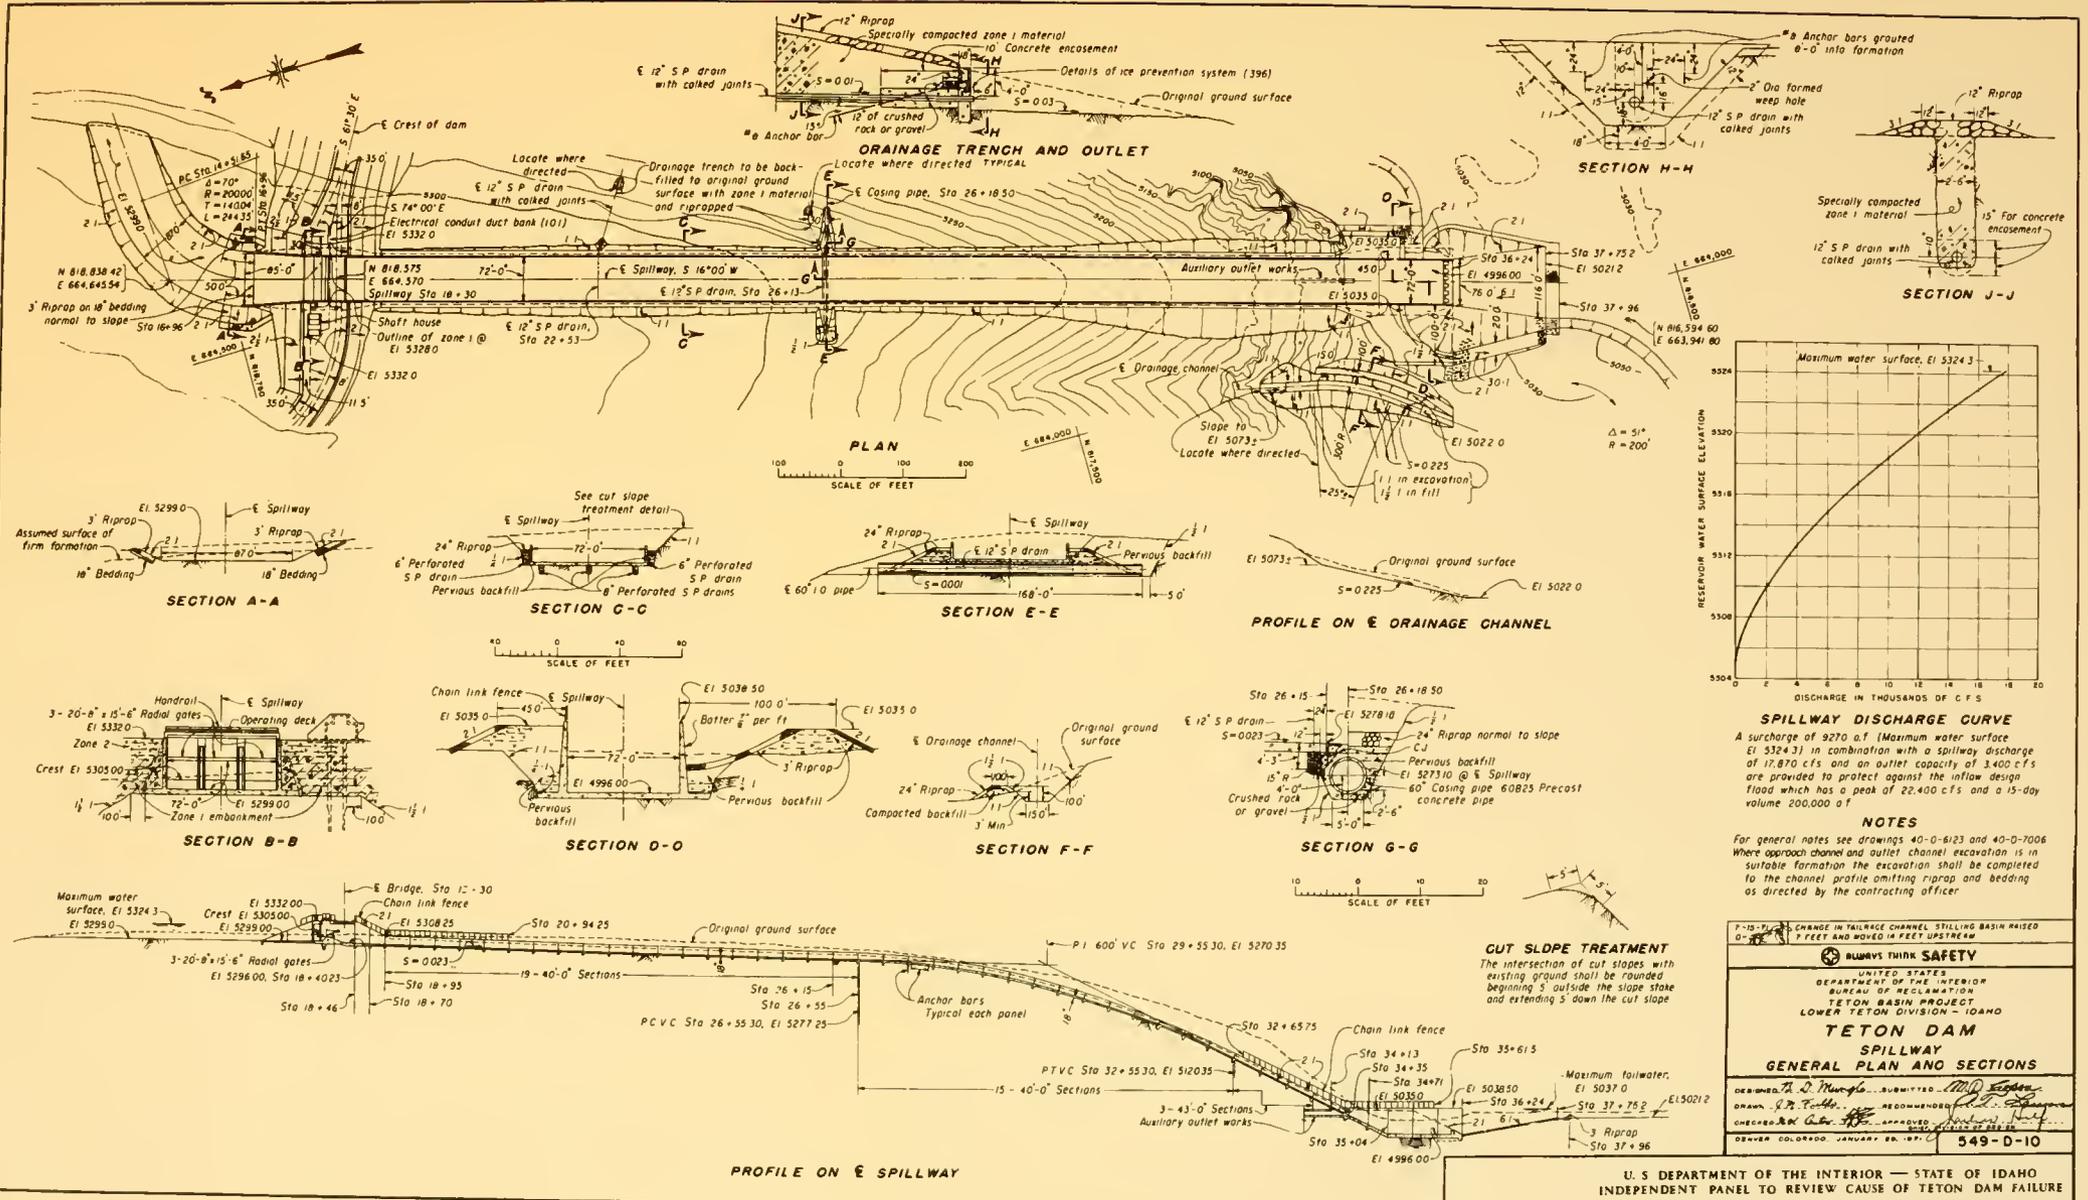
Figure 12.—Teton Dam—spillway.

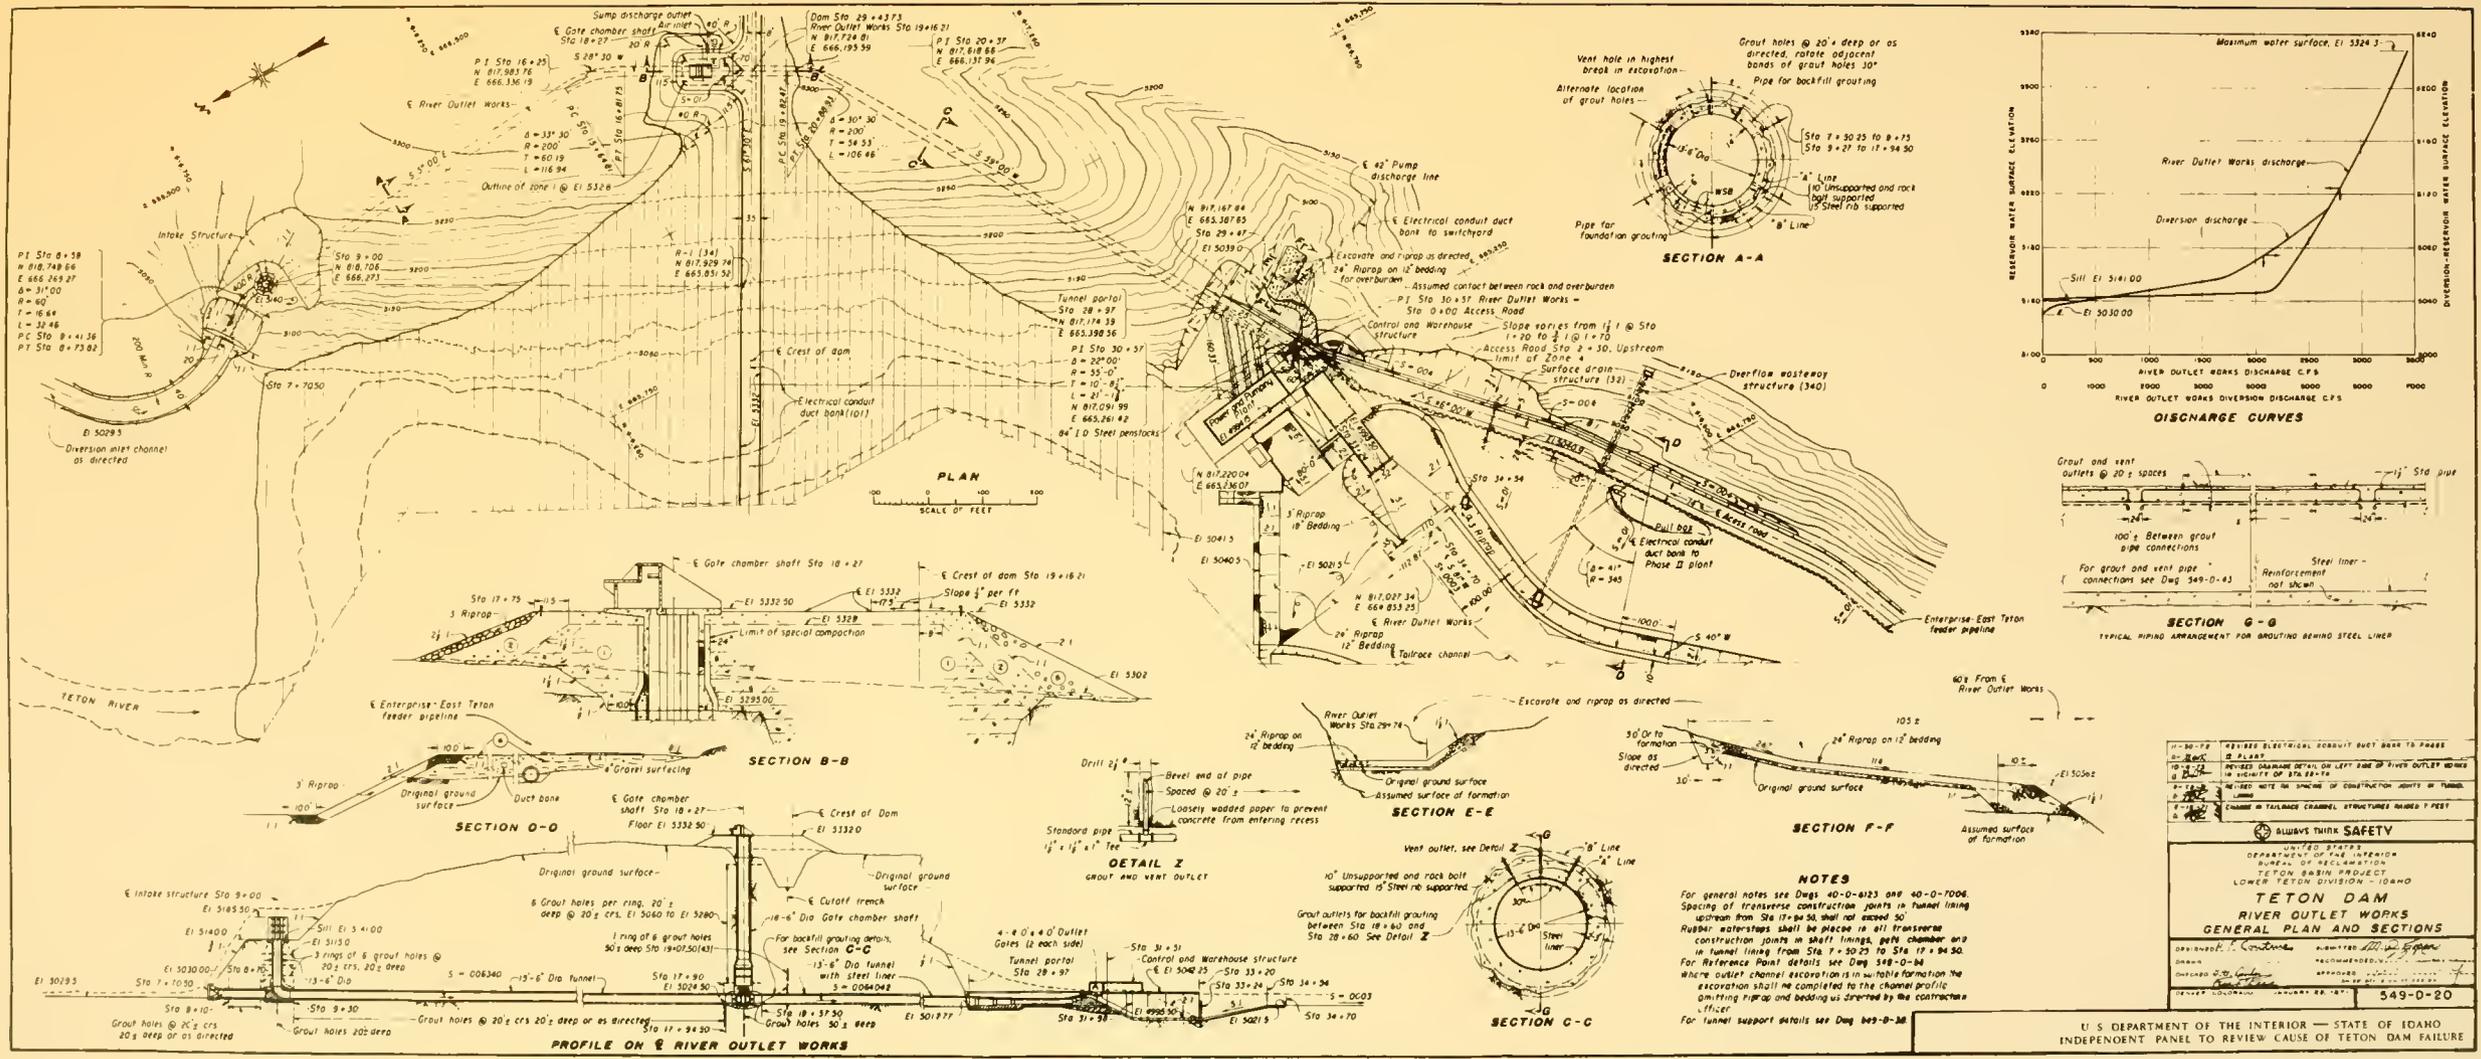
Figure 14.-Teton Dam-river outlet works
