603  
I 1.2'  
T29/2

BOSTON PUBLIC LIBRARY  
3 9999 06317 343 7

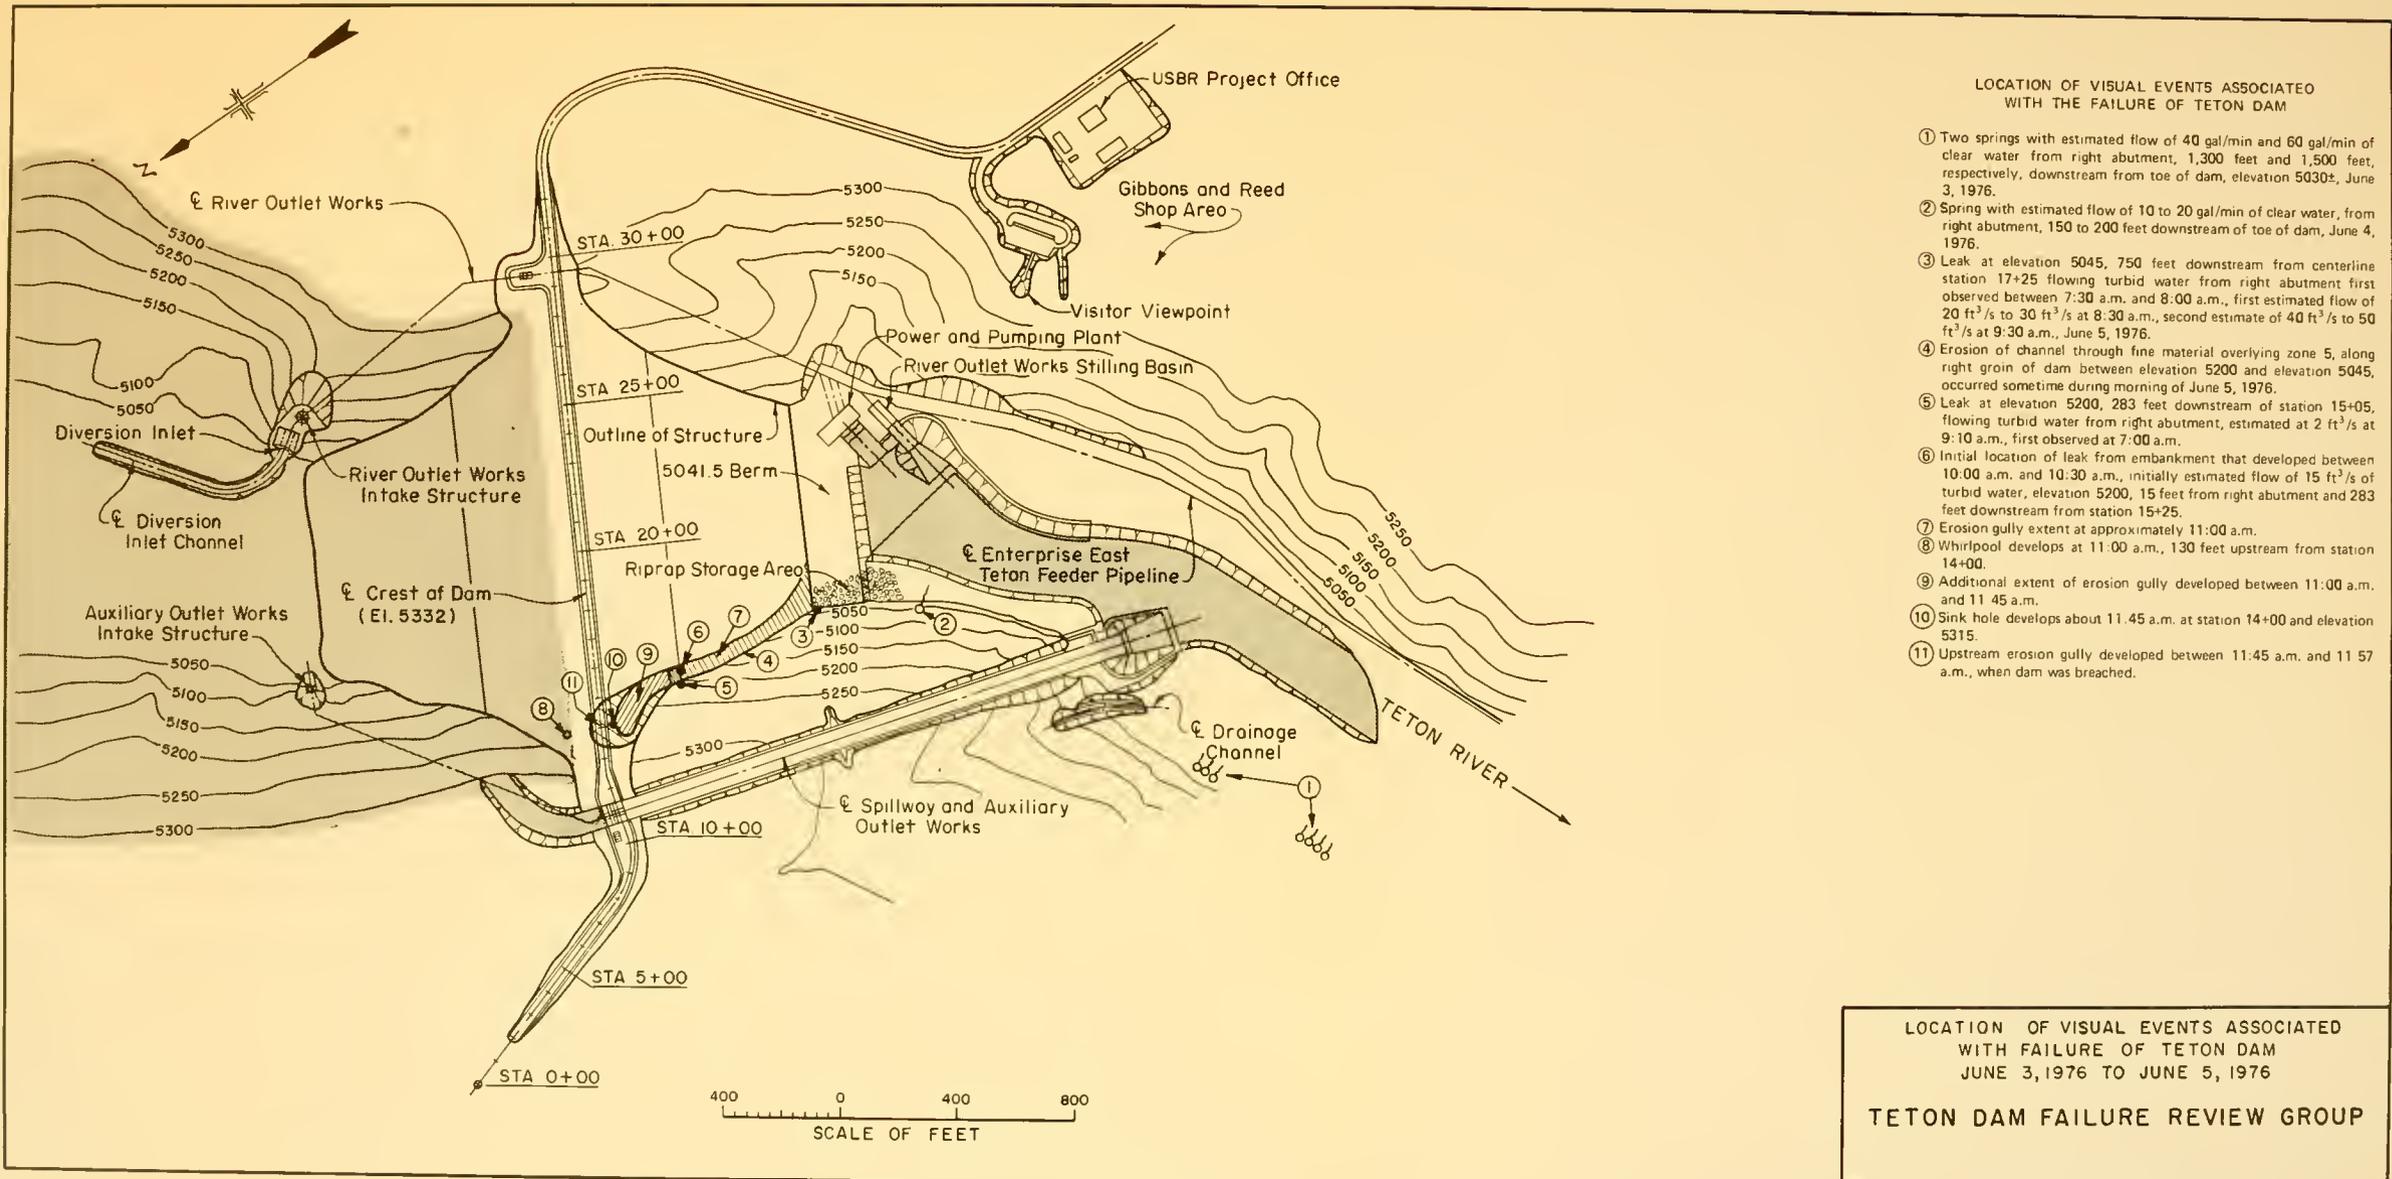
LOCATION OF VISUAL EVENTS ASSOCIATED WITH THE FAILURE OF TETON DAM

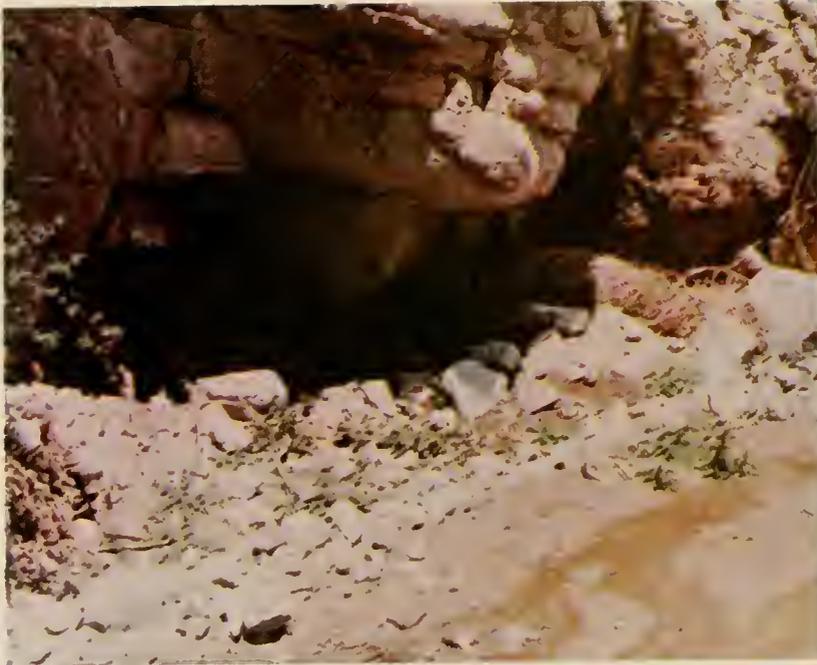
Figure 17.—North canyon wall about 1300 feet downstream from Teton Dam. Clear water from several small seeps flowing about 60 gpm, June 3, 1976.

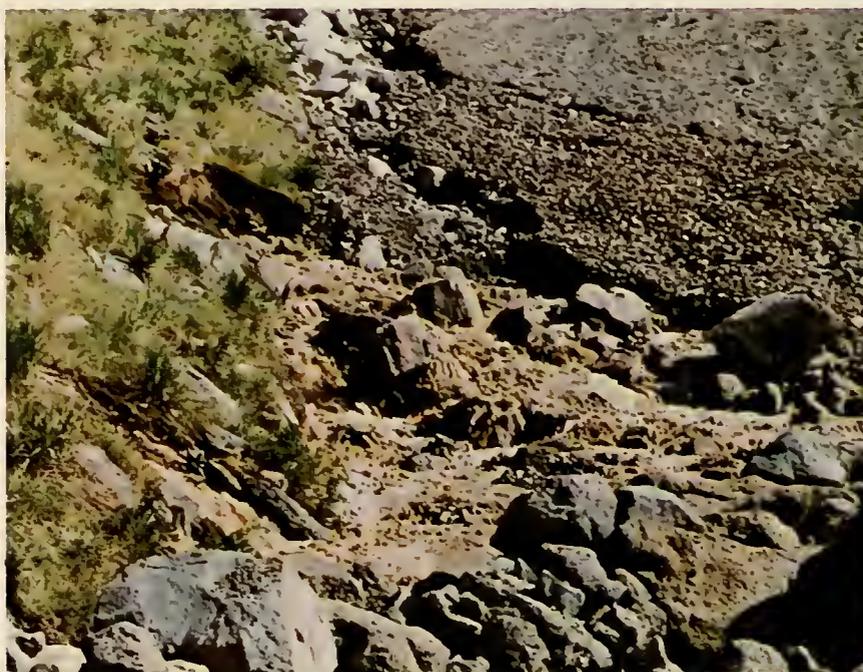
Figure 20.—Closeup of leak shown on Figure 19.

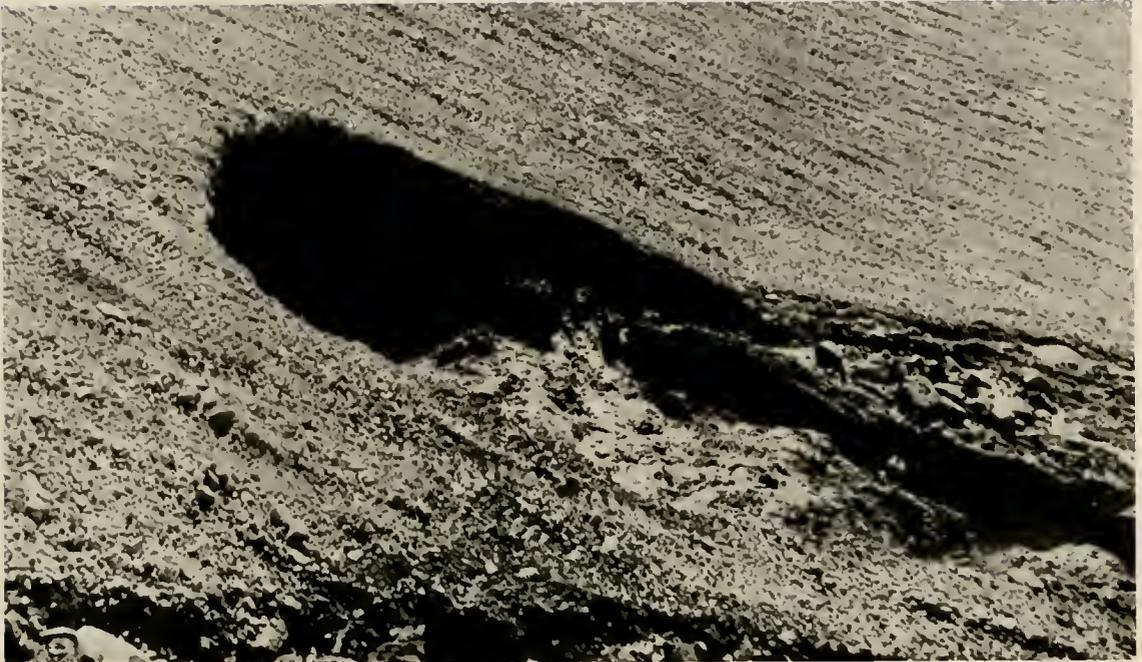
Figure 21.—Closeup of leak at El. 5200 near right abutment. About 10:30 a.m., June 5, 1976.

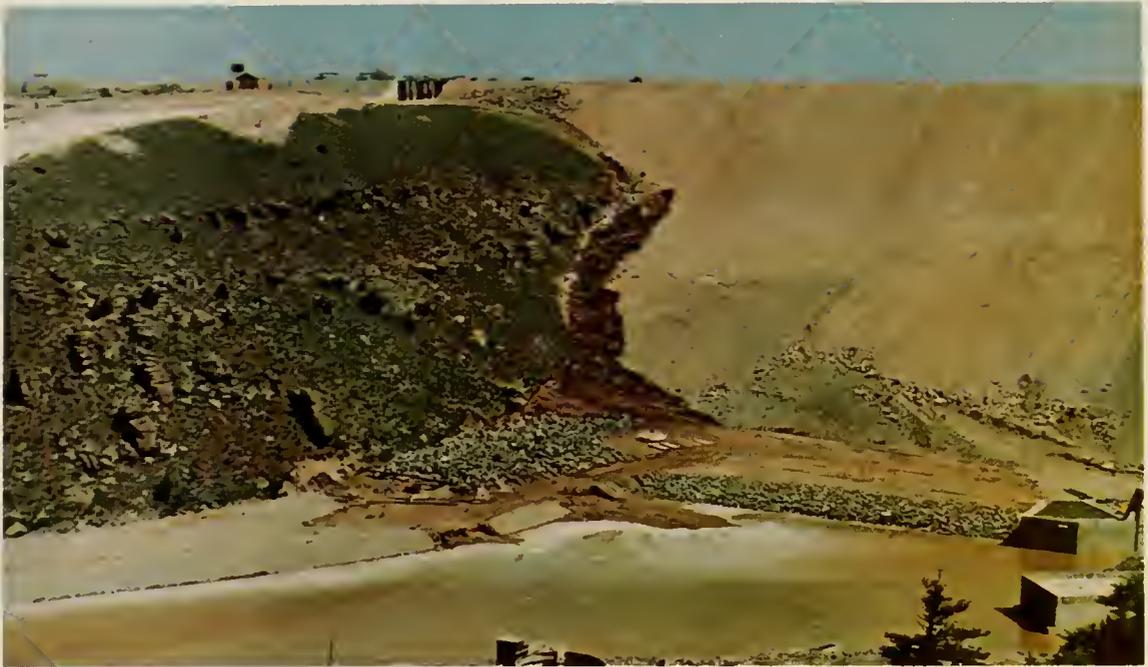
Figure 22.—Flow increasing from leak at El. 5200.

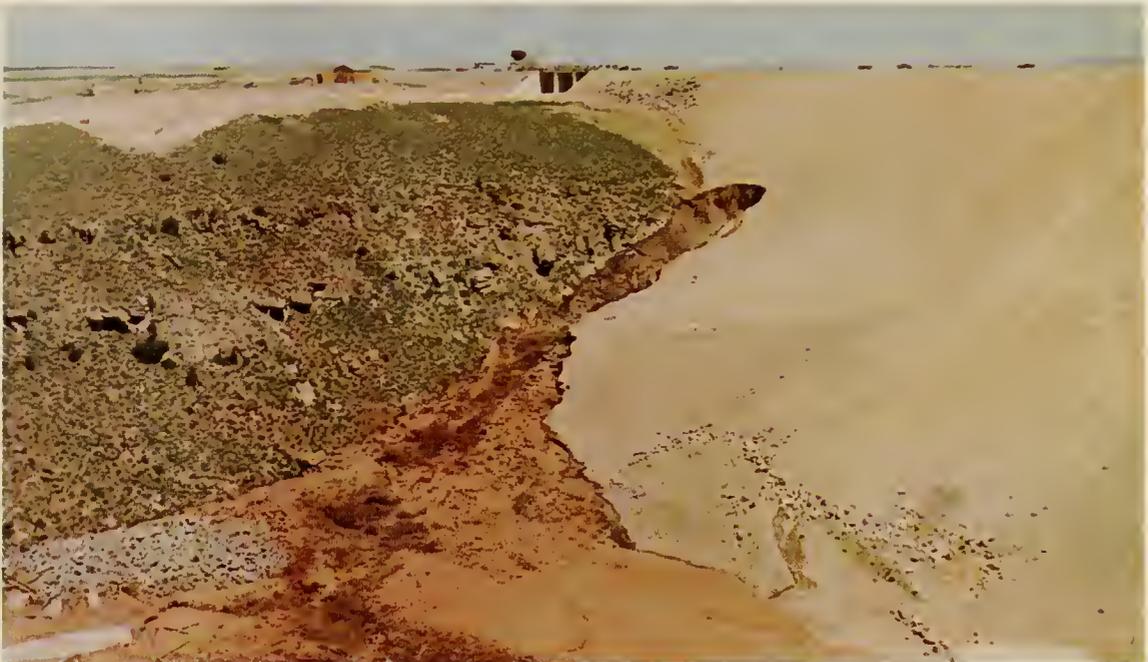
Figure 23.—Dozers lost in leak at El. 5200.

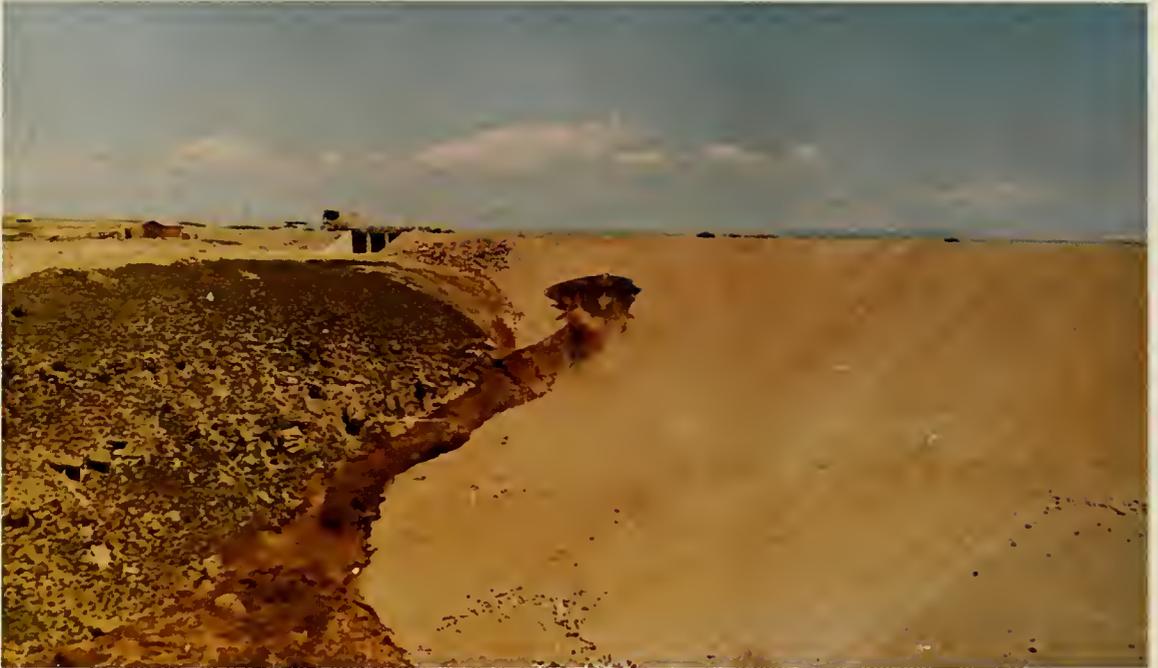
Figure 24.—Approximately 11:30 a.m., June 5, 1976.

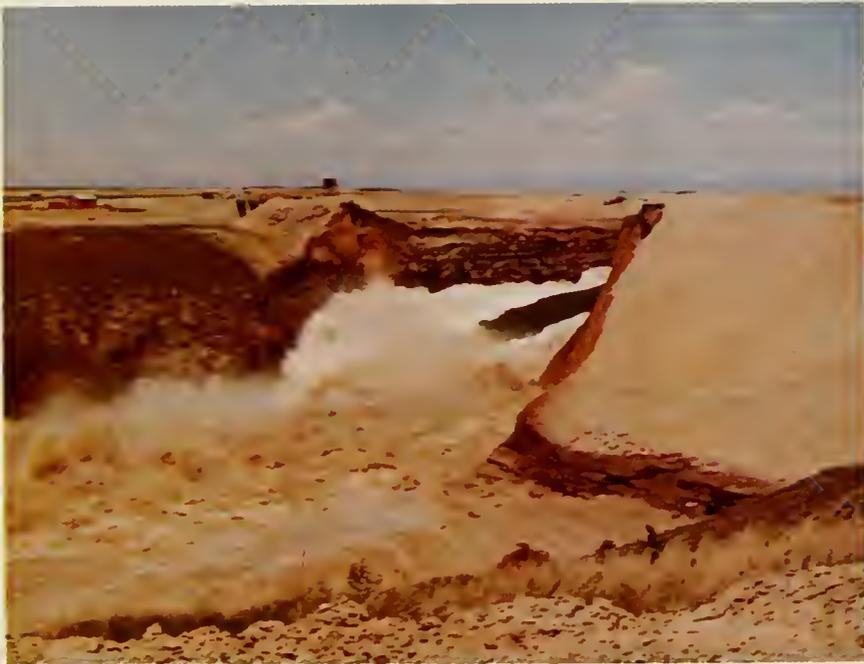
Figure 28.—Early afternoon, June 5, 1976.

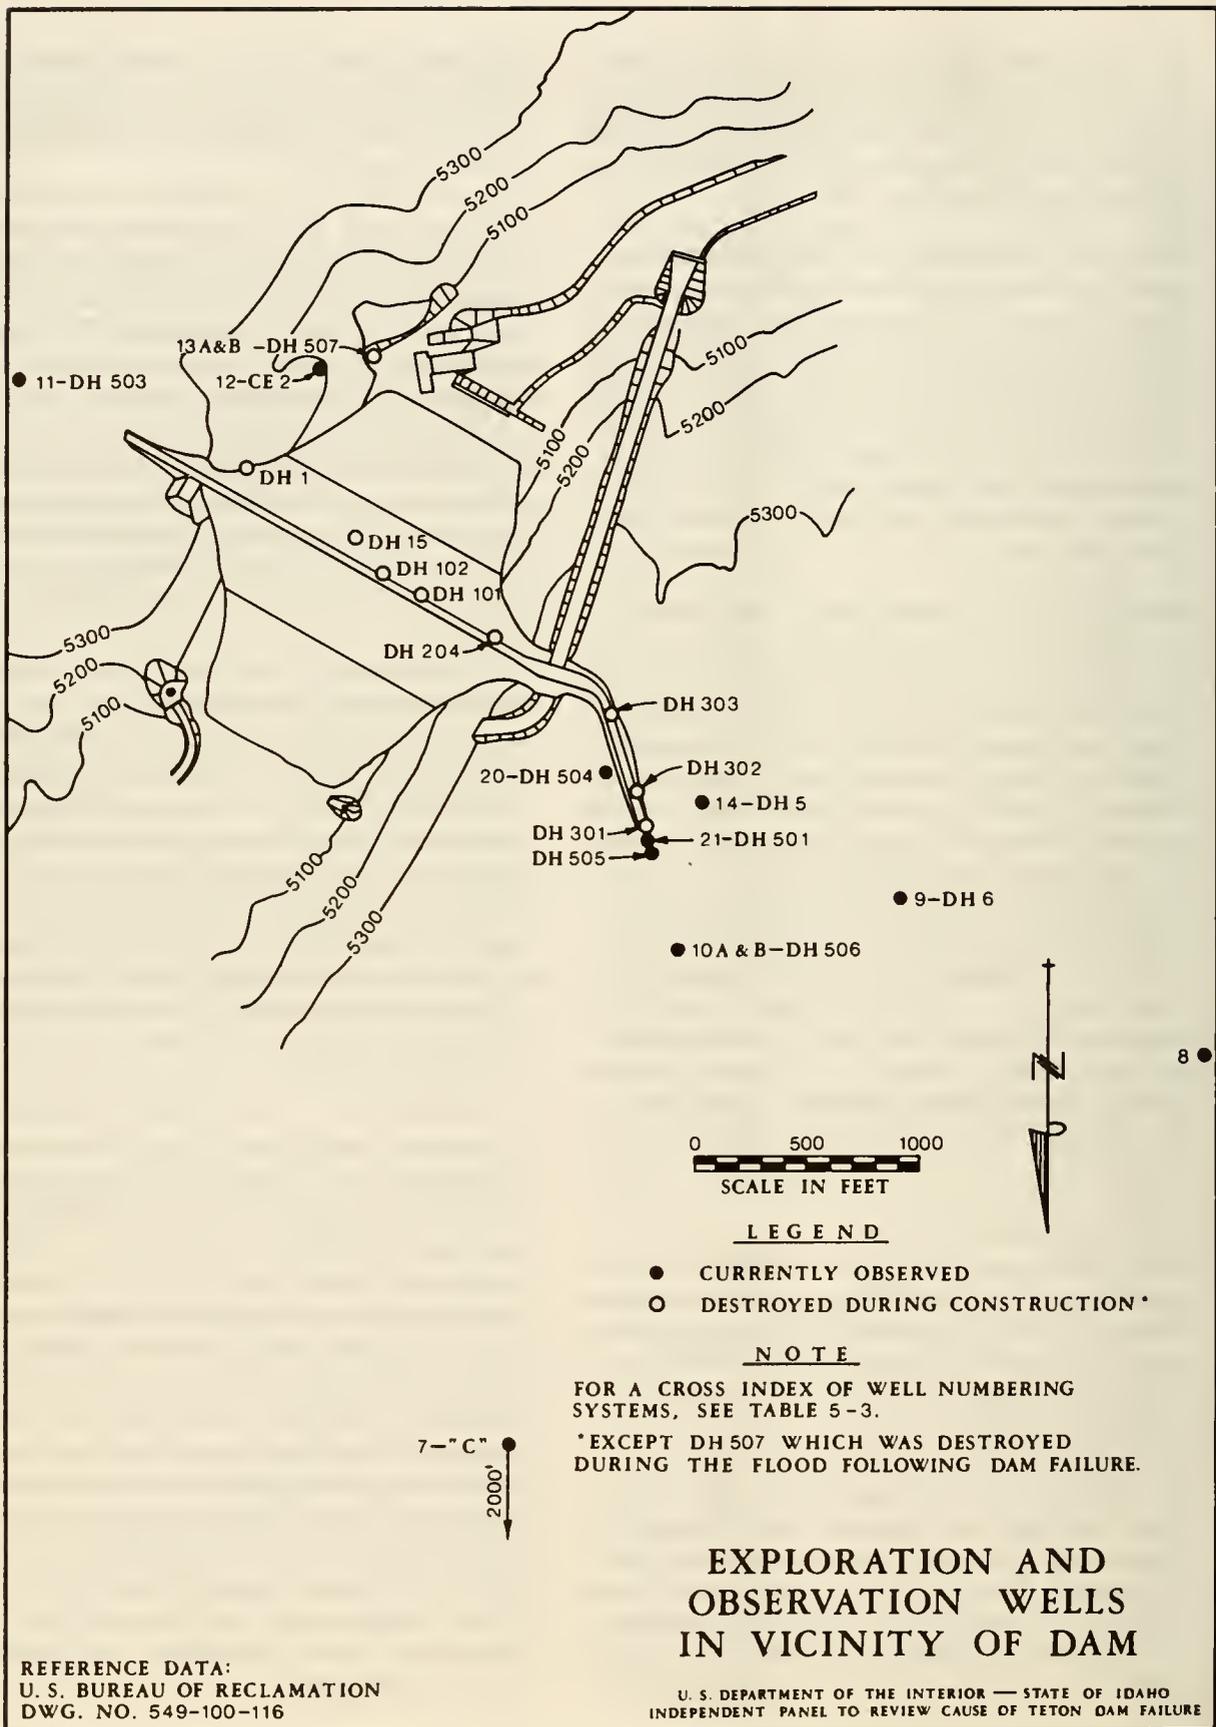
Figure 29.—Location of exploration and observation wells in the vicinity of Teton Dam.

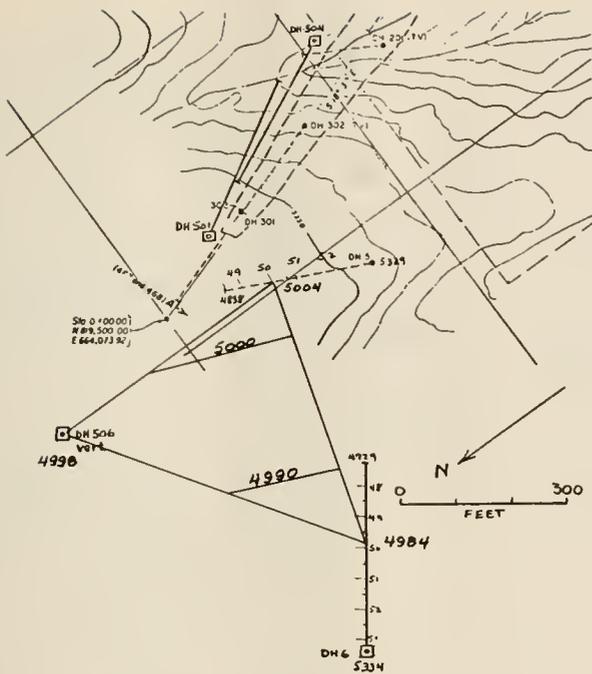
*Curtain Grouting.*—A pilot grouting program was instituted in 1969 to determine the groutability of the basalt in the canyon floor, the alluvial material below the basalt, and the welded tuff in the abutments. Bids were let for the injection of an estimated 260,000 cubic feet of grout in the testing program. More than twice that amount was pumped during the course of the pilot grouting program.

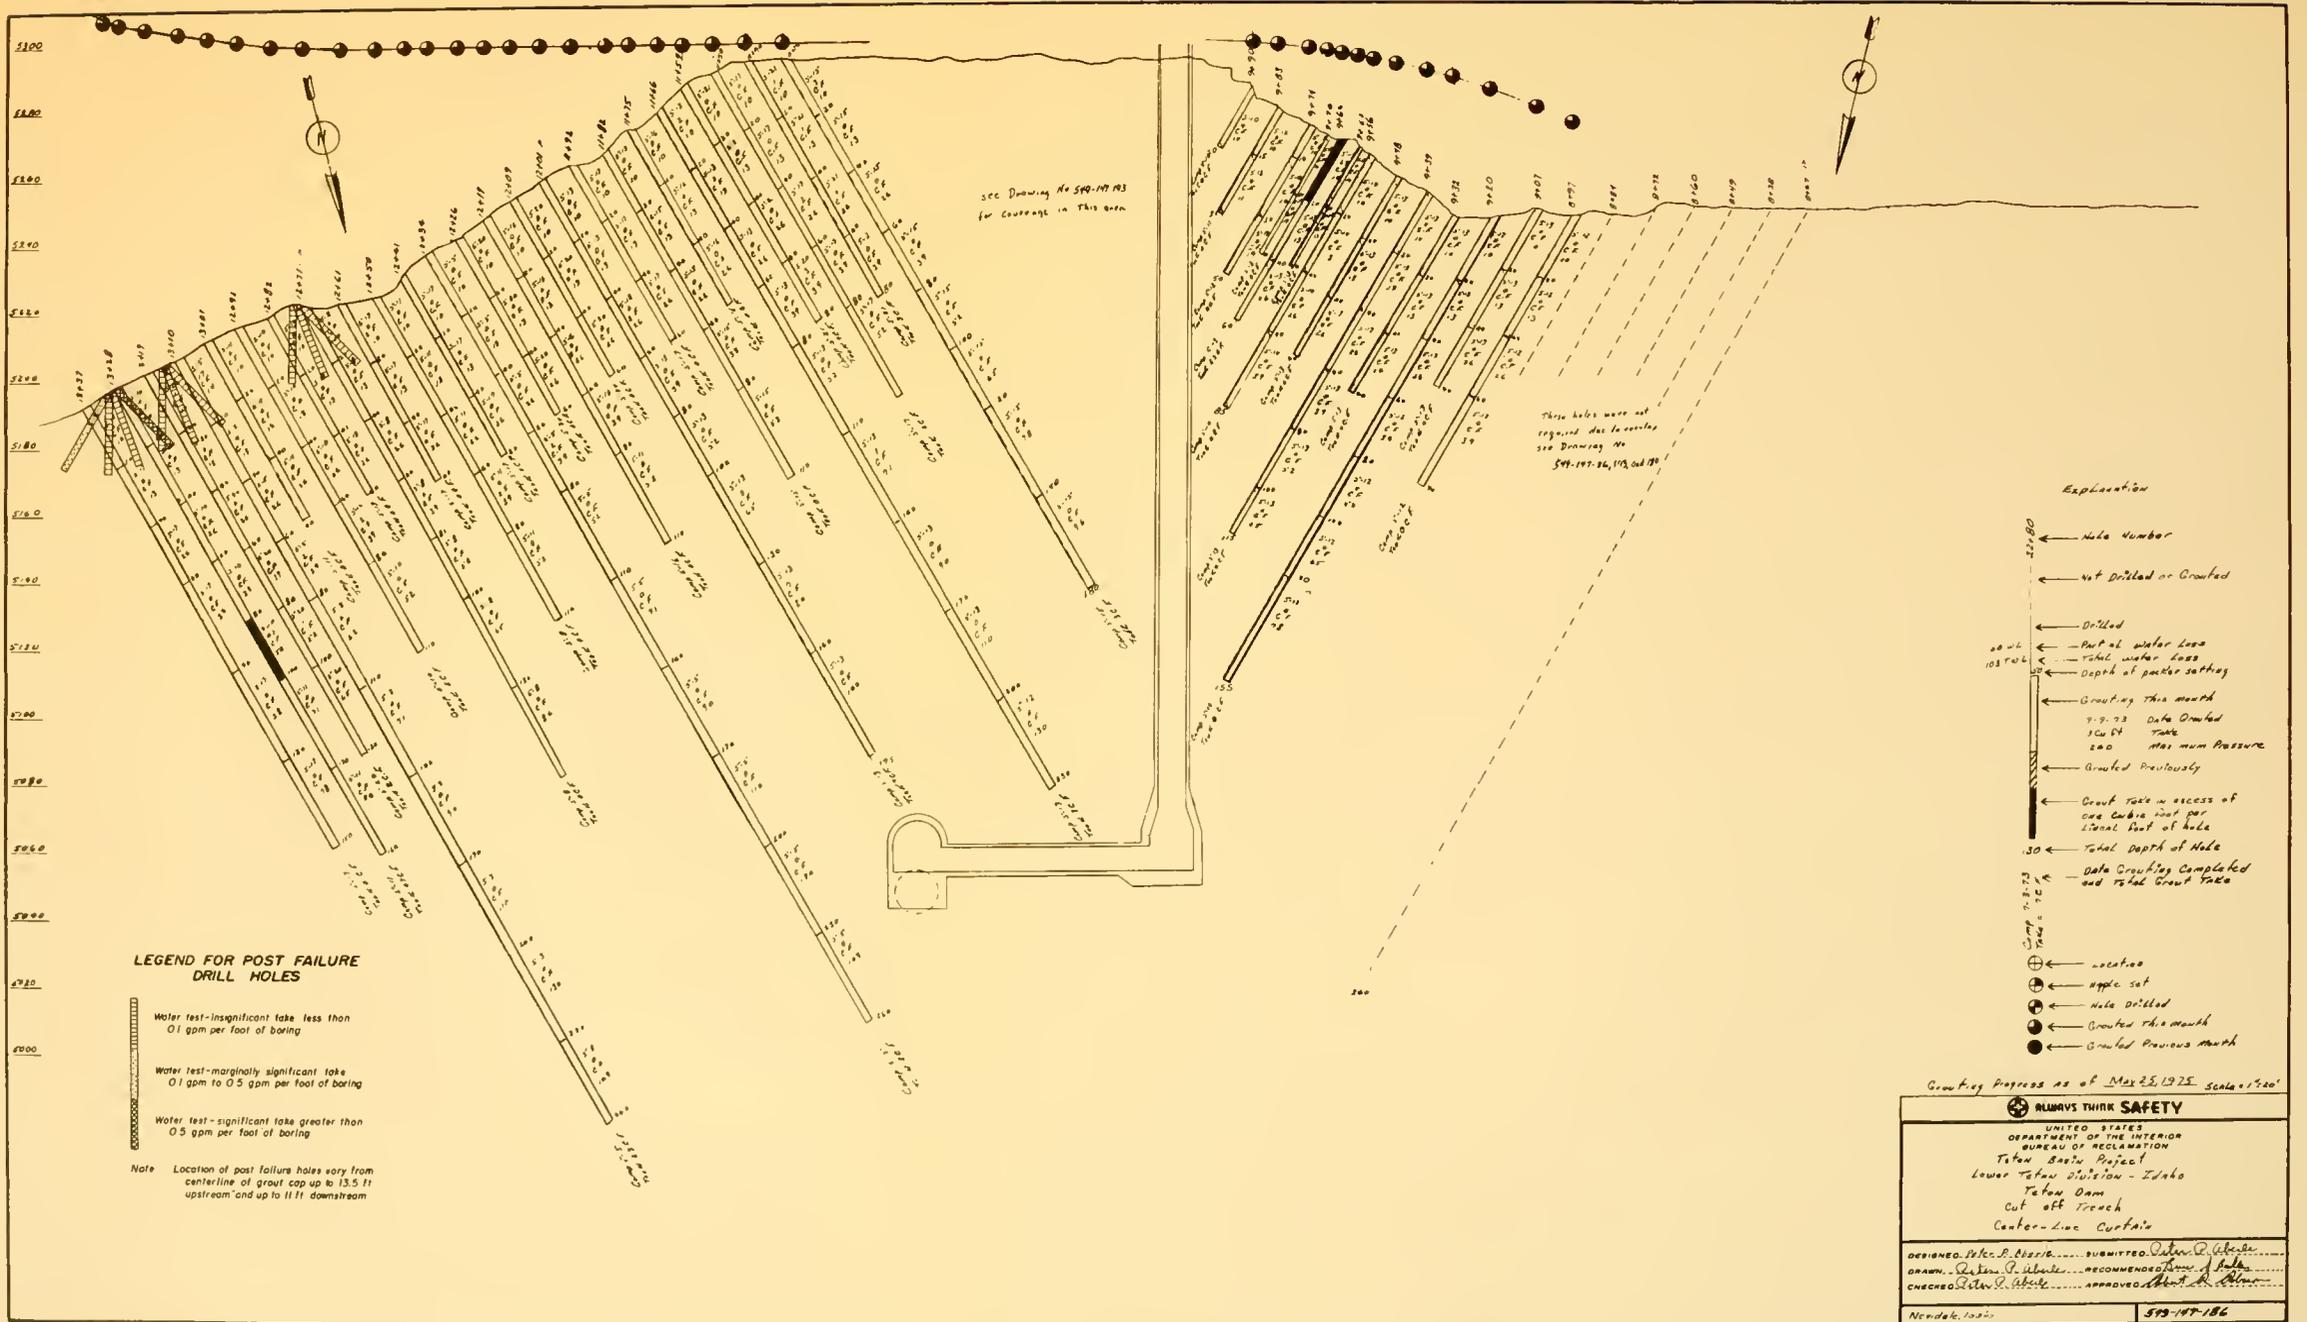
Figure 33.—Details of the right abutment centerline grout curtain including postfailure core borings (sheet 1 of 3).

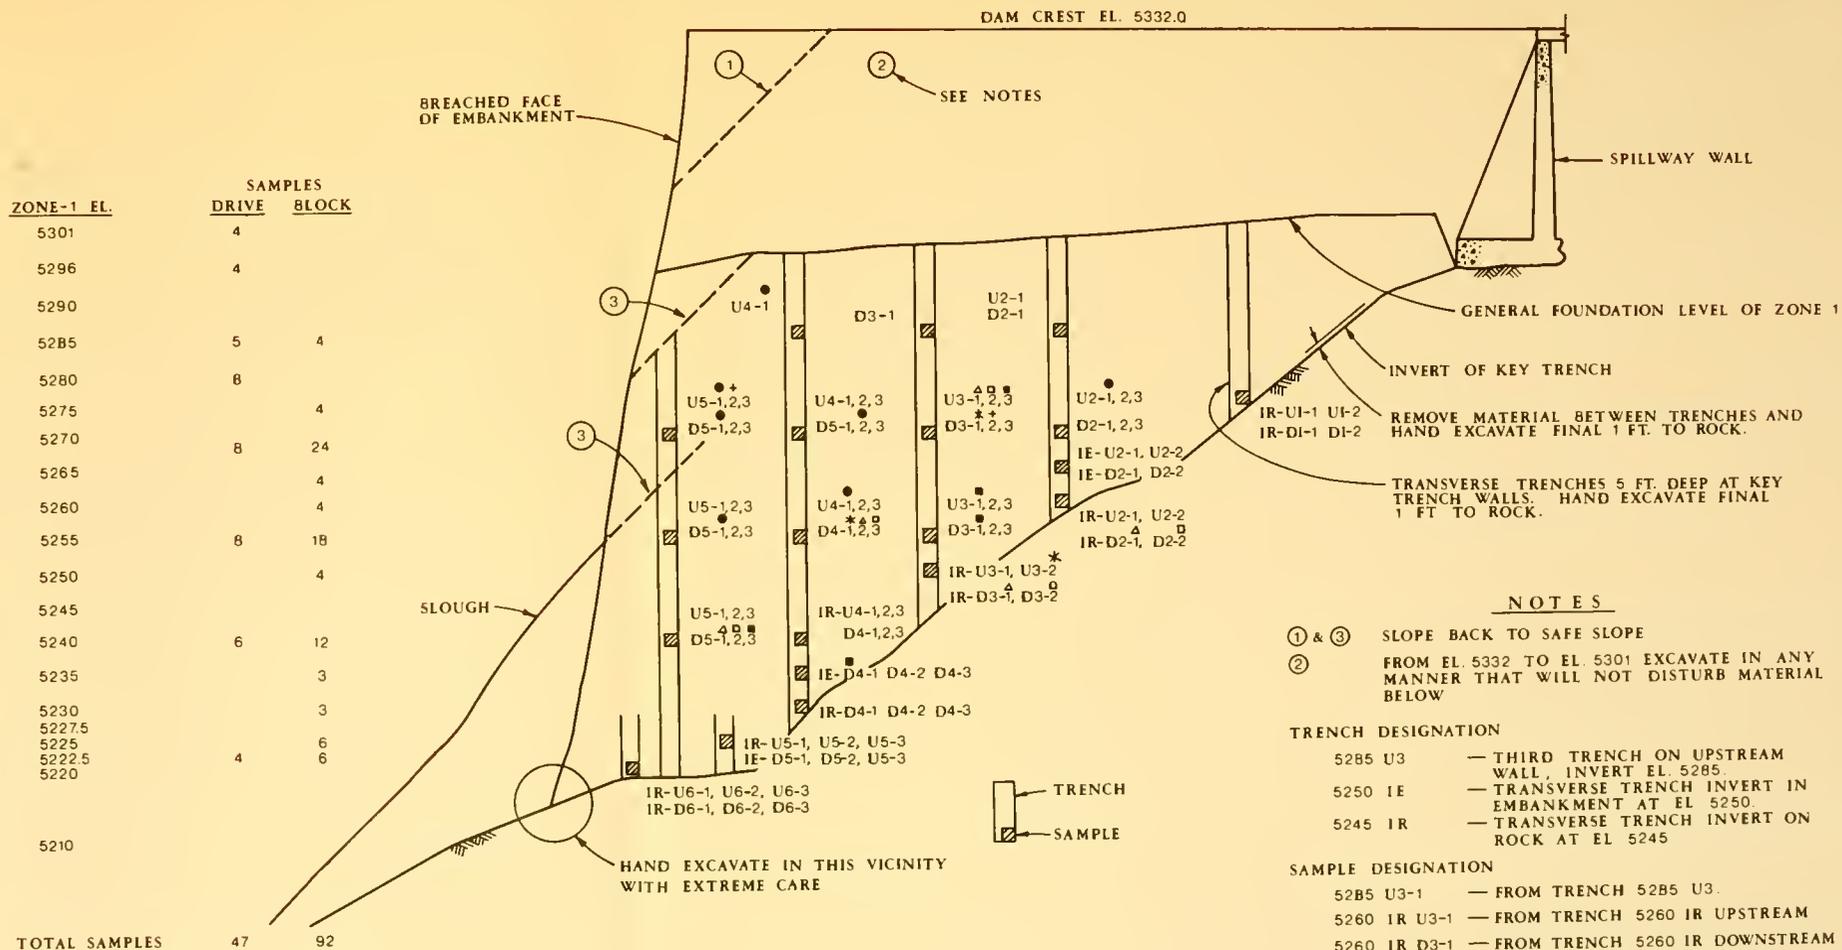
At El. 5265, near-vertical cracks roughly paralleling the breach face were encountered in the fill approximately 12 feet from the breach face. The cracks were as much as 2 inches wide and some were filled with water-borne sediment. A crack and sheared zone adjacent to the breach face extended to the bottom of the key trench as the excavation progressed. It was concluded that this disturbance was the result of postfailure movement; however, it did demonstrate the cracking potential of the fill.

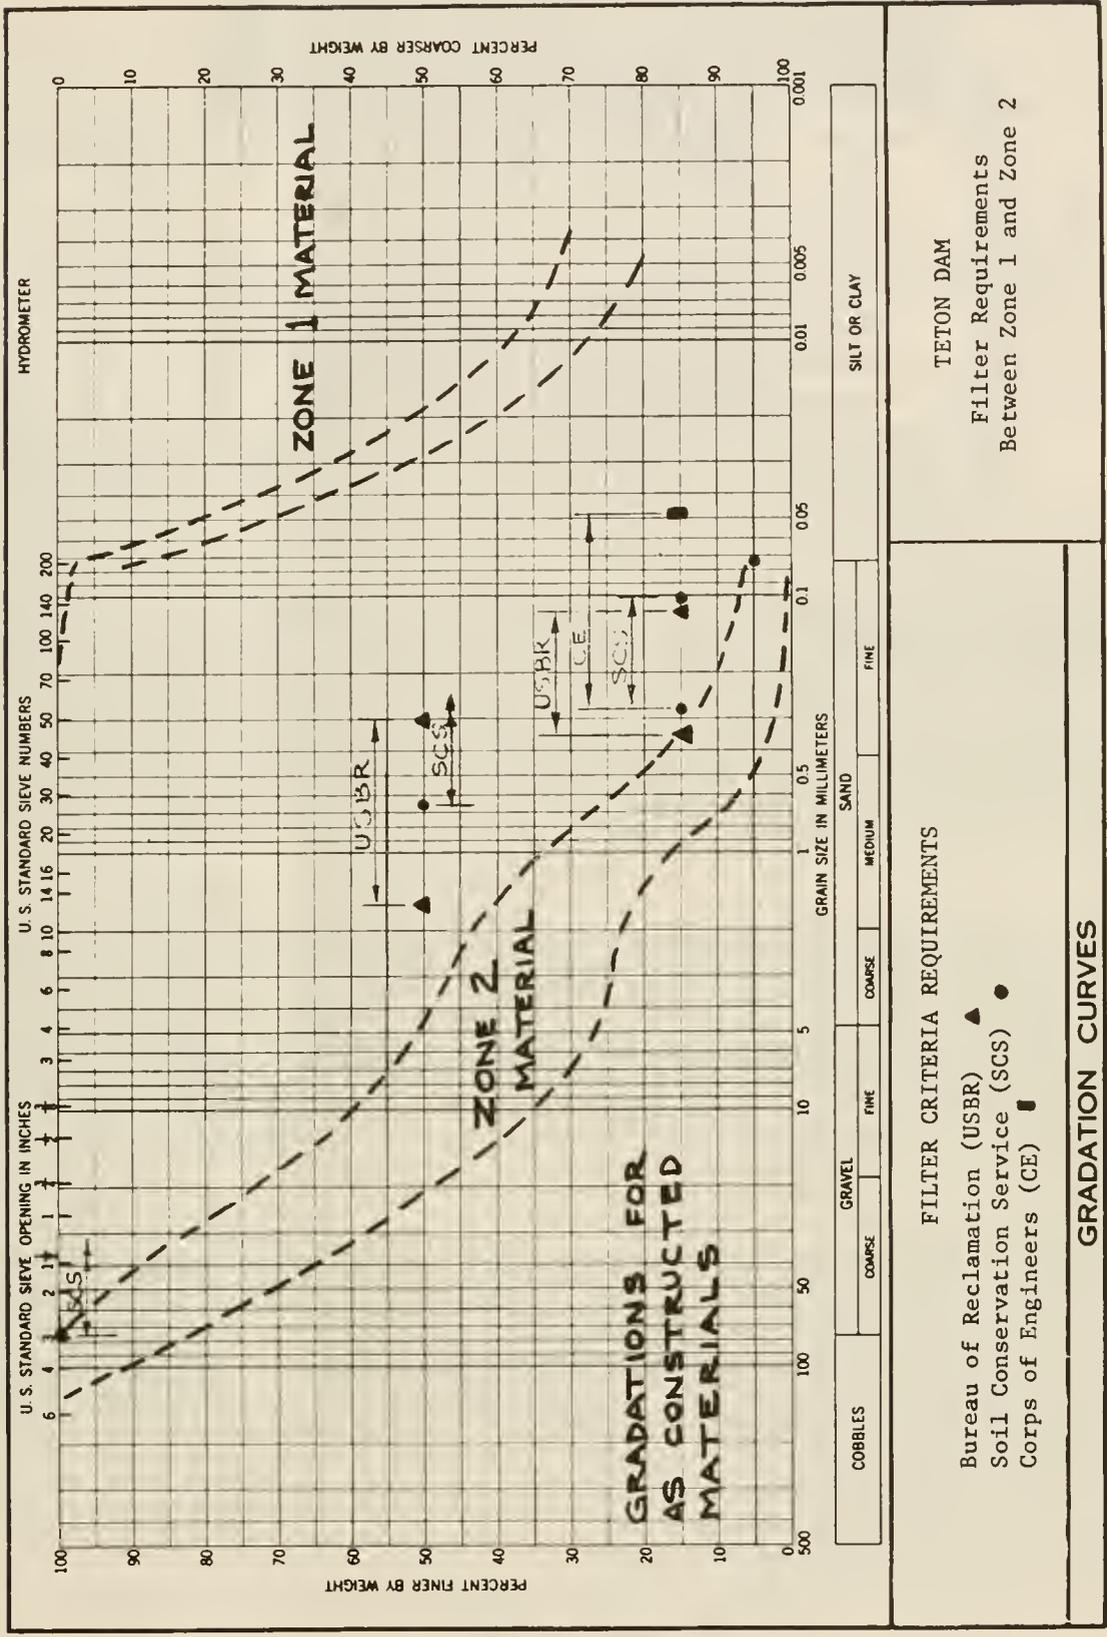
Figure 36.—Filter requirements between zone 1 and zone 2.

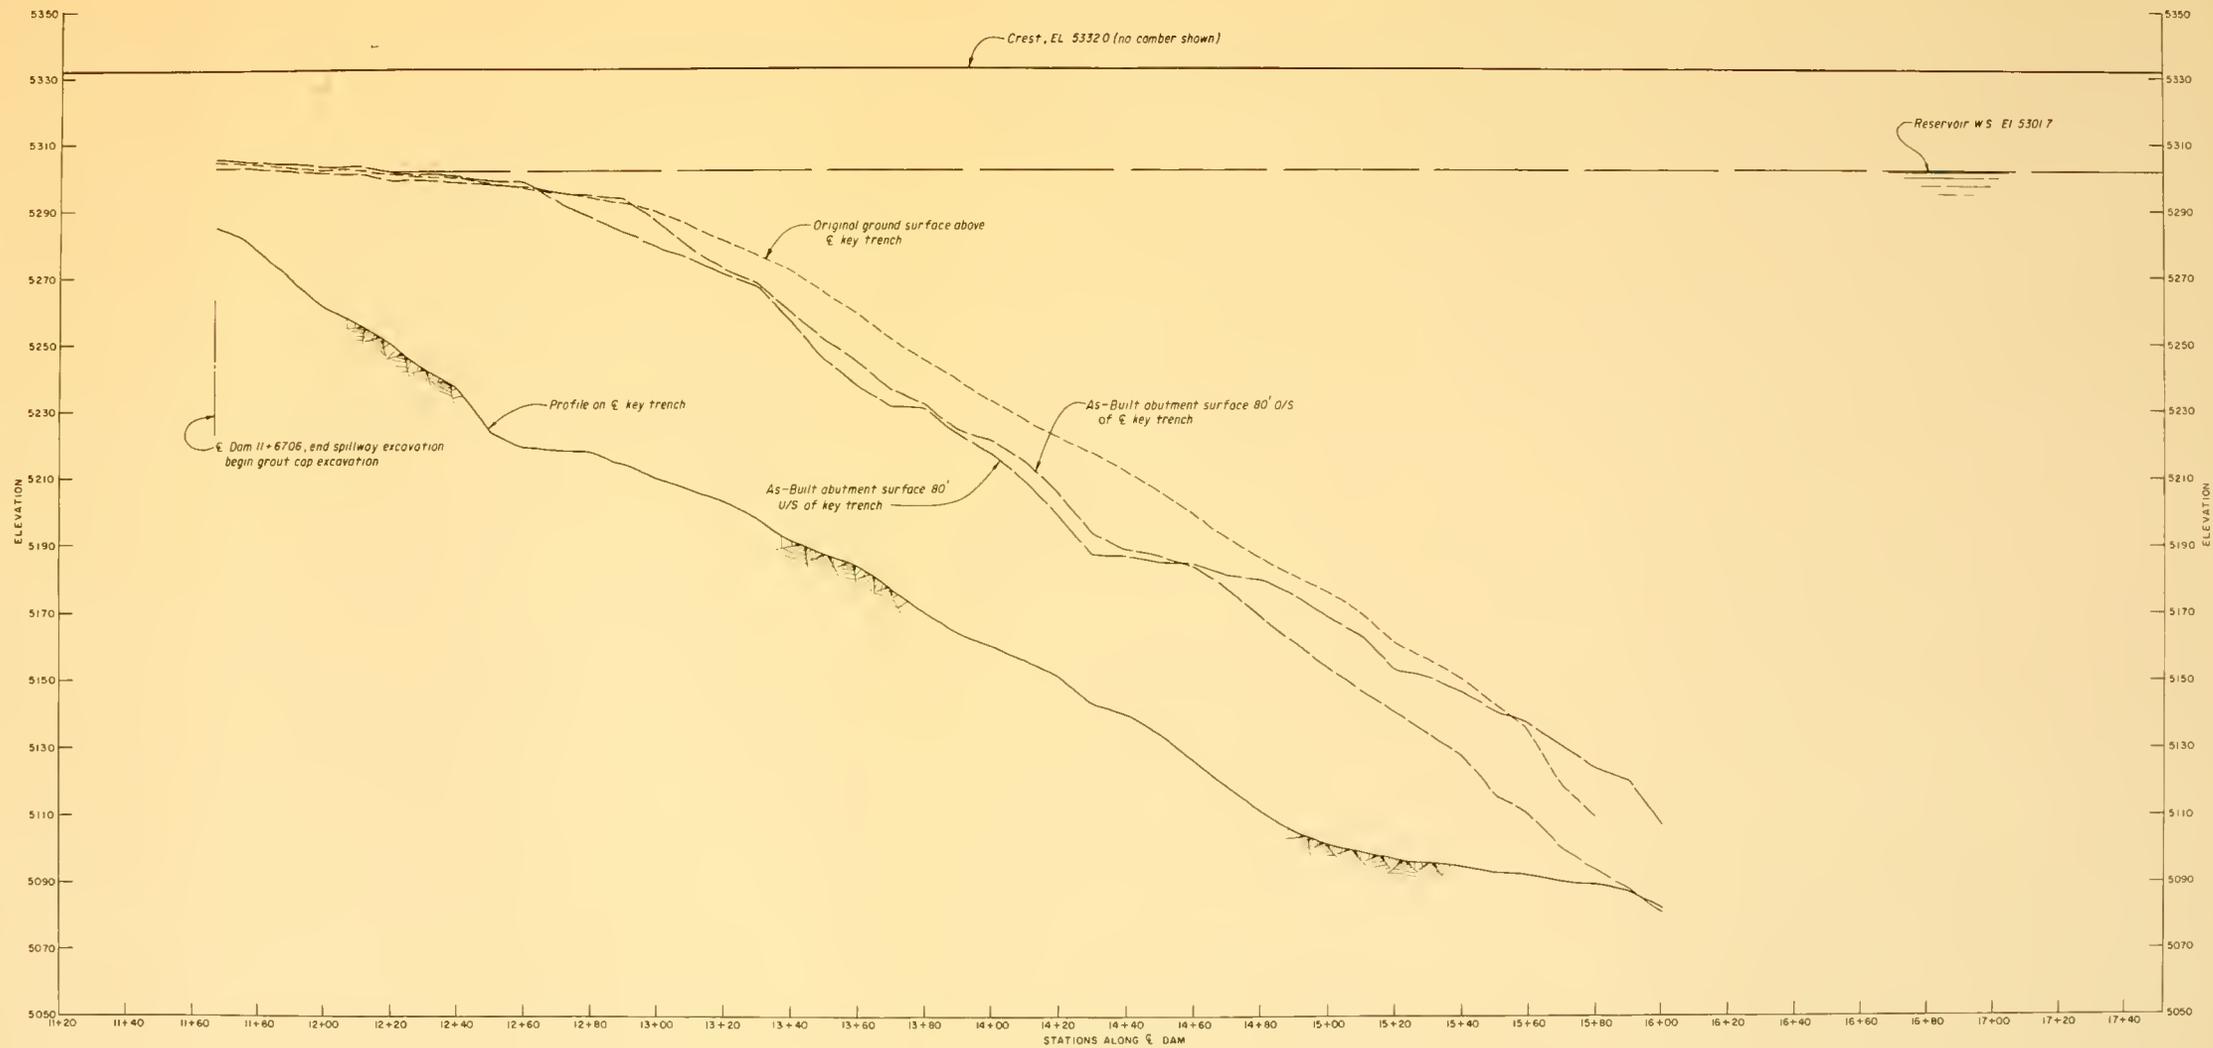
**TETON DAM**  
 PROFILES ALONG C OF RT. ABUTMENT  
 KEY TRENCH AND U/S AND O/S  
 ABUTMENT SURFACE

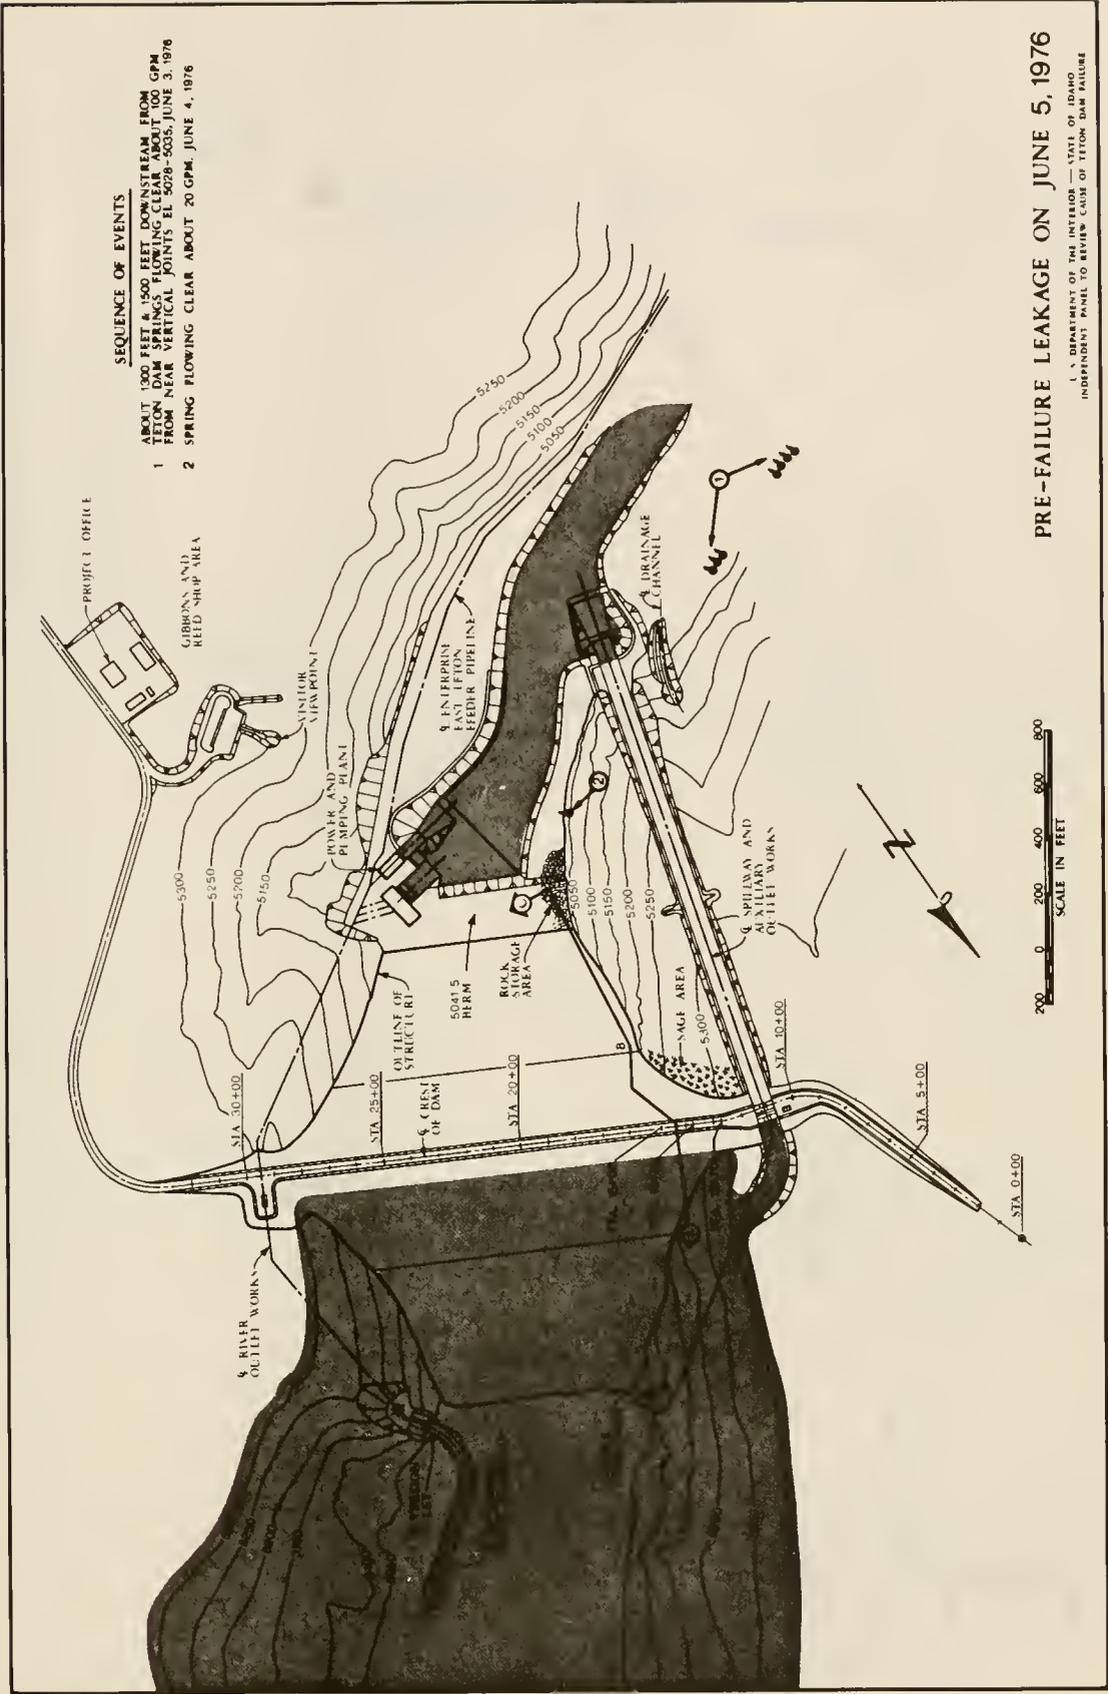
Figure 39.—Pre-failure leakage June 5, 1976.

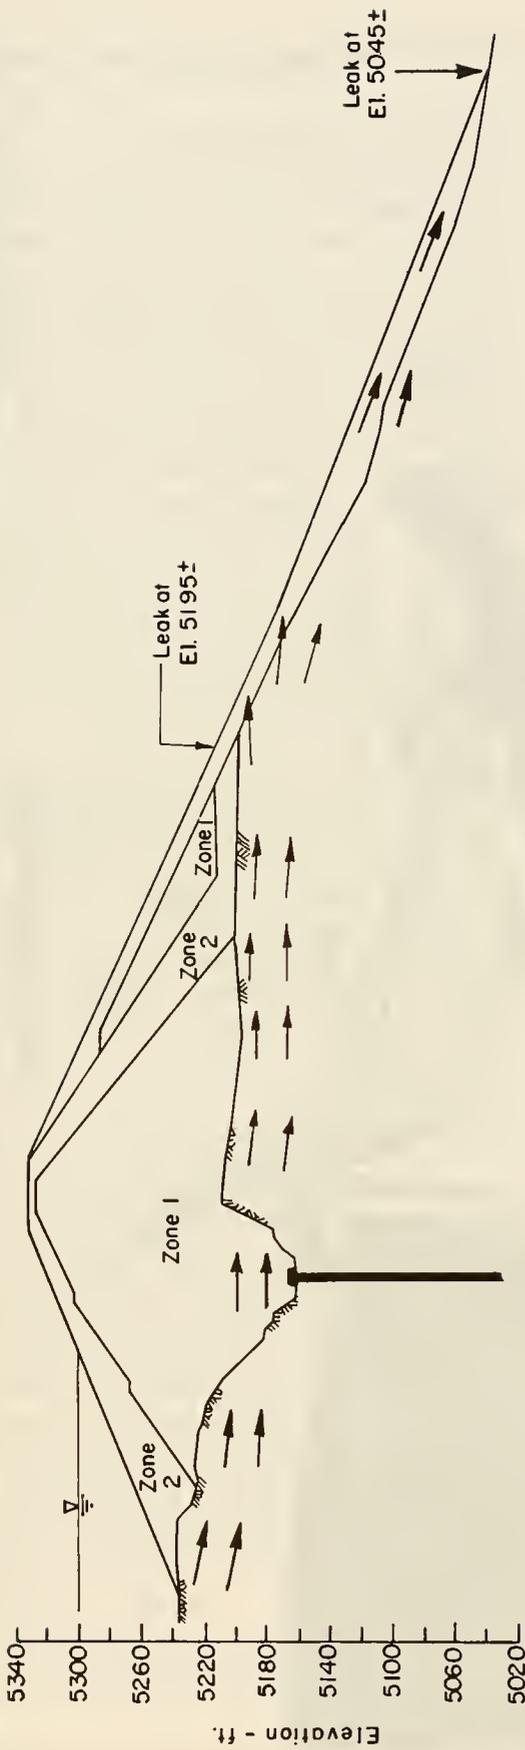
## PROBABLE PATH OF WATER IN EARLY STAGES OF LEAKAGE
