603  
I 1.2'  
T29/2

BOSTON PUBLIC LIBRARY  
3 9999 06317 343 7

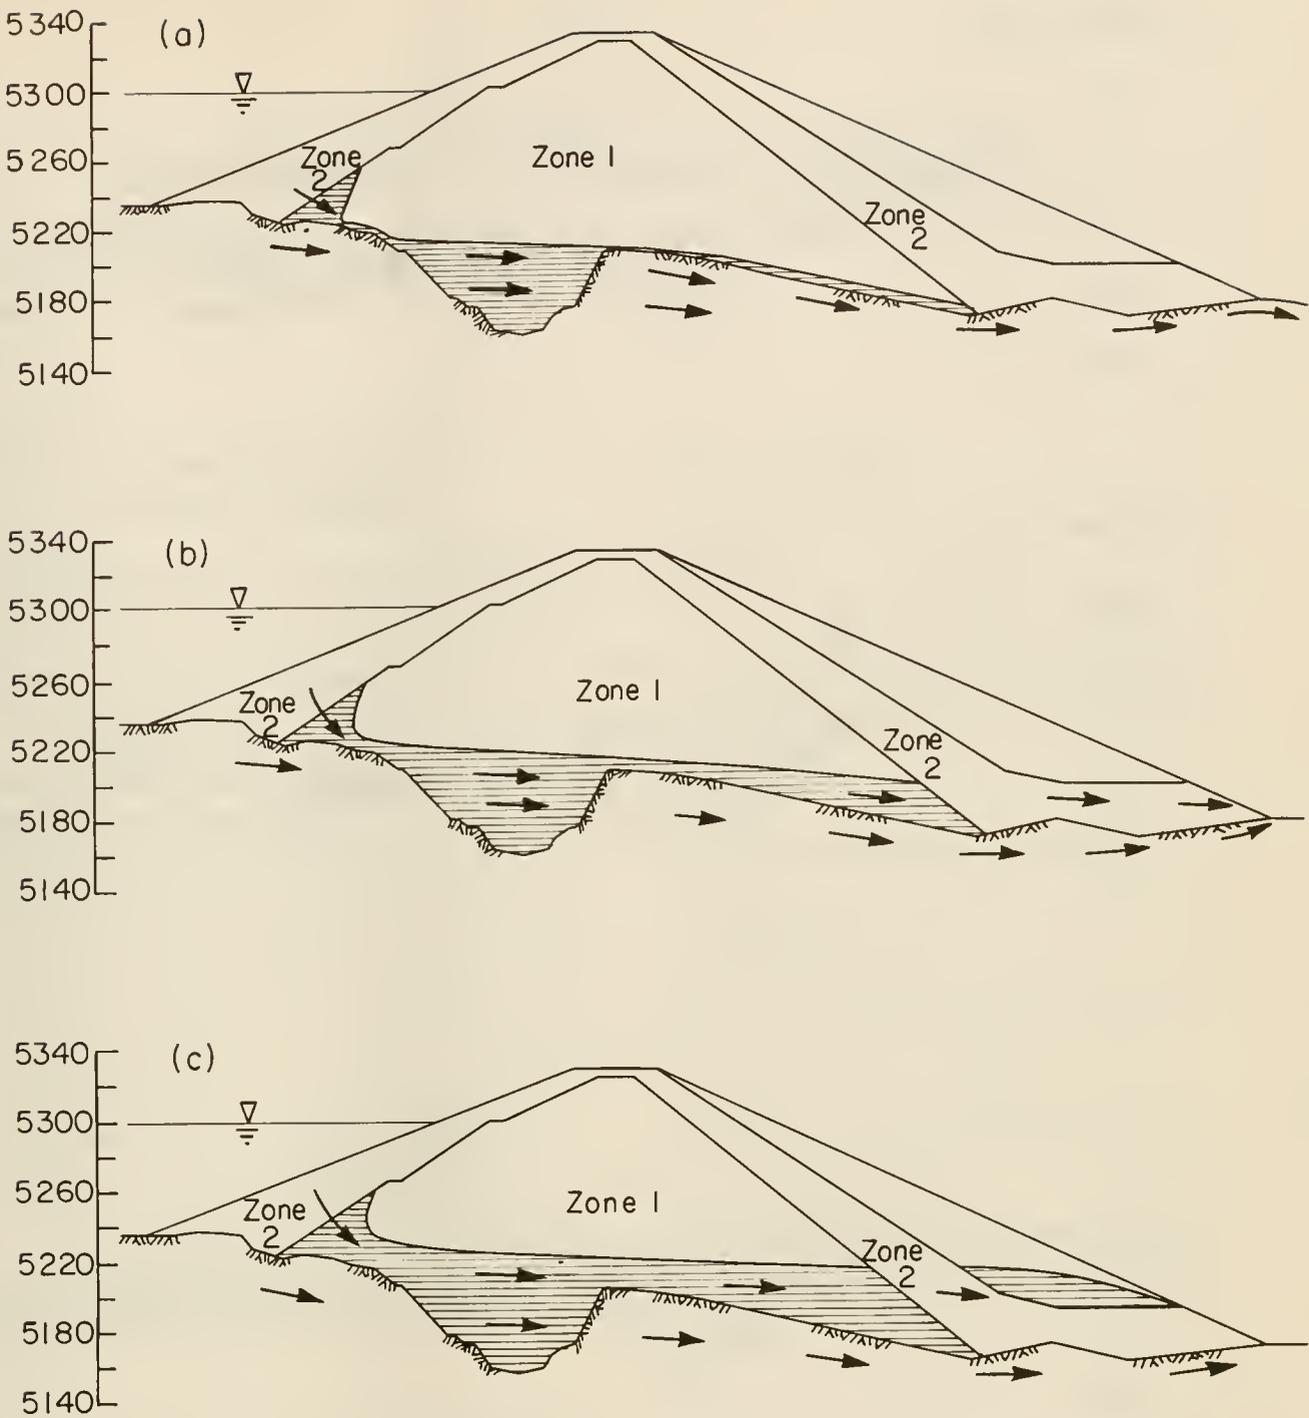
**CONCEPTUAL MECHANISM OF PROGRESSIVE FAILURE ALONG SECTION A-B-C**

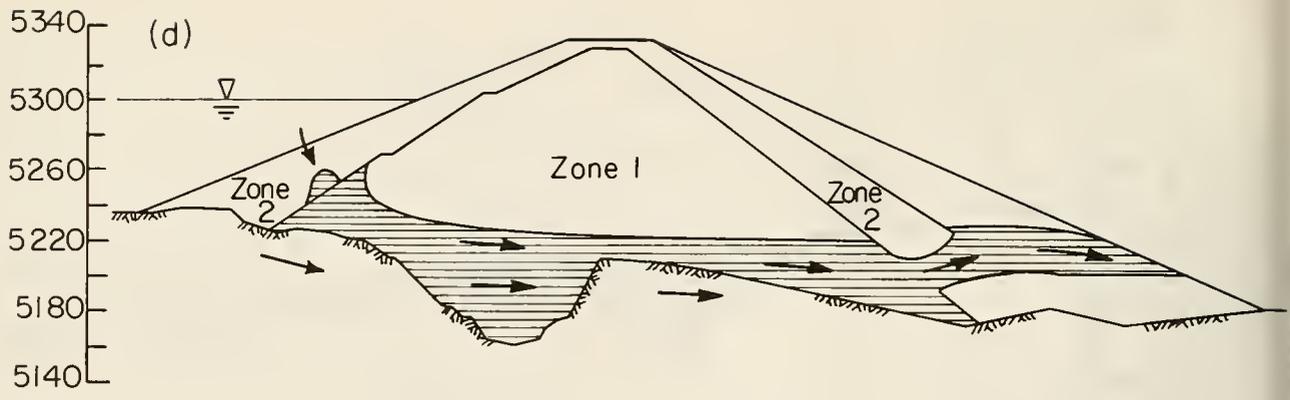
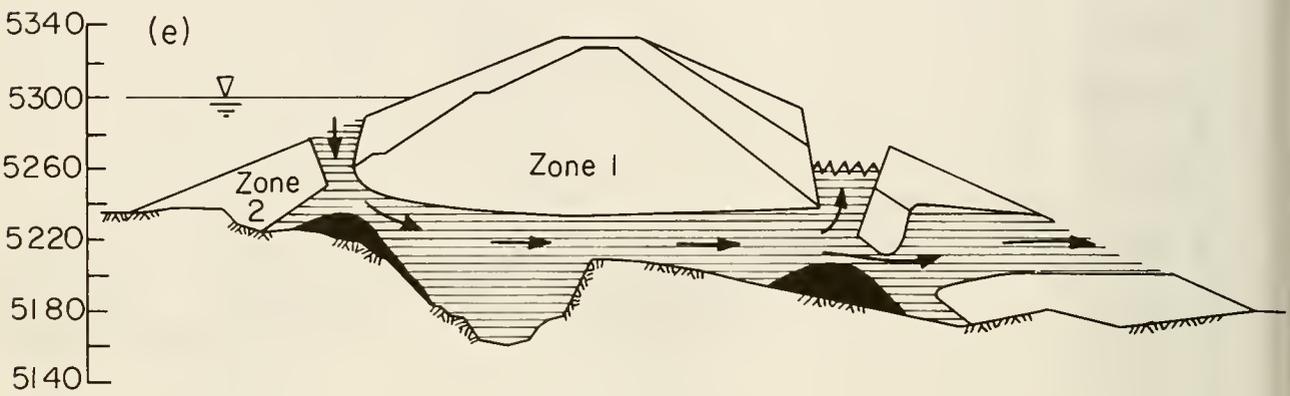
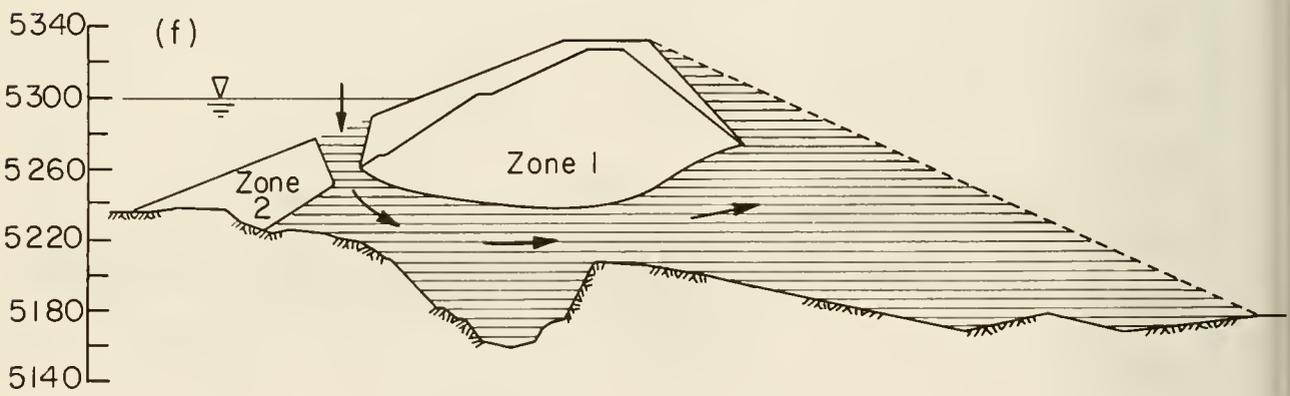
**CONCEPTUAL MECHANISM OF PROGRESSIVE FAILURE ALONG SECTION A-B-C**

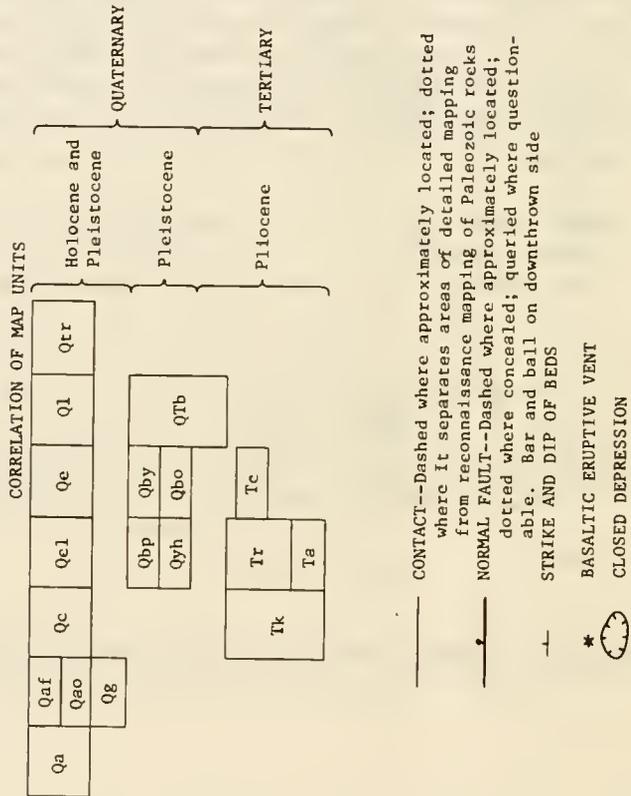
Figure B2.--Geologic map of the region of Rexburg Bench and the canyon of Teton River. (From Prostka, H. J., and Hackman, R. J., 1974, Preliminary geologic map of the NW 1/4 Driggs 1° by 2° quadrangle, southeastern Idaho: U.S. Geol. Survey Open-File Report 74-105.) (Sheet 1 of 2)

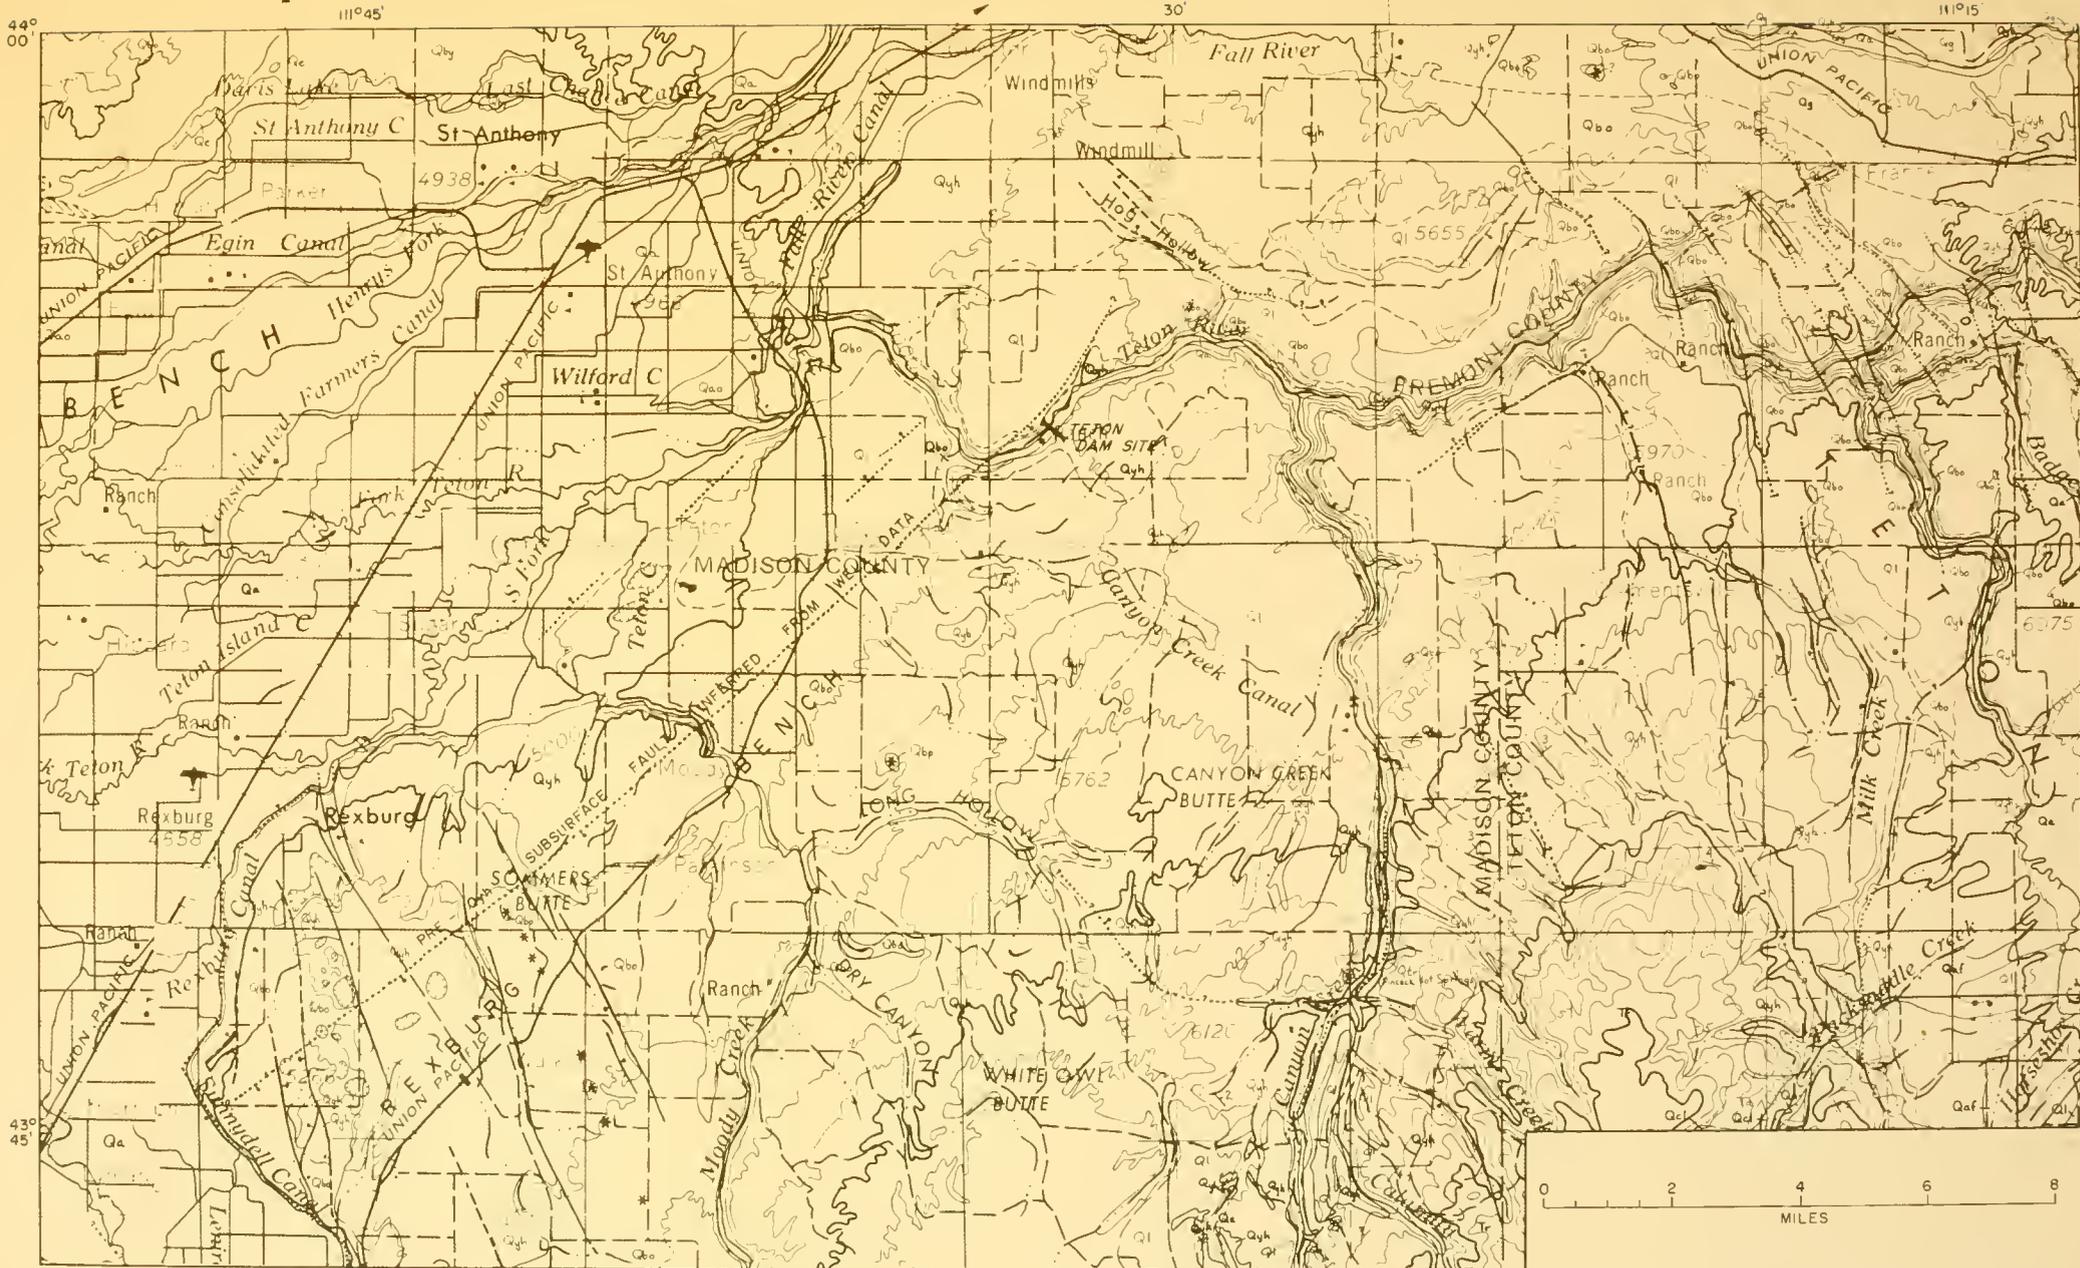
Figure B2.—Geologic map of the region of Rexburg Bench and the canyon of Teton River. (From Prostka, H. J., and Hackman, R. J., 1974, Preliminary geologic map of the NW 1/4 Driggs 1° by 2° quadrangle, southeastern Idaho: U.S. Geol. Survey Open-File Report 74-105.) (Sheet 2 of 2)

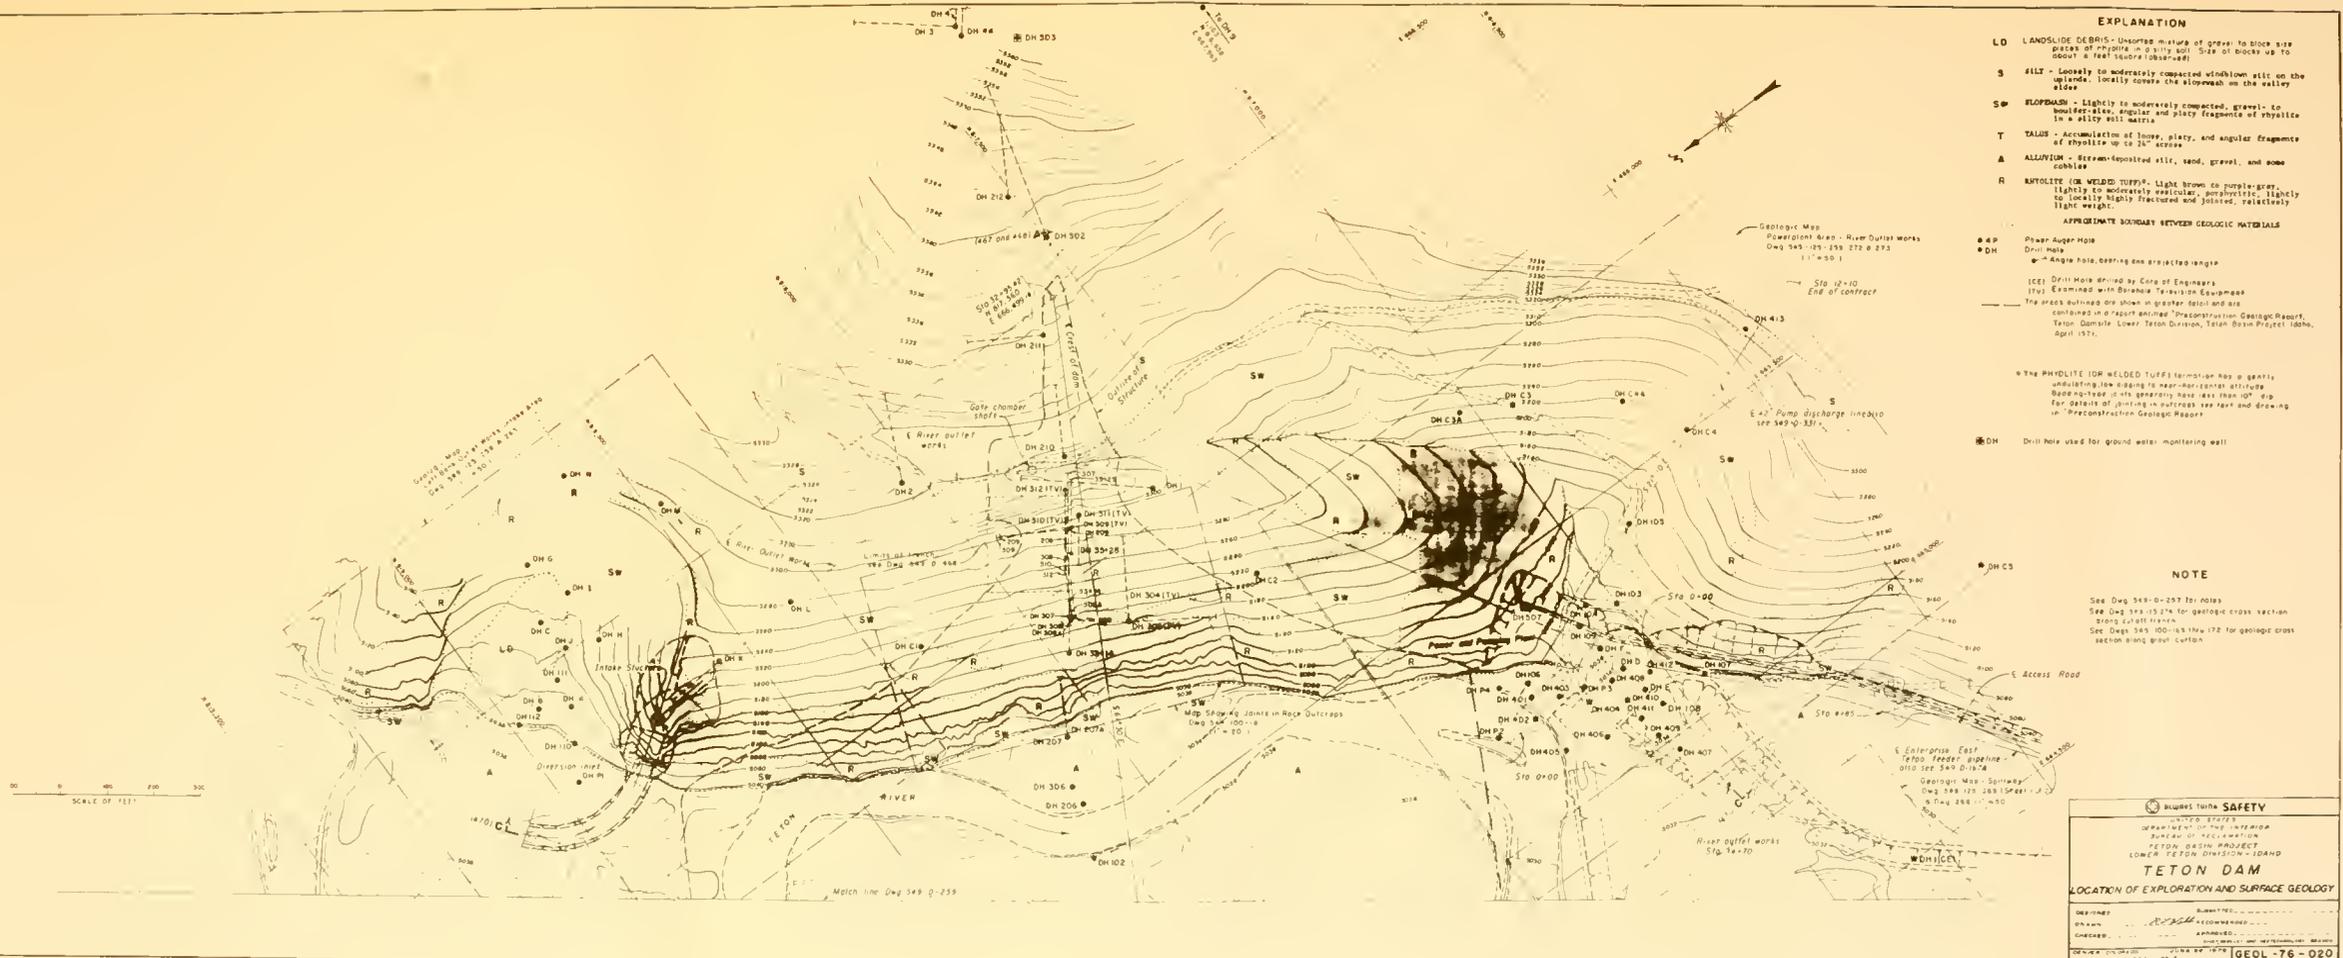
- EXPLANATION**
- LG LANDSLIDE DEBRIS - Unsorted mixture of gravel to block size pieces of rhyolite in a silty soil. Size of blocks up to about 4 feet (about 1000-1500)

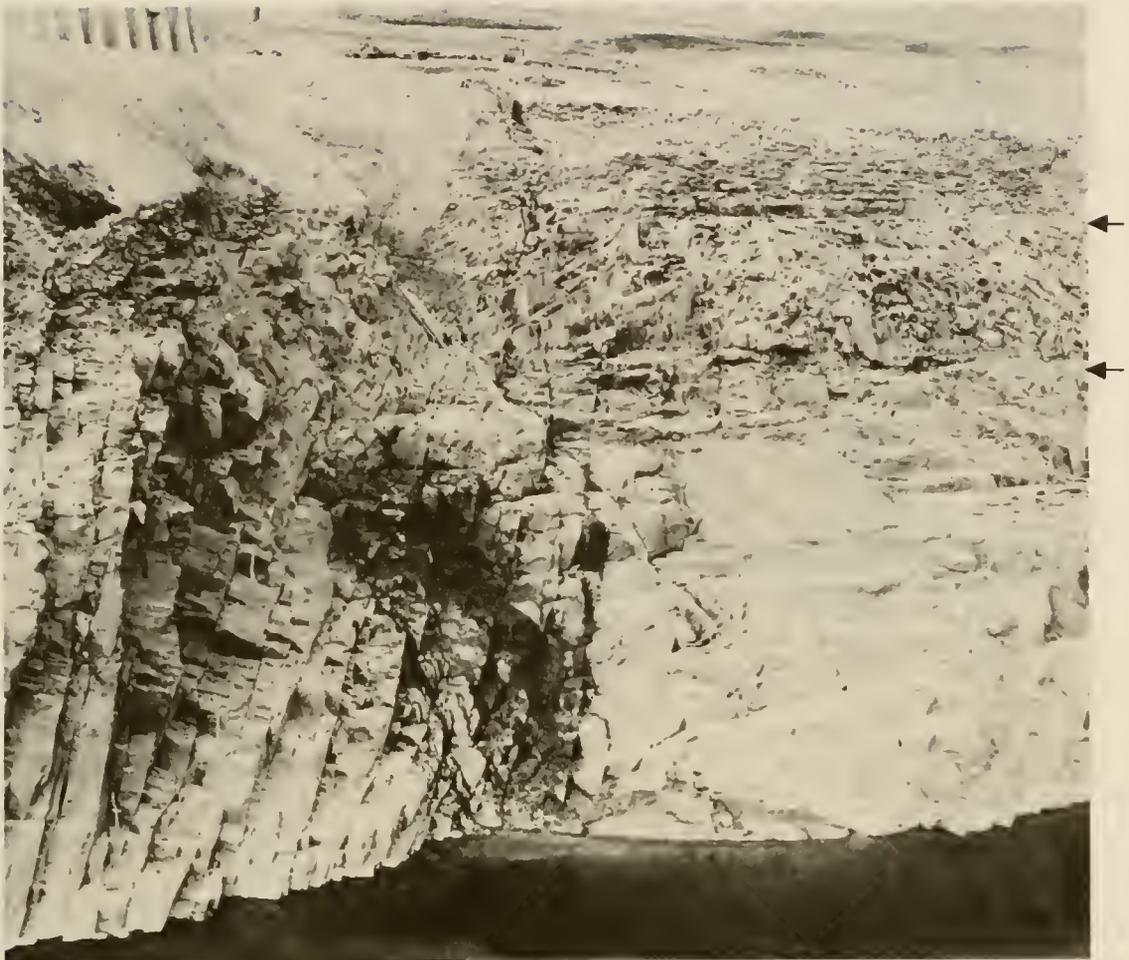
Figure B9.—Aerial view of right abutment in November 1976, after embankment material removed from key trench. Small area of loose fill on bench in right center is temporary stockpile of excavated embankment material. Grout cap extends diagonally across center of photograph. Gap in grout cap between two throughgoing near-vertical joints is at grout cap centerline stations 13+98 to 14+22. The exposed rock is welded tuff. Upper arrow indicates the nearly horizontal contact between unit 1 (above, with platy joints) and unit 2. Lower arrow indicates the unit 2-unit 3 contact, which extends downstream (to the left) about 50 feet beyond the grout cap, where it apparently is abruptly terminated by a high-angle joint. Dark area in lower center is water from abutment cleanup operation. View to north-northwest. Photograph by Bureau of Reclamation.

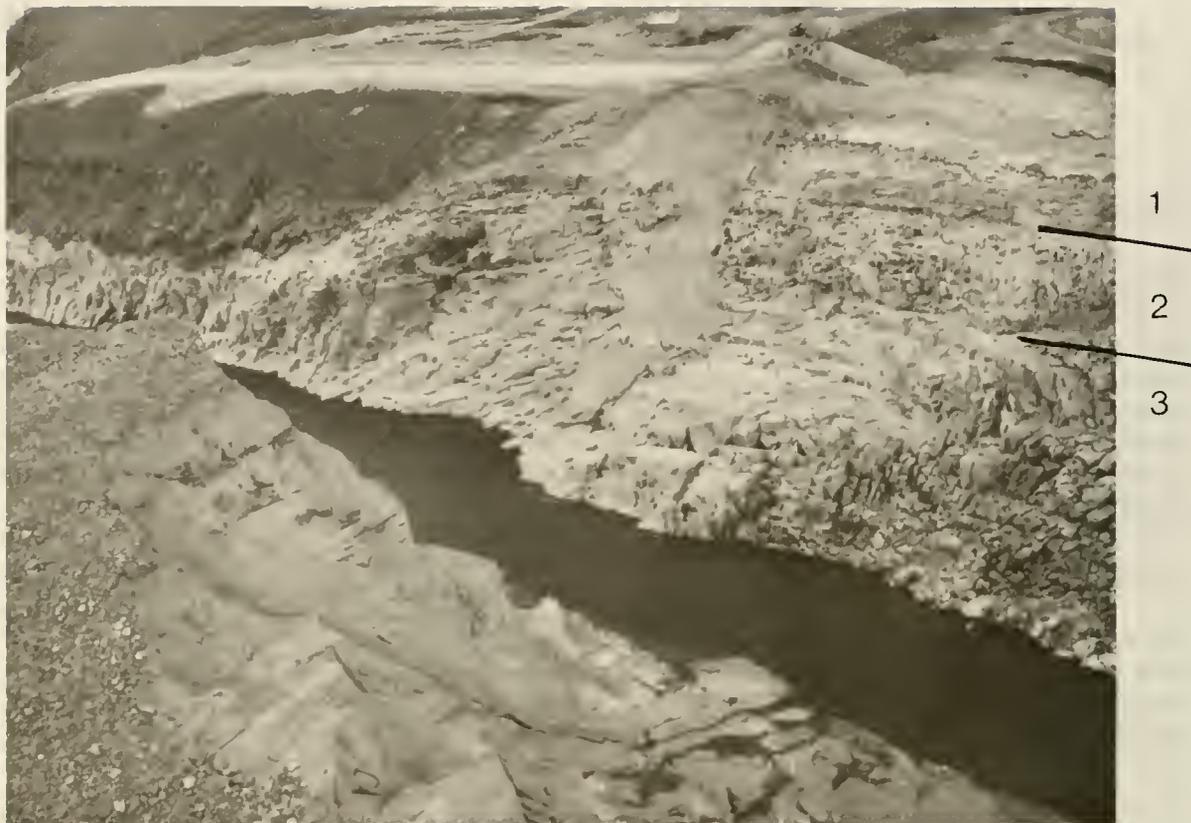
Figure B1-1.—Oblique aerial view of right abutment, Teton Dam, showing overall appearance of rhyolite welded ash-flow sheet. Note threefold subdivision of sheet upstream (to the right) of the embankment remnant in the key trench. View to west taken June 1976.

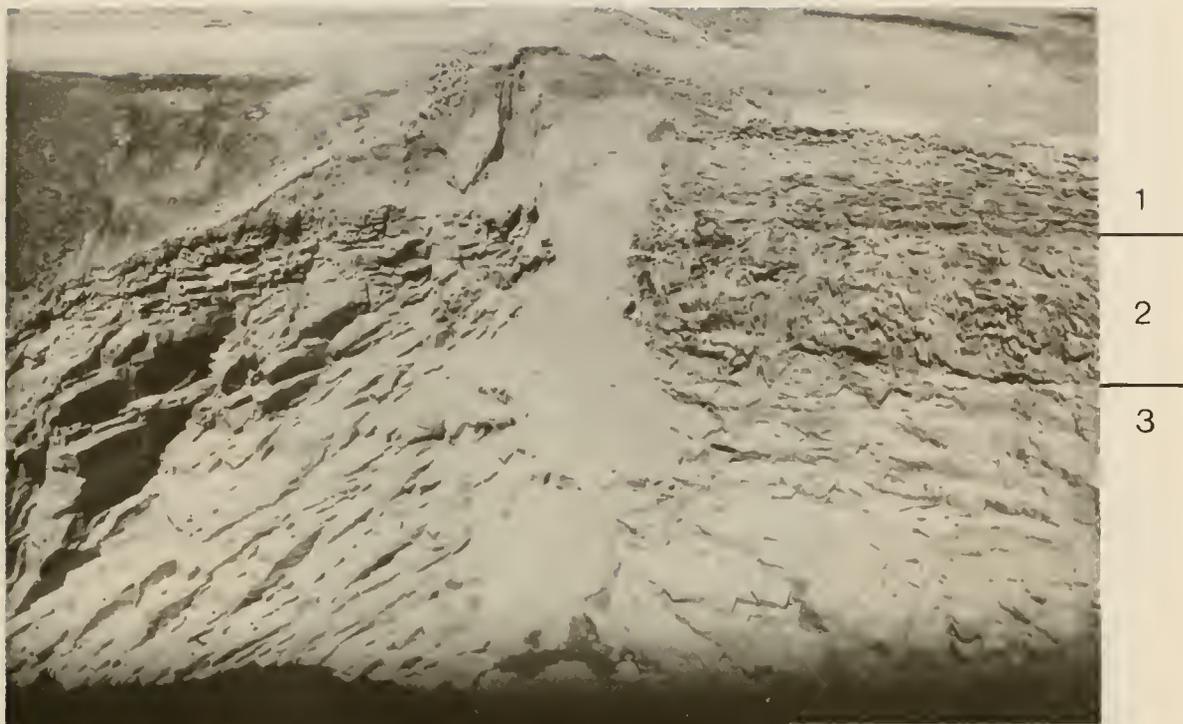
Figure B1-2.—Aerial view of right abutment, Teton Dam, nearly perpendicular to the canyon wall. Note abrupt termination of unit 2 just downstream from the embankment remnant. View to northwest taken June 1976.

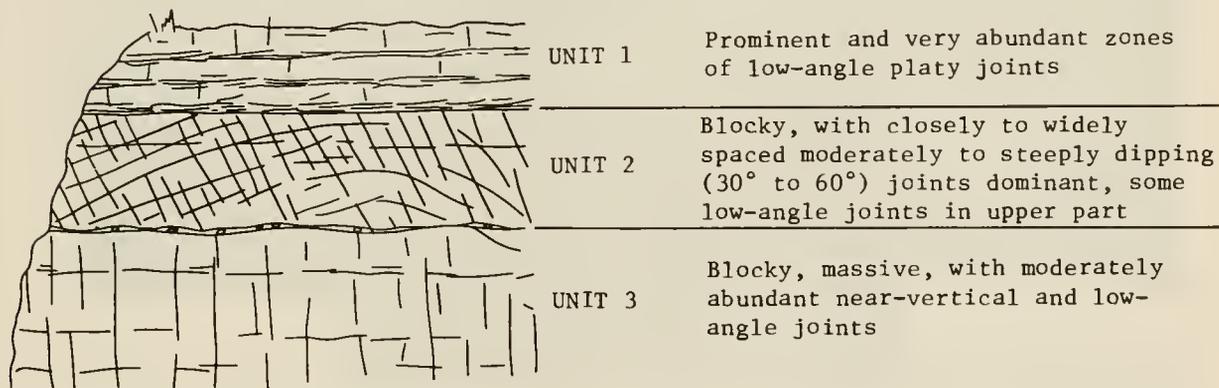
Figure B1-3.—Schematic section of welded rhyolite ash-flow tuff in right abutment, Teton Dam, as exposed after failure just upstream from the embankment remnant, showing principal joint features of the three informal units distinguished on Bureau of Reclamation post-failure geologic maps.

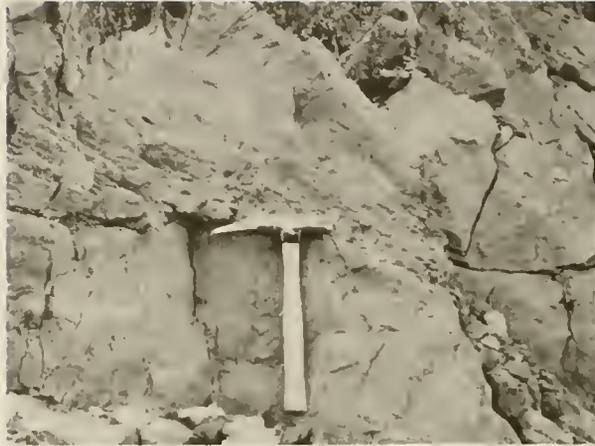
Figure B1-4.—Zone of closely spaced, short imbricate joints in unit 1 exposed along a haul road a short distance upstream from the right abutment. Hammerhead is at the contact between the imbricate zone and underlying blocky welded tuff.

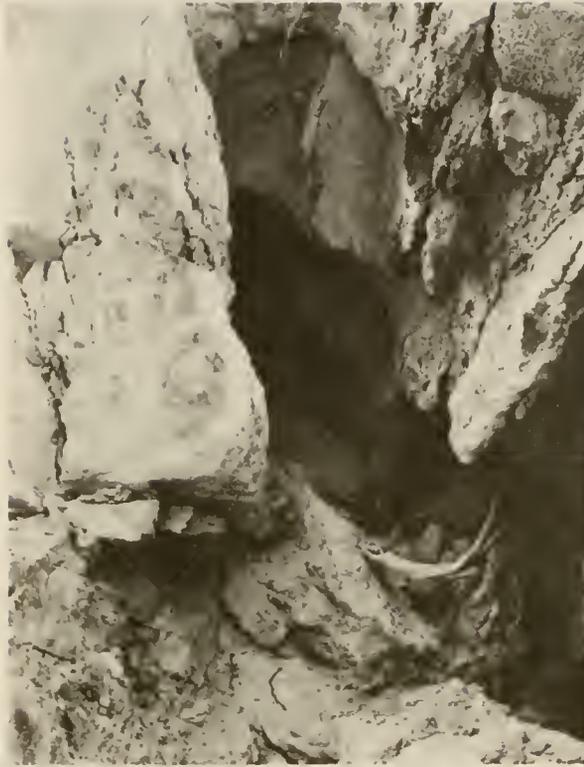
Figure B1-6.—Steeply dipping irregularly shaped fissure about 2 feet wide that probably formed as a viscous pull-apart structure during secondary flowage of the rhyolite. Note small steeply dipping tension cracks along the left side of the large void. This fissure is exposed in unit 1 along a haul road a short distance upstream from the right abutment.

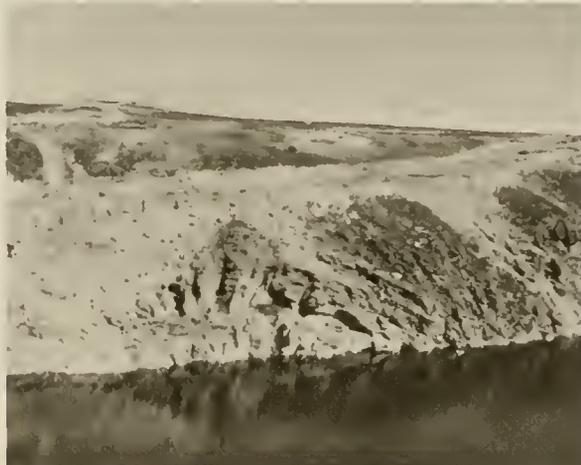
Figure B1-7.—Fold in lower part of ash-flow sheet exposed in right canyon wall less than 1/2 mile upstream from the dam. The axis of this fold is about in line with the arching of foliation over a pre-rhyolite topographic high exposed in the left side of the canyon just upstream from the intake tower.

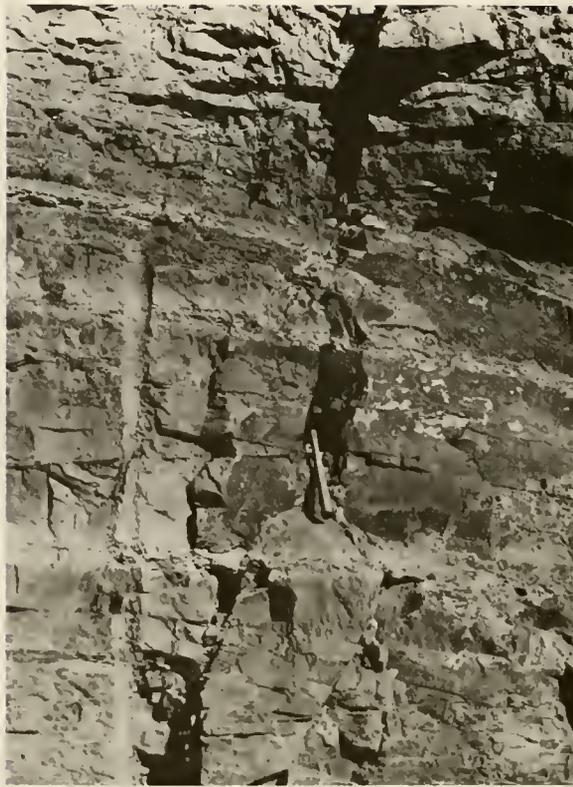
Figure B1-8.—Large vertical fissure apparently offset along several low-angle joints in unit 1.

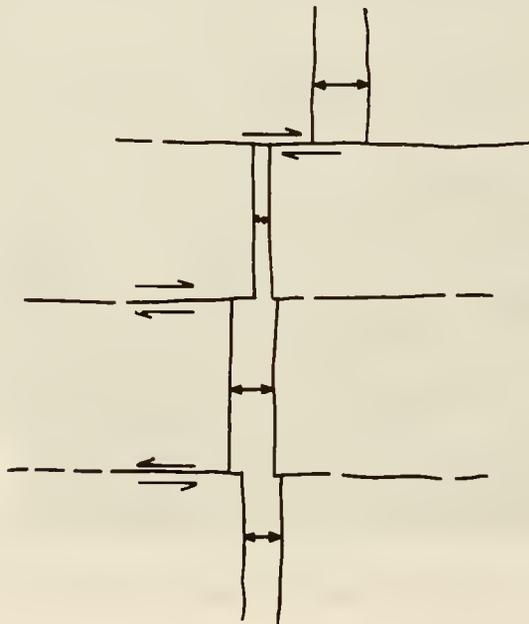
Figure B1-9.—Diagram of vertical fissure; horizontal offsets show how different separation ( $\leftrightarrow$ ) along a vertical joint is accommodated by slippage ( $\rightleftarrows$ ) along low-angle joints in rhyolite at damsite.

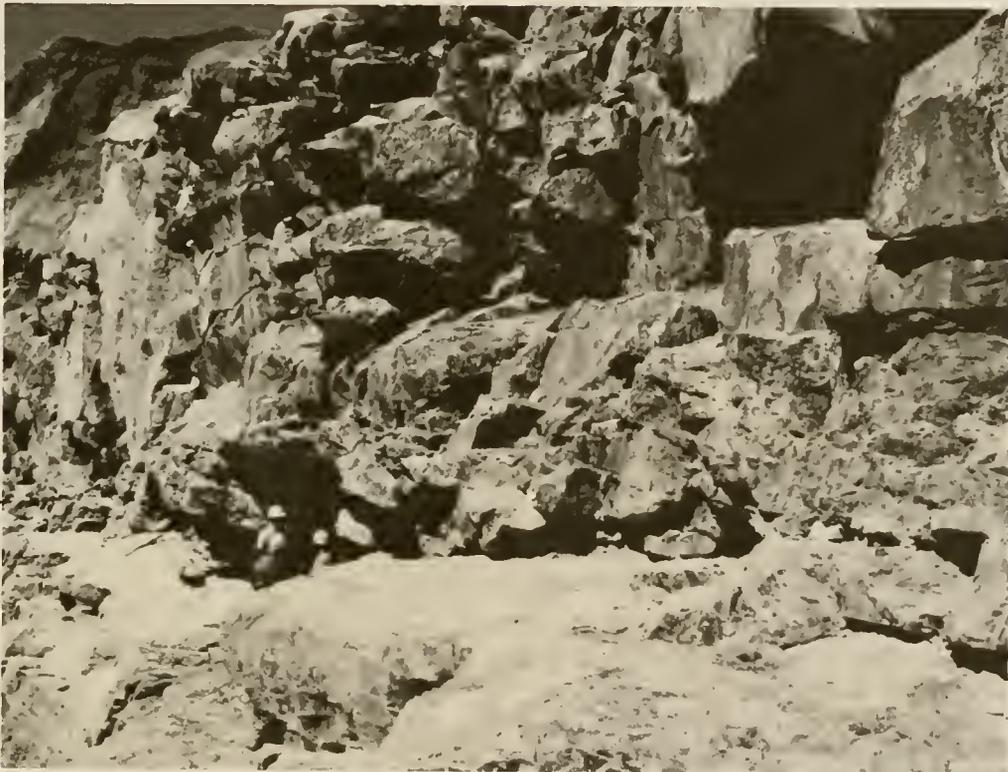
Figure B1-10.—View of prominent contact between unit 2 and unit 3 just upstream from embankment remnant. Arrows indicate location of contact.

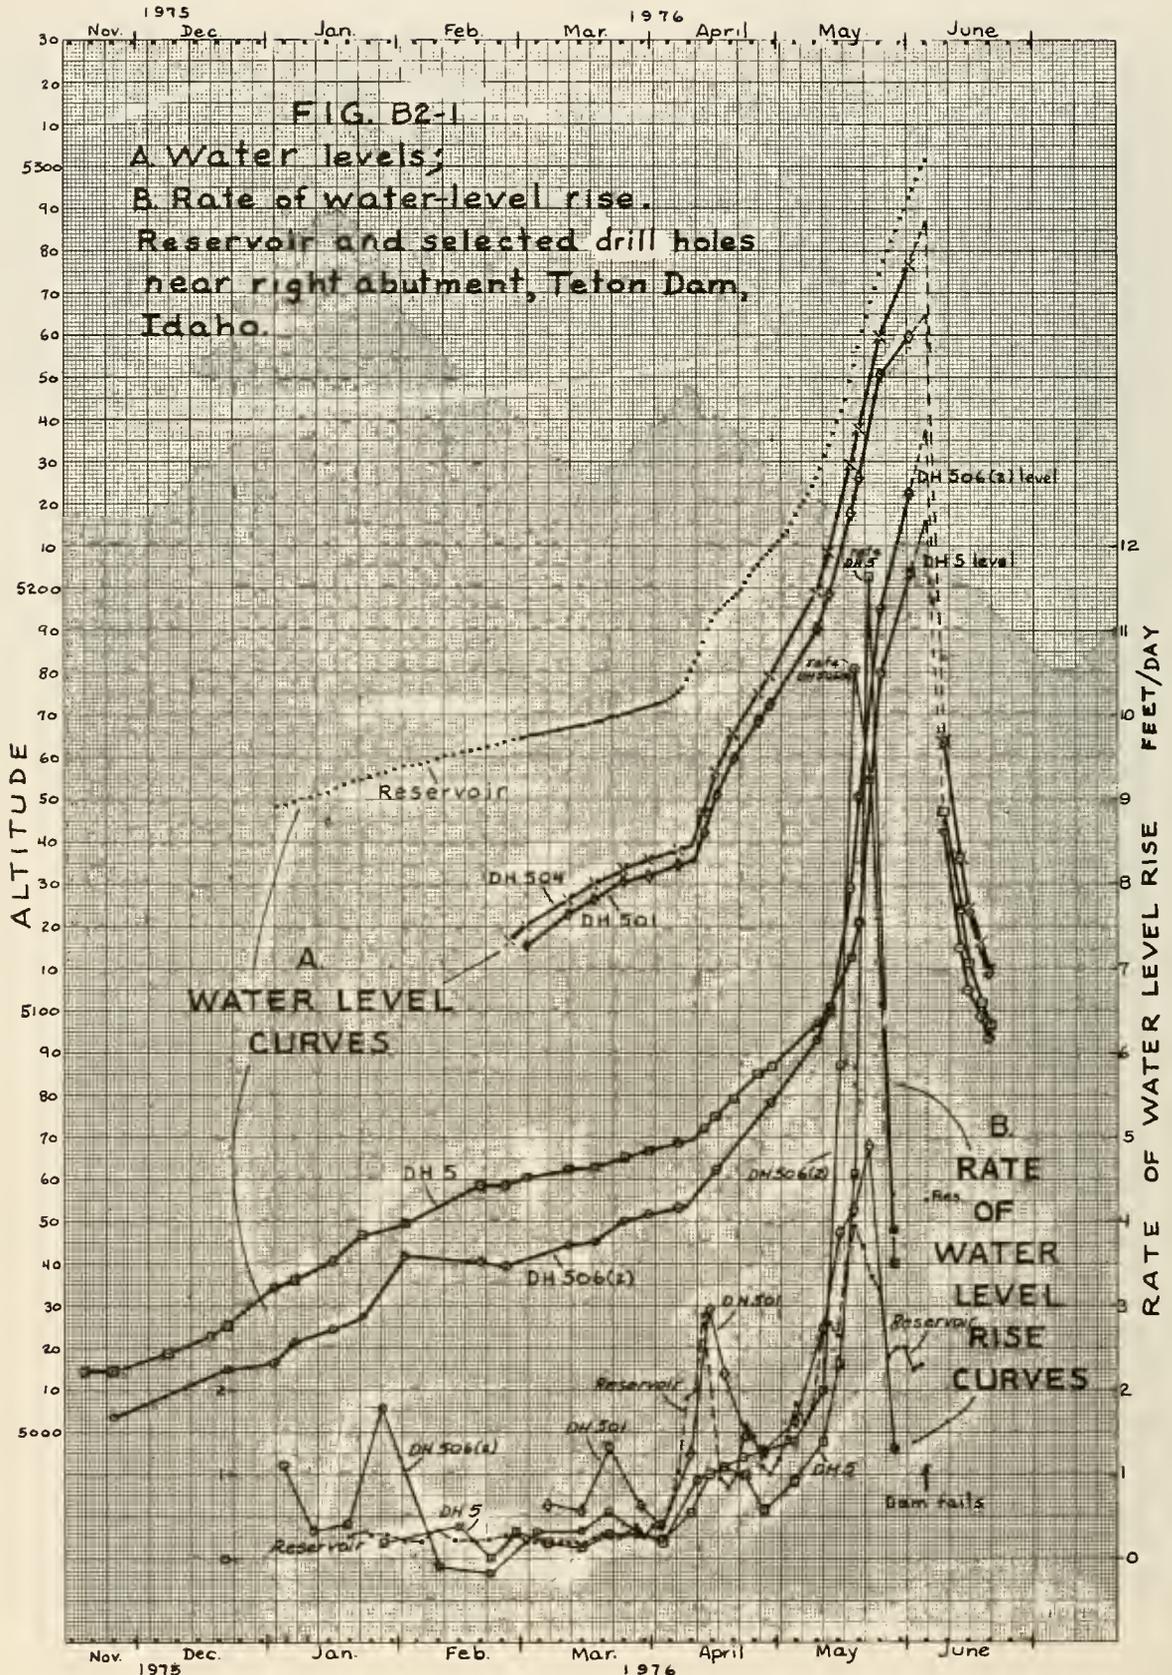
Figure B2-1.—A, Water levels; B, Rate of water-level rise. Reservoir and selected drill holes near right abutment, Teton Dam, Idaho.

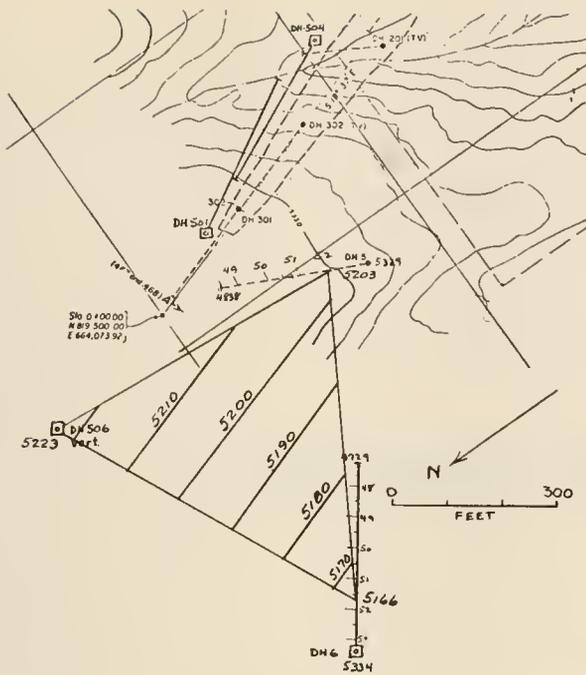
Figure B2-3.—Contours on an assumed plane water table defined by water levels in drill holes 5, 6, and 506; shown at various times before and during reservoir filling and after failure. (Sheet 1 of 2)

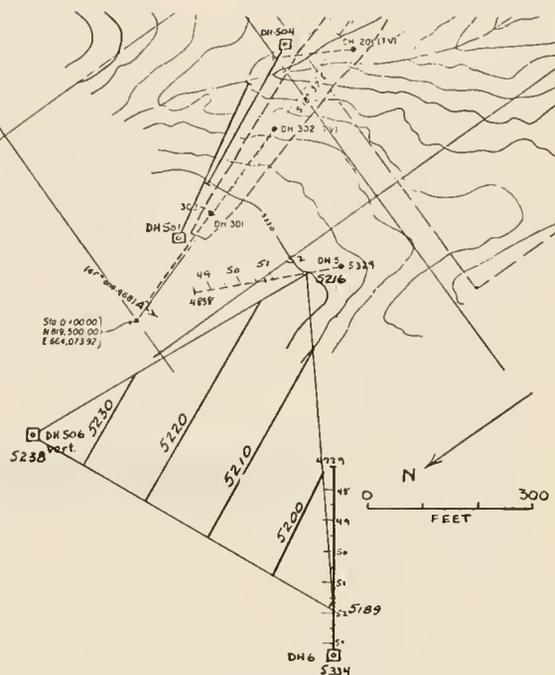
June 5, 1976  
(before failure, from  
projected data)

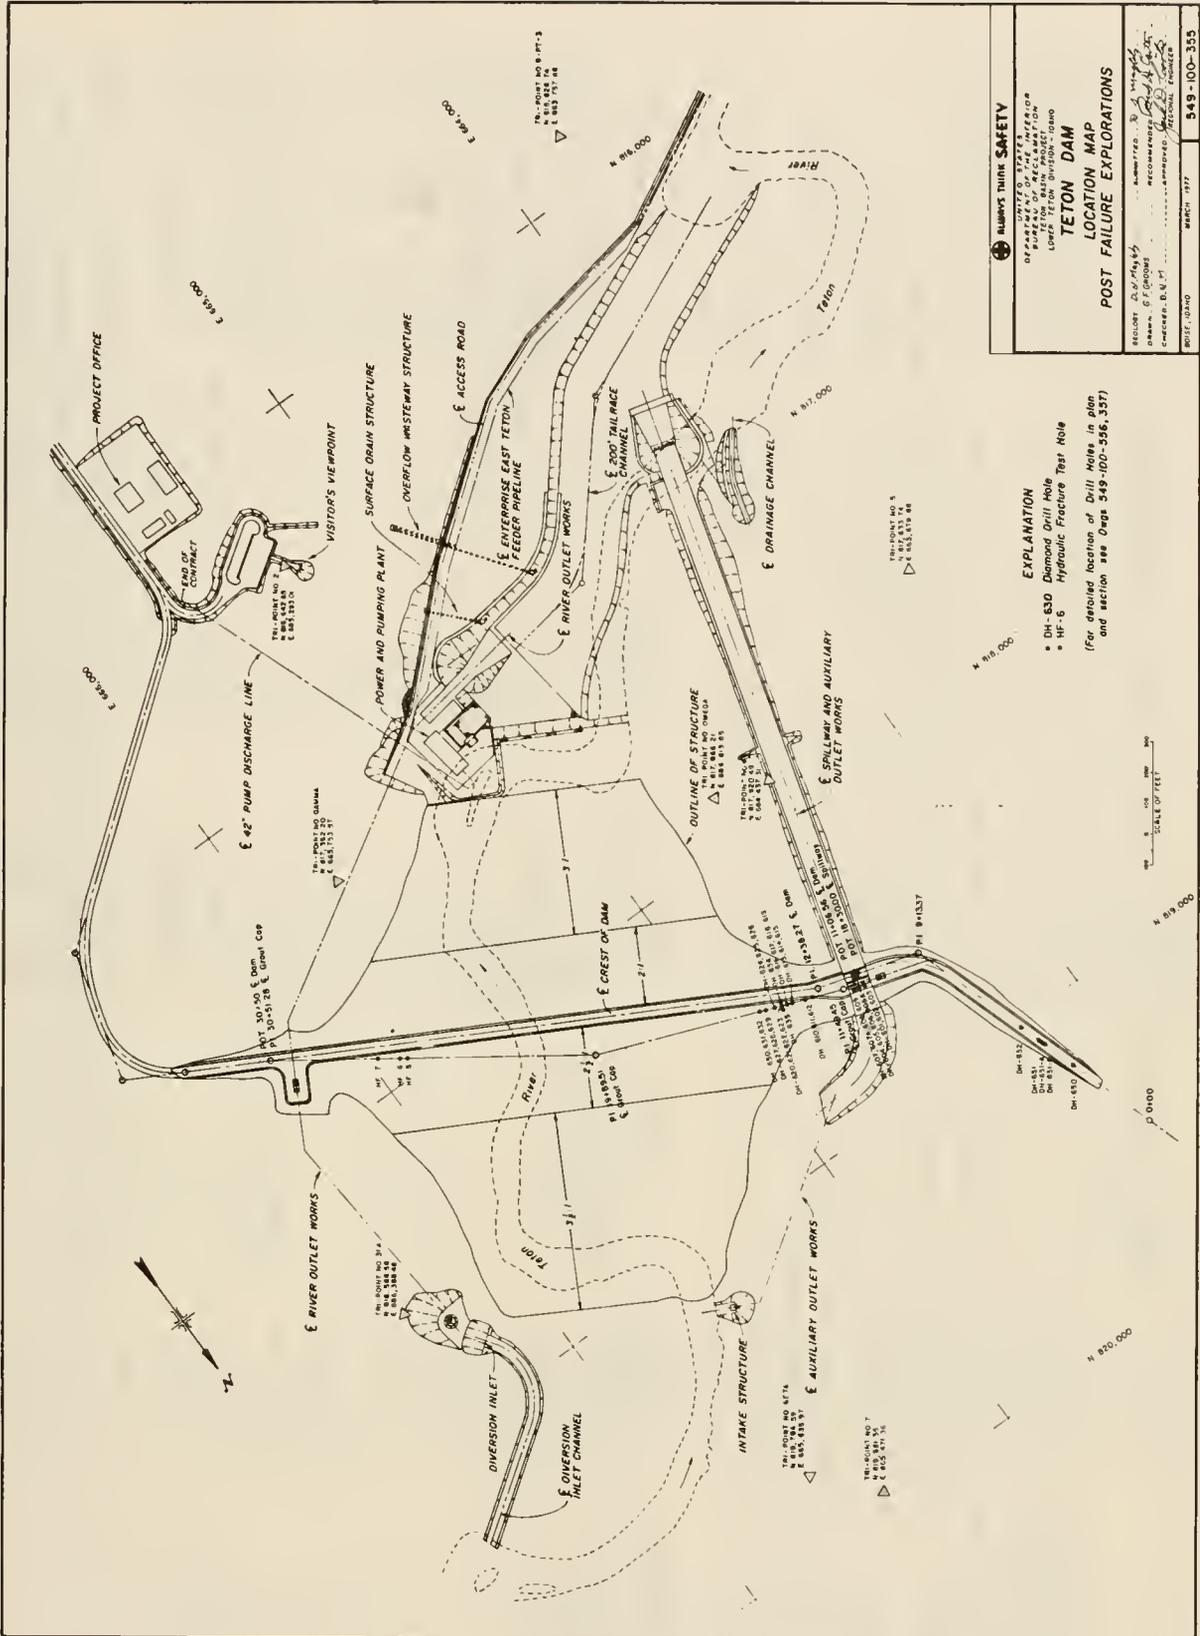
**ALWAYS THINK SAFETY**

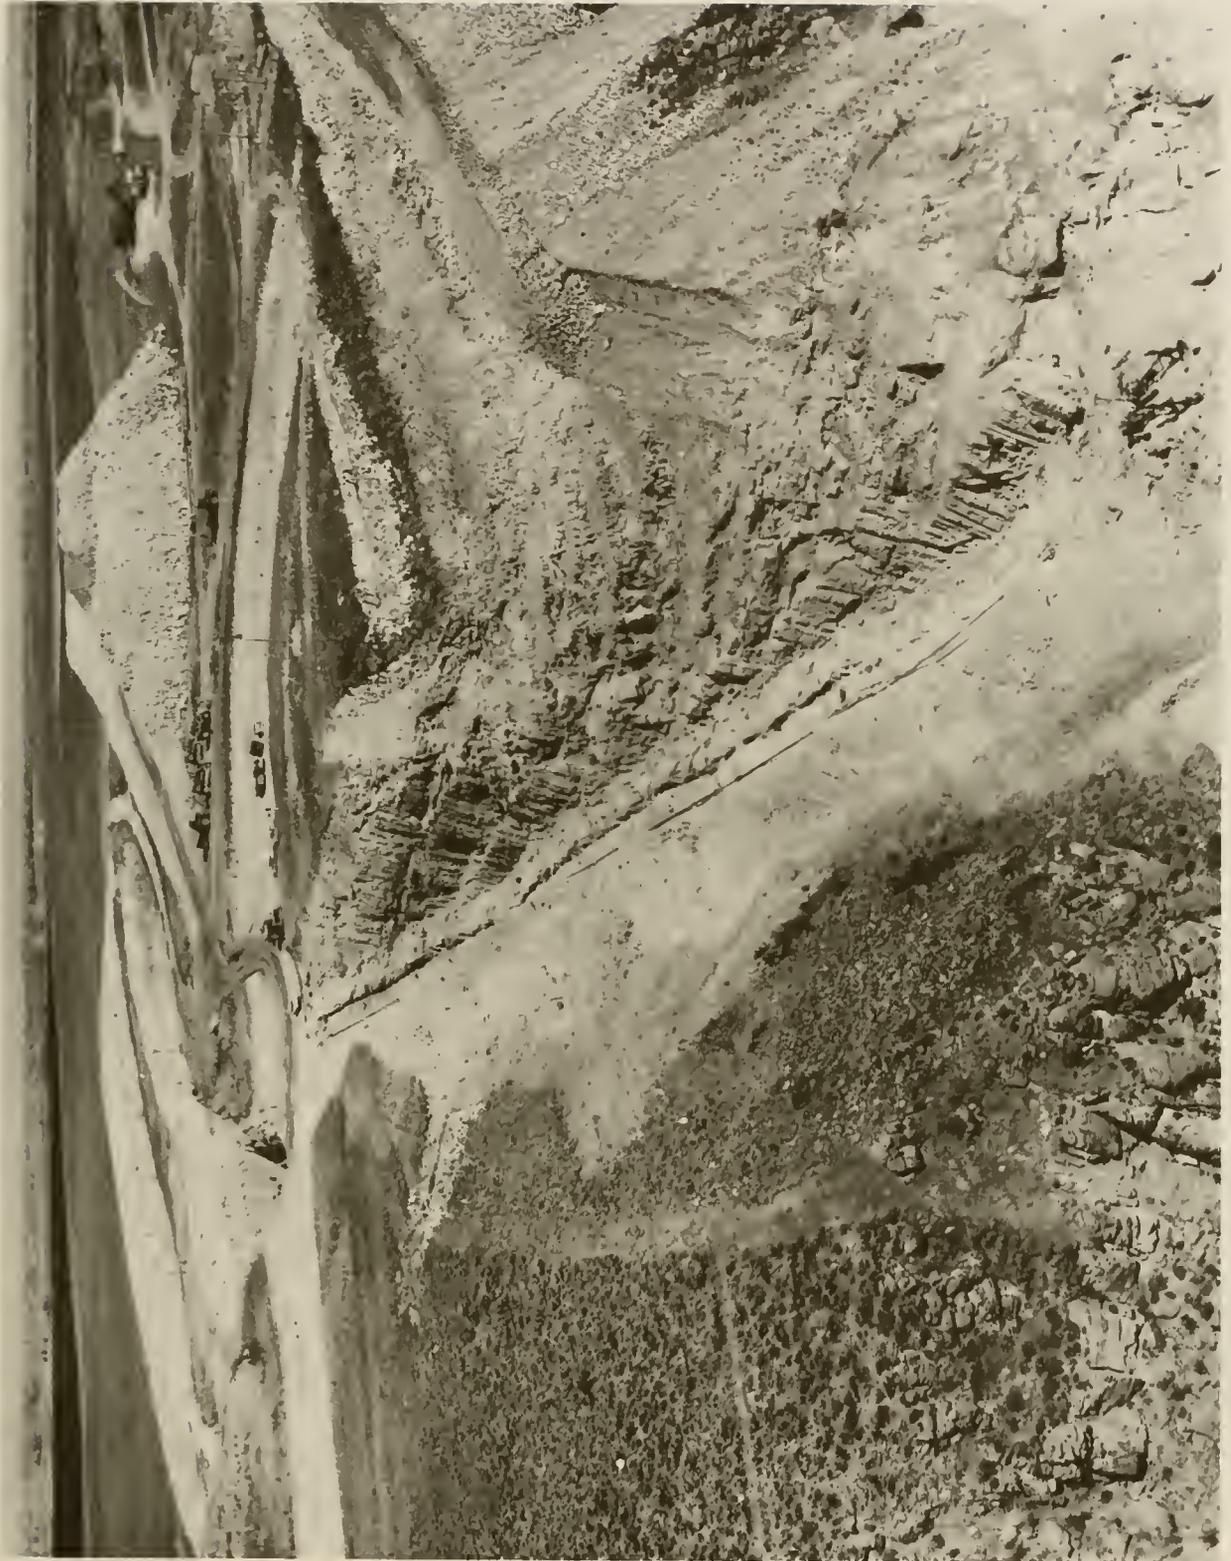
1.-View of right foundation keyway trench and zone 5 stockpile, also portion of spillway area, 7/19/73; P549-147-2912 NA.  
Note number of benches with adjacent steep faces.
