603  
I 1.2'  
T29/2

BOSTON PUBLIC LIBRARY  
3 9999 06317 343 7

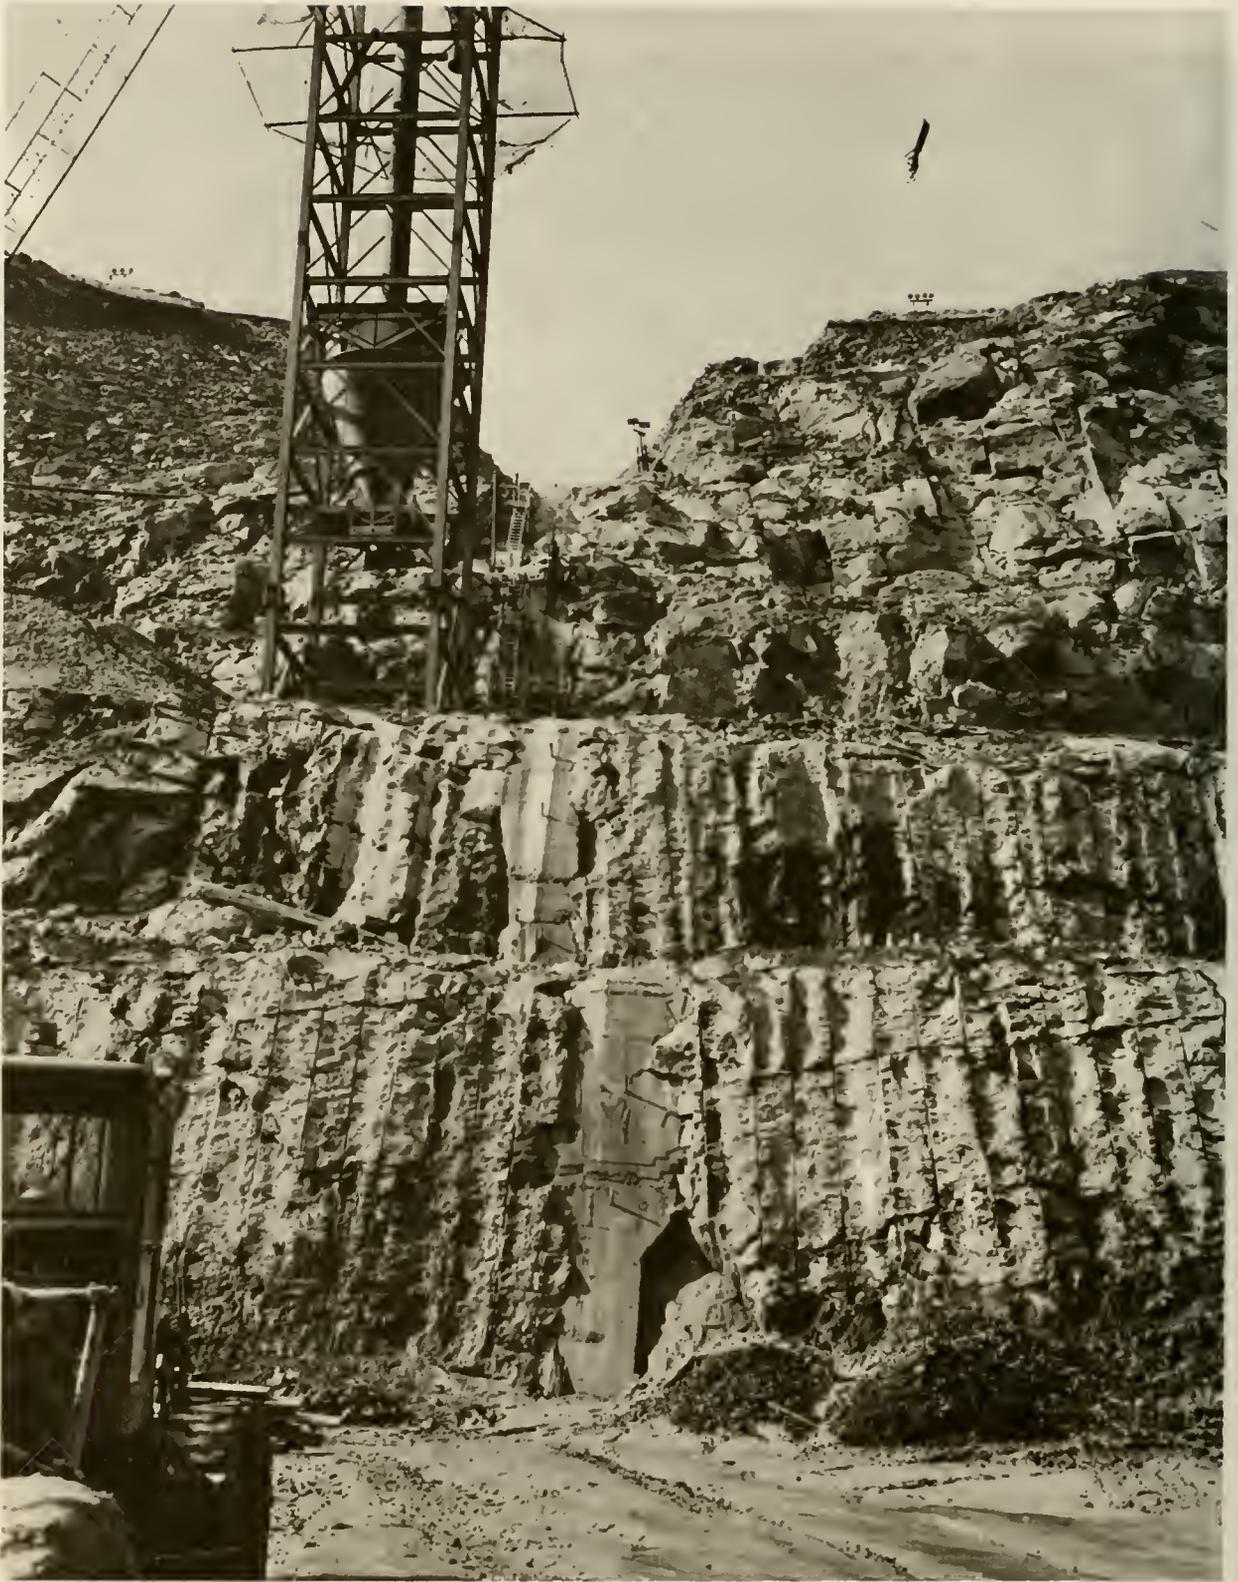
2.—View of grout cap looking toward right abutment in cutoff trench. Photo taken at station 19+00, 100 feet upstream from centerline of dam. 10/9/73; P549-147-3297 NA.

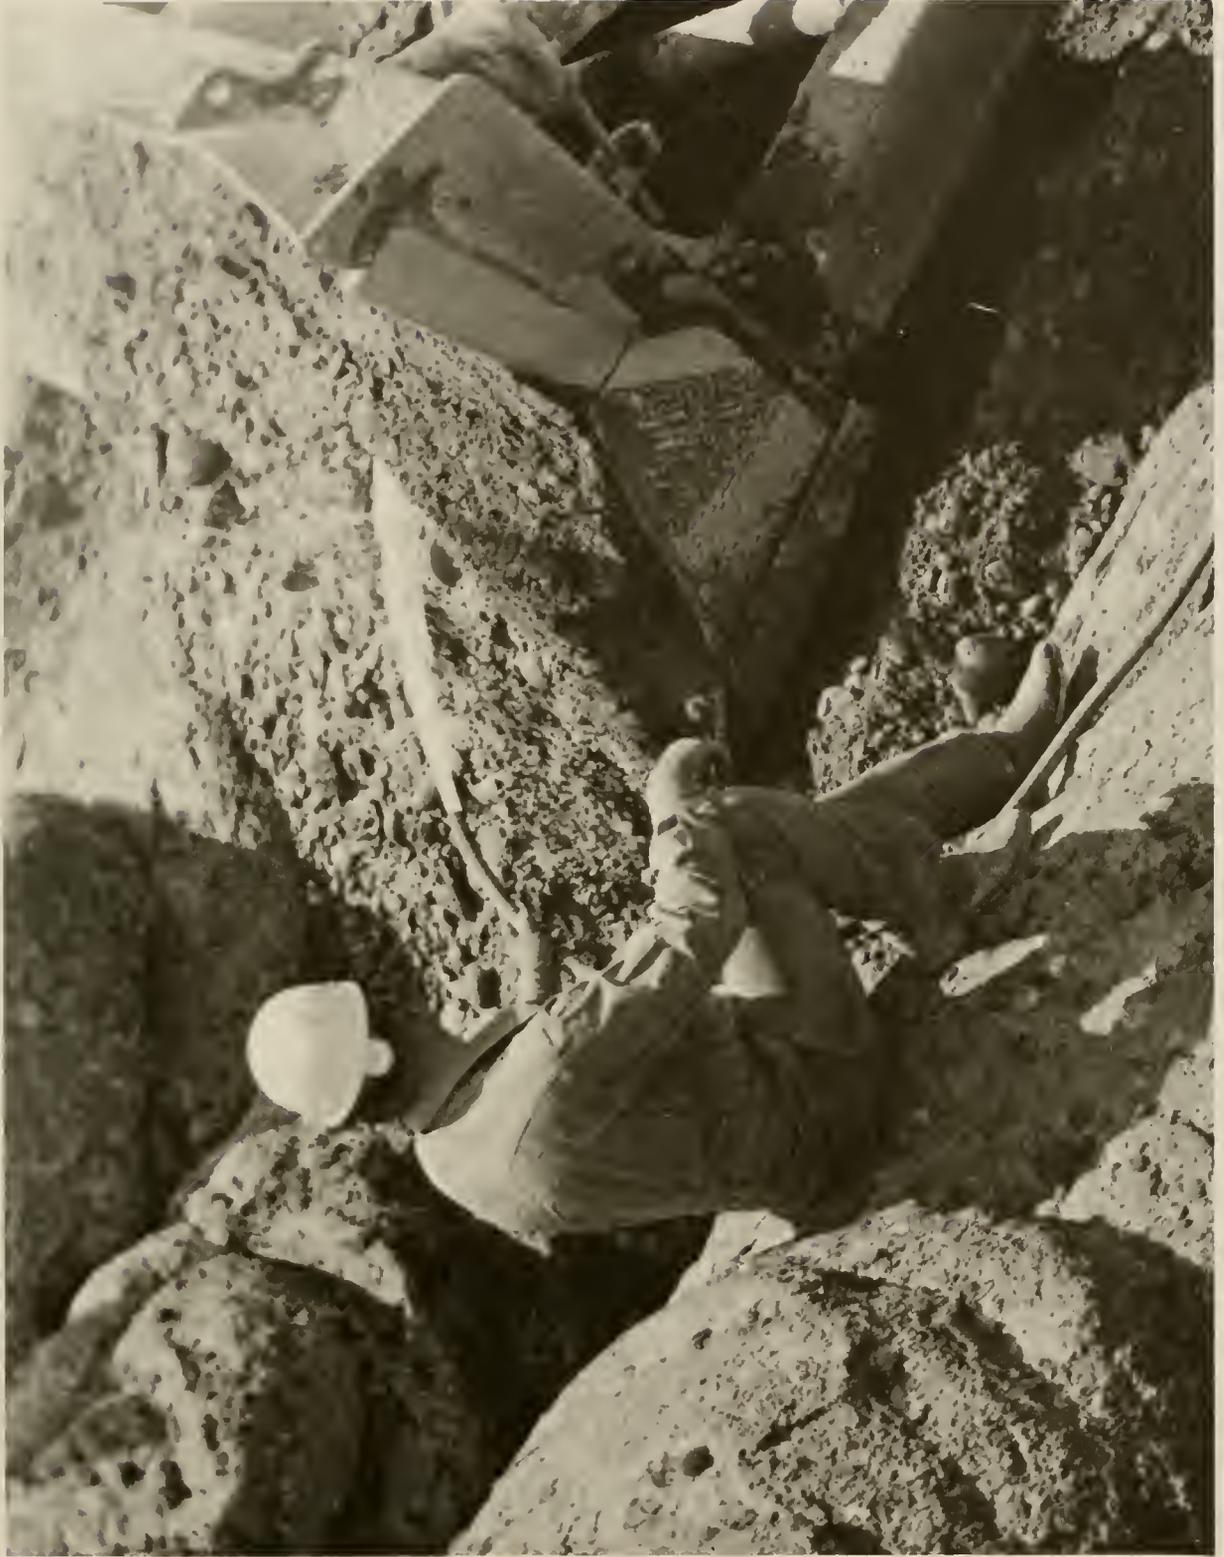
9.—View of sluicing operation on zone 2 blanket area. Material is sluced into cracks between rocks to insure all voids are filled.  
7/19/72; CN549-147-140 NA.

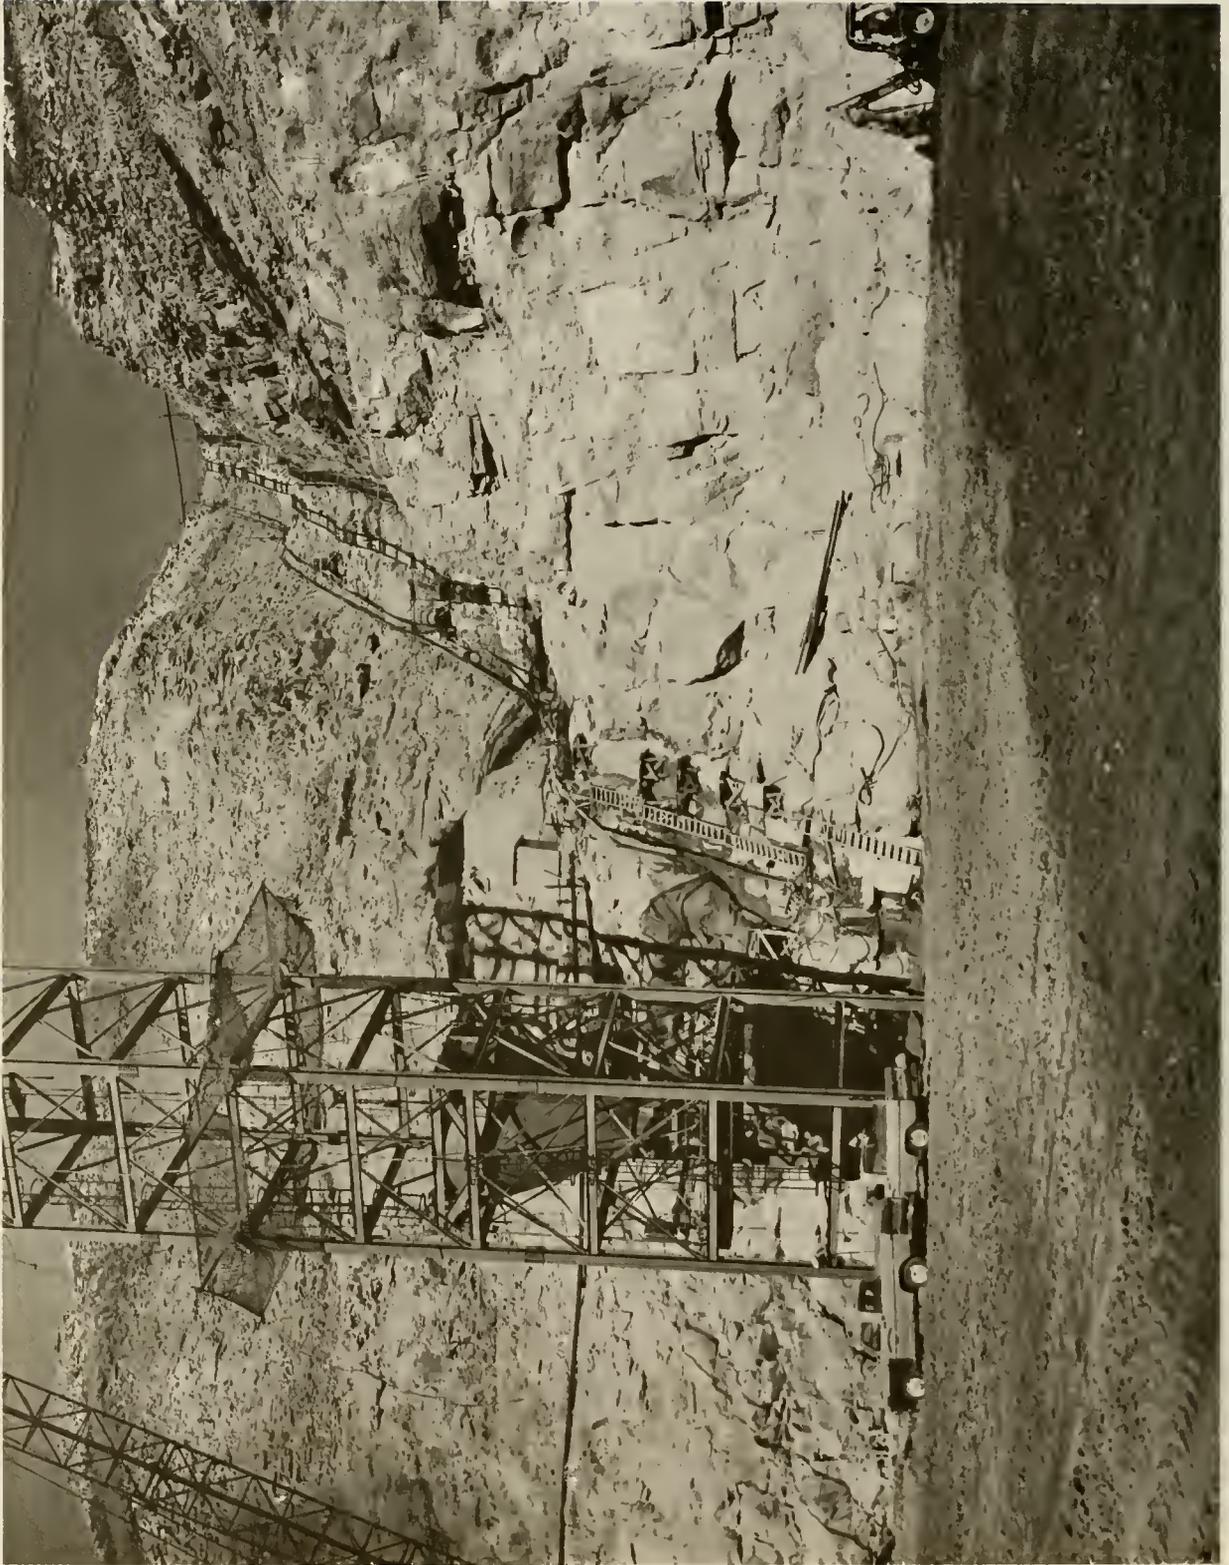
10.—View of grout leaking out of cracks in rocks, right abutment from 110 feet downstream to centerline of dam, 7/22/74; P549-147-4692 NA.

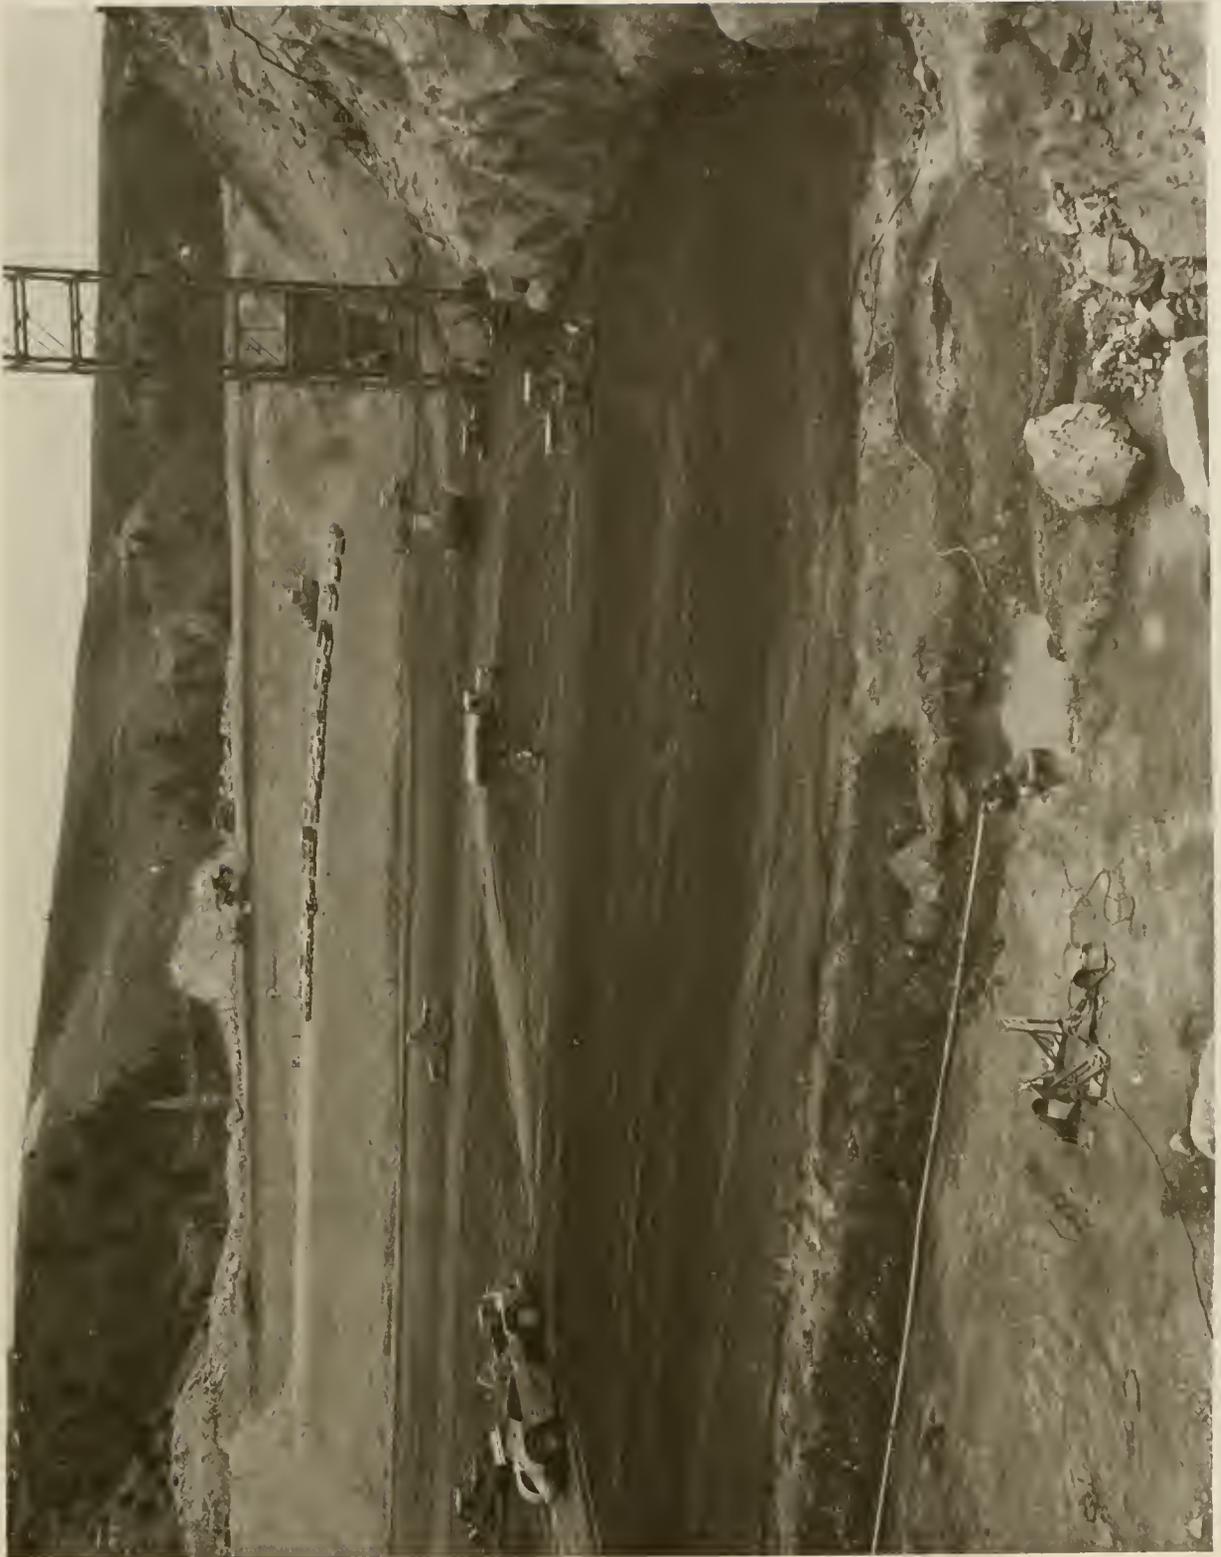
11.--Viewing zone 1 fill and preparation work. Taken from station 16+00, 550 feet upstream, 7/2/74; P549-147-4589 NA.

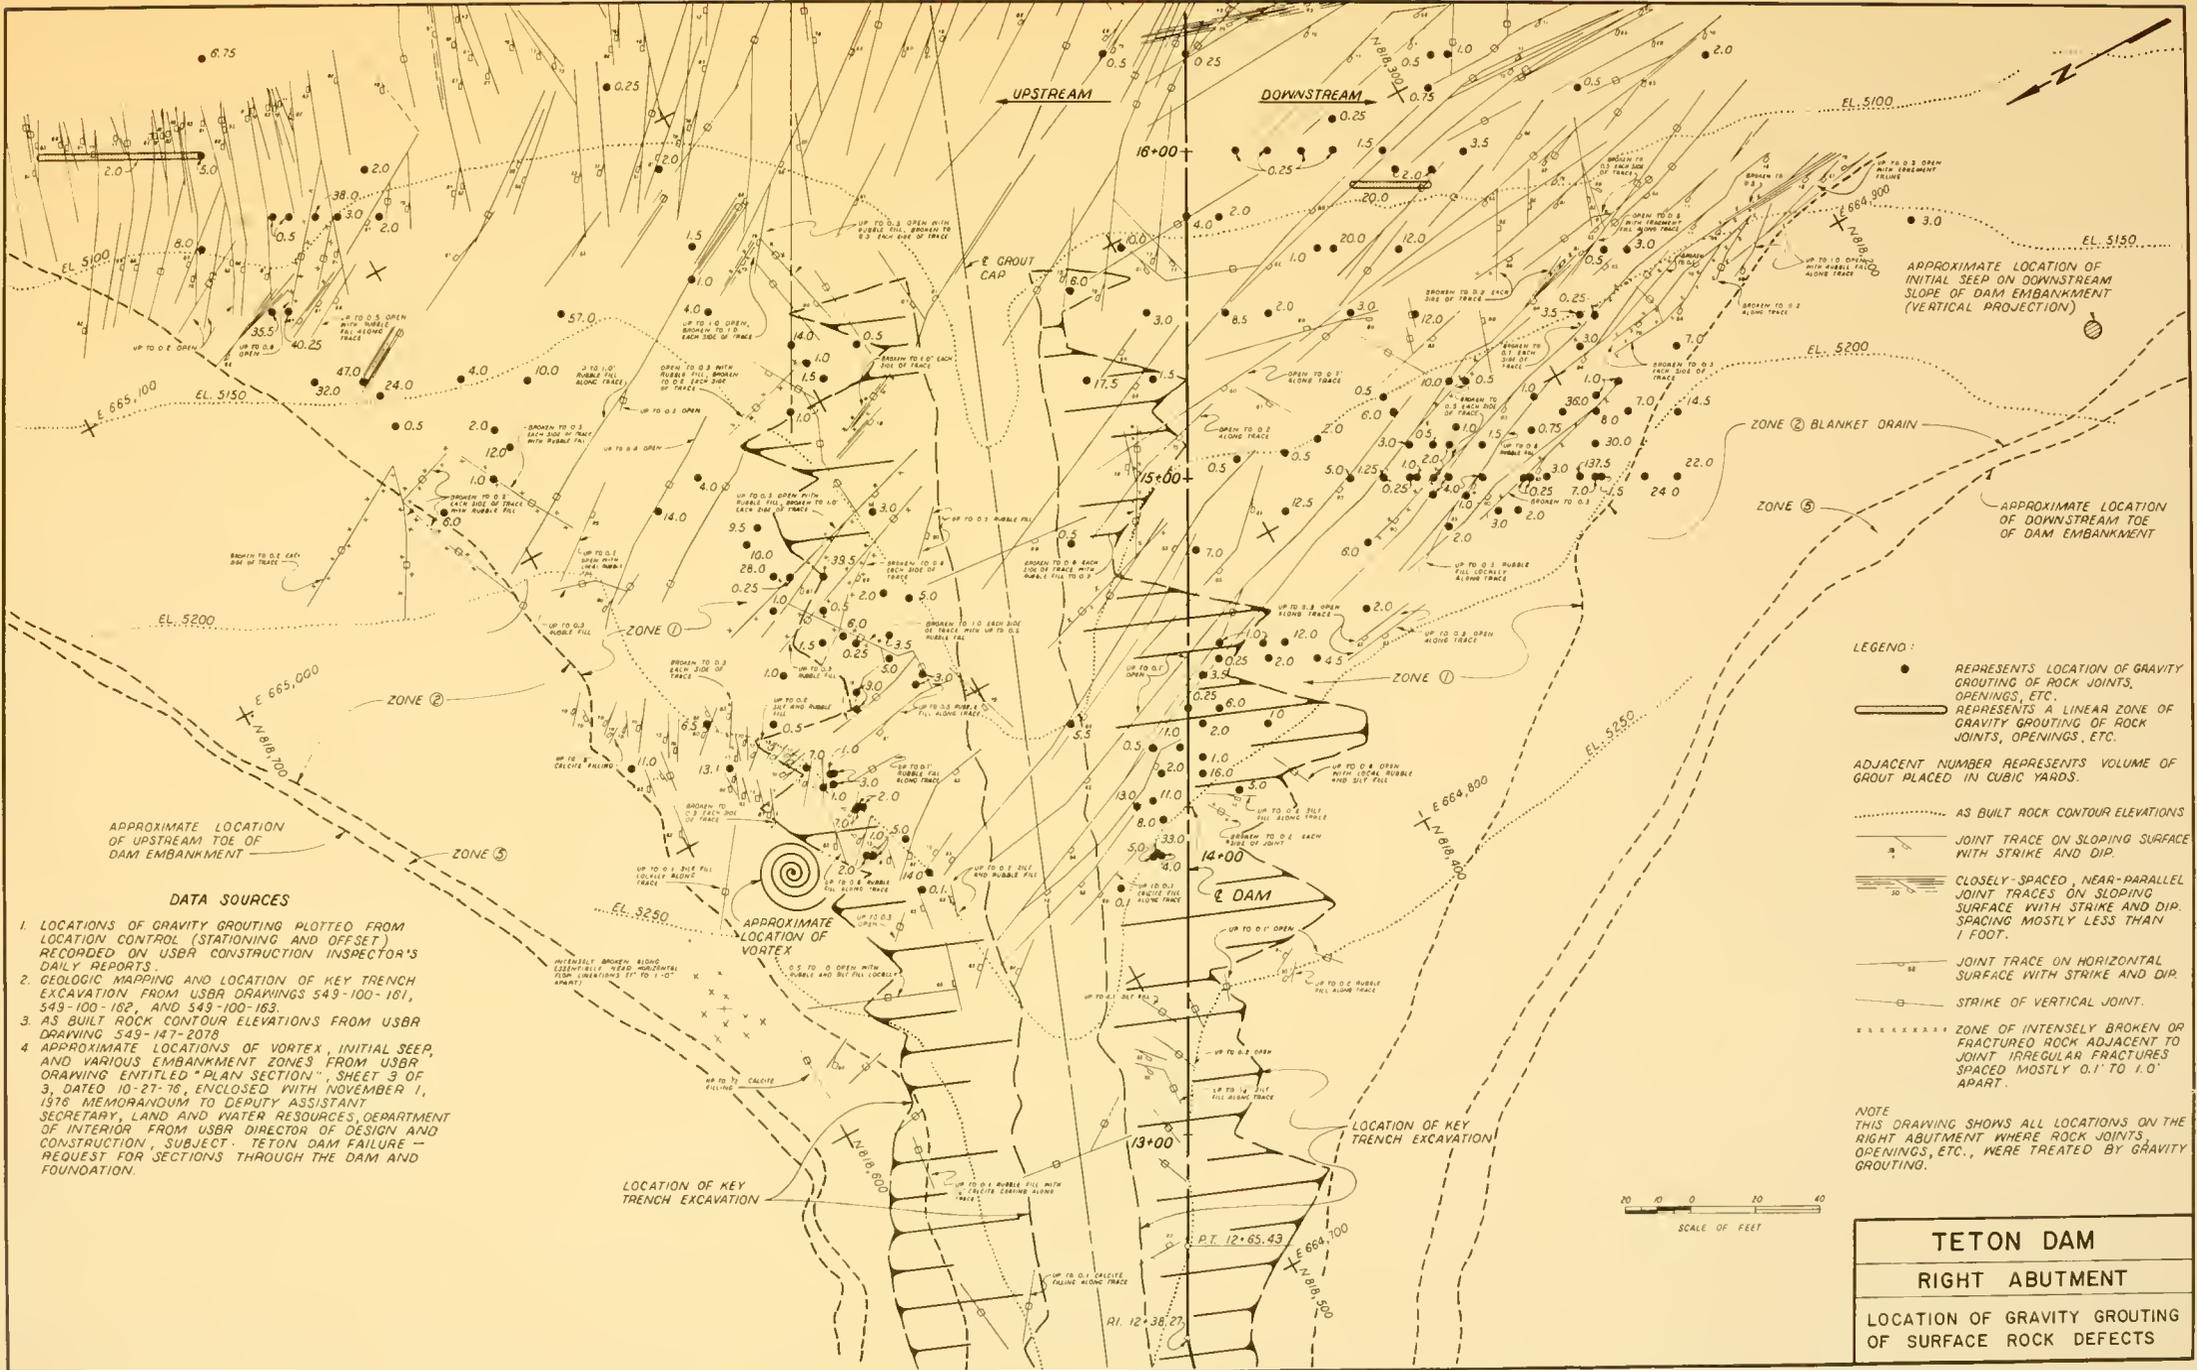
- DATA SOURCES**
1. LOCATIONS OF GRAVITY GROUTING PLOTTED FROM LOCATION CONTROL (STRIKE AND OFFSET) RECORDED ON USBR CONSTRUCTION INSPECTOR'S DAILY REPORTS.
  2. GEOLOGIC MAPPING AND LOCATION OF KEY TRENCH EXCAVATION FROM USBR DRAWINGS 549-100-161, 549-100-162, AND 549-100-163.
  3. AS BUILT ROCK CONTOUR ELEVATIONS FROM USBR DRAWING 549-147-2078.
  4. APPROXIMATE LOCATIONS OF VORTEX, INITIAL SEEP, AND VARIOUS EMBANKMENT ZONES FROM USBR DRAWING ENTITLED "PLAN SECTION", SHEET 3 OF 3, DATED 10-27-76, ENCLOSED WITH NOVEMBER 1, 1976 MEMORANDUM TO DEPUTY ASSISTANT SECRETARY LAND AND WATER RESOURCES, DEPARTMENT OF INTERIOR FROM USBR DIRECTOR OF DESIGN AND CONSTRUCTION, SUBJECT: TETON DAM FAILURE - REQUEST FOR SECTIONS THROUGH THE DAM AND FOUNDATION.

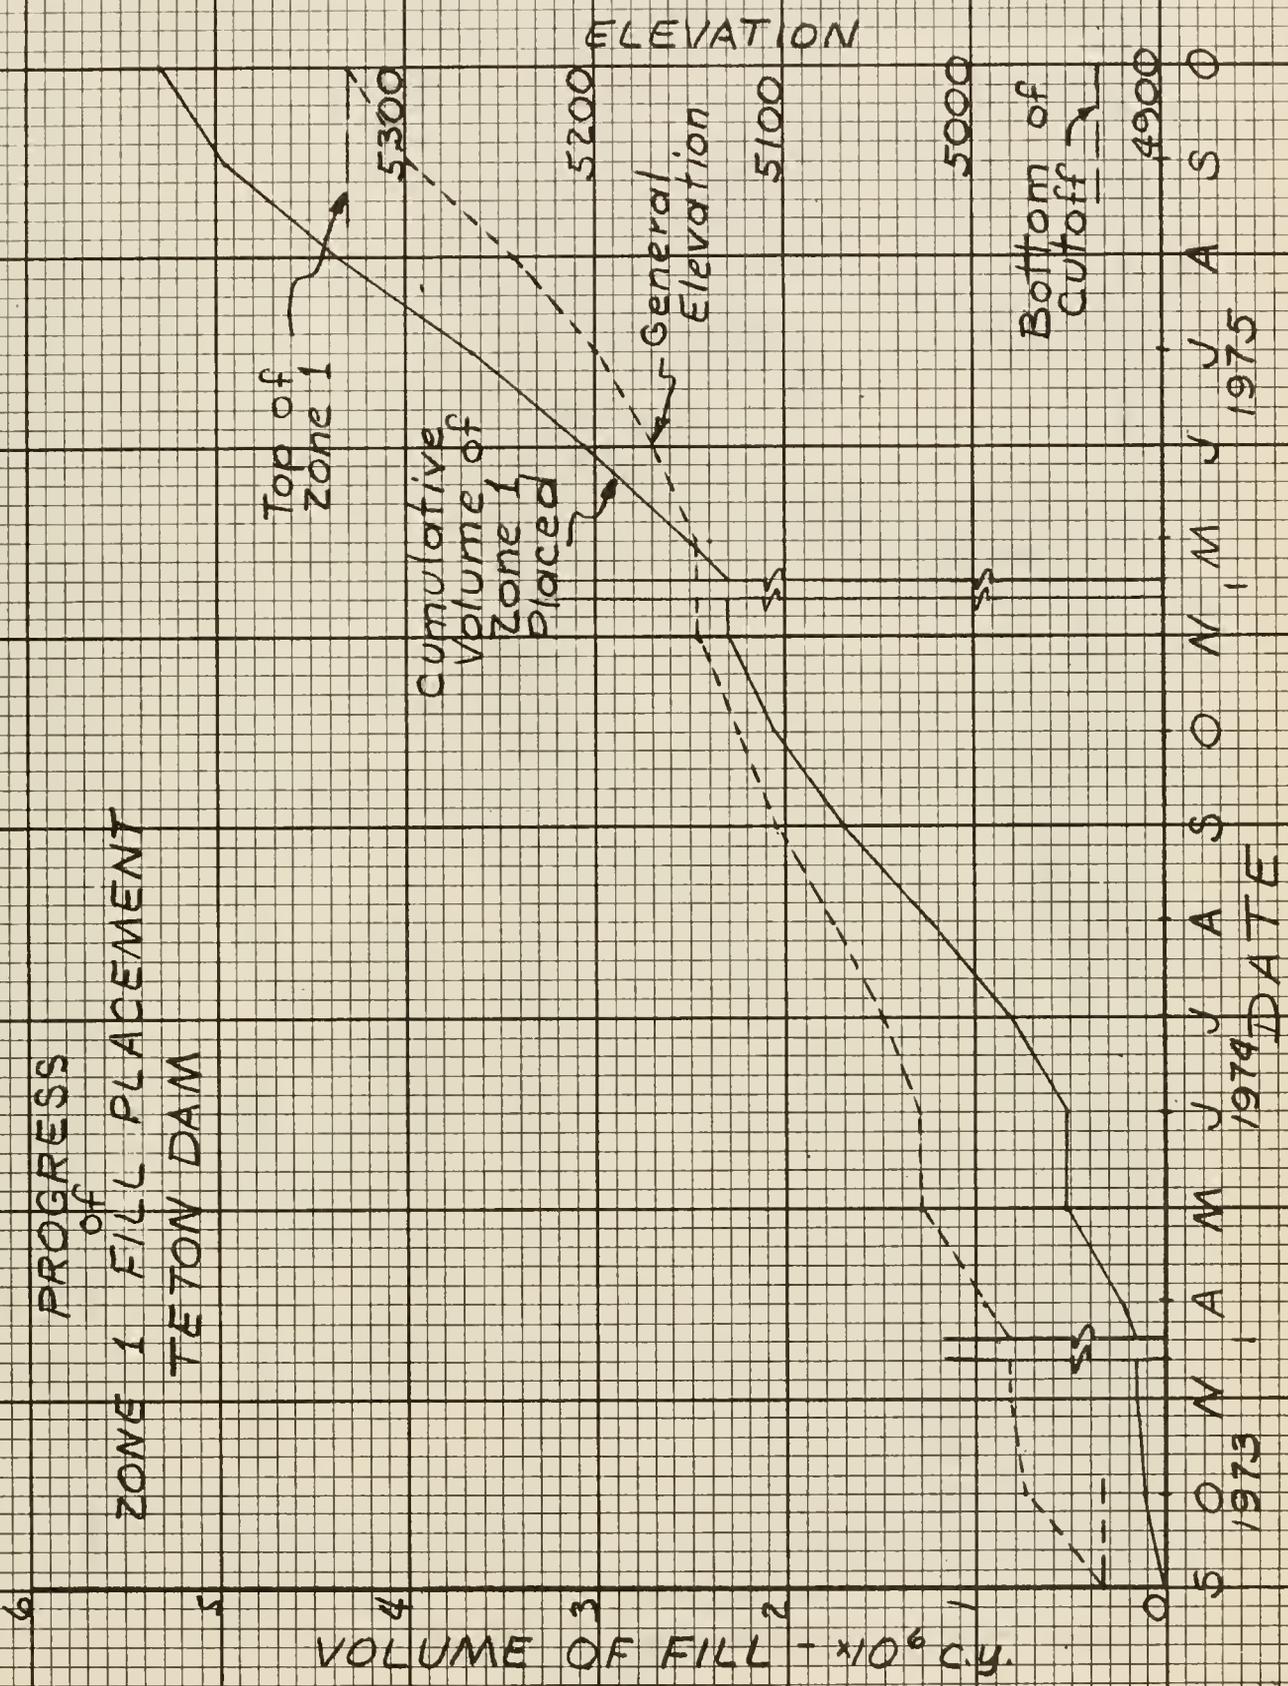
PROGRESS  
of  
ZONE 1 FILL PLACEMENT  
TETON DAM

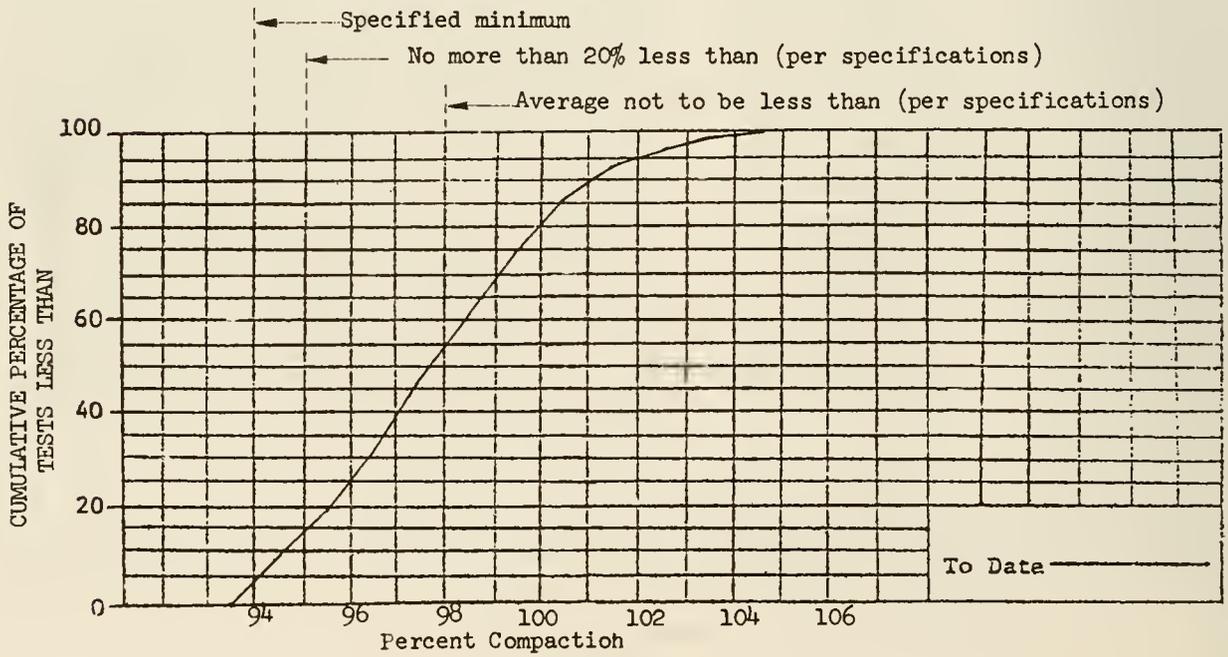
Prev.	This Period	To Date
Avg. fill dry density, $\gamma_{df}$ , pcf			99.1
Avg. maximum dry density, $\gamma_{dL}$ , pcf (Lab.)			100.8
Mean percentage of lab. max. dry density			98.3

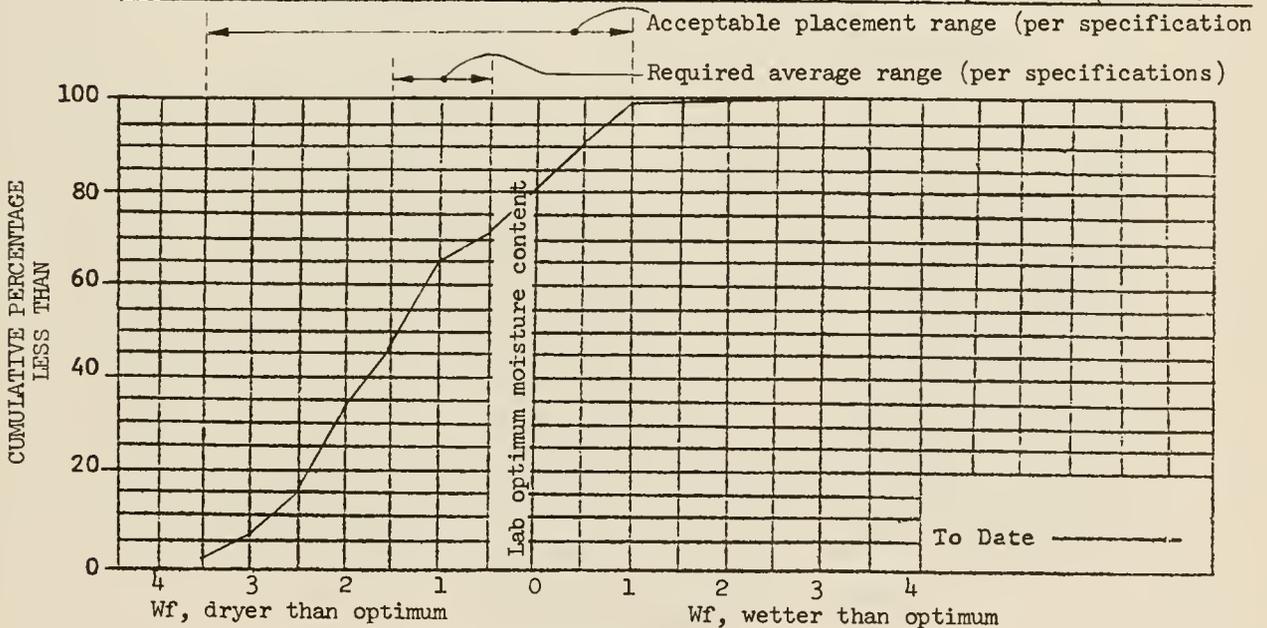
Prev.	This Period	To Date
Avg. fill moisture content, W <sub>f</sub> , %			18.5
Avg. optimum moisture content, W <sub>o</sub> , %			19.6
Mean variation from optimum moisture content			1.1 Dry

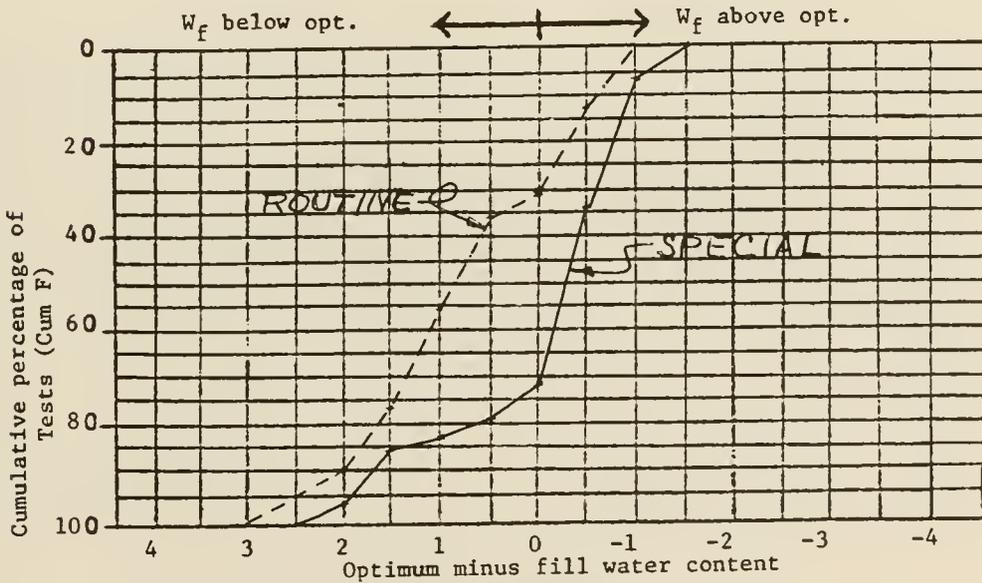
SPECIAL			ROUTINE		
		F*	Cum F	Cum %	F*	Cum F	Cum %
W <sub>f</sub> is above opt.	4.2 - 3.8						
	3.7 - 3.3						
	3.2 - 2.8						
	2.7 - 2.3						
	2.2 - 1.8						
	1.7 - 1.3			0			
	1.2 - 0.8	2	2	7			0
	0.7 - 0.2	8	10	34	5	5	13
+0.2 to -0.2		11	21	72	7	12	31
W <sub>f</sub> is below opt.	0.3 - 0.7	2	23	79	2	14	36
	0.8 - 1.2	1	24	83	8	22	56
	1.3 - 1.7	1	25	86	8	30	77
	1.8 - 2.2	3	28	97	5	35	90
	2.3 - 2.7	1	29	100	2	37	95
	2.8 - 3.2				2	39	100
	3.3 - 3.7						
Totals		29	-	-	39	-	-

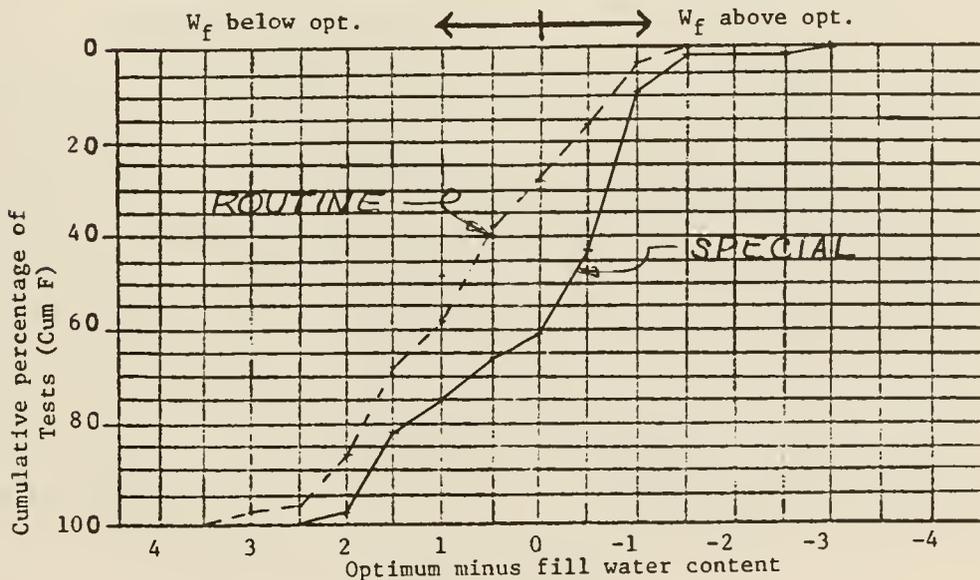
\*F = Frequency distribution of tests  
Figure D5-9

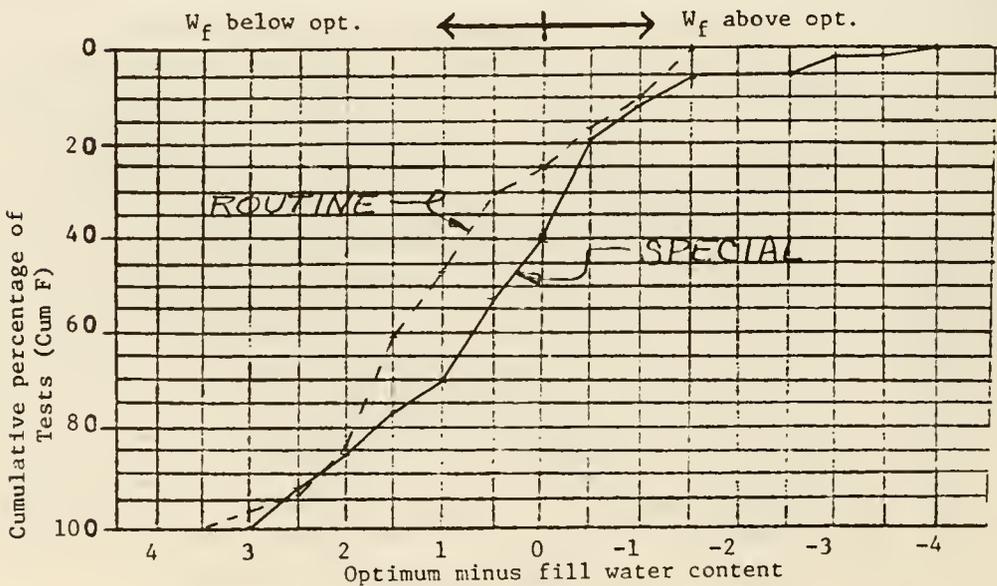
SPECIAL			ROUTINE		
		F*	Cum F	Cum %	F*	Cum F	Cum %
		F*	F	%	F*	F	%
W <sub>f</sub> is above opt.	4.2 - 3.8			0			
	3.7 - 3.3	1	1	2			
	3.2 - 2.8		1	2			
	2.7 - 2.3	1	2	5			
	2.2 - 1.8		2	5			
	1.7 - 1.3		2	5			0
	1.2 - 0.8	3	5	12	15	15	10
	0.7 - 0.2	3	8	19	12	27	17
±0.2 to -0.2	9	17	40	11	38	25	
W <sub>f</sub> is below opt.	0.3 - 0.7	6	23	53	9	47	30
	0.8 - 1.2	7	30	70	26	73	47
	1.3 - 1.7	3	33	77	22	95	61
	1.8 - 2.2	4	37	86	35	130	84
	2.3 - 2.7	3	40	93	15	145	94
	2.8 - 3.2	3	43	100	5	150	97
	3.3 - 3.7				5	155	100
Totals		43	-	-	155	-	-

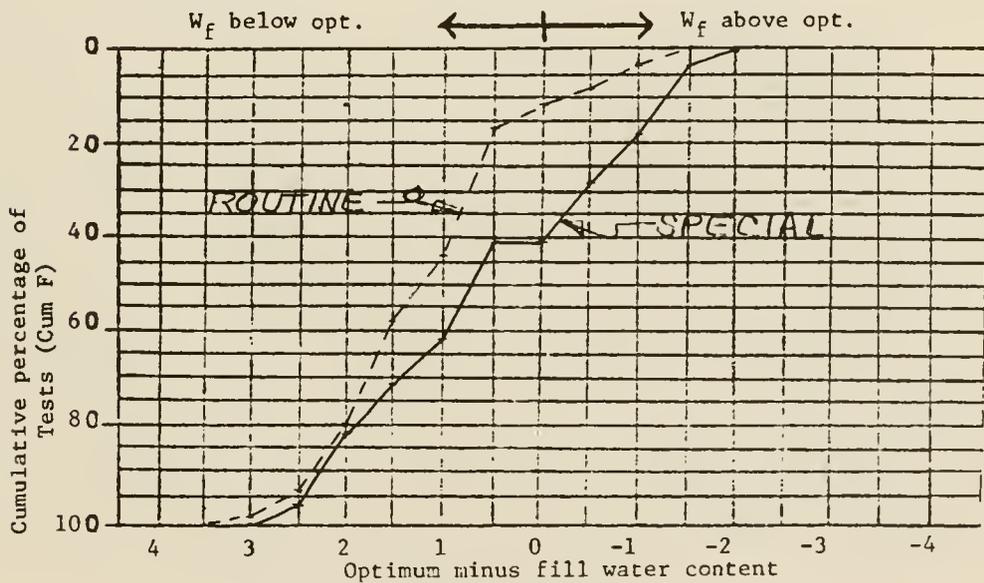
\*F = Frequency distribution of tests  
 Figure D5-11

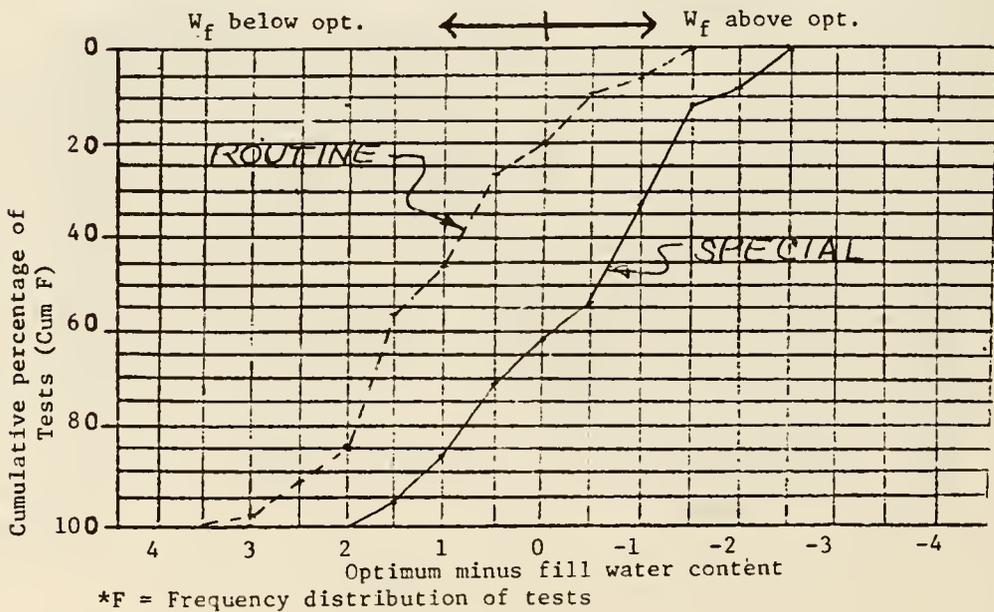
Figure D5-14  
D-120

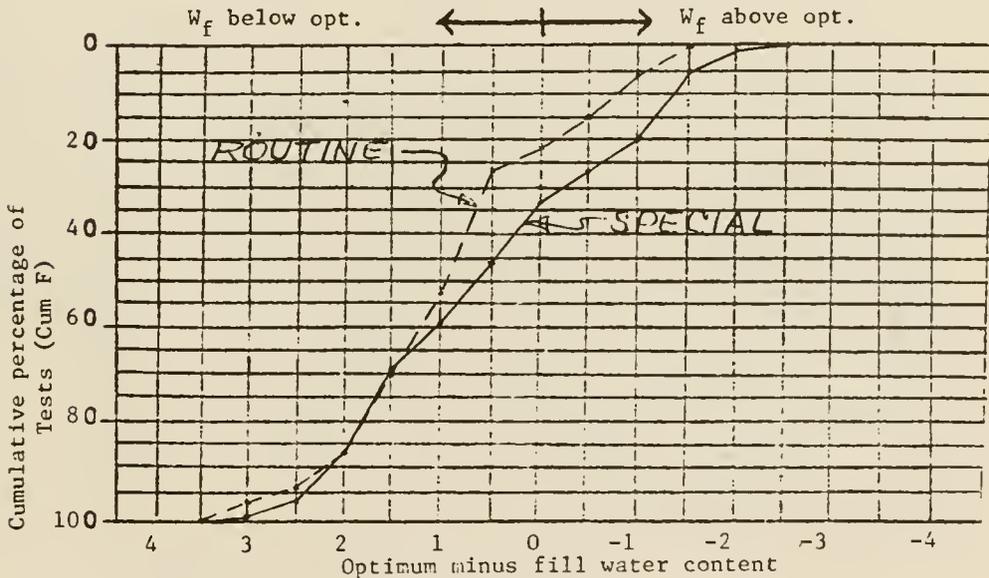
\*F = Frequency distribution of tests  
Figure D5-17

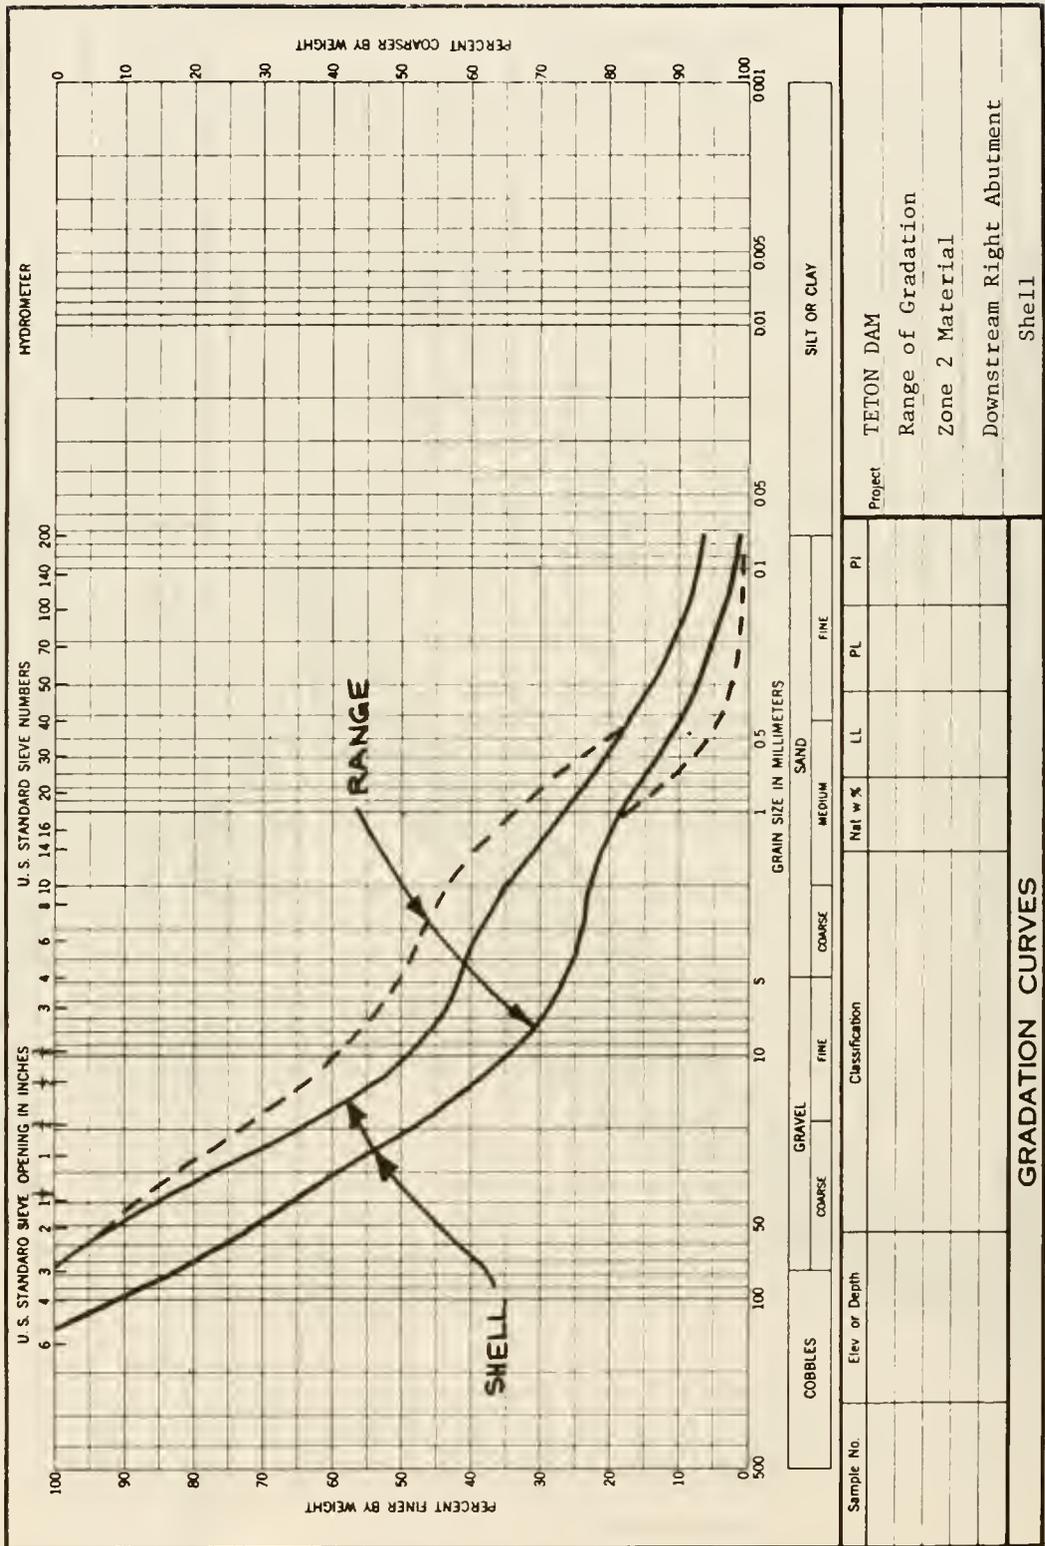
E&RC = Engineering and Research Center, USBR, Denver, Colorado

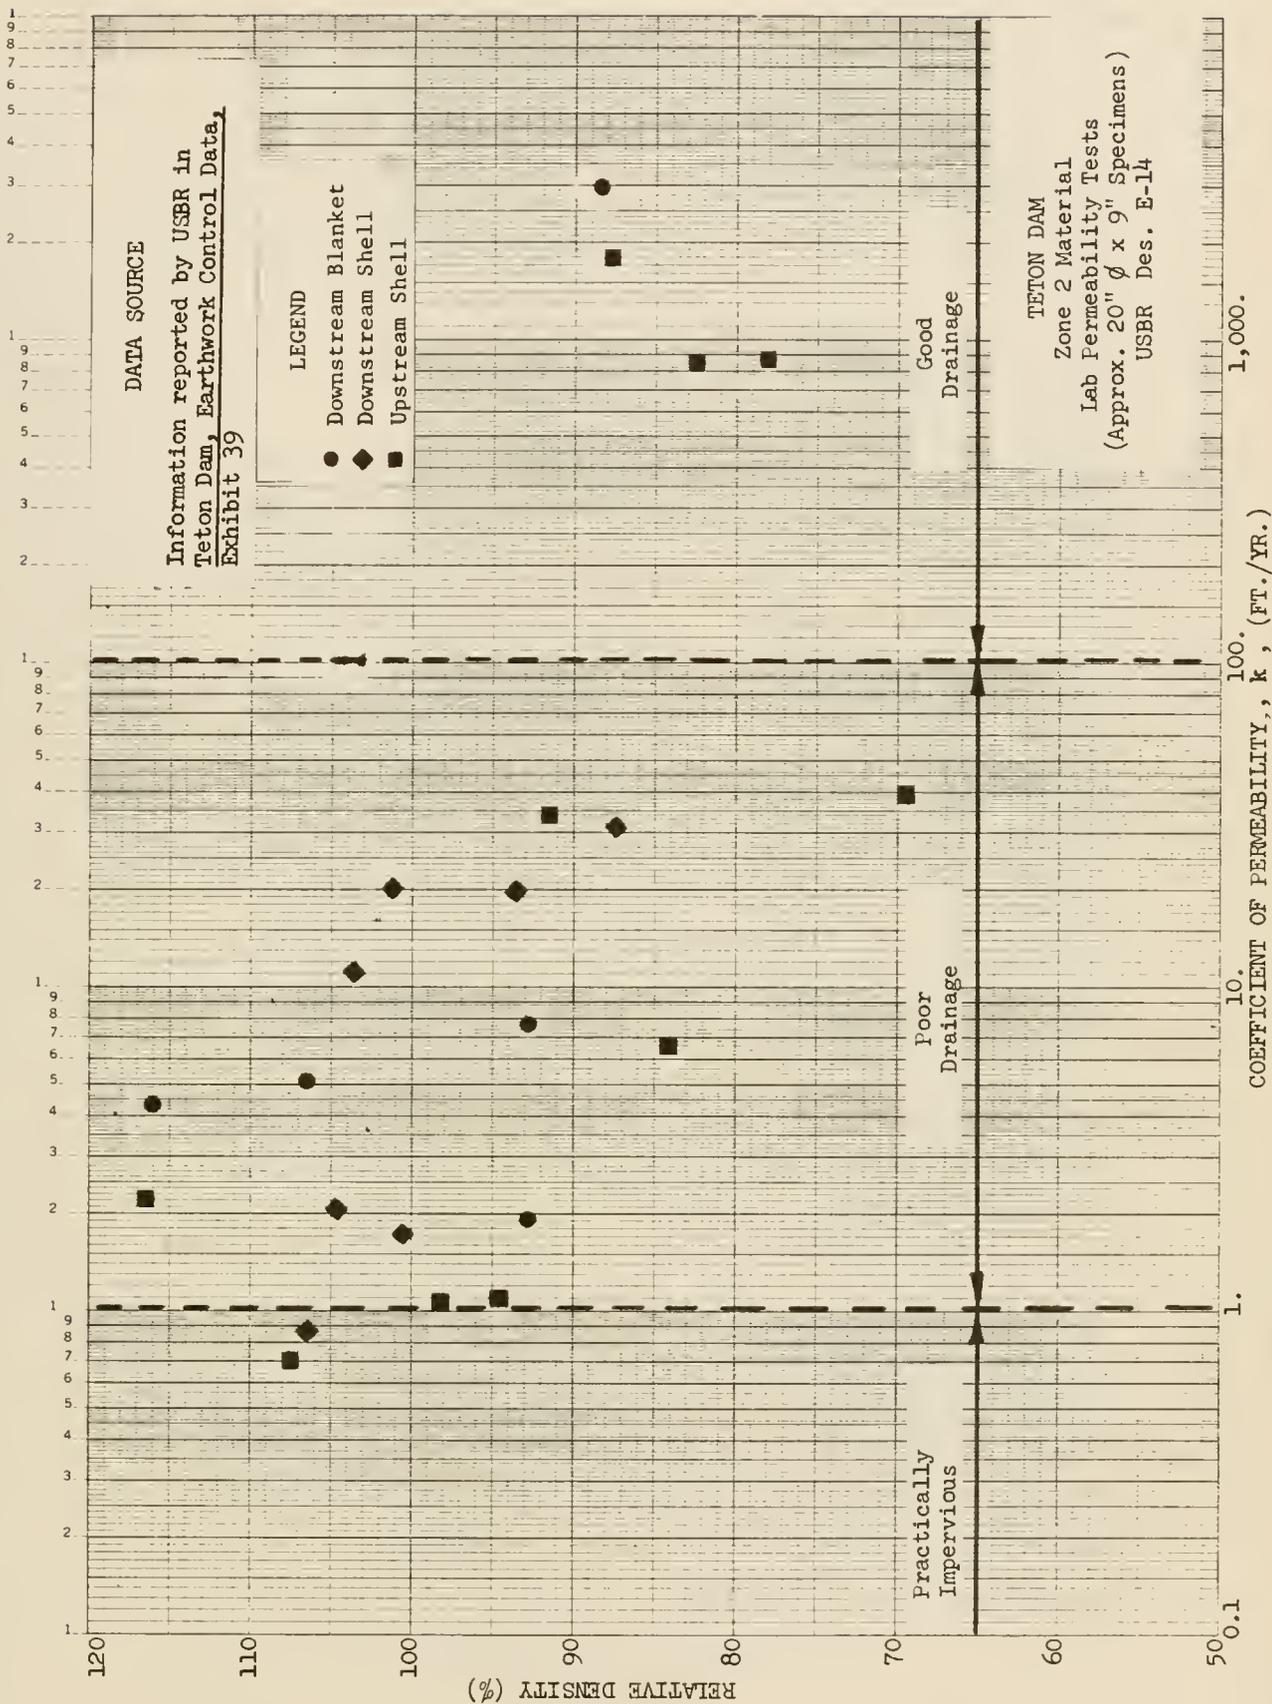
Figure D5-25  
D-131
