603  
I 1.2'  
T29/2

BOSTON PUBLIC LIBRARY  
3 9999 06317 343 7

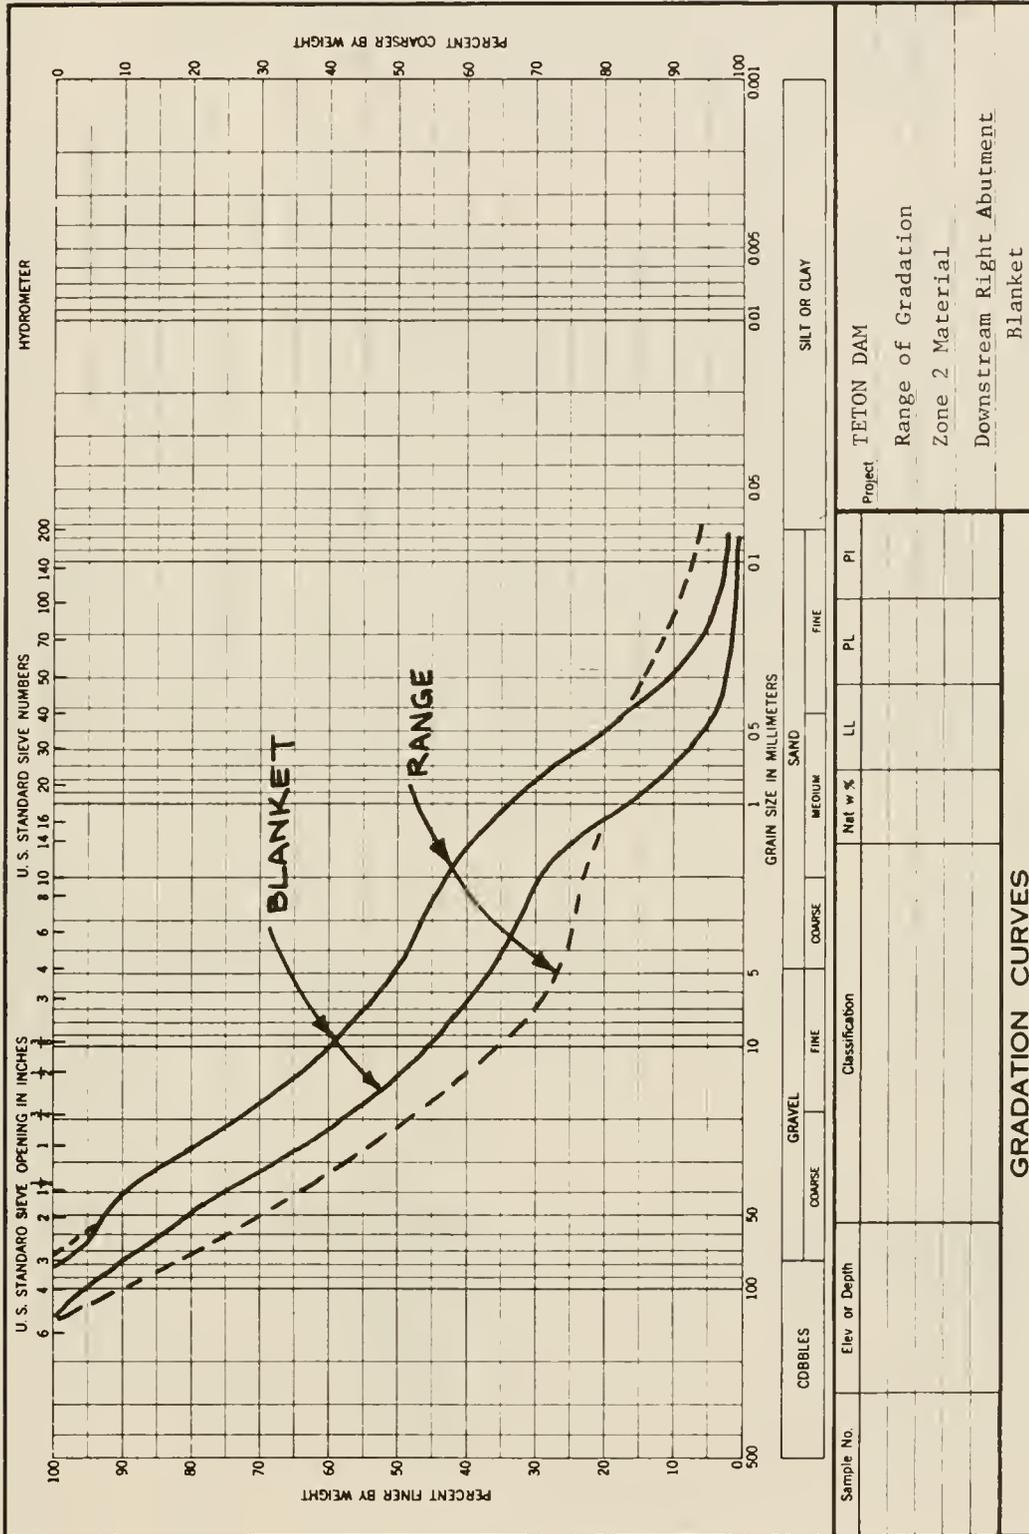
Note:  
 NA = Not available  
 L-29 = Monthly Construction Reports  
 Control = Based on Earthwork Control Data  
 D = Percentage of maximum standard compacted density  
 Special = Control tests on specially compacted earthfill  
 Routine = Control tests on zone 1 fill not including specially compacted earthfill  
 $w_o - w_f$  = Moisture content at optimum minus compacted field moisture  
 E&RC = Engineering and Research Center, USBR, Denver, Colorado

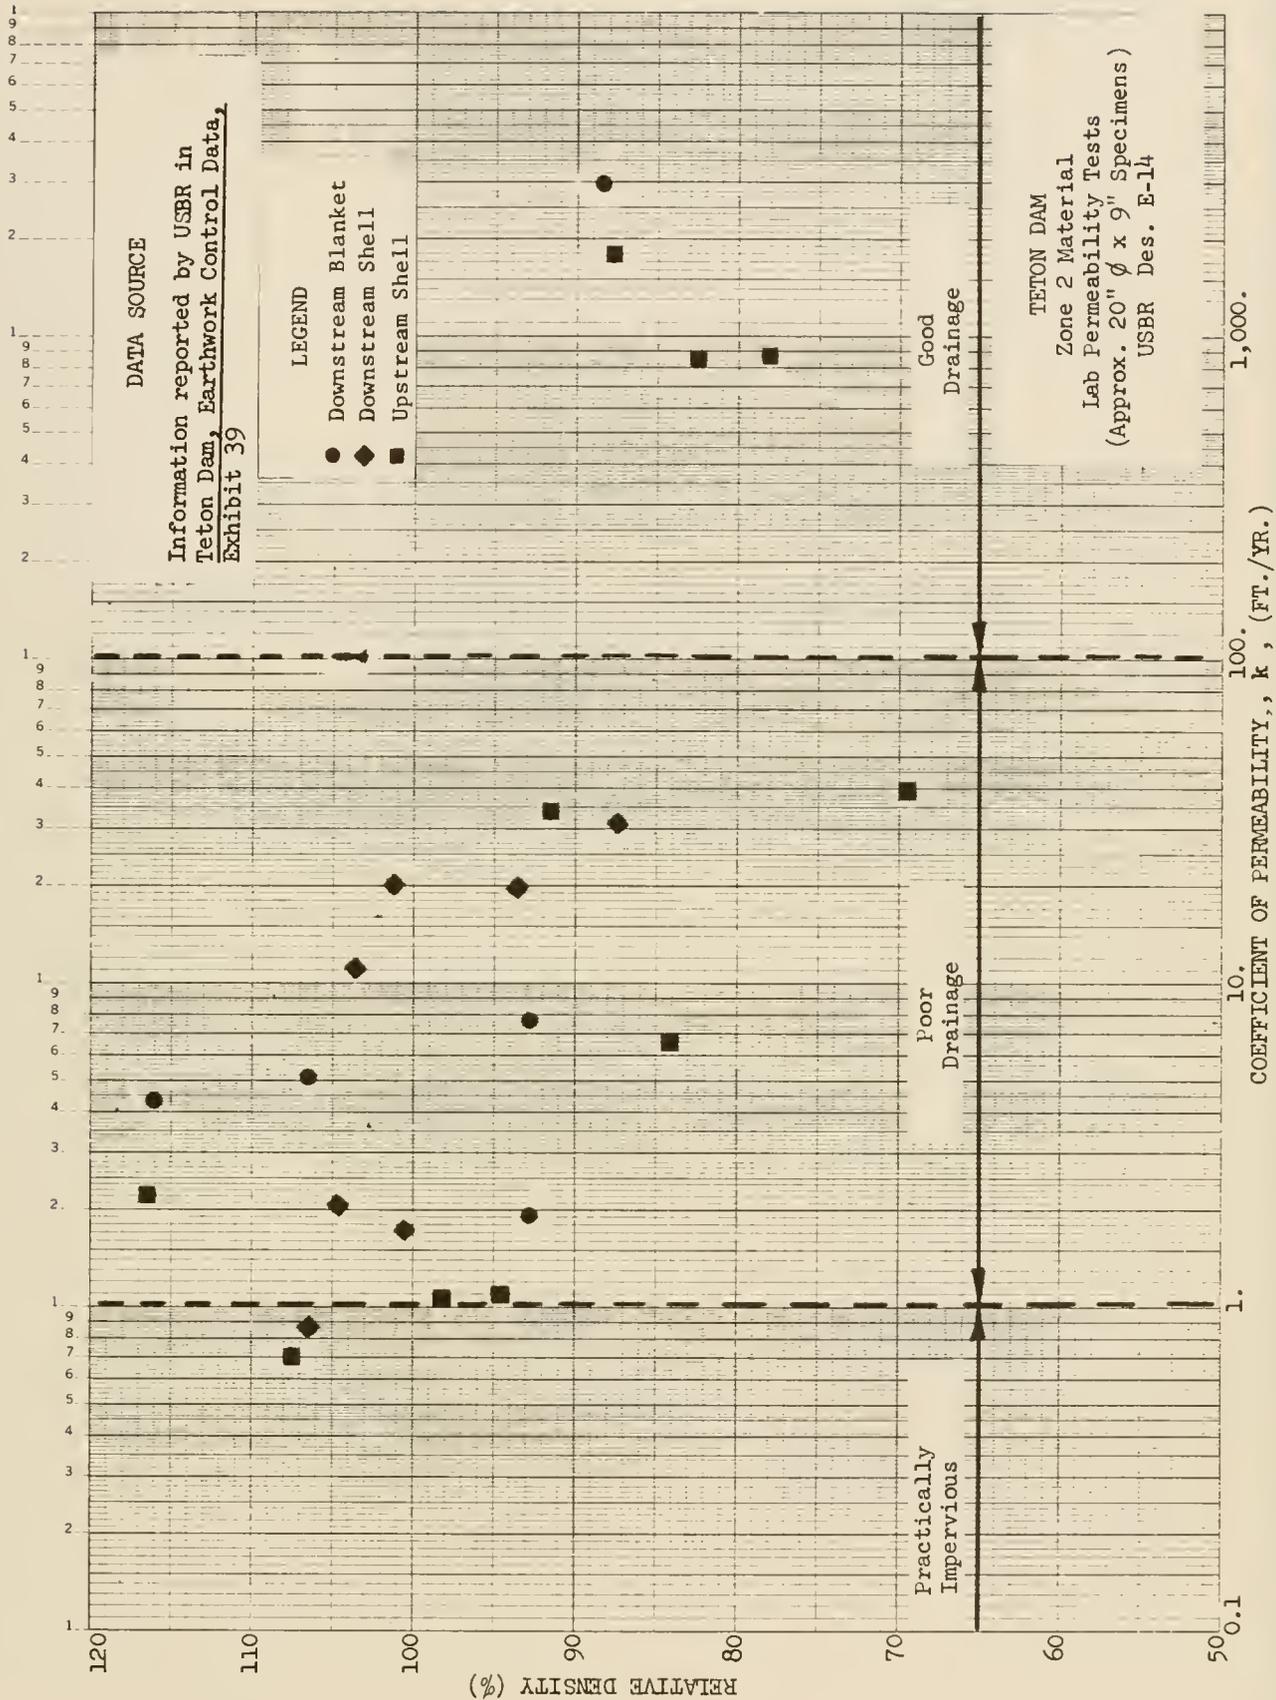
Figure D5-25  
D-131

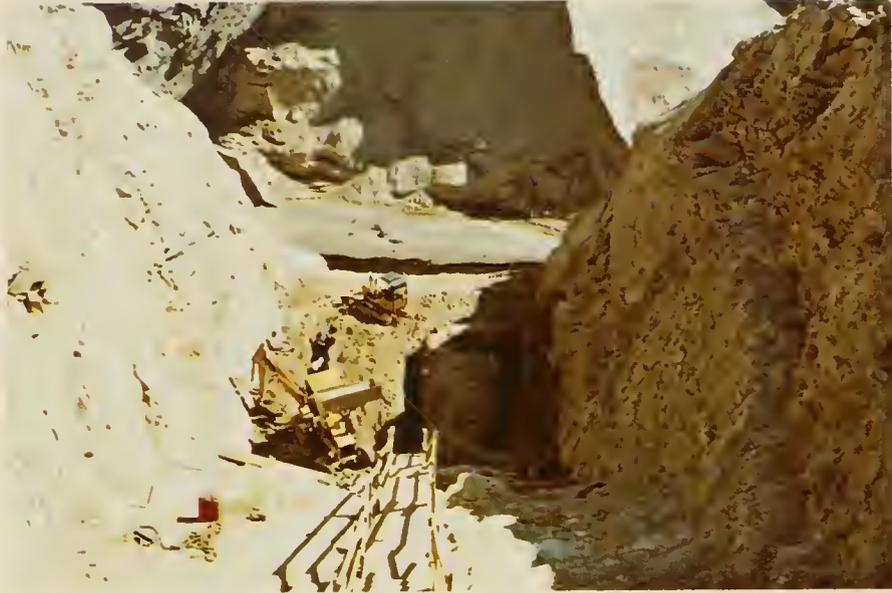
Fig. 3-1 Exploration trenches

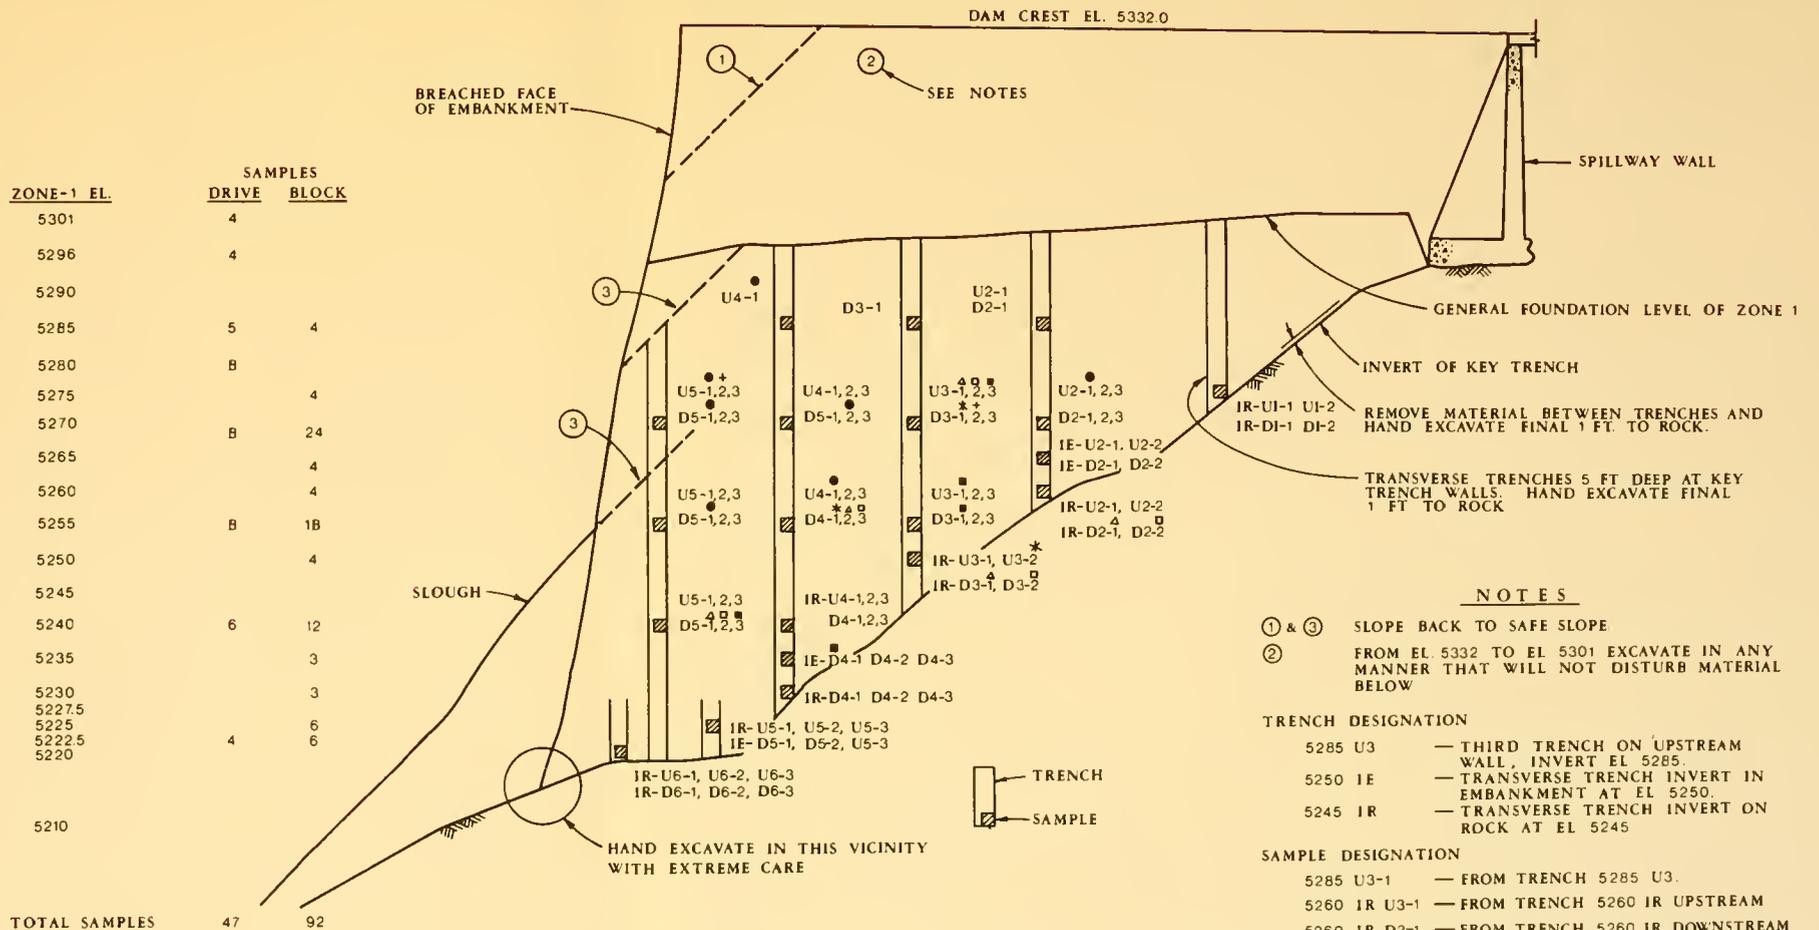
- NOTES**
- ① & ③ SLOPE BACK TO SAFE SLOPE
- ② FROM EL. 5332 TO EL. 5301 EXCAVATE IN ANY MANNER THAT WILL NOT DISTURB MATERIAL BELOW
- TRENCH DESIGNATION**
- 5285 U3 — THIRD TRENCH ON UPSTREAM WALL, INVERT EL. 5285.
- 5250 IE — TRANSVERSE TRENCH INVERT IN EMBANKMENT AT EL. 5250.
- 5245 IR — TRANSVERSE TRENCH INVERT ON ROCK AT EL. 5245.
- SAMPLE DESIGNATION**
- 5285 U3-1 — FROM TRENCH 5285 U3.
- 5260 IR U3-1 — FROM TRENCH 5260 IR UPSTREAM
- 5260 IR D3-1 — FROM TRENCH 5260 IR DOWNSTREAM
- TRENCH AND SAMPLE LOCATIONS ARE SCHEMATIC ONLY

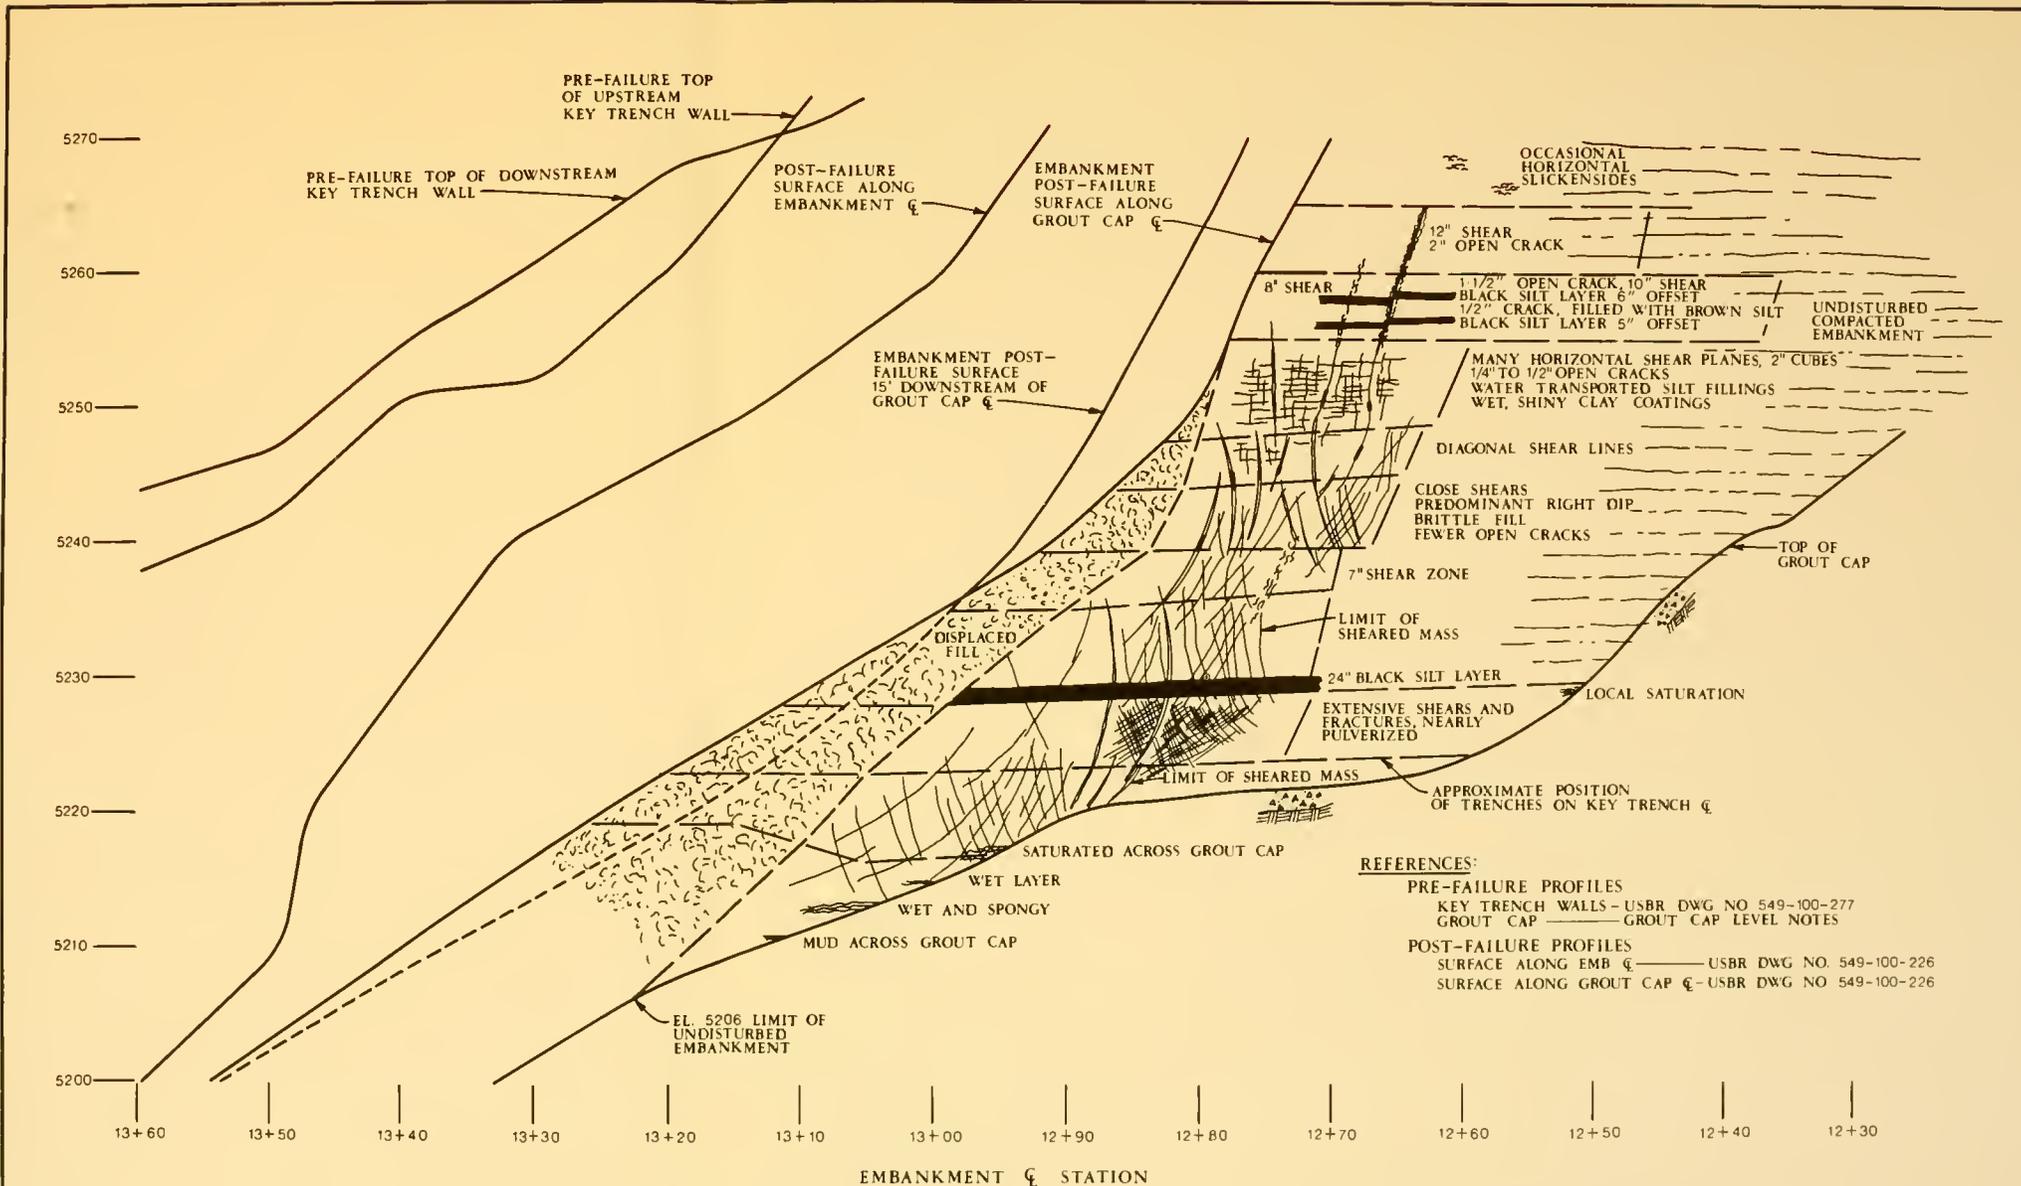
LONGITUDINAL EXPLORATION TRENCHES  
GENERAL OBSERVATIONS

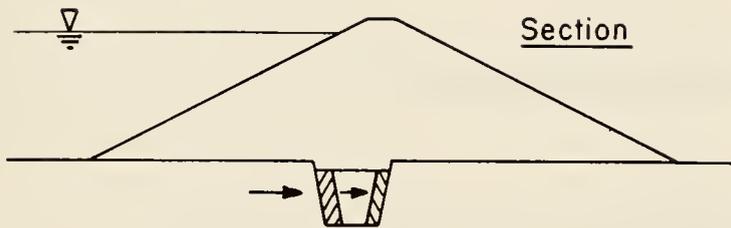
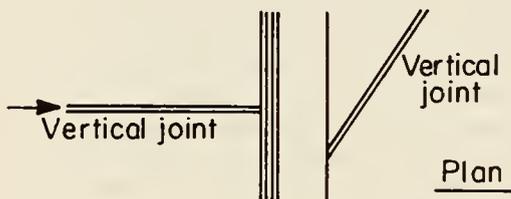
1. Flow in vertical upstream joint to face of key trench followed by longitudinal hydraulic fracturing of fill near face of trench allowing water to spread along face

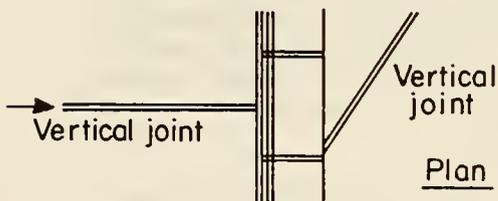
2. Transverse hydraulic fracturing producing multiple fractures through soil in key trench and giving water access to downstream side of trench (may occur before Step 1)

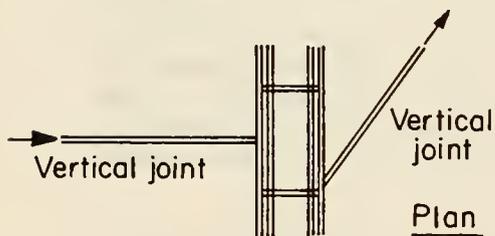
3. Longitudinal hydraulic fracturing of soil near downstream face of key trench allowing water to spread along face and find egress through open downstream joints in rock

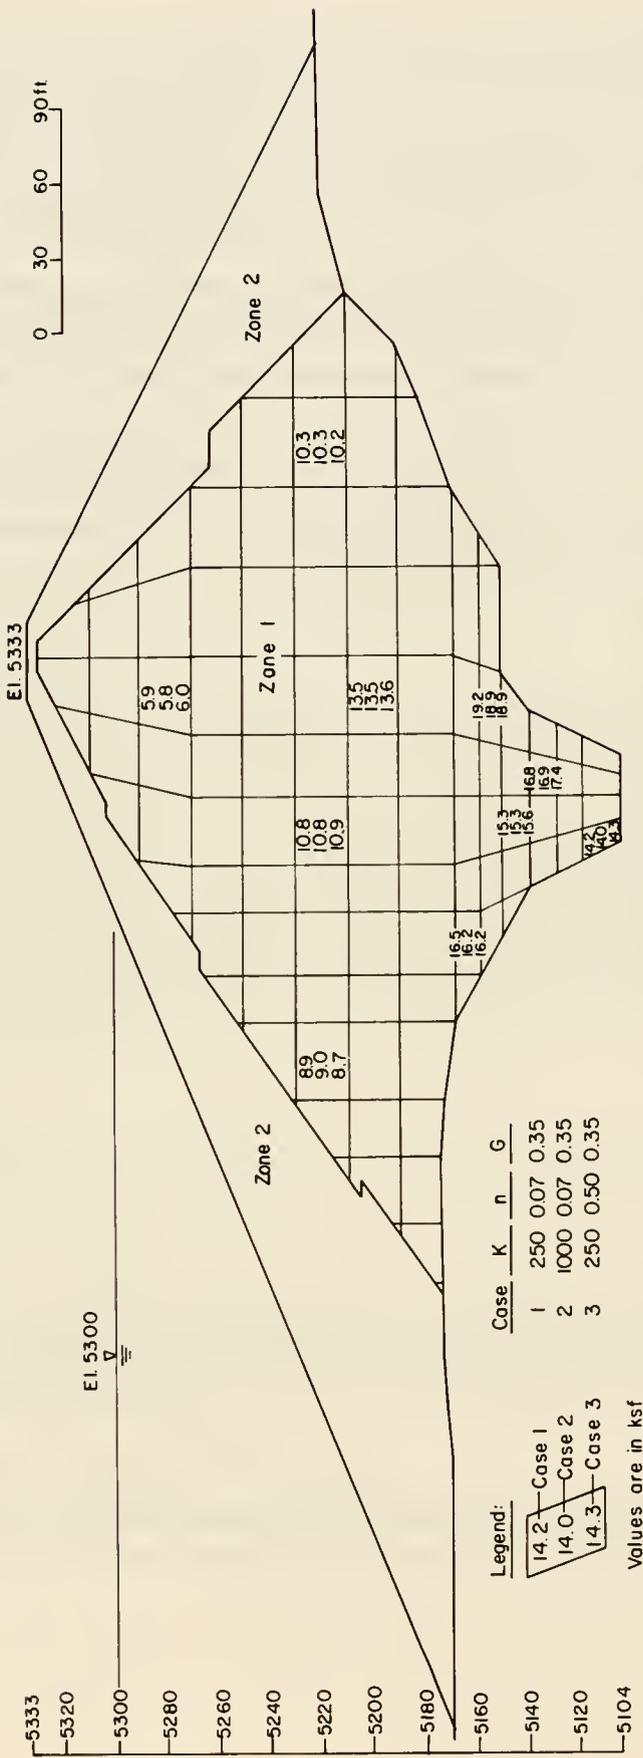
FIG. 2 EFFECT OF VARIATIONS IN PARAMETERS K AND n  
 ON COMPUTED VALUES OF MAJOR PRINCIPAL  
 STRESS AT STA. I5+00

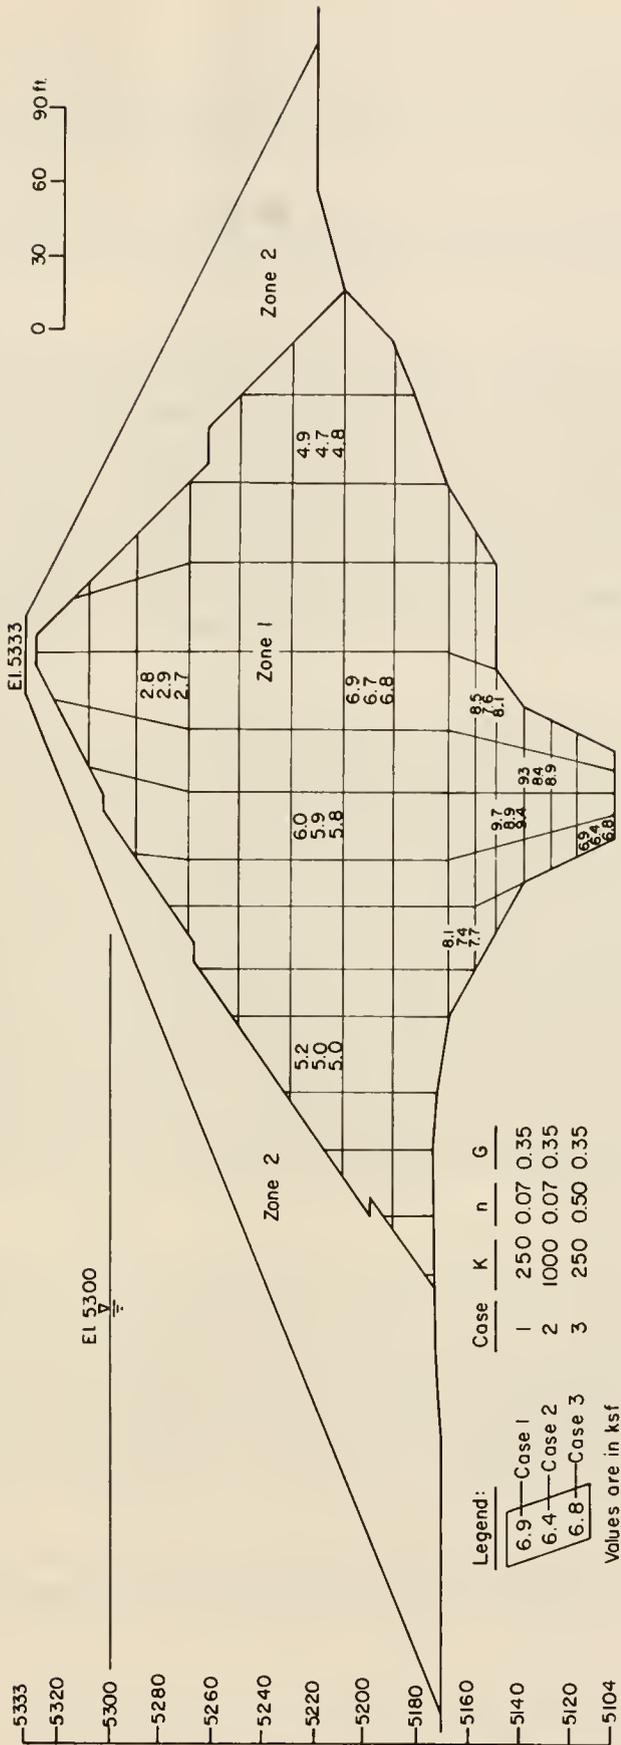
**FIG.3** EFFECT OF VARIATIONS IN PARAMETERS K AND n ON COMPUTED VALUES OF MINOR PRINCIPAL STRESS IN TRANSVERSE PLANE AT STA. 15+00

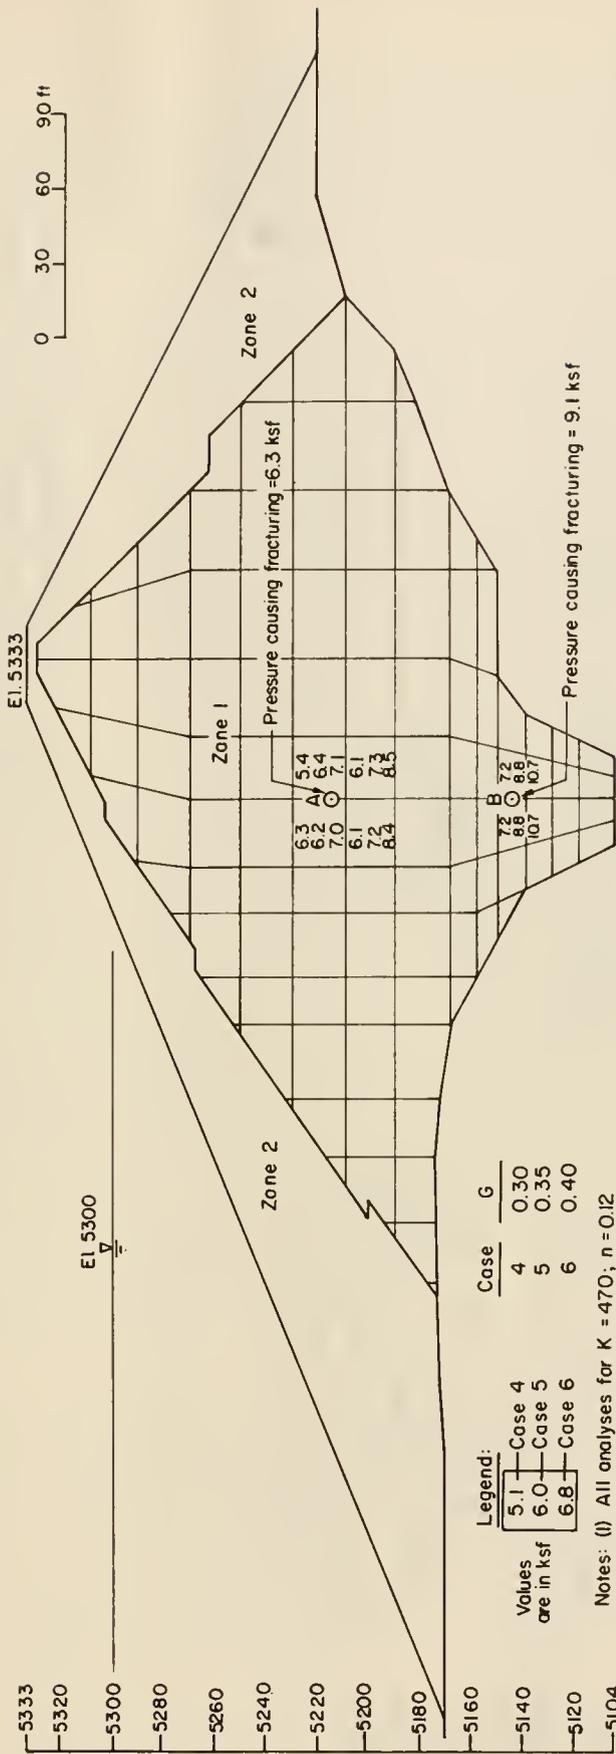
**FIG. 4** EFFECT OF VARIATIONS IN PARAMETER G  
 ON COMPUTED VALUES OF SUM OF MINOR  
 PRINCIPAL STRESS AND TENSILE STRENGTH  
 OF SOIL- STA. 15+00 KEY TRENCH ASSUMED  
 TO BE UNWETTED

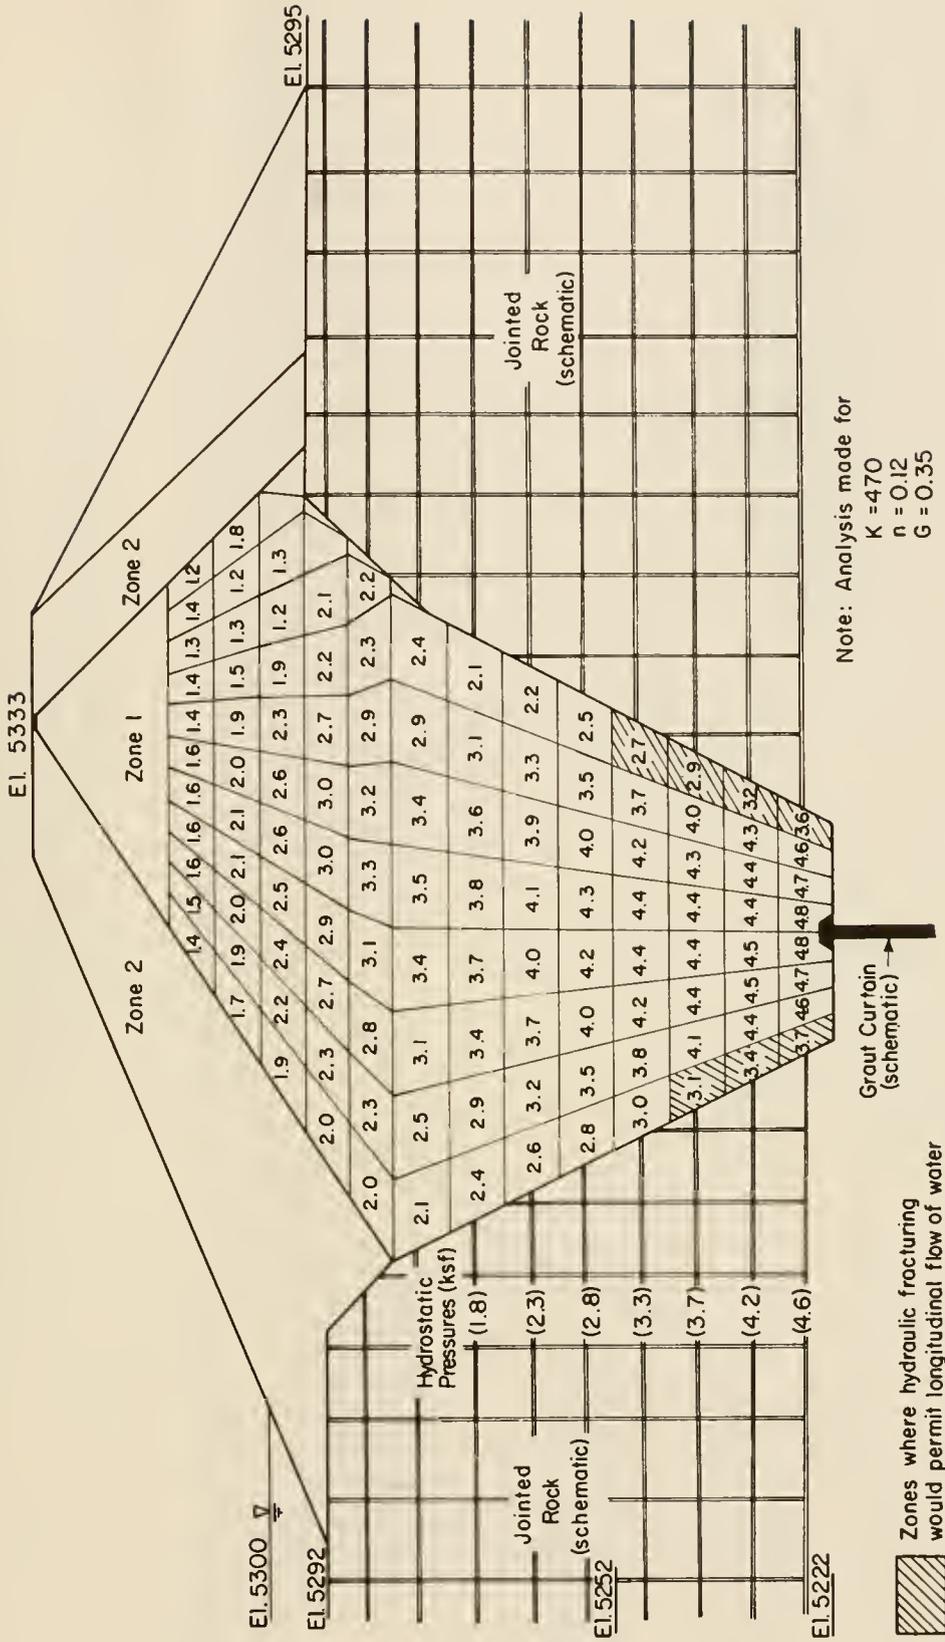
**FIG. 7** COMPUTED VALUES OF MINOR PRINCIPAL STRESS  
 IN PLANE OF SECTION ksf STA. 12+70

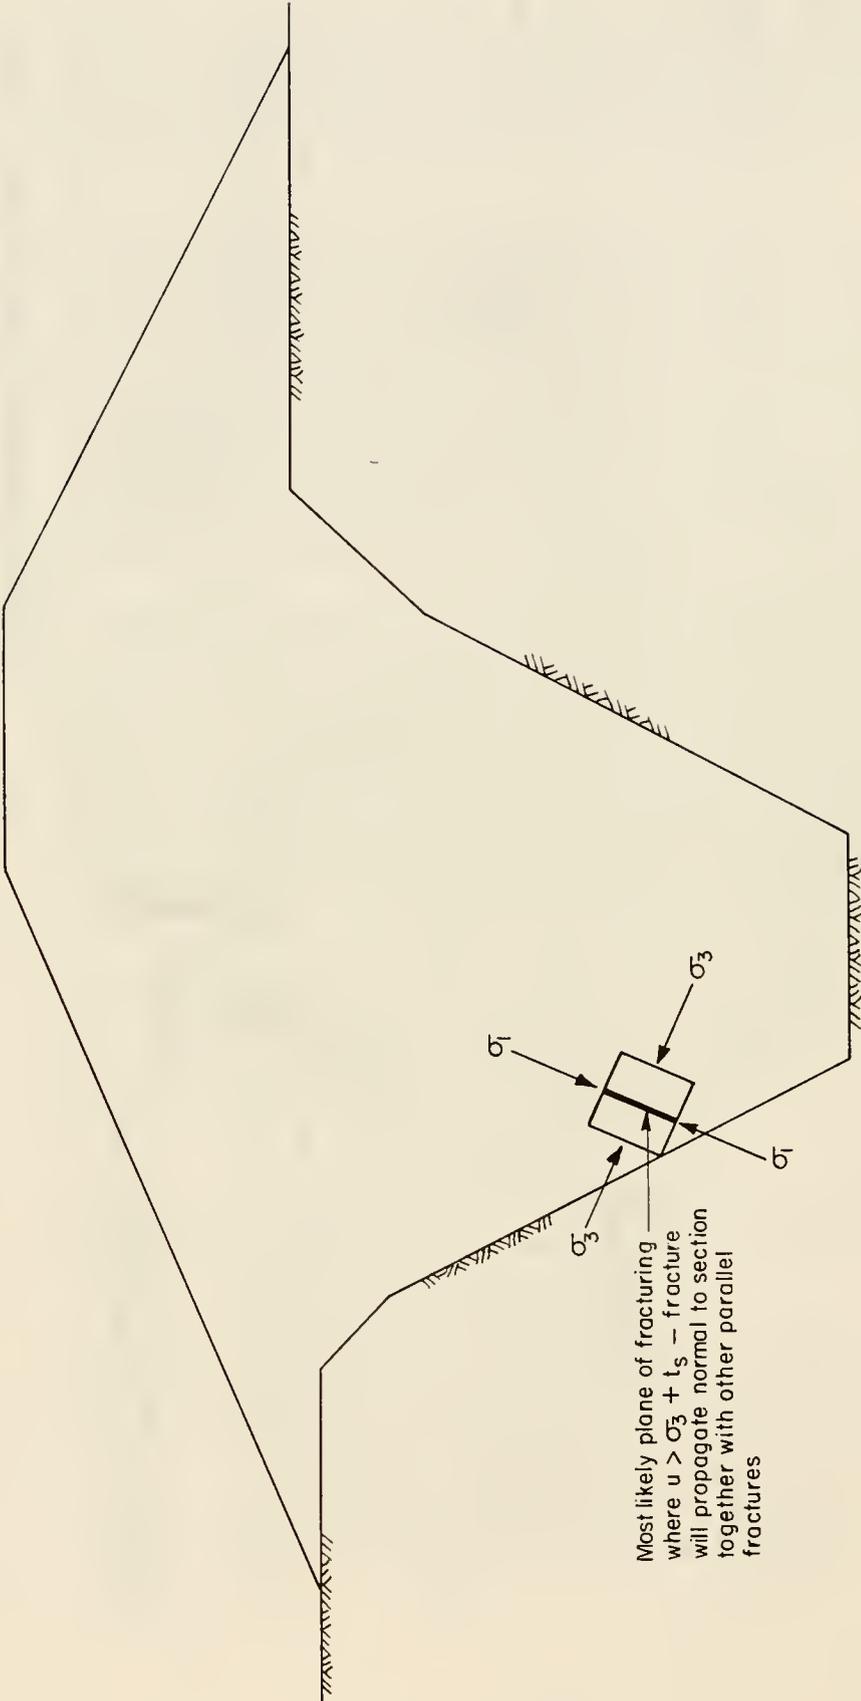
Most likely plane of fracturing  
 where  $\sigma_1 > \sigma_3 + t_s$  - fracture  
 will propagate normal to section  
 together with other parallel  
 fractures

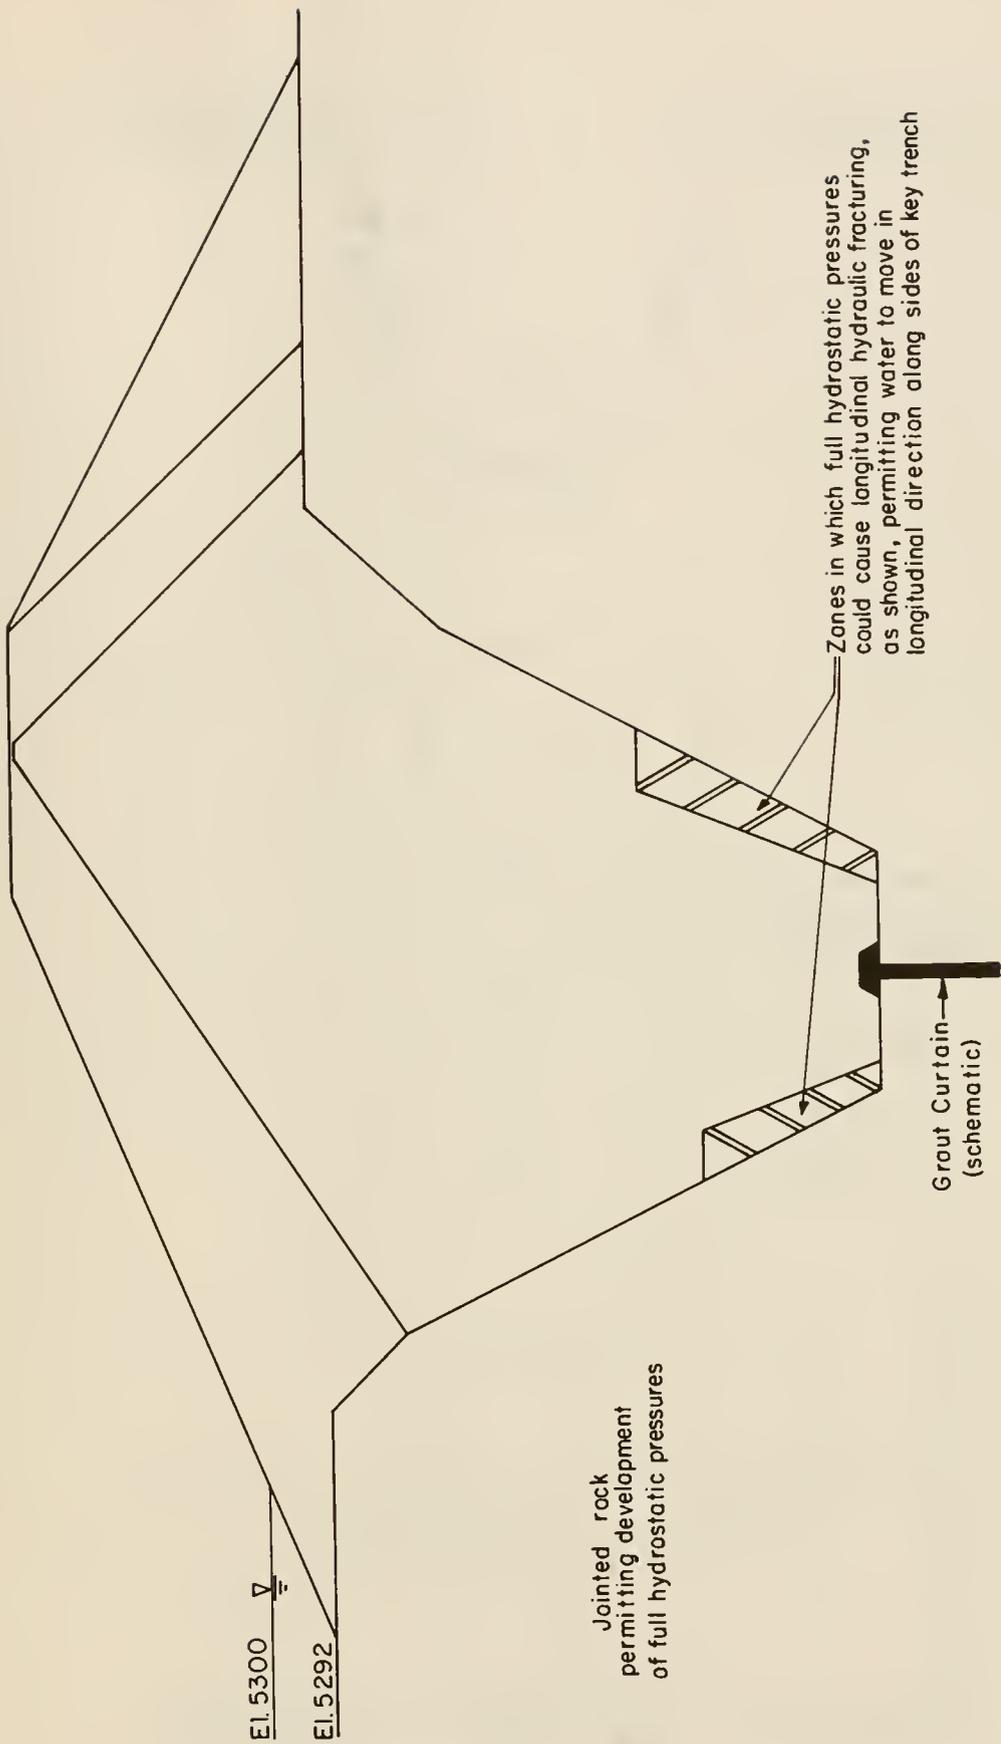
FIG. 9 ZONES OF POTENTIAL LONGITUDINAL FRACTURING AT STA. 12 + 70

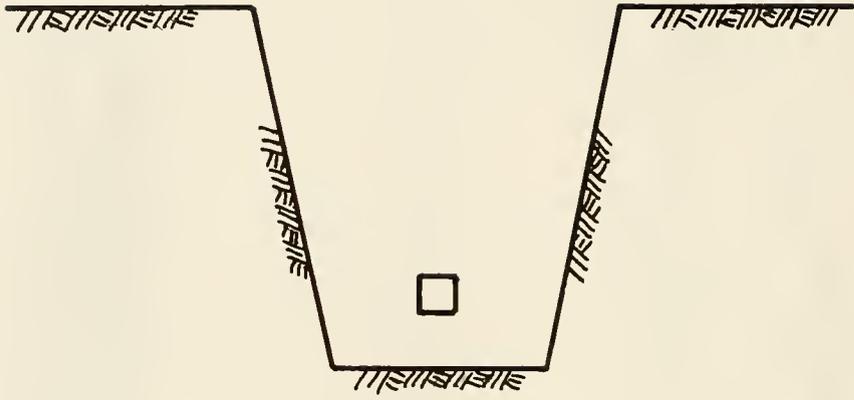
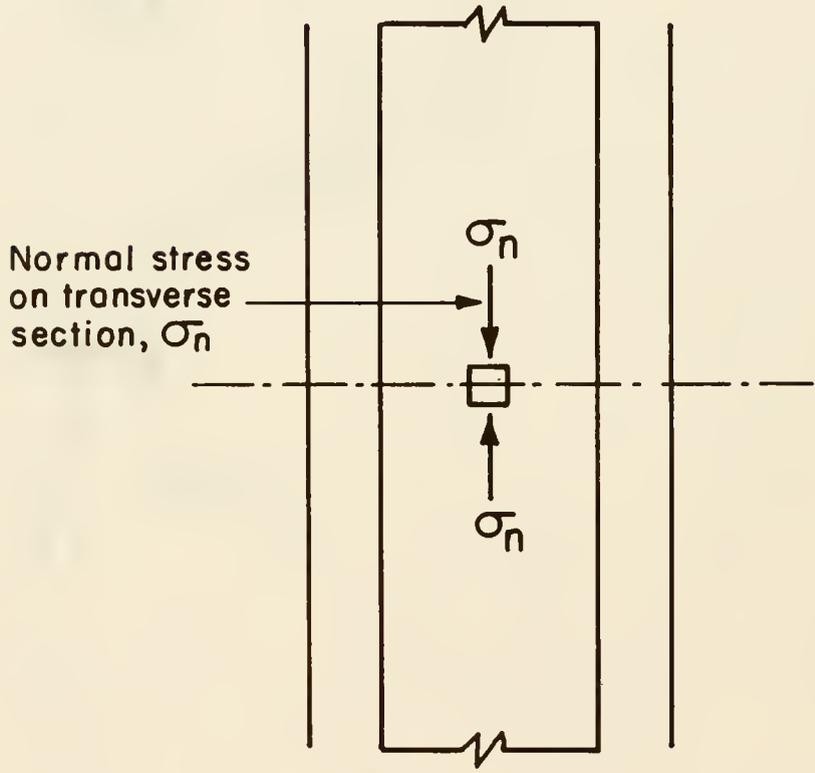
Transverse fracturing occurs if  $u > \sigma_n + t_s$

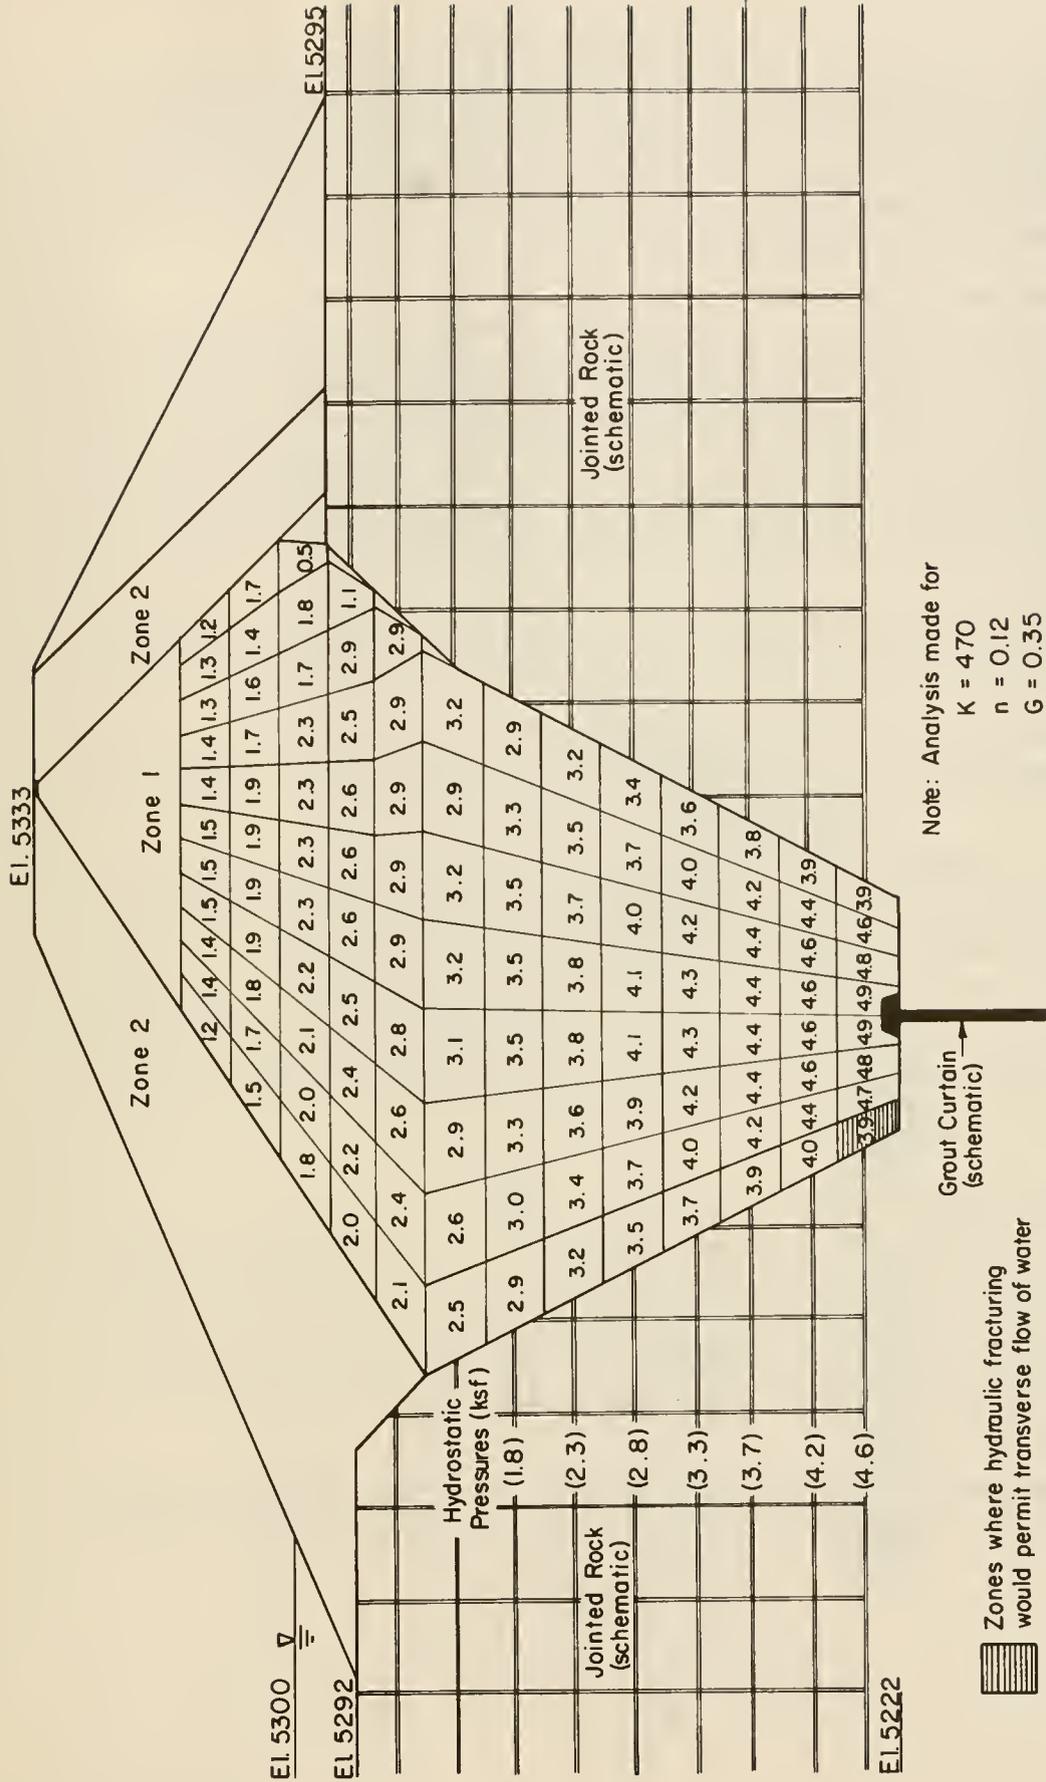
FIG. 11 COMPUTED VALUES OF NORMAL STRESS ON TRANSVERSE SECTION ksf STA. 12+70

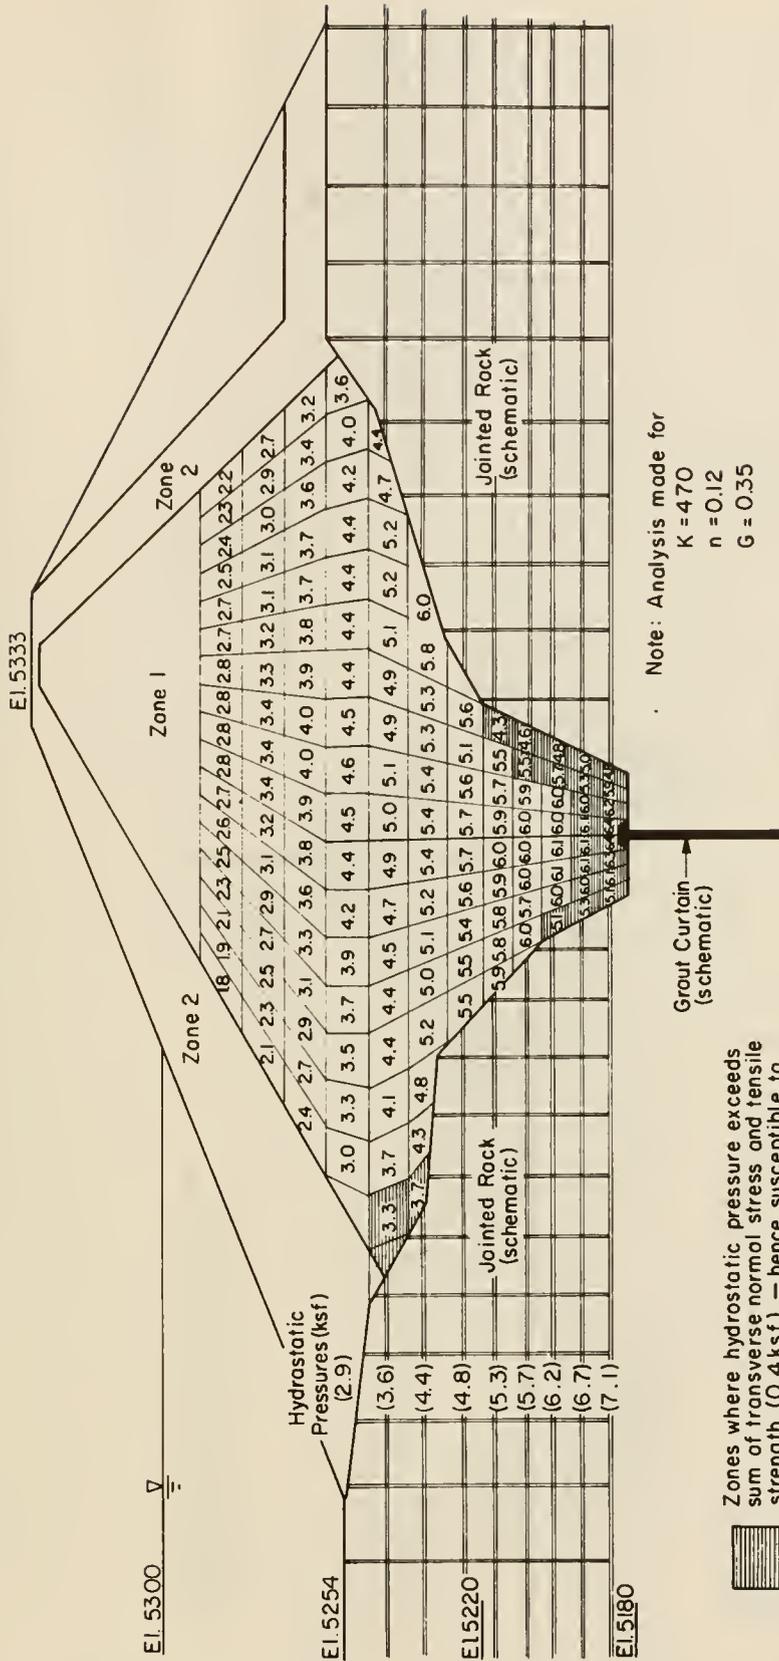
FIG. 12 COMPUTED VALUES OF MINOR PRINCIPAL STRESS IN PLANE OF SECTION STA. 13+70

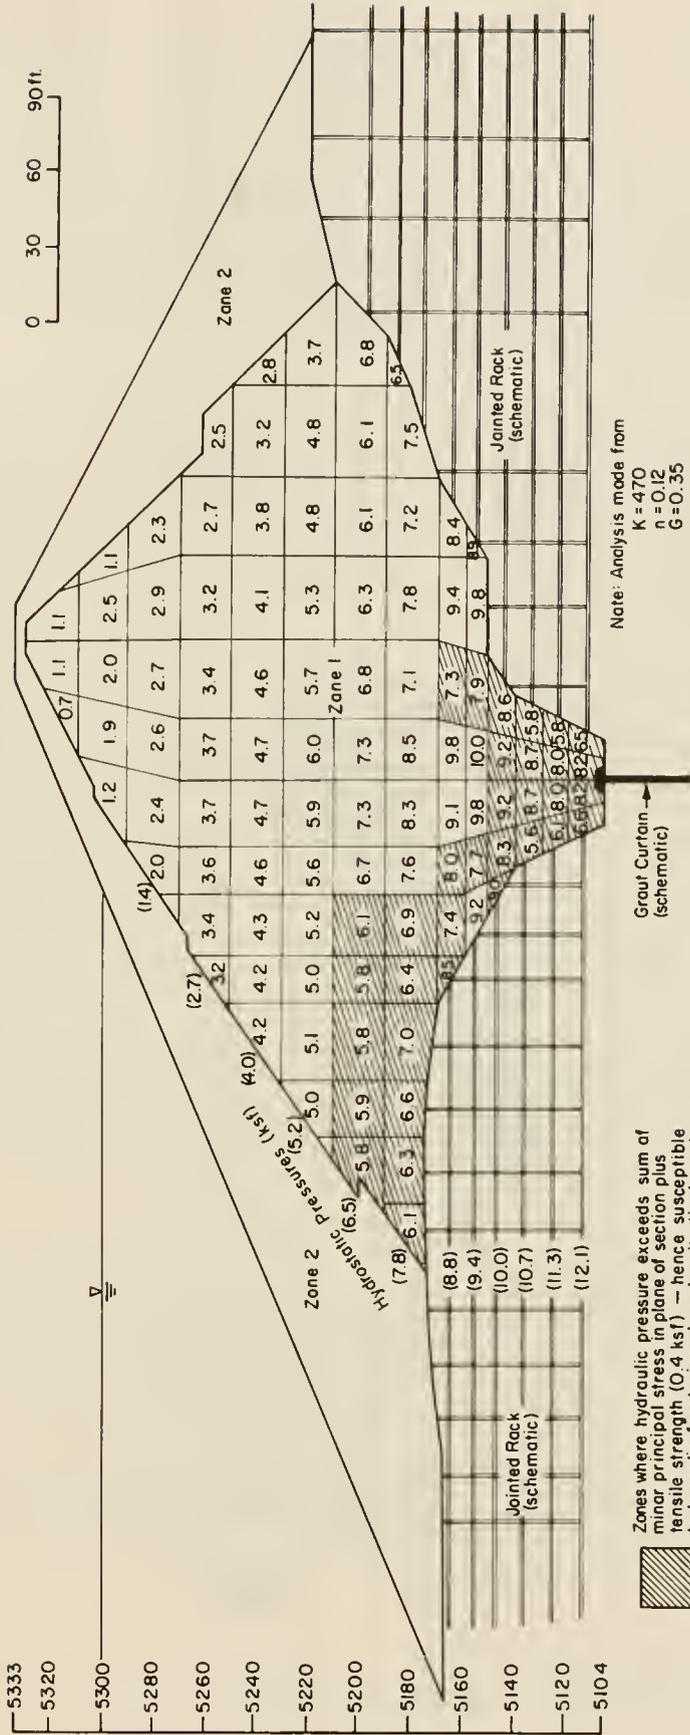
FIG.14 COMPUTED VALUES OF MINOR PRINCIPAL STRESS IN PLANE OF SECTION ksf STA. 15+00
