603  
I 1.2'  
T29/2

BOSTON PUBLIC LIBRARY  
3 9999 06317 343 7

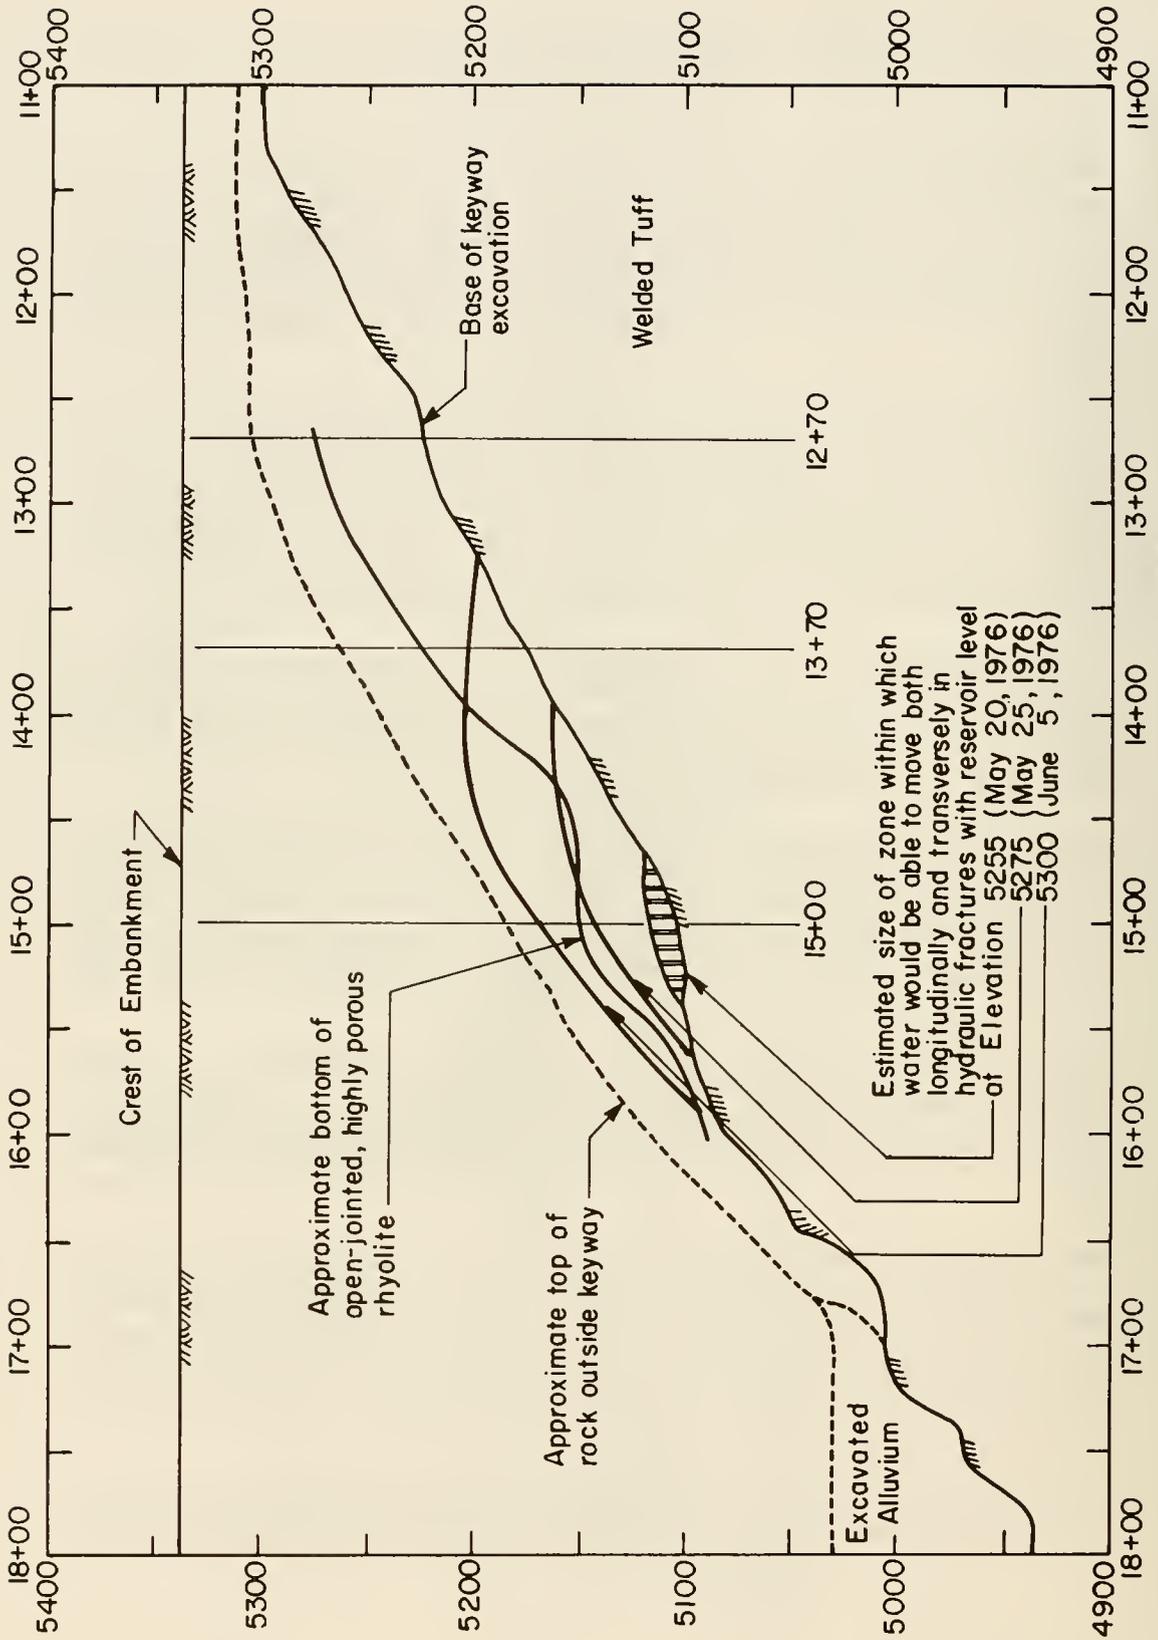
LONGITUDINAL SECTION THROUGH CENTER LINE  
 CREST AND GROUT CAP  
**FIG.16**

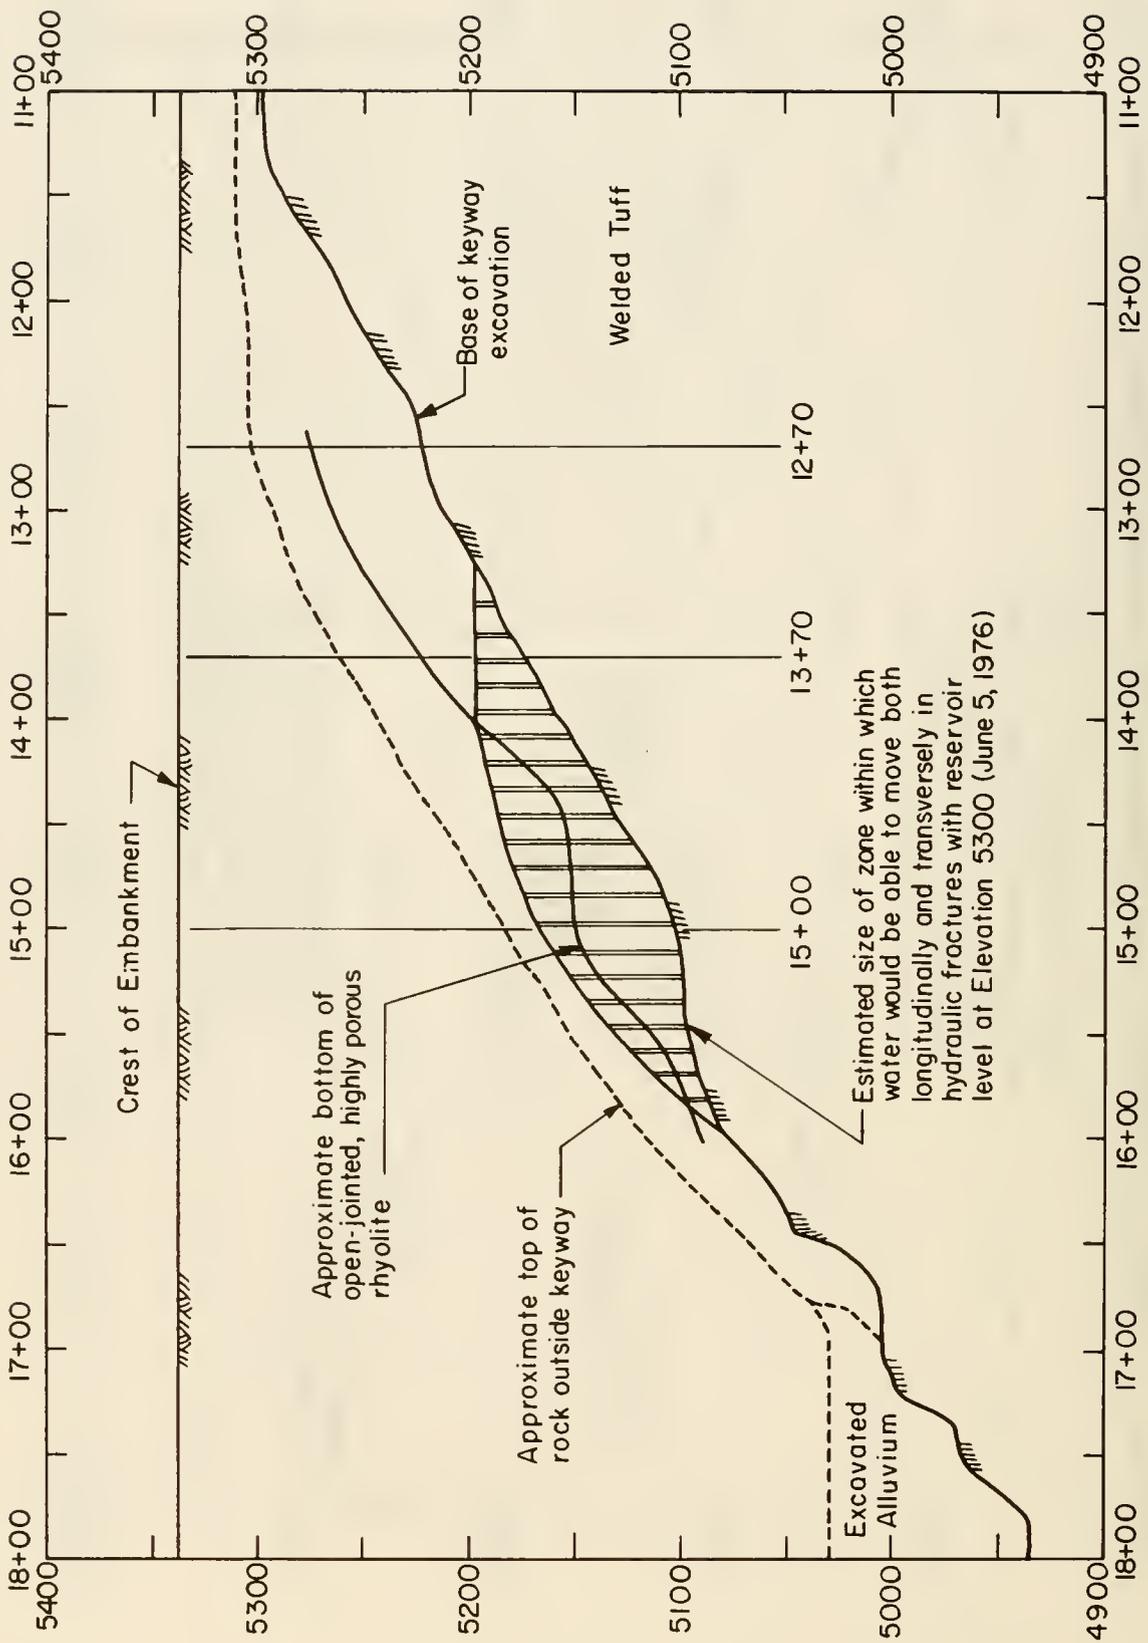
**FIG.18** LONGITUDINAL SECTION THROUGH CENTER LINE  
CREST AND GROUT CAP

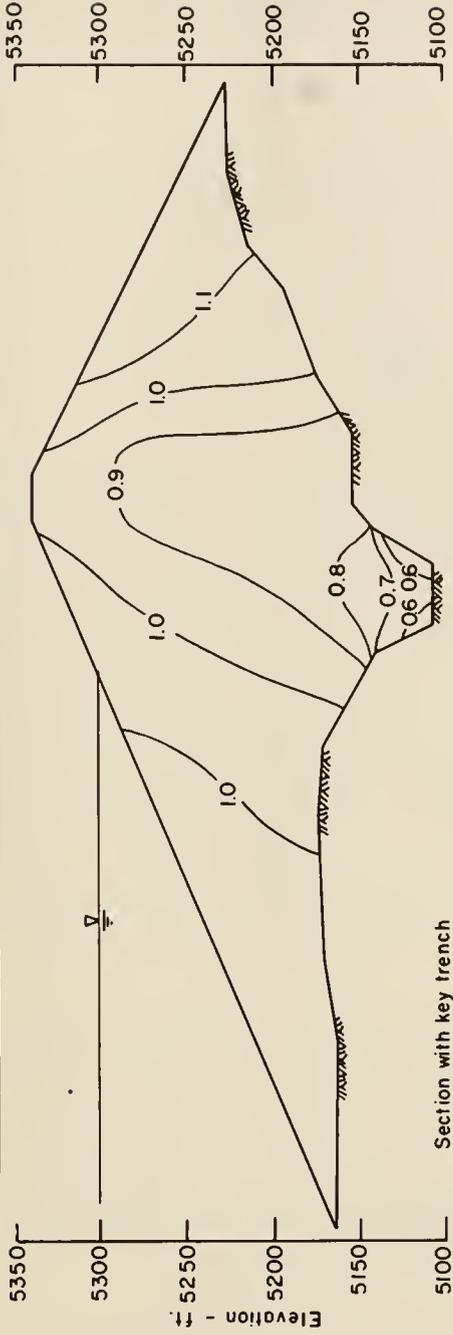
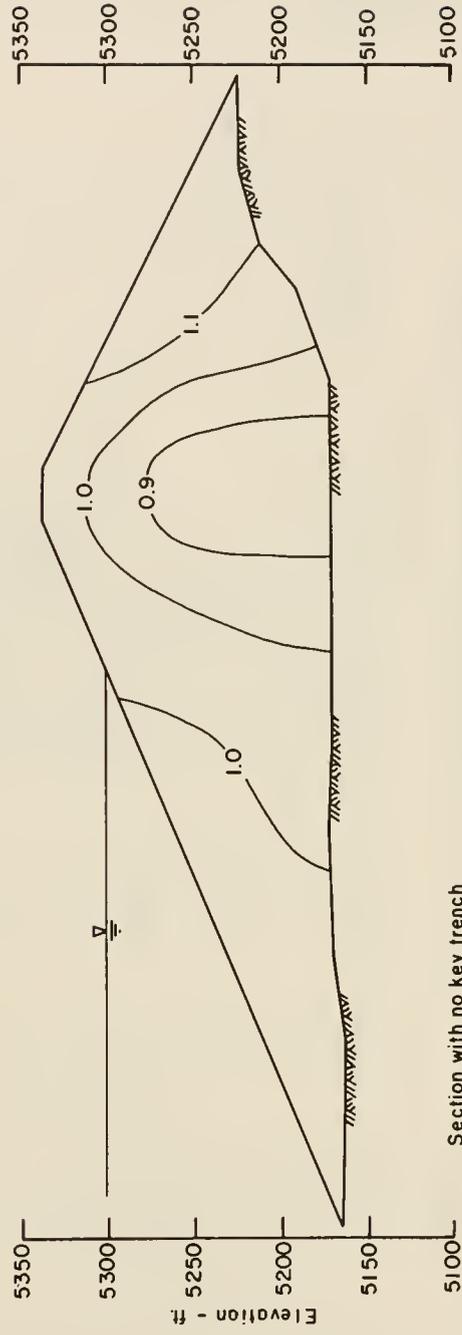
**FIG.19** CONTOURS SHOWING RATIO OF VERTICAL STRESS IN EMBANKMENT TO OVERBURDEN PRESSURE FOR CONDITIONS WITH AND WITHOUT KEY TRENCH AT STA.15+00 - BEFORE WETTING OF SOIL IN KEY TRENCH

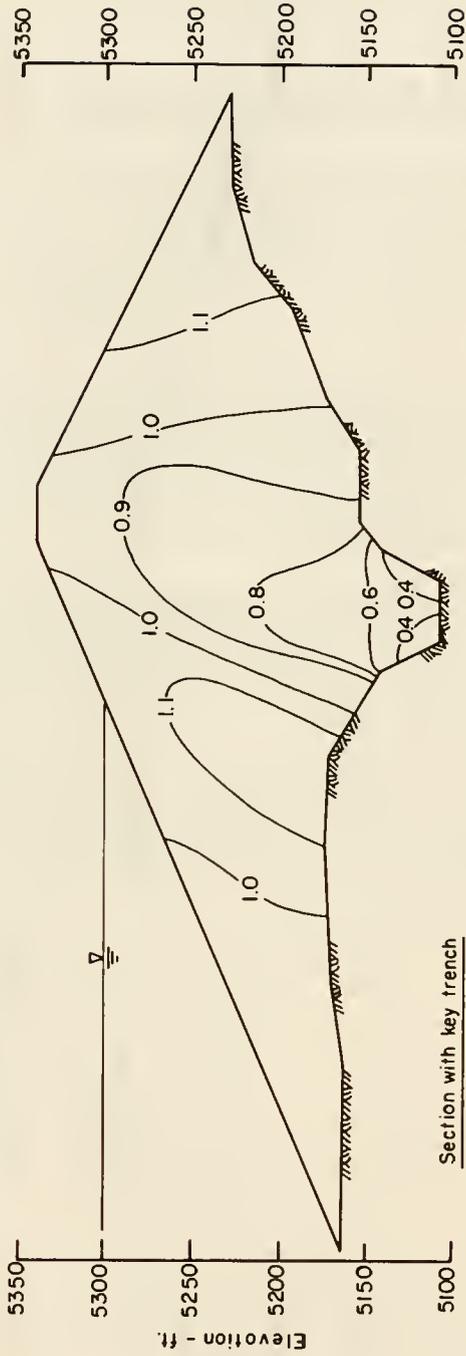
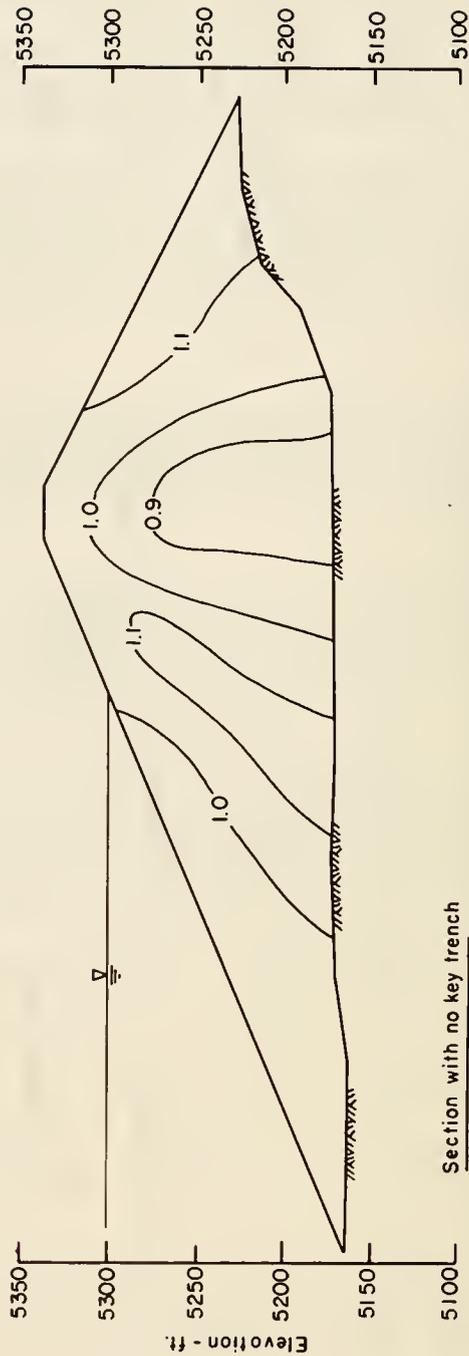
**FIG.20** CONTOURS SHOWING RATIO OF VERTICAL STRESS IN EMBANKMENT TO OVERBURDEN PRESSURE FOR CONDITIONS WITH AND WITHOUT KEY TRENCH AT STA.15+00-AFTER WETTING OF SOIL IN KEY TRENCH

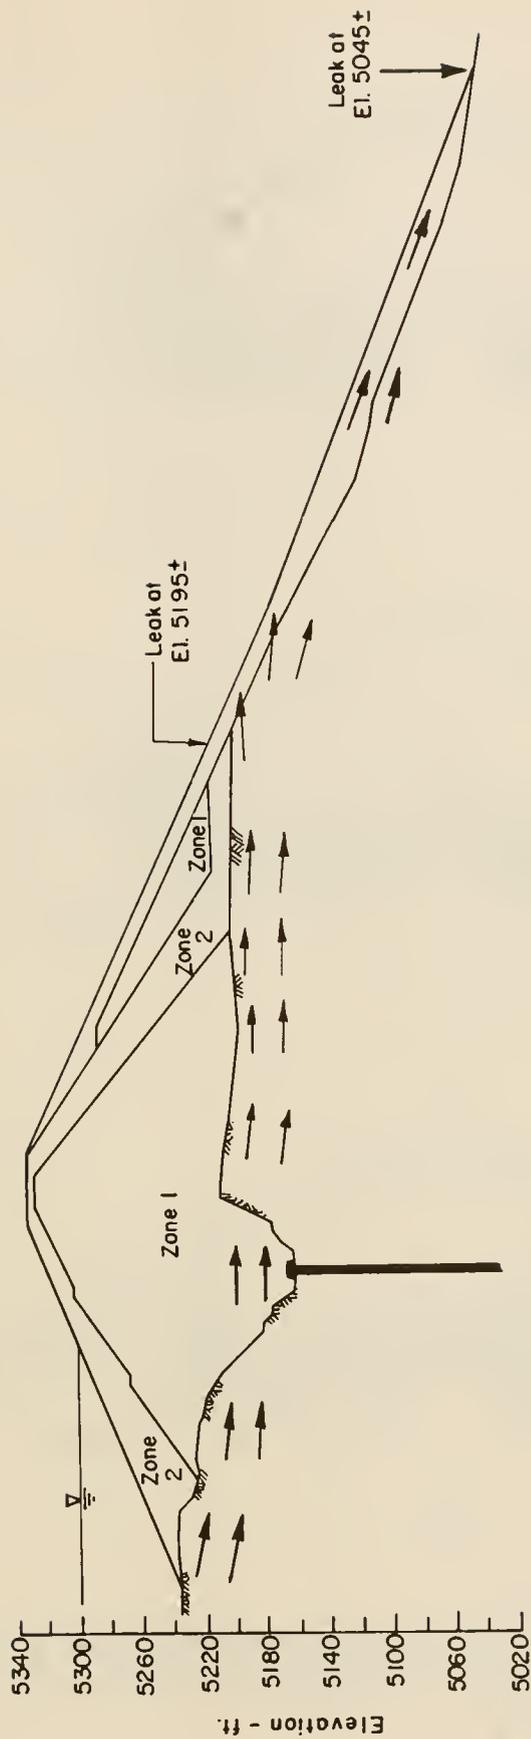
PROBABLE PATH OF WATER IN EARLY STAGES OF LEAKAGE

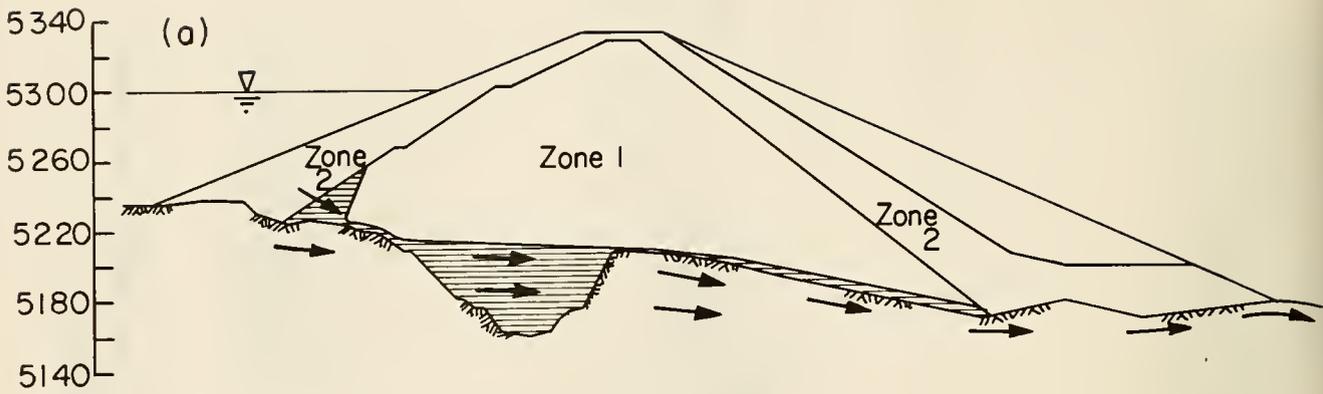
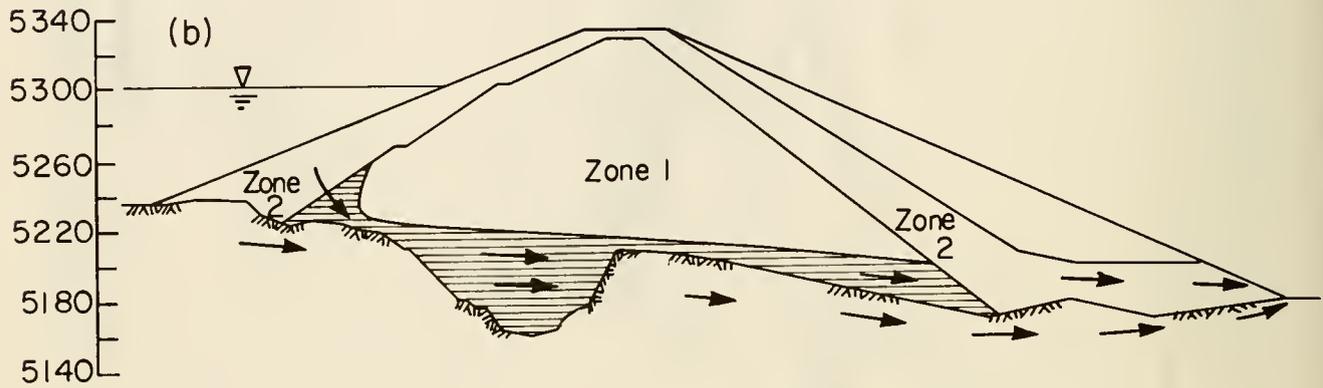
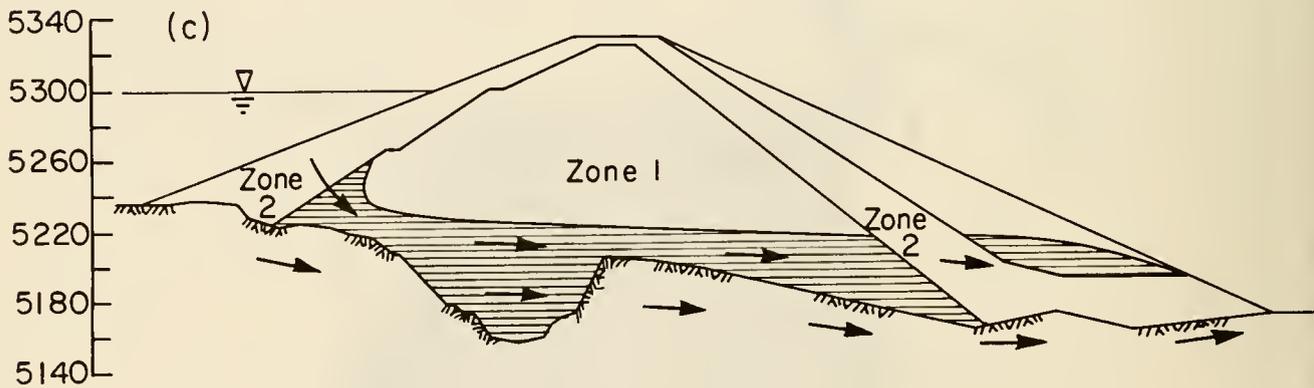
(A, B, C, OF F) **FIG.23** CONCEPTUAL MECHANISM OF PROGRESSIVE FAILURE ALONG SECTION A-B-C

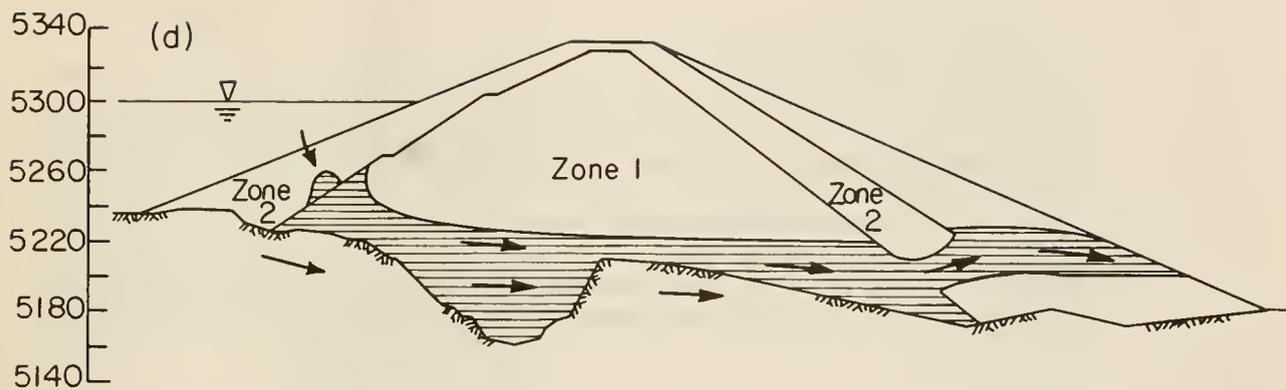
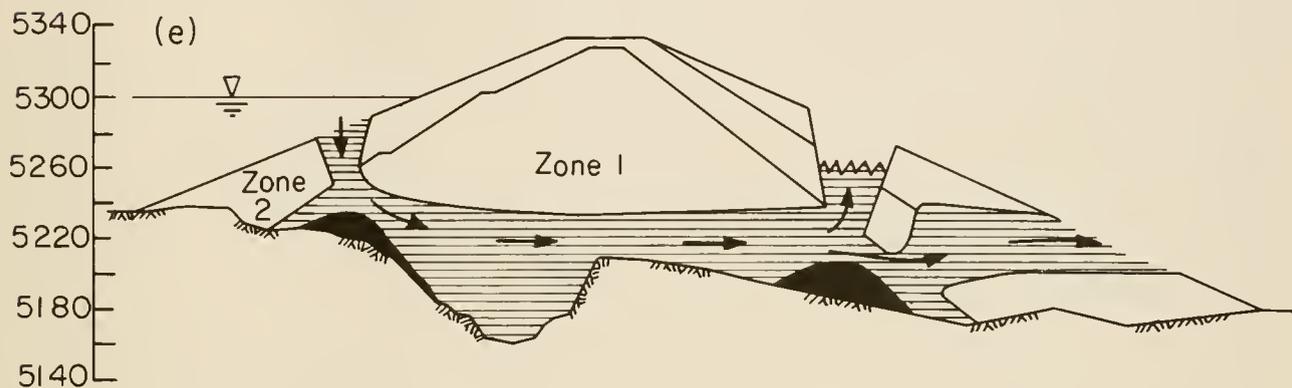
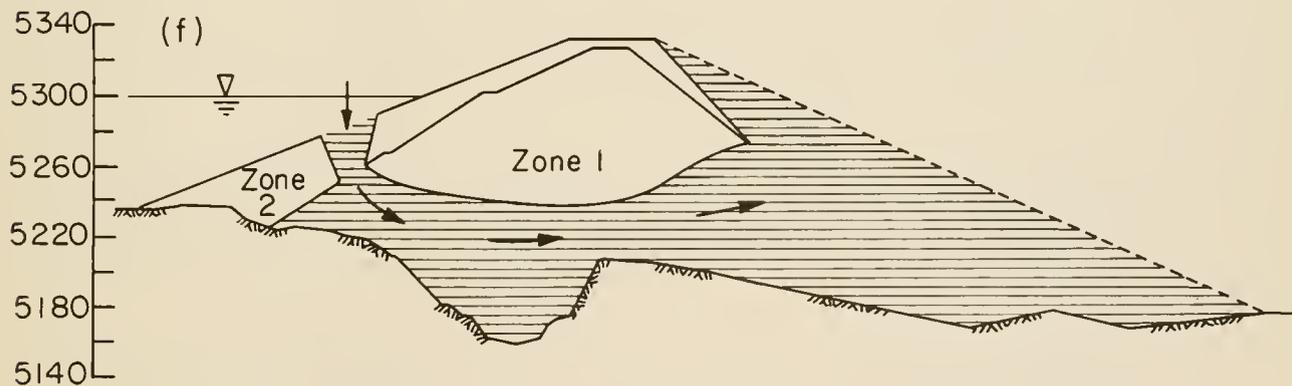
(CONT. D, E, F)  
**FIG. 23** CONCEPTUAL MECHANISM OF PROGRESSIVE FAILURE ALONG SECTION A-B-C

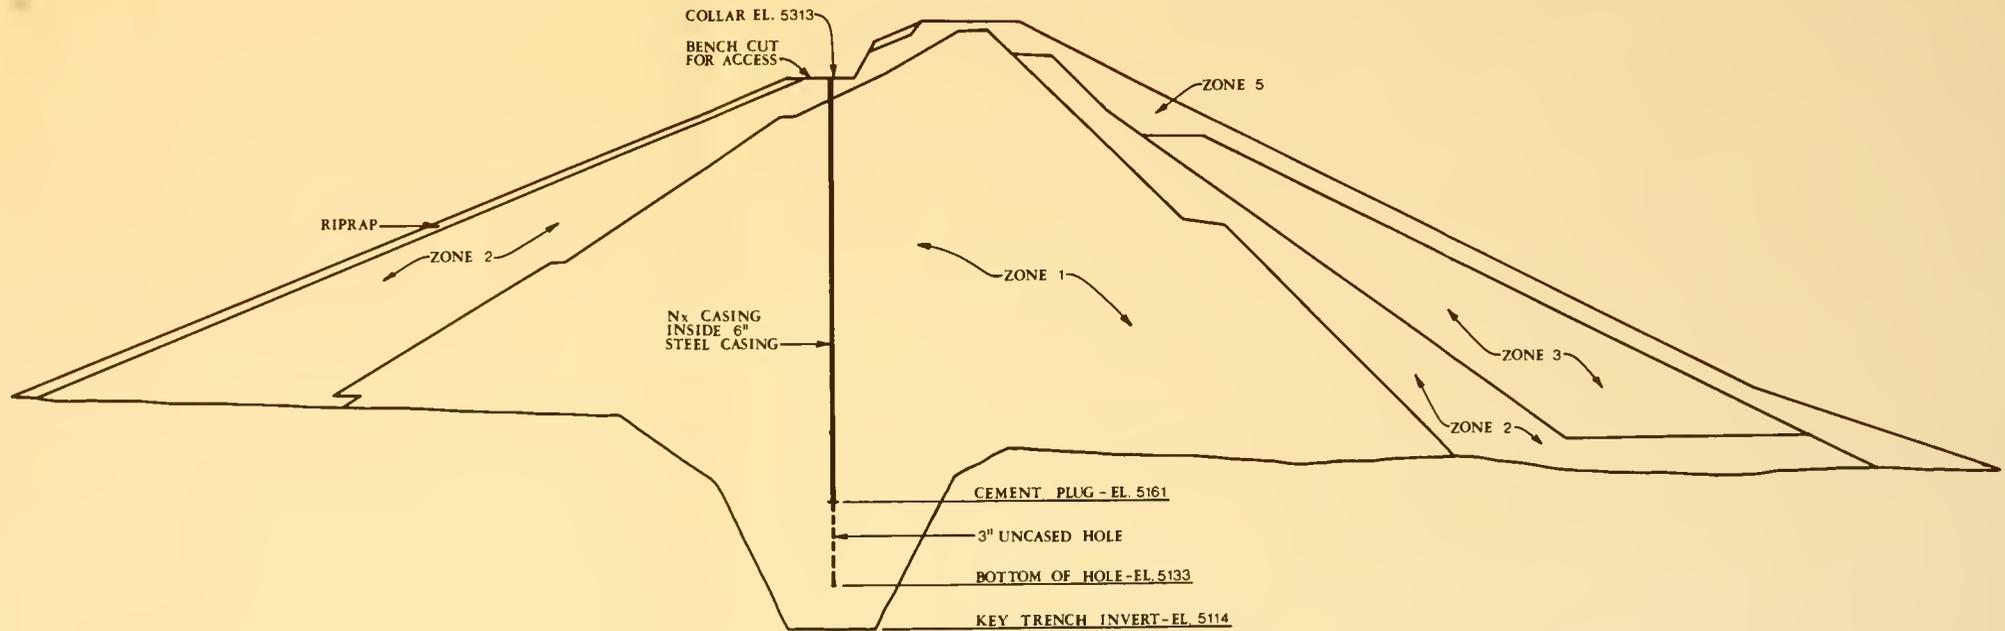
BORE HOLE STA. 26+00

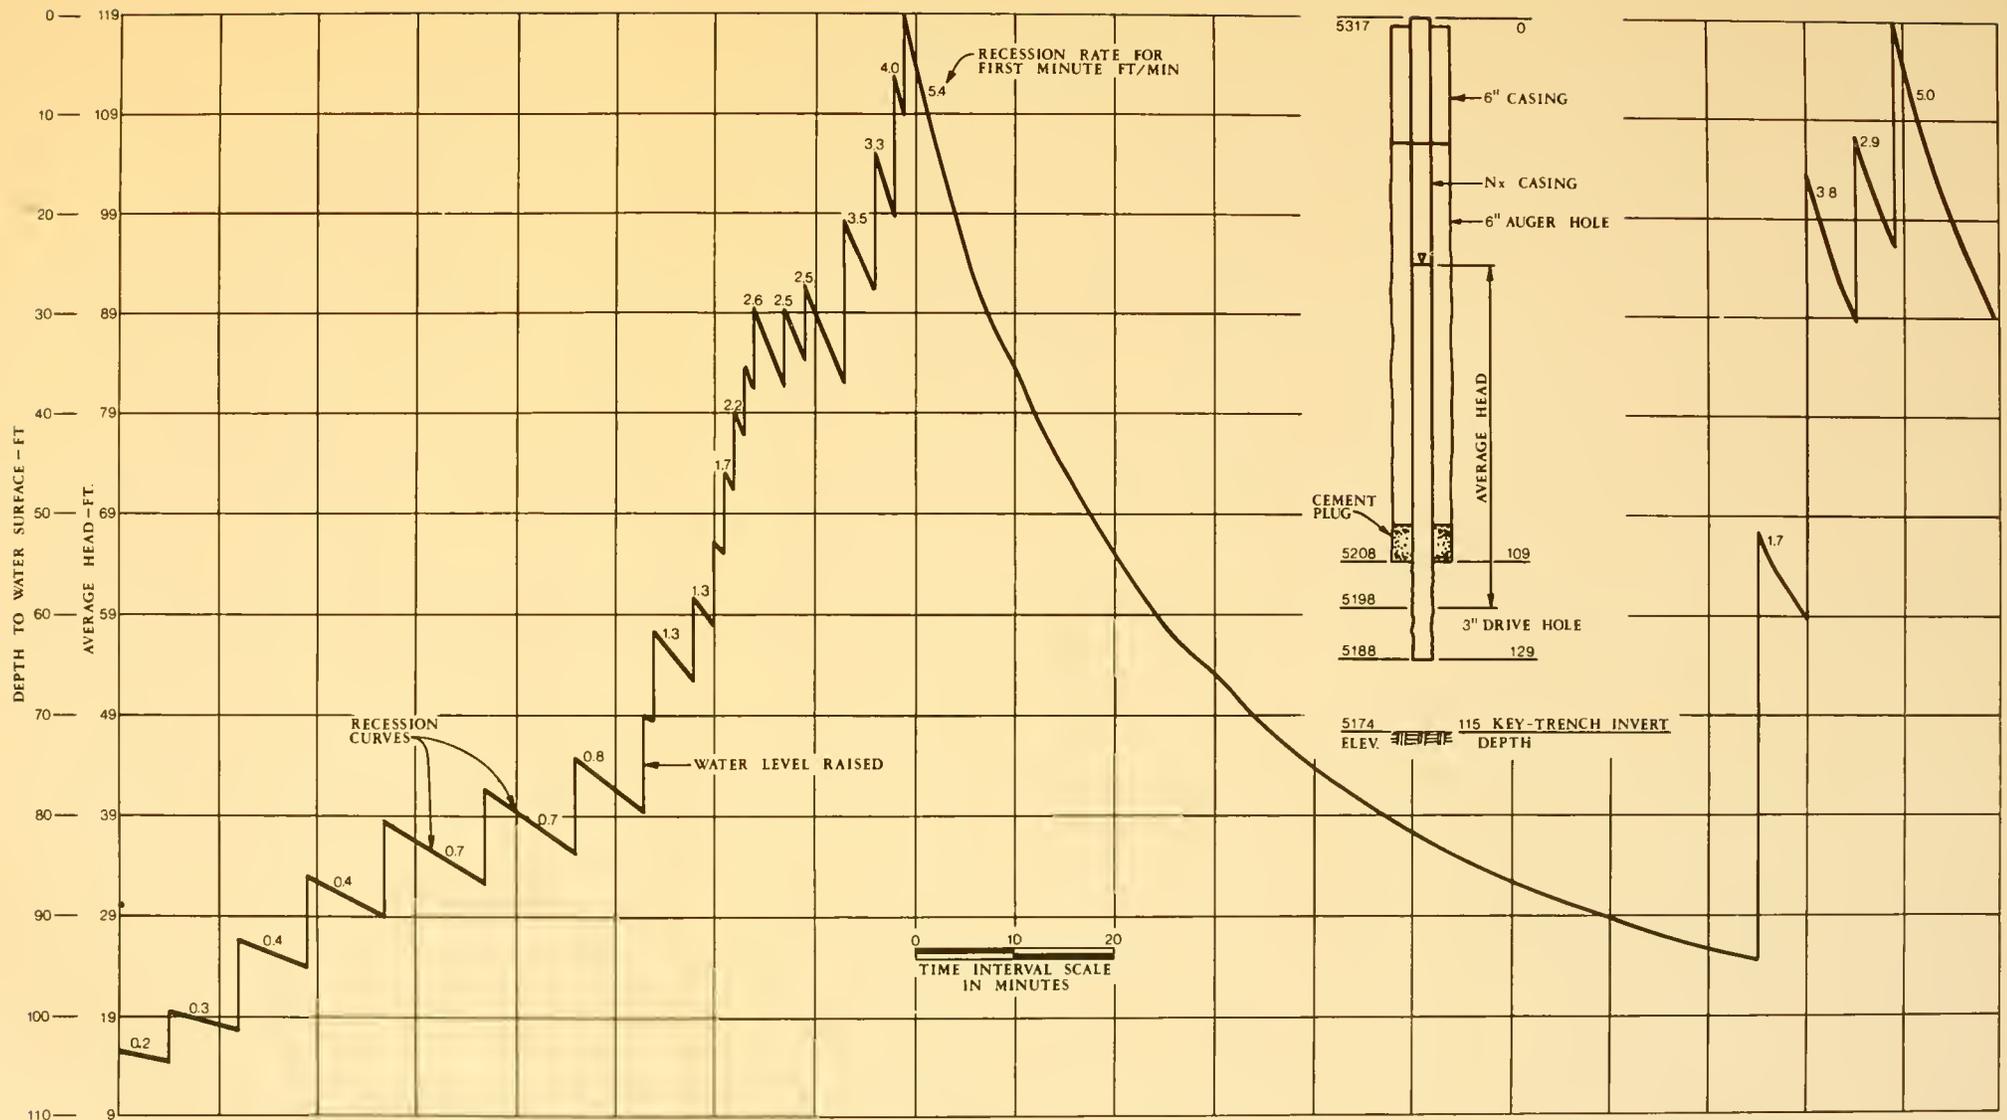
BORE HOLE HYDRAULIC FRACTURING TEST,  
STA. 27+00 WATER LEVEL RECESSON RATES

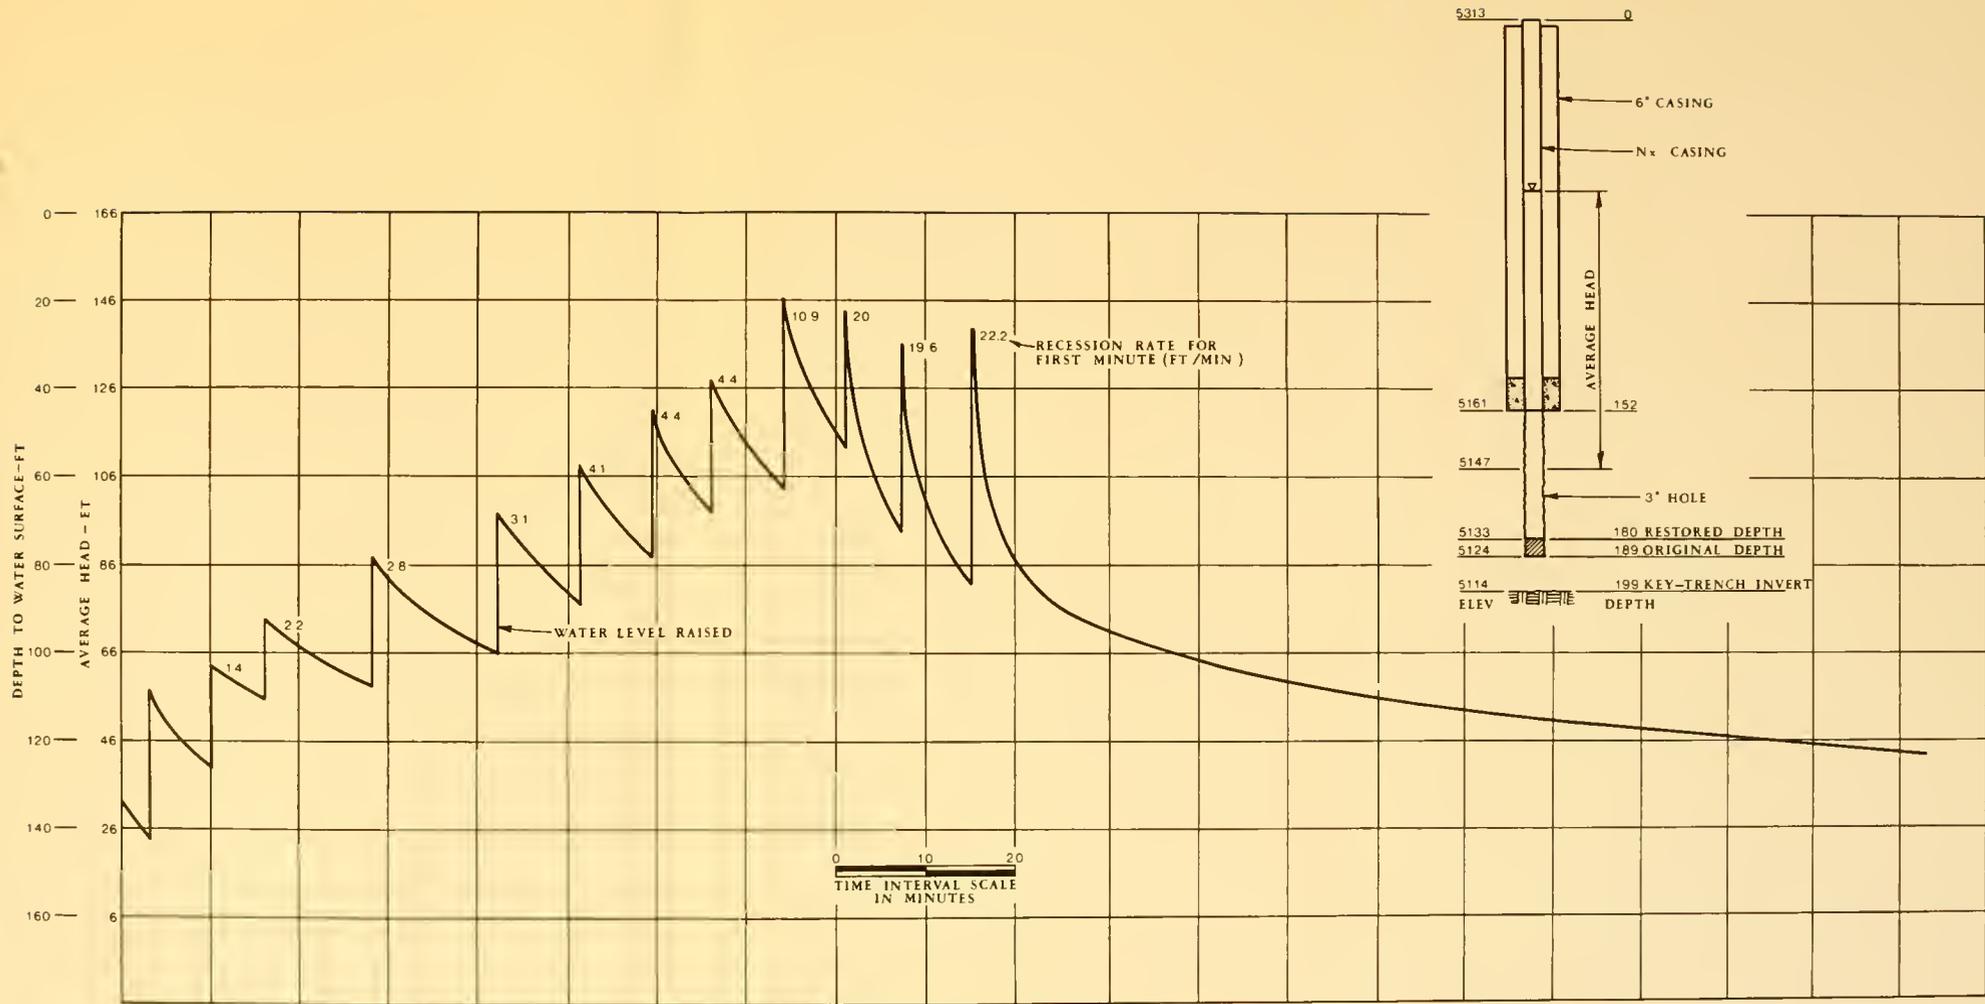
BORE HOLE HYDRAULIC FRACTURING TEST  
STA. 26+00 WATER LEVEL RESSION RATES
