REPORT NO.
EERC 73-2
June 1973

ANALYSIS OF THE SLIDES IN THE SAN FERNANDO DAMS DURING THE EARTHQUAKE OF FEB. 9, 1971

H. BOLTON SEED
K. L. LEE
I. M. IDRIS
F. MAKDISI

State of California Department of Water Resources
Los Angeles Department of Water and Power
National Science Foundation

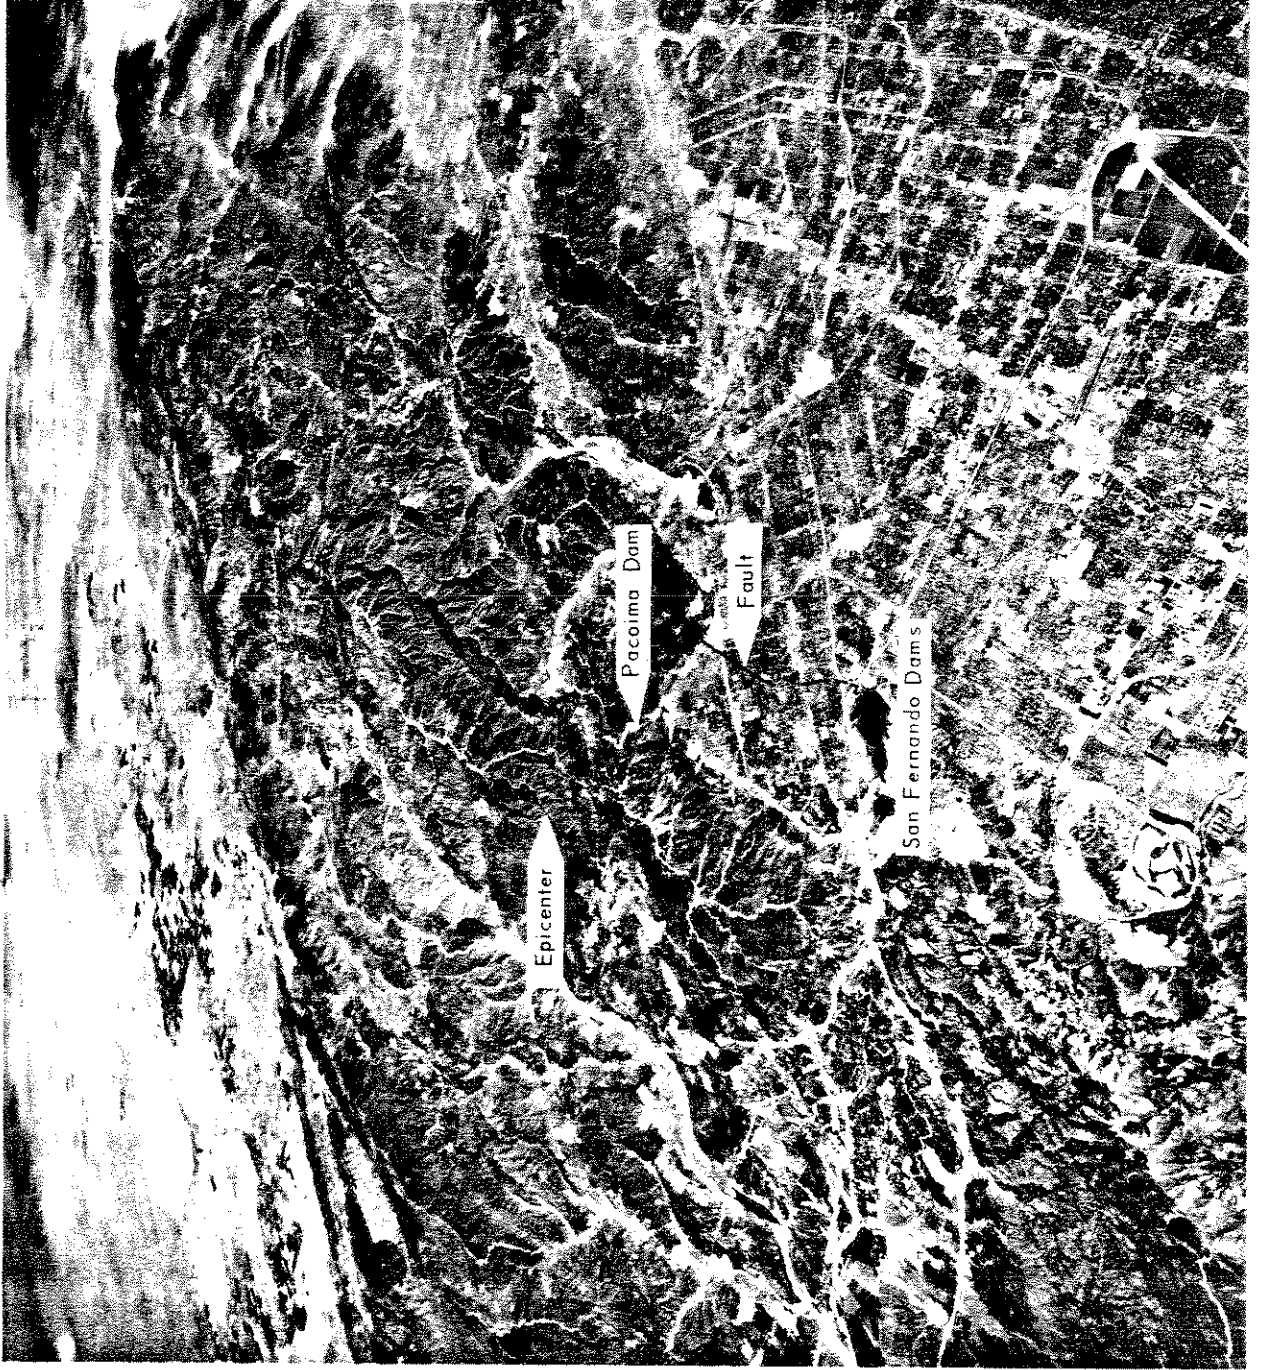
An aerial photograph showing the relative location of the dams to the epicenter and the surface fault scarps produced by the earthquake is shown on Fig. III-1. The dams are located approximately 8-1/2 miles southwest of the epicenter, and near the extreme western extension of the observed surface fault breaks.

FIG. III-1 LOCATION OF SAN FERNANDO DAMS IN RELATION TO EPICENTER AND SURFACE FAULTS.
(Photographed by U.S. Geological Survey)

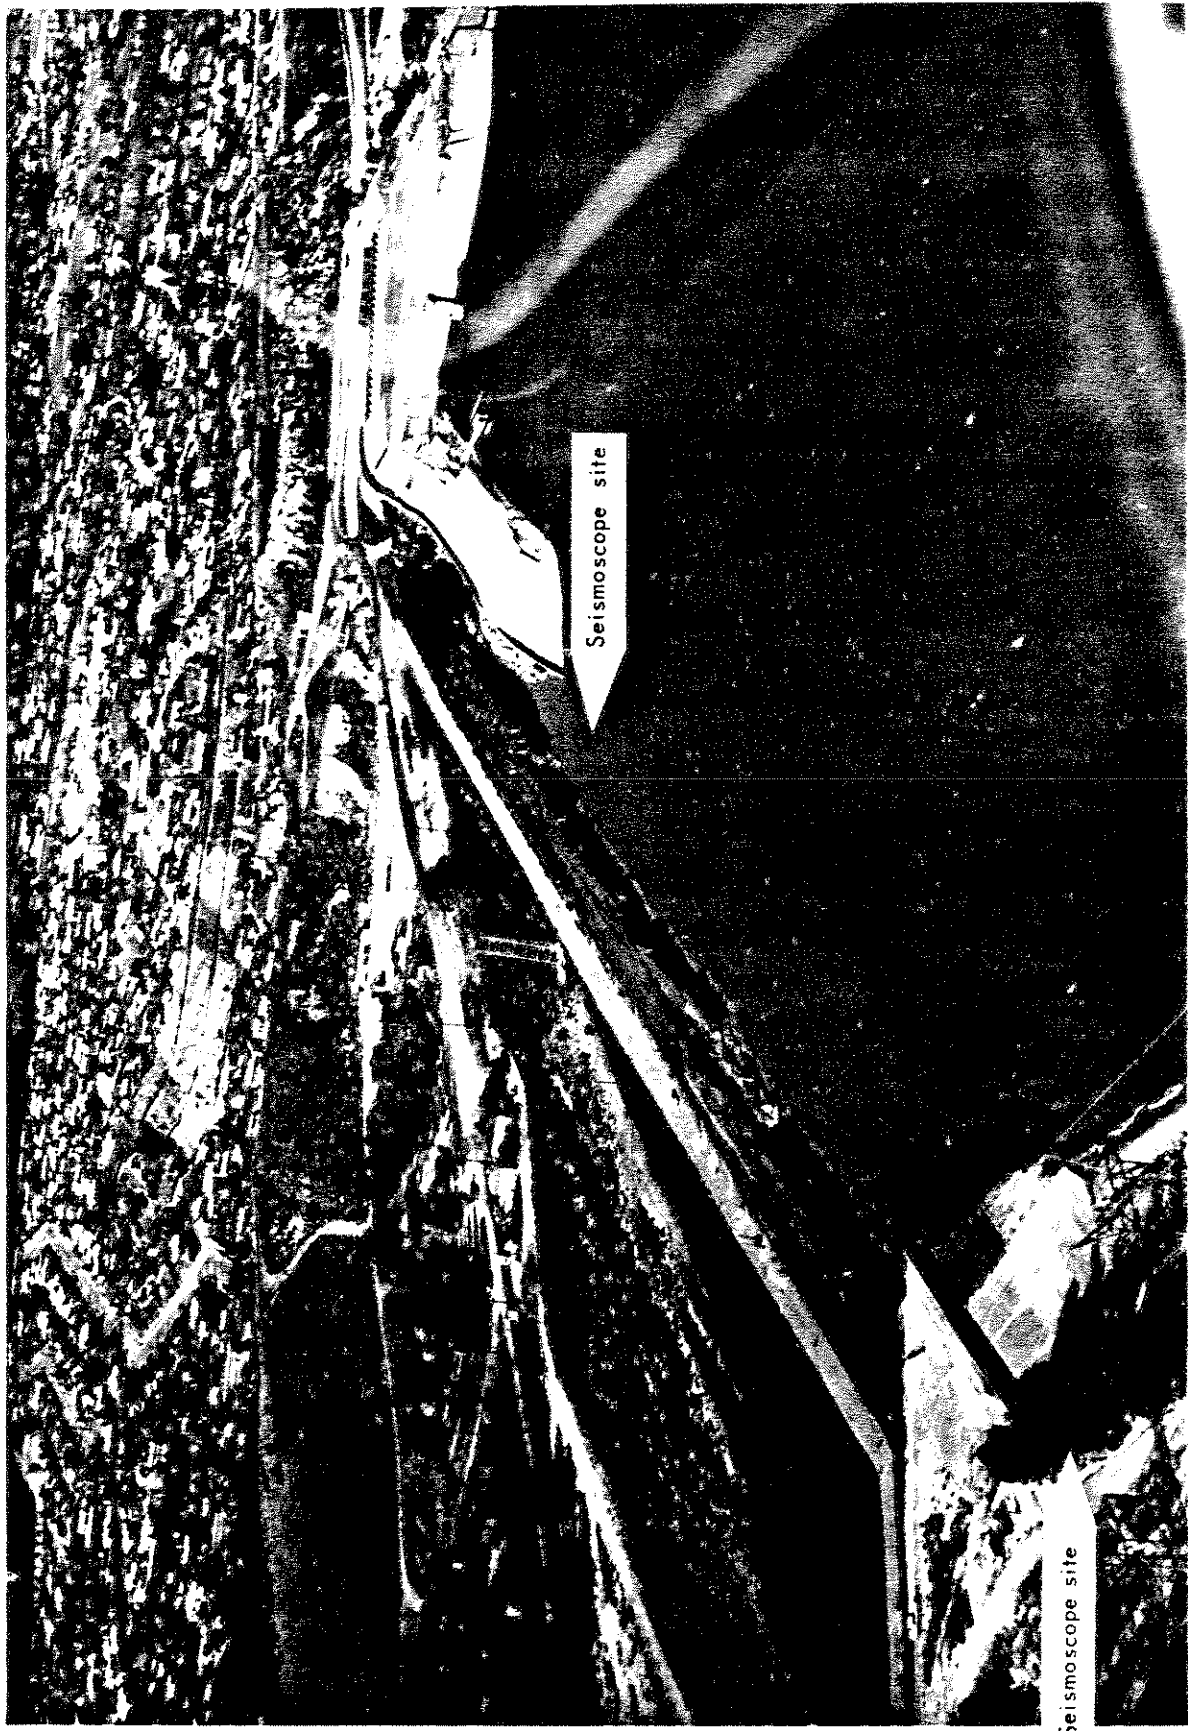
FIG. III-2 AERIAL VIEW OF LOWER SAN FERNANDO DAM AFTER EARTHQUAKE OF FEBRUARY 9, 1971. ARROWS INDICATE SEISMOSCOPE SITES. THE CREST SITE WAS COMPLETELY SUBMERGED FOLLOWING THE EARTHQUAKE.

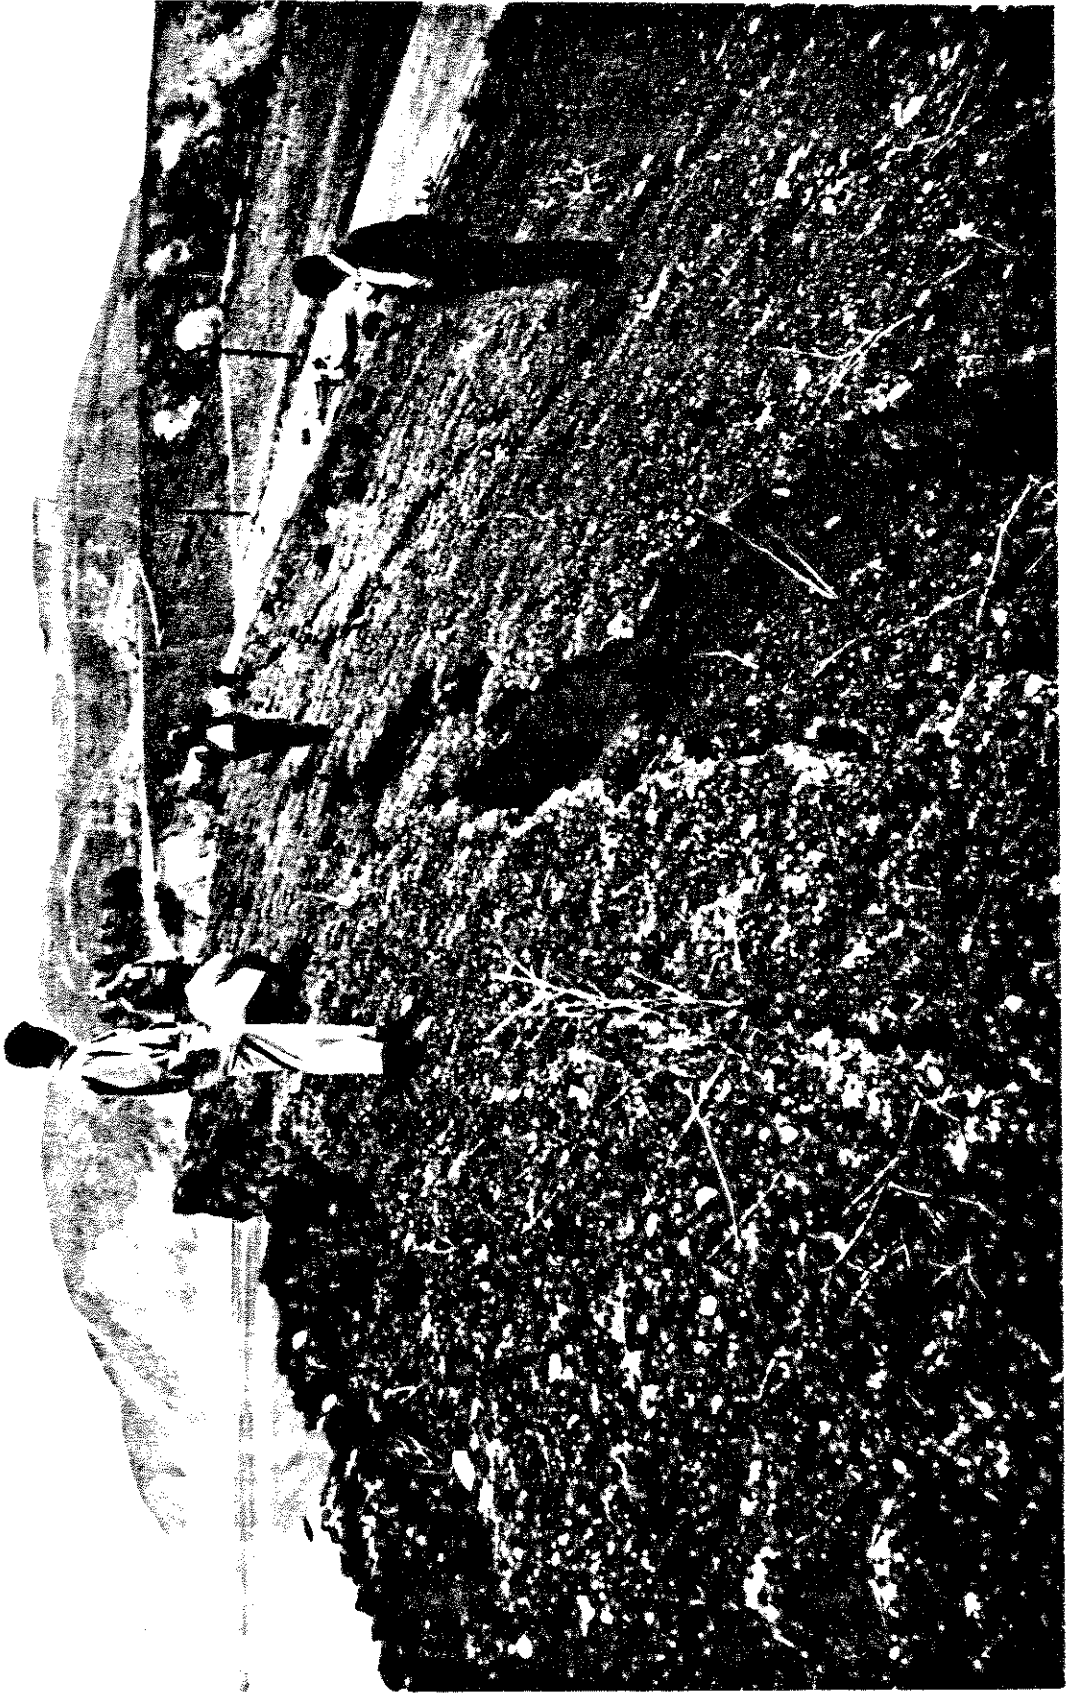
FIG. III-14 LONGITUDINAL CRACKS IN REMAINING PORTION OF EMBANKMENT
- LOWER SAN FERNANDO DAM

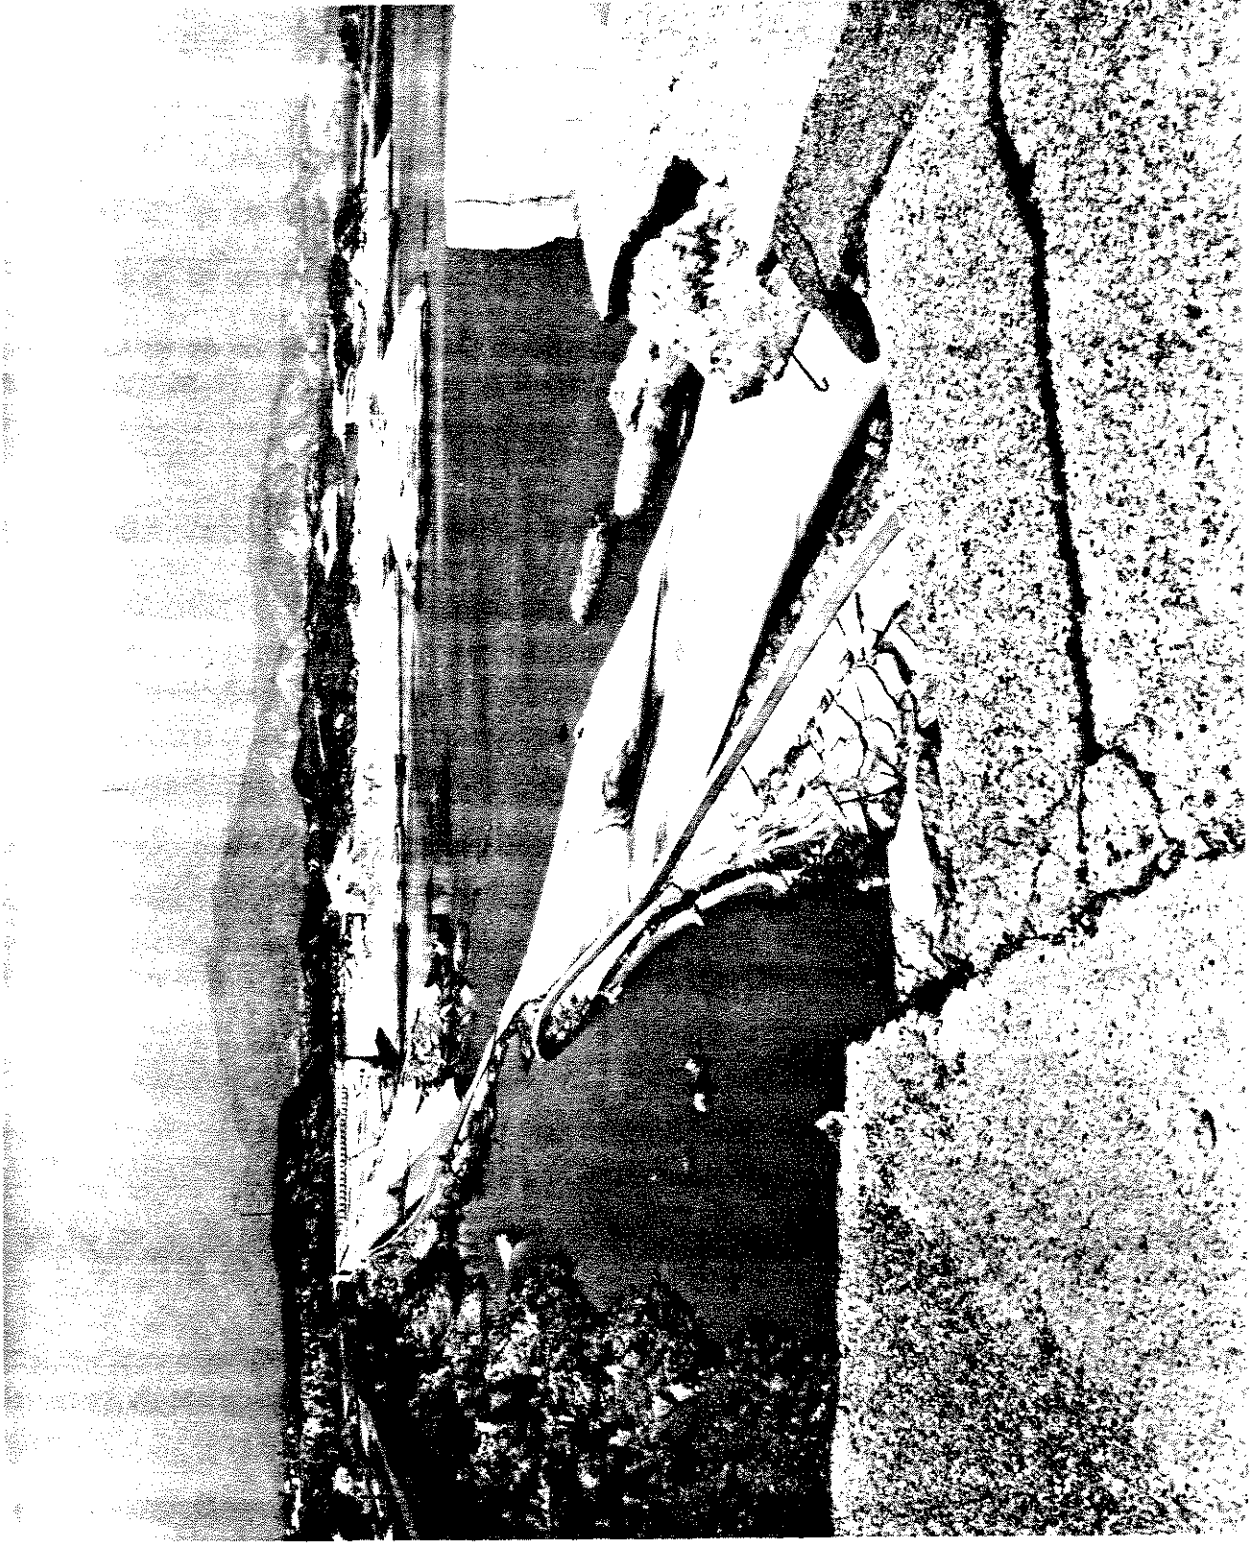
FIG. III-17 SLIDE DAMAGE TO LOWER SAN FERNANDO DAM.
(Photograph by Department of Water Resources, Feb. 22, 1971)

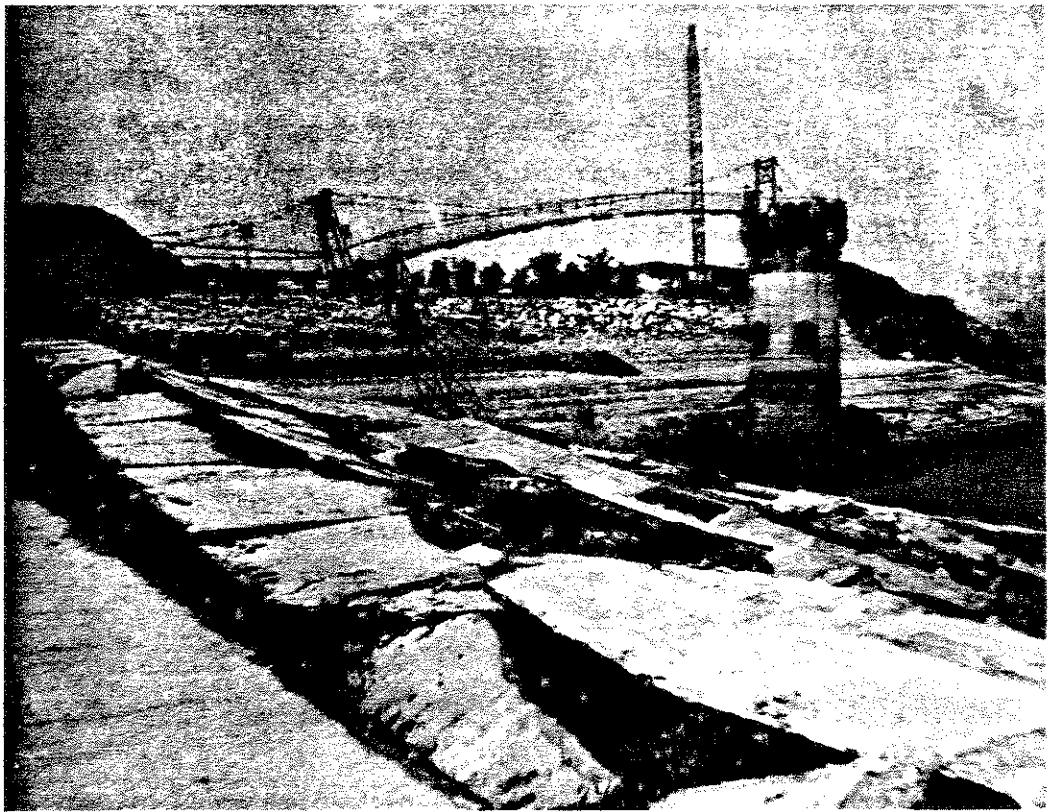
FIG. III - 18 SLIDE DAMAGE NEAR WEST ABUTMENT -
LOWER SAN FERNANDO DAM

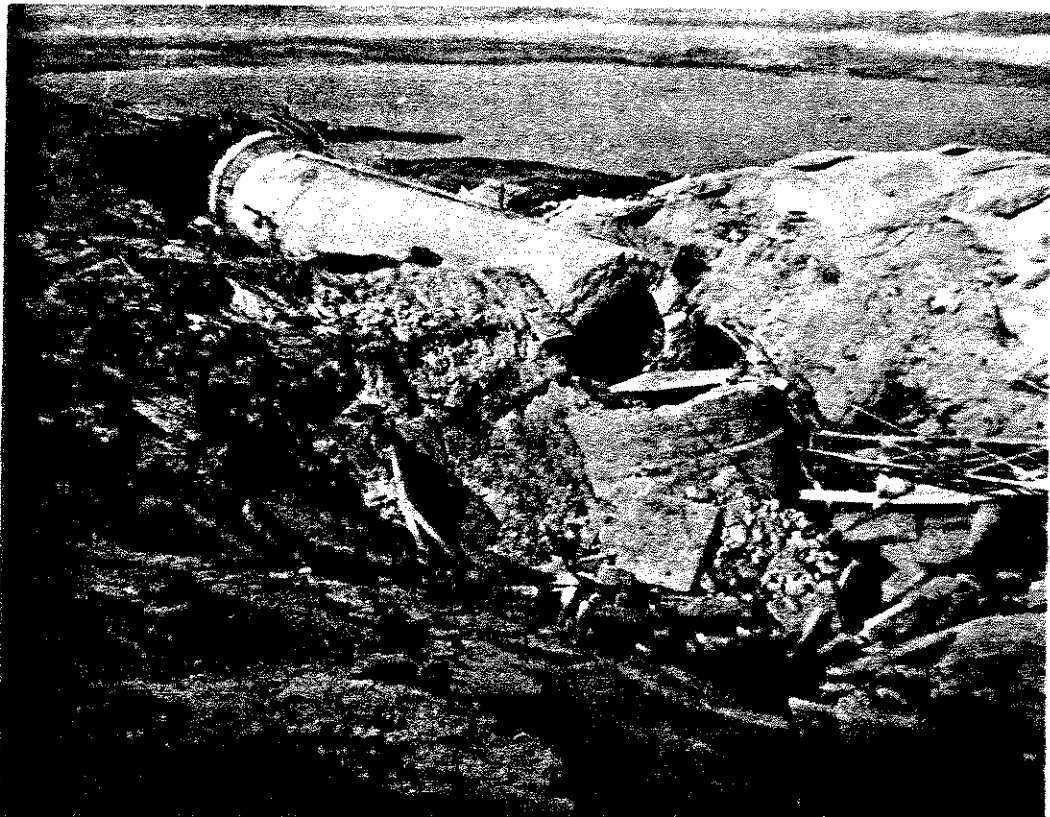
FIG. III-19 CENTRAL OUTLET TOWER - LOWER SAN FERNANDO DAM

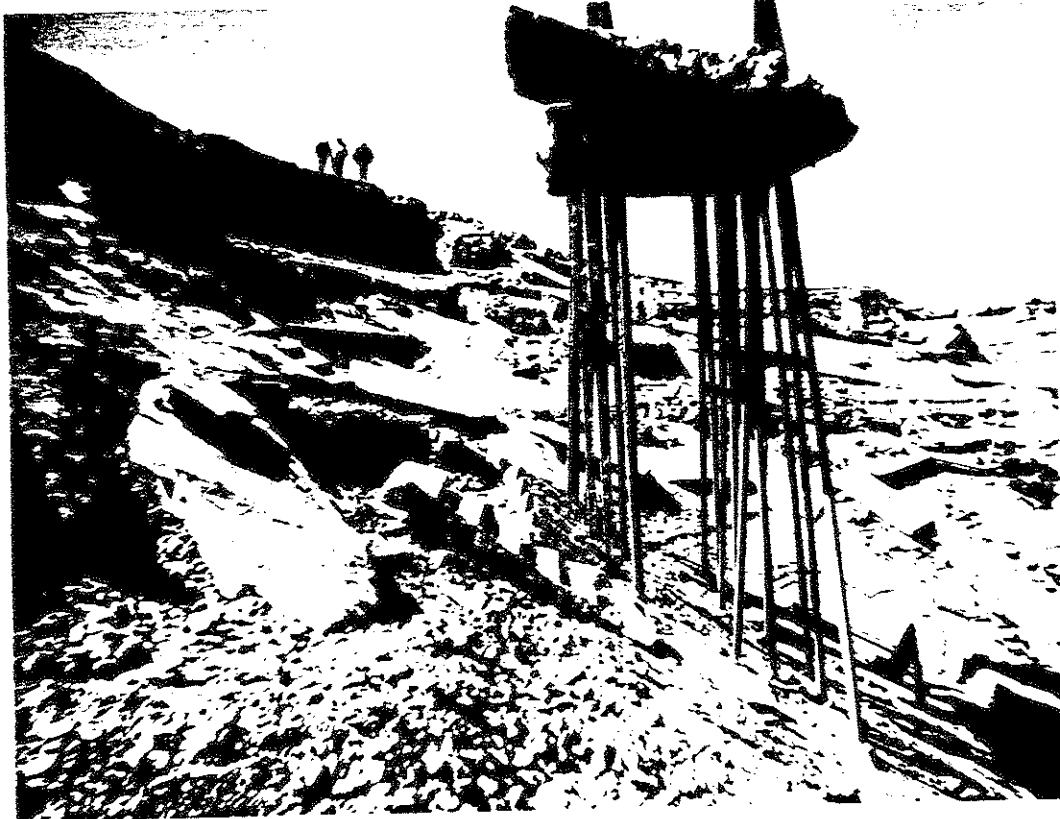
FIG. III - 21 PILE-SUPPORTED FOOTING FOR BRIDGE TO
CENTRAL OUTLET TOWER - LOWER
SAN FERNANDO DAM

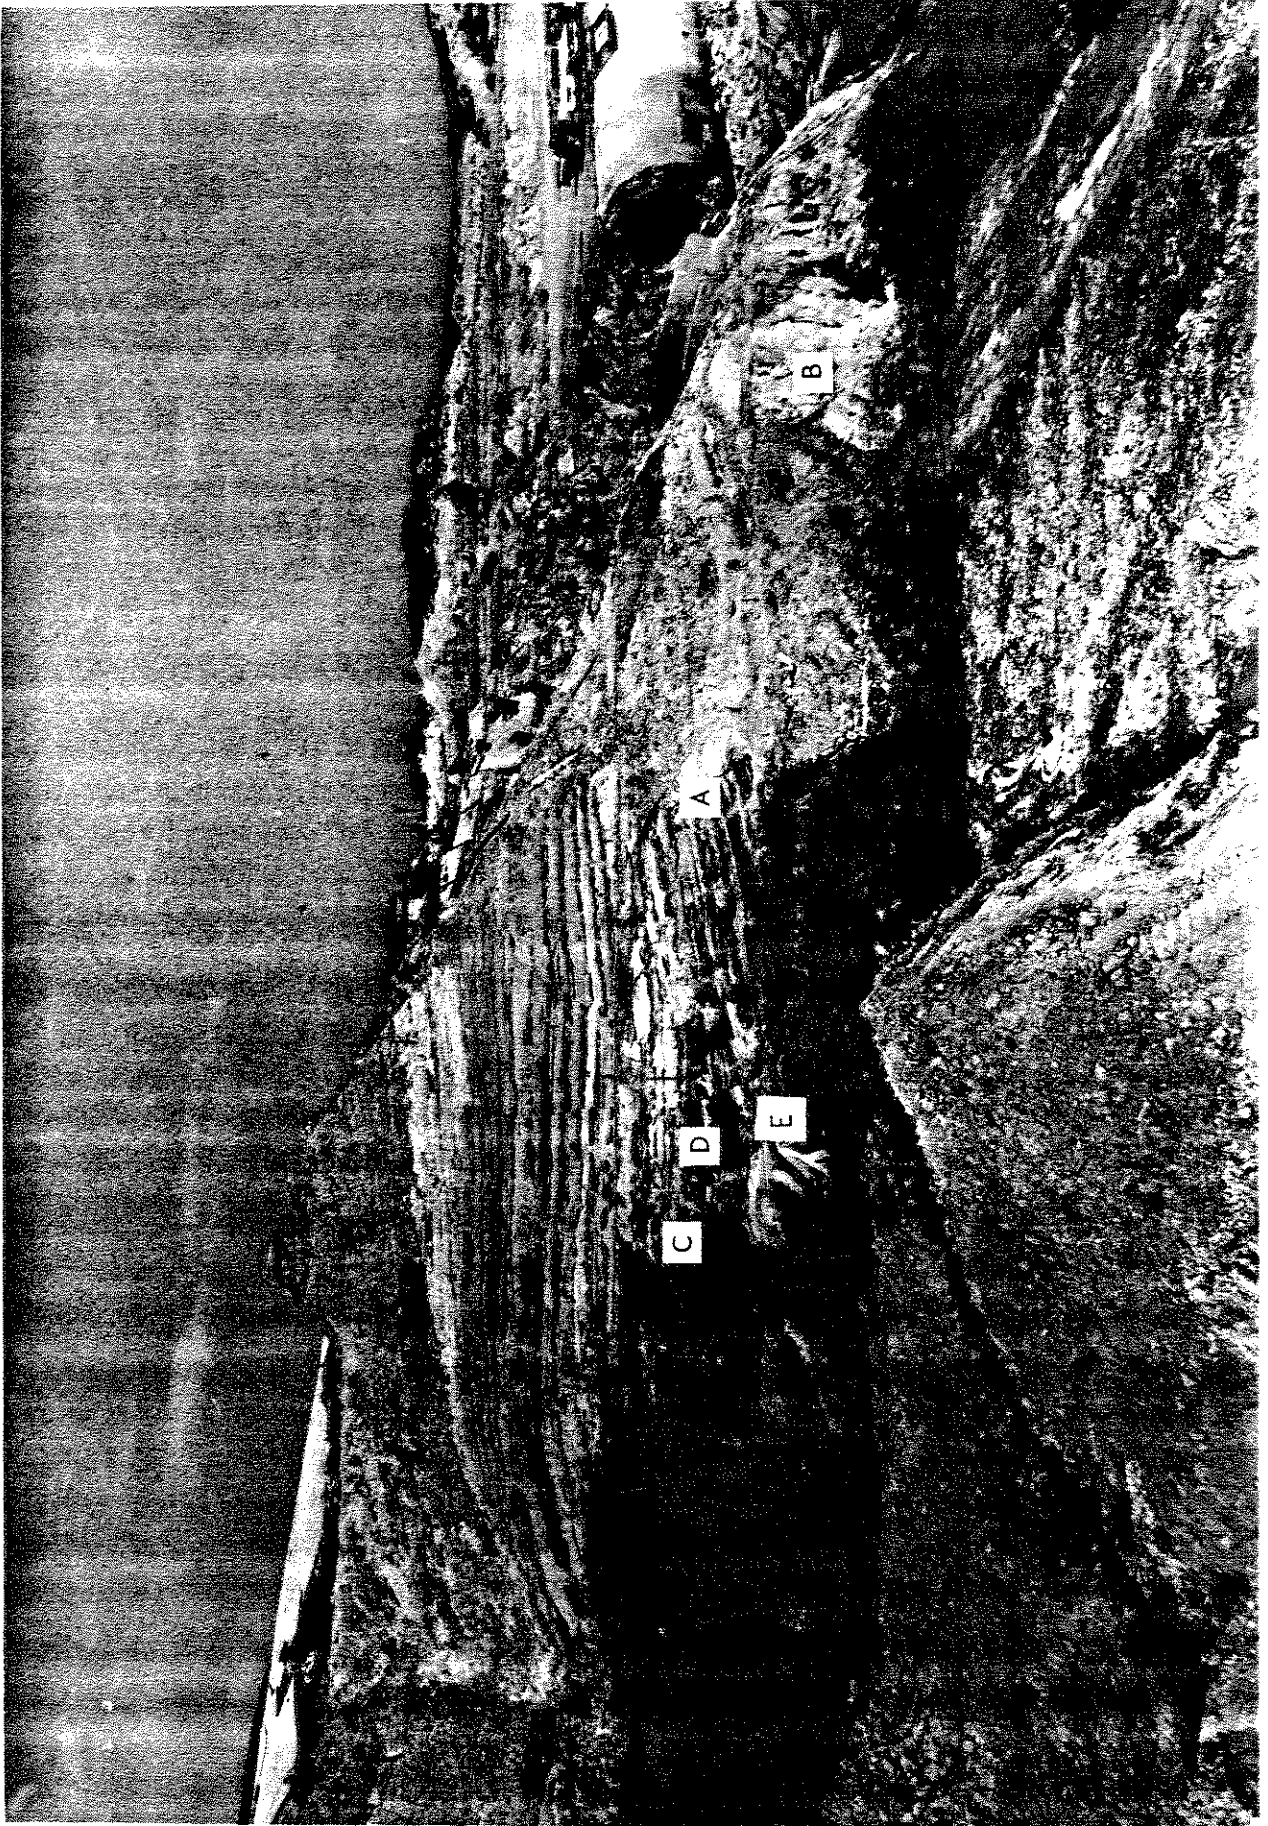
FIG. V-2 VIEW OF TEST TRENCH THROUGH SLIDE DEBRIS OF LOWER DAM
SHOWING LOCATIONS OF ENLARGED PHOTOGRAPHS

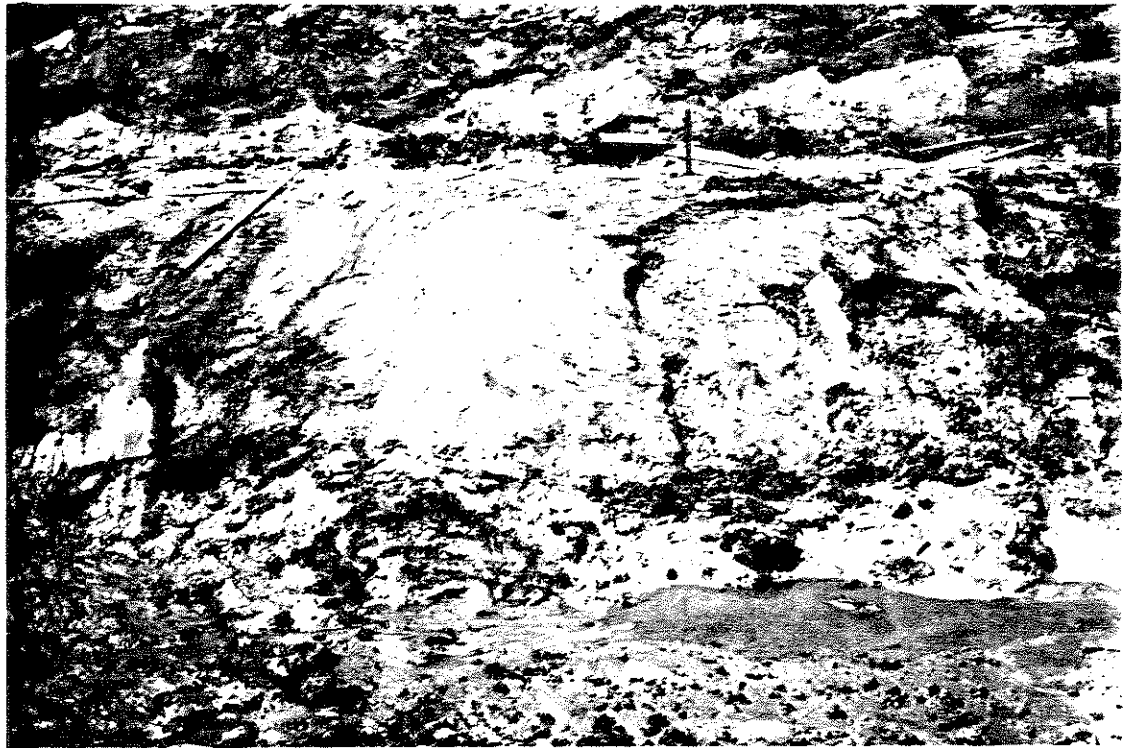
FIG. V-9 ENLARGED VIEWS OF LOCATION E, IN FIG. V-2. THE LIGHT COLORED VERTICAL ZONE AT THE BOTTOM OF THE PHOTOGRAPH IS A SAND DIKE OF LIQUEFIED SAND WHICH HAS BEEN EXTRUDED UPWARD FROM BELOW.

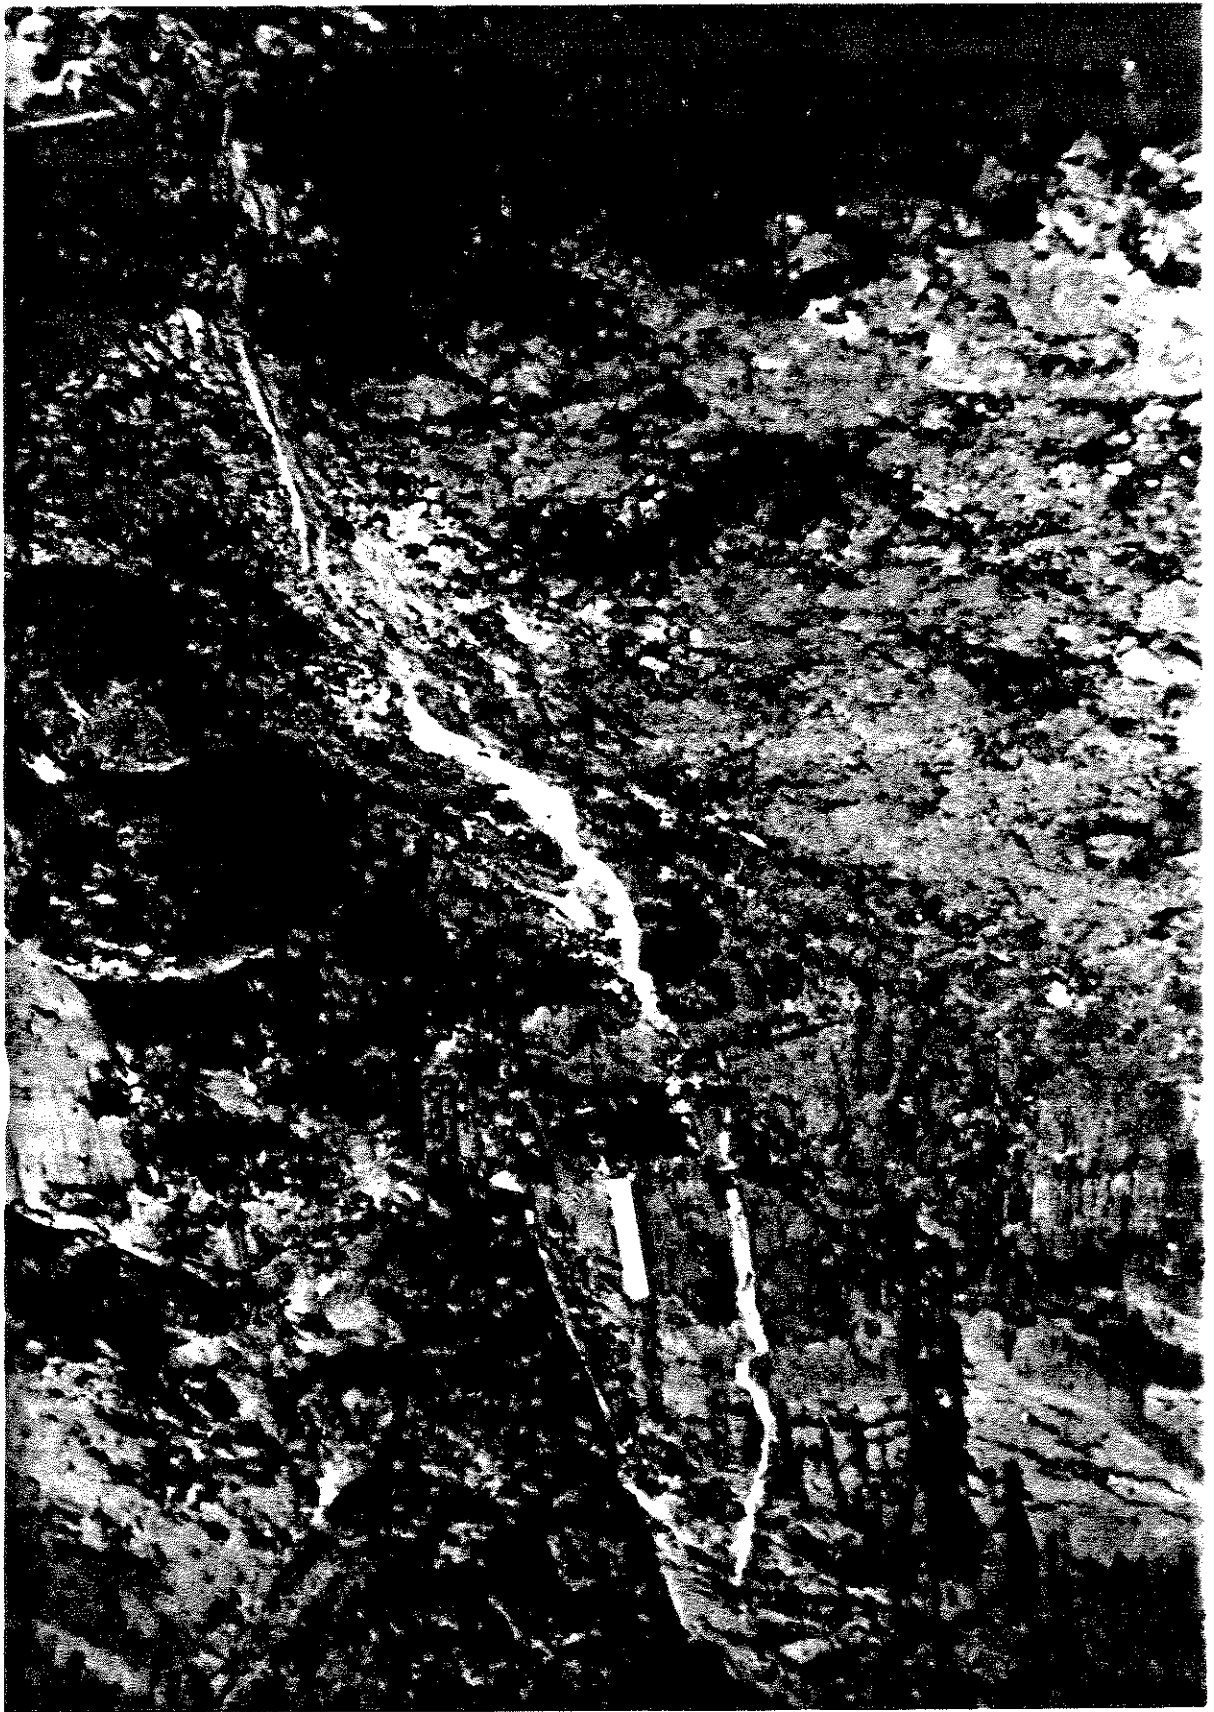
FIG. V-12 CLOSE UP OF ONE VERTICAL SAND-FILLED CRACK IN THE CLAY CORE. CRACK IS ABOUT 3/4 INCH WIDE.

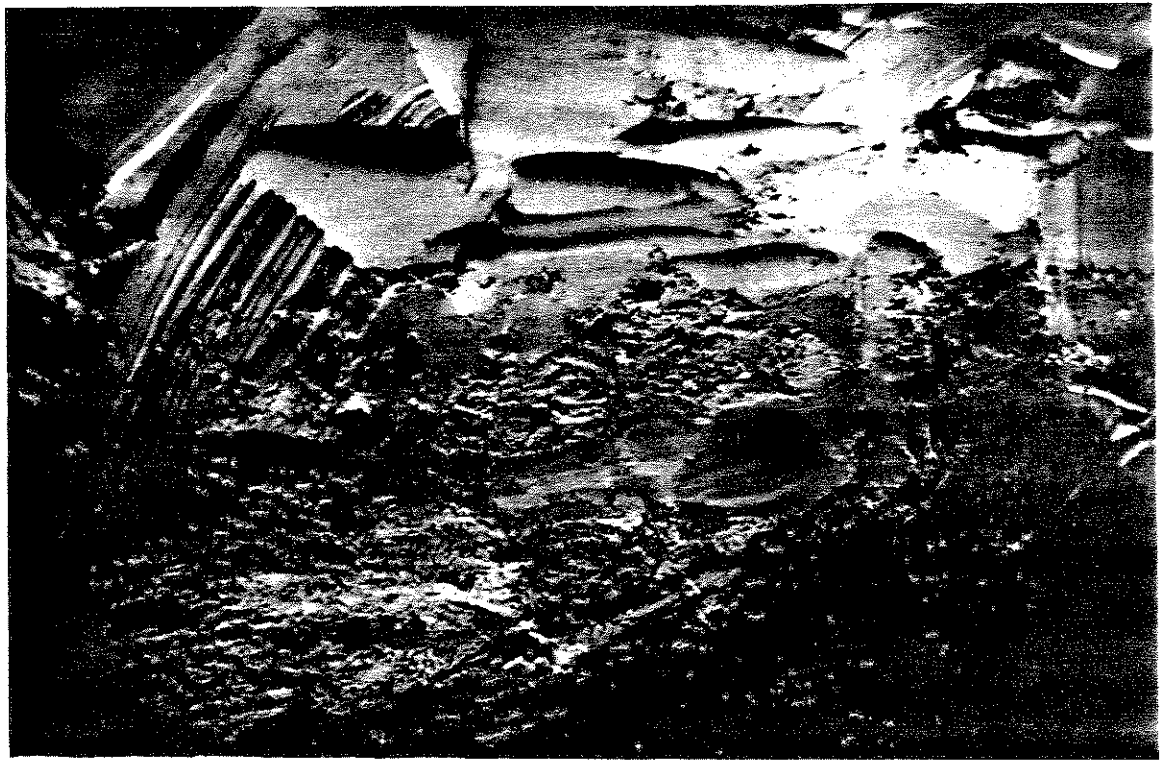
FIG. V-13 SAND POCKETS EMBEDDED IN CLAY IN THE LOWER PART OF THE SLIT TRENCH.
