**Failure Mode and Design
Modifications Technical
Memorandum
for
Mt. Carmel Dam
Cavalier County, North Dakota**

GEI Consultants, Inc.

North Dakota State Water Commission

January 2004
Project 03254

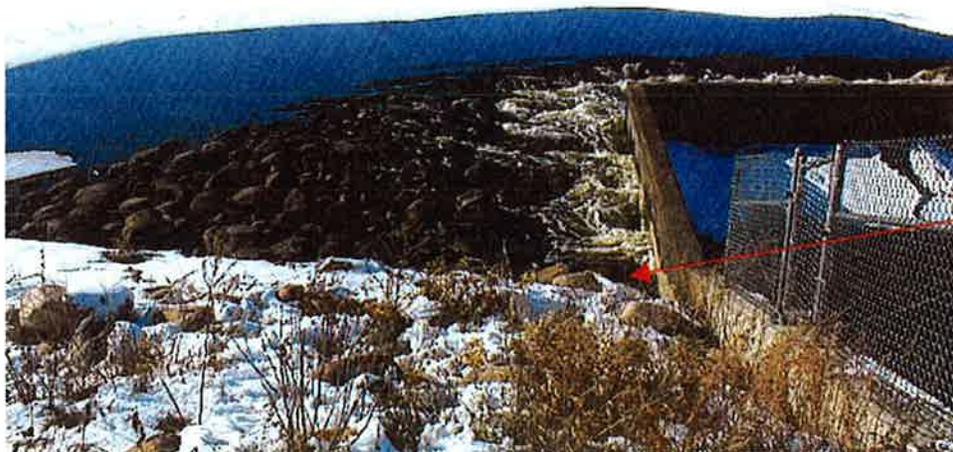
Erosion Hole

2. Photo taken March 30, 2003 during erosion failure. Looking upstream at right wall of drop inlet structure. Note water flowing over riprap berm and down along all sides of the drop inlet. Note location of large erosion hole on right side of structure. Photo provided by NDSWC.

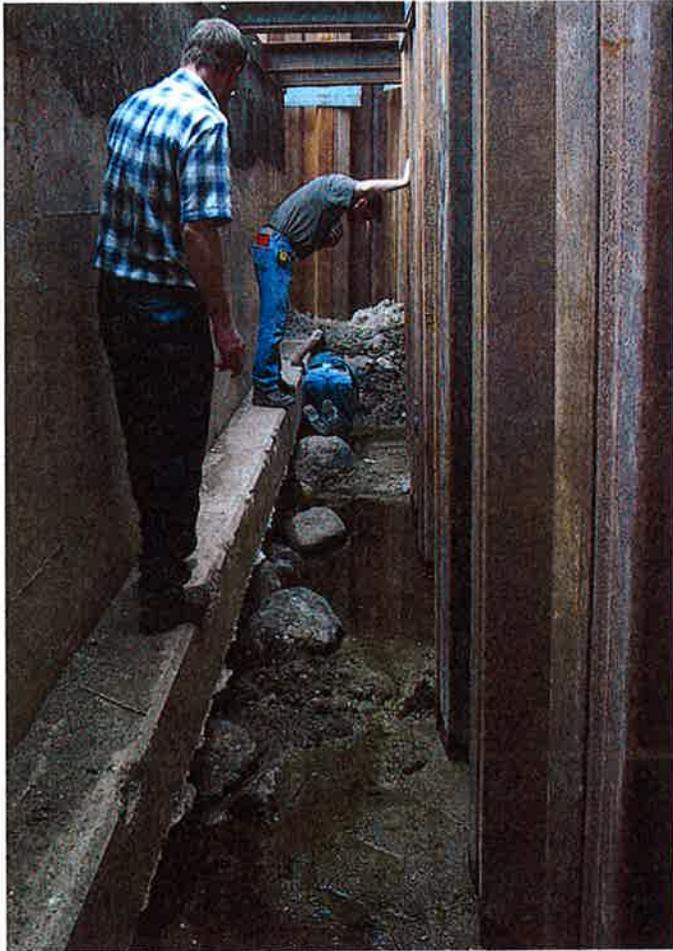
3. Looking right along upstream footing of principal spillway intake structure. Note up to 2-foot-deep void beneath slab. Note riprap that has fallen under slab. All remaining backfill and riprap was removed for installation of emergency sheetpile cofferdam.

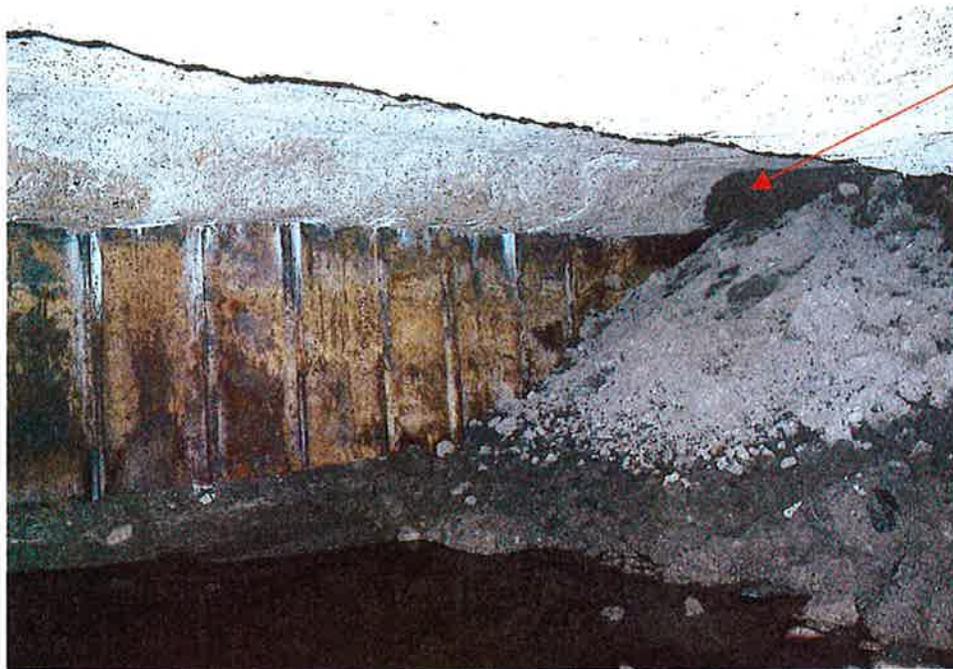
Moist soil and
concrete

5. Looking upstream and left at centerline sheetpiles. Note moist soil and concrete at upper left area of sheetpiles.

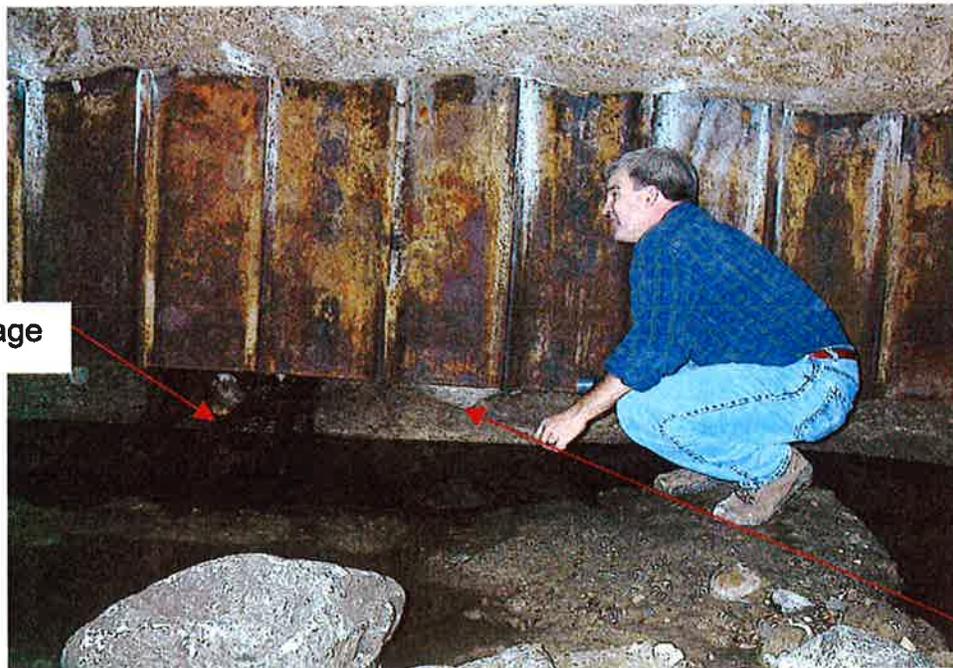
Seepage

Wedged rock

6. Looking upstream at centerline sheetpiles. Note firm condition of exposed embankment fill. Note minor seepage through void beneath sheetpiles. Note riprap in foreground that has passed beneath sheetpiles.

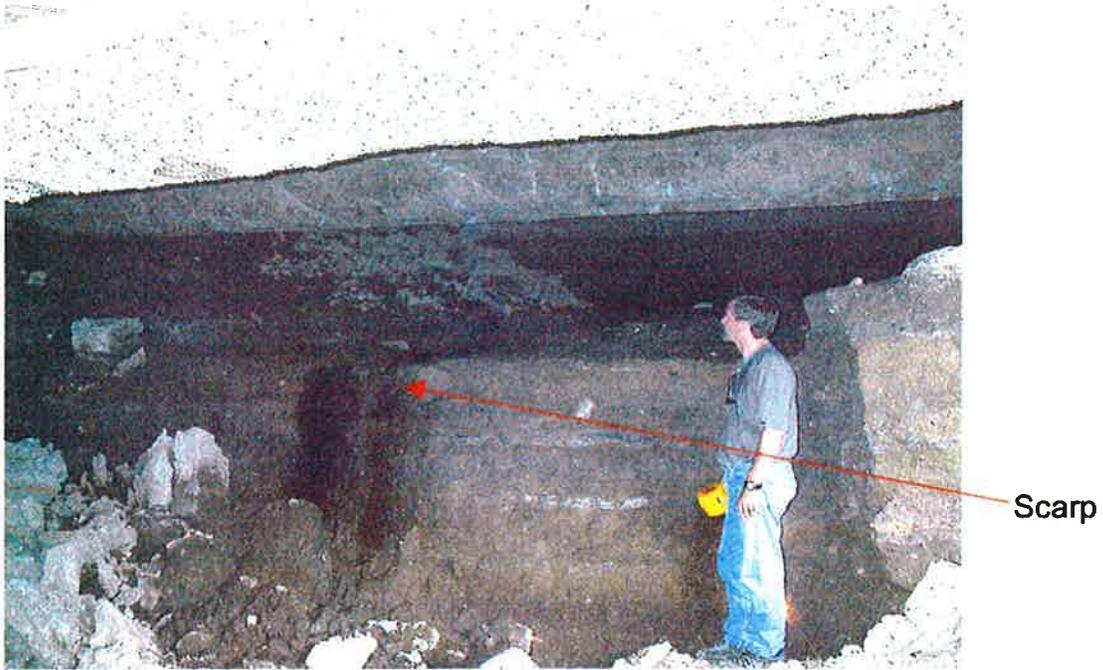
7. Erosion under Segment F. Note 5-foot-high scarp likely resulting from headcutting. Embankment fill is exposed in scarp.

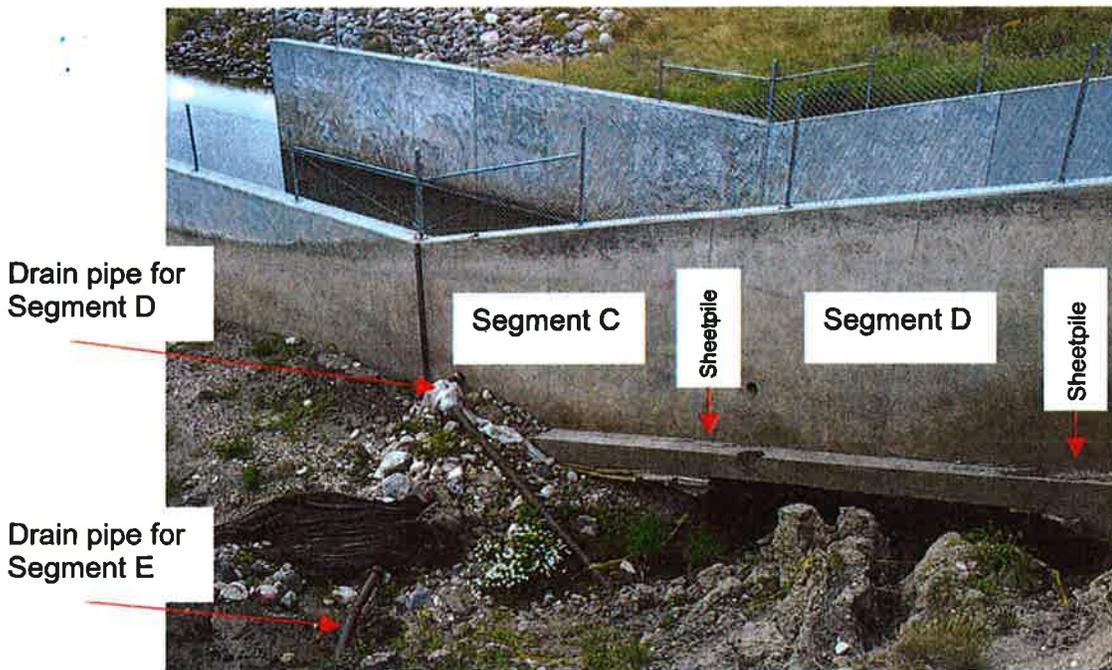
8. Looking downstream and to the right at left wall of chute and void beneath structure. Note the displaced ductile iron pipe drain pipes. Note black geotextile that envelops a gravel drain installed to control seepage during construction.

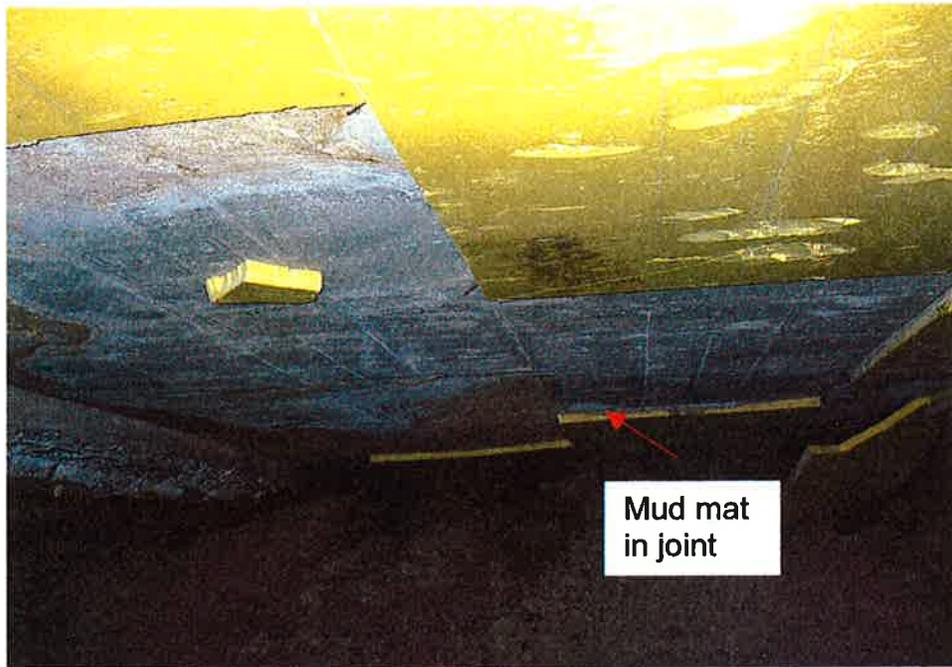
9. View of underside of slab Segment E and rigid insulation board. Two layers of 2-inch-thick insulation were installed during construction. Note concrete mud mat in joints between insulation panels.

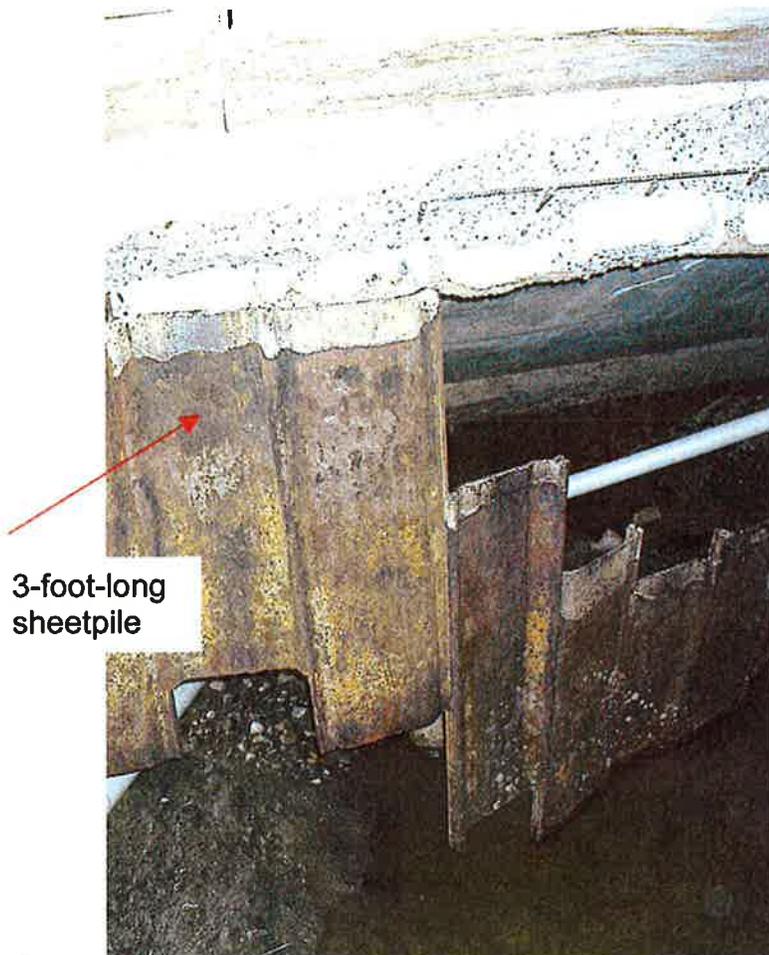
10. Looking downstream and right at sheetpiles for Segment D/E joint. Note undermined sheetpiles have fallen down from broken slab embedment. Note short sheetpile (only 3-foot long) versus 4-foot length specified. Note displaced PVC drain pipe beneath Segment D.

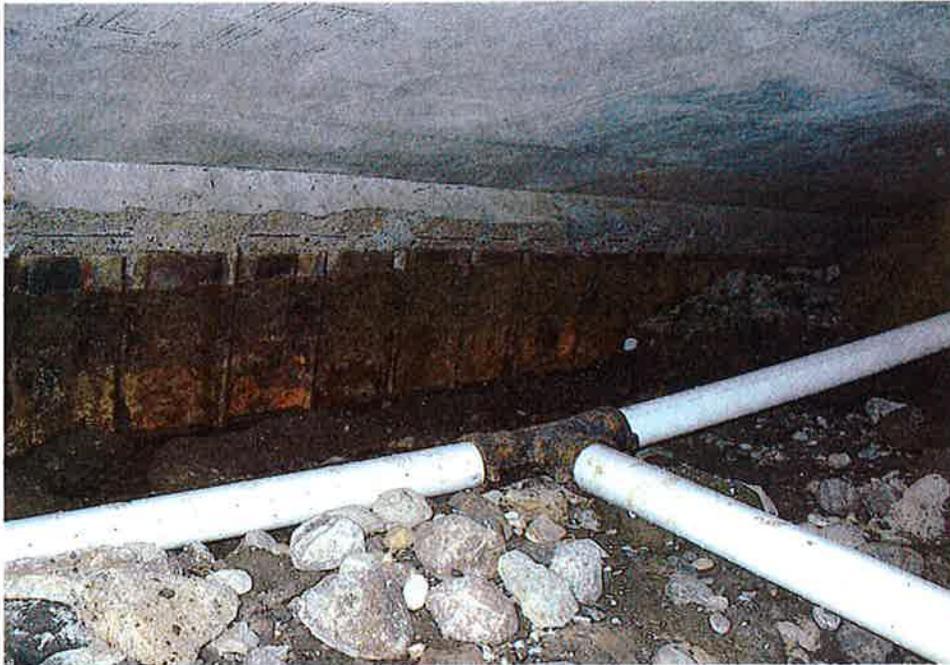
11. Looking downstream and to the right at sheetpiles for Segment C/D. Note 4-inch-diameter underdrain lying in foreground.

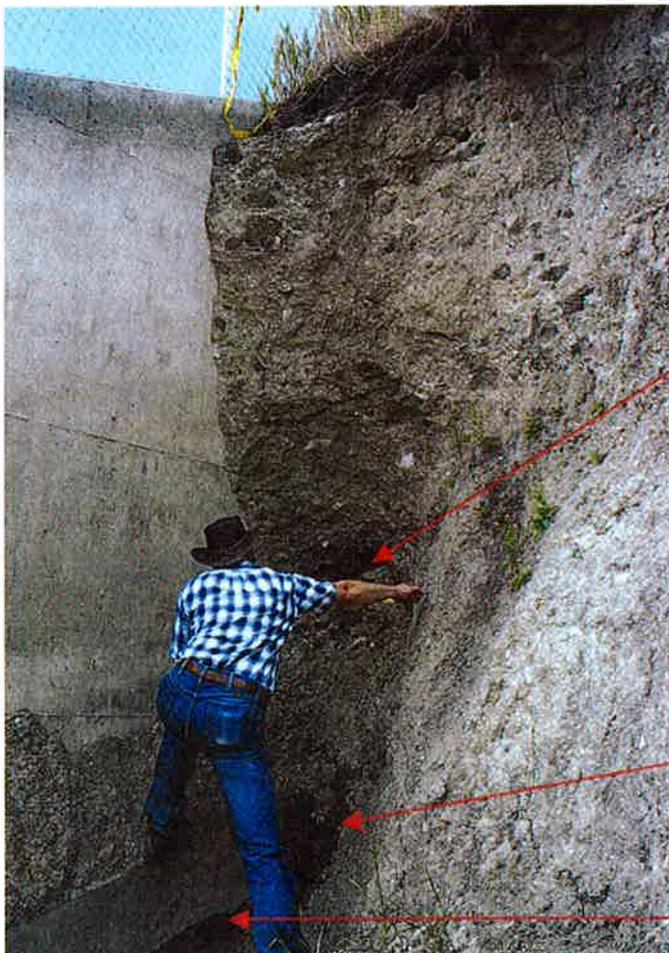
Erosion hole, partially collapsed

12. Looking upstream at left side of spillway chute at erosion scarp.

Moist soil

Void beneath structure

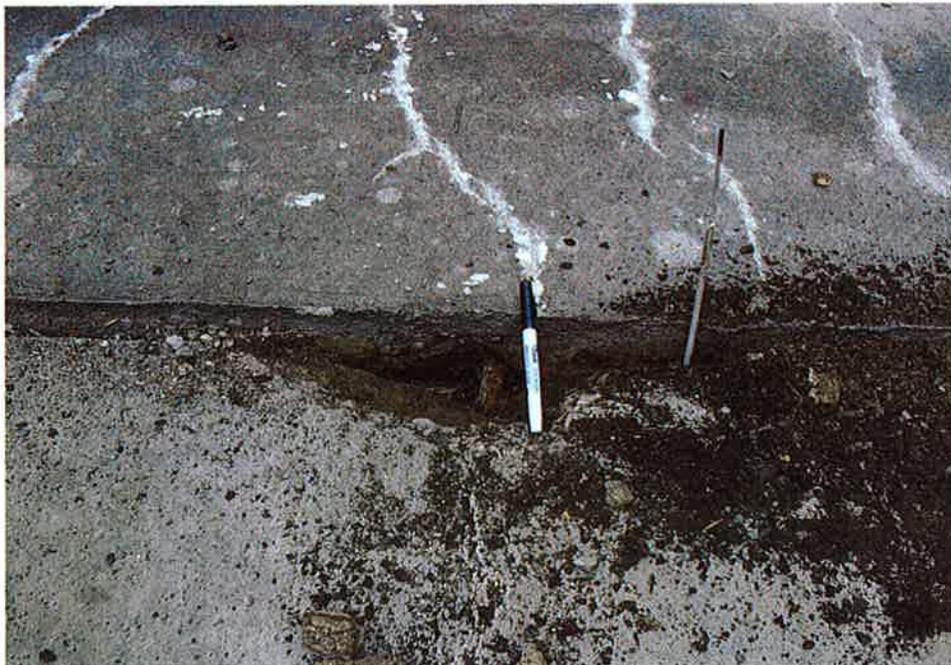
15. Close-up view of slab joint K/L. The waterstop visible to left of dowel is no longer embedded on upstream edge.

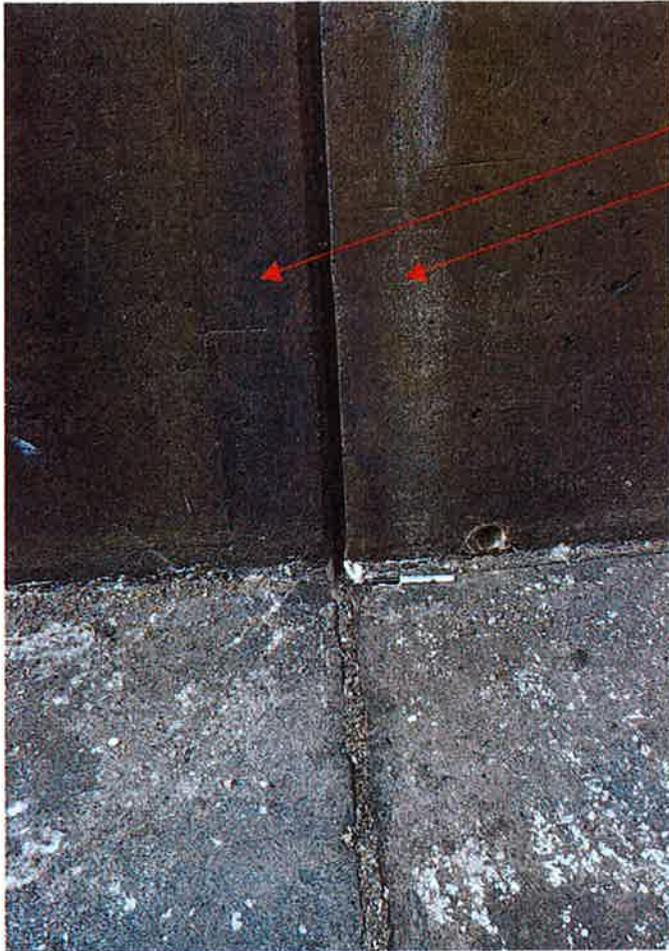
Segment K

Segment L

16. Waterstop visible in joint.
Looking right at right wall of
spillway intake structure.

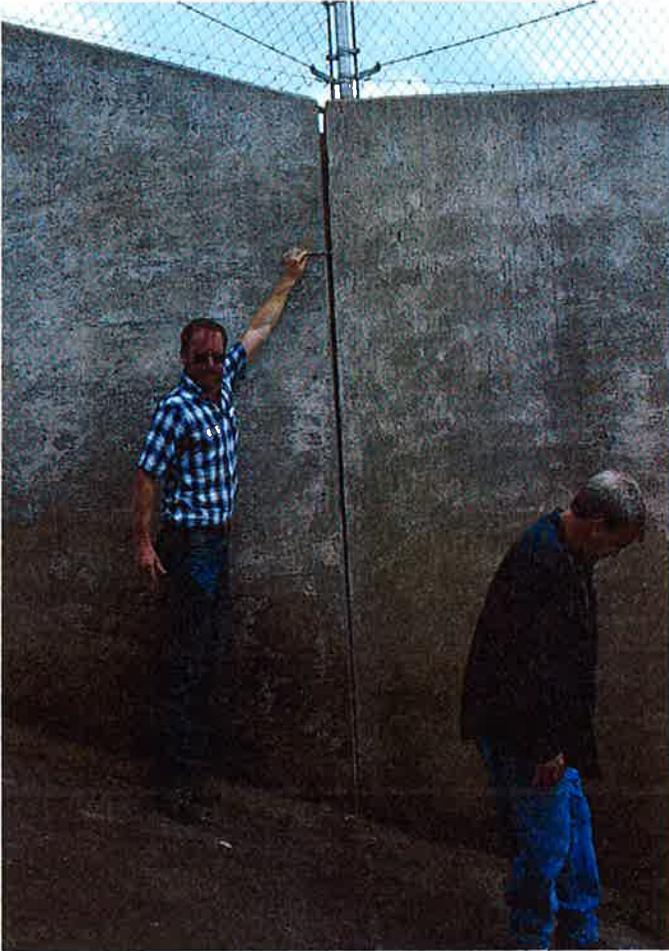
17. Joint displacement between Segments B and C on left wall of principal spillway.

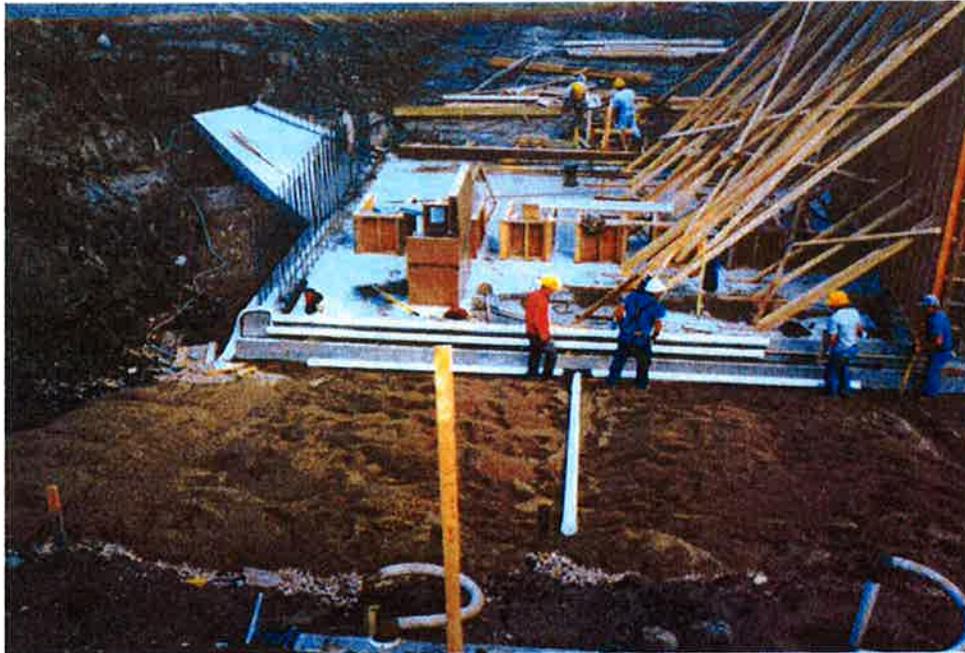
The granular drain material may not have been laterally confined during placement. As indicated on Section B of Sheet 13 and construction photos (see Photo 1 in Appendix B), the granular drain material appears to have not been laterally unconfined because it was not placed either in a trench-type condition or between concrete walls that would have confined the material. Adequate compaction of backfill around the drain materials would have been difficult to achieve. Likewise, the drain materials themselves were likely not adequately compacted. Poor compaction at the important contact between these materials would result in loose materials that have increased porosity and potential for development of preferred erosion pathways along the contact boundary.

Photo 1, Appendix B). The drain material placement was terminated at the edge of the structure and the footing/slab poured on top of the drain material in accordance with Section B on Sheet 13 of the Drawings. The footing/slab was poured on top of the drain material before any backfill was placed adjacent to the drain system as can be seen in Photo 2, Appendix B. Adequate compaction of the subsequent backfill placed next to the drain system would have been hindered by the overlying slab and loose granular drain material. As a result, the important contact between the backfill and the drain system was not likely adequately compacted.

1. Looking downstream at construction of underdrain for Segment B. Note lack of lateral confinement of fine drainfill material. Note 1-1/2-inch-minus gravel used for subgrade stabilization beneath fine drainfill.

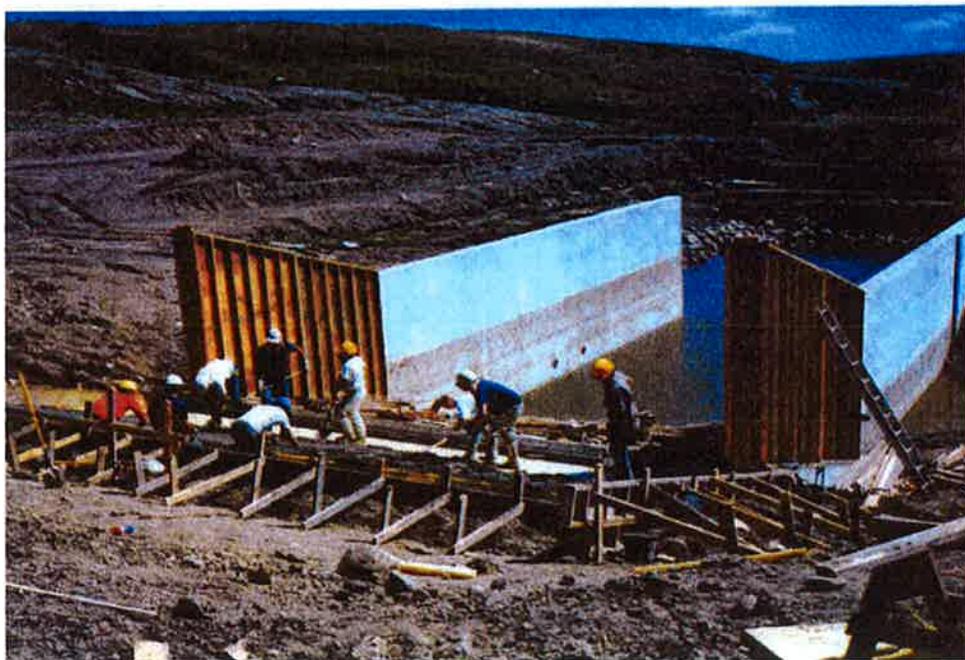
2. Looking downstream and to the left at formwork for the Segment D slab. Note the concrete forms that temporarily enclose the drain system will be subsequently removed and lack of backfill to provide lateral confinement of the drain system.

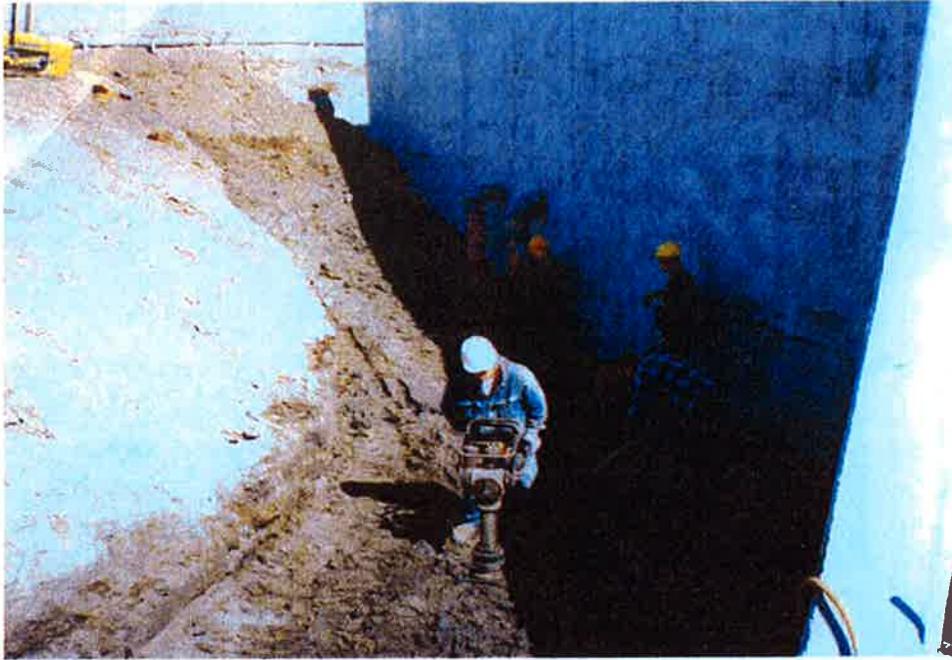
As indicated in Photo 3 (Appendix B), there is a potential for damage to the exposed drain discharge pipes during backfilling and compaction operations. The drain discharge pipes were not structurally supported prior to backfilling except at the top of the pipe by the penetration through the structure wall and at the bottom by the granular drain material. However, damage or disturbance to the vertical exposed pipes and pipe joints does not appear to have occurred during construction because if such damage occurred, large quantities of soil would have likely been discharged from the drain outlets prior to the failure.

3. Backfill compaction using lightweight equipment adjacent to stilling basin Segment A. Photo looking upstream and to the left. Note exposed underdrain discharge pipes and insulating wrap.

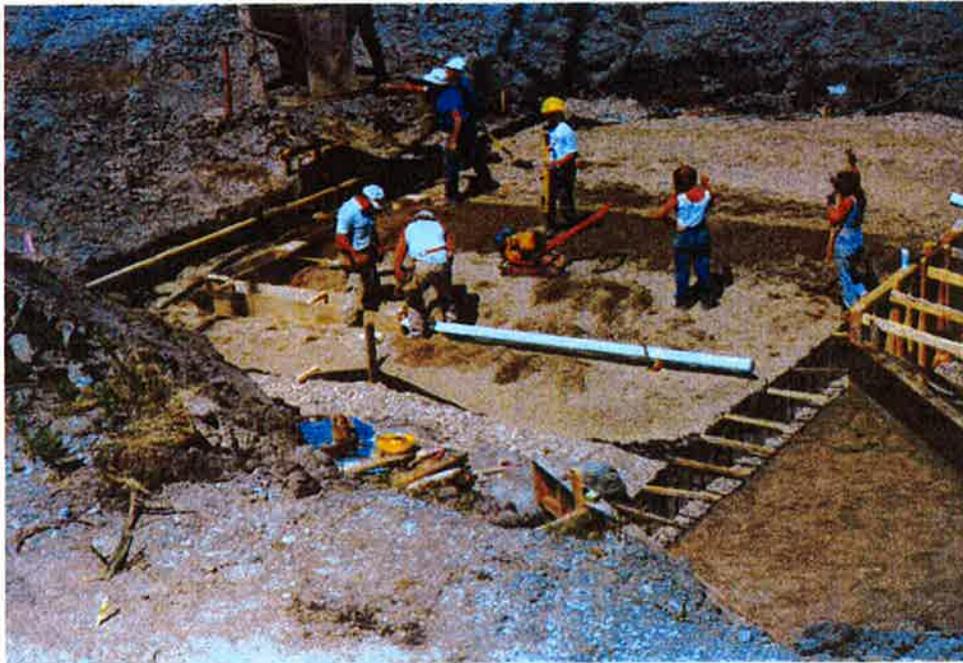
4. Placement of fine drainfill for Segment A stilling basin. Note the perforated drain pipe supported at grade before coarse drainfill is placed around the pipe using the guide forms. Note the fine drainfill is placed over 1-1/2-minus gravel foundation stabilization material and a non-woven geotextile that was installed to address wet subgrade conditions. Photo taken looking upstream and to the left.

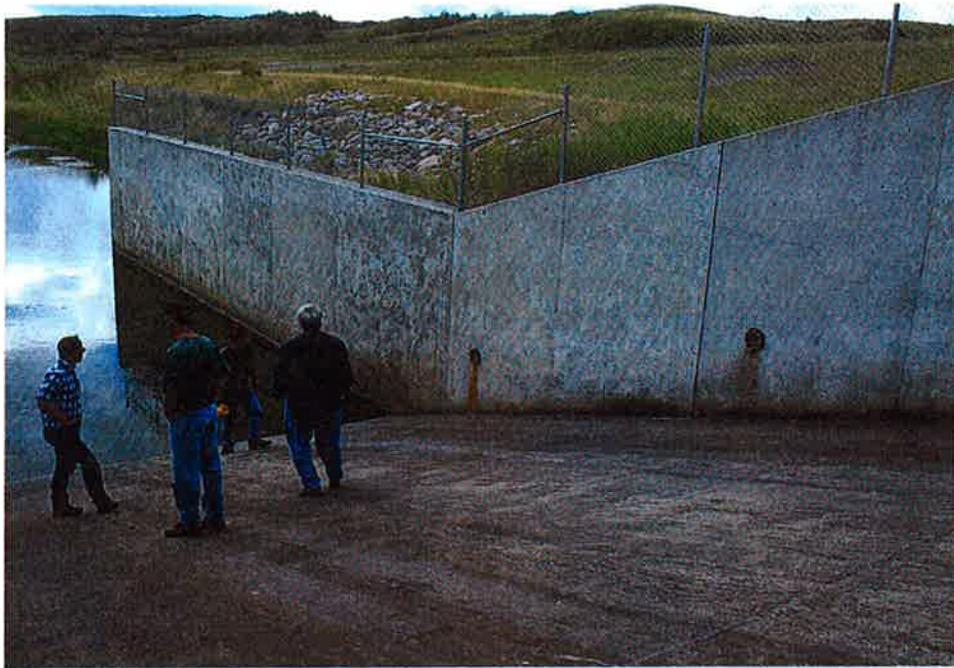
- Stained concrete adjacent to underdrain discharge locations indicates upstream drains flowed more than downstream drains. Underdrains flowed for long periods prior to failure to cause the stains on the chute walls (Photos 5, 6, and 7, Appendix B).

5. Looking downstream and to the right at spillway chute and right wall. Spillway underdrain outlets for Segment E and D are visible, whereas the outlet for Segment C is beneath the tailwater in the stilling basin.

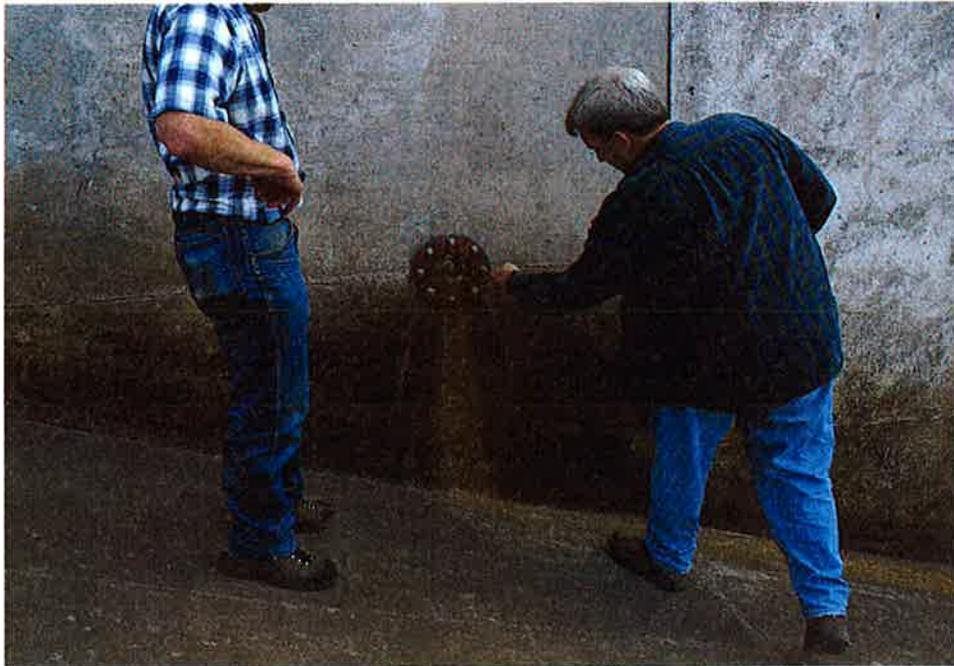
6. Looking to the left in the spillway chute at the outlet for spillway underdrain Segment E. Note the increased concrete staining that has occurred at this location compared to the outlets in Photos 5 and 7.

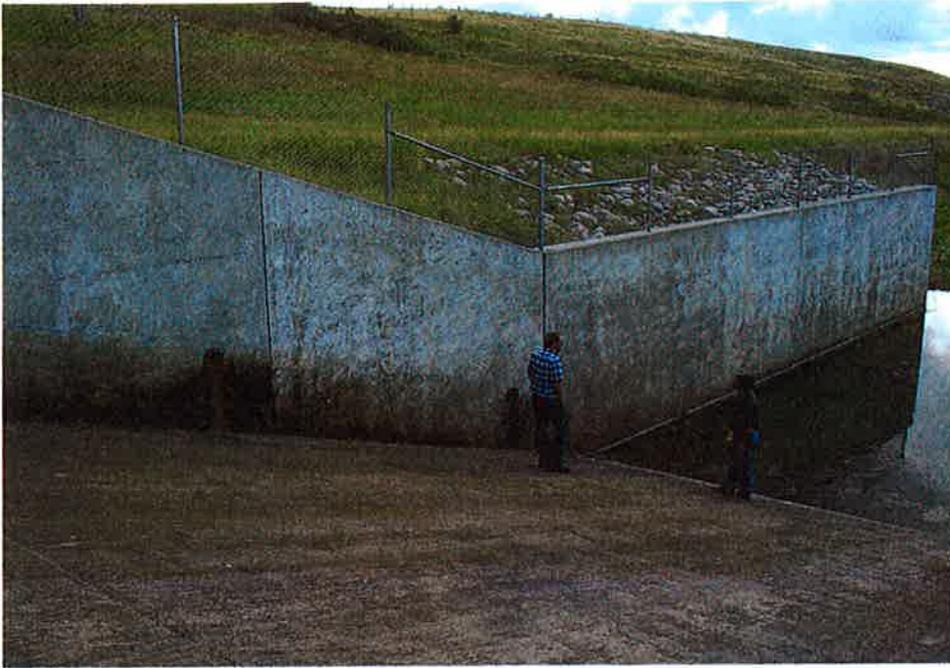
7. Looking downstream and to the left at spillway chute and left wall. Spillway underdrain outlets for Segments E and D are visible, whereas the outlet for Segment C is beneath the tailwater in the stilling basin. Note increased concrete staining at the outlet for Segment E. See close-up Photo 6.
