Technical Evaluation of the Gold King Mine Incident

San Juan County, Colorado

U.S. Department of the Interior
Bureau of Reclamation
Technical Service Center
Denver, Colorado

October 2015

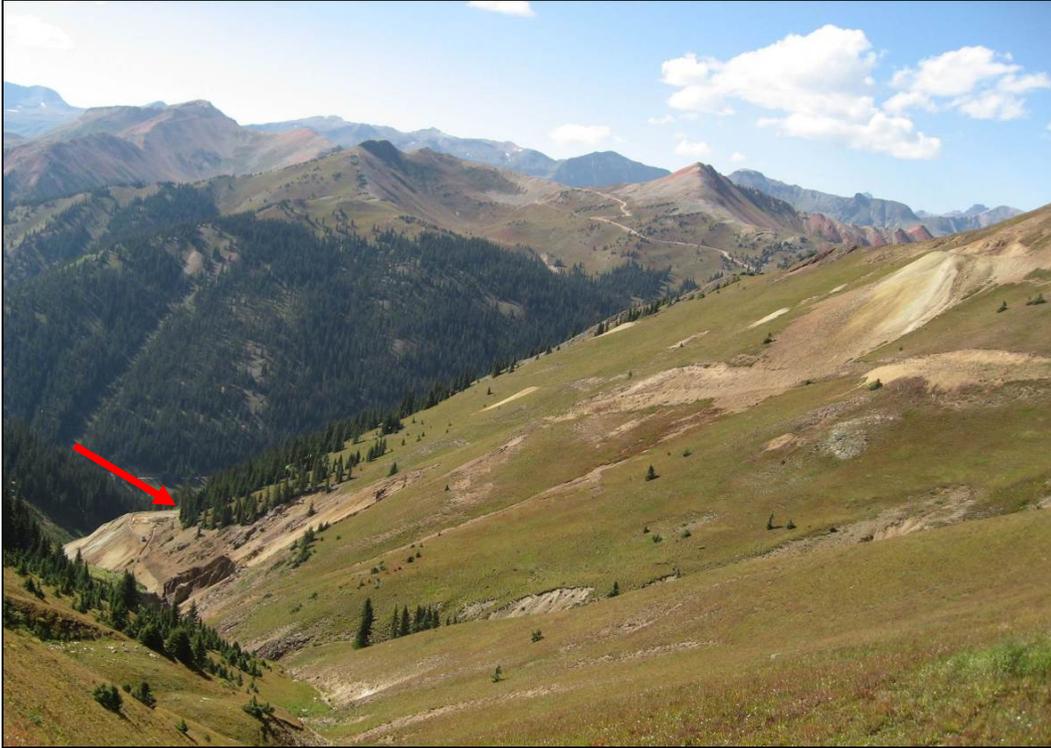
Figure 1.—Photograph of the Gold King Mine looking west. The red arrow points to the location of the mine blowout, which occurred on August 5, 2015.

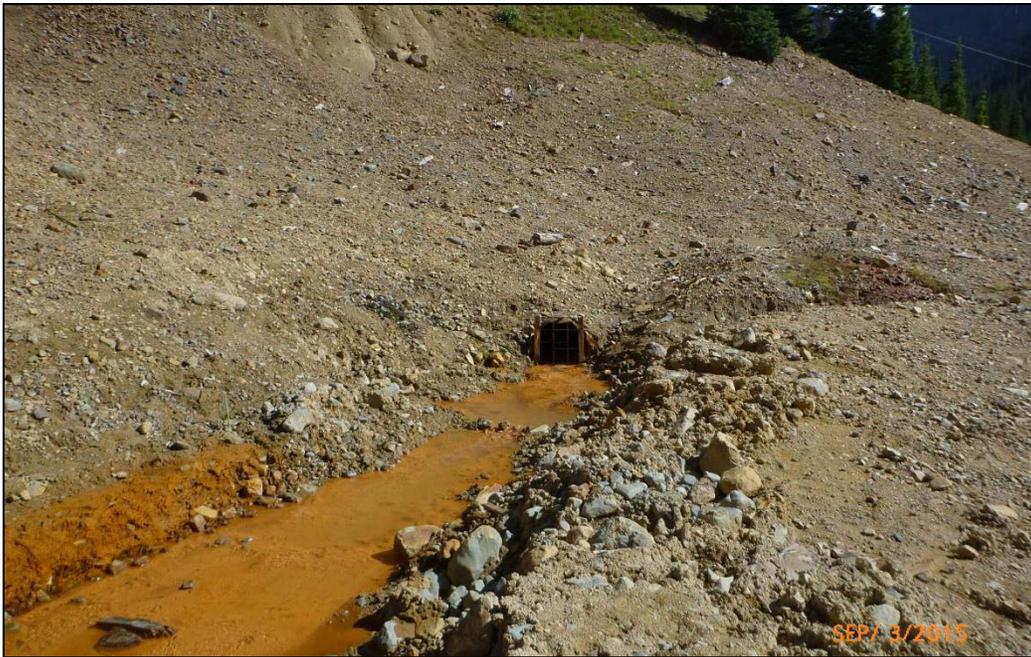
Figure 7.—Photograph showing the seepage outflow from the drain pipe at the American Tunnel at Gladstone, Colorado, as it appeared on September 3, 2015, with about 100 gpm of acid water flowing out.

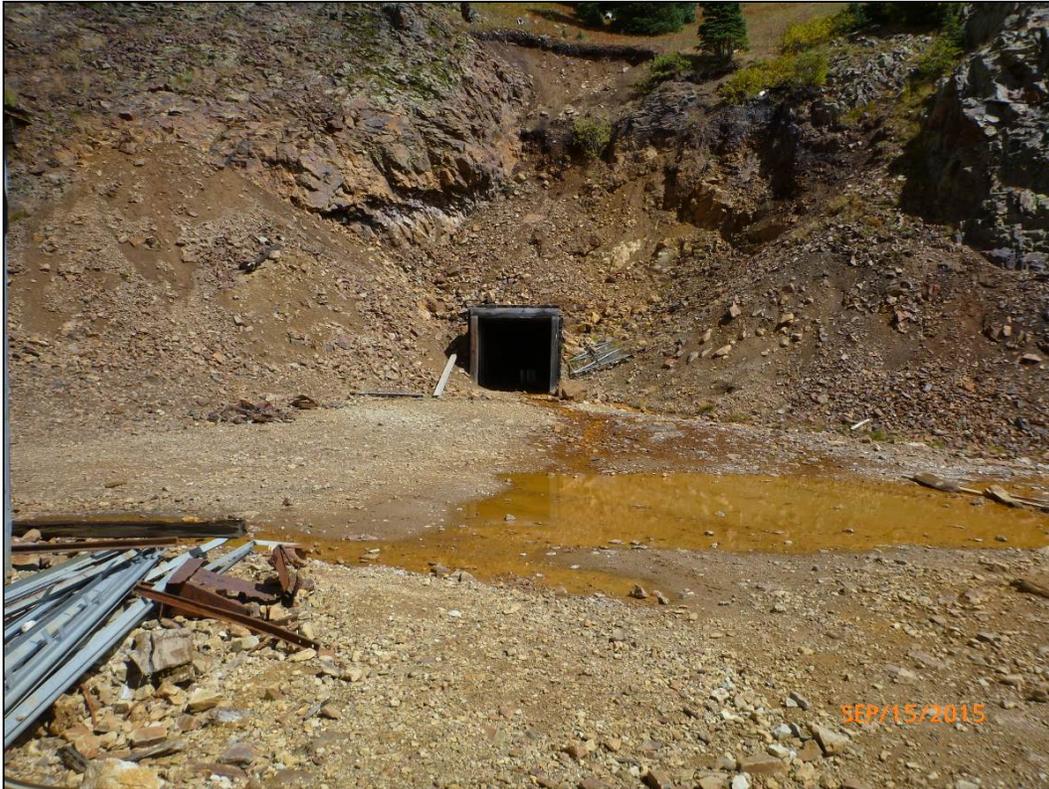
Figure 10.—Photograph showing seepage from the Mogul Mine on September 15, 2015. This mine has hydraulic bulkheads to limit the outflow of water from the Sunnyside Mine.

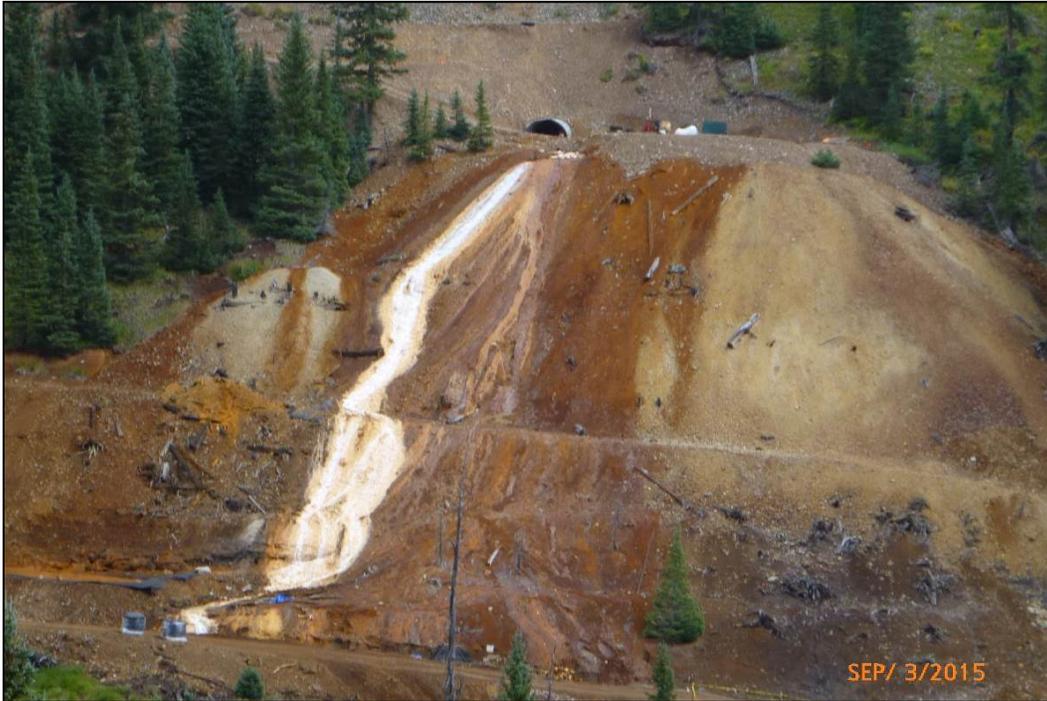
Figure 11.—Photograph showing acid drainage flowing out of the Red and Bonita Mine on September 3, 2015.

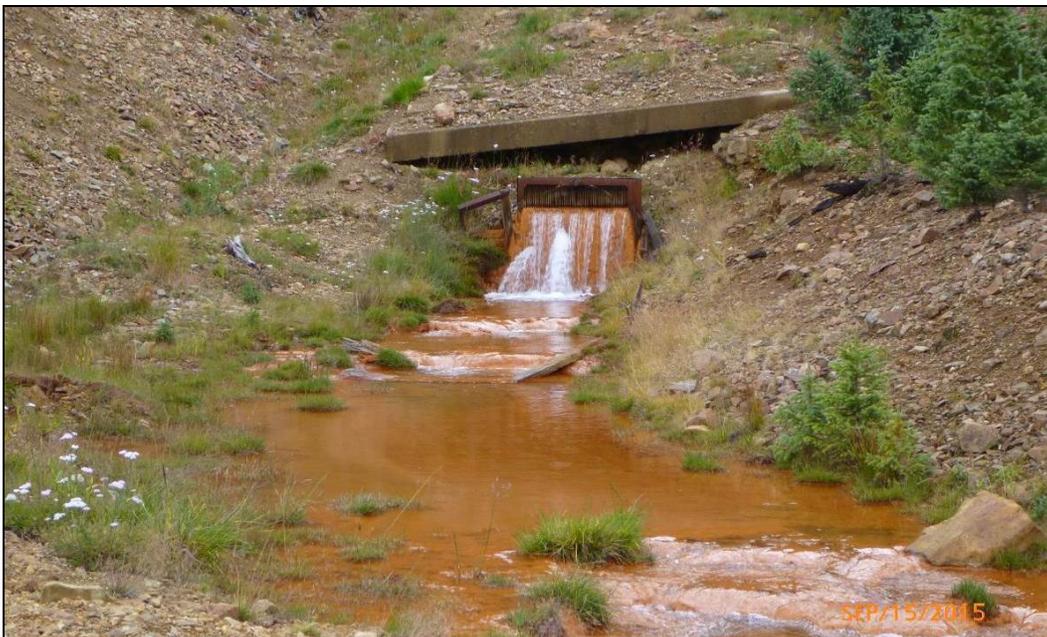
Figure 12.—Photograph taken on September 15, 2015, of drainage from the Silver Ledge Mine, which is located south of the Gold King Mine.

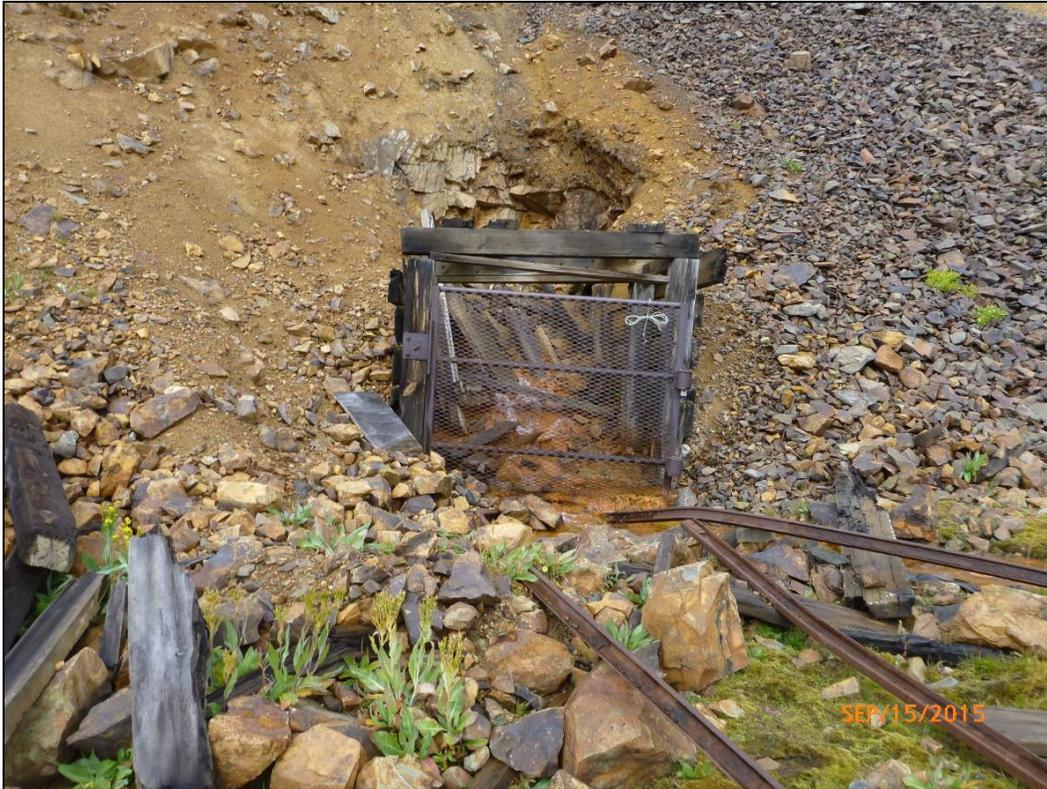
Figure 13. Photograph taken on September 15, 2015, showing acid seepage from the Blackhawk Mine located south of the Gold King Mine.

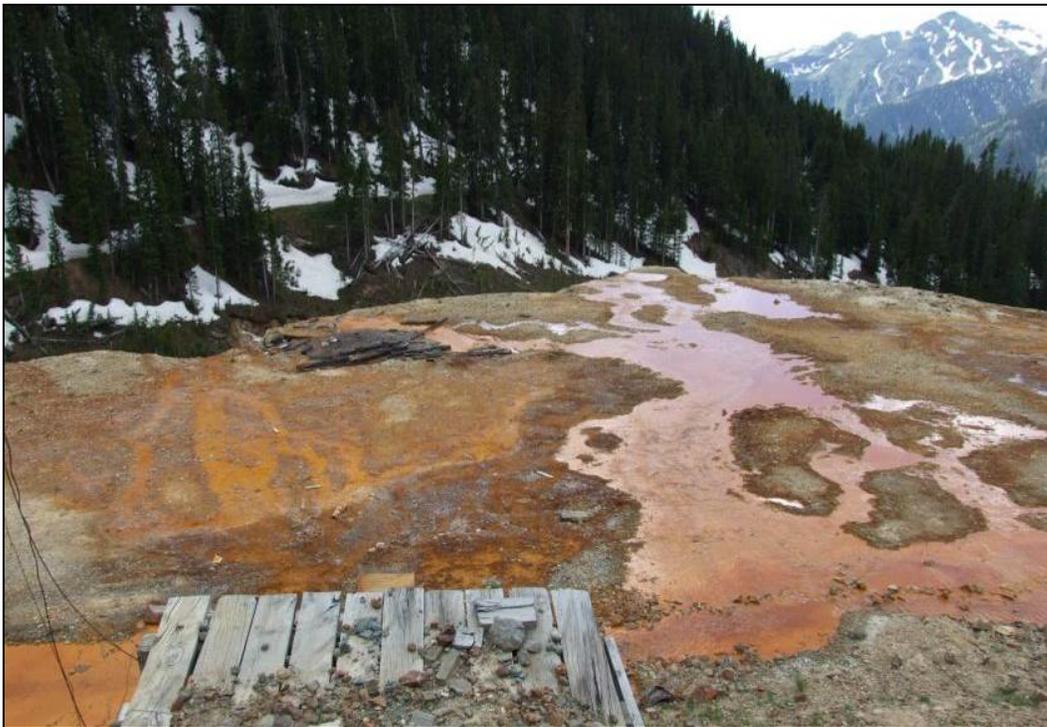
Figure 14.—Photograph showing adit seepage infiltrating into the Gold King Mine Level 7 waste-rock dump in 2007 (from DRMS project files).

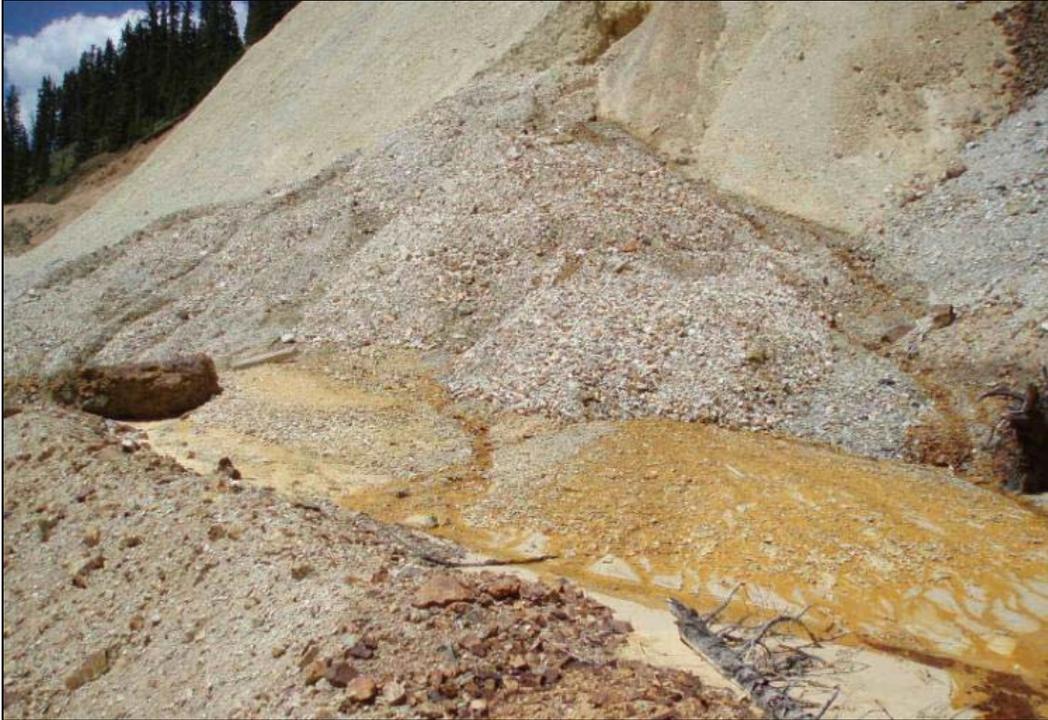
Figure 15.—Photograph showing deposition of landslide material in 2007 blocking a portion of the access road near the base of the waste-rock dump (from DRMS project files).

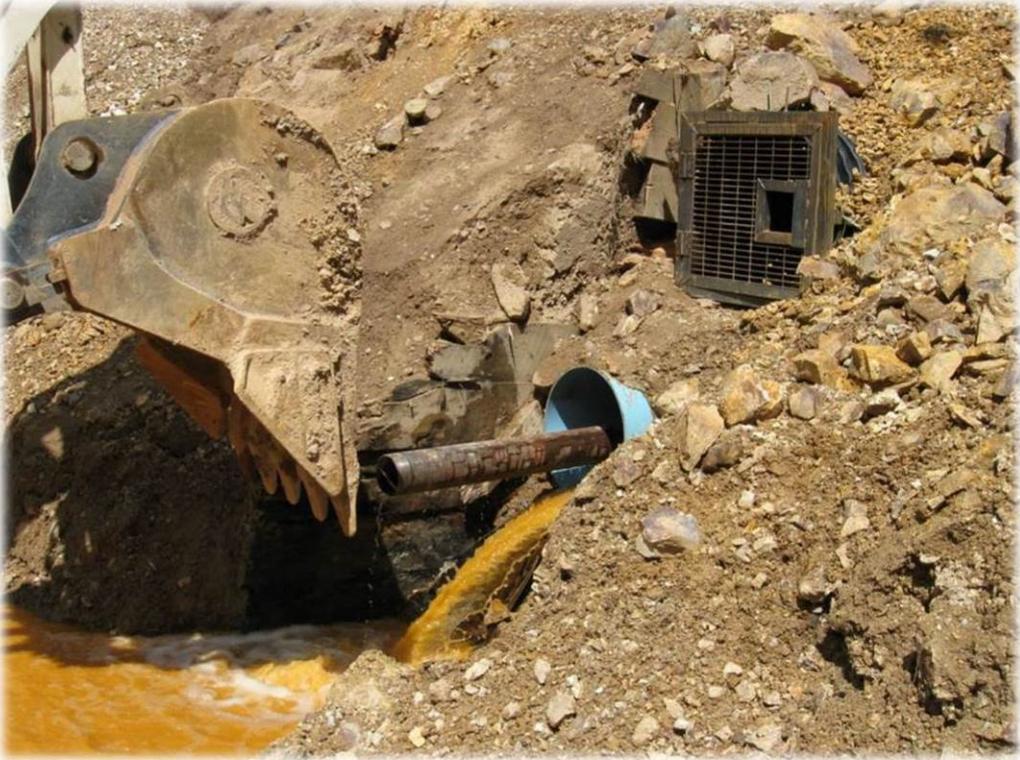
Gold King Level 7 Old Portal with well-point installed through the drain pipe. This portal may be re-opened in a future project to help stabilize the mine drainage and prevent future increases in mine pool head.

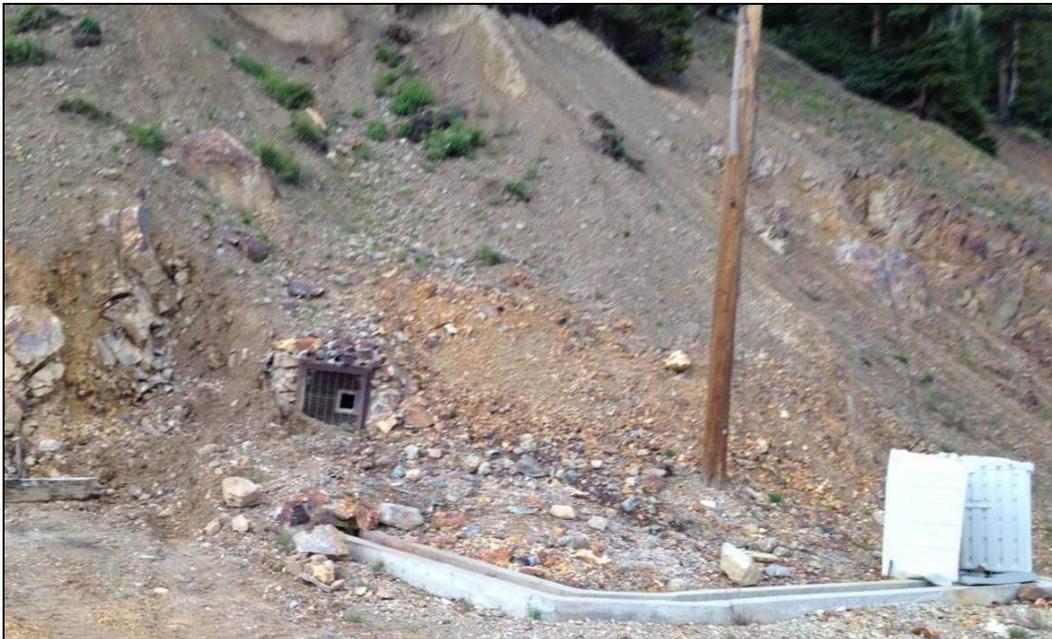
Figure 22.—Photograph showing the condition of the Gold King Level 7 New Adit portal on August 27, 2014, prior to any EPA modifications. Soil and rock debris have migrated downslope and covered a portion of the drain installed in 2009 (photograph from EPA project files).

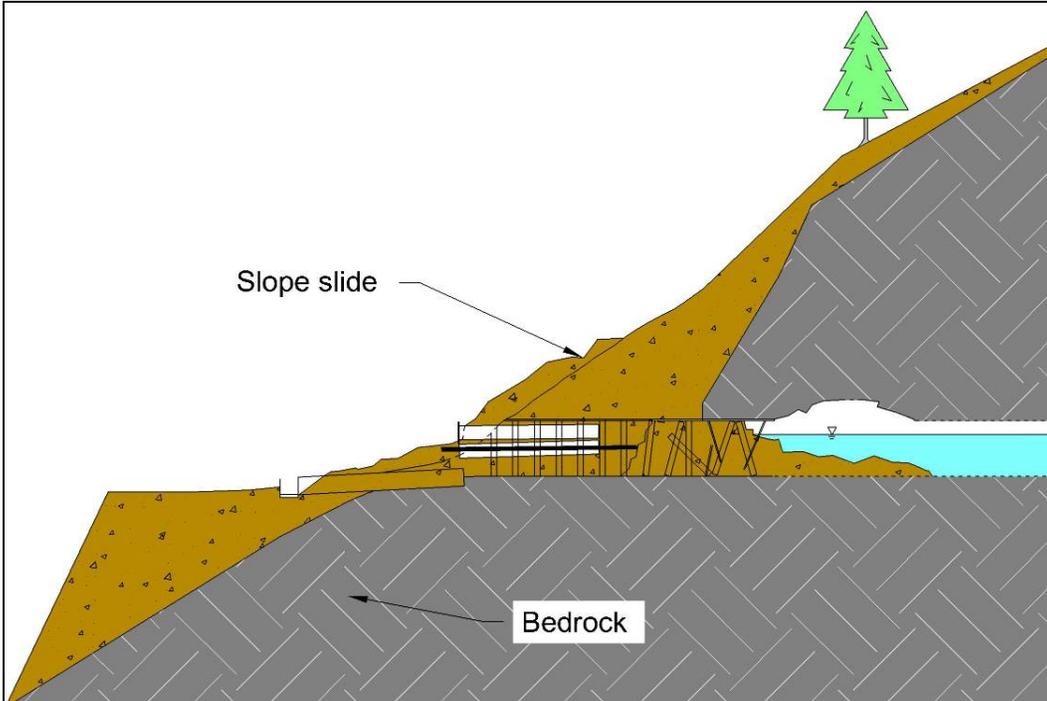
Figure 23.—Cross-section showing the condition of the Gold King Mine Level 7 New Adit in 2014 (water level as assumed by EPA and DRMS), more rock and soil had come down off the slope and were partially blocking the drain, which indicates a lack of maintenance (not to scale).

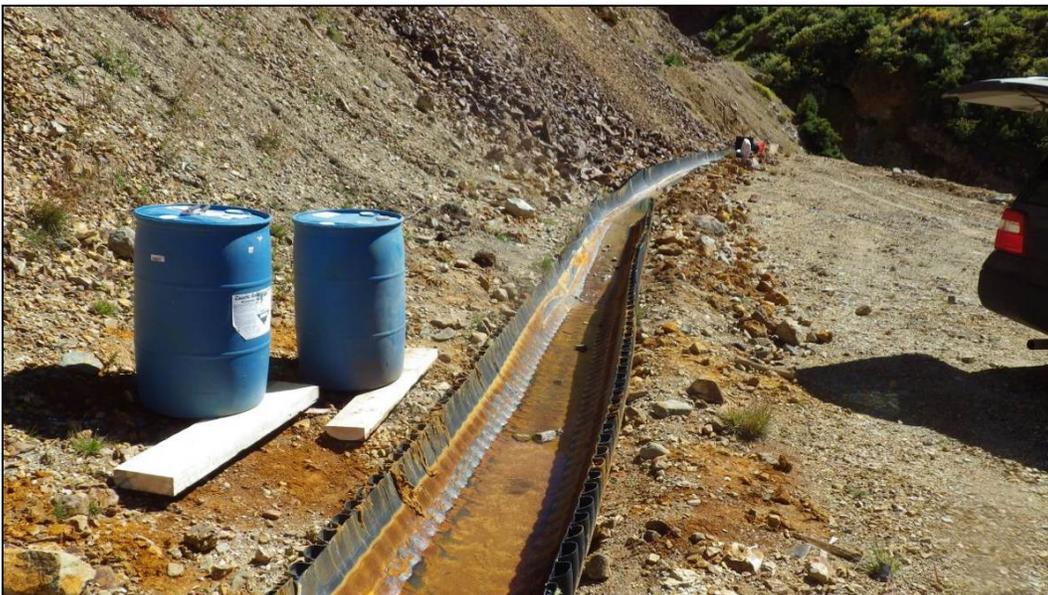
Figure 24.—Photograph showing seepage flow in the half-pipe channel at the Gold King Mine Level 7 New Adit area on September 11, 2014. Flow of approximately 12.6 gpm was recorded (photograph from EPA project files).

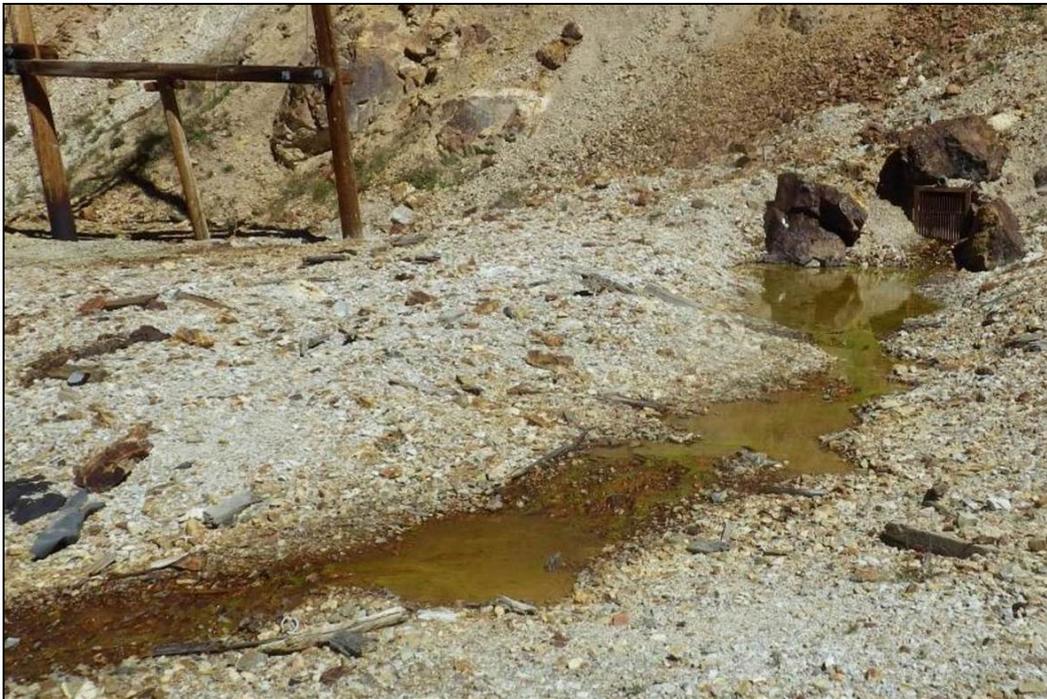
Figure 31.—Gold King Mine Level 7 OLD Adit (upper right) showing a small amount of seepage flow on September 11, 2014. At the portal, the floor of the old adit is approximately 2 feet higher than the floor of the old adit portal (photograph from EPA project files).

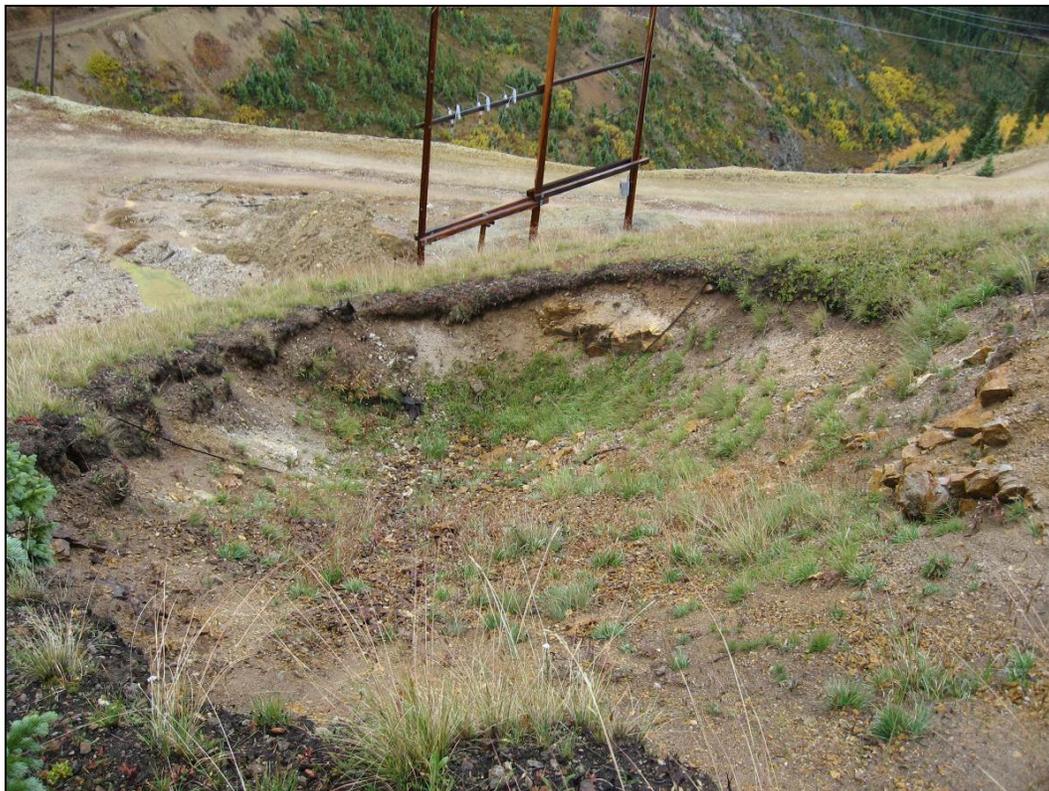
Figure 32.—Photograph taken on September 22, 2014, looking downhill at the subsidence pit located above the Gold King Mine Level 7 Old Adit.

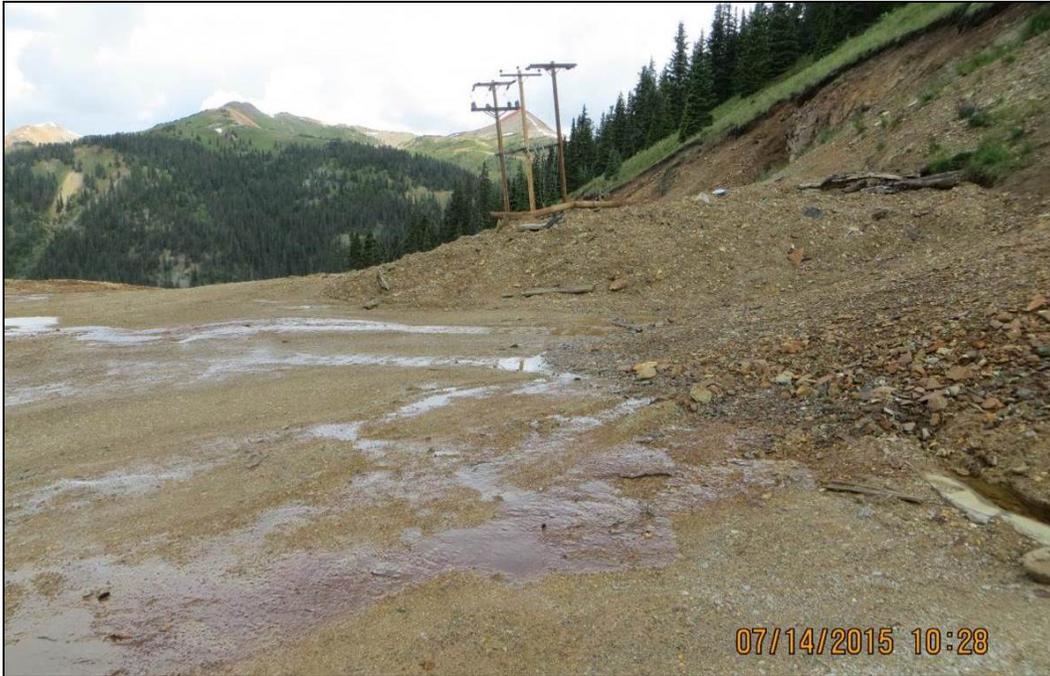
Figure 33.—Photograph showing the condition of the Gold King Mine Level 7 Old Adit portal area on July 14, 2015. Note that more soil and rock had slid from the slope area and had buried a portion of the concrete diversion channel including the ends of the two drain pipes (photograph from EPA project files).

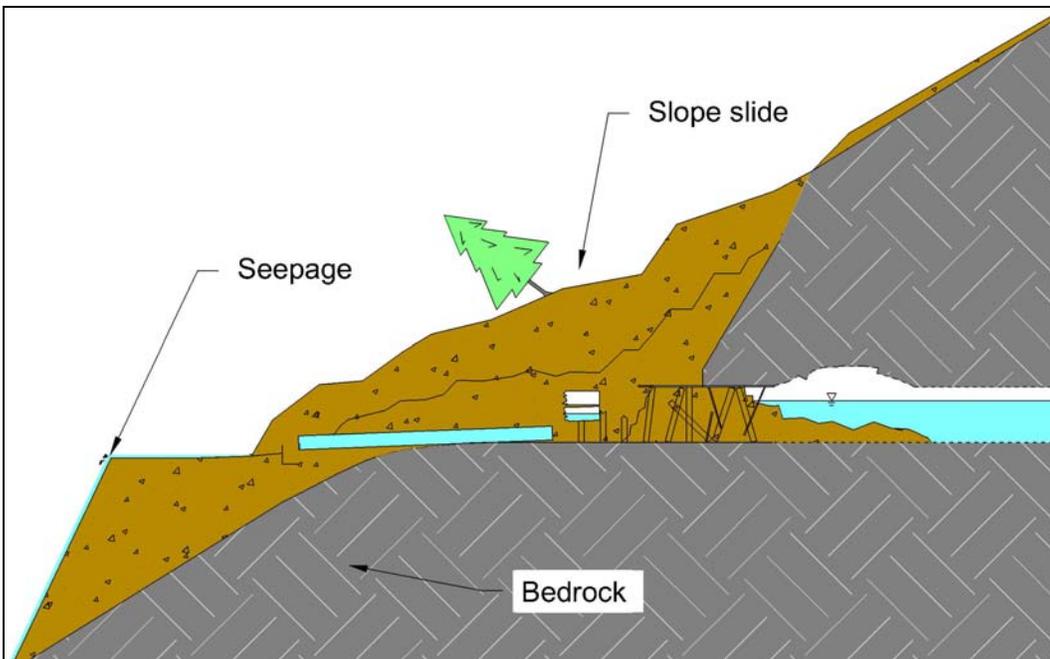
Figure 34.—Cross-section showing the condition of the Gold King Mine Old Adit on July 14, 2015 (water level as assumed by EPA and DRMS), when EPA returned to the site to begin work. More rock and soil and a tree had slid down onto the drains, and seepage was again saturating part of the waste-rock dump (not to scale).

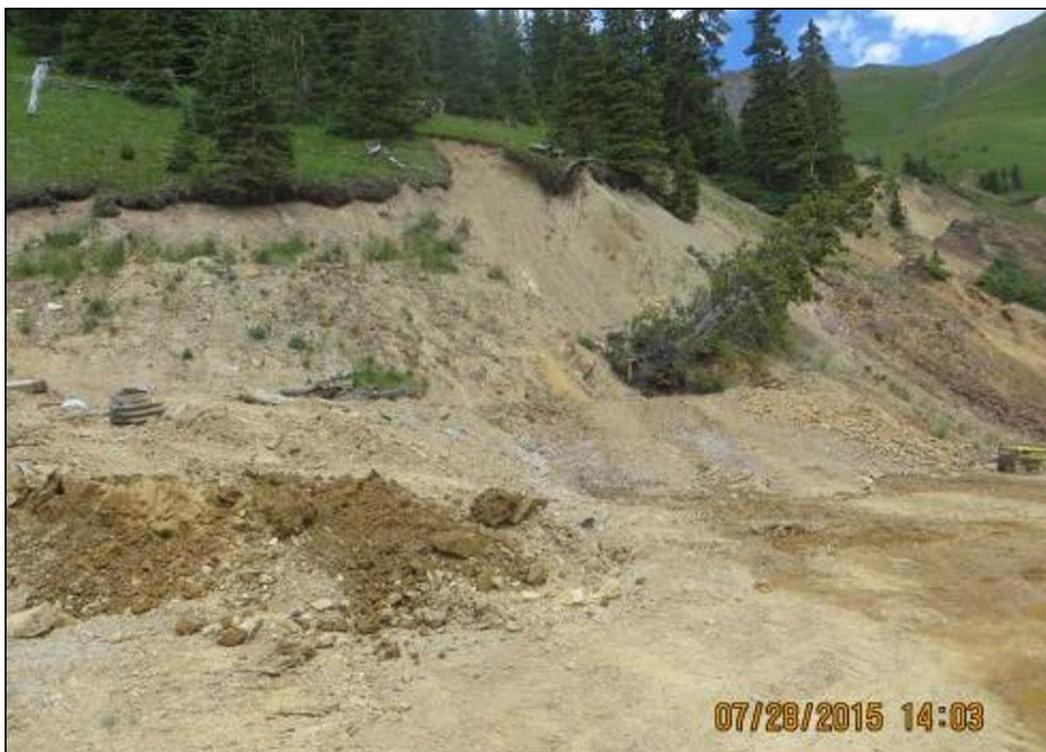
Figure 35.—Photograph showing the condition of the Gold King Mine Level 7 New Adit portal area on July 28, 2015. Note the soil and a tree that has slid downslope onto the portal area; at this time the seepage had been returned to the concrete trough, and the dump was drying out (photograph from EPA project files).

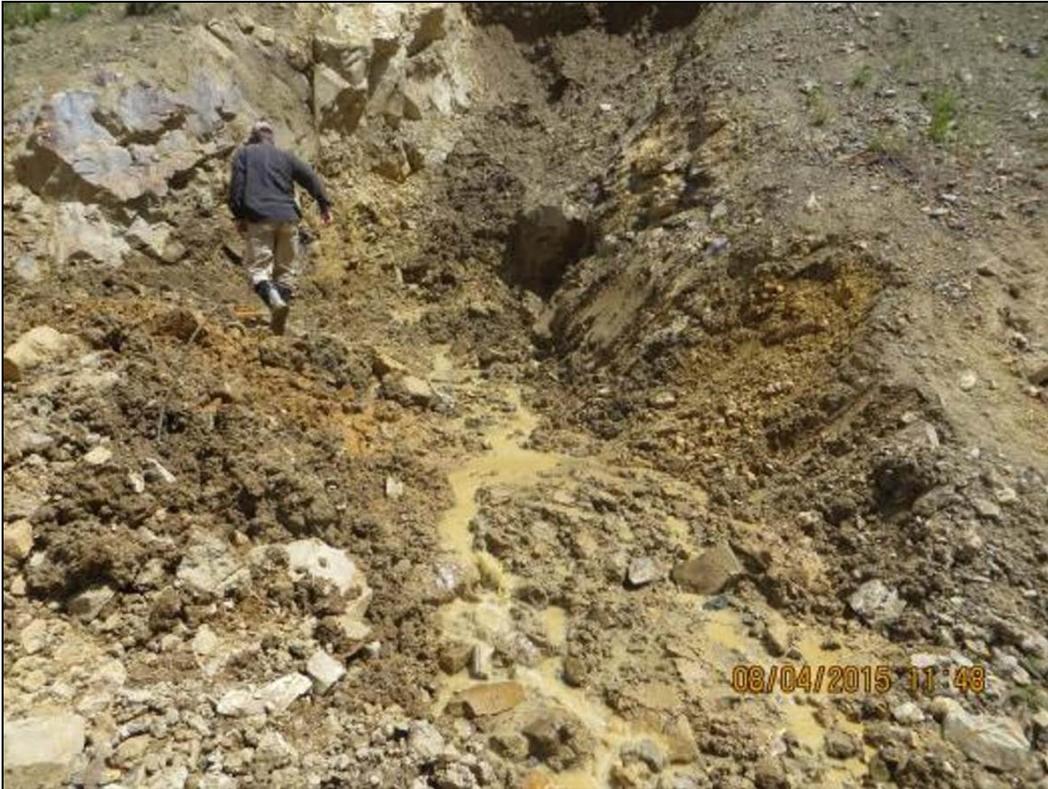
Figure 38.—Photograph showing seepage flow from the excavation at the Gold King Mine new portal at 11:48 a.m. on August 4, 2015. The flow is emerging approximately 5 to 6 feet above the floor of the adit (photograph from EPA project files).

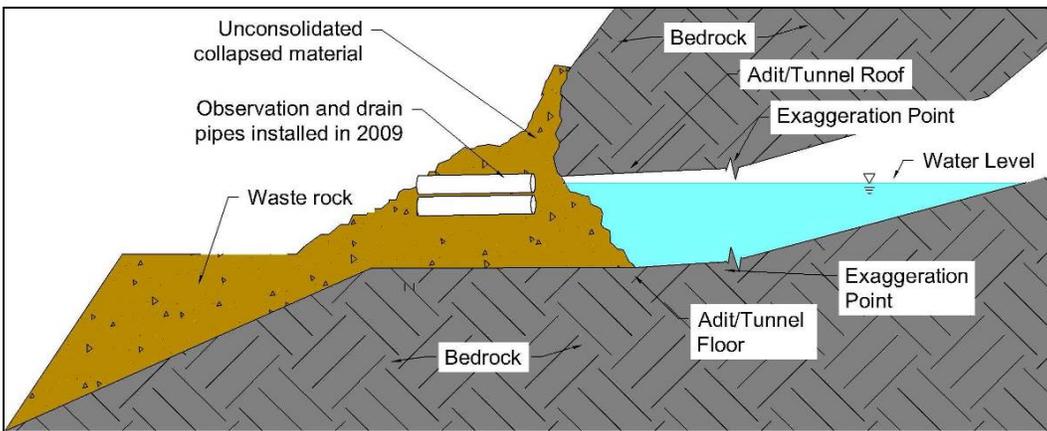
Figure 40.—Cross-section illustration showing the condition of the adit that was assumed by the EPA OSC and the abandoned mine experts from DRMS for use in planning to open the adit (not to scale). The “exaggeration point” means the right side of the drawing has an exaggerated vertical scale in order to show the 1% uphill slope of the adit. If drawn without exaggeration, the uphill slope of the adit would not be obvious on the drawing.

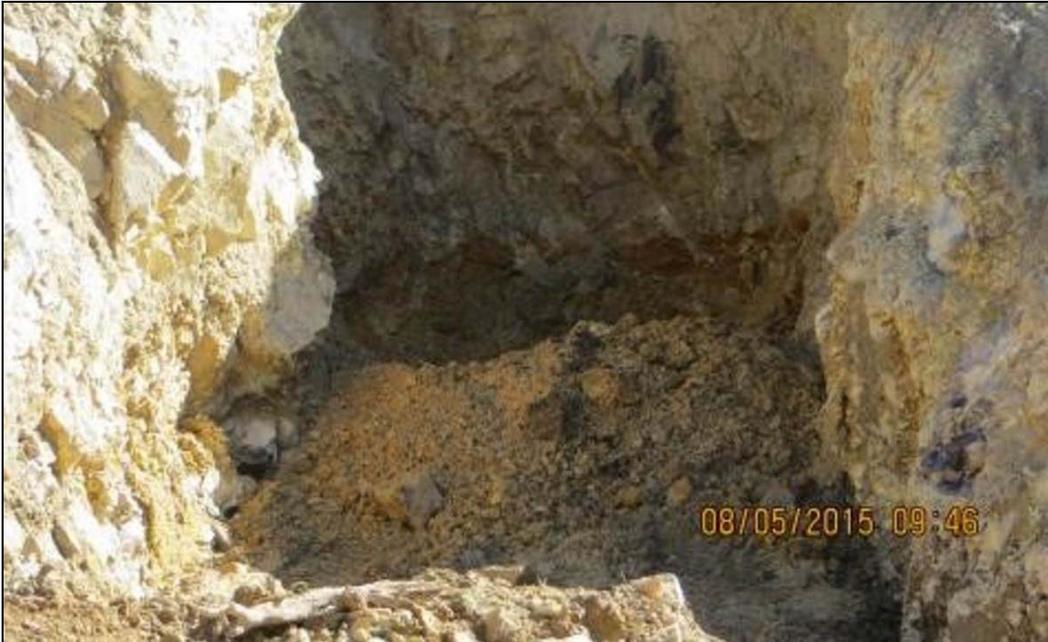
Figure 47.—Photograph taken at 9:46 a.m. August 5, 2015, showing that the loose soil from the upper end of the excavation had been removed exposing fractured and crumbly rock (photograph from EPA project files). The fill derived from the excavation had now covered the timbers, lagging, and seep visible in the previous photograph (figure 46). This indicates that the bottom of the excavation was about 10 feet above the level of the floor of the adit; this corroborates reports that they were digging high, trying to stay above the assumed water level in the adit.

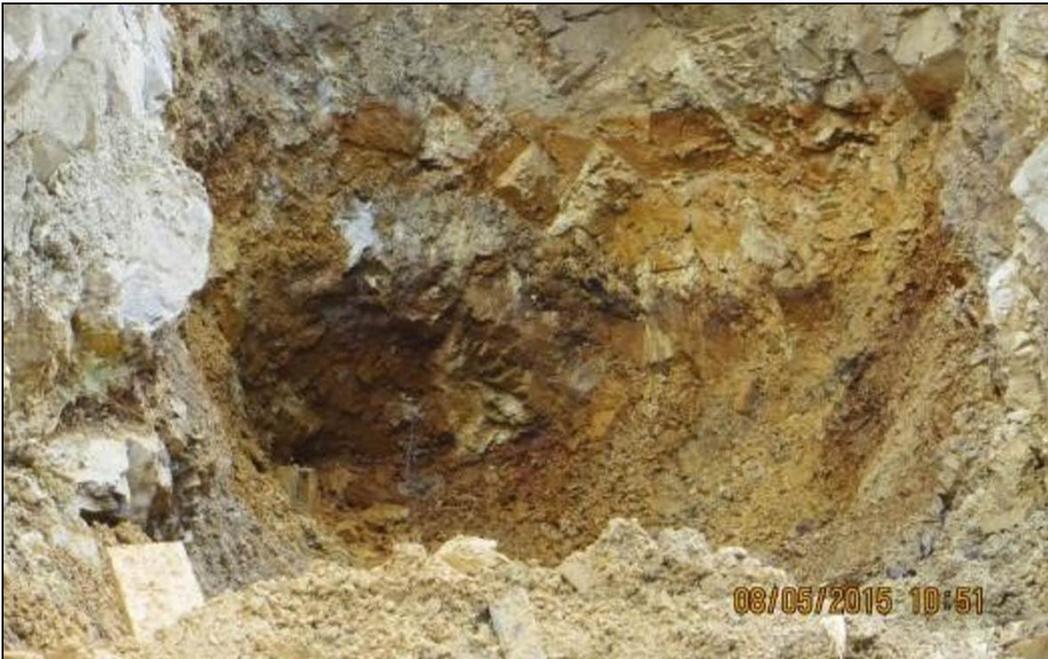
Figure 48.—Photograph taken at 10:51 a.m. on August 5, 2015, showing the initial spurt of clear water (photograph from EPA project files). The center of this photograph is shown enlarged in figure 49.

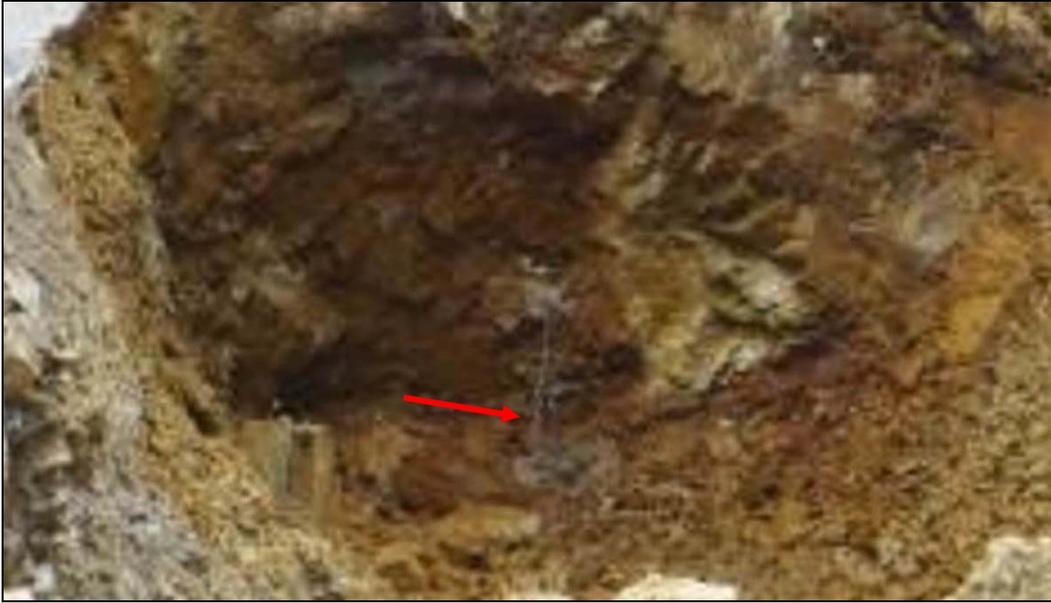
Figure 49.—A cropped and enlarged version of a portion of the photograph taken at 10:51 a.m. on August 5, 2015 (figure 48). Red arrow points to the initial vertical spurt of clear water shooting up about 1.5 to 2 feet as described by the EPA OSC (photograph from EPA project files).

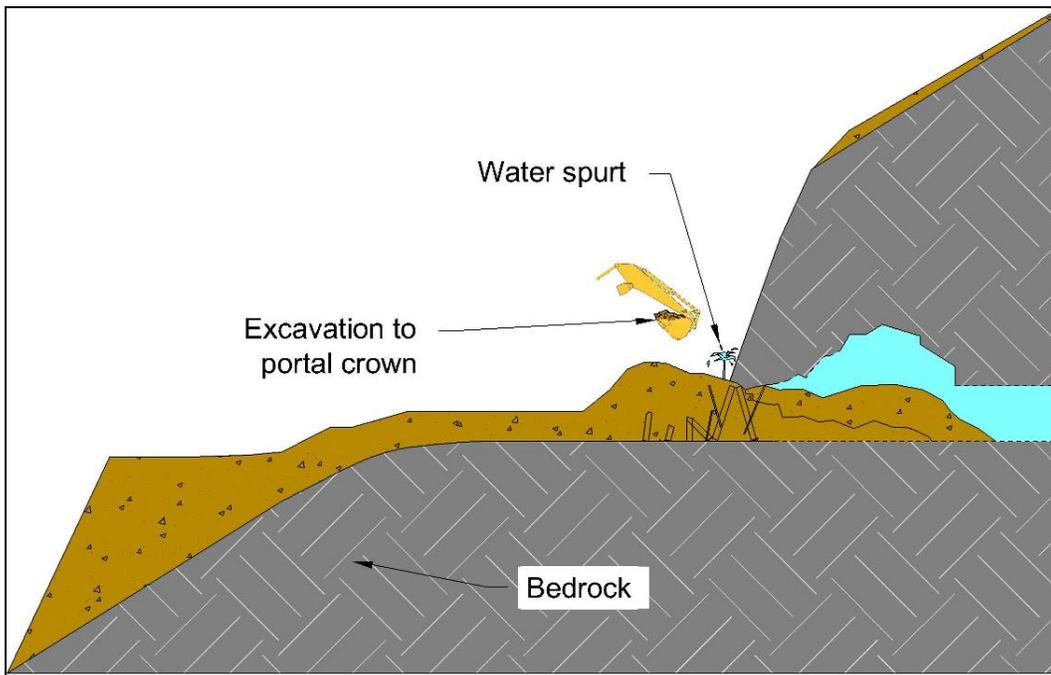
Figure 50.—Cross-section showing BOR's interpretation of the conditions immediately before the blowout as the spurt of water appeared indicating the adit was full and under pressure (not to scale).

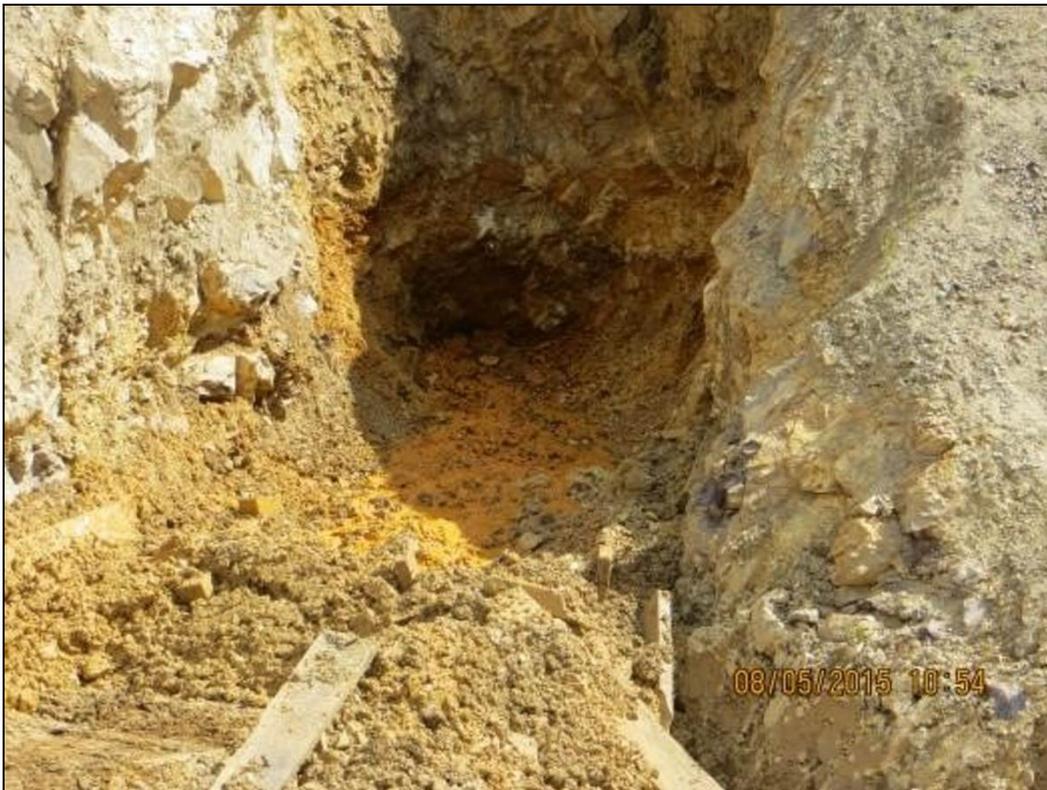
Figure 51.—Photograph of the uncontrolled flow taken at 10:54 a.m. on August 5, 2015. In 3 minutes, the flow progressed from a vertical spurt of water to the flow erosion evident in this photograph. The EPA OSC then made a decision to evacuate the portal opening to safeguard personnel onsite. A few moments later the flow erupted in an uncontrolled release (photograph from EPA project files).

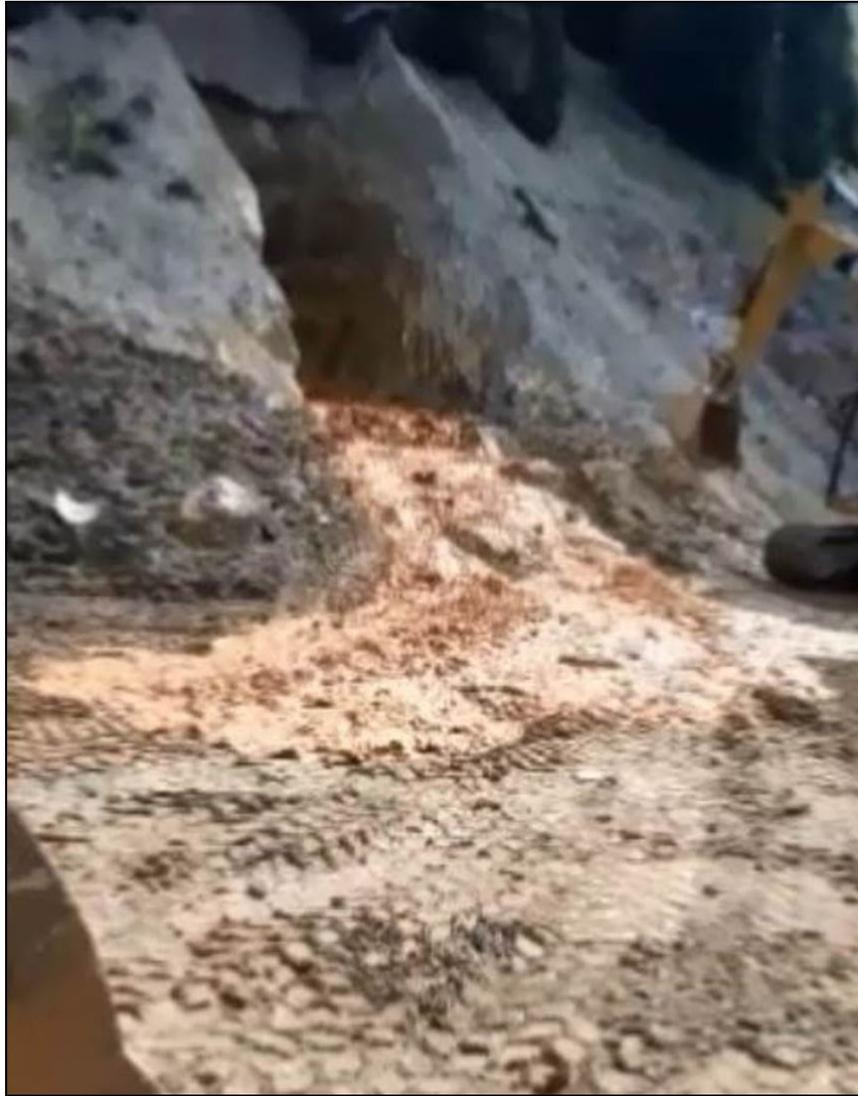
Figure 52.—Photograph showing the initial blowout from the adit. At this point, the flow is surging up over the backfill that was present in the portal area (still frame extracted from a video taken on August 5, 2015, at approximately 10:55 a.m.).

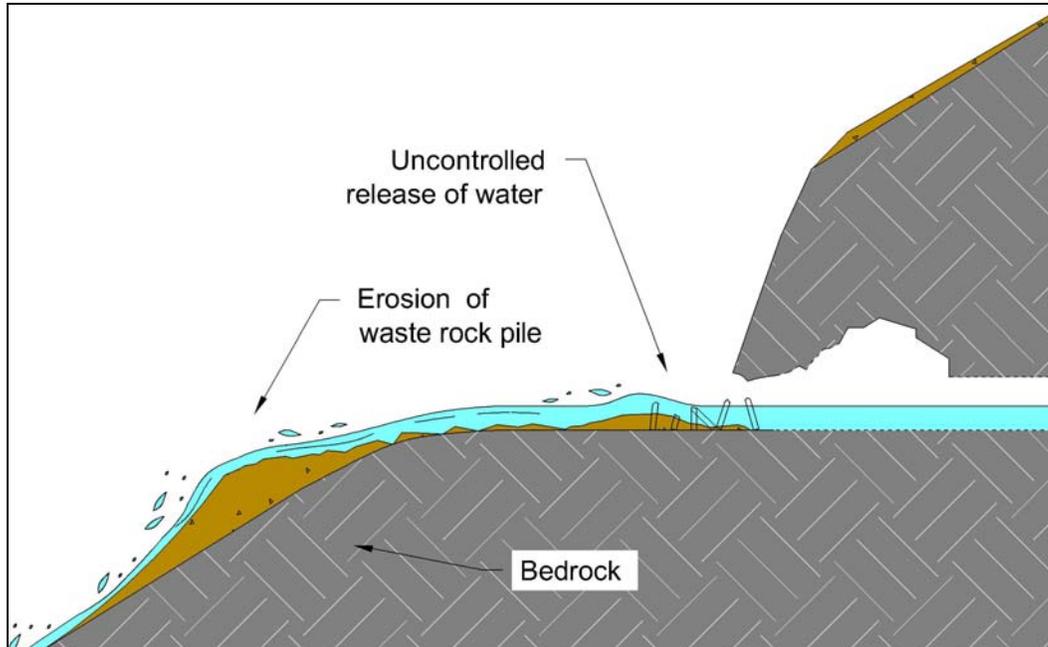
Figure 55.—Cross-section showing the blowout as it eroded the blockage and eroded fill from the waste-rock dump (not to scale).

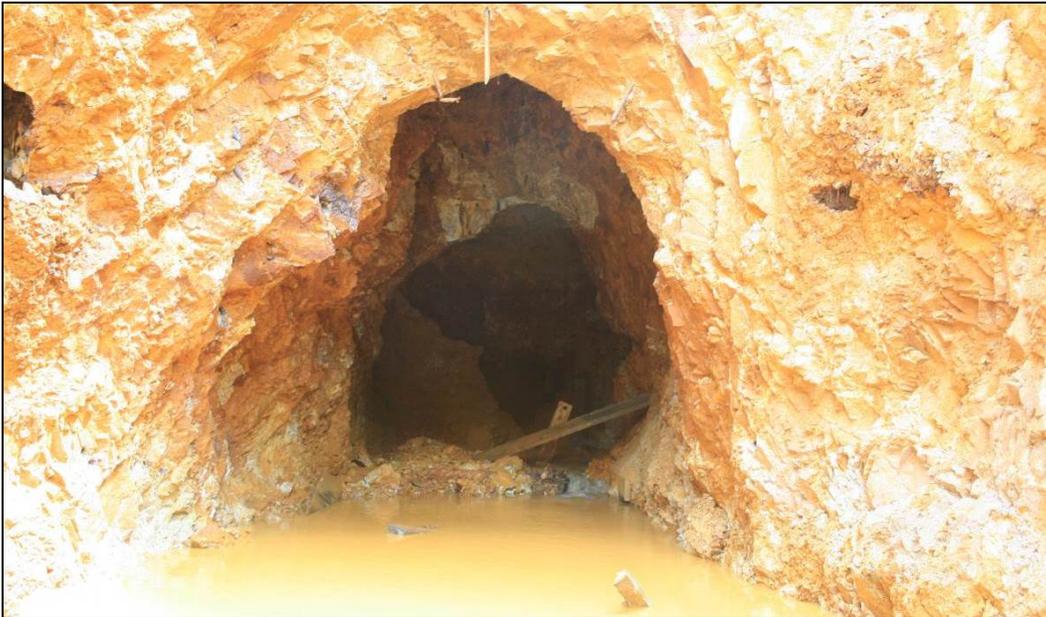
Figure 62.—Photograph showing the Gold King Mine Level 7 New Adit on August 16, 2015, after an excavator was used to reach inside the mine opening and remove the timbers. Note piles of debris from partial roof collapses inside the adit.

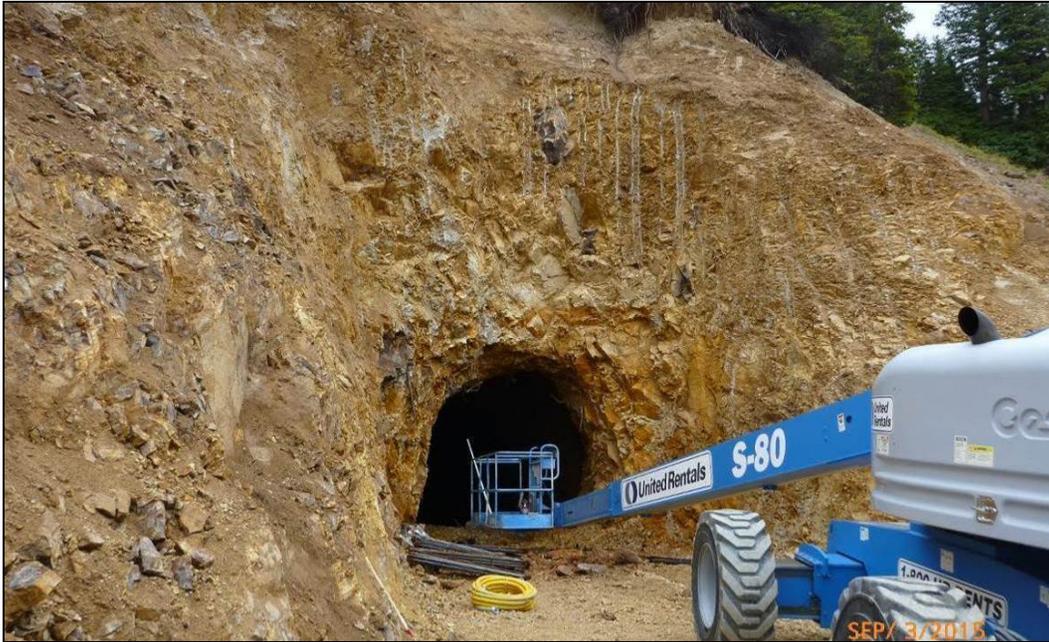
Figure 64.—Photograph showing the adit on September 3, 2015, at the initiation of rock bolting. The rock had been excavated to provide a larger work area. Note the excavator teeth marks left in the rock, an indication that the rock is altered and contains a significant amount of clay.
