BUFFALO CREEK (W. VA.) DISASTER, 1972

PREPARED FOR THE
SUBCOMMITTEE ON LABOR
OF THE
COMMITTEE ON LABOR AND
PUBLIC WELFARE
UNITED STATES SENATE

Part I of II
**THE FAILURE OF REFUSE
DAMS ON MIDDLE FORK
Buffalo Creek**

**An Engineering Survey of
Representative Coal Mine Refuse Piles as
Related to the Buffalo Creek,
West Virginia, Disaster**

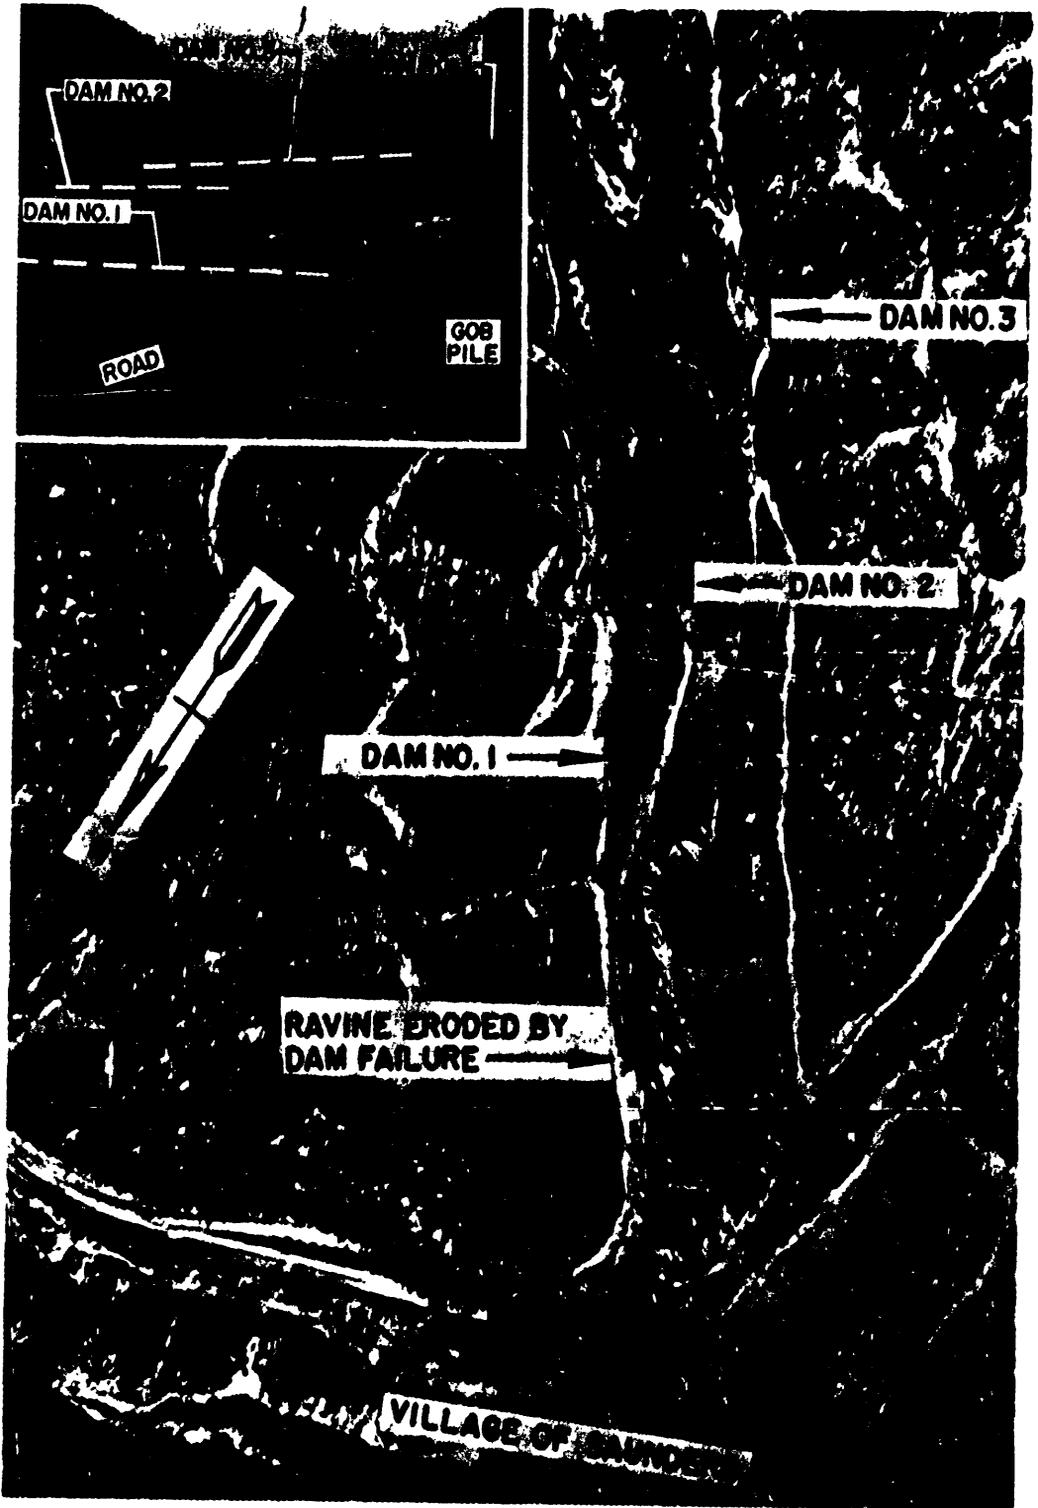
PLATE NO. 2

AERIAL VIEW OF MIDDLE FORK AND JUNCTION
WITH BUFFALO CREEK AFTER FAILURE OF DAMS

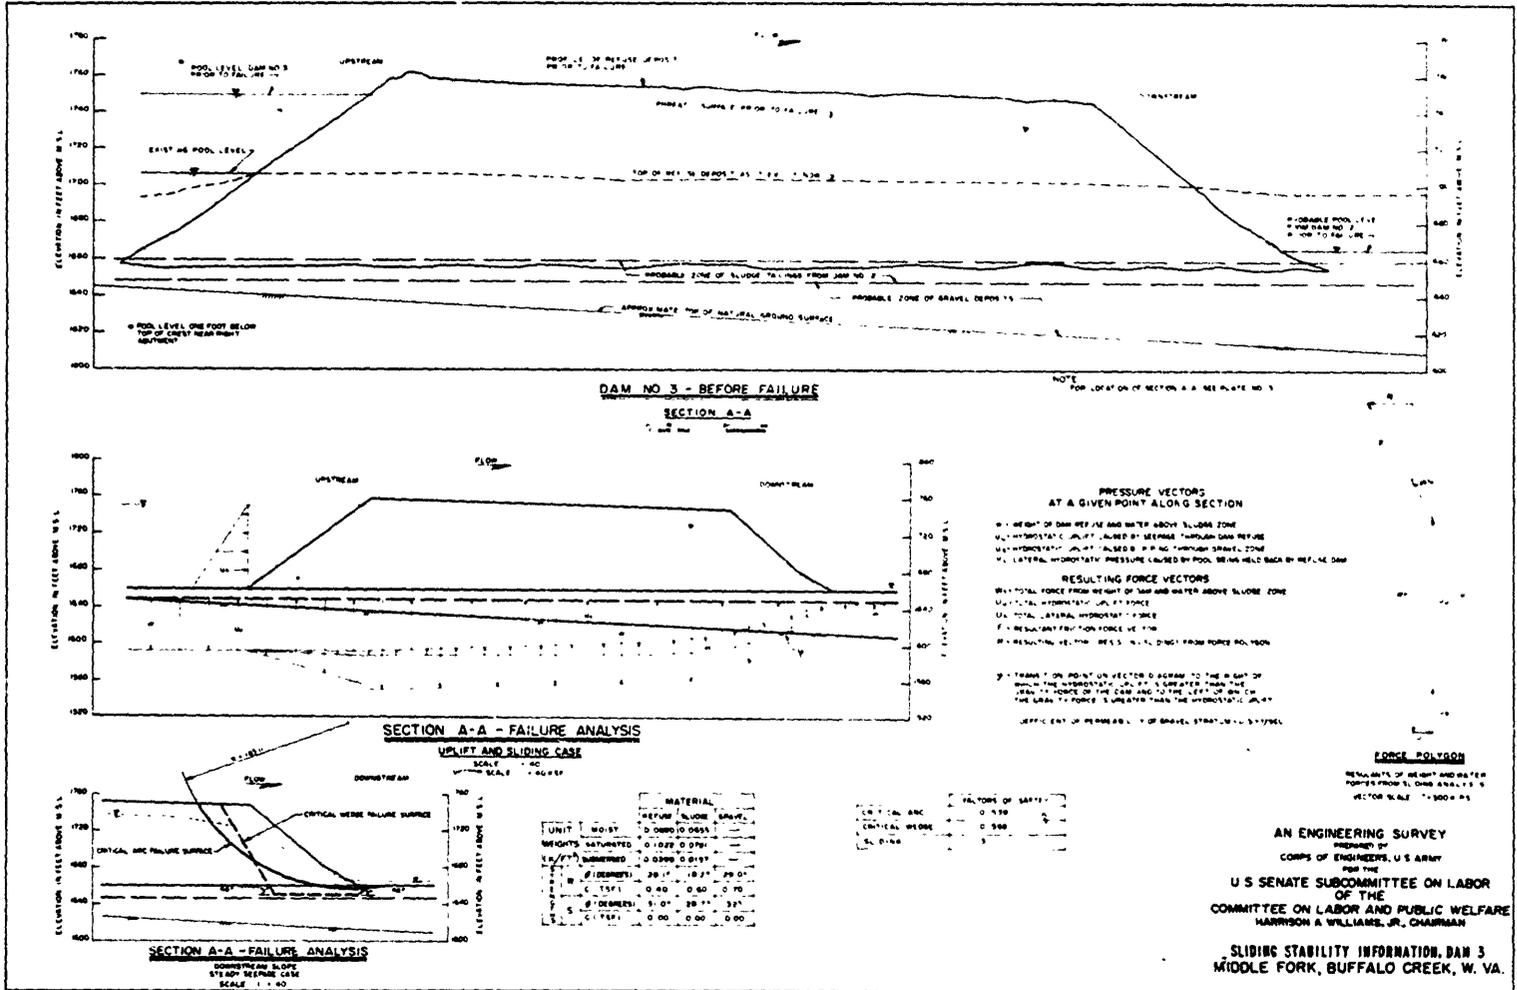
PLATE 6B

SLIDING STABILITY INFORMATION, DAM 3
MIDDLE FORK, BUFFALO CREEK, W. VA.

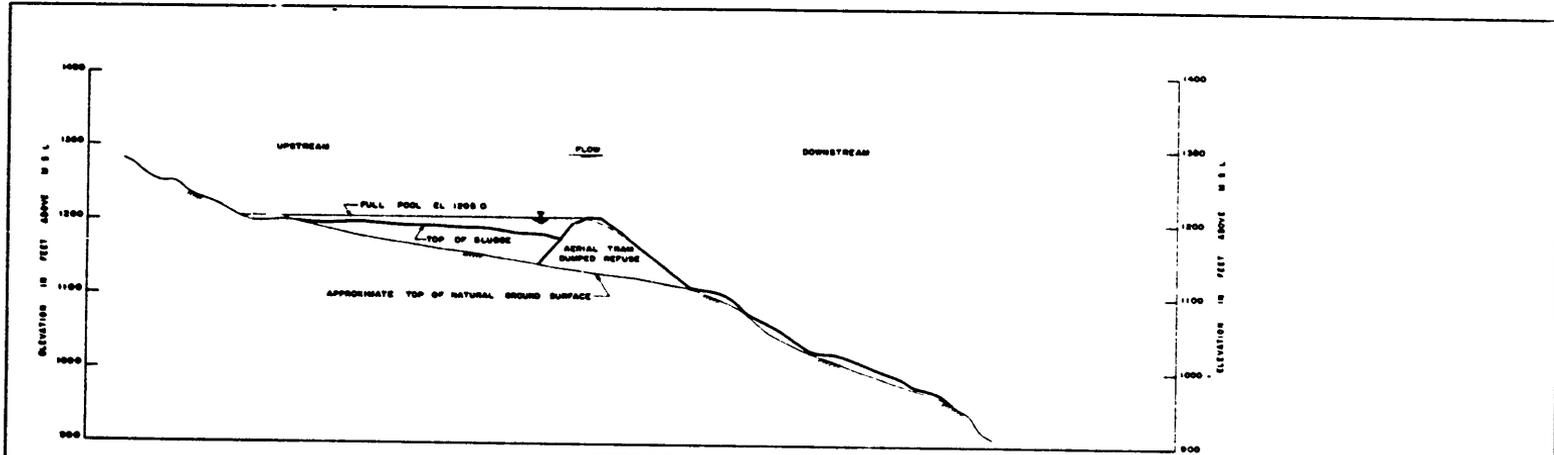
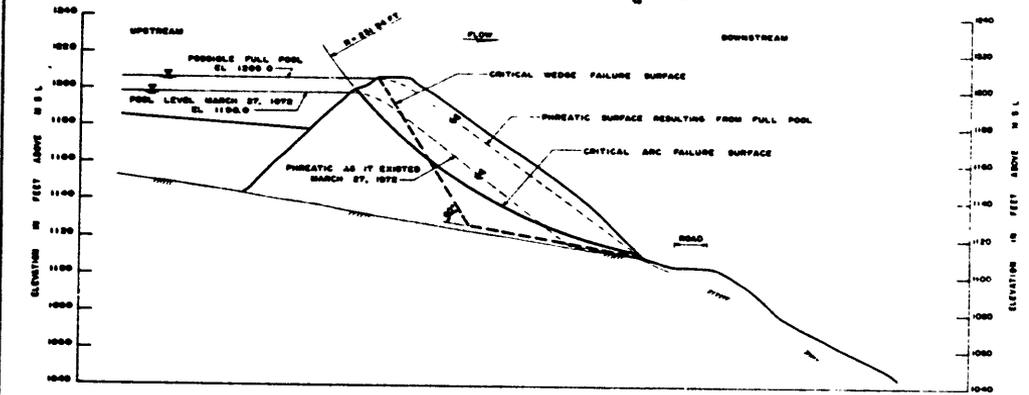
SECTION C-C
 YOUNGTOWN MINES CORP.
 DEHUE MINE REFUSE IMPOUNDMENT

STEADY SEEPAGE CASE
 SECTION C-C FAILURE ANALYSIS
