DEPARTMENT OF THE ARMY
U.S. ARMY CORPS OF ENGINEERS
RISK MANAGEMENT CENTER
12596 WEST BAYAUD AVE., SUITE 400
LAKEWOOD, CO 80228

05 October 2015

SUBJECT: Review of the Technical Evaluation of the Gold King Mine Blowout, San
Juan County, CO

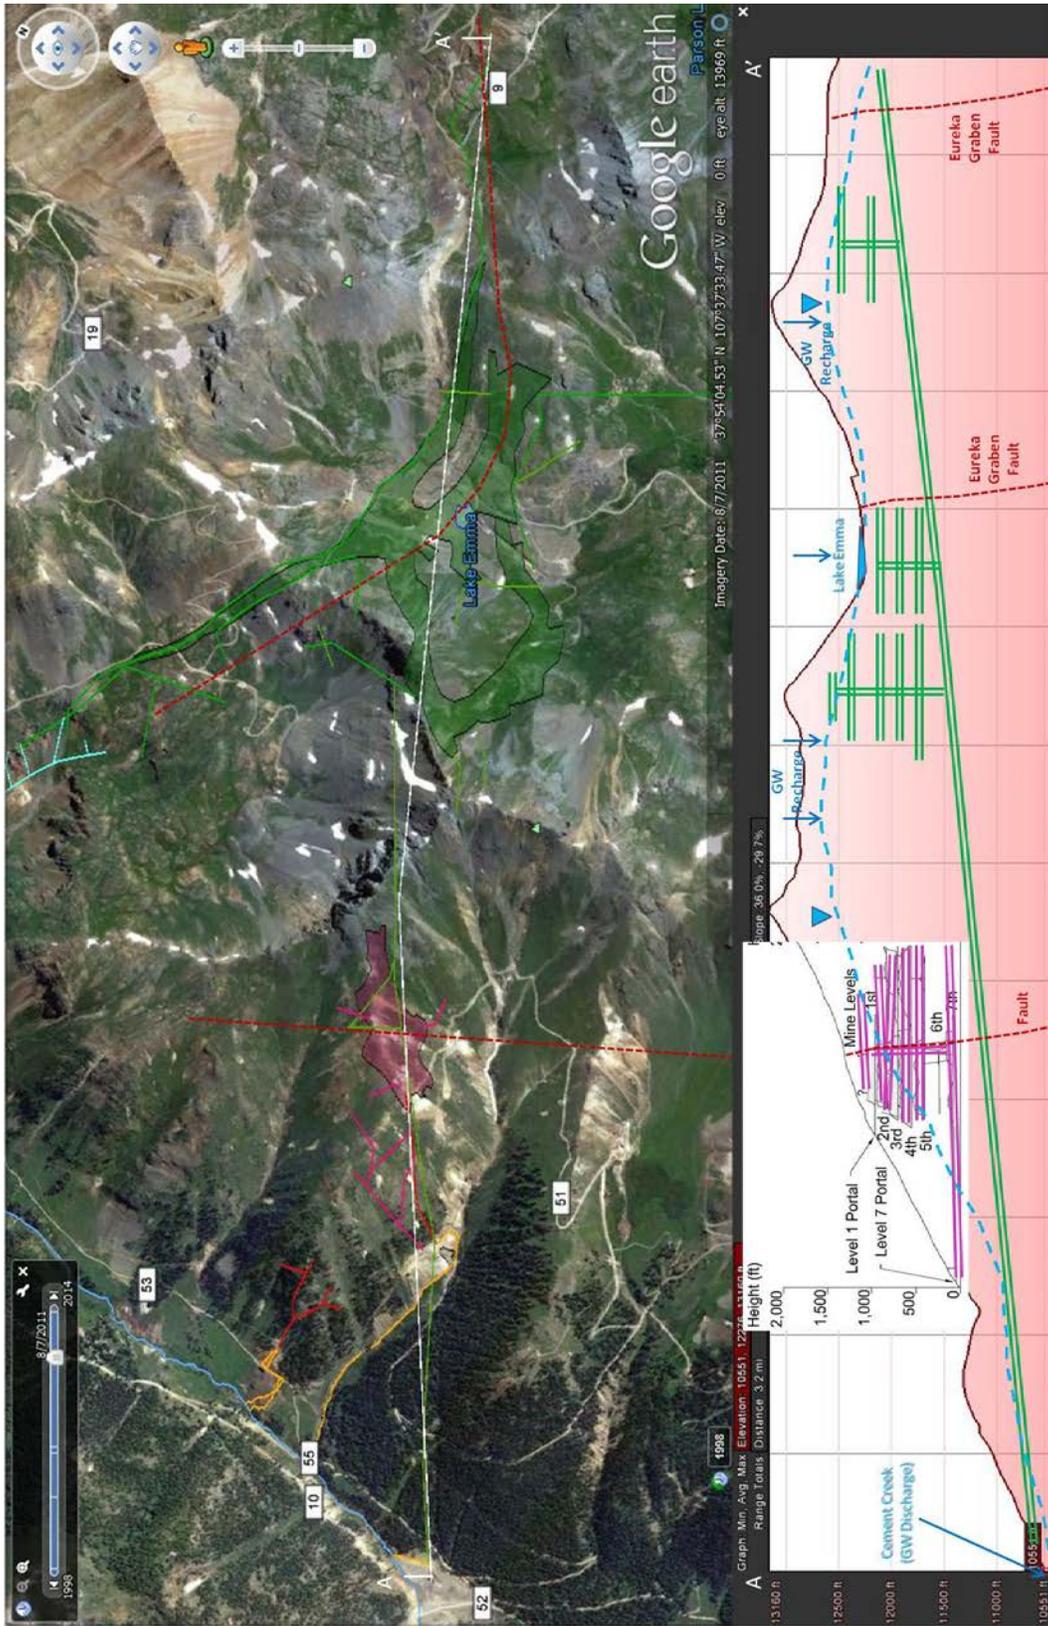
contacts, bedding, and different lithology from the volcanic flows; add wells and any subsurface penetrations including known plug locations; and develop interpretation of the groundwater surface and any other pertinent information. Enclosure 1 to this document shows an example of what this might look like. This graphic would help describe the scale of the mine interactions and the potential for interconnections and the potential groundwater volume.

- b. Where do different mines tie into each other (RBM and GKM); relative separation between the underground workings (GKM and American tunnel).
 - c. A cross section along the American Tunnel alignment, showing the GKM and its various levels, the Sunnyside mine levels, and where the RBM connects to the GKM. This would help the reviewer understand the relative spatial configuration of the system (see Figure 1 as an example).
