# The 1977 Toccoa Flood, Report of Failure of Kelly Barnes Dam Flood and Findings

by Federal Investigative Board

December 21, 1977

## ABSTRACT

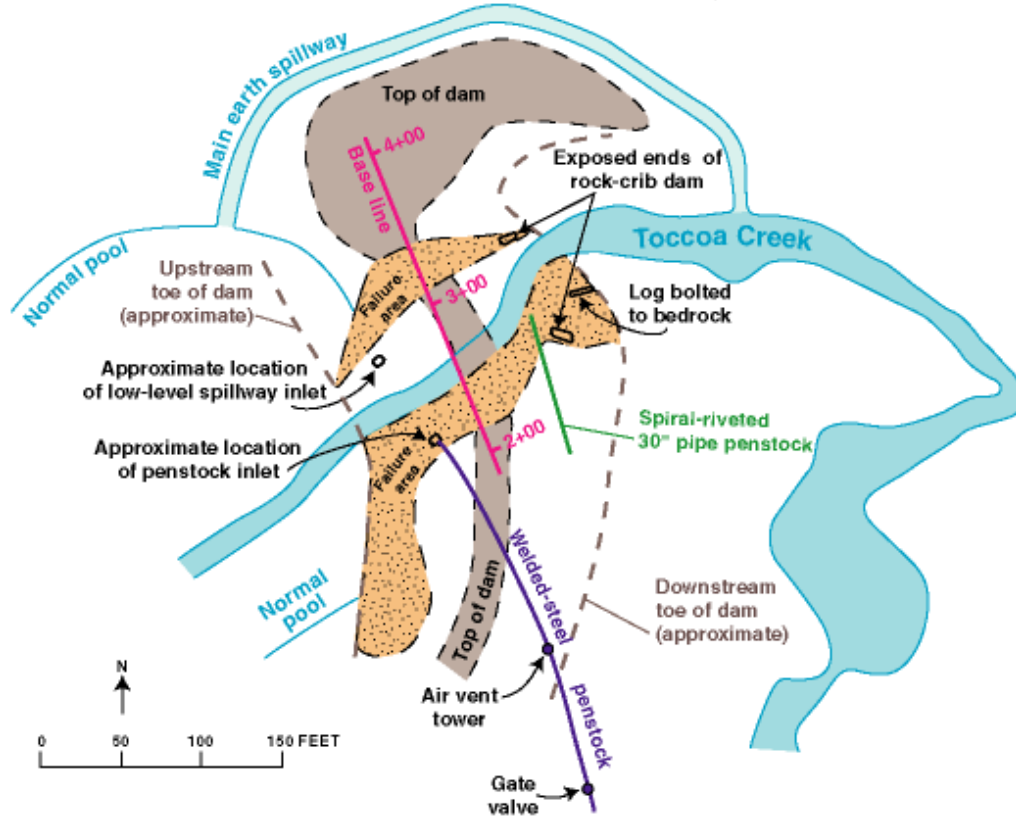
**Figure 1  
PLAN OF KELLY BARNES DAM  
AFTER FAILURE OF NOVEMBER 2-6, 1977**

spillway (glossary.html#spillway) and a welded steel penstock (glossary.html#penstock) to the power plant. The low-level spillway had a rectangular shaped masonry inlet which could be shut off with stop logs (glossary.html#stoplog) or flashboards (glossary.html#flashboard). The inlet for the welded steel penstock was also masonry and controlled with a slide gate at the upstream toe of the dam (glossary.html#toe). The approximate location of these inlets are shown on Figure 1.

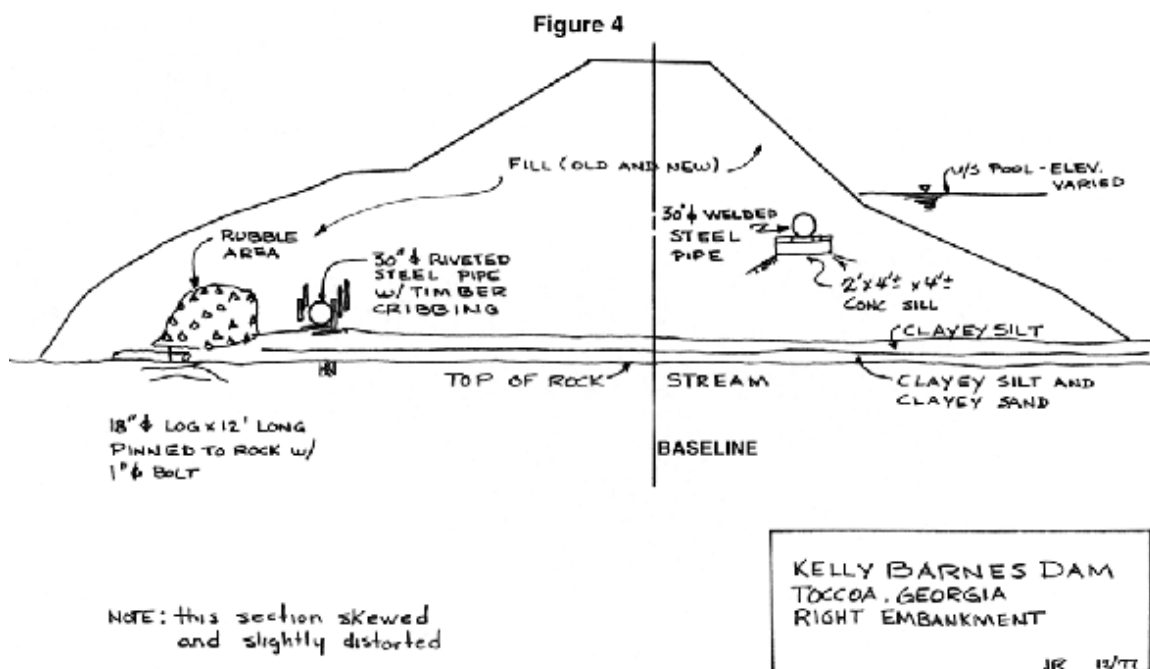
Though it is impossible to fully reconstruct the dam condition and configuration prior to the failure, the following is considered a reasonable reconstruction of recent conditions in the vicinity of the failure. Figure 4 is a probable configuration based on site inspections, historical data, and old photographs.

The embankment ([glossary.html#embankment](#)) in the area of the failure was approximately 38-feet high with a crest width of about 20 feet. The upstream slopes were approximately 1V on 1H and the downstream slopes were about 1V on 1H. The main or newer embankment was constructed over portions of the old rock crib dam ([glossary.html#rockcribdam](#)), all of which may or may not have remained beneath the downstream toe ([glossary.html#toe](#)). There was probably a berm ([glossary.html#berm](#)) approximately halfway up the downstream slope.

Examination of the cross section that remains discloses four feet of different colored soil below the crest. Whether this is part of the 1939 or 1948 additions, or was added by later maintenance, is not known. Therefore, it can be concluded that the dam was built in two to four stages commencing with a rock crib dam in 1899.

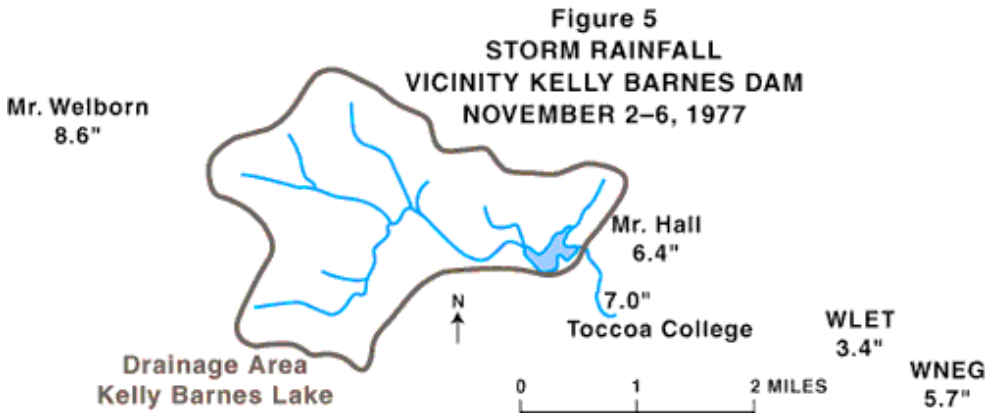
Rainfall reports are received by the National Weather Service from radio stations WLET and WNEG in Toccoa. Since these stations are located some distance from the drainage area (glossary.html#drainagearea) above Kelly Barnes Dam, a rainfall survey was made. Three additional storm total values were obtained as shown on Figure 5. In addition to the storm totals, measurements of rainfall at 11:00 p.m. each night were available from one source while the 24-hour amount from 8:00 a.m., November 5 to 8:00 a.m., November 6 was measured by another local citizen. These measurements, interviews with local residents, radar echoes, and hourly values from nearby recording stations were used in estimating the rainfall distribution for the drainage basins above Kelly Barnes Dam. Although

radar echoes indicated that the heaviest rainfall probably occurred between 6:30 p.m. and 7:30 p.m., on November 5, the estimated maximum one-hour value is shown between 6:00 p.m. and 7:00 p.m. since points are plotted on the hour.

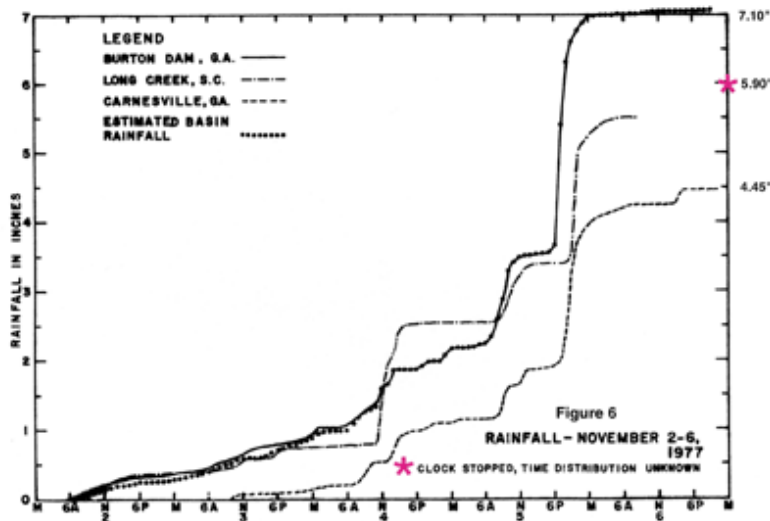
As indicated on Figure 6, the rainfall was light for the first two days with slightly over one inch falling in the Toccoa area by Friday morning, November 4. Rainfall intensity increased somewhat for the next 24 hours, with a storm total of approximately 2-1/2 inches by 8:00 a.m., Saturday morning, November 5. The storm total increased to approximately 3-1/2 inches by noon on Saturday and then the rainfall was apparently light until about 6:00 p.m., when showers moved into the area. From 6:30 p.m. to 7:30 p.m., radar echoes indicated periods of torrential rainfall with frequent intense lightning and thunder. A small tornado apparently touched down about five miles southeast of Kelly Barnes Dam at approximately 8:00 p.m. The damage to trees was limited to only 100 yards in width and about one-fourth mile in length but the tornado was indicative of the severity of the weather. After 8:00 p.m. the showers were less frequent and had practically ceased by midnight. Estimated basin rainfall for the entire period is about seven inches with almost 3-1/2 inches occurring between 6:00 p.m. and midnight on November 5.
