Taum Sauk Dam Failure

December 15th, 2005

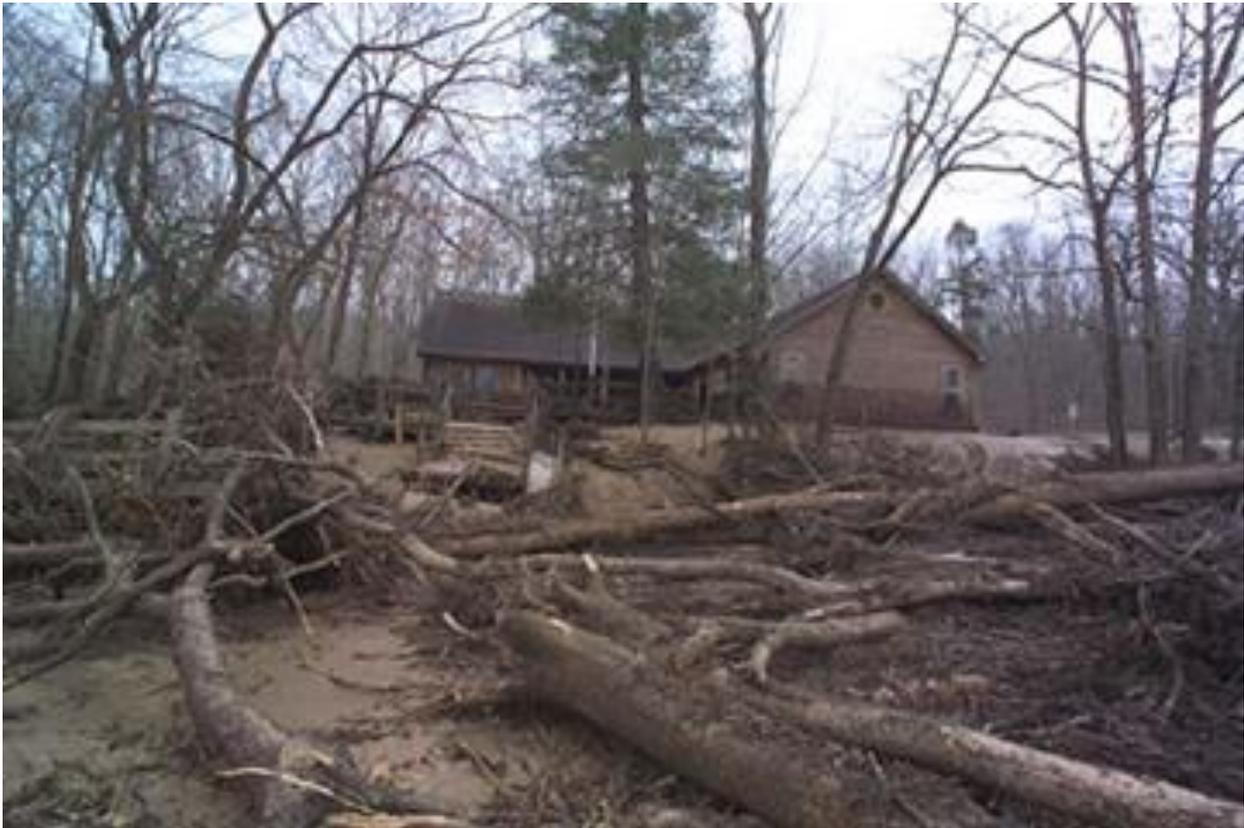
After

"The destruction at the site was incredible. All of the trees in the path of the flowing water were stripped off the earth's surface. What remained were large rocks and exposed bedrock surfaces. The flowing water removed soil from the valley floor, and created large scour holes. The large flowing debris piles created by downed trees came to rest throughout the park and up against the downstream side of the highway N bridge over the Black River. The USGS stream gage located on that bridge was damaged by the debris flow about the time the water moved through providing an approximate time of when this event unfolded. While the Johnson's Shut-Ins State Park received the most damage, private property located northwest of the Park became a debris field for trees and the Park Superintendent's home destroyed by the flowing water.
