Michigan Dam Incident Response Review

An Analysis of the 2020 Edenville and Sanford Dam
Failure Response

April 2022

FEMA

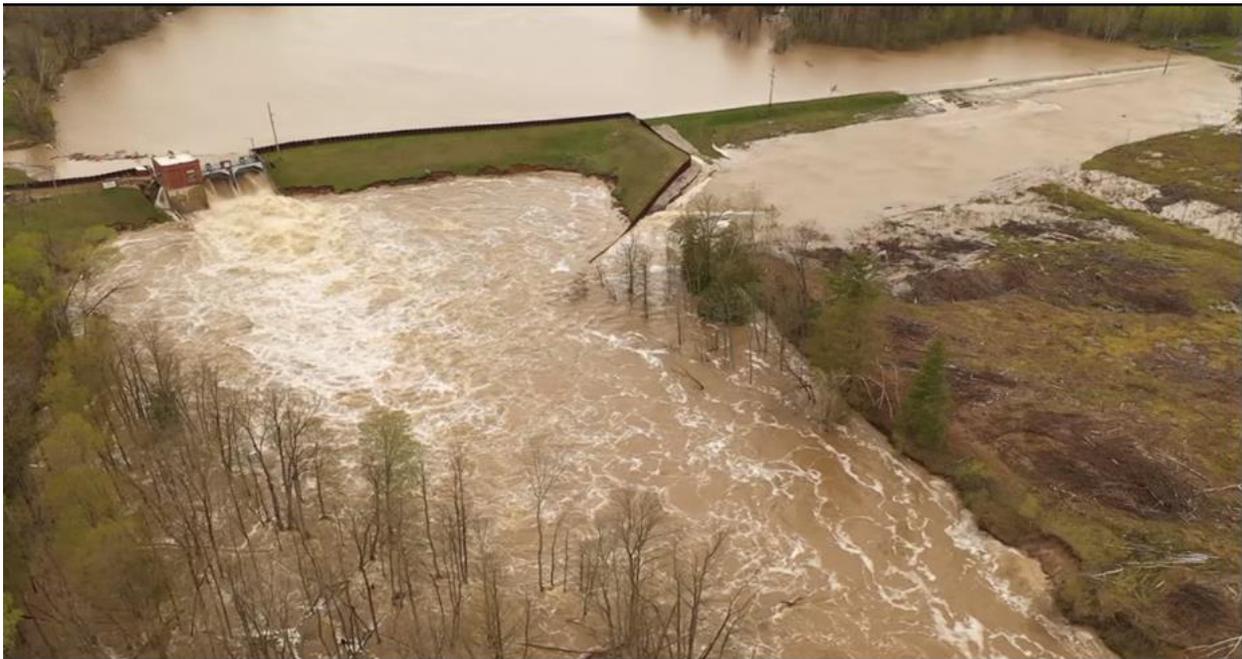
On the evening of Monday, May 18, 2020, concern in Gladwin County centered around the Chappel Dam on the Cedar River and Smallwood Dam on the Tittabawassee River. The Chappel Dam was near overtopping and experiencing some erosion issues because of high flow conditions and water lapping over the side of the dam near the old powerhouse, which was no longer producing energy. Fortunately, the dam operators, who were onsite with the dam engineer and emergency responders (i.e., Gladwin County EM and Sheriff), were able to stabilize the dam using backfill (e.g., gravel and sand), mitigate the issue, and prevent failure (North 2020, Trumble 2020). At the Smallwood Dam (Figure 6), the auxiliary spillway activated as designed, but significant erosion was occurring at multiple locations due to high flow conditions, water escaping through the powerhouse structure, and turbulent eddy currents in the tail water area of the dam (North 2020, Trumble 2020). As with Chappel Dam, dam operators were able to successfully mitigate some of the damage and prevent failure.

Figure 6: Smallwood Dam erosion and emergency spillway activation during the May 2020 flood event (Jacuzzibusguy 2020)

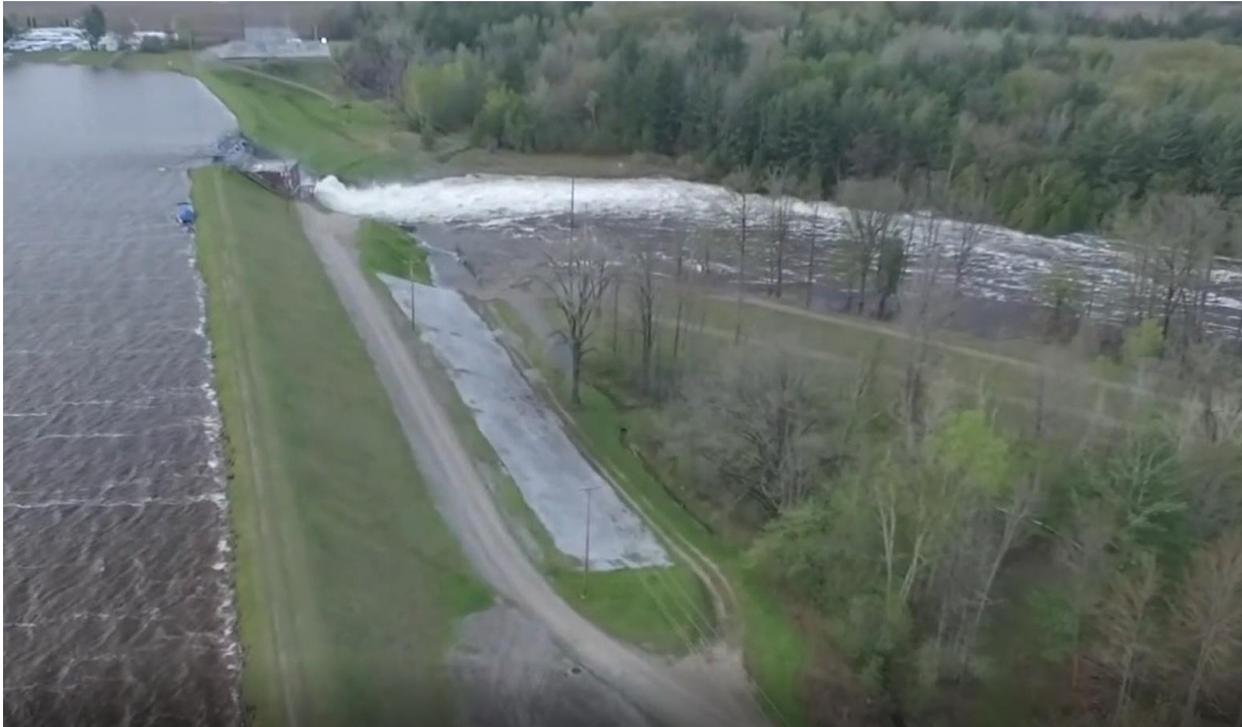
is also shown in Figure 7. However, the dam was experiencing multiple other issues as well. Wave action due to high winds was causing erosion along the upstream face of the Tittabawassee River side of the dam. Adjacent to the Tobacco River spillway on the downstream side of the dam, additional erosion was occurring because of discharge splashing up and over the wing walls, along with weep-hole seepage within the retaining walls. Increased seepage was also observed from the toe drains, which were not properly daylighted (i.e., open to allow water flow), along with some sluffing along the toe drain ditches (DeVaun 2020, Trumble 2020).

Figure 7: Tittabawassee River side embankments near capacity and fully open spillway gates on May 19, before the dam's failure (PBS 2020)

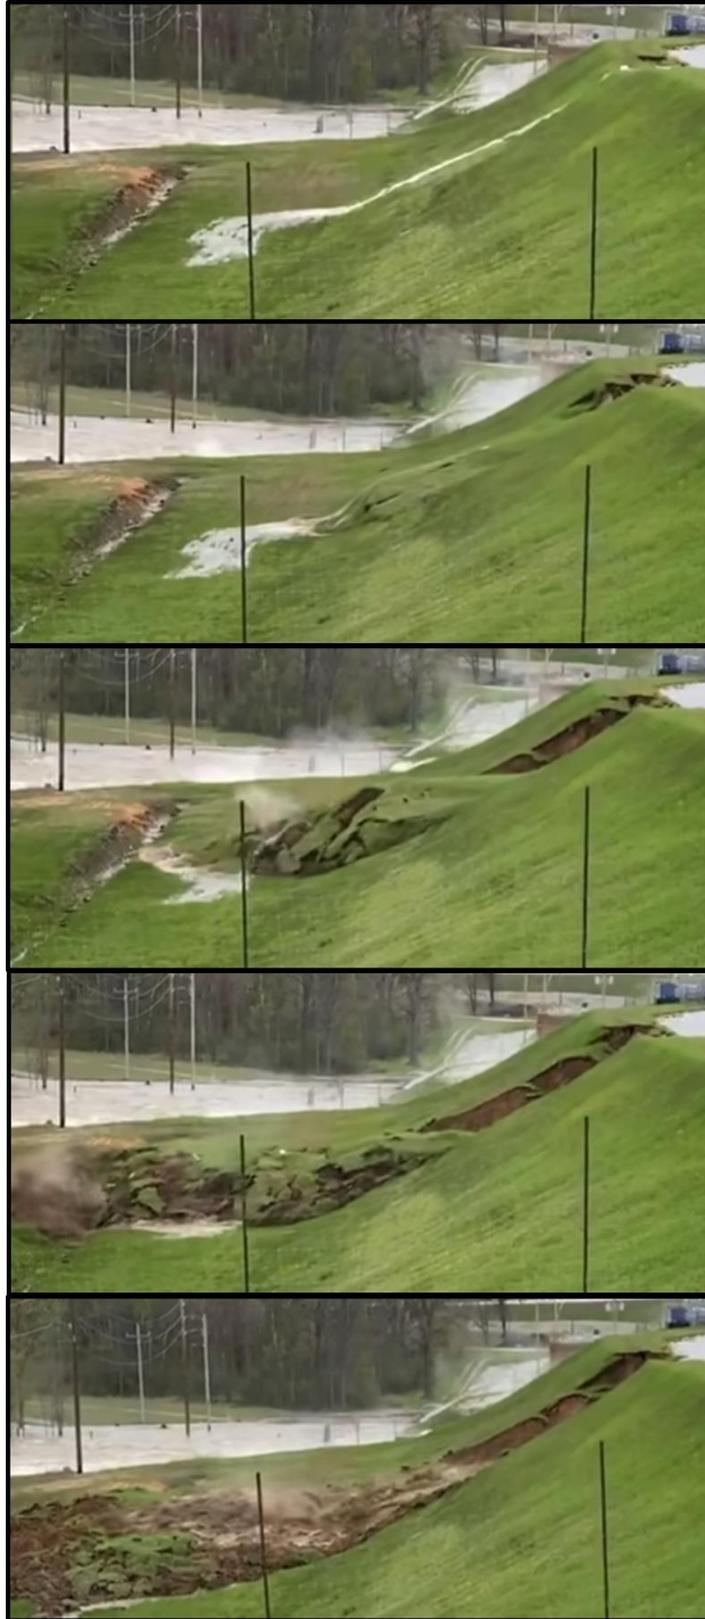
On the evening of Tuesday, May 19, 2020, around 5:40 pm the Edenville Dam failed when a section of the dam started sloughing, which rapidly progressed to slope failure along the eastern Tittabawassee River portion structure's embankment wall (EGLE 2020). The exact cause(s) of the Edenville Dam failure is still under independent investigation by a team of qualified individuals (outside of FERC, EGLE, and Boyce Hydro) with expertise in the various disciplines of dam safety engineering (EGLE 2020). However, Figure 8 illustrates the progression of the breach along the Tittabawassee River embankment immediately after it began. A small stream of water overtopping the dam appears to have caused sloughing on the downstream face of the embankment. The sloughing eventually led to slope failure, likely caused by the instability of the embankment rather than erosion of the crest. This is supported by the observation that the breach discharge, after the failure of the downstream slope, initially remained small because it was controlled by the higher upstream slope crest. The increased muddy flow that followed was due to the increased erosion and subsequent failure of the upstream face of the embankment.

Figure 8: Progression of Edenville Dam breach along the Tittabawassee River embankment as it began, 20-second time-lapse (from top to bottom) (Coleman 2020)

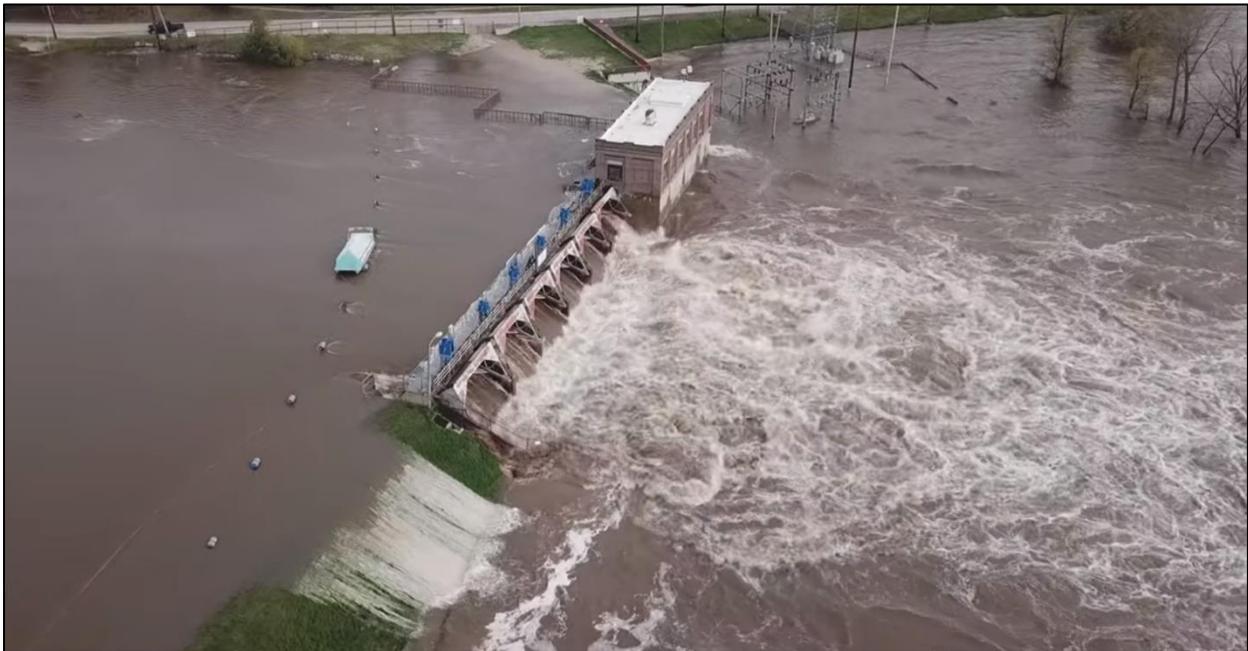
The design of the Sanford Dam embankment included a “fuse-plug spillway” section, which consisted of a concrete weir overtopped by an embankment designed to wash away in high flood conditions. It was assumed that, once the embankment failed, the underlying concrete weir would serve as an auxiliary spillway to increase the discharge released downstream and thereby prevent the overtopping of the dam and potential subsequent failure. At around 7:45 pm, the fuse plug began to wash out, but the rate of water level rise was so fast that the dam overtopped the earthen embankment before the washout process was complete (Figure 9). The overtopping of Sanford Dam sent floodwaters further downstream through Sanford and toward the cities of Midland and Saginaw, where the Tittabawassee River joins the Saginaw River and ultimately outlets to Saginaw Bay. In the end, the entire right embankment with fuse plug eroded down; the spillway, powerhouse, and left embankment largely remained intact.

Figure 9: Sanford Dam overtopping on May 19, 2020 (CFI Media 2020)

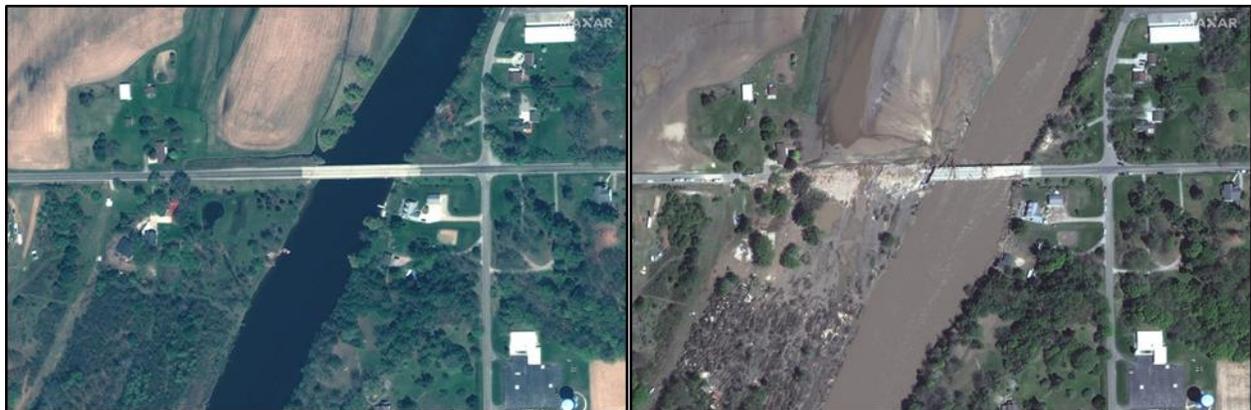
Figure 10: Curtis Road Bridge: Aerial imagery before and after the Edenville dam failure (left, May 2019, and right, May 21, 2020) (Wilkinson/Maxor 2020)

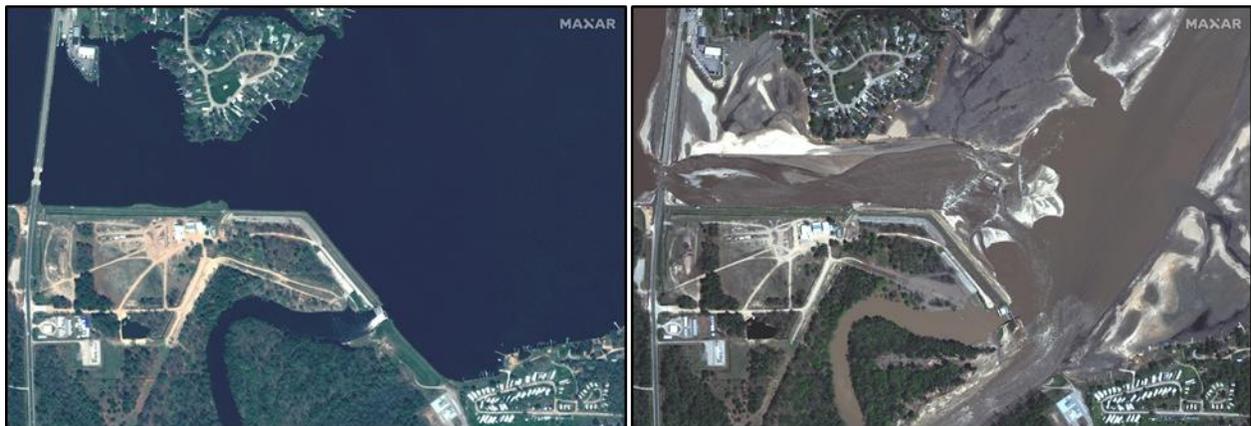
Figure 12: Edenville Dam: Aerial imagery before and after the dam failure (left, May 2019, and right, May 21, 2020) (Wilkinson/Maxor 2020)

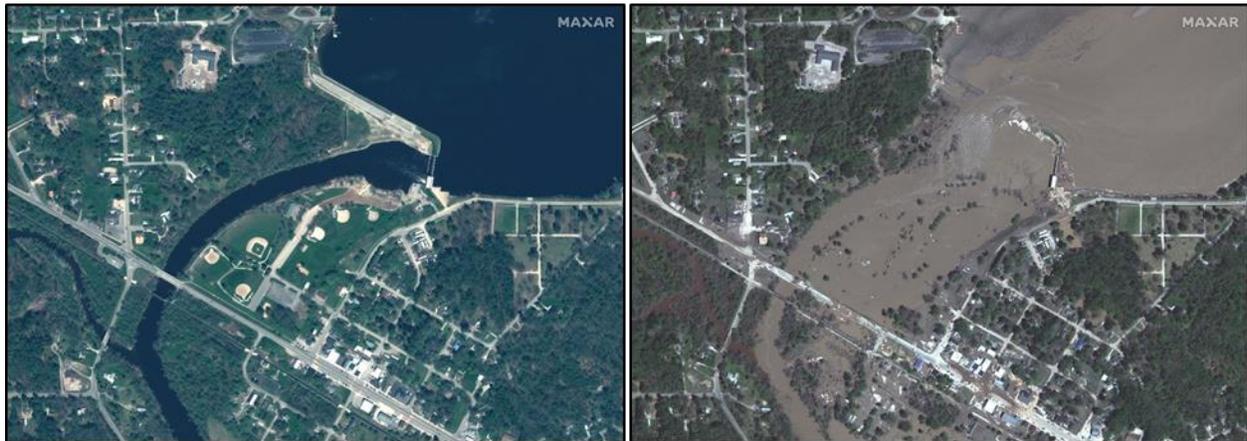
Figure 13: Sanford Dam: Aerial imagery before and after the dam failure (left, May 2019, and right, May 21, 2020) (Wilkinson/Maxar 2020)

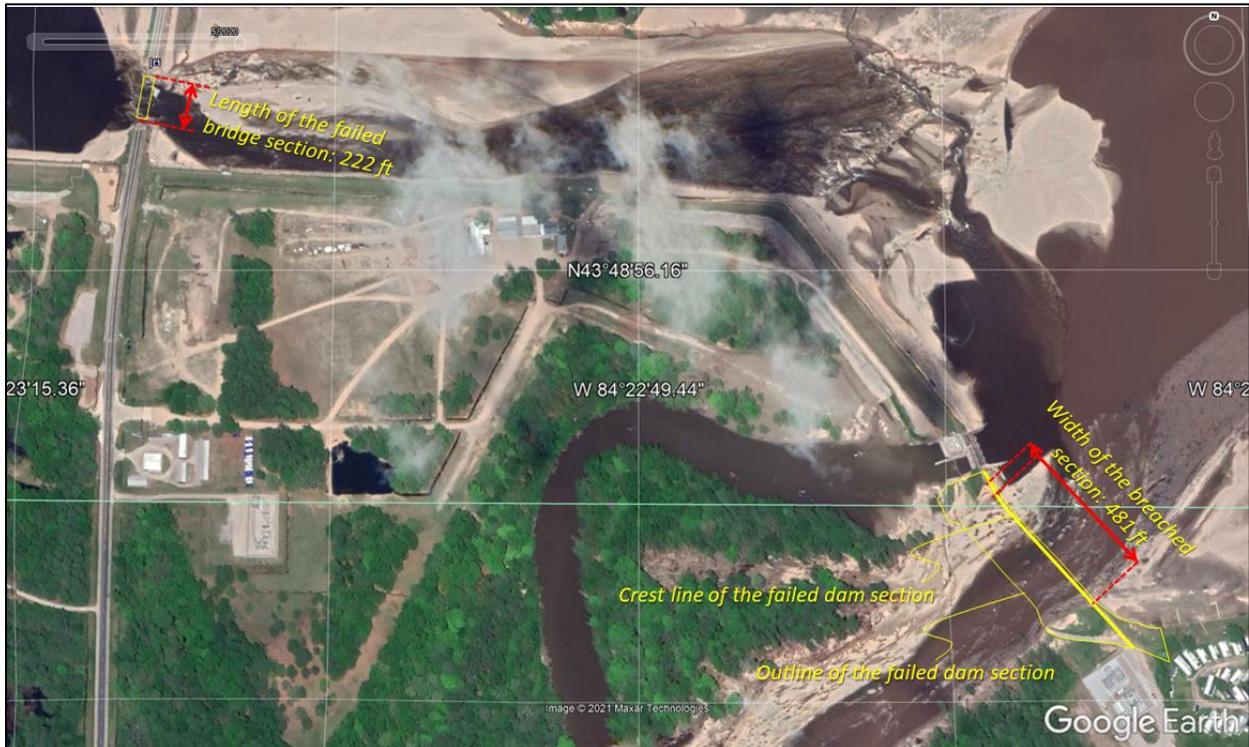
Per the request of EGLE, Boyce Hydro contracted a professional engineering firm to perform an inspection and visual assessment of the Edenville Dam to determine if immediate action should be taken on the remaining sections of the dam to mitigate risk to public safety, natural resources, and public transportation (TRC Engineers Michigan, Inc. 2020). The inspection was conducted on June 10, 2020, approximately three weeks after the dam failure and flooding incidents. Figure 2 provides an illustration of the various dam components assessed.

**Figure 18: Aerial imagery of Edenville Dam after floodwaters receded (May 25, 2020)
(Google Earth 2021)**

indicate the component “is not expected to fulfill intended function; repair, replacement, or modification is necessary.” (TRC Engineers Michigan, Inc. 2020)

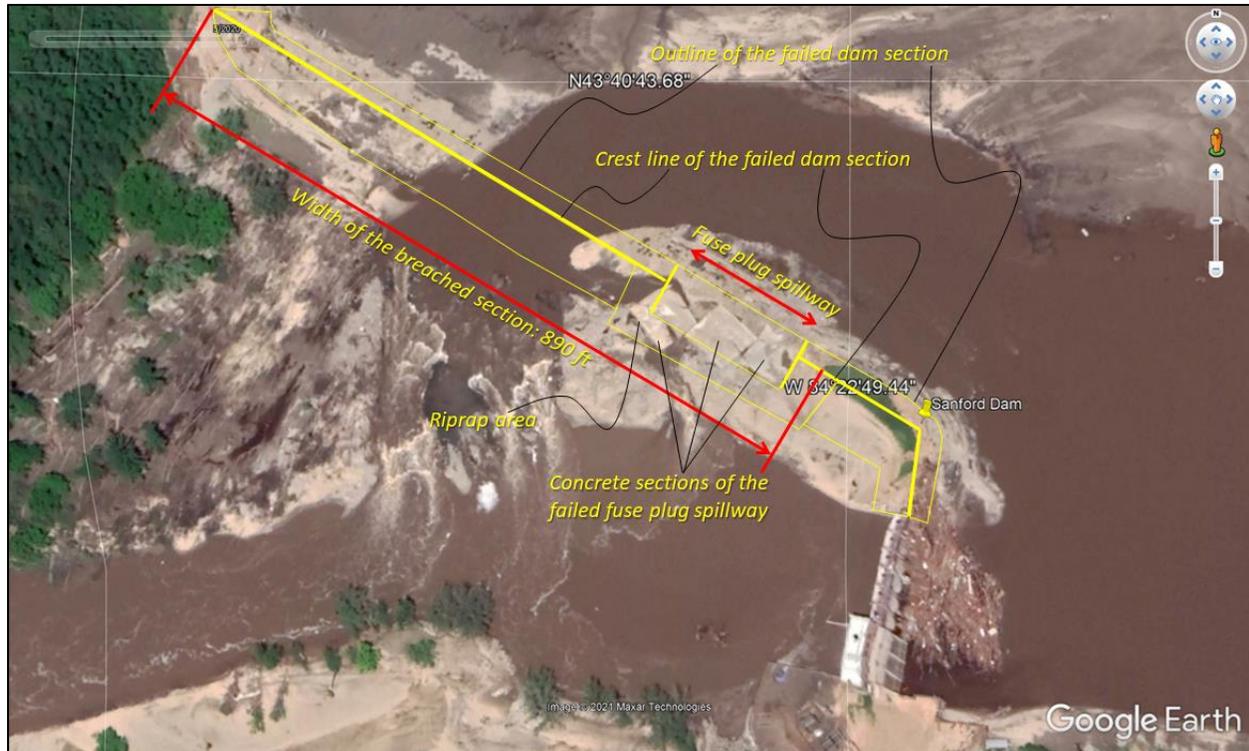
Figure 20: Aerial imagery of Sanford Dam after floodwaters receded (May 25, 2020)
(Google Earth 2021)

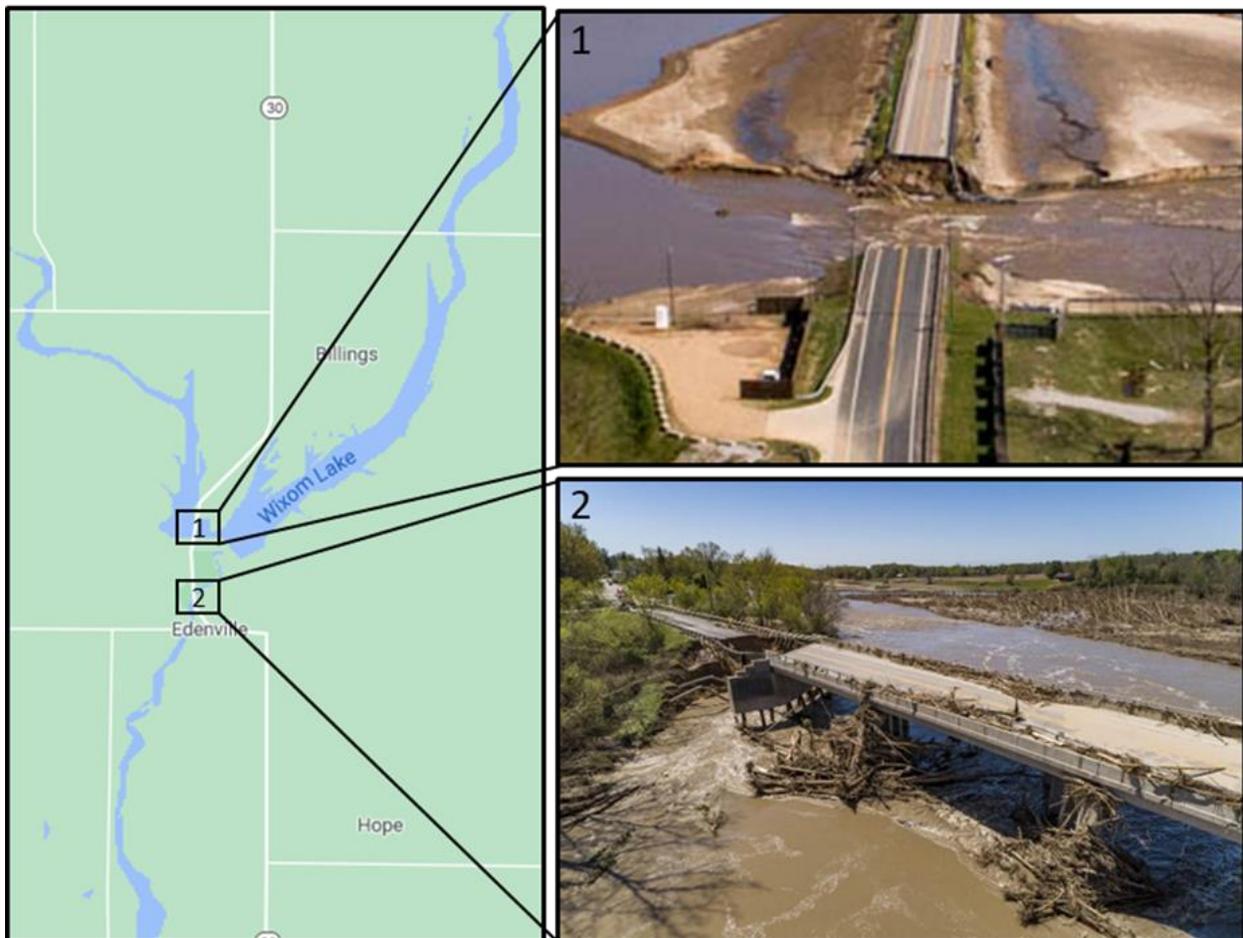
The damage to the two M-30 bridges, in conjunction with the closure of two other bridges (Highwood Road and Estey Road) that crossed the Tittabawassee River between Smallwood and Edenville Dams, created considerable access issues in the area surrounding Wixom Lake. The absence of these bridges created a peninsula north of Edenville Dam between the Tobacco and Tittabawassee rivers, which isolated several homes and businesses in Tobacco and Billings townships. Residents and first responders faced a 45-minute detour north around the lake because they could not cross the Tittabawassee River directly north or south of Edenville Dam (Eickholt 2020, North 2020). In response, Midland County positioned 25,000-gallon water tanks throughout the area to cut down the response time for vital firefighting and first responder activities (Eickholt 2020, Boyer 2020).

Figure 21: M-30 bridges over the Tobacco River (Box 1) and Tittabawassee River (Box 2) following the Edenville Dam failure (MDOT 2020b, 2021)

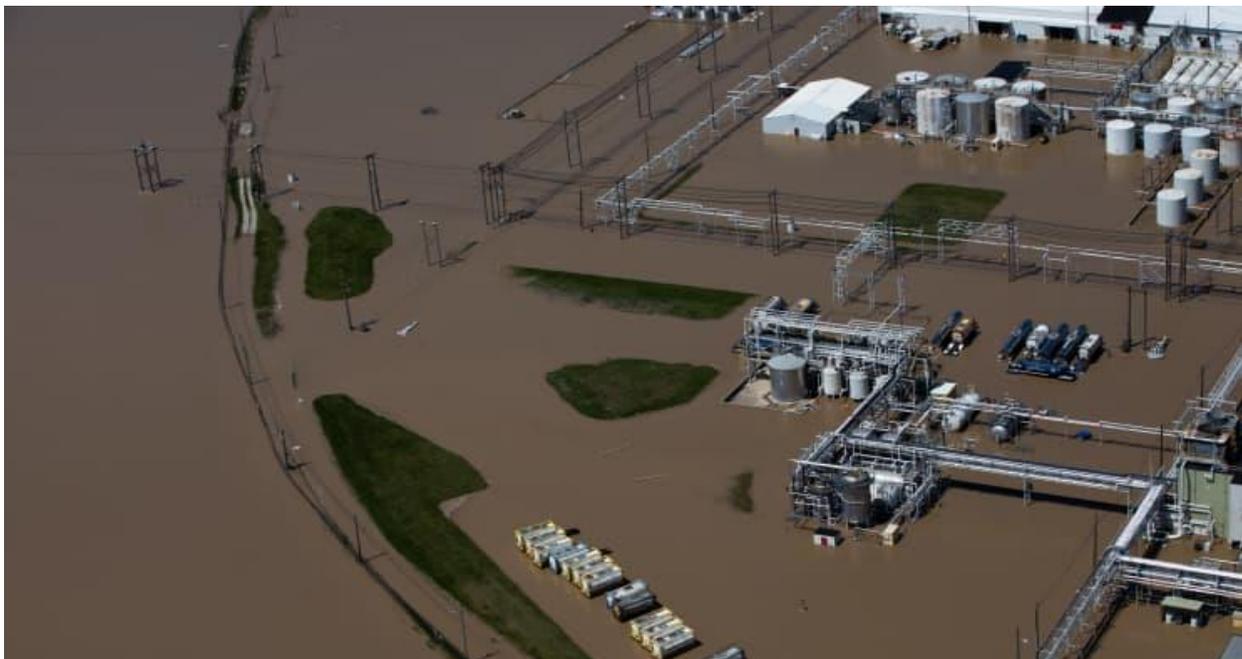
By the time the river crested at about 35 feet, the Dow plant had experienced some inundation (Figure 22), but much of the impact was successfully mitigated. Many reports focused on floodwaters that mixed with an onsite pond. Fortunately, Dow responded that the pond was filled with saltwater used for ground water remediation (not waste) and posed no public safety concerns (Schafer 2020d). There were no reported chemical or product releases.

Figure 22: Dow Chemical facility along the Tittabawassee River on May 20, 2020 (Jeffery and Miller/Elconin 2020)

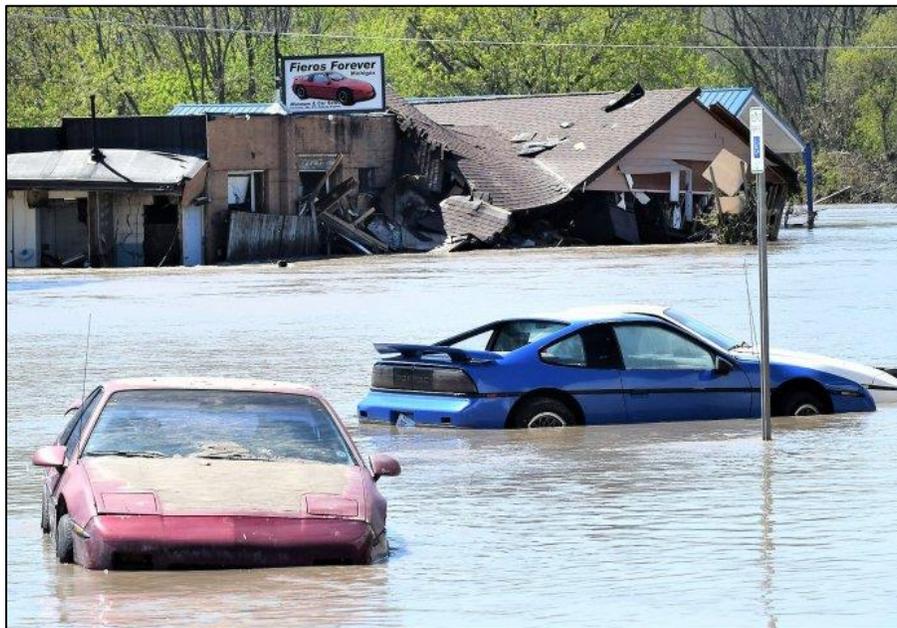
Floodwaters destroyed the Fieros Forever car museum (Figure 25) in downtown Sanford. The 3,000-square-foot building housed an automotive shop and Fiero museum, which featured 30 Pontiac Fieros including kit cars, a pace car, and super duty engines. When floodwaters receded, the cars were found spread across the once-flooded downtown area.

Figure 25: Fieros Forever car museum in downtown Sanford (Hunter/Mears 2020)

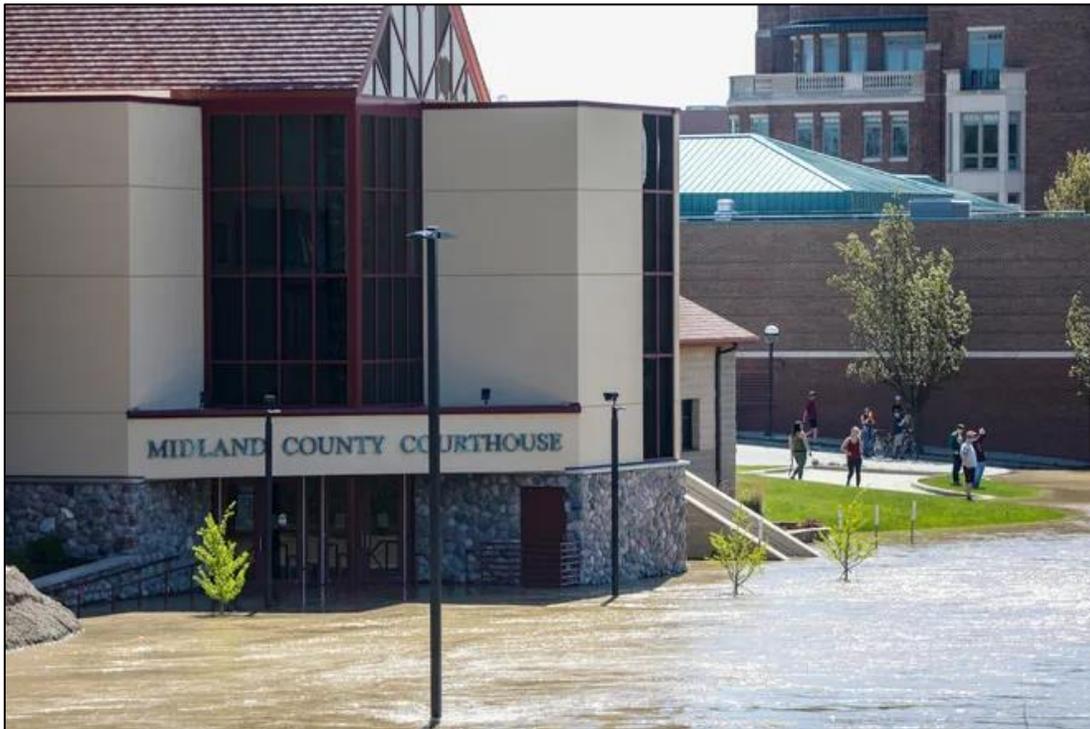
damaged in the flooding, although the courthouse temporarily lost power and had its air handler system submerged. The elevators were destroyed and needed replacement. The District Court was able to remain open and resume normal operations; however, until the elevators could be replaced, there was no public access to the Probate or Circuit Court levels of the courthouse. Temporary courtrooms were set up in an adjacent building for jury trials and hearings that required in-person attendance. All other court sessions were conducted virtually (i.e., Zoom) or were adjourned to a later date, as per COVID-19 protocols (Midland Daily News 2020).

Figure 26: Midland County Courthouse in downtown Midland following the May 2020 dam failure and flooding incidents (Witsil 2020)

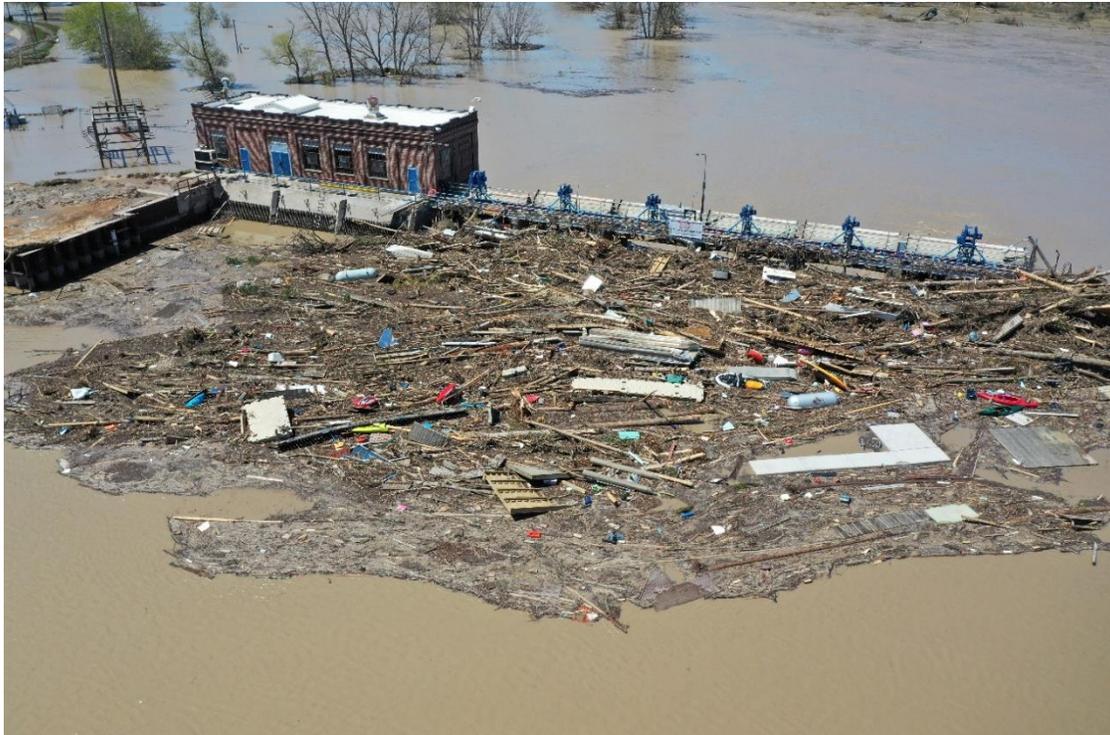
Removal of the debris behind the Sanford Dam did not begin until late October 2020. Its removal was critical to beginning the initial engineering work to stabilize the dam. The FLTF funded the debris removal using state and federal grant money and volunteers helped sort through the material. Property owners were asked to submit claims if they thought they owned anything found in the debris. All unclaimed debris was sent to a landfill (Ellison 2020).

Figure 34: Debris pile remaining behind Sanford Dam (MSP 2022)

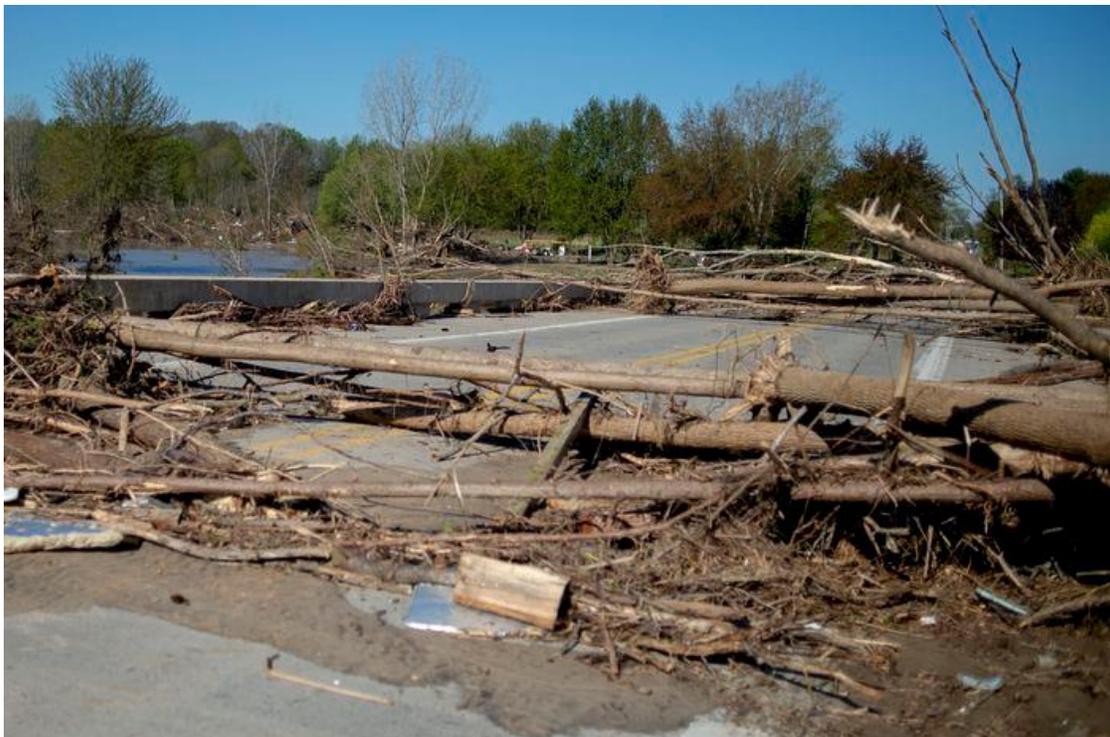
Figure 35: Debris and sediment left on Curtis Road Bridge after floodwaters receded (May 2020)
(Johnson/May 2020)
