Report of the Commission

Causes Leading to the Failure of the St. Francis Dam

NEAR SAUGUS, CALIFORNIA

CALIFORNIA STATE PRINTING OFFICE
SACRAMENTO, 1928

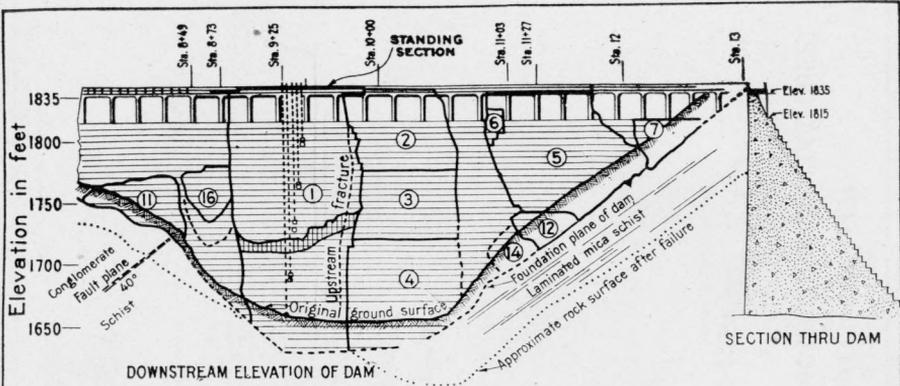
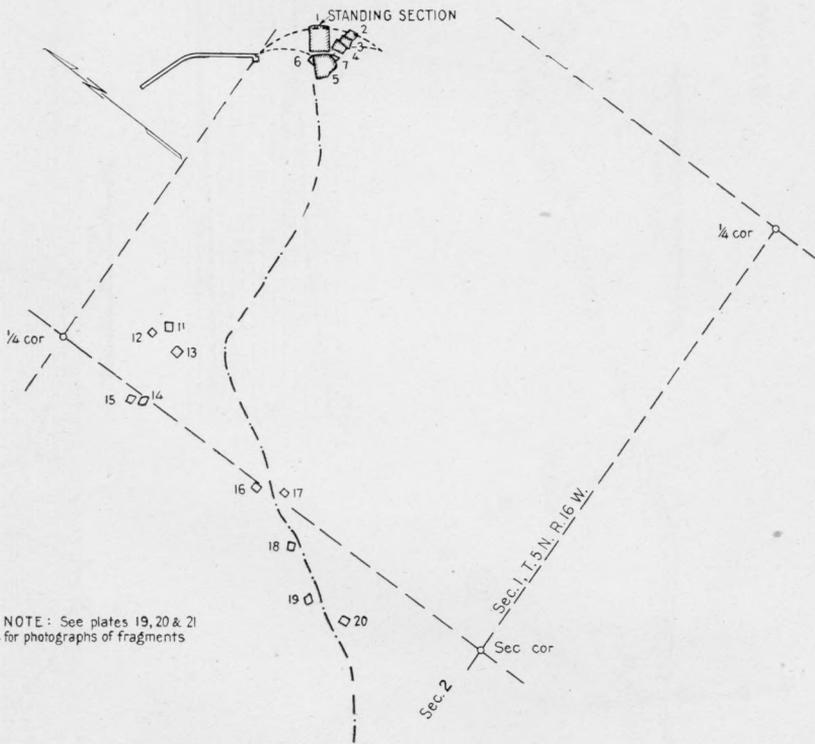
ST. FRANCIS DAM
DISTRIBUTION OF FRAGMENTS

It appears that the failure of the dam took place at, or slightly before, 11.58 p.m., March 12, when the main dam structure, with the exception of a section near its middle, failed completely, leaving the greater part of the left or easterly portion in very large fragments at and just below the dam site and great blocks of concrete up to about 10,000 tons in weight, chiefly from the right or westerly end, distributed for a distance of several thousand feet downstream. See Plate 8.

It is probable that the rush of water released by failure of the west end caused a heavy scour against the easterly canyon wall at the toe of the dam. This rapidly cut away the schist including the material under the toe of the east part of the dam and caused the failure of that part of the structure. The escaping water then continued to cut away the schist from the east wall of the canyon until a maximum

depth of about 30 feet below the original foundation level was reached. See Plate 8.

DIAGRAM SHOWING EROSION AND ORIGINAL POSITION OF IDENTIFIED FRAGMENTS

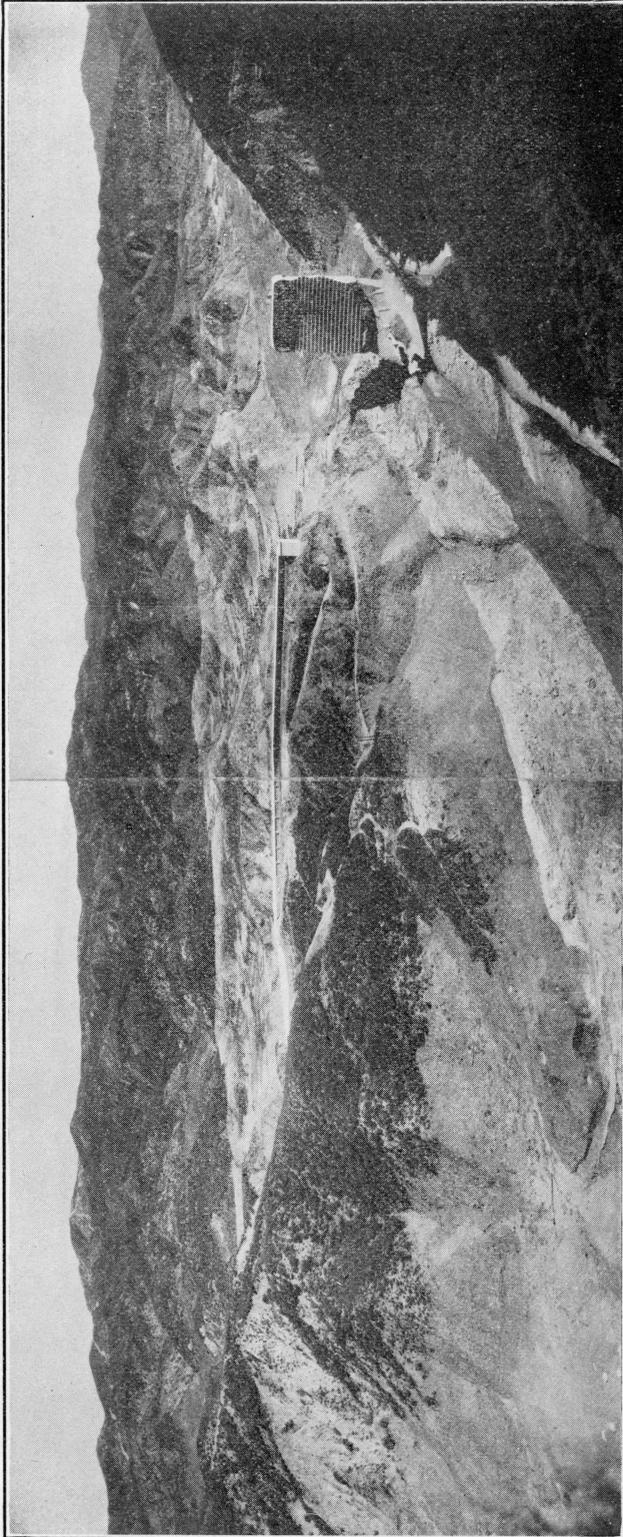
The rapid lowering of the water in the reservoir caused several large landslides that are very conspicuous as shown in pictures looking upstream from the dam site. The most important of these is on the easterly side of the reservoir a short distance upstream from the dam, where displacement of a road shows vertical movement of approximately forty or fifty feet along the junction of surface earth and material that is probably very similar to that against which the east abutment of the dam rested.

PANORAMA UPSTREAM SHOWING RUINS OF DAM AND LOWER PART OF RESERVOIR SITE.

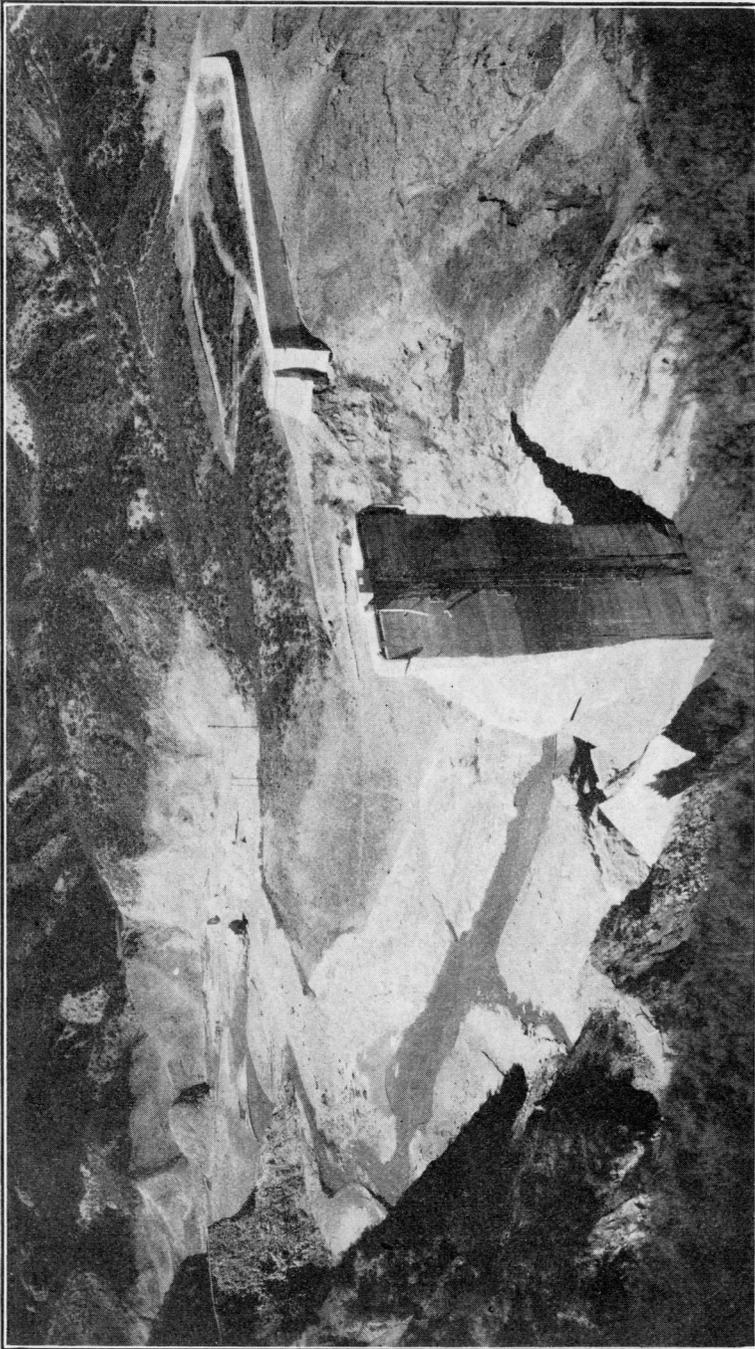
PLATE 18

GENERAL VIEW DOWNSTREAM FROM EASTERLY BANK SHOWING DAM AND WRECKAGE.

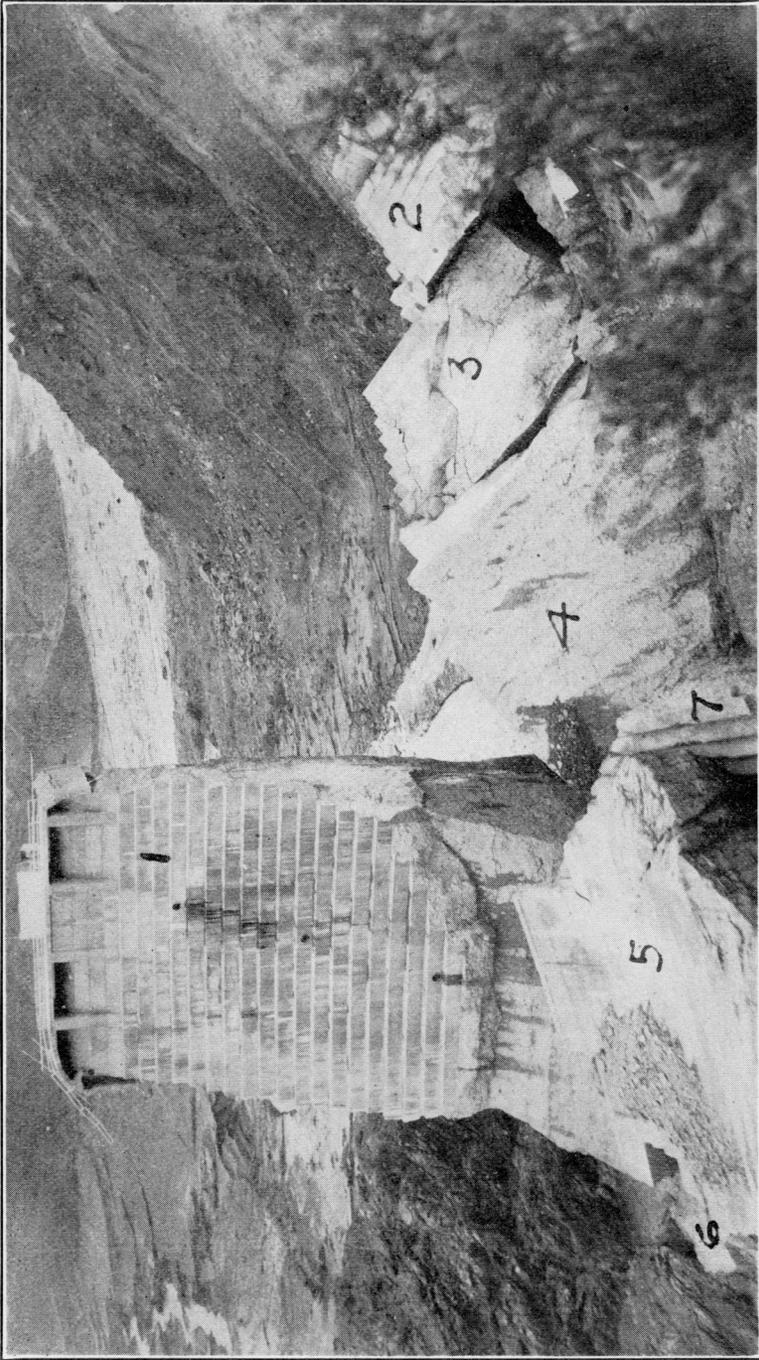
PLATE 19

VIEW UPSTREAM SHOWING WRECKAGE OF EAST ABUTMENT SECTION.

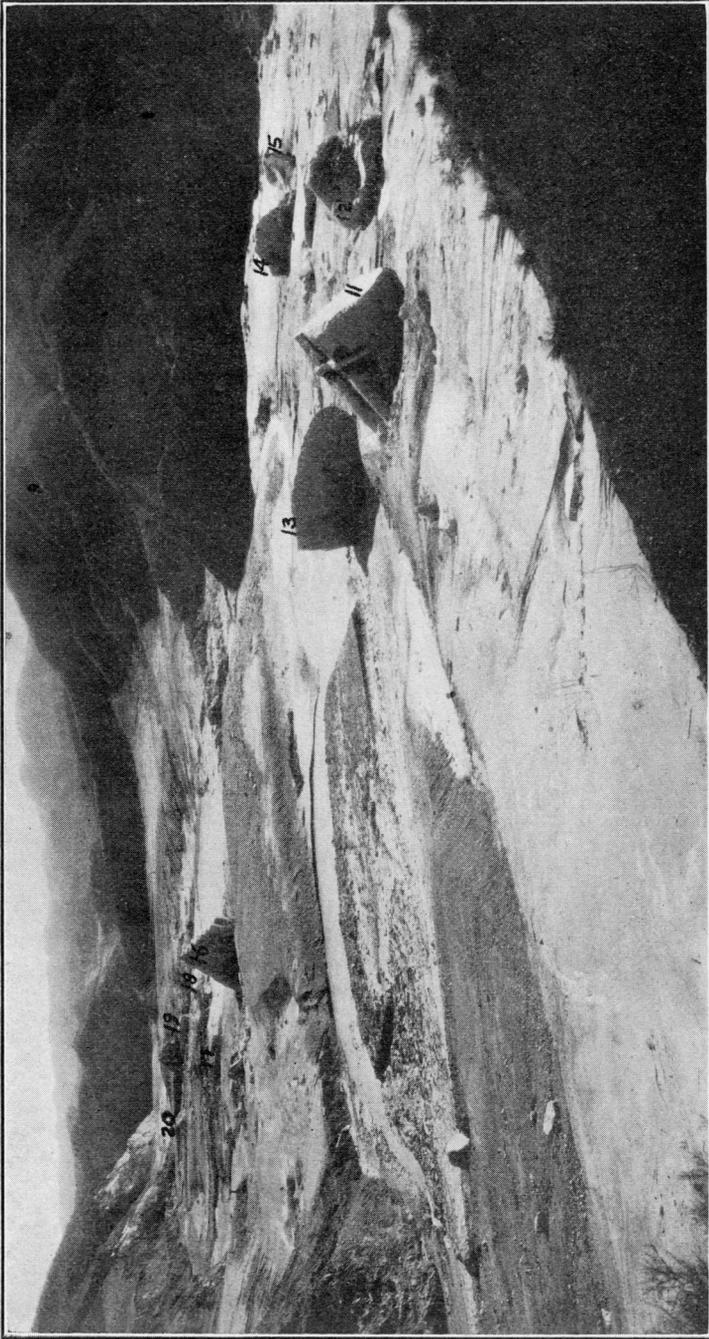
PLATE 20

CONCRETE FRAGMENTS OF DAM DEPOSITED DOWNSTREAM BY FLOOD WAVE.

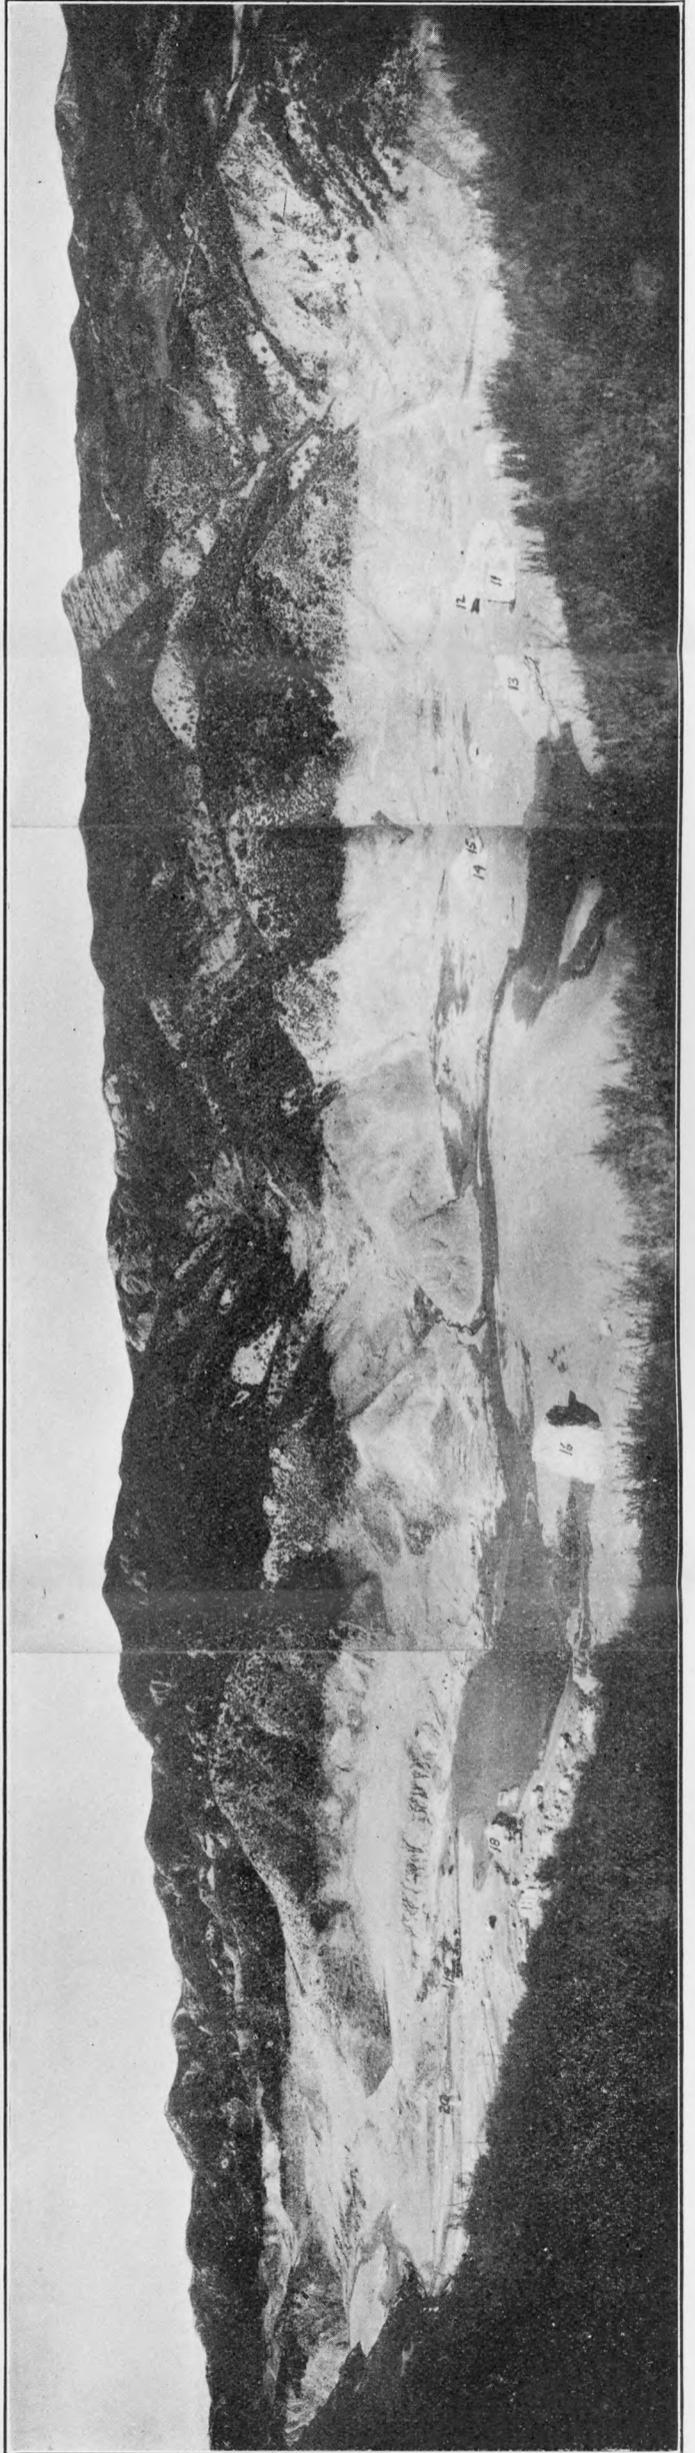
PLATE 21

PANORAMA SHOWING FRAGMENTS DEPOSITED DOWNSTREAM.

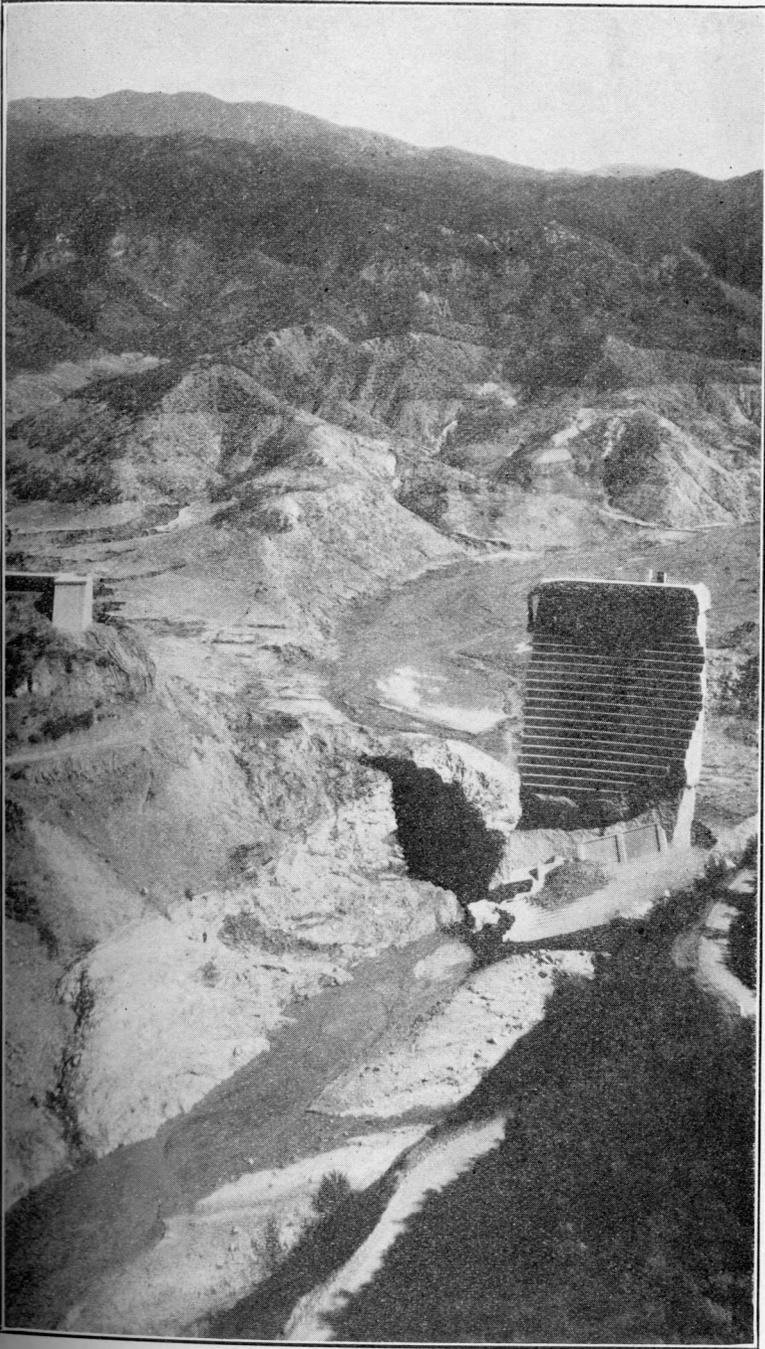
GENERAL VIEW OF DAM SITE FROM DOWNSTREAM.

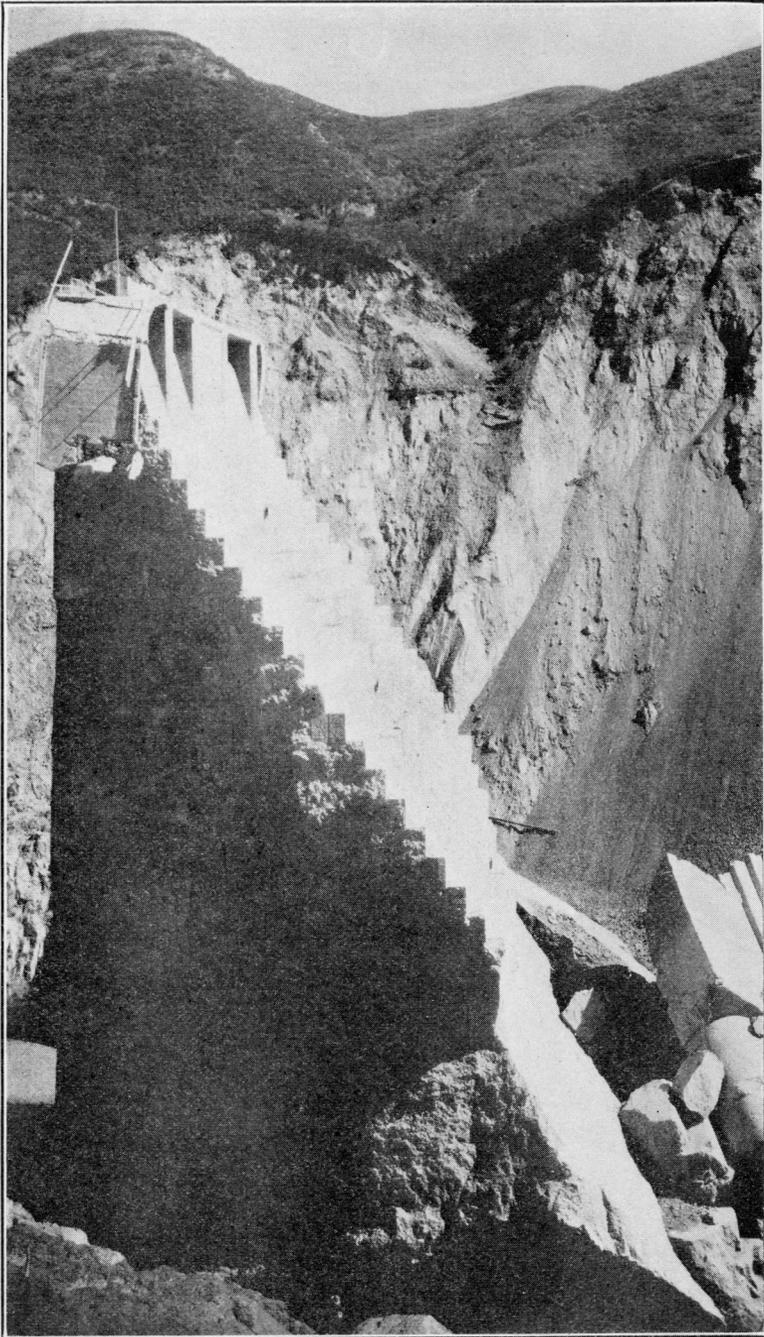
PROFILE OF STANDING SECTION AND VIEW OF EAST ABUTMENT.

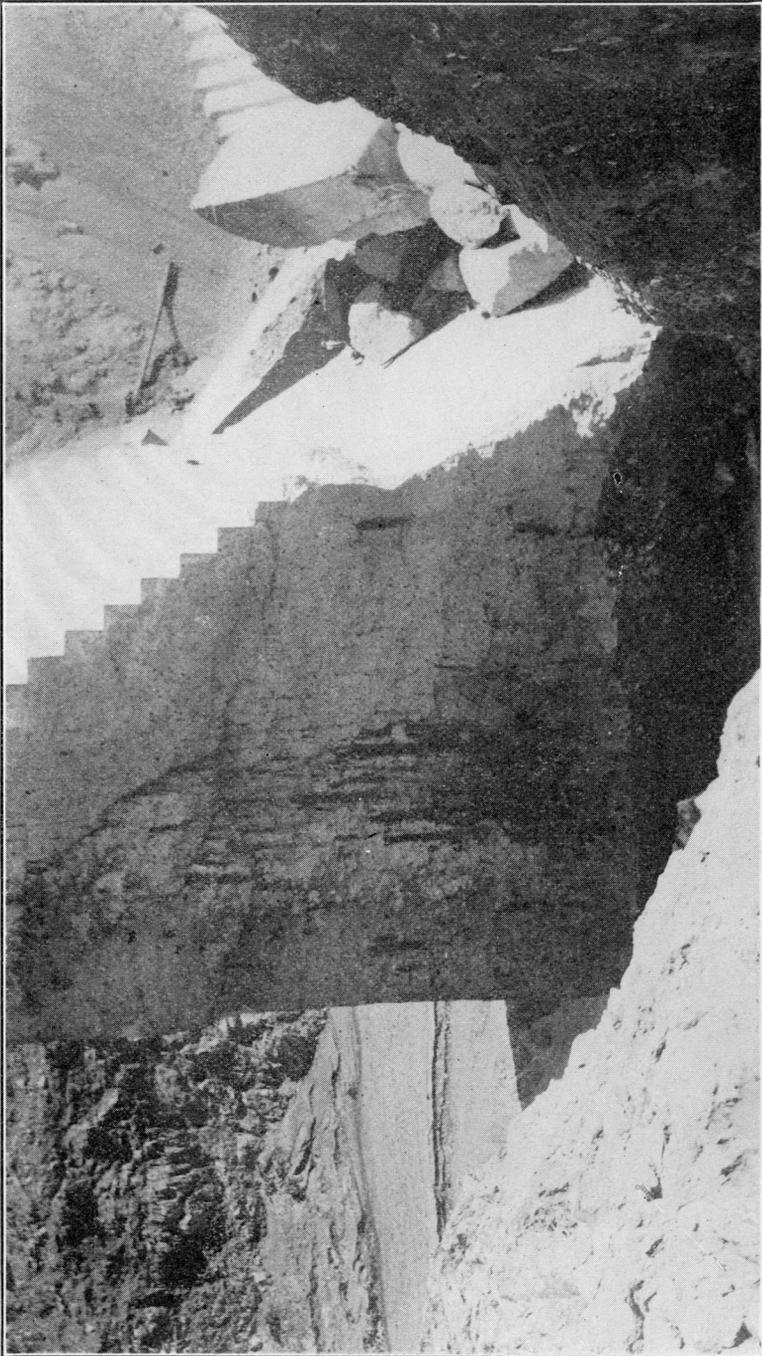
PLATE 24

WEST FACE OF STANDING SECTION SHOWING CONTACT PLANE WITH FOUNDATION.

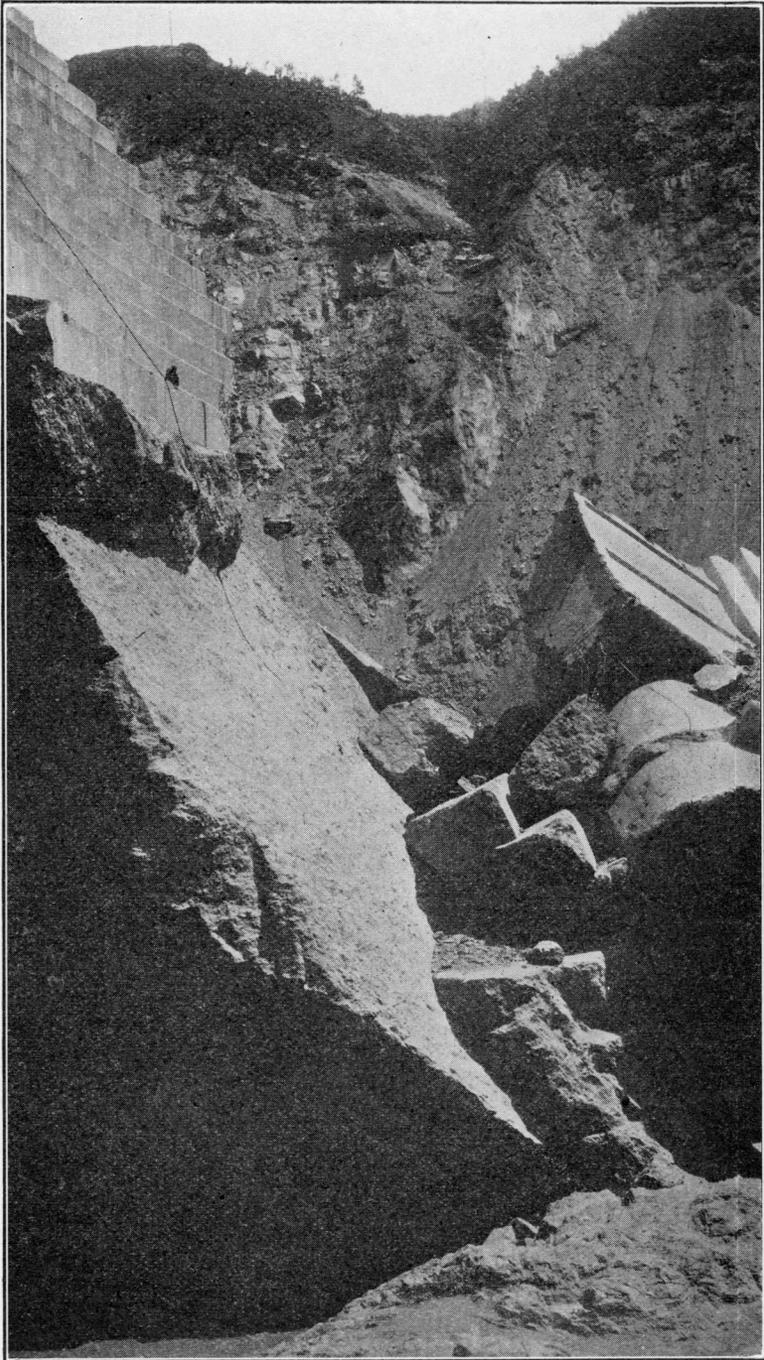
CONTACT PLANE BETWEEN CONCRETE AND FOUNDATION NEAR
DOWNSTREAM TOE OF STANDING SECTION.

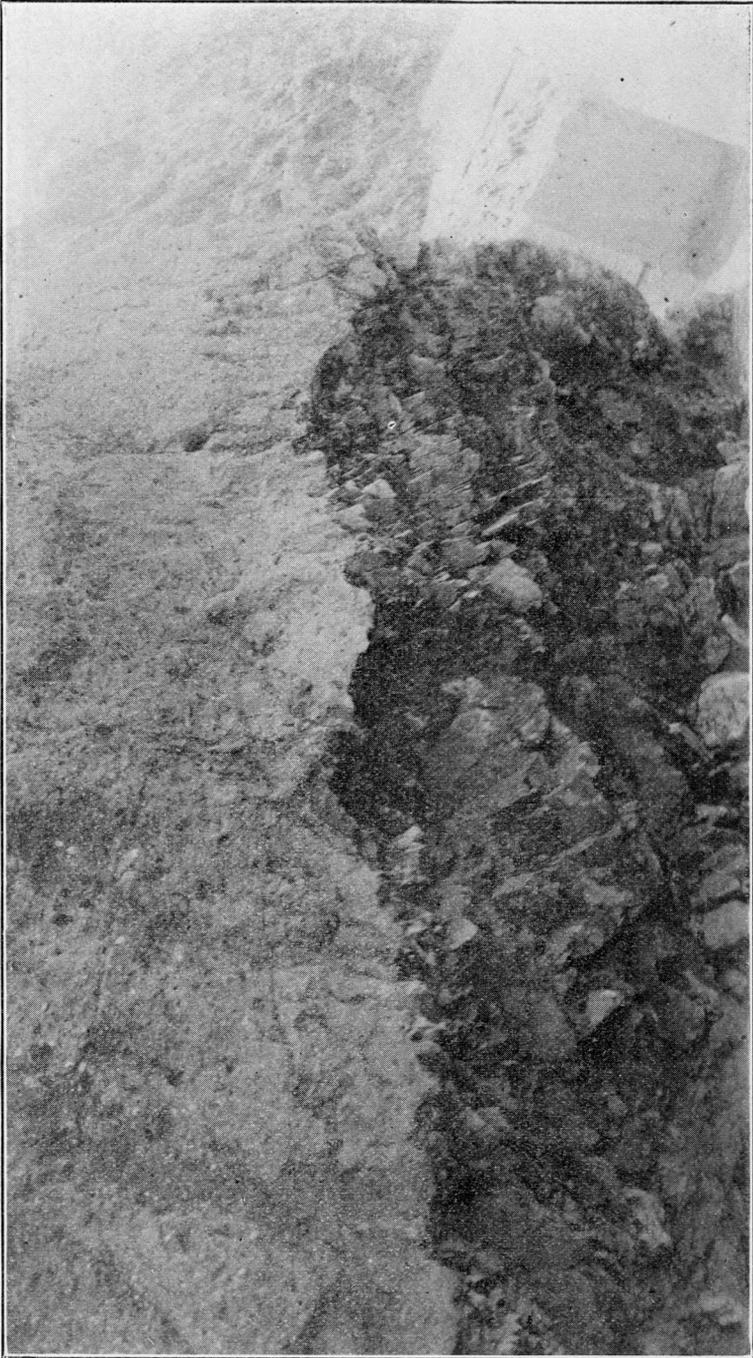
DOWNSTREAM PROFILE OF STANDING SECTION SHOWING SHEER PLANE.

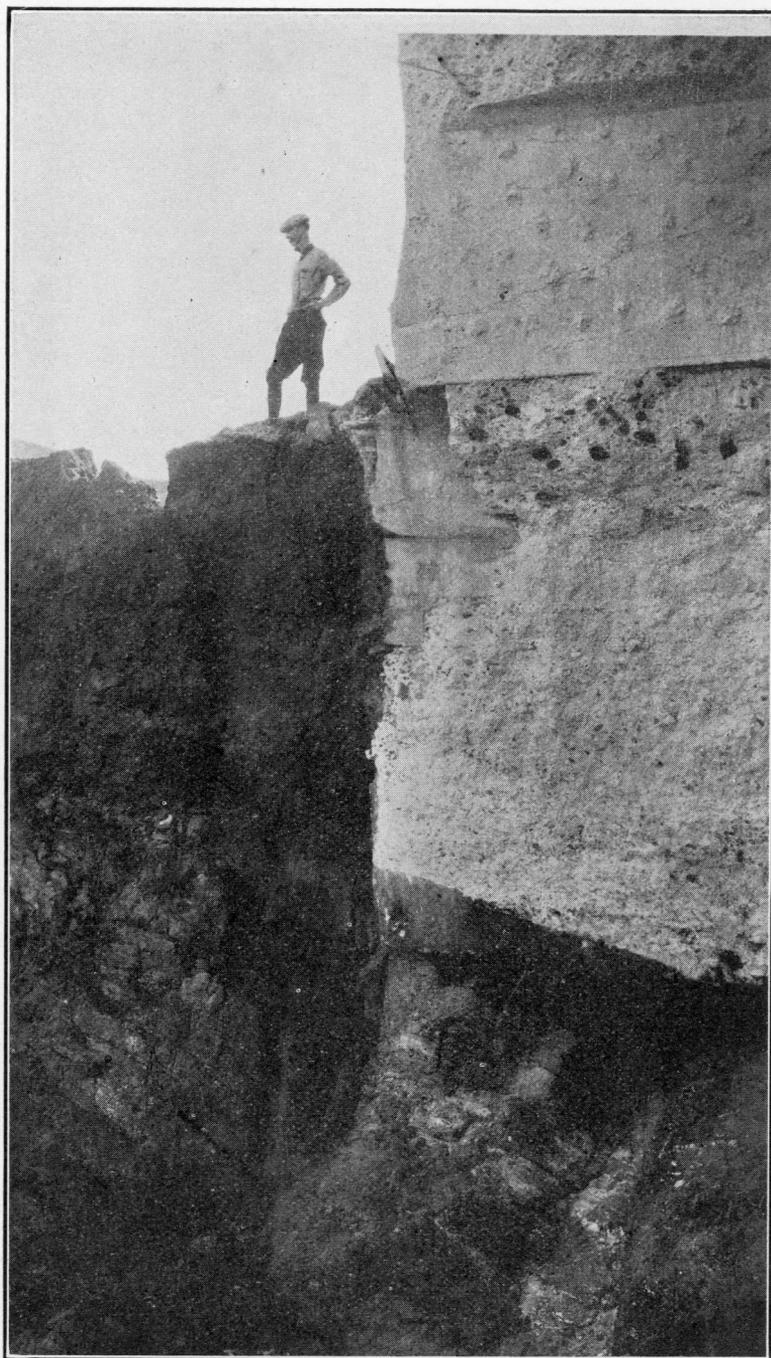
FACE OF BUTTRESS AT WEST END OF MAIN DAM.

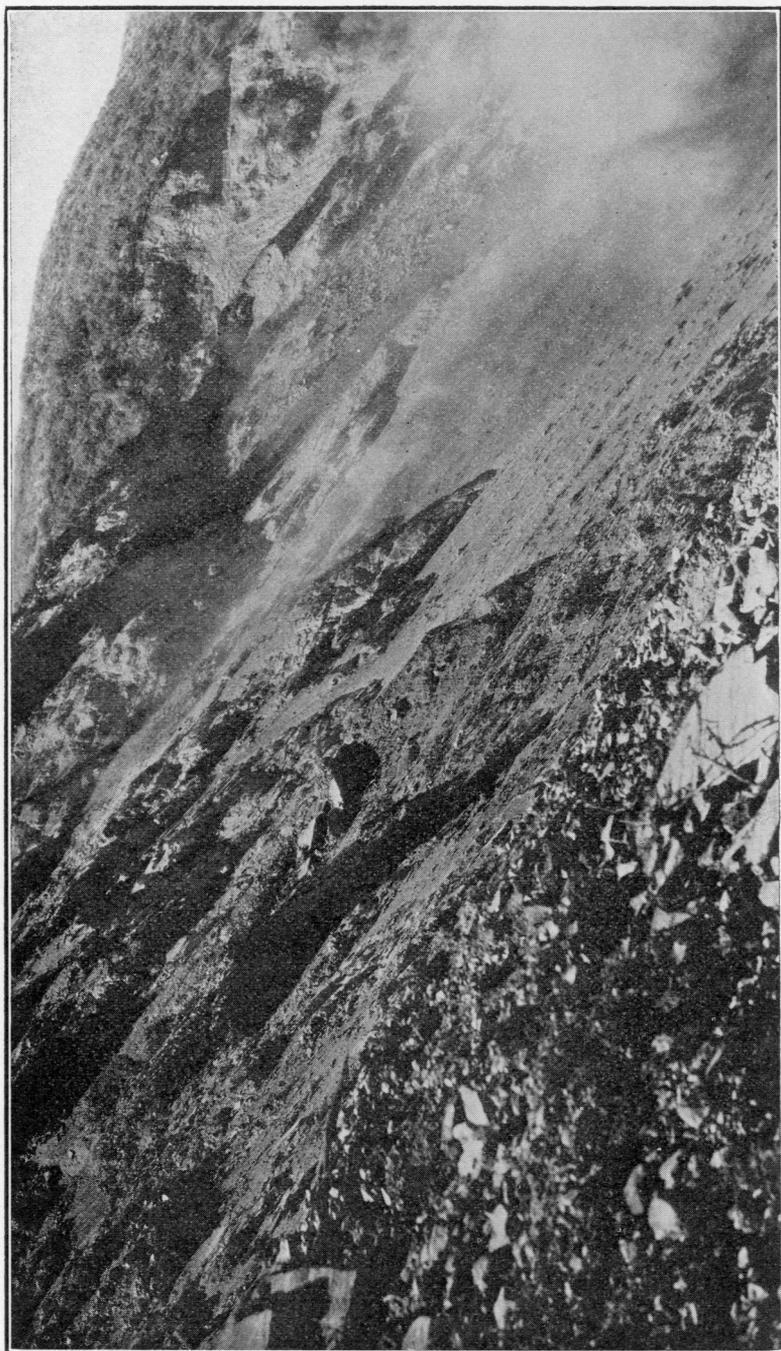
PLATE 28

At the east abutment of the dam and immediately below the dam site much recent sliding has taken place, and during the visits of the commission to the dam site a continuous rain of rock fragments was coming down the slope, accompanied by clouds of dust as shown in Plate 28. This sliding is evidently due to the removal of support as a result of the destruction of the dam and the undercutting of the slope by the waters released by the dam failure.

EAST ABUTMENT SHOWING ACTIVE SLIDING.

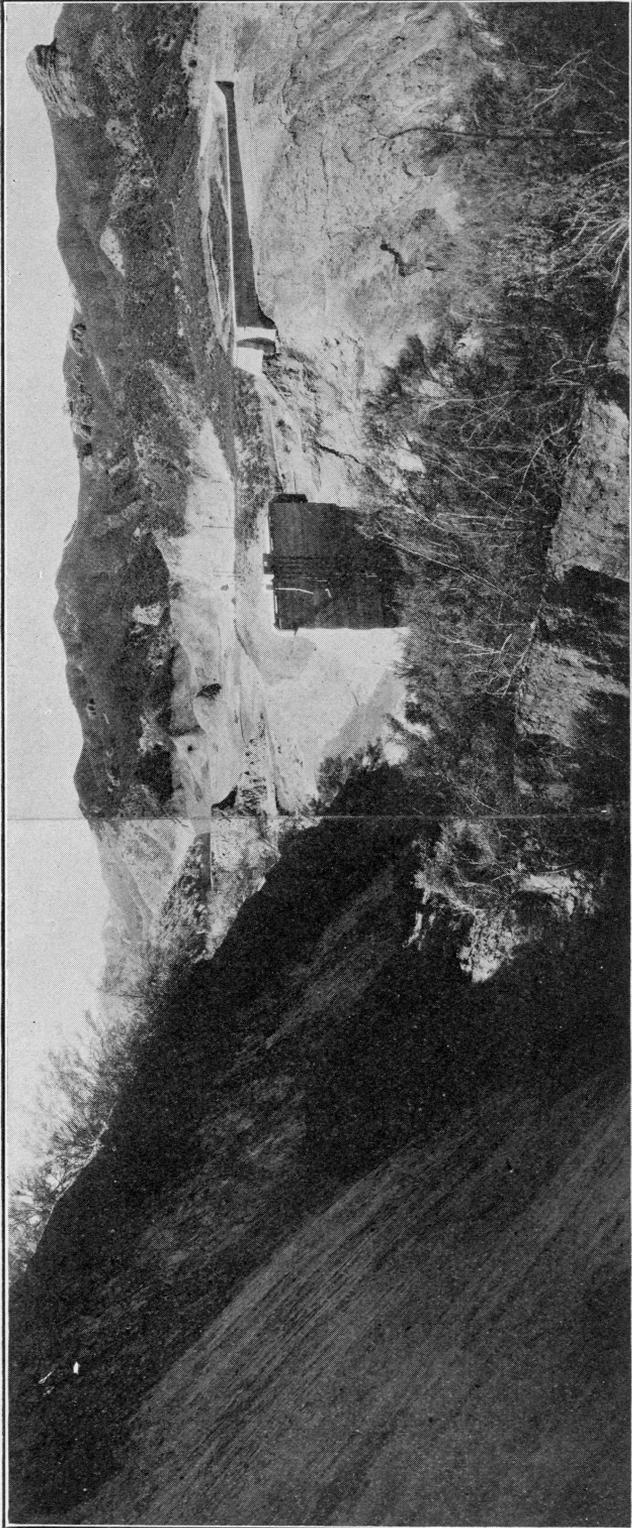
Above the dam site several marked recent slides have taken place. One, a short distance upstream from the dam, broke the road and carried a large mass of rock and earth down to the floor of the valley. See Plates 29 and 30. A careful examination of the surface of this slide shows no water lines, erosion furrows, or other evidences of the action of the standing or moving water of the reservoir. Evidently the sliding occurred after the withdrawal of the water from the reservoir. The added weight of the infiltrated water while the reservoir was full, and the rapid removal of the water support when the dam failed are sufficient causes for the landslides above the dam.

GENERAL VIEW OF DAM SITE FROM HEAD OF LANDSLIDE UPSTREAM FROM DAM.

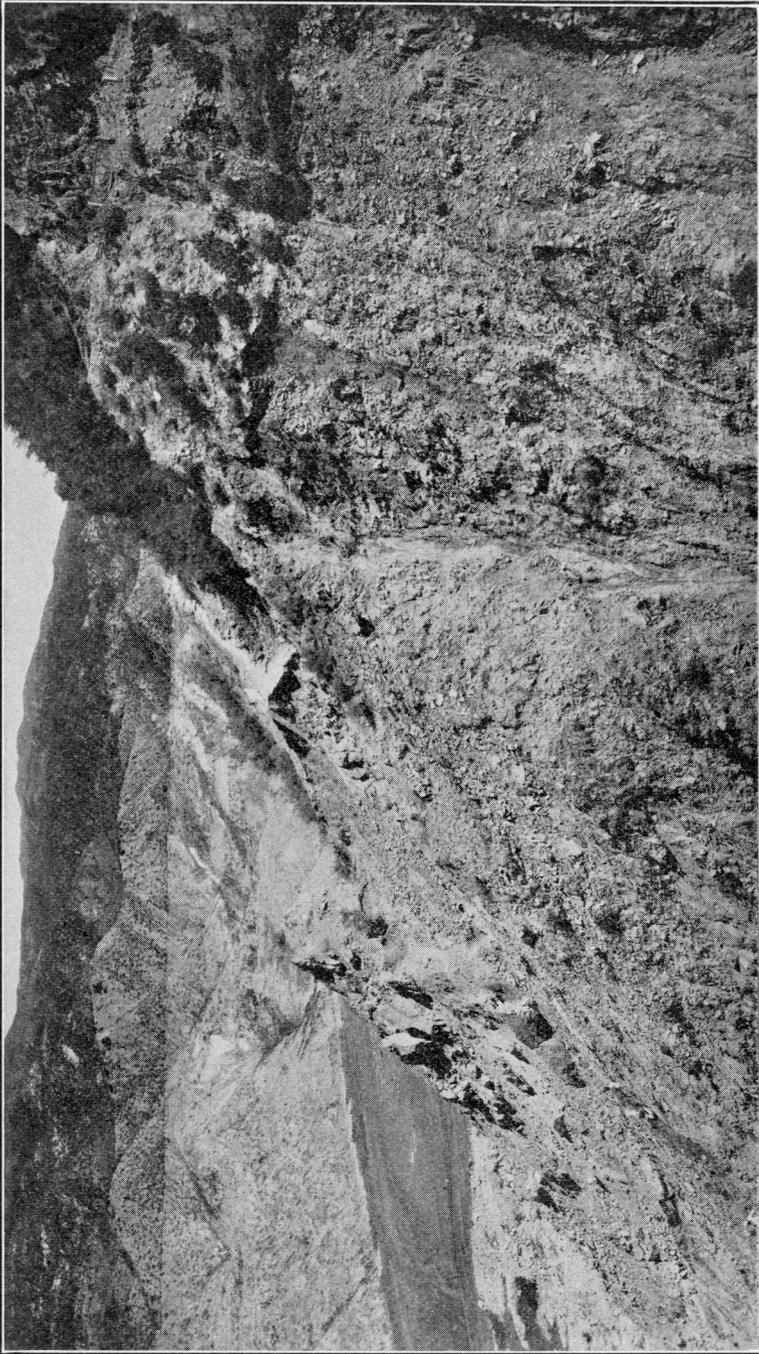
PLATE 30

VIEW OF LANDSLIDE EASTERLY BANK UPSTREAM FROM DAM.
