STATE OF MONTANA

STATE WATER CONSERVATION BOARD

Chronology of Events leading up to the failure of the Frenchman Creek dam on April 15, 1952.

REPORT ON THE FAILURE OF FRENCHMAN CREEK DAM

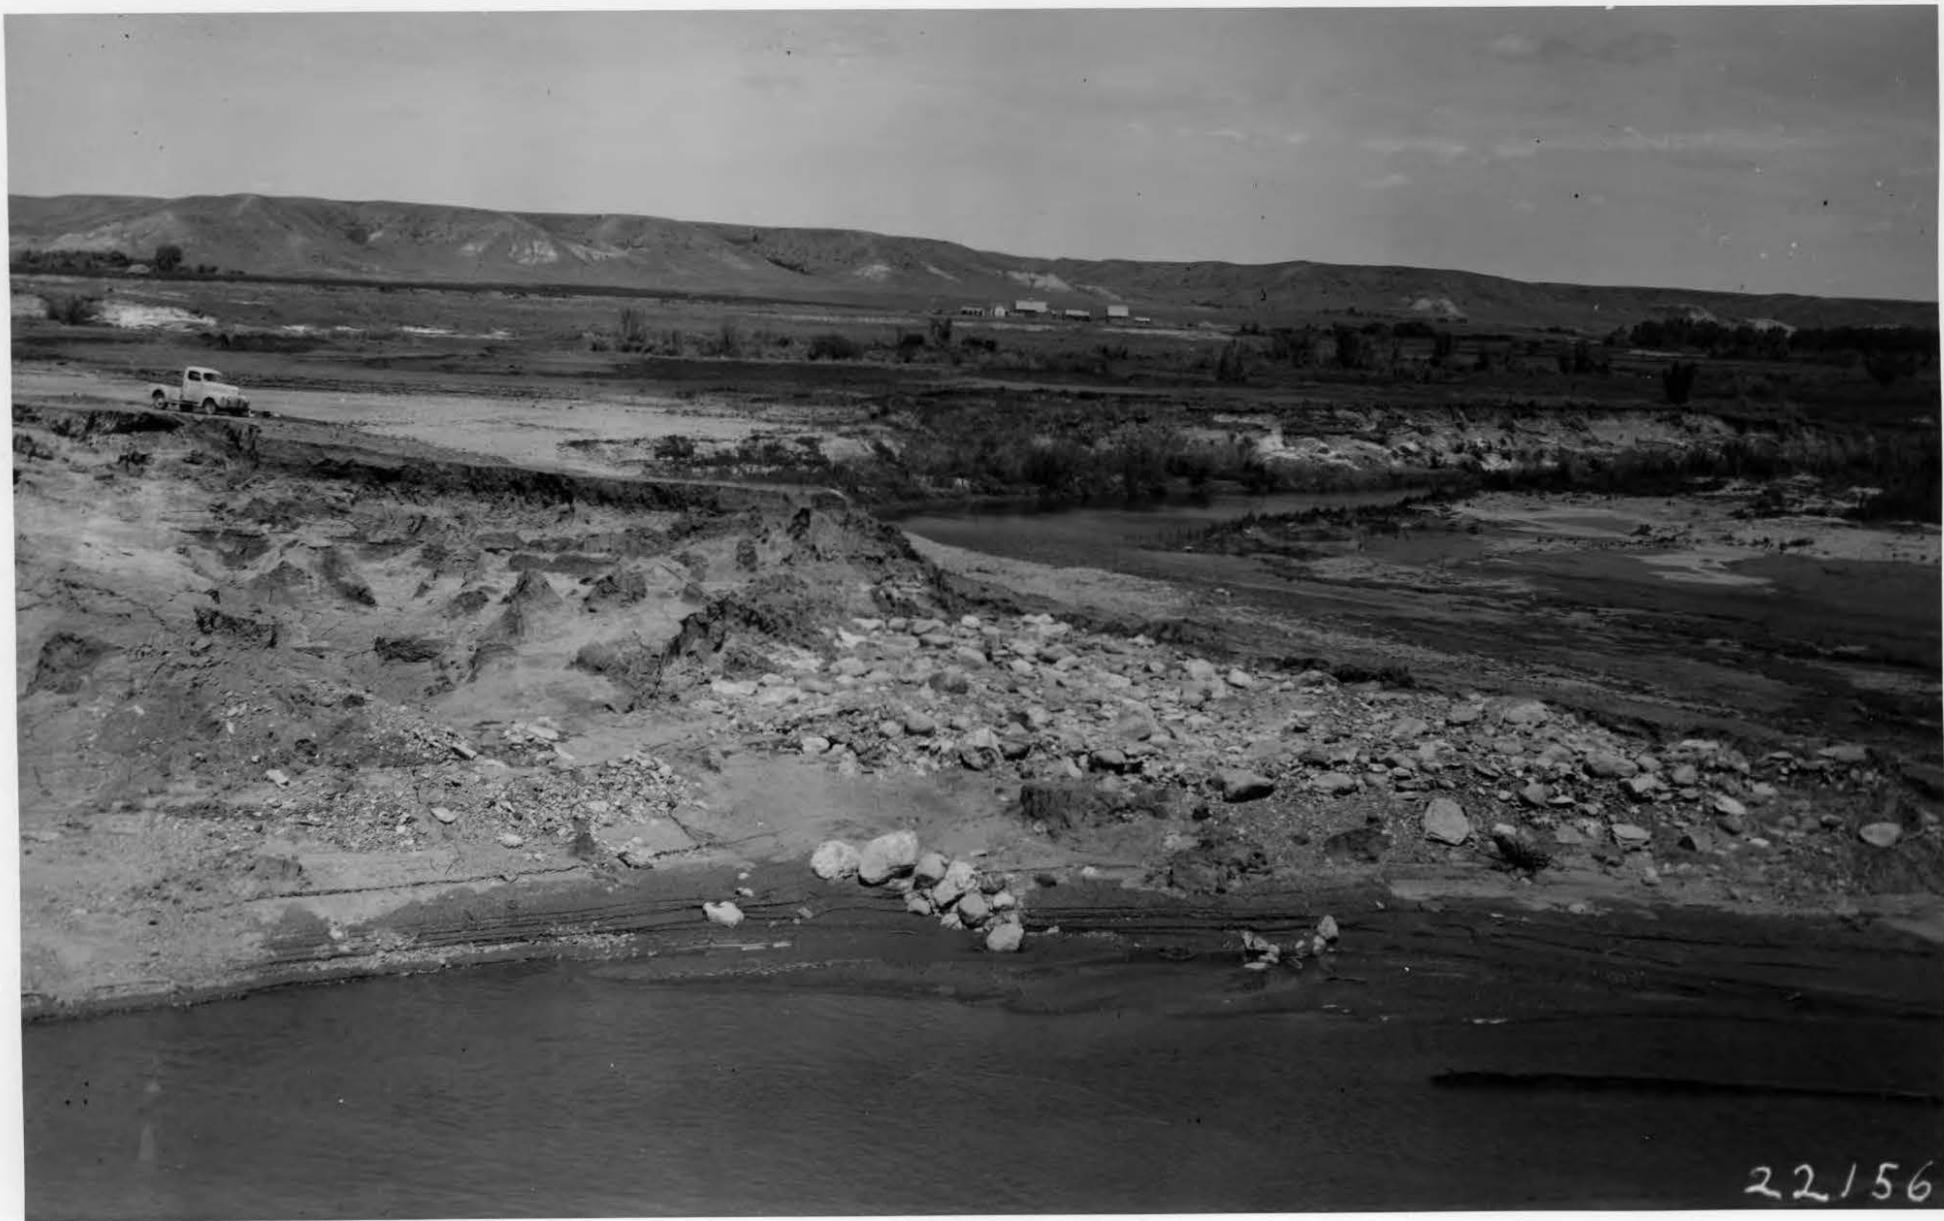
22156

View looking west toward the west spillway retaining wall. Top of wall was originally at same elevation as top of fill in background. Note gravel strata exposed along training wall.
