CAUSE AND CONSEQUENCE OF THE FUJINUMA DAM FAILURE FROM THE 2011 TOHOKU EARTHQUAKE

Paul Risher, PE
Senior Water Resources Engineer

September 13, 2021 • ASDSO Dam Safety National Conference

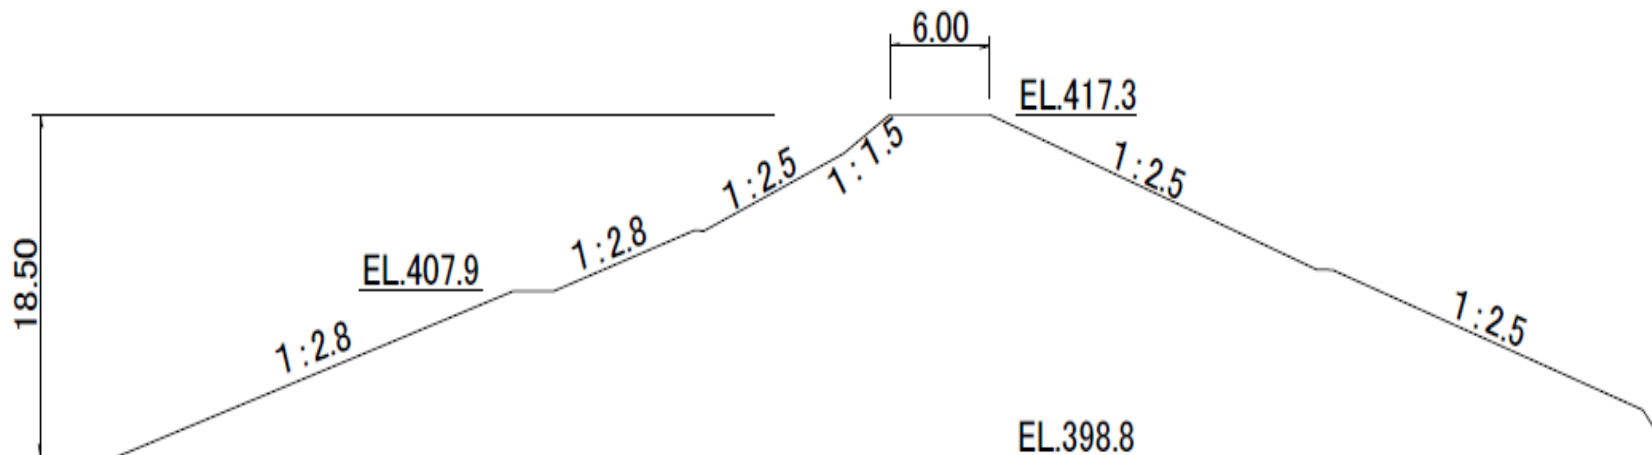
Discrete layers of different materials noted by field investigators. Mostly cohesive, w/ sandier upper zone. Highly organic layer in foundation.

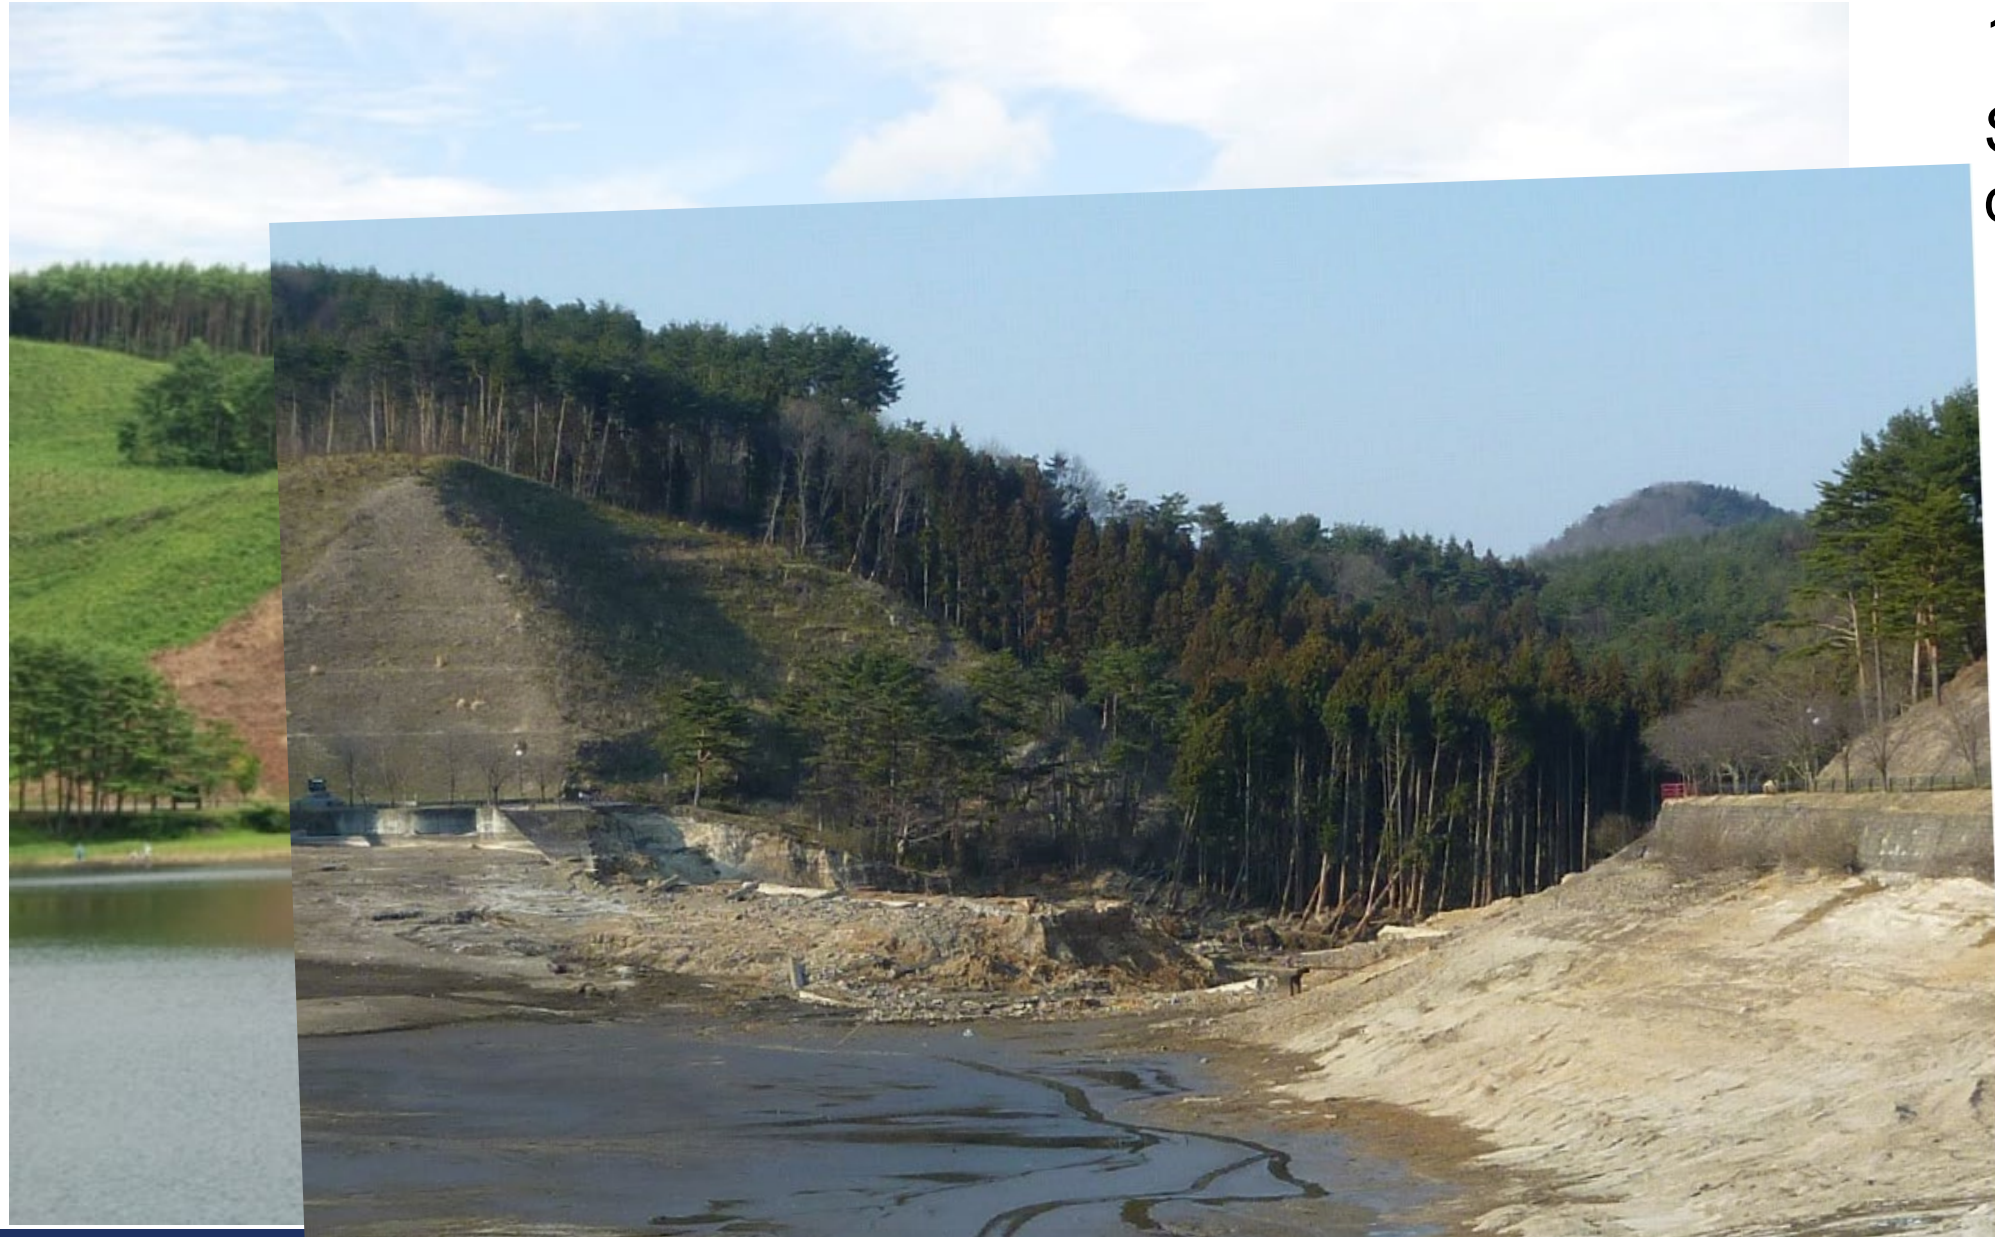
Final Breach Opening

120 m top width
Some residual
did not erode

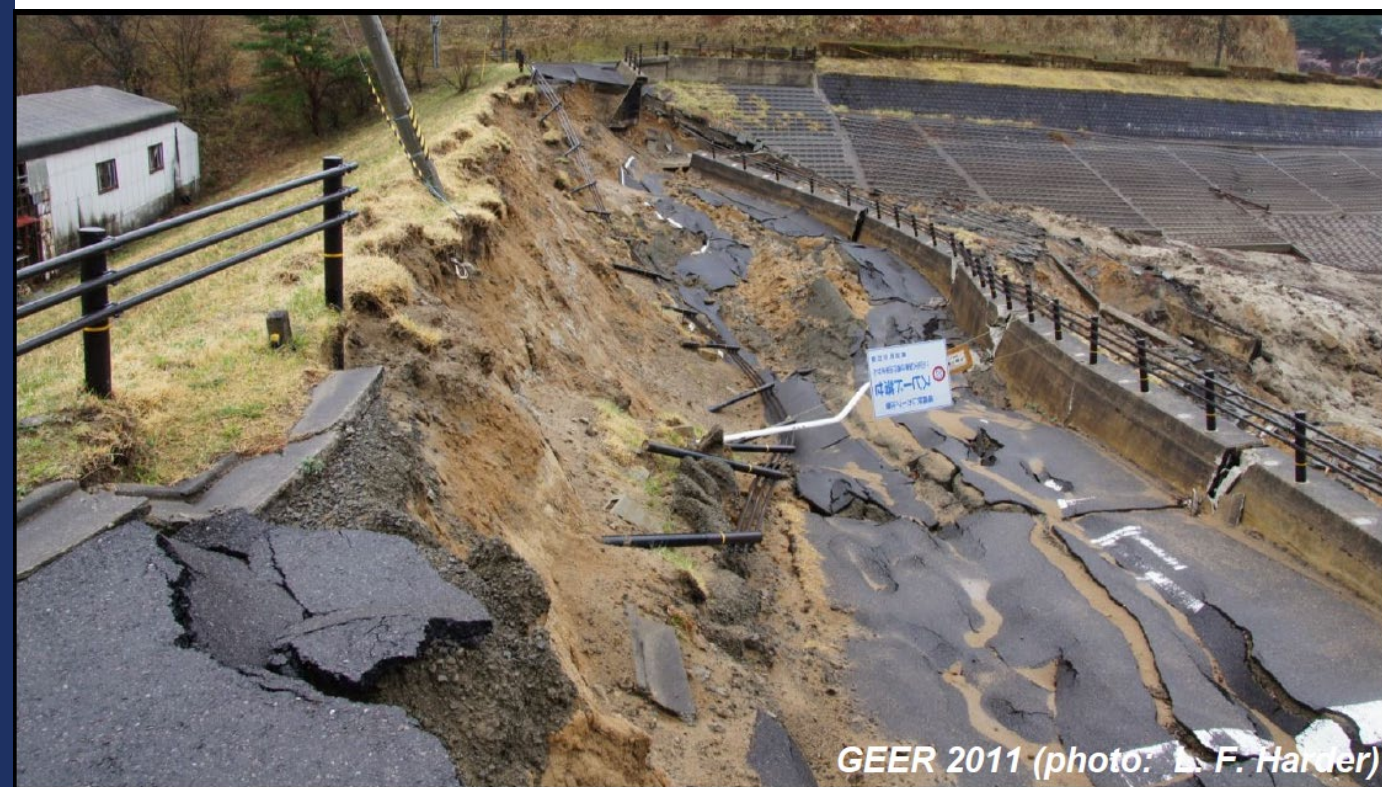
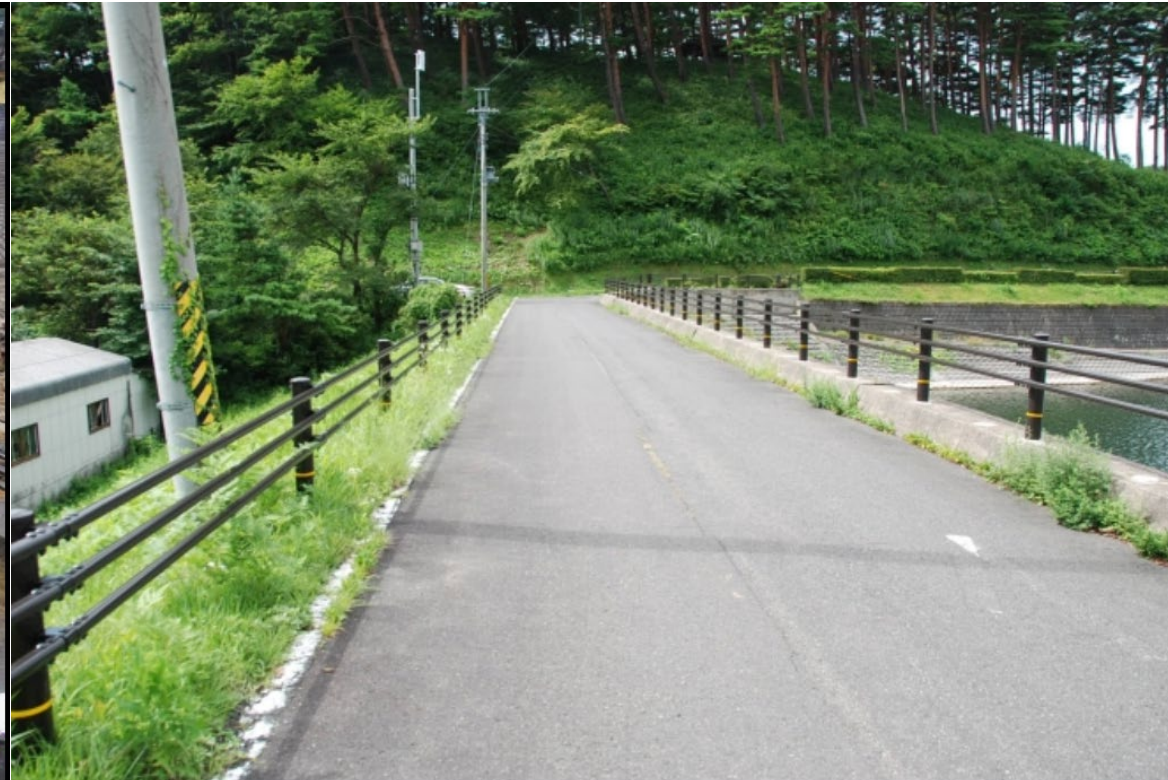
Saddle Dam

Rapid drawdown failure postulated

Several slope failures also observed around the reservoir rim

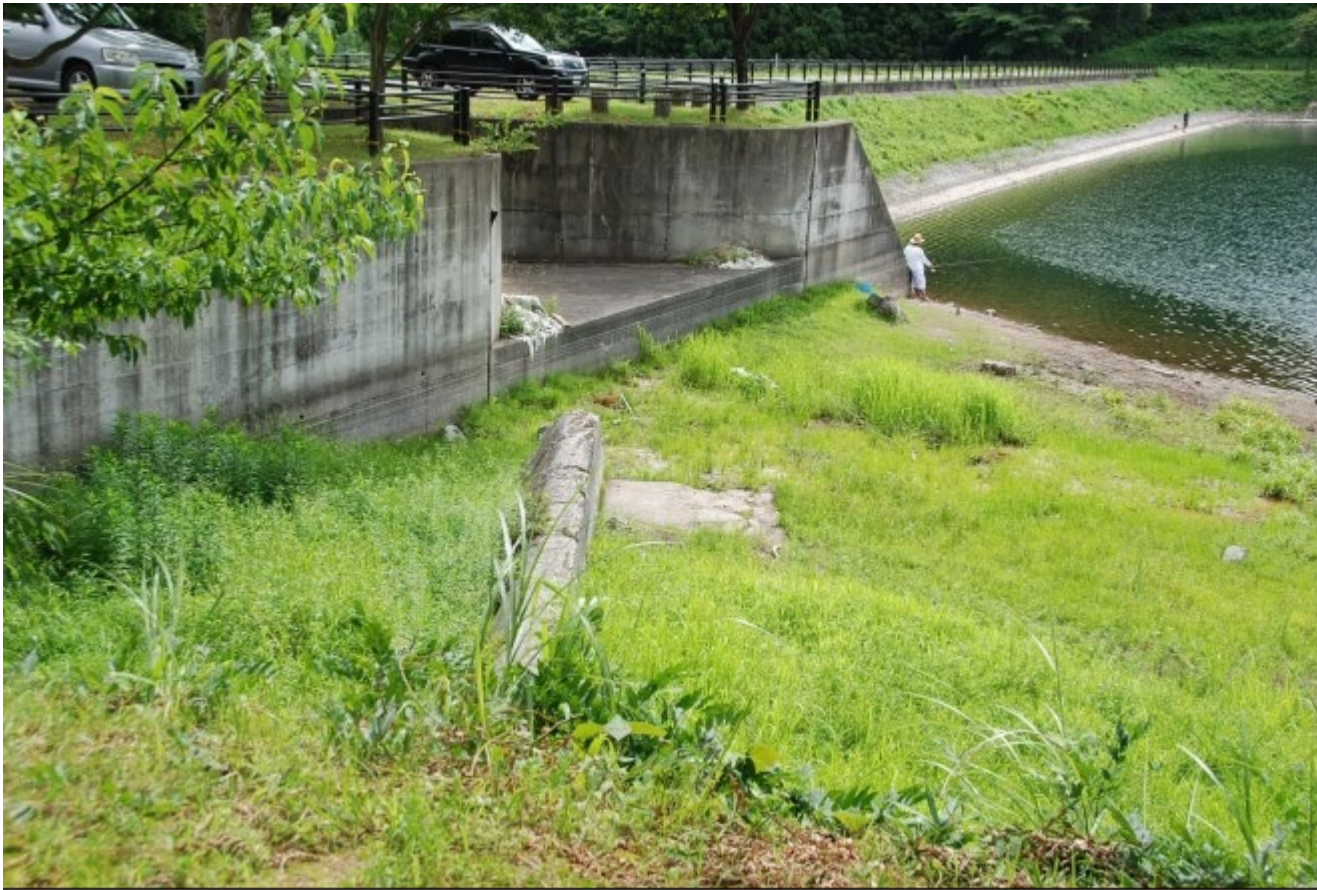
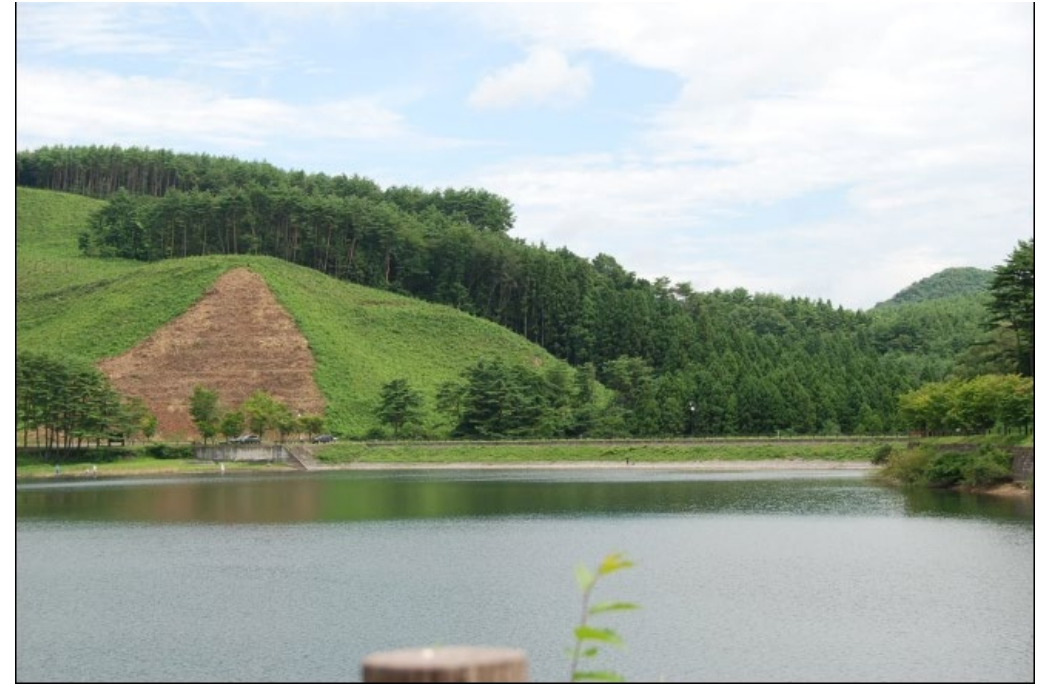
Spillway inlet and upstream side of dam
