The Meadow Pond Dam Dam Tragedy

Human and Physical Failures

ABSTRACT

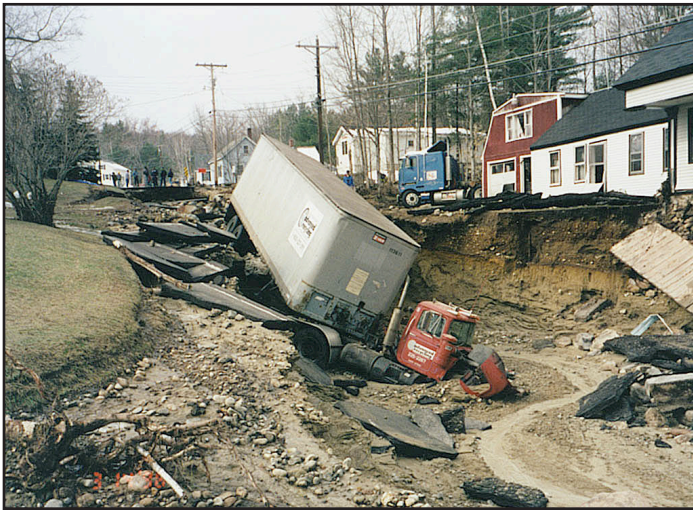
Fig. 3 – Larry Sinclair's Tractor Trailer

large gully in Route 140. Larry's semi jackknifed and submerged into the gully (Fig. 3; note: all photos, Figs. 3-6, are from NH DES files). He was able to climb out of the cab onto the truck roof, where he was rescued with a rope by John Young who lived across Route 140. The flood waters grabbed, spun, and carried away Lynda Sinclair's pickup. The crushed pickup was found after the flood in a downstream ravine (Fig. 4). Searchers discovered Lynda's body six days later in the debris, which filled the Merrymeeting River (Fig. 5). The Sinclair house was undamaged by the flood.

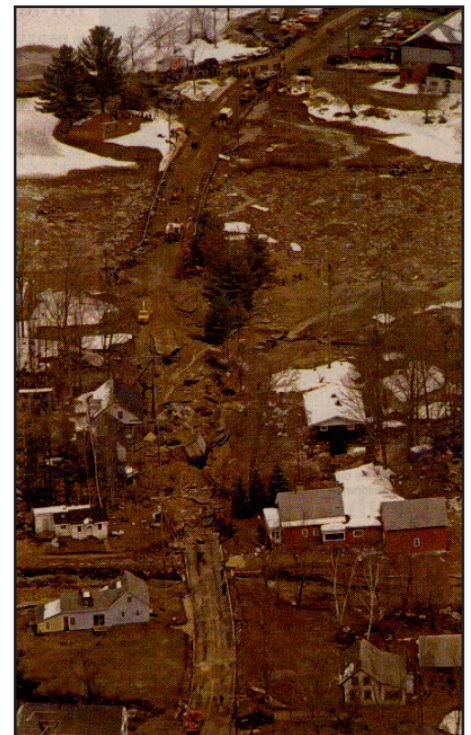
Fig. 6 – Route 140 after the Flood

In addition to killing Lynda Sinclair, the flood damaged about ten houses or properties and eroded a quarter mile section of Route 140 (Fig. 6).

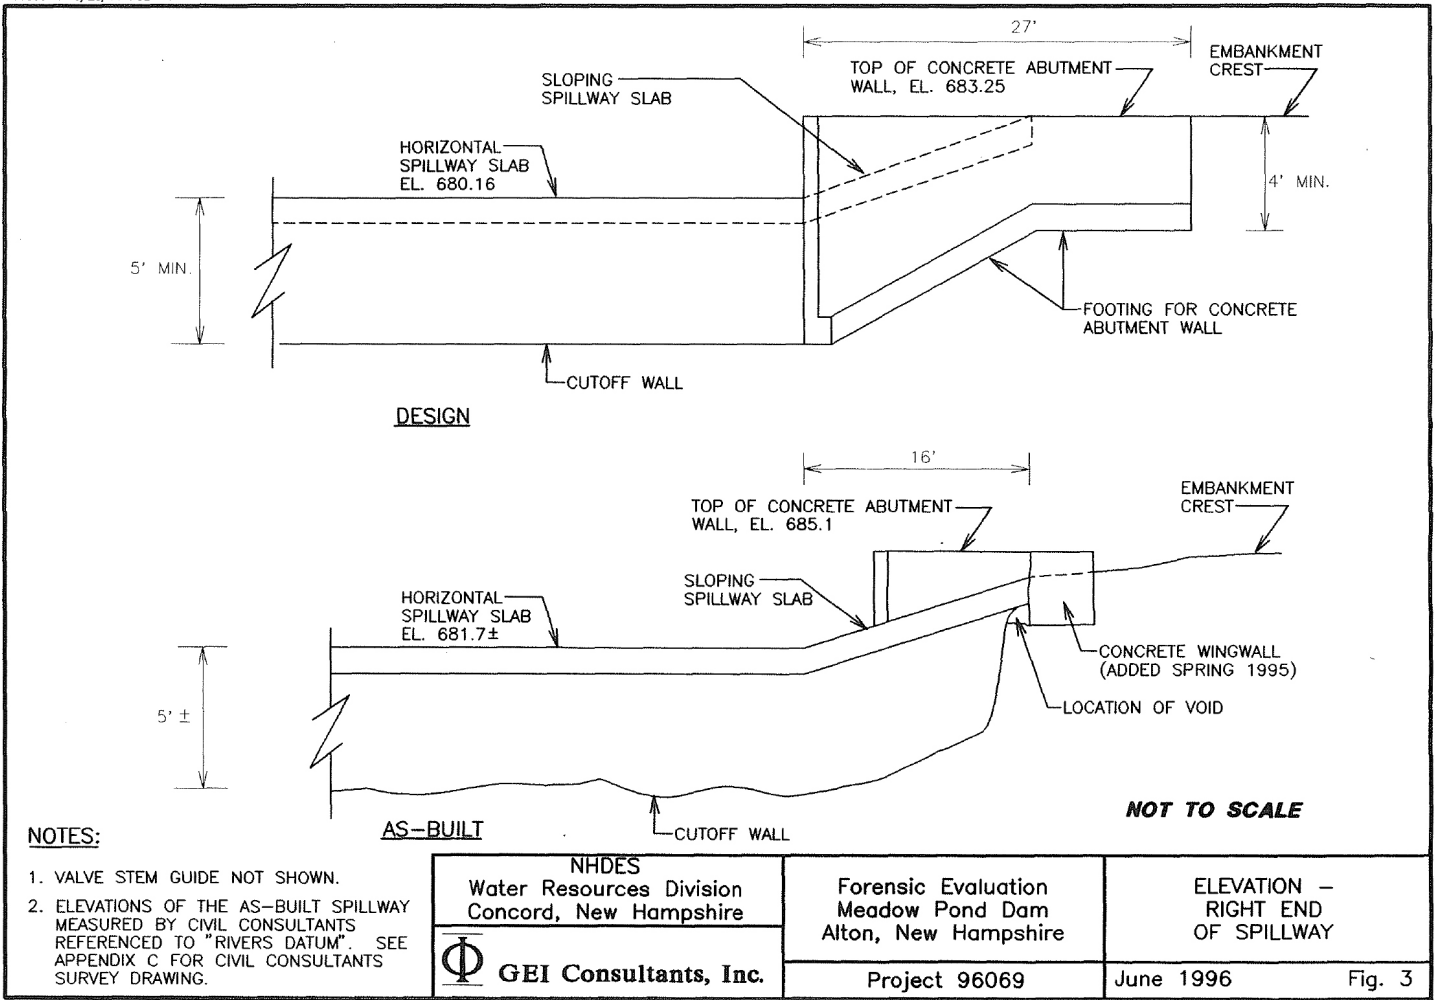
Fig. 12 – Design and As-Built Spillway Cutoff (GEI Consultants, Inc.)

- A limited length of cutoff footings on either side of the spillway (Fig. 12). The upstream wall cutoff footings for the sloped side channels extended only 16 ft beyond the level part of the spillway rather than the design length of 27 ft.

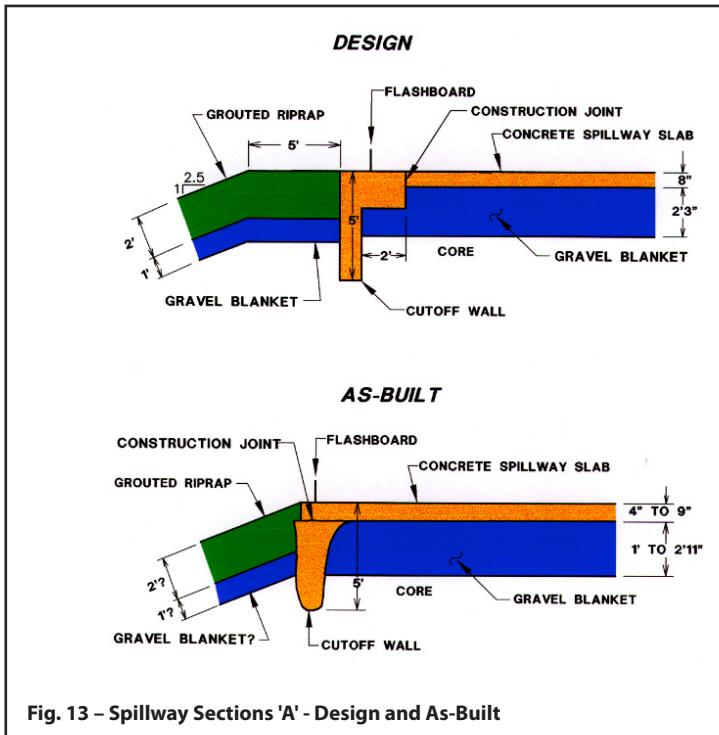
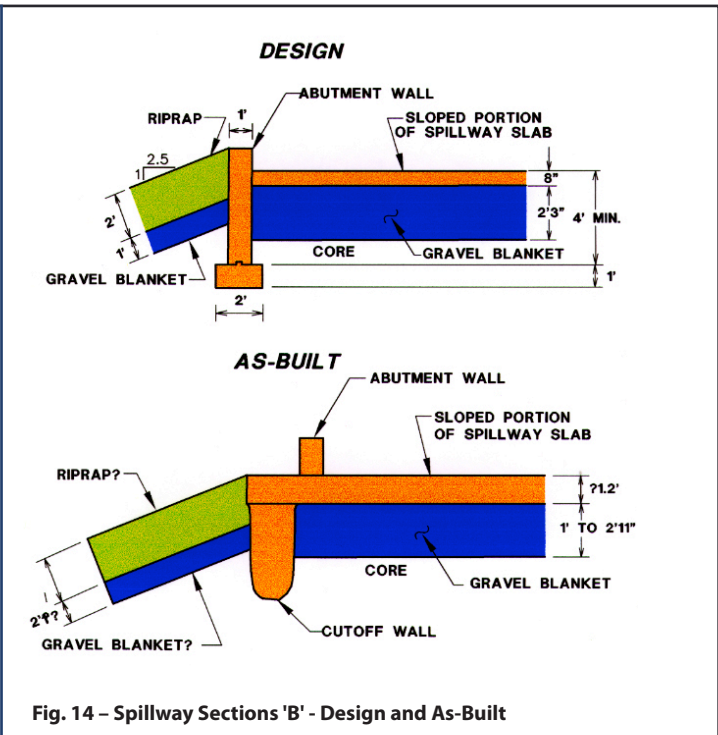
- No level approach channel bench (Fig. 13). The channel upstream of the concrete weir was placed at the 2.5H:1V slope of the dam, without the 5-ft-wide design bench.

- The riprap immediately upstream of the spillway was not grouted to the extent called for in the design (Fig. 13).
- No horizontal reinforcing in the cutoff wall. The investigators found none of the horizontal reinforcing called for by the design in the cutoff wall.

- A horizontal construction joint between the spillway and the cutoff wall (Figs. 13 and 14). Investigators found that the contractor used a horizontal joint with no waterstop between the spillway slab and the cutoff wall. The design called for this section to be formed without a horizontal joint at this location.

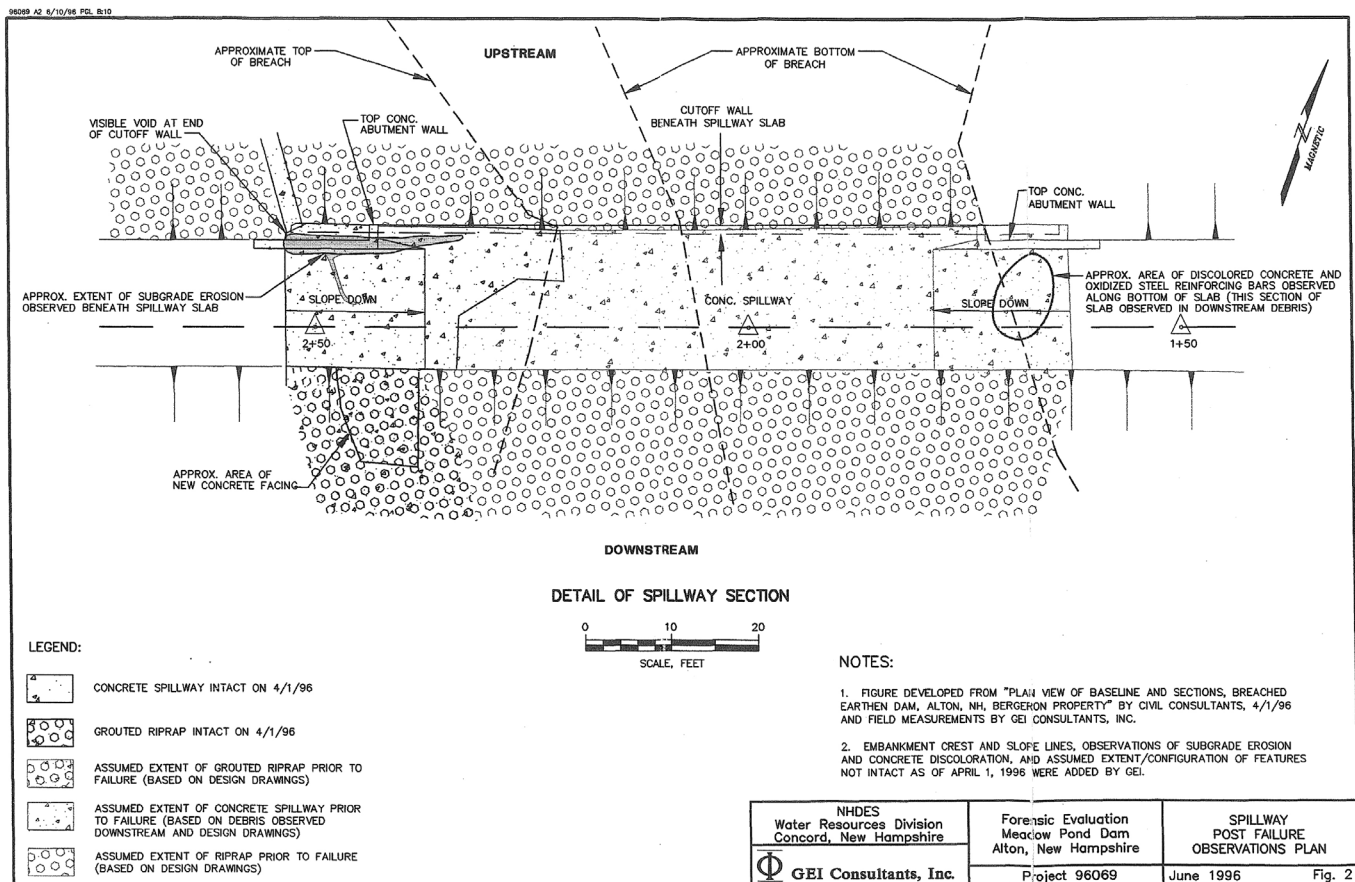
Fig. 15 – Spillway Post Failure Observations Plan (GEI Consultants, Inc.)

- A void at and behind the right end of the remaining cutoff wall (Fig. 15). The location and extent of the void led investigators to conclude that the void was caused by erosion and piping.
- Ice lenses in the embankment material.
- Evidence that the pond level was slightly above the flashboards at the time of failure.
- Cracks in the intact portions of the spillway slab and cutoff wall. Investigators observed caulking in some of the cracks.
- Heavy rusting in the steel reinforcing bars located (improperly) on the bottom of the spillway slab.

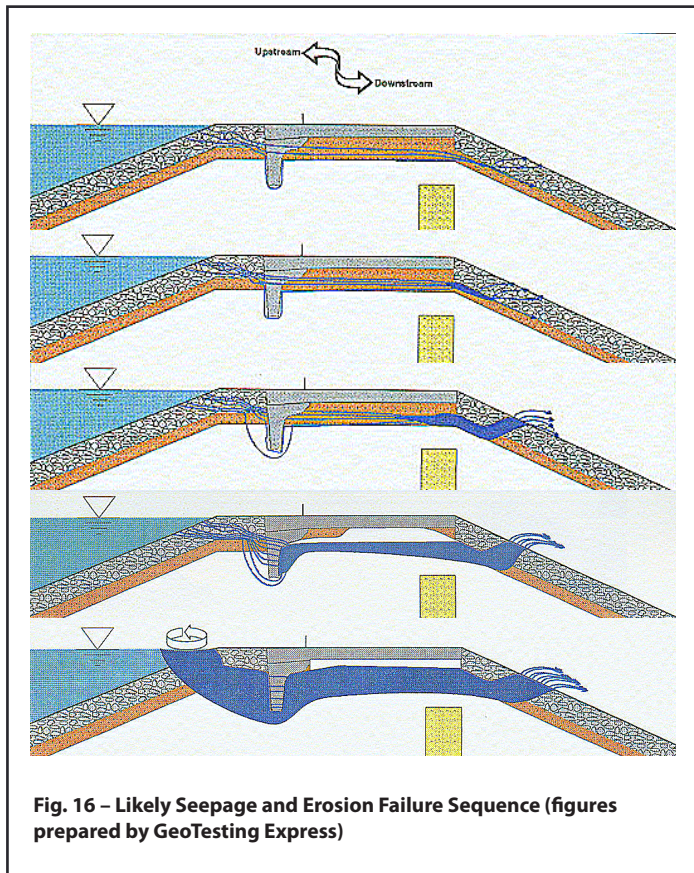
Fig. 16 – Likely Seepage and Erosion Failure Sequence (figures prepared by GeoTesting Express)

Investigators concluded that Meadow Pond Dam failed due to erosion and piping beneath the spillway slab. Figure 16 shows a likely sequence of conditions during the seepage and erosion failure. Investigators reported the following contributing factors:

- Shortened seepage paths around the end of the cutoff wall resulting from the shorter lateral extent (16 ft versus 27 ft) of the cutoff walls.
- Shortened seepage paths through the cutoff and slab through cracks resulting from a lack of longitudinal steel, settlement of the embankment, and ice lens heaving.
- Shortened seepage paths through the horizontal joint between the spillway slab and the cutoff wall, which was not included in the design and did not include a waterstop.
- Ice heaving of the slab due to contamination of the gravel layer and the lack of sufficient cover for frost-susceptible embankment material.
- Shortened seepage paths between the reservoir and the bottom of the cutoff wall due to lack of a 5-ft-wide level bench and due to poor design.
- Lack of adequate drainage in the spillway gravel layer due to high fines content, contamination, and irregular thickness.
