WALTER BOULDIN DAM FAILURE  
AND RECONSTRUCTION

SEPTEMBER 1978

FEDERAL ENERGY REGULATORY COMMISSION  
OFFICE OF ELECTRIC POWER REGULATION  
WASHINGTON, D.C. 20426

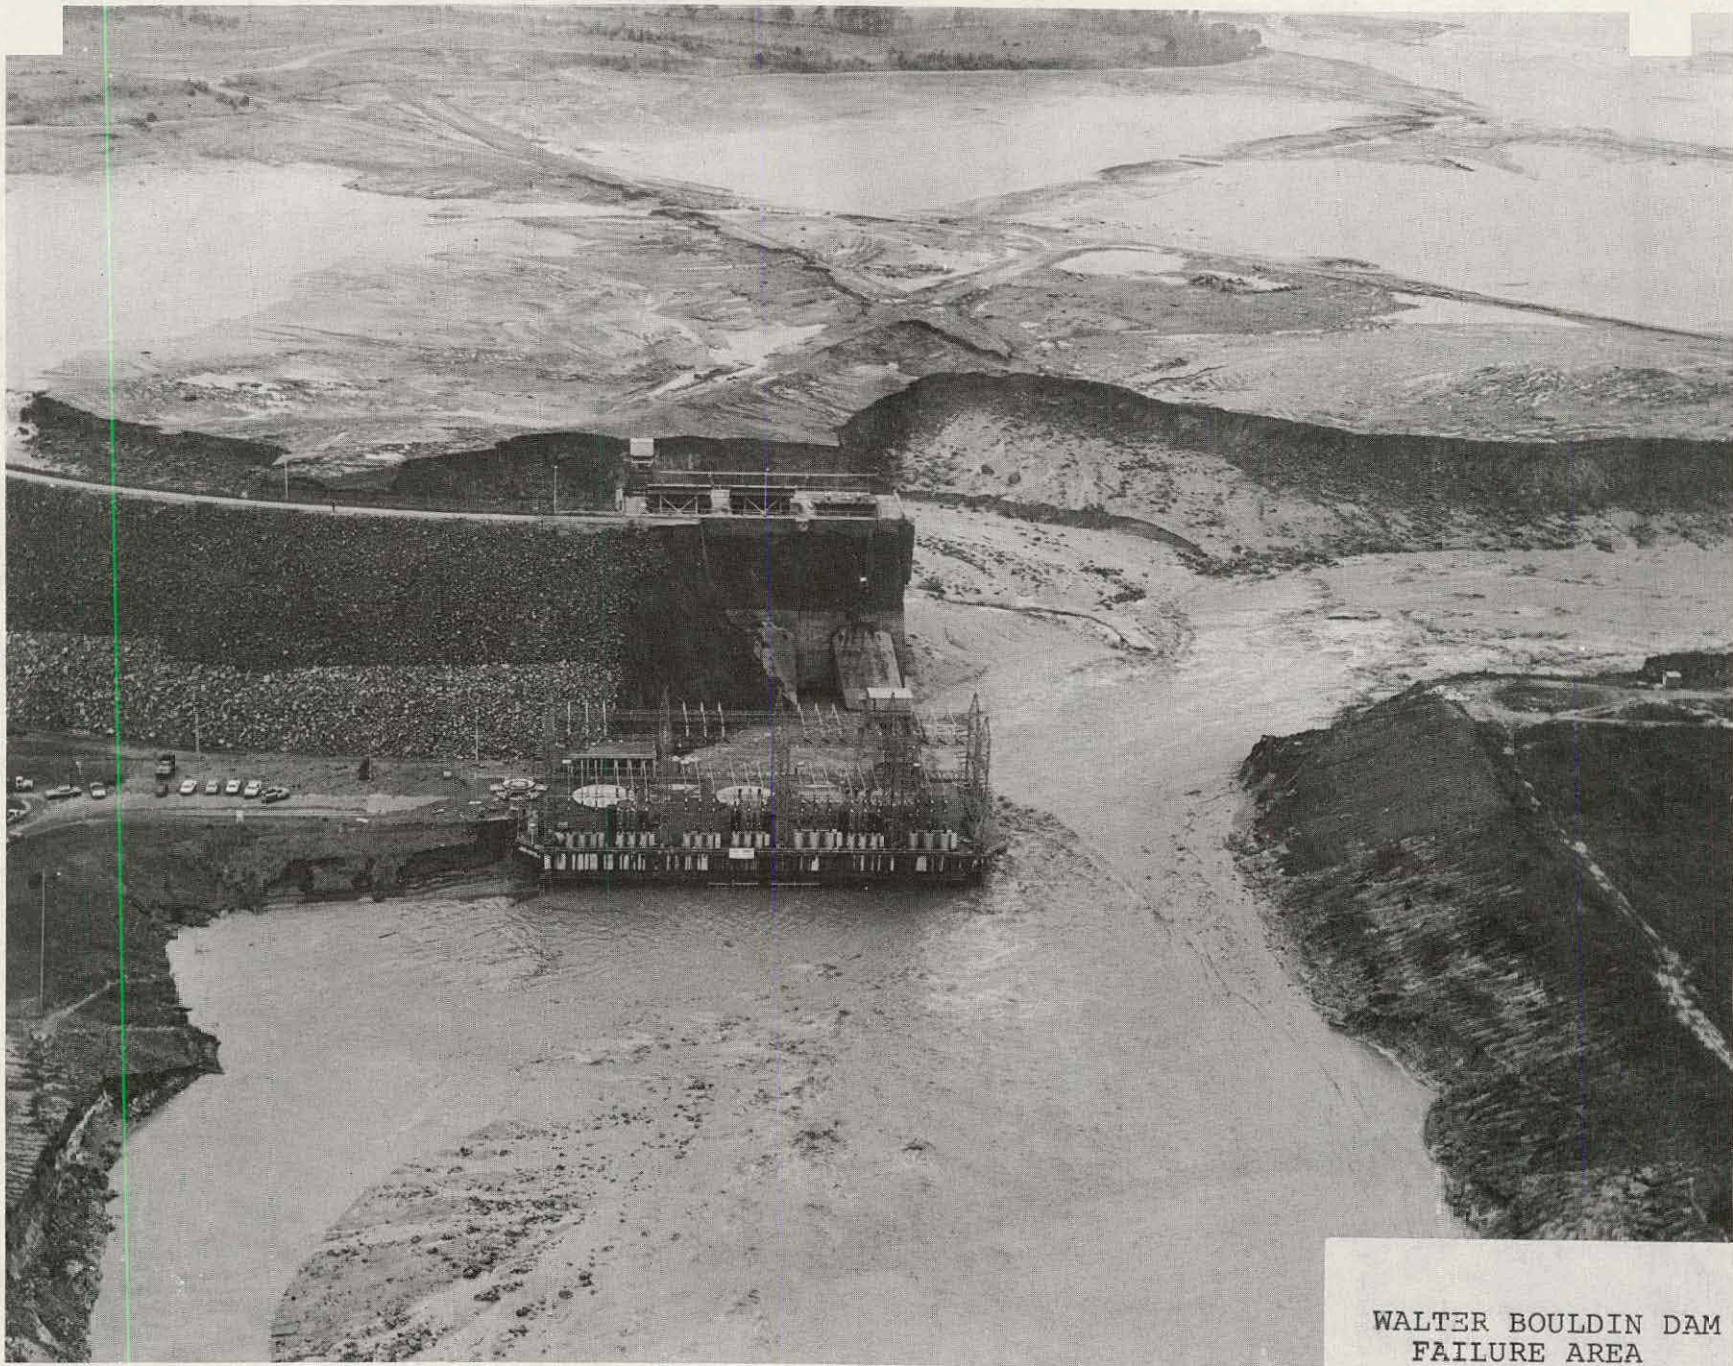
WALTER BOULDIN DAM  
FAILURE AREA

1-02 Failure of Earth Embankment. The Bouldin Dam earth embankment was breached at approximately 1:30 a.m. on February 10, 1975. The breach occurred adjacent to the intake on the east side. Plate 5 shows the location of the failure area with respect to project features. Before- and after-photographs of the failure area are shown on Plates 6 and 7. The breach in the earth embankment extended about 300 feet eastward of the east face of the intake structure. Erosion at the breach extended vertically downward to remove a significant volume of the foundation and the backfill at the east end of the concrete structure. A portion of the scoured area was backfilled with granular material, apparently from the action of gradually decreasing water velocities following the breach. Subsequent investigations indicated that the scour exceeded the depth of the original excavation for the construction. The maximum depth of scour was 165 feet below the top of the earth embankment and occurred near the east edge of the powerhouse. A cross section of the designed embankment section at the location of the breach east of the intake is shown on Plate 8.

Erosion to a depth of 50 feet below the original reservoir bottom continued along the upstream toe of the dike both east and west of the concrete structure. The semicircular trash rack structure, enclosing the entrance of the intake, was demolished and deposited in the foundation and tailrace area. The upstream slopes of both the east and west dikes were undercut extensively, creating numerous slides. Two of the more conspicuous failure zones included: (1) a 500-foot section of the east dike beyond the 300-foot breach which had its upper portion removed to about station 54 and (2) a drawdown slide, a secondary failure over 500 feet long, which occurred at the upstream slope of the west embankment near the location of the microwave tower.

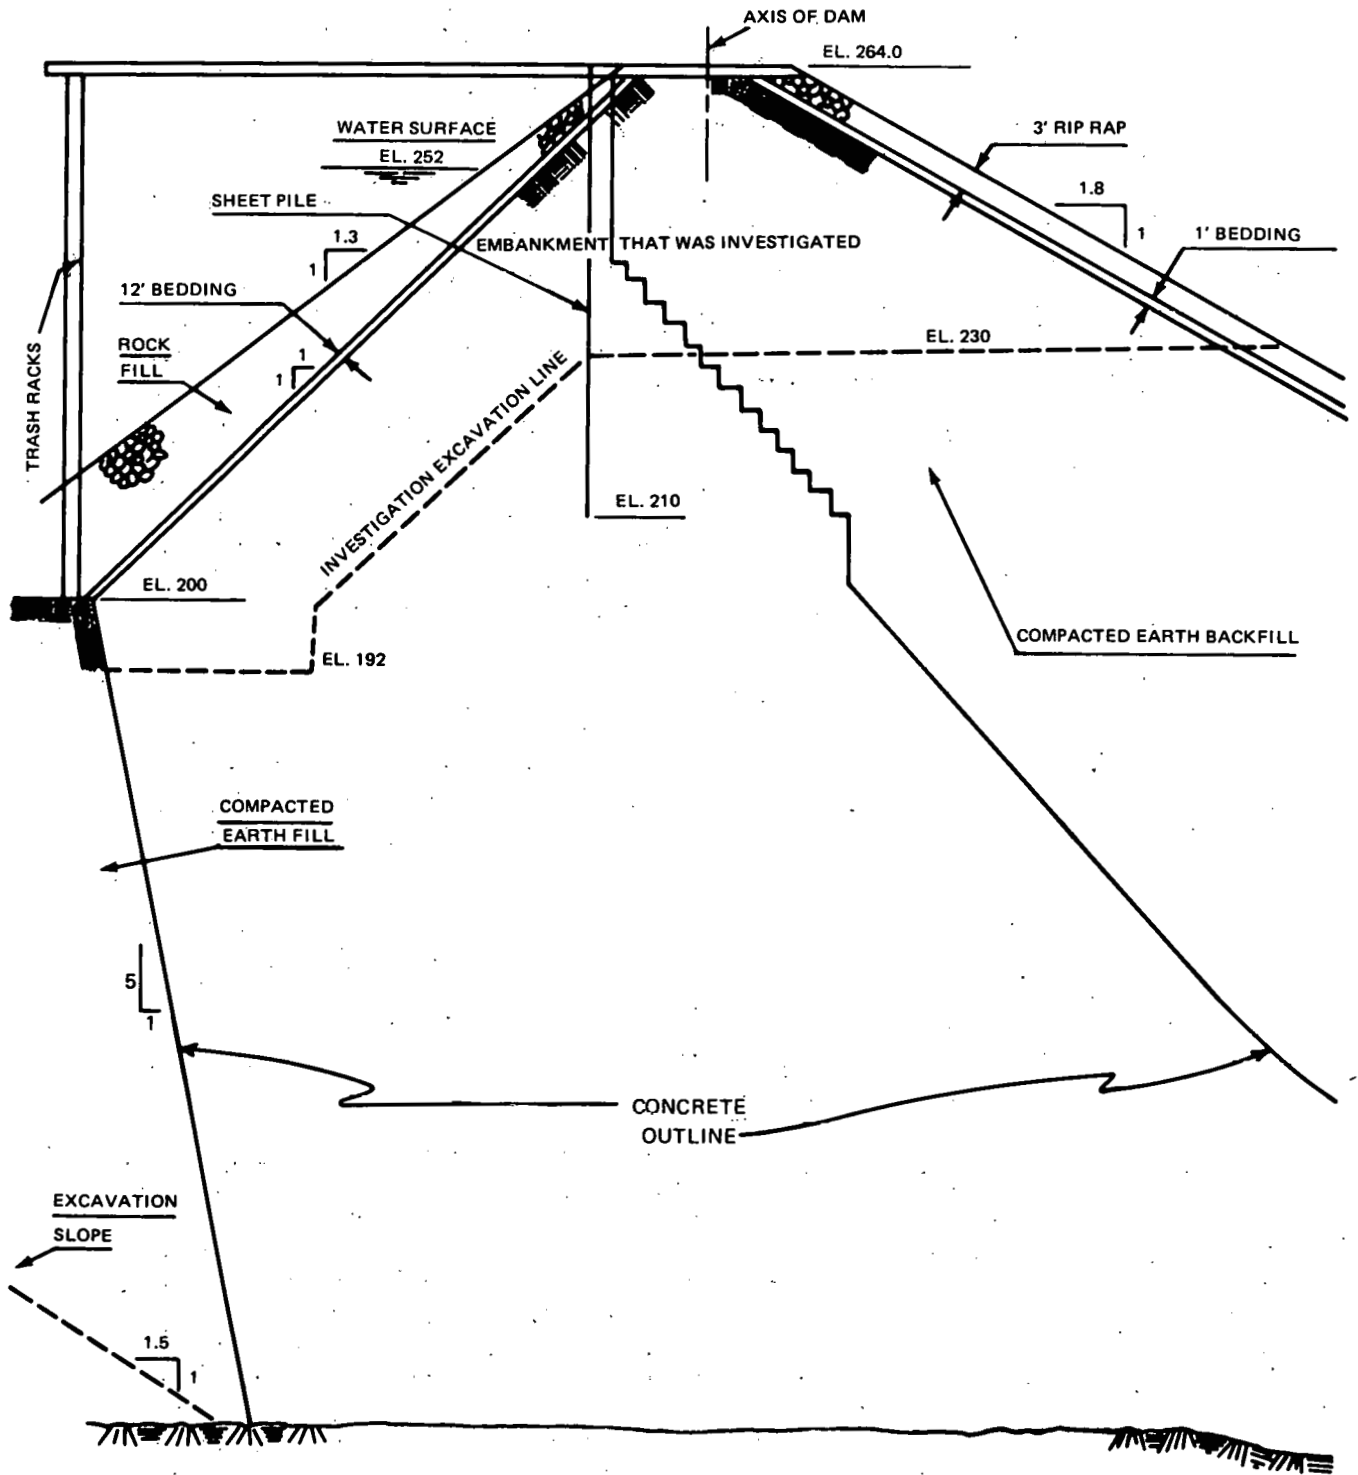
WALTER BOULDIN PROJECT NO. 2146  
 WEST FACE IN TAKE STRUCTURE

The exploratory investigation of the as-built west side found the embankment zoning to be generally excellent from the standpoint of controlling possible through seepage. The upstream impervious diaphragm consisted of reddish brown, sandy, lean clays and clayey sands, while the downstream embankment zone was a well-graded granular material, an ideal material for resisting any tendency toward piping.

However, many instances of poor construction practice were noted. Sand and gravel lenses were found in the upstream impervious blanket. In some areas clay lenses were found in the upstream rock-fill zone. A lift of relatively impervious blanket material was found in the more

pervious downstream shell. Some lift thicknesses in excess of 12 inches were noted. Test results indicated that, at many locations, the moisture content of the material had been too high to achieve proper compaction. Also, it was apparent that the specified uncompacted lift thickness was too thick for the type of compaction equipment used.

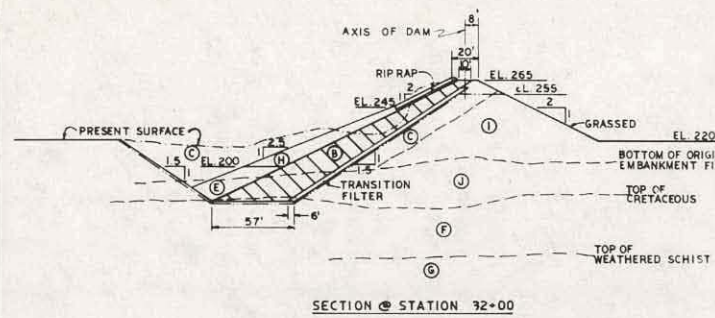
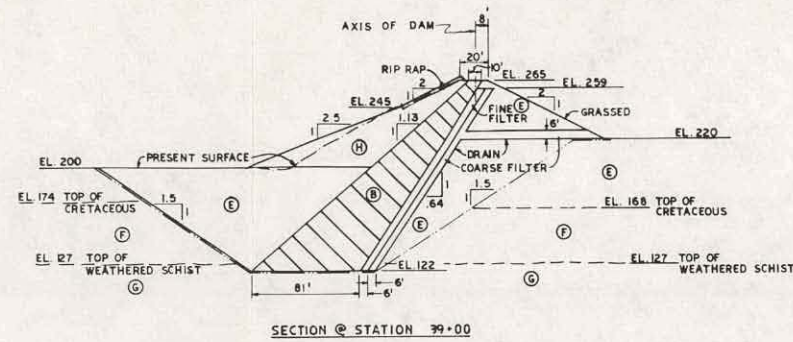
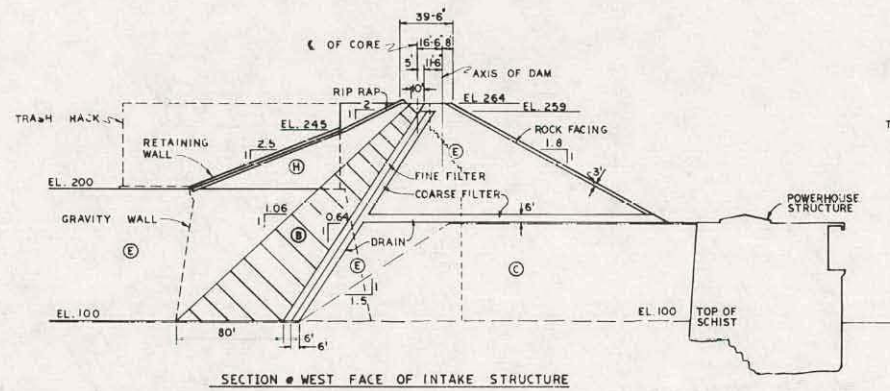
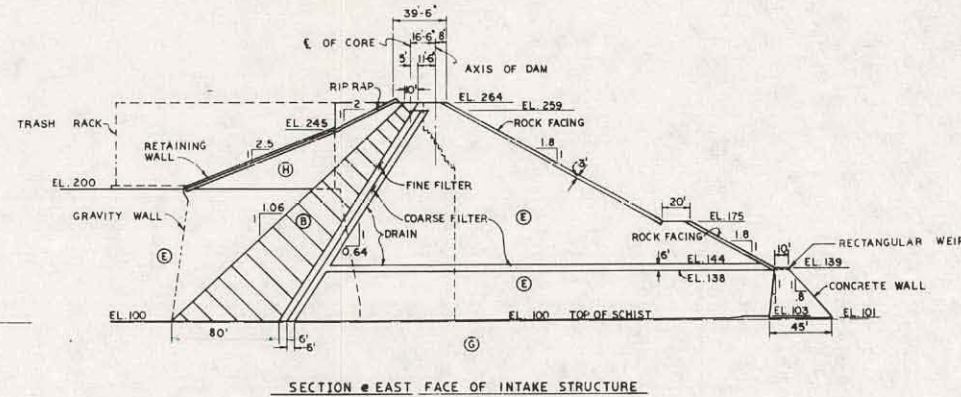
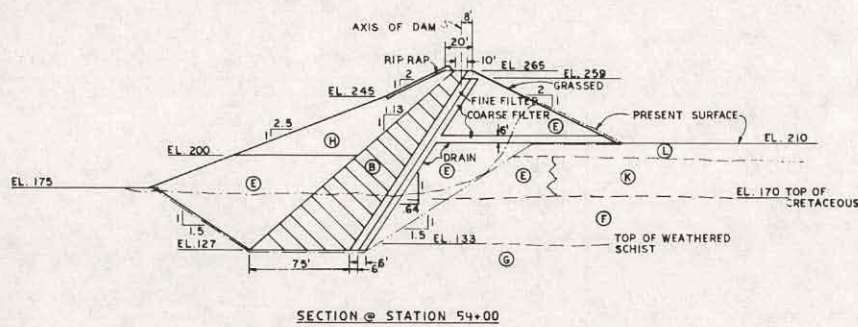
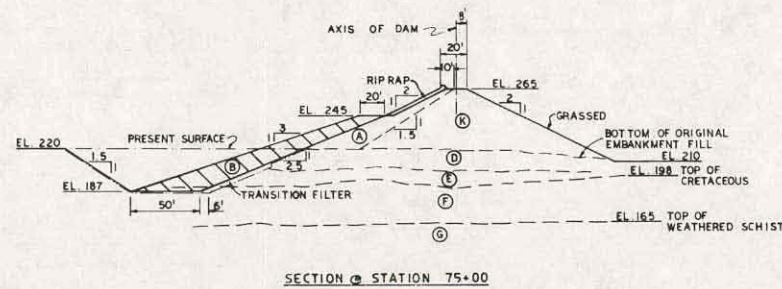
All of the remaining original embankment required some modification. Representative cross sections of the repair or remedial measures, as shown on Plate 11, include an inclined core and a conventional open cutoff trench concept throughout. Required excavation of existing foundation and embankment material was conservatively estimated to provide for the removal of all questionable material.

- 2) FROM THE INTAKE STRUCTURE TO STATION 39+00 AND STATION 54+00, THE CLAY CORE IS FOUND ON COMPETENT WEATHERED SCHIST (I.E. SARROLITE) EXCEPT FOR THE PORTION CLOSE TO THE INTAKE STRUCTURE WHERE IT IS FOUND ON SOUND ROCK.

- 4) THE POSITIVE CUT-OFF SYSTEM IS PROVIDED FROM STATION 24+00 TO STATION 30+00 BASED ON THE SITE GEOLOGY AND PAST PERFORMANCE OF THE DAM.
- 5) NEAR THE INTAKE STRUCTURE THE CLAY CORE IS FOUND ON SOUND ROCK FOR A LENGTH OF ABOUT 30'. THEN THE FOUNDATION BASE OF THE CLAY CORE IS BROUGHT ON EITHER SIDE UP WITH A 4:1 SLOPE TO EL. 127 AND IS CONTINUED UP TO STATIONS 39+00 AND 54+00 (SEE DRG. NO. D-PS-4154).

- 6) GOING FROM STATION 39+00 AND 54+00 ON EITHER SIDE, THE FOUNDATION BASE OF THE CLAY CORE IS BROUGHT UP WITH A 4:1 SLOPE TO THE TOP OF THE COMPETENT CRETACEOUS FORMATION AND CONTINUED ALONG THE REST OF THE NEWLY PLACED CUT-OFF SYSTEM. (SEE DRG. NOS. DRG. 4150, 4152 - 4154).
