## Risk Analysis Perspectives on the Camará Dam Failure

Cassandra Wagner, P.G., Engineering Geologist, Bureau of Reclamation, Technical Service Center  
Dom Galic, P.E., Geotechnical Engineer, Bureau of Reclamation, Technical Service Center

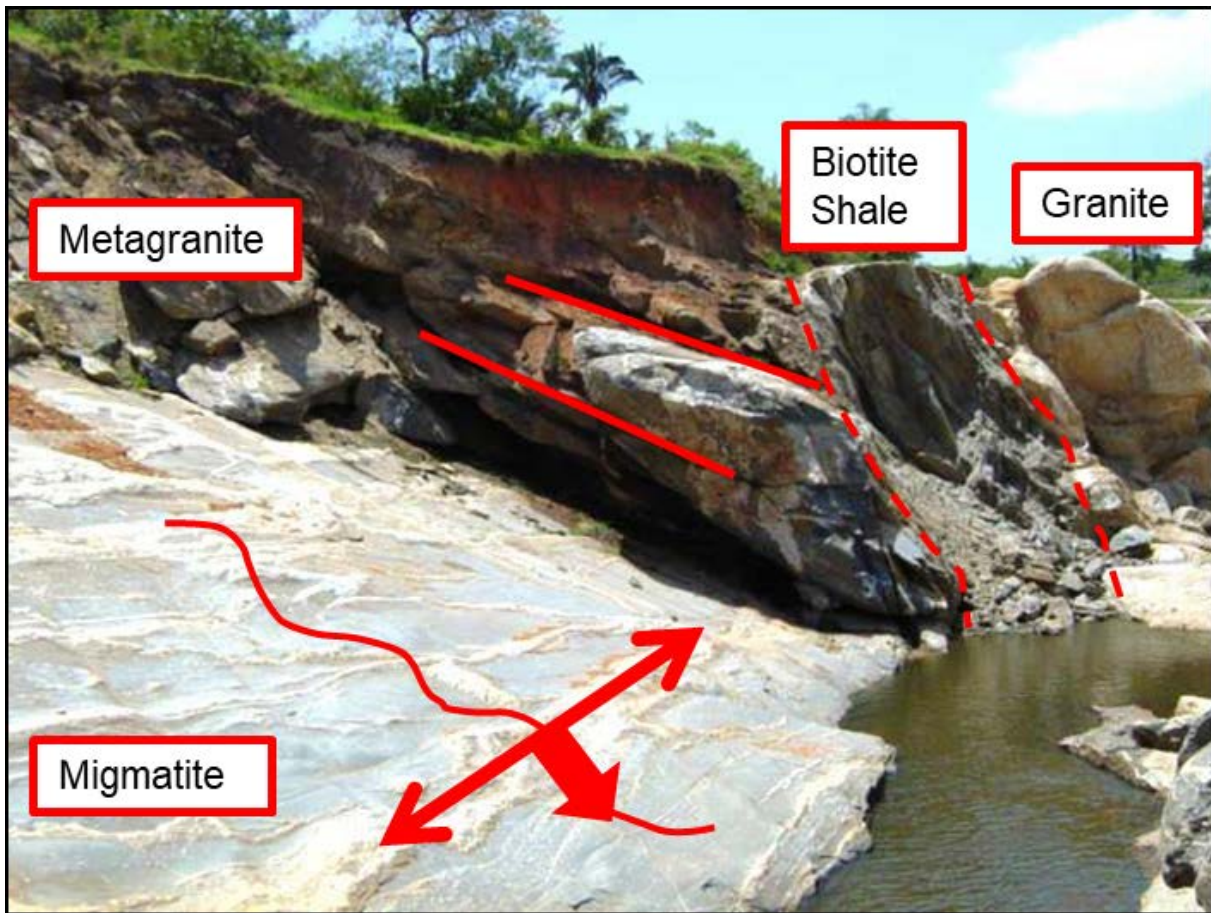
As is common in a sharply incised mountainous landscape, stress relief fractures are present parallel to the ground surface in both abutments of the dam, extending in the upstream to downstream direction. These stress relief fractures were especially prominent in the left abutment, where the overlying metagranite was noted to be heavily altered during post-failure investigations. In drawings developed by Kanji following the failure [1], the fracture planes and foliations within approximately 5 m of the ground surface were noted to contain residual soils and saprolitic materials. The degree of alteration was noted to decrease with depth, with most of the altered rock occurring within approximately 10 m of the ground surface. However, these fracture planes and foliations did not appear to be continuous from the top to the bottom of the left abutment along the dam centerline. Post-failure photos show that, while the contact between the metagranite materials and underlying migmatite materials dips at approximately 35 degrees, the contact between the migmatite and the overlying biotite shale and granite has a significantly steeper dip, which is attributed to a potential fault [1]. Refer to Figure 1 for geologic contacts.

Figure 1. Photo adapted from Kanji [1]. This photo illustrates the foliation of the migmatite, which strikes upstream to downstream and dips approximately thirty-five degrees. The light and dark alterations of the migmatite (representing ductile/brittle materials) causes “ripples” in the rock. Red lines illustrate the stress relief fractures in overlying, heavily altered rock. Note the unconformity with granite exposed at the surface of the abutment.

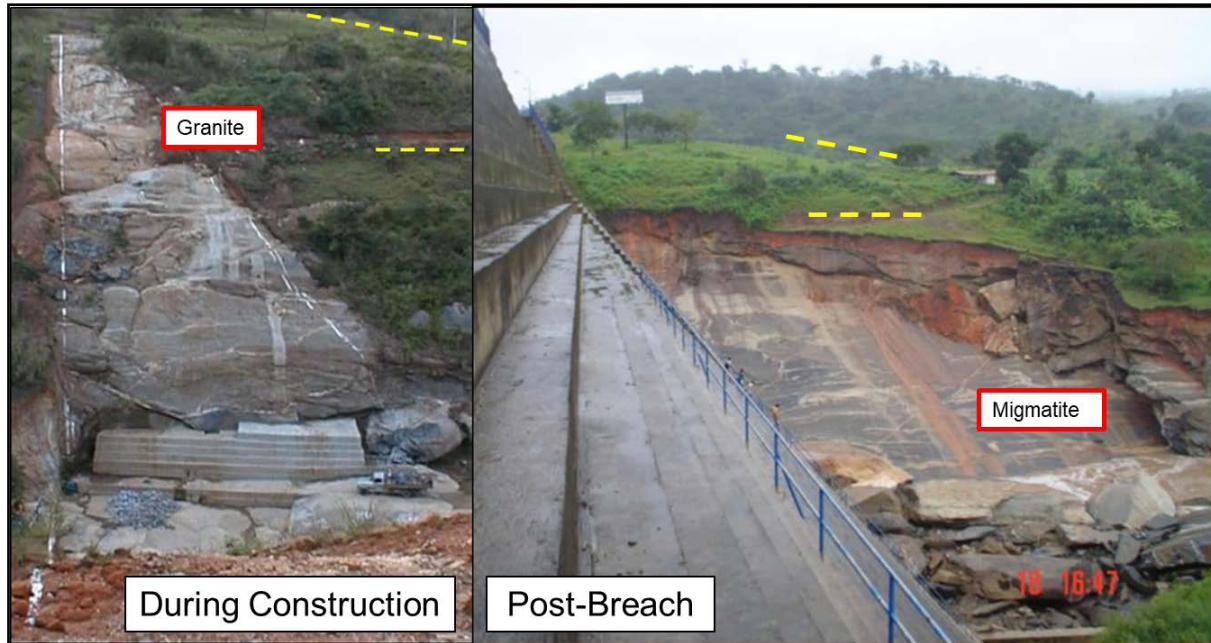
Construction photos indicate that the rock surfaces for the dam footprint along the abutments and main section were stripped and cleaned. While the extent of foundation treatment is unknown, it can be inferred that some effort was made to shape or level uneven rock surfaces given the timeframe that the dam was constructed (2000 through 2002). When a soil-filled shear zone was encountered near the base of the abutment, efforts were made to further investigate and treat this zone. However, those investigations were limited to three drill holes and did not cover the extent of the shear zone. The drill holes were limited to the lower left abutment, proximate to the location of the visible shear, and were shallow in depth. The drill holes seemed to indicate that the shear zone was thinning as it extended into the abutment, and an interpretation was made that the shear zone likely pinched out at some distance beyond the furthest left drill hole. [1] Refer to Figure 2 for photos during construction and after breach.

Figure 2. The granite exposed along the left abutment appeared to be relatively intact and fracture free (left photo). the underlying migmatite is exposed following the breach (right photo). Note the yellow lines for scale between photos. Left photo adapted from [2]. Right photo by Silas Porto (dated 18 June 2004), adapted for this paper.

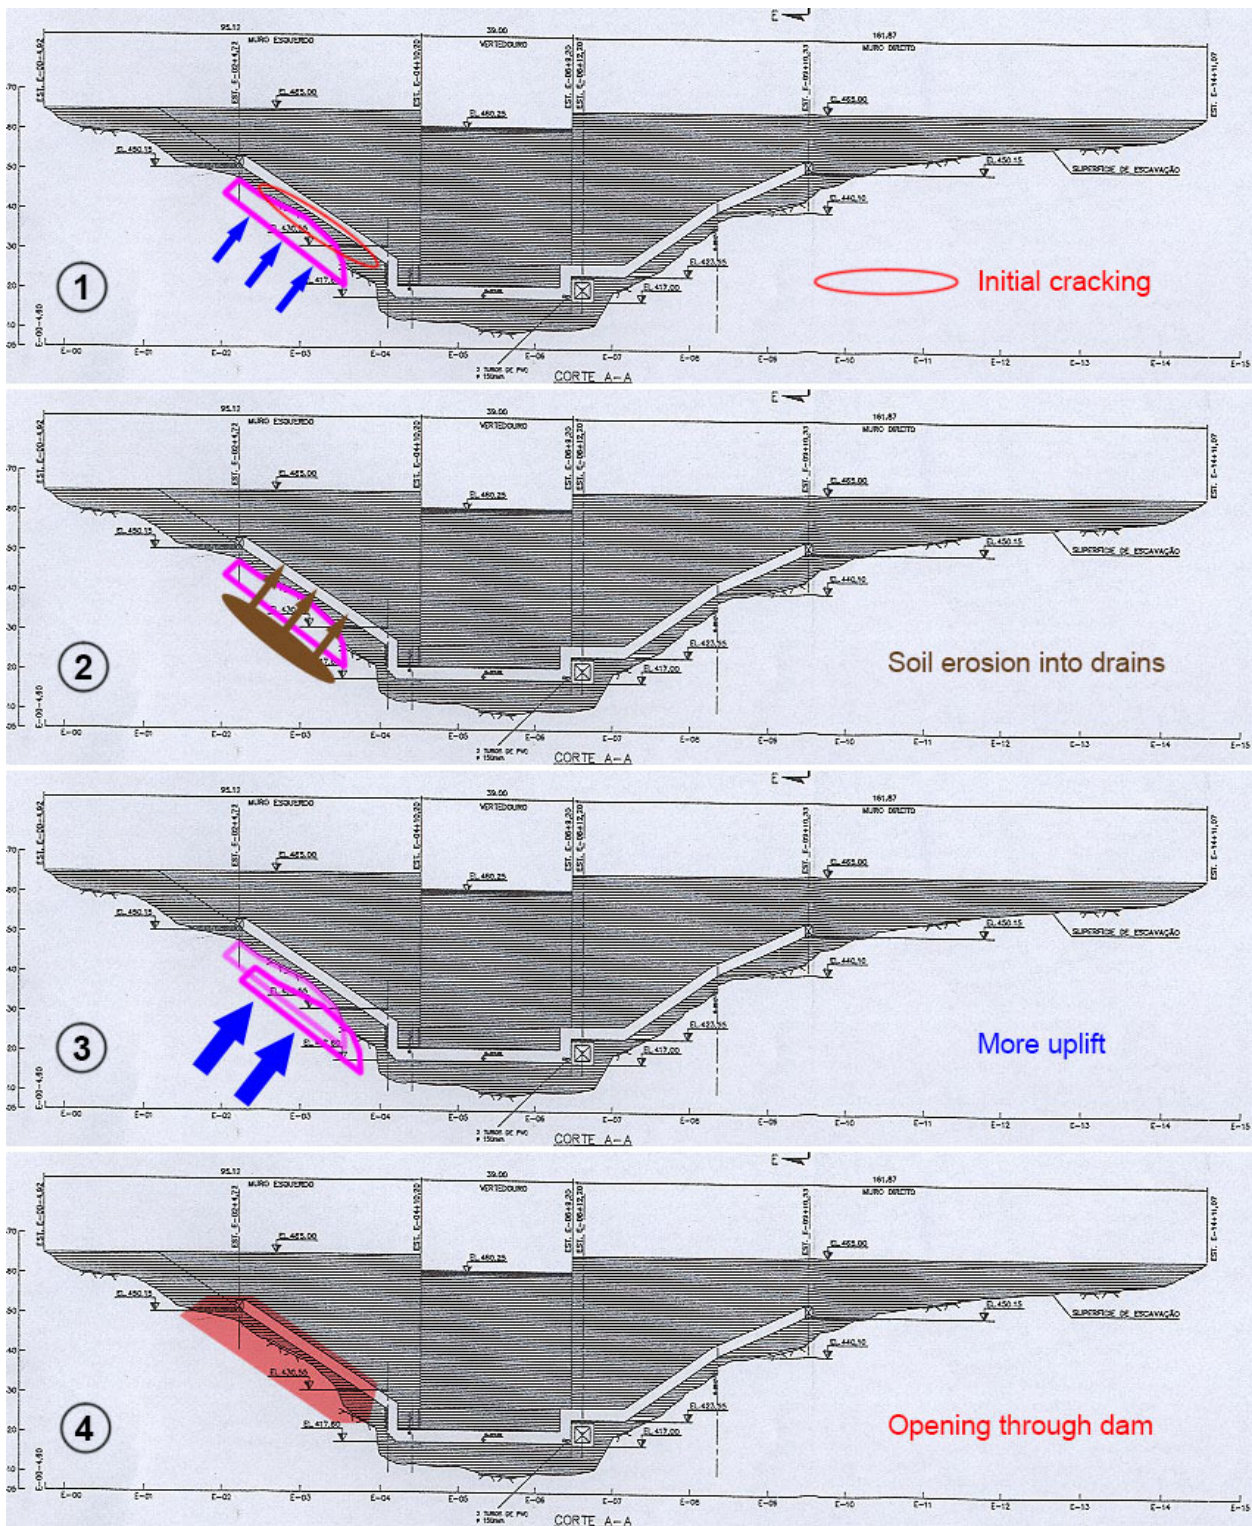
*As the reservoir fills, the single-line grout curtain is defeated, and seepage begins to occur along the base of the large granite slab overlying the left abutment shear zone. Due to the size of the slab and the absence of fractures open enough to allow drainage near its downstream end, higher than anticipated uplift pressures develop, resulting in an upward force being imparted to the dam and in the formation of cracks along the drainage gallery. Although the drains are initially effective in controlling the uplift pressure, they eventually become plugged with soils eroded from the shear zone. As the reservoir continues to fill, hydraulic jacking of the smooth, low-friction, slope-parallel, granite slab occurs to the extent that it is prevented from sliding downstream by the resistance of the dam concrete alone. As the tensile and shear stresses begin to exceed the strength of the concrete, it cracks through between the base of the dam and the gallery, resulting in concentrated flows through the area. Intervention fails, the damaged concrete and rock along the left abutment contact are progressively washed out, and an uncontrolled release of the reservoir occurs.*

Figure 3. Conceptual sketch of the failure process. Adapted from [2].
