A Synopsis of Notable U.S. Dam Failures

1874 to present

U.S. Department of the Interior Bureau of Reclamation

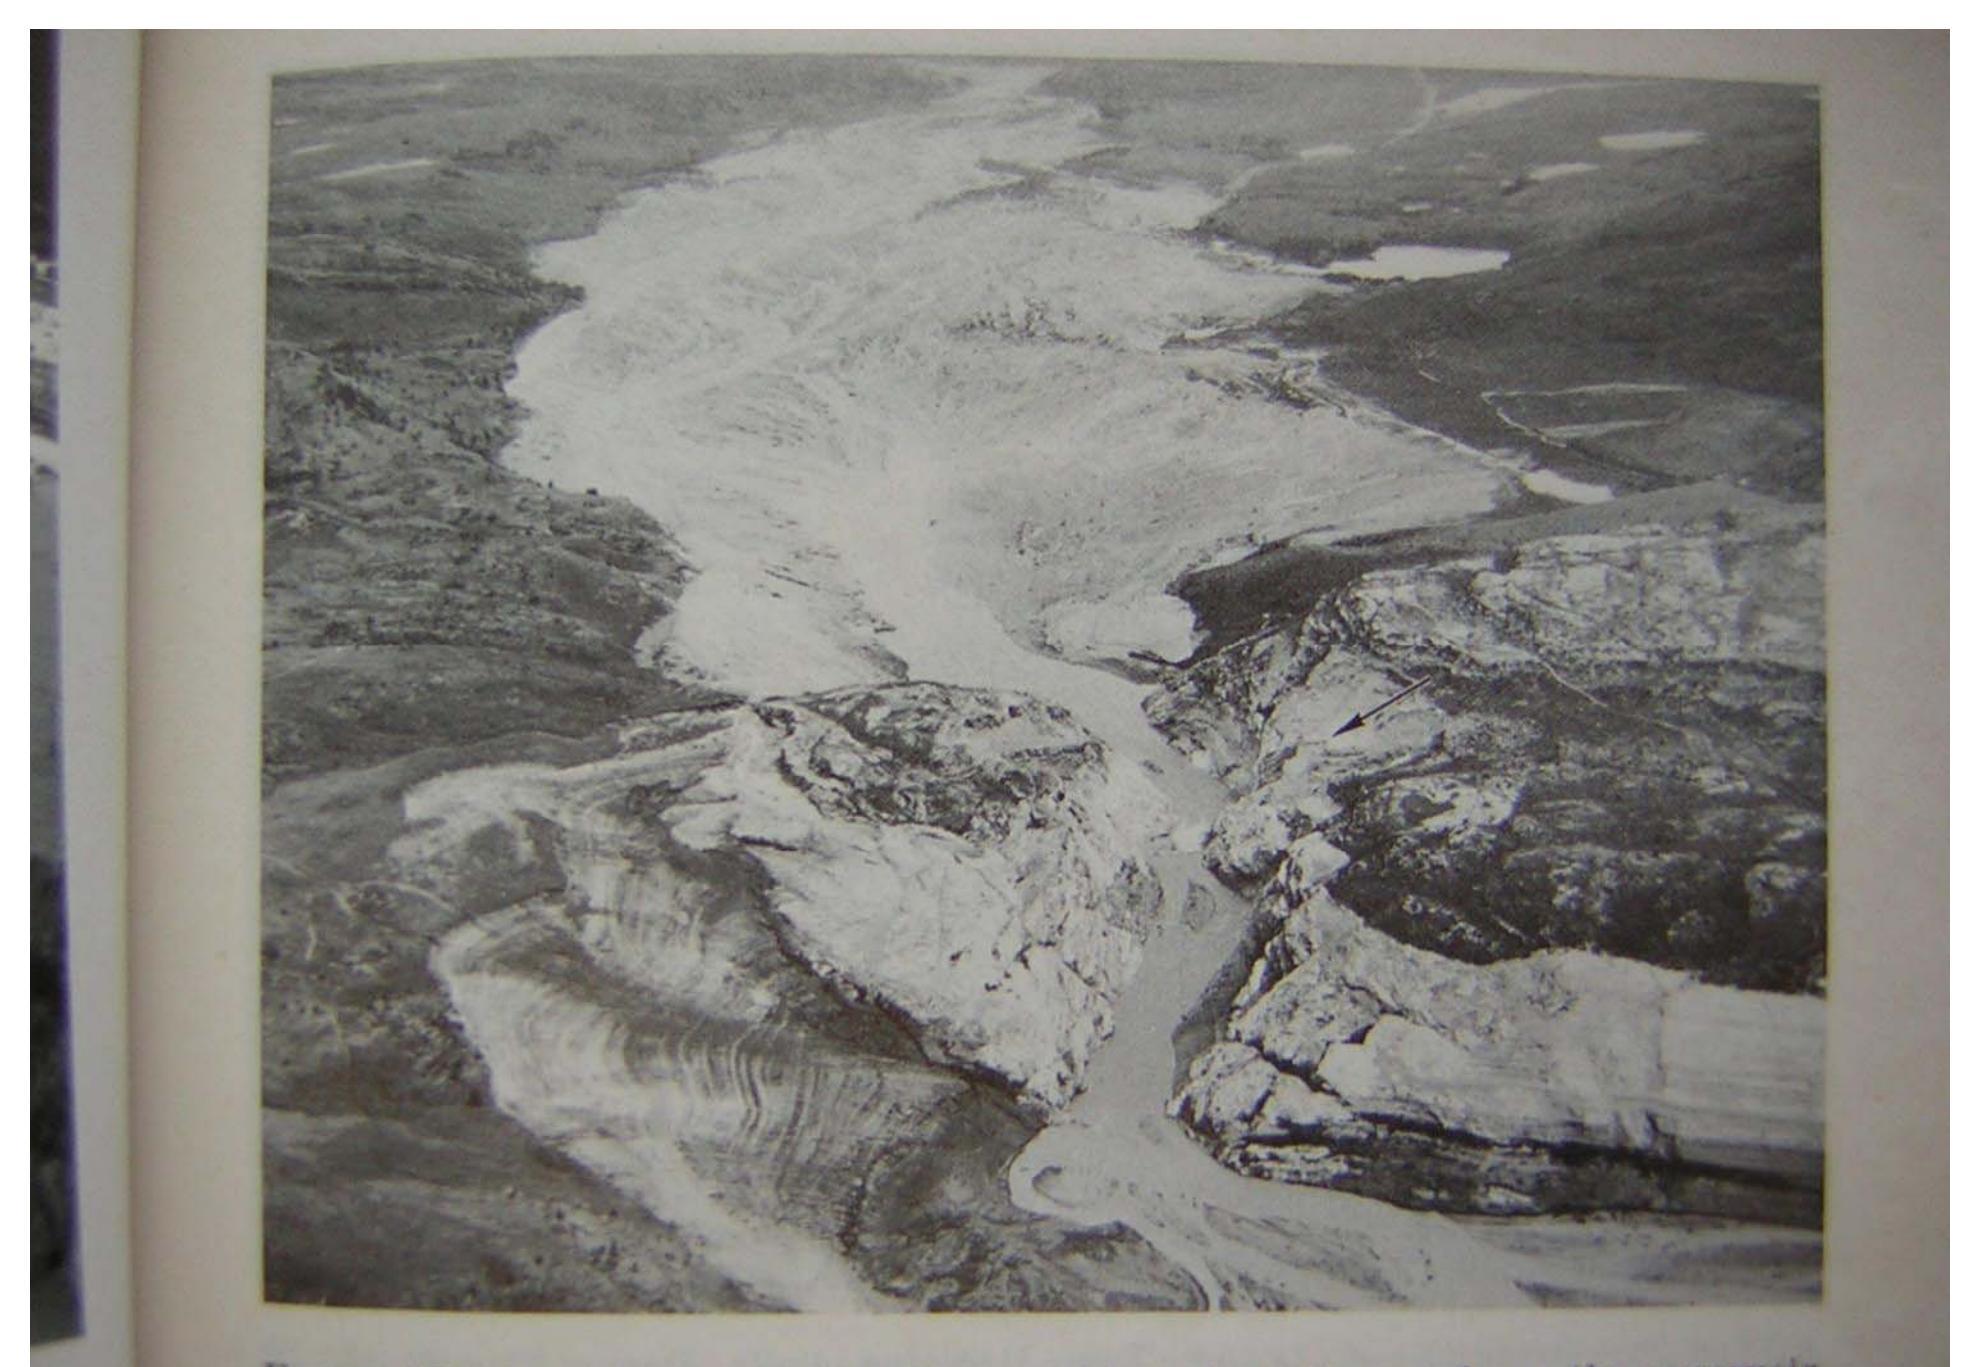
FIGURE 27.—Remains of Swift Dam looking downstream from the reservoir area. Arrow points to a part of the right end of the upstream face of the dam.

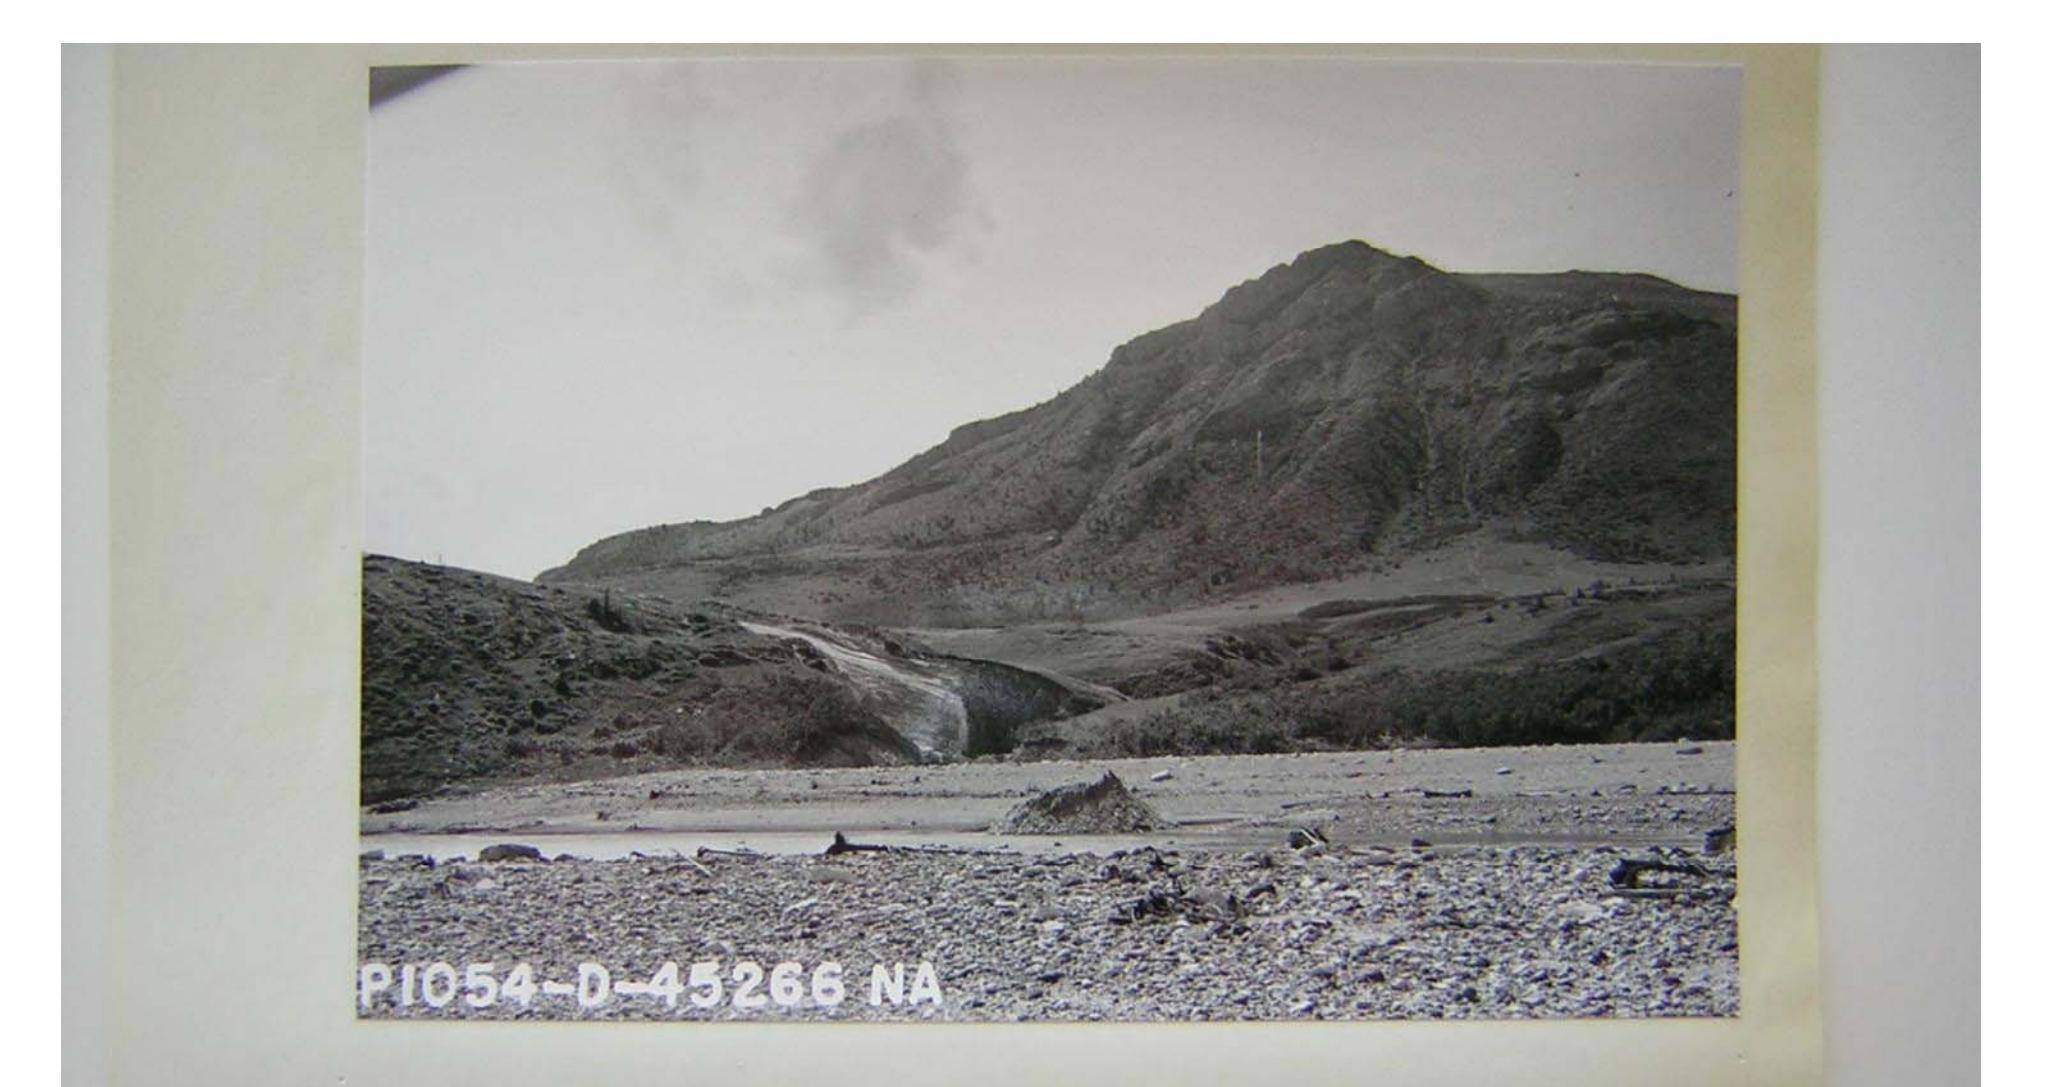
Picture No. Pl05h-D-45266. Emergency-type spillway on the north abutment of Swift Dam. The flood plain immediately below Swift Dam is several hundred feet wide. Pieces of large rock and debris carried out of Swift Dam at the time of failure are scattered downstream for a mile or more.

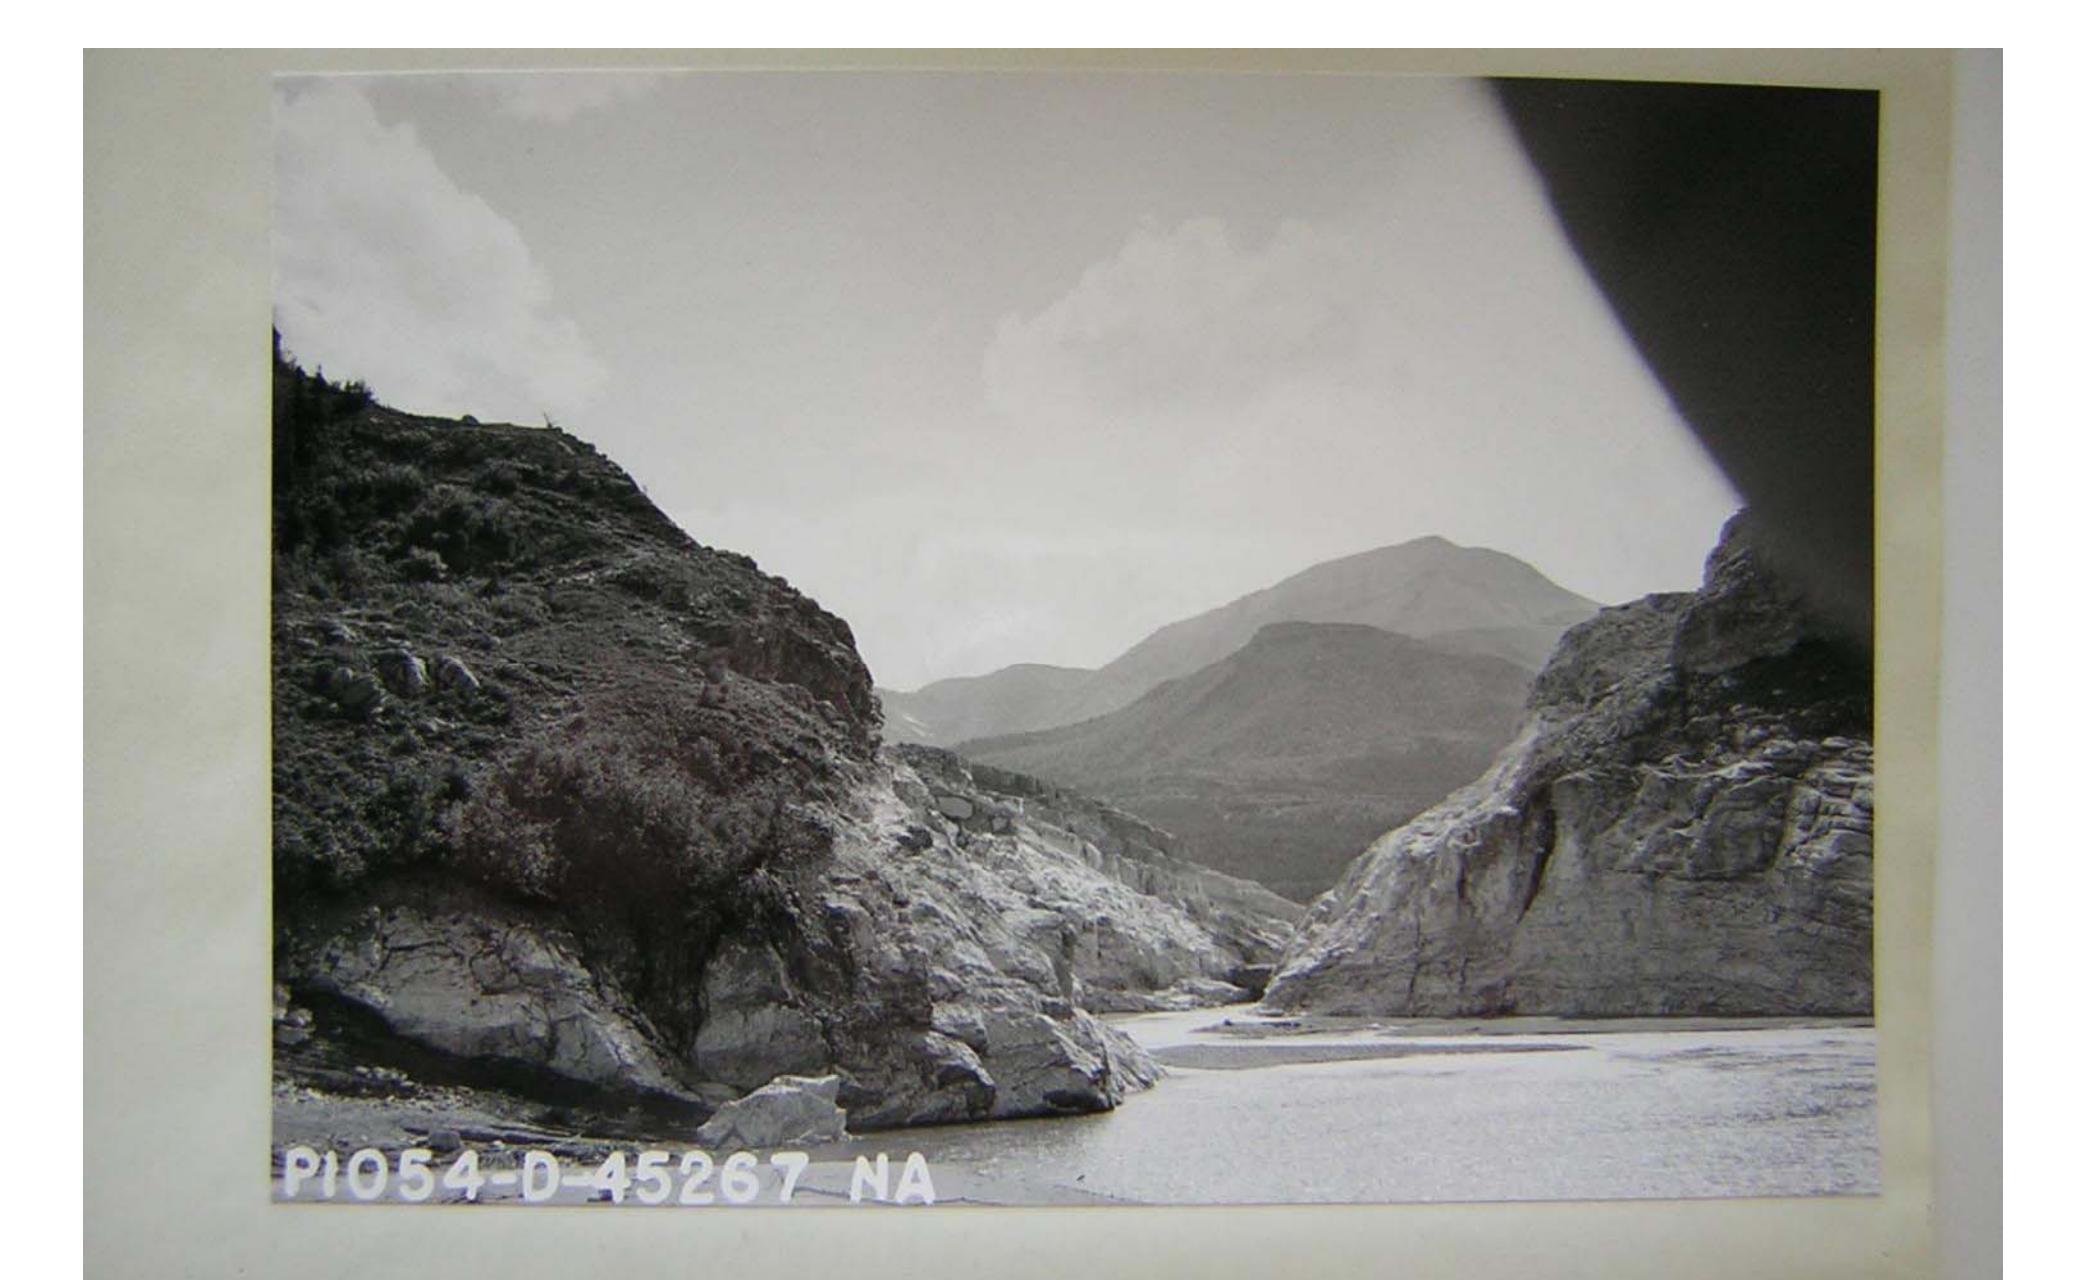
Picture No. P1054-D-45267. Picture taken looking at the abutments of Swift Dam, from a point below the dam. July 14, 1964

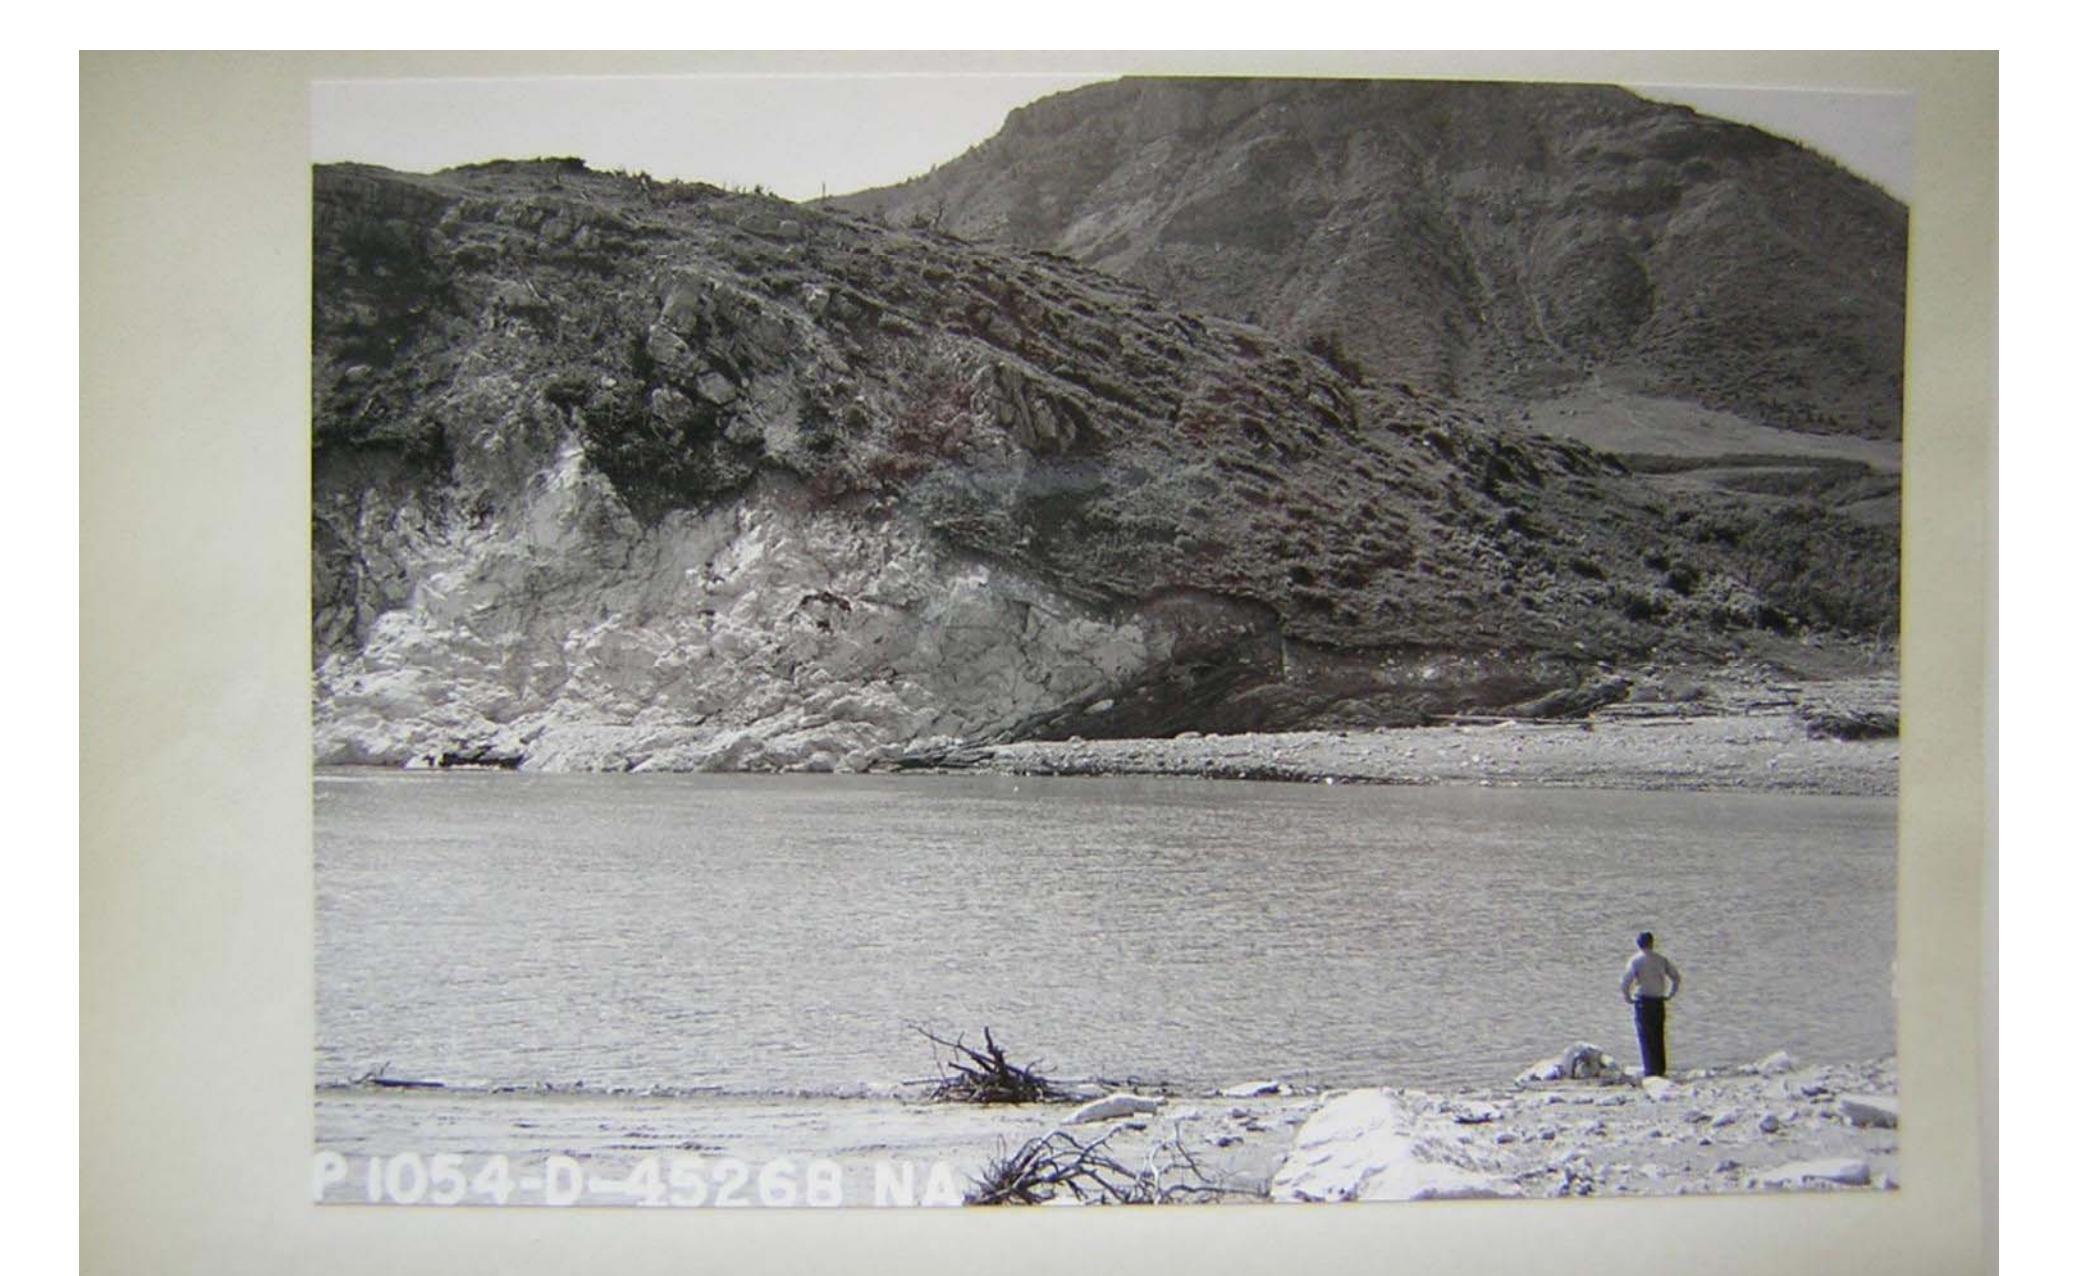
Picture No. P1054-D-45268. Looking across Birch Creek to the north abutment where Swift Dam used to be. July 14, 1964

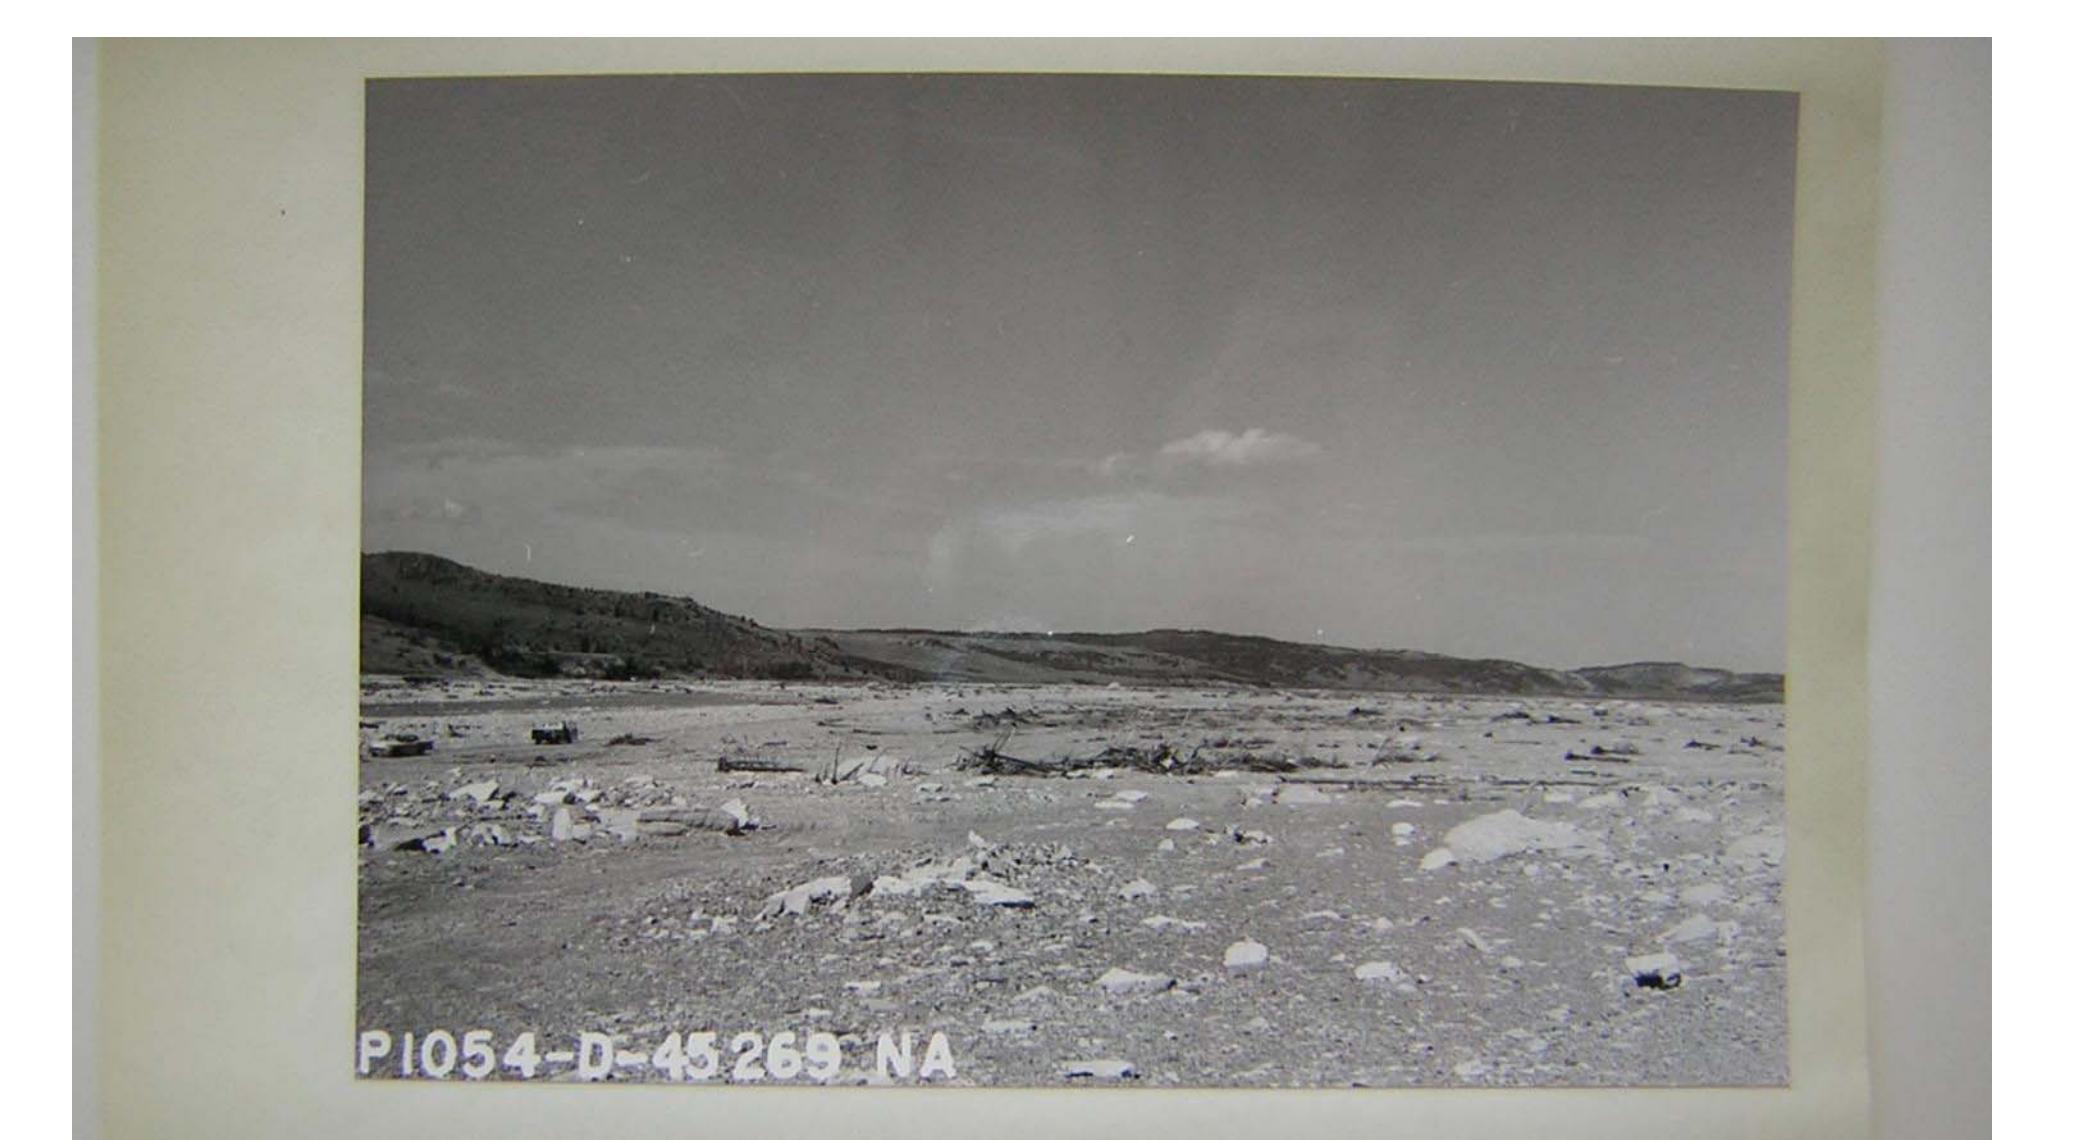
Picture No. P1054-D-45269. Taken from same location as P1054-D-45268, looking downstream showing the debris that has been spread out over the flood plain as a result of the failure of Swift Dam. The dam failed at 10:10 a.m. on June 8, 1964. Practically all the water was released within a matter of minutes.

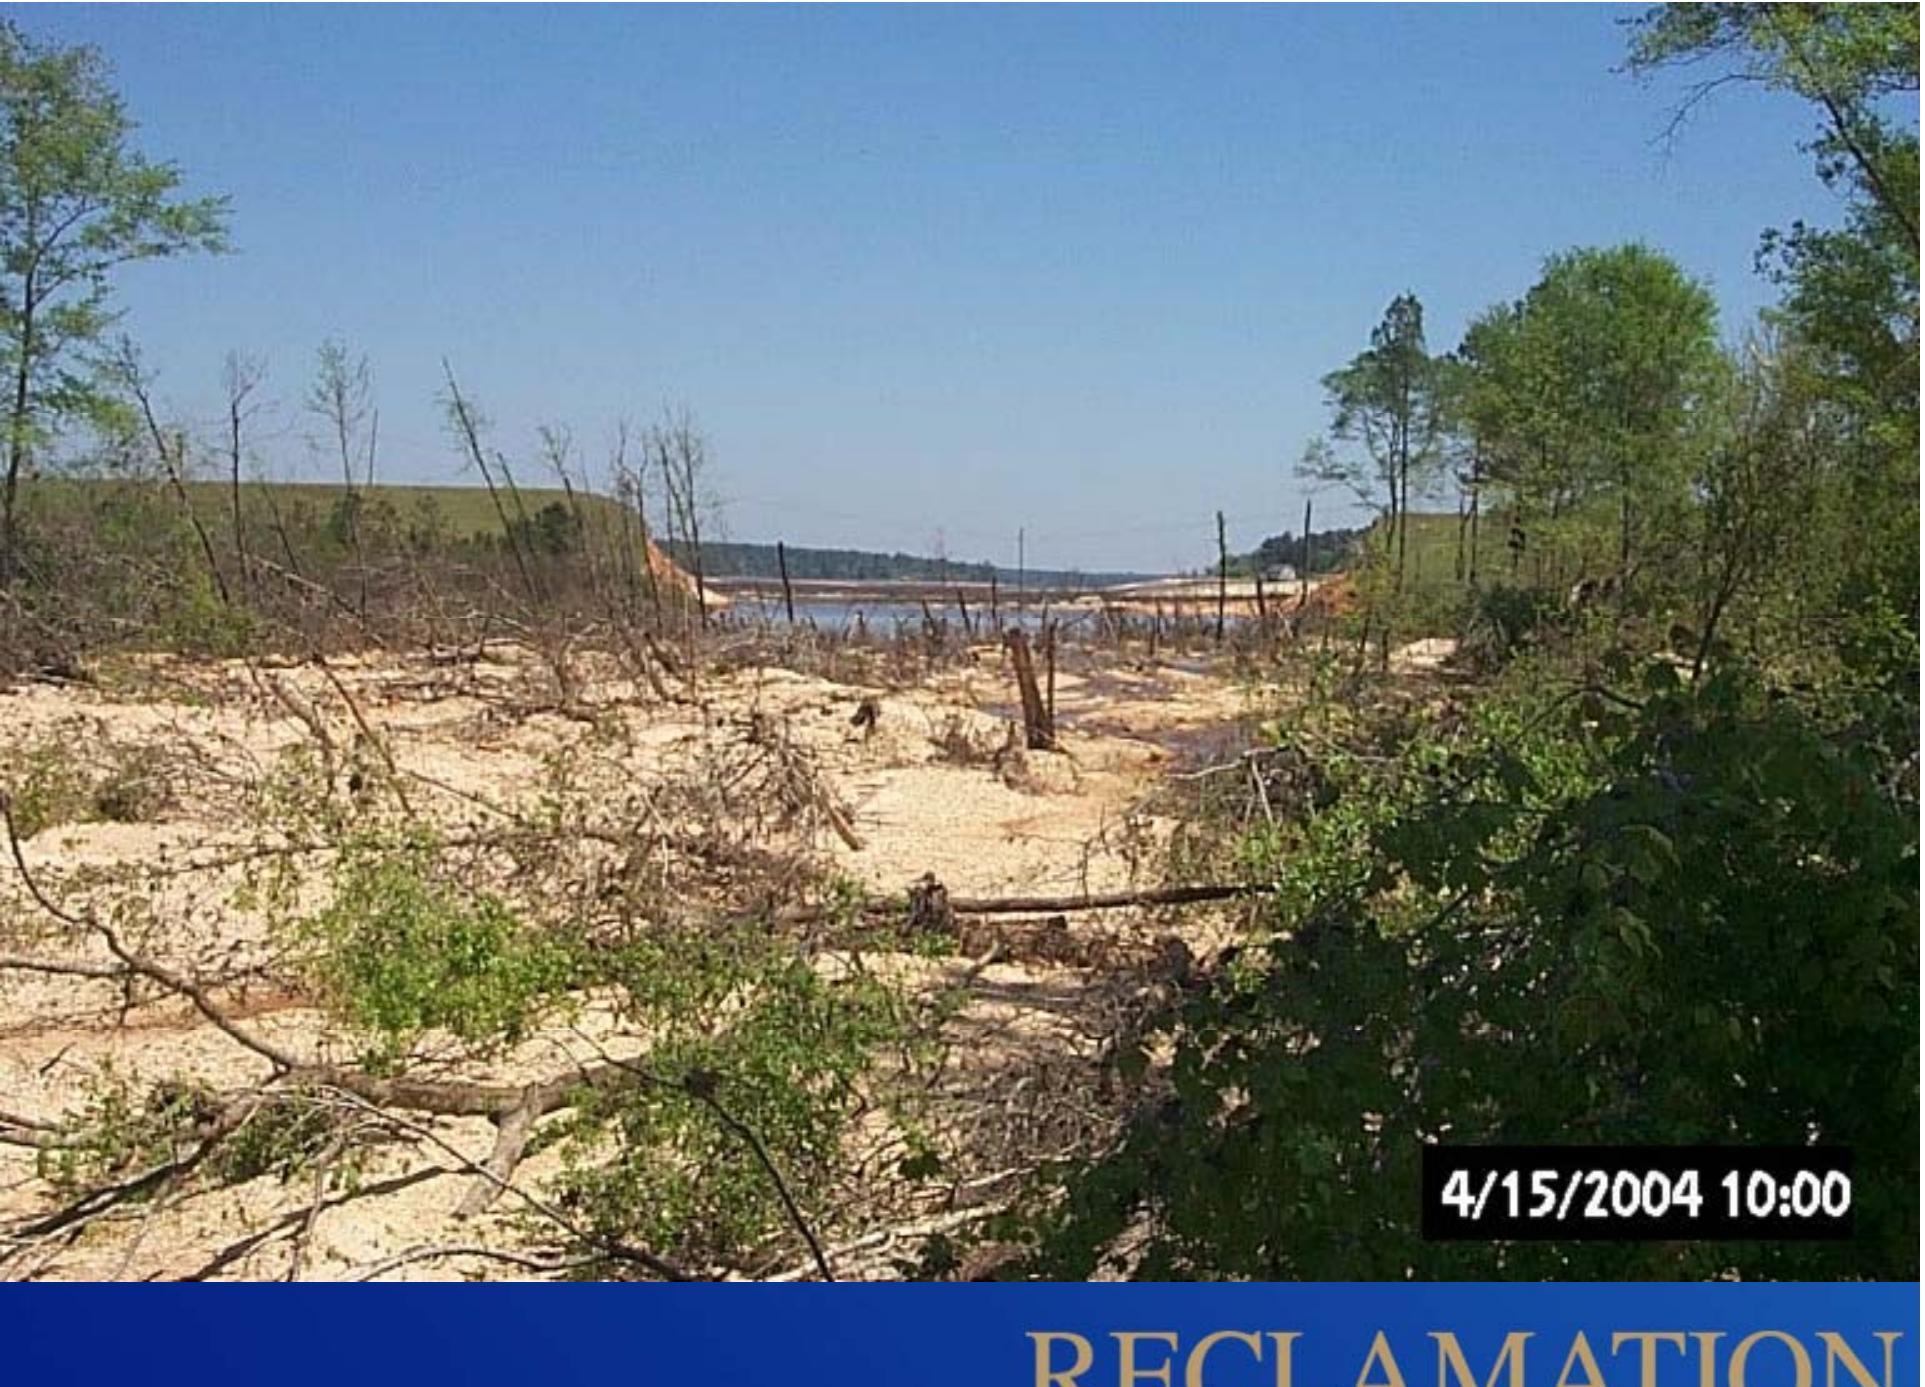
Many vehicles were swept one-quarter mile into the woods

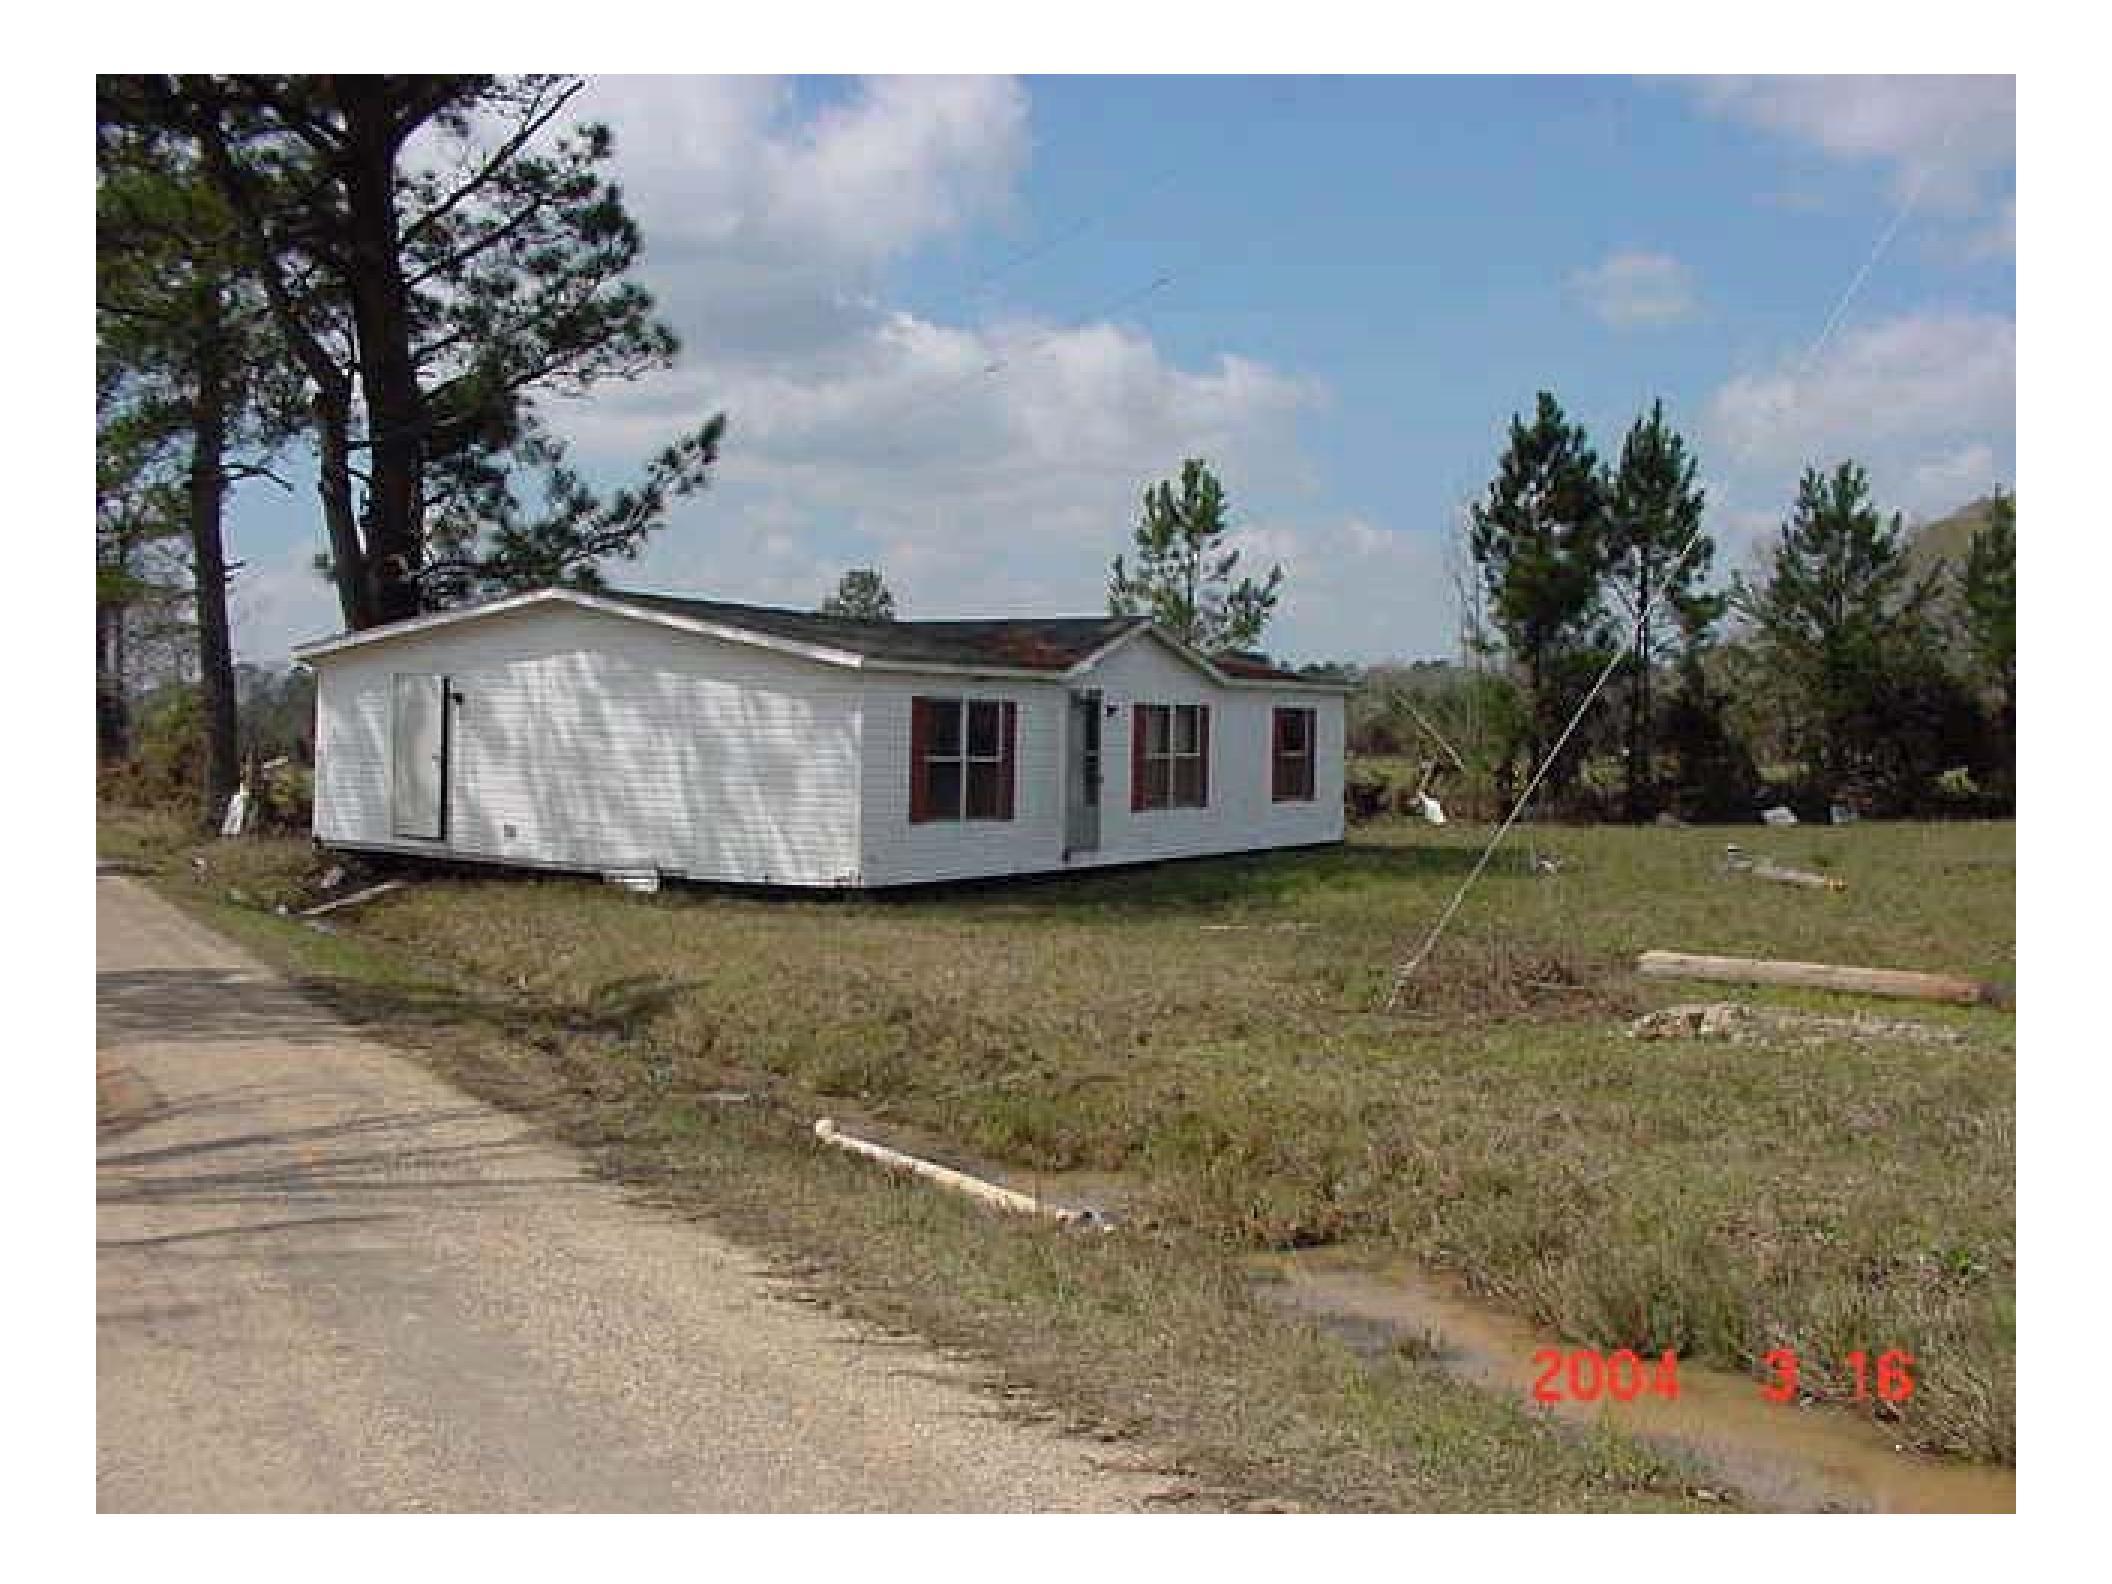
Many homes on Robbins Road Were Severely Damaged or Washed Away
