“It is a New Dam, How Can it Fail? - FMEA for Design of New Tempe Town Lake Dam”

**Dean B. Durkee, Ph.D., P.E. Gannett Fleming, Inc.
Christopher Kabala, P.E. City of Tempe**

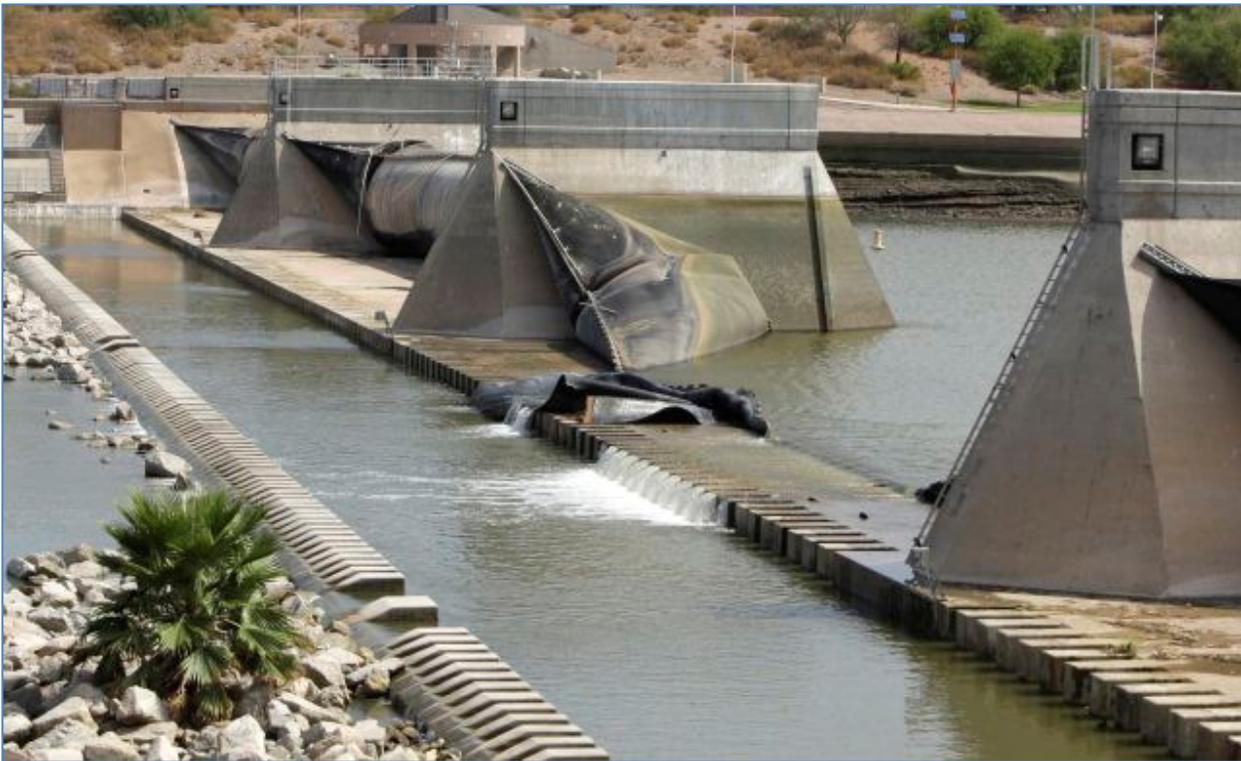
Figure 1. Photo of Failed 16-foot-High Rubber Dam at Tempe Town Lake, July 21, 2010.

A forensic investigation performed by SEA, Ltd. (SEA, Ltd., 2010), determined that the failure was the result of the age of the dam and the high temperature to which the dam was subjected. These conditions caused delamination or separation of the layers of reinforced rubber that comprise the rubber bladder. This separation is characteristic of Intra Carcass Pressurization (ICP). The bladder carcass breach occurred at the bottom of the bladder where the bladder made contact with the concrete apron at the location where the bladder curvature deviates from its "cylindrical" profile and flattens on the foundation. The bladder flexes where the change in curvature occurs. This flexure was caused by a back and forth motion resulting from the movement of the bladder in response to the force of the water against the dam. The flexure within the bladder carcass is believed to have caused small internal tears which then became the accumulation location for air that penetrates the reinforced rubber carcass.

After the failure, the scheduled bladder replacement was performed and all four downstream rubber bladders were replaced (Stantec, 2011). The replacement bladders were provided by Bridgestone under a five-year lease agreement to the City, although Bridgestone had, by that time, discontinued sales of their rubber dams. The replacement bladders are scheduled to be removed at the end of December 2015; the end of the lease period.
