A Tragedy in the Italian Alps (50th Anniversary)

VAJONT DAM

Lee Mauney, Wayne Graham
Bureau of Reclamation

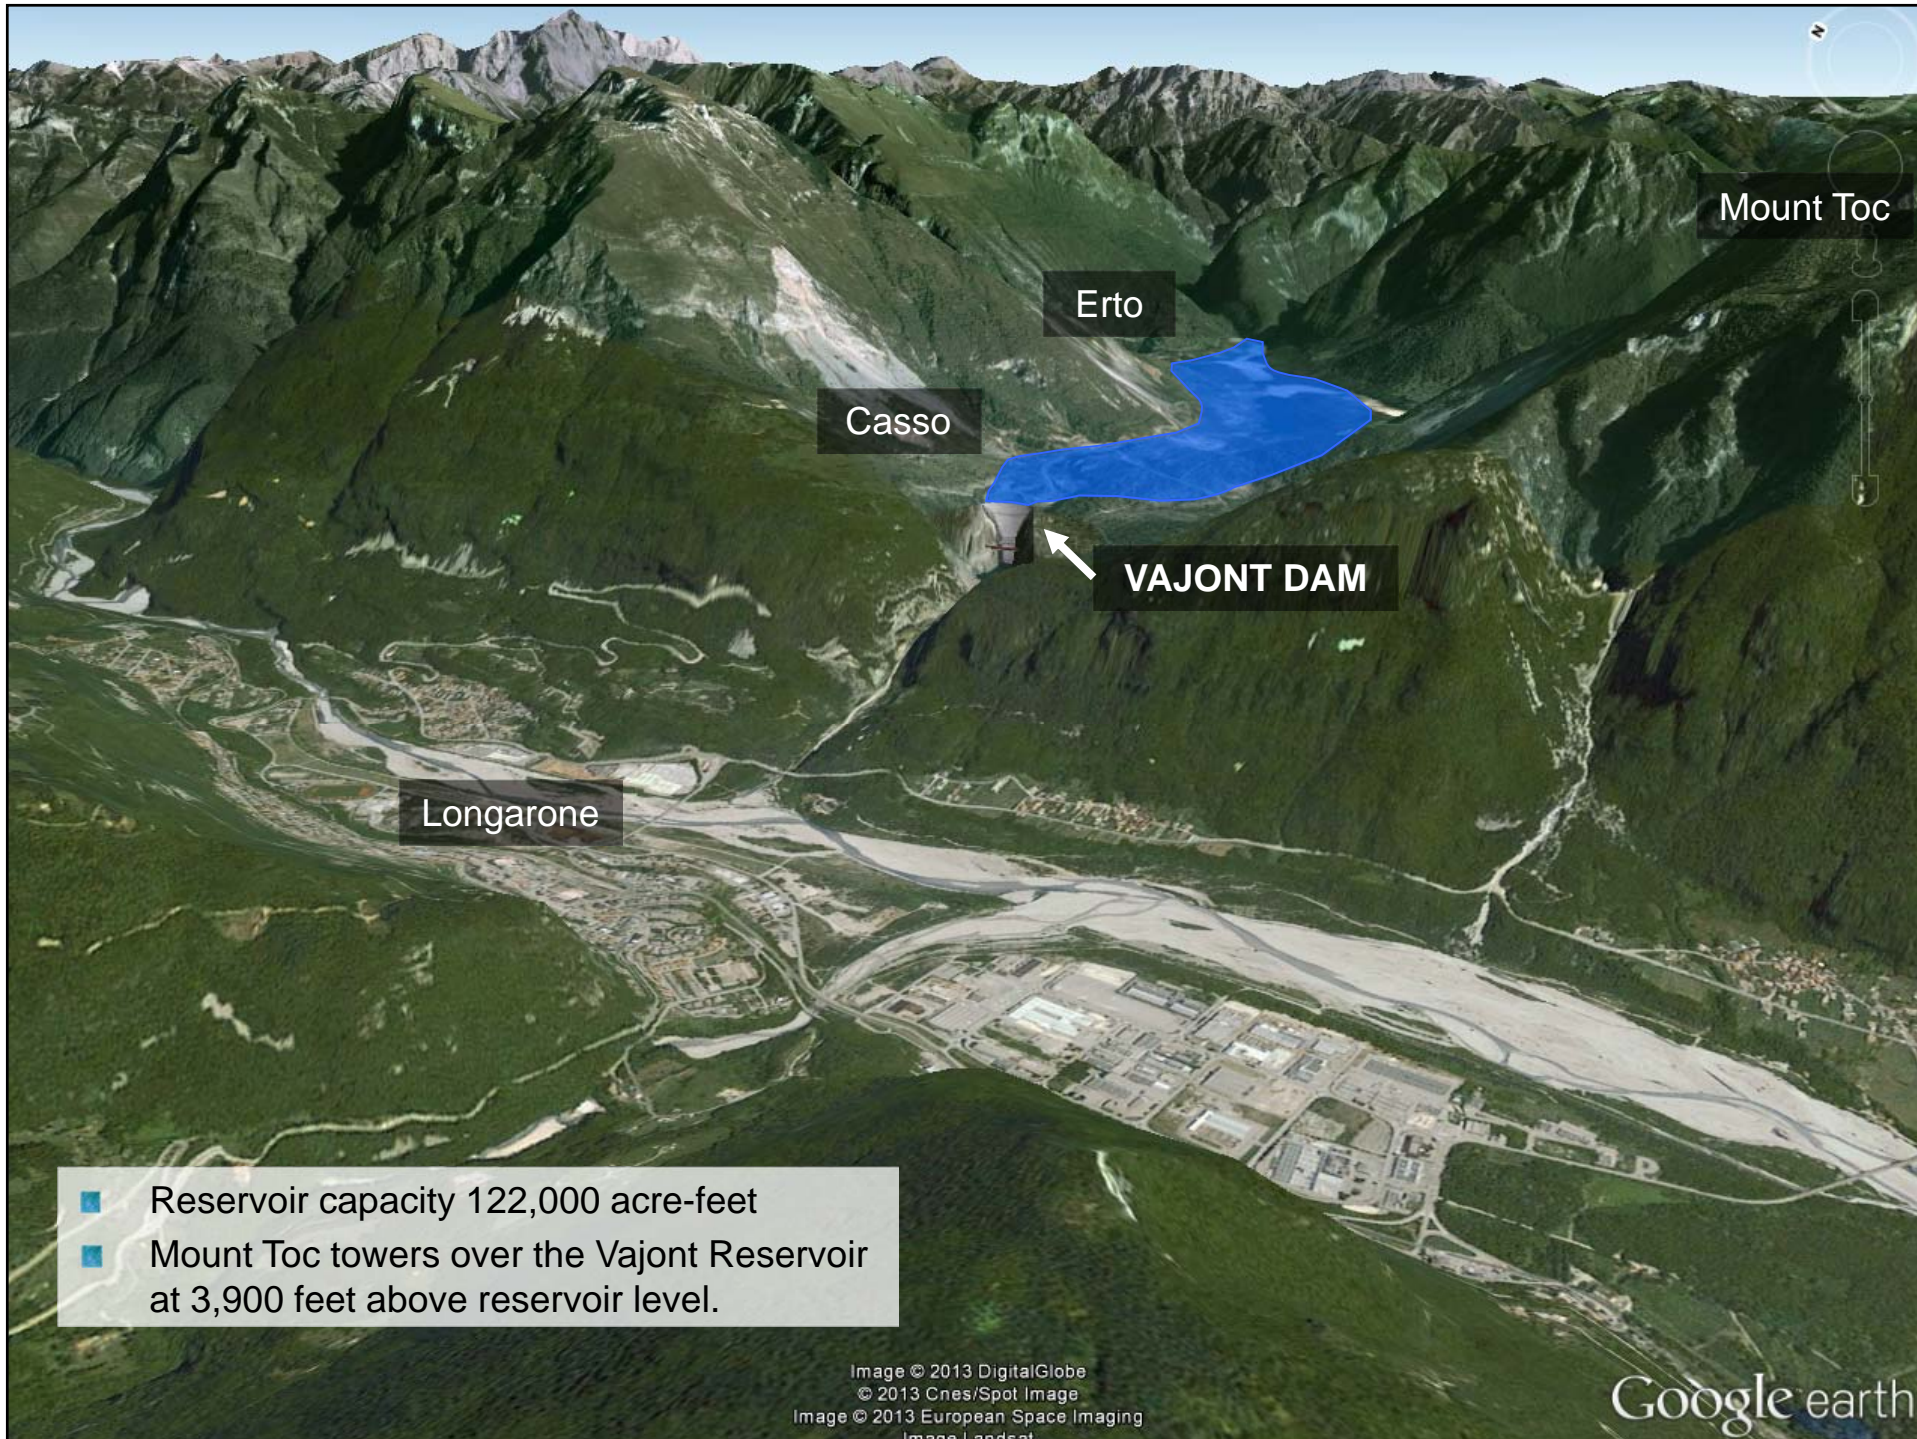
Mount Toc

Erto

Casso

VAJONT DAM

Longarone

- Reservoir capacity 122,000 acre-feet
- Mount Toc towers over the Vajont Reservoir at 3,900 feet above reservoir level.

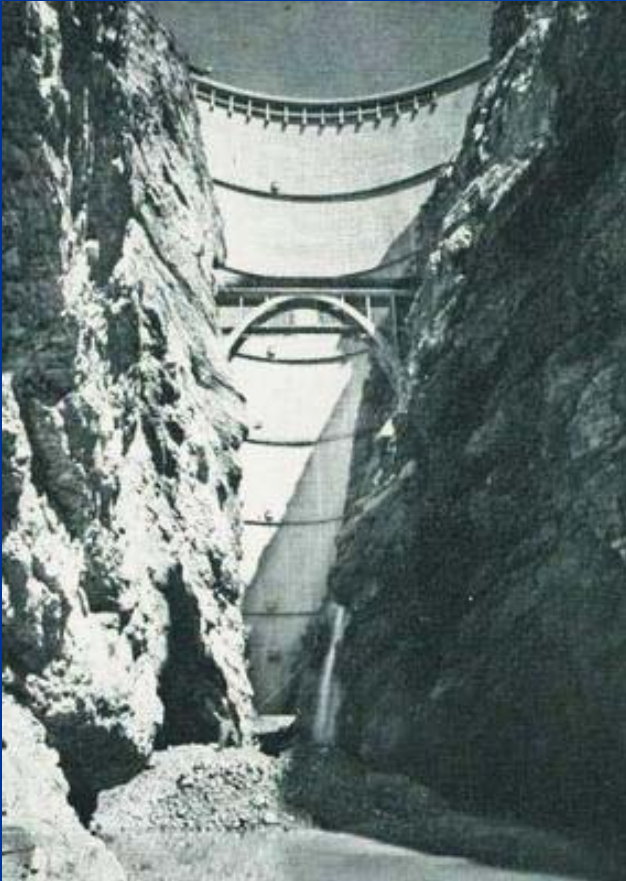
- 860 feet high
- Double-curved, thin-arch dam
- Constructed for hydro-electric power generation

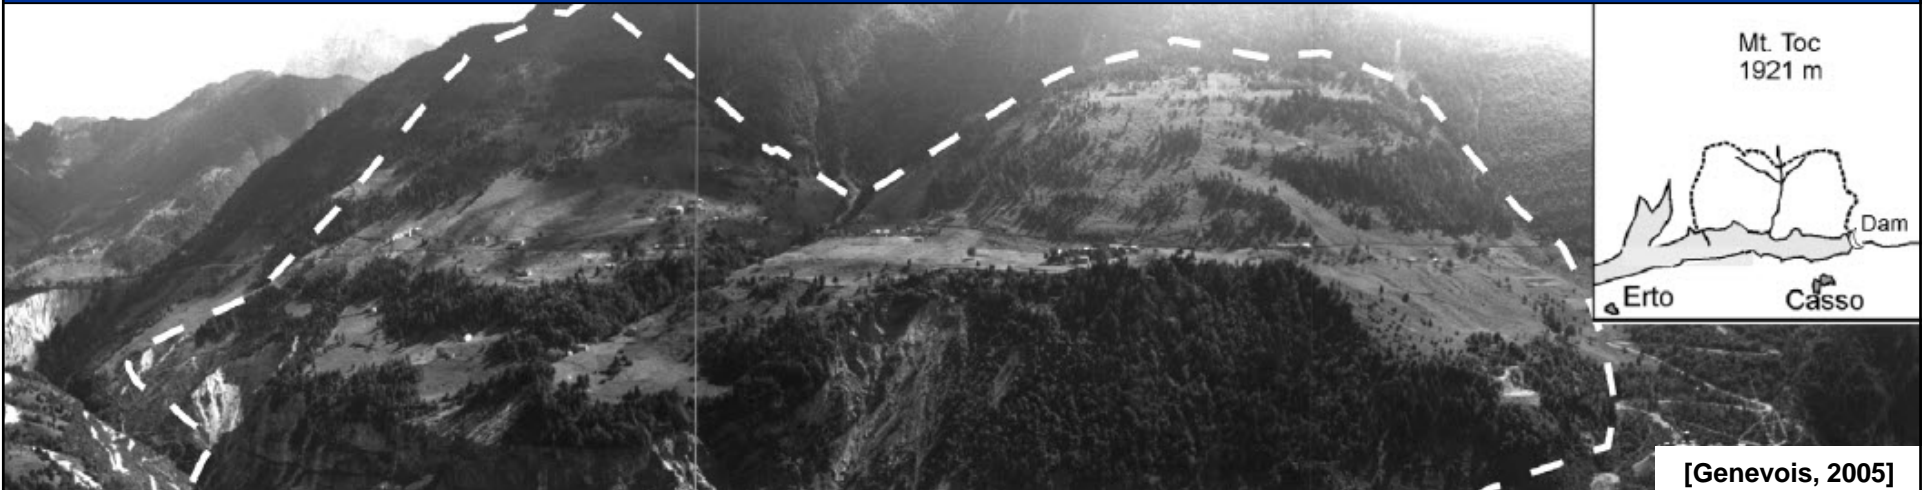
- Reservoir volume 93,000 acre-feet at time of slide
- The volume of the slide was about twice the volume of water impounded behind Vajont Dam.
- Updraft of air rocks and water climbed canyon wall ~ 850 feet above the reservoir.
- Waves of water over abutments > 300 feet above dam crest.

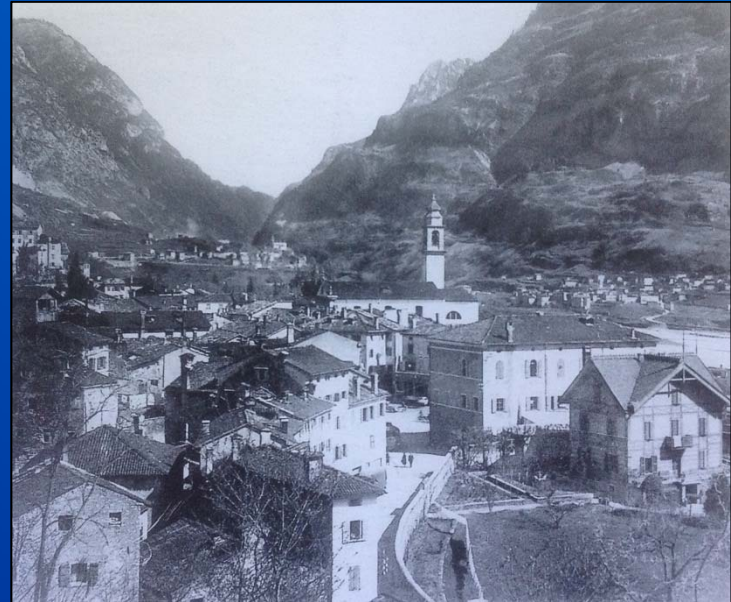
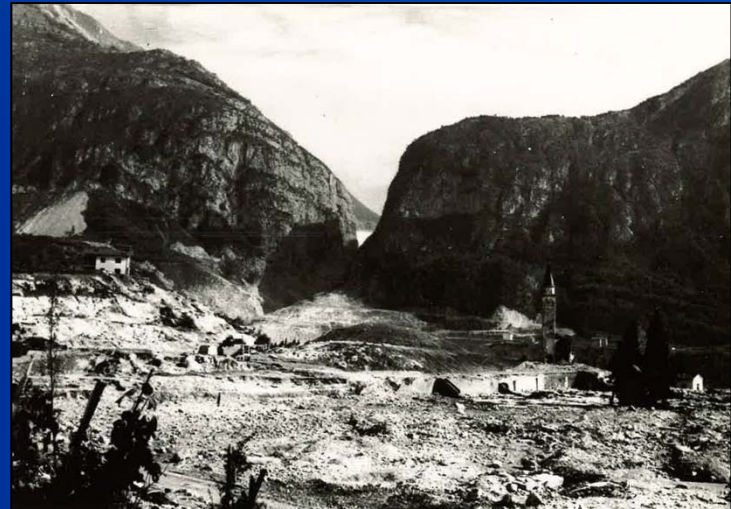
AFTER THE DELUGE. The townsite of Longarone is demolished almost as though it never existed. Beyond the old woman, and across the river valley where the search for the dead goes on, is the

gorge from which, only hours earlier, the 300-foot-high wall of water had spilled. Of the 2,300 who were in the town of Longarone at the time of the disaster, fewer than 200 lived to see it in ruins.

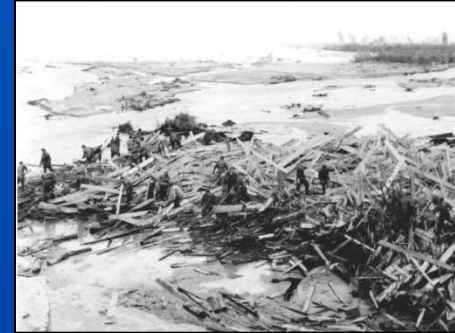
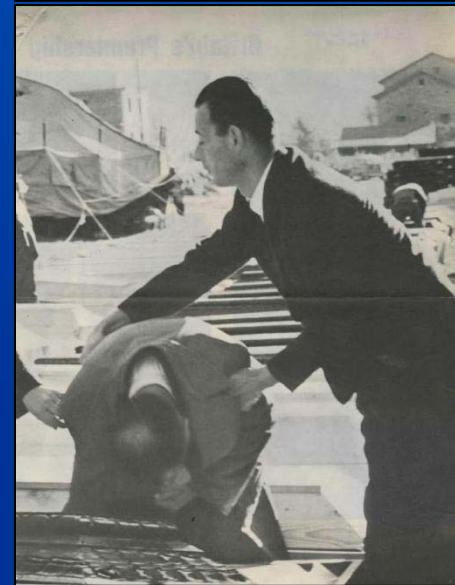
- Surprisingly, the Vajont Dam structure had little damage, even though subjected to a force estimated at 4 million tons from the combined slide and overtopping wave, far in excess of design pressures.
- Lesson: Hazards can exist at dams, even if a structure is considered safe and does not fail.
