A Geotechnical Analysis of the Behavior of the Vaiont Slide

A.J. HENDRON, JR., & F.D. PATTON

ON OCTOBER 9, 1963, in the Italian Alps near Longarone, more than 270 million m³ of rock slid from the side of Mt. Toc at speeds estimated at 20 to 30 m/sec into the newly completed Vaiont Reservoir. Some 2,043 persons died directly as a result of the wave of water that was displaced from the reservoir. The large volume and high velocity of the Vaiont Slide, combined with the great destruction and loss of life that occurred, make it a precedent landslide, particularly for slides caused by reservoir filling. The Vaiont Slide is frequently cited as illustrating one of the hazards that can be caused by dam construction even when the dam is shown to be safe. In fact, the 1963 Vaiont Slide marked a turning point in the amount of emphasis given in hydro

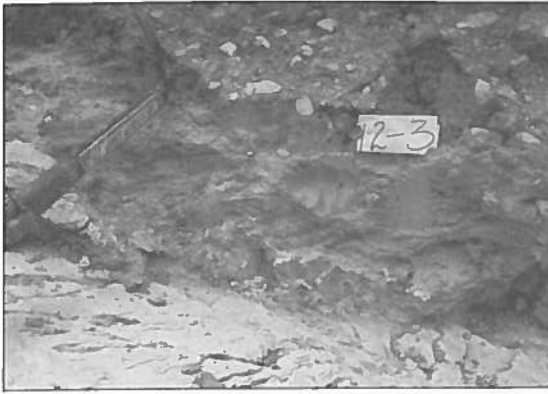
FIGURE 10. A clay layer 5 to 20 cm thick along the failure surface at location 12-3, near the east side of the slide.

Where the surface of sliding is overlain by slide debris, the clays were generally found preserved (for example, see Figures 10, 11 and 12). However, where the failure plane has been exposed, the clays are rapidly eroded by rainfall and by debris flows from the large catchment surfaces (see Figures 13 and 14). Small folds and faulted monoclinical (cascade) structures, which are present in many areas of the slide but are not visible at a

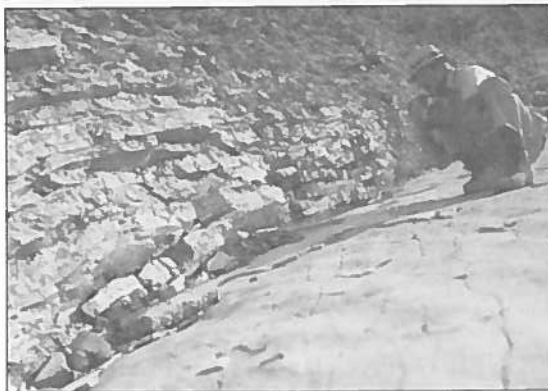
FIGURE 11. A view of the failure surface below the headscarp at location 18-9, about at the western third point of the slide.

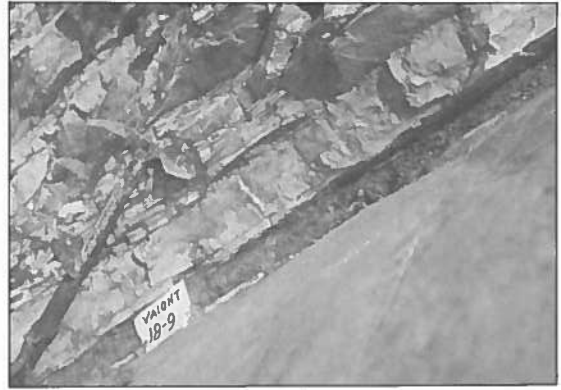
FIGURE 12. Clay interbed 5 cm thick along the failure surface at location 18-9. Other thin clay interbeds up to 0.5 cm thick lie in the rock mass.

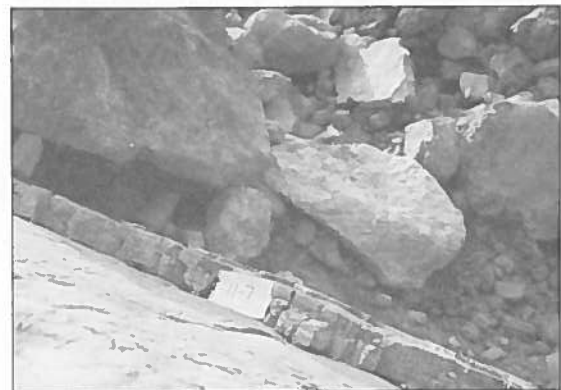
FIGURE 13. Slide debris overlies the failure surface where a clay layer 4 to 6 cm thick has been eroded from beneath the debris at location 11-7, the lower portion of the fourth gully from the west side of the slide.

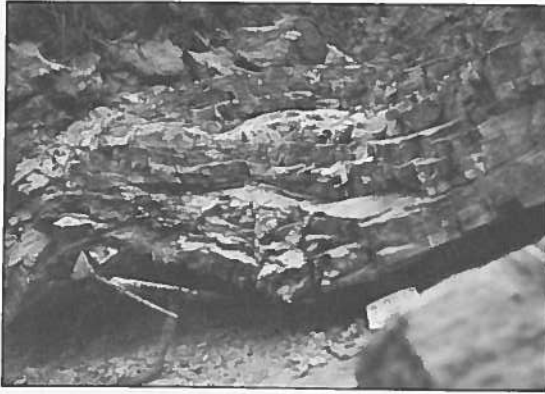
FIGURE 14. A view of a clay interbed 7 to 10 cm thick protected by a small fold and associated with adjacent failure surfaces at location 22-8, the fifth gully from the west side of the slide, one-third the way up the rock face.

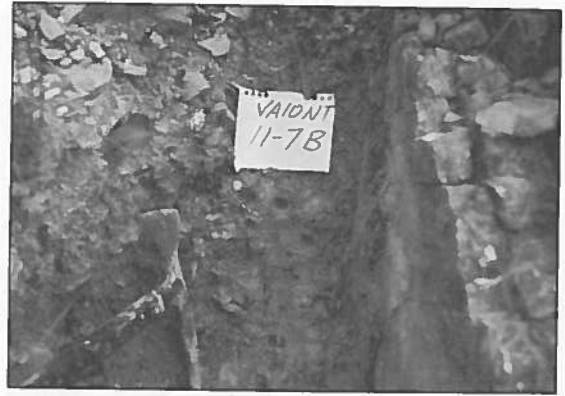
FIGURE 16. A clay layer, at location 11-7B, 10 cm thick lying between bedrock to the right and slide debris to the left. The clay is protected by a cascade structure, but is associated with the nearby failure surface.

distance (Figure 15), have served to protect and preserve small portions of the clay interbeds that are strategically continuous with large adjacent areas of the 1963 sliding surface (for example, see Figure 16).

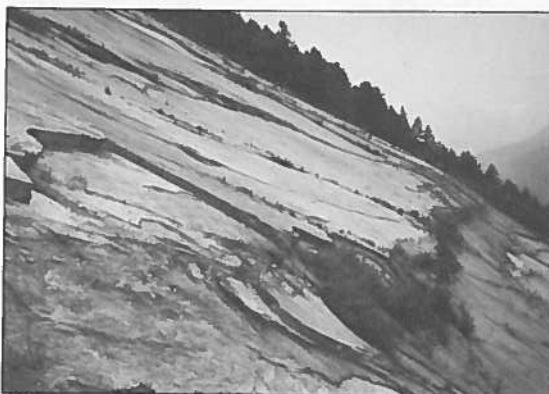
FIGURE 15. A monocline located in the middle of the western rock face. The surface, exposed after the October 1963 slide, is associated with a clay interbed 0.2 to 1 cm thick.

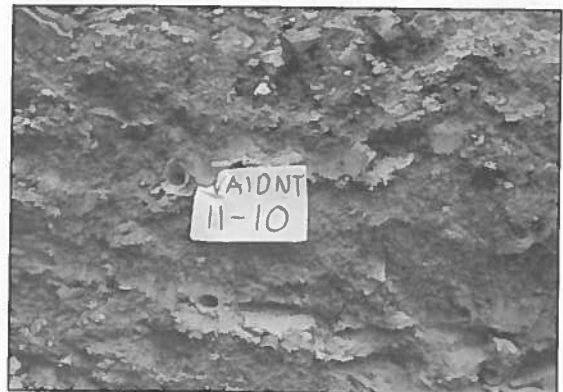
FIGURE 17. Five clay layers 1 to 2 cm thick within the lower 1.5 m of slide debris at location 11-10, the fourth gully from the west side of the slide. The failure surface appears in the lower left corner.

debris exposed along the base of the rock outcrops on the west side of the slide consists of an uncemented angular gravel and sand-sized breccia with frequent layers of clay and breccia with a clay matrix (for example, see Figure 17). The clay layers in this breccia fre-

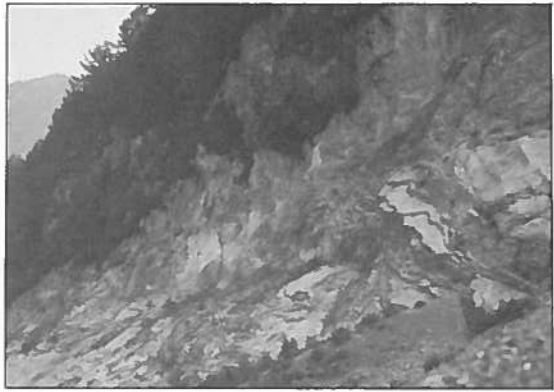
FIGURE 28. The western portion of the headscarp above location 18-6. The old headscarp is visible in the vegetated area above with a steep monoclinical fold changing to a fault at the scarp. Fragments of partly cemented breccia containing solution features remain attached to the cliff above.

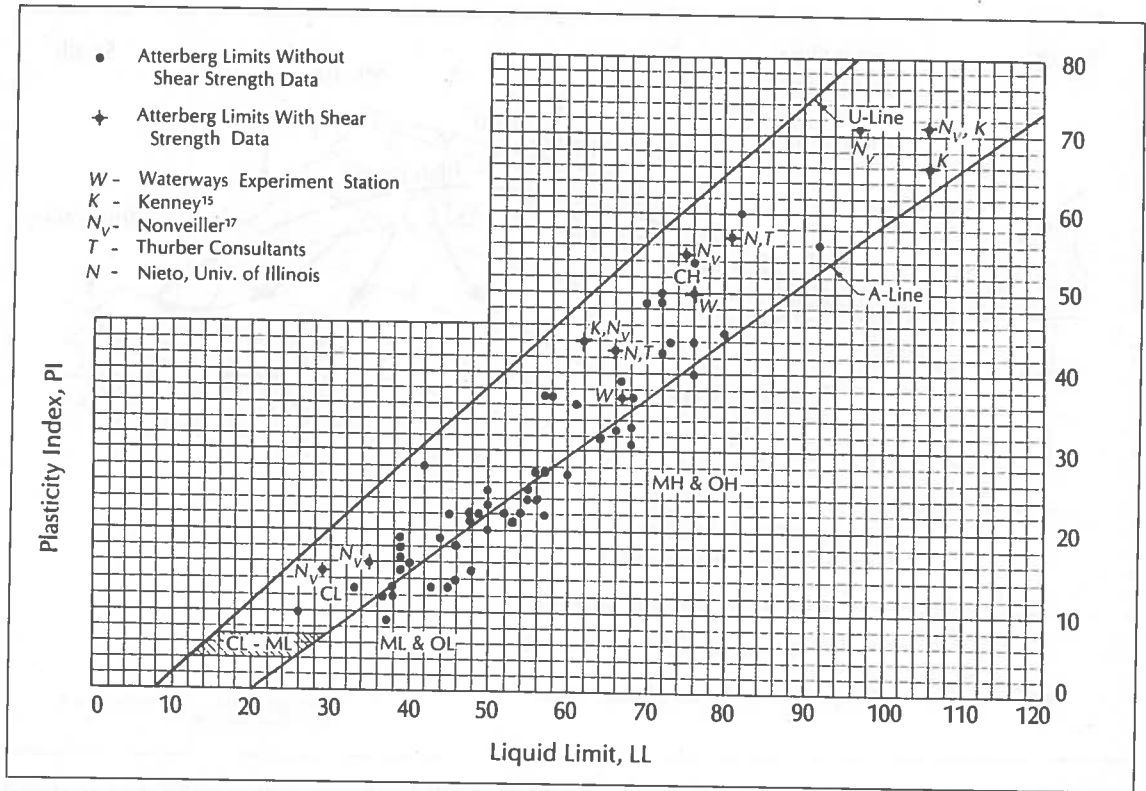
FIGURE 35. Plasticity chart for the clay samples from the slide site.

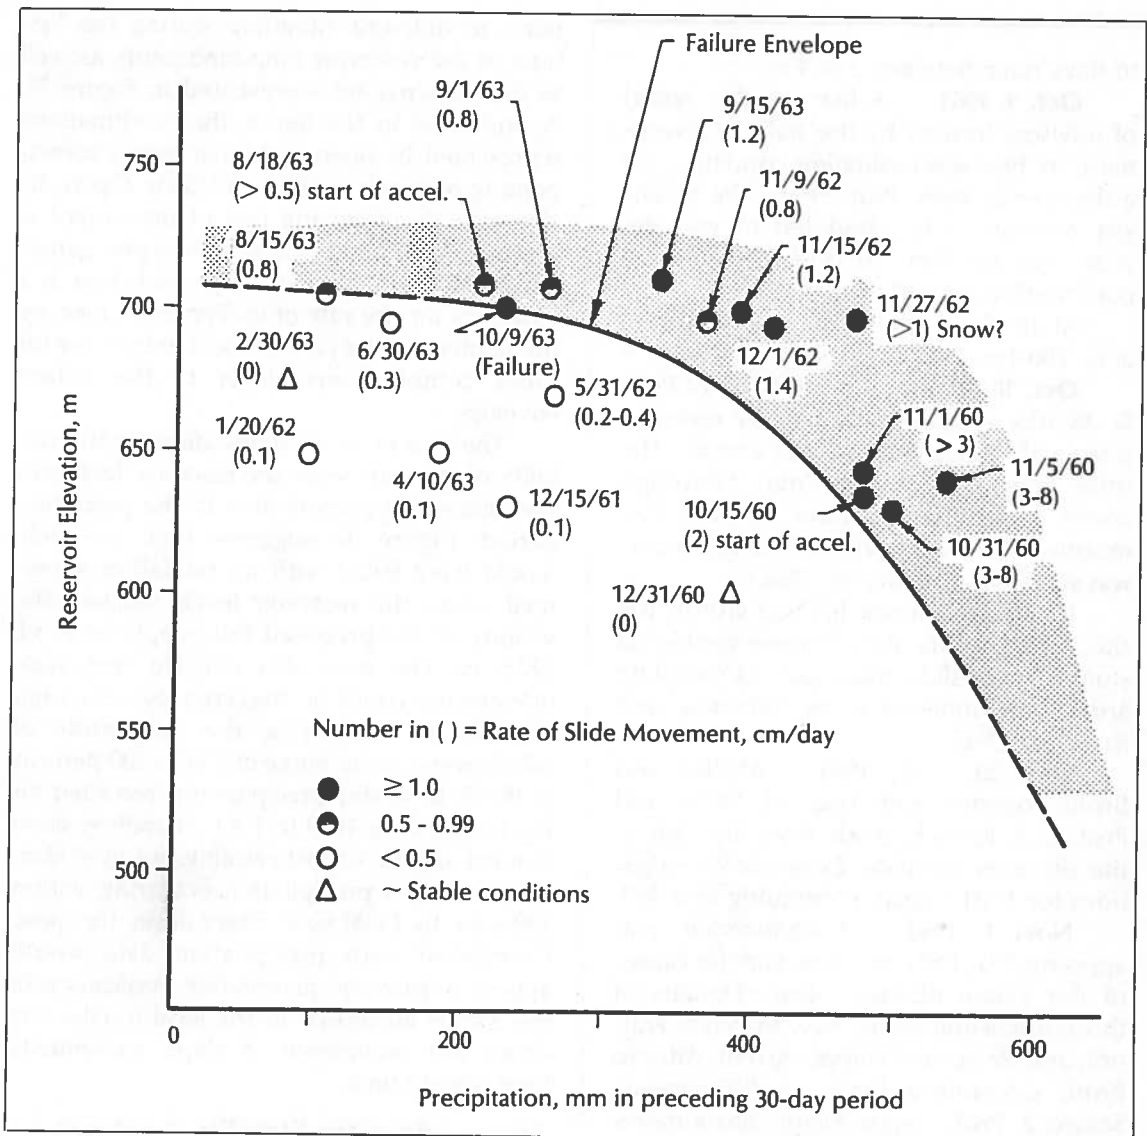
FIGURE 37. The stability of the Vaiont Slide for reservoir elevation vs. 30-day precipitation.

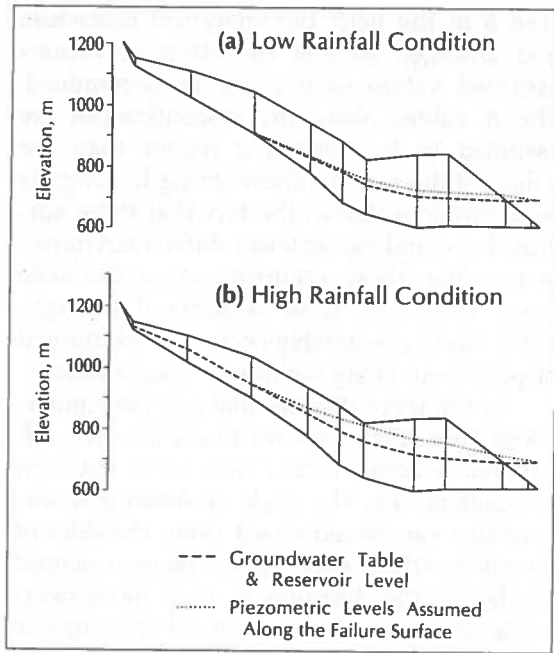
FIGURE 38. Piezometric levels used in stability analyses for Section 2, at a reservoir elevation of 710 m.

report.¹⁸ An example of the actual piezometric levels used is illustrated in Figure 38 for Section 2 with a reservoir level of 710 m.
