Reexamining the dam and geotechnical engineering aspects of the 1889 South Fork Dam breach and Johnstown Flood

By Michael D. Bennett, P.E. – GFT (Audubon, PA)

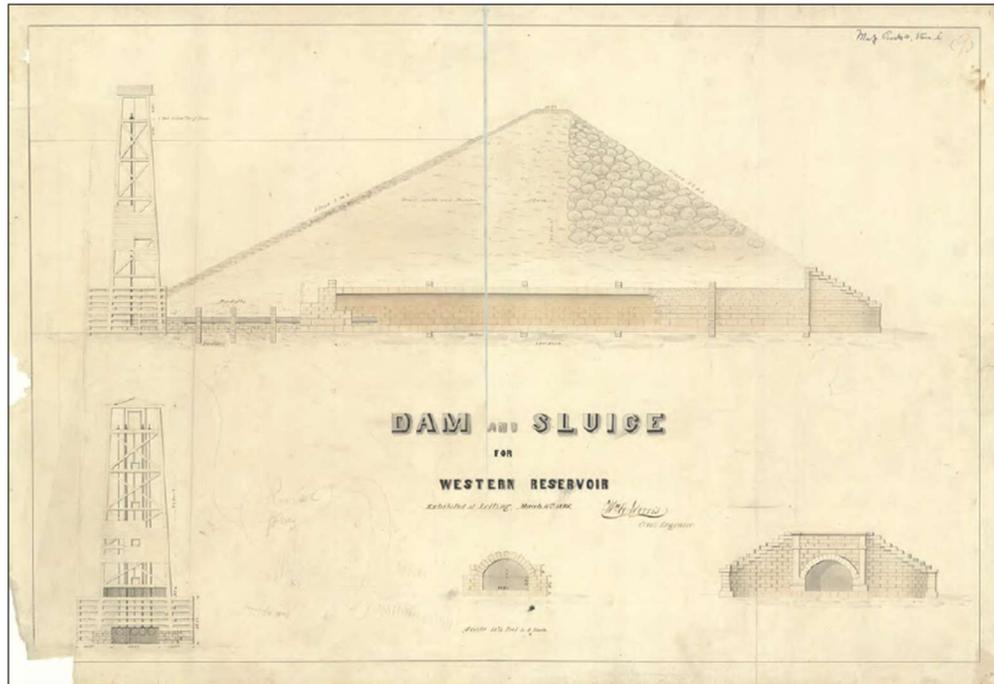
Figure 6: William Morris's final design for the Western Reservoir dam. Source: Hanna (2021).

For the dam itself, Morris stuck closely to Welch's recommendations. He designed an embankment structure measuring 72 feet high, about 860 feet long, roughly 265 feet wide at its base, and 10 feet wide at its crest. Morris value engineered the dam by going with Welch's idea to build its upstream half of puddled clay. Notably, modern dam engineers recognize that wet, compacted clay is erodible; it thus has limited shear strength and needs a shell of overlying heavy material for protection against an overtopping failure. Engineers of the era had yet to fully understand the mechanics of this process, but Morris appears to have recognized it at least intuitively. He thus called for the structure's downstream half to be built of massive boulders measuring at least 4 cubic feet in volume with soil filling the spaces between them. Morris designed a center section of gravel and weathered rock fragments lying immediately next to the boulders to separate them from the clay. Finally, Morris ordered the dam's upstream face covered with cobble-sized mortared masonry riprap to prevent scour damage to the puddled clay from waves in the reservoir. His design specifications called for a field engineer to inspect construction; the engineer would have the authority to make the contractor redo all poorly done work (Coleman 2019, Francis et al. 1891, Unrau 1980).

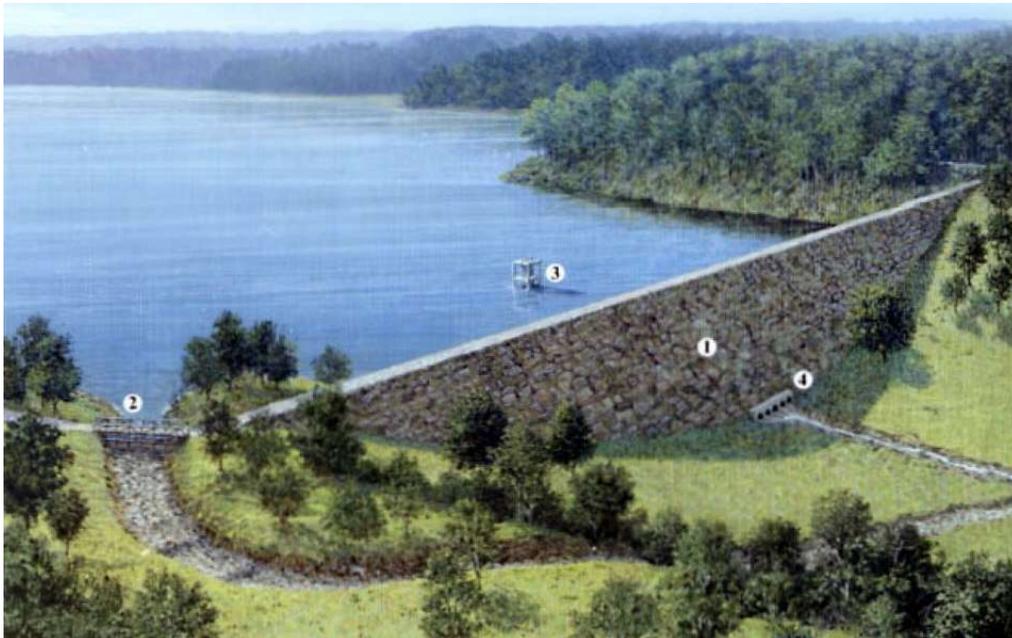
Figure 8: The Western Reservoir dam, 1853-1862. Note its (1) sturdy construction with downstream riprap, (2) northeast spillway, (3) control tower, and (4) discharge culvert. The drawing erroneously omits the southwest spillway and shows the culvert with five openings rather than one. Source: NPS (2023 C).

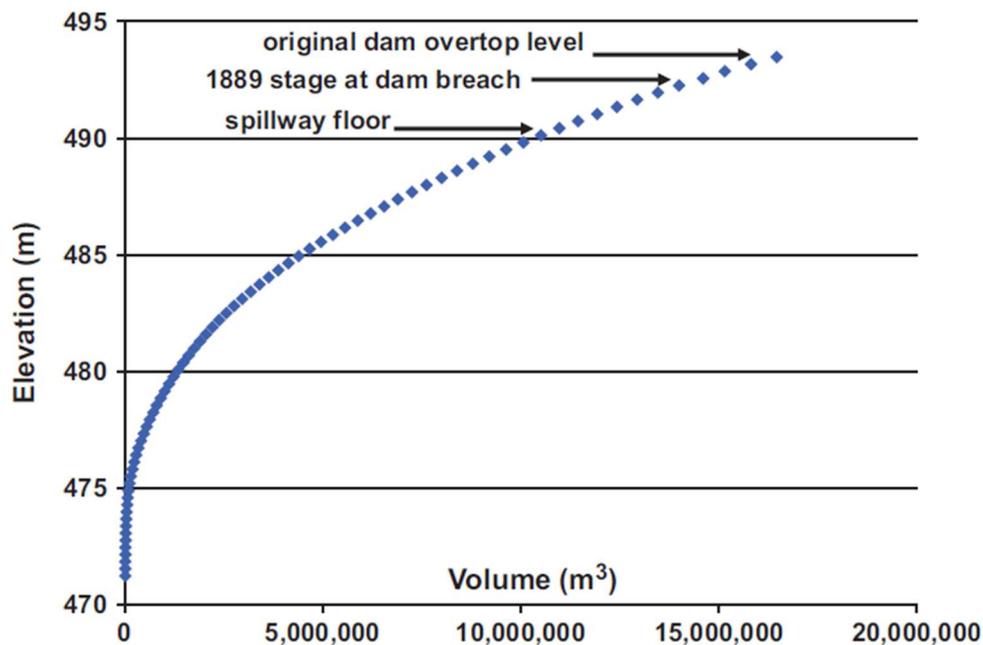
Figure 9: Storage-elevation curve generated by researchers at UPJ for the Western Reservoir and its successor, Lake Conemaugh. Source: Coleman et al. (2016).

Researchers from the University of Pittsburgh at Johnstown (UPJ) performed hydraulic analyses in the 2010s of the Western Reservoir and its dam. For these studies, they took LiDAR scans of, and soil samples from, the former reservoir bed and used them together with modern software to construct a stage-storage curve to estimate the reservoir's capacity. The researchers found that the original reservoir could hold roughly 13,200 acre-feet of water (4.3 billion gallons or 575 million cubic feet) weighing about 17.9 million tons. The researchers also estimated the

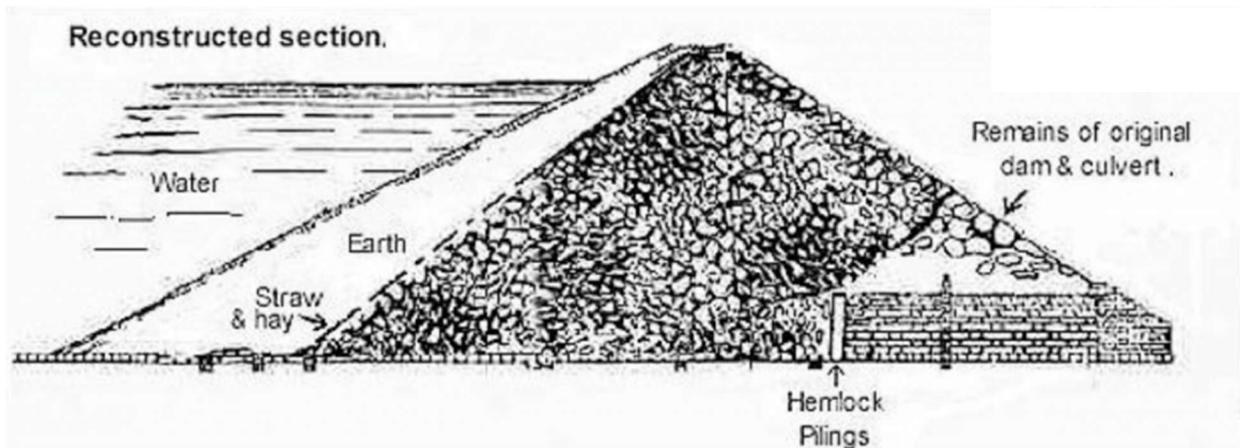
Figure 12: Cross-section of the South Fork Dam as rebuilt. Source: Frank (1988).

The actions of Kaine's crews upon returning to work reflected Benjamin Ruff's woeful inexperience in dam construction. The laborers resumed work by driving a double layer of hemlock sheet piles to block off the upstream end of the outlet conduit remnants. However, the poorly driven sheet piles were less than 6 inches thick. Contemporary civil engineers would almost surely have recommended thicker sheet piling based on the lateral earth pressure theories of the time. No evidence survives as to whether the crews backfilled the massive void formed by the conduit (Kaktins et al. 2013, Unrau 1980, Wellington and Burt 1889 B).

properly compact or puddle these materials during placement, thereby failing to meet the contemporary standard of care for embankment construction. Nor, it appears, did they try to bench the material used to fill the old breach into the surviving remnants of the original dam (Kaktins et al. 2013, Unrau 1980, Wellington and Burt 1889 B).

Ruff's crew did cover the new fill's downstream face with riprap, as had William Morris's contractors. However, the new riprap was noticeably smaller than the original dam's colossal boulders. The weak, poorly placed fill thus had less overtopping protection and shear strength than the material surrounding it, which created a dangerous plane of weakness right in the center of the dam. At no time did the laborers remove the trees, brush, and grass that had grown on the dam remnants since the Western Reservoir's completion. The overgrowth had almost certainly tapped into and worsened existing leaks in the dam as it spread its roots. It also made thoroughly inspecting the dam next to impossible (Francis et al. 1891, Kaktins et al. 2013, McCullough 1968, NPS 2023 C, Wellington and Burt 1889 B, Unrau 1980).

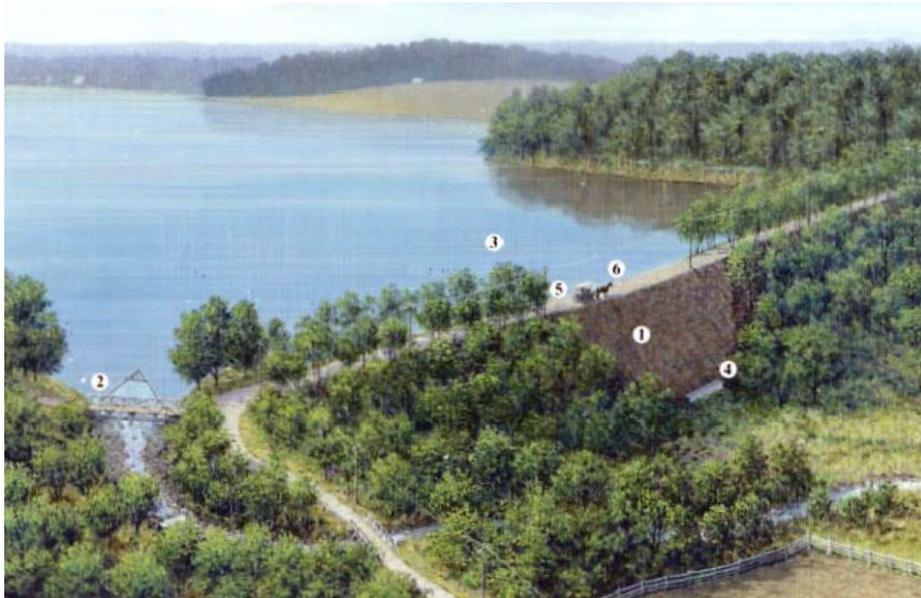
Figure 16: The South Fork Dam, 1881-1889. Note its (1,6) poorly rebuilt breach, (2) northeast spillway with fish screens and log boom, (3) lack of a control tower, (4) abandoned discharge culvert, and (5) lowered crest. Source: NPS (2023 C).

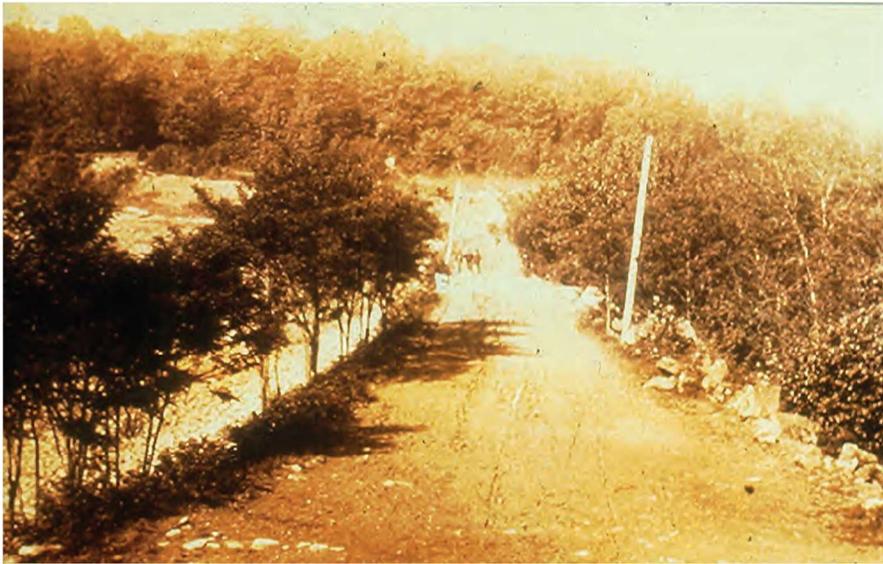
Figure 22: The South Fork Dam's crest looking southwest, 1880s, with its perceptible central sag. Source: Hanna (2021).

of the uncontrolled fill dumped into the 1862 breach had created a sag at least 1 foot deep in the dam's center. The increasingly perceptible sag further reduced the lake's storage capacity and the dam's discharge capacity. Moreover, new leaks kept appearing on the dam's downstream face of the dam, indicating ever-worsening internal stability issues which further compromised its integrity. Several leaks smelled of sulfur, suggesting that some of the uncontrolled fill was indeed comprised of sulfur-rich clays scrounged from local coal mine refuse. Meanwhile, Club picnickers were apparently oblivious as to how the burbling water which gave the spillway its ambience also indicated that the lake was perpetually almost full and could not be proactively lowered (Coleman 2019, Davis Todd 2017, McCullough 1968, Roker 2018).

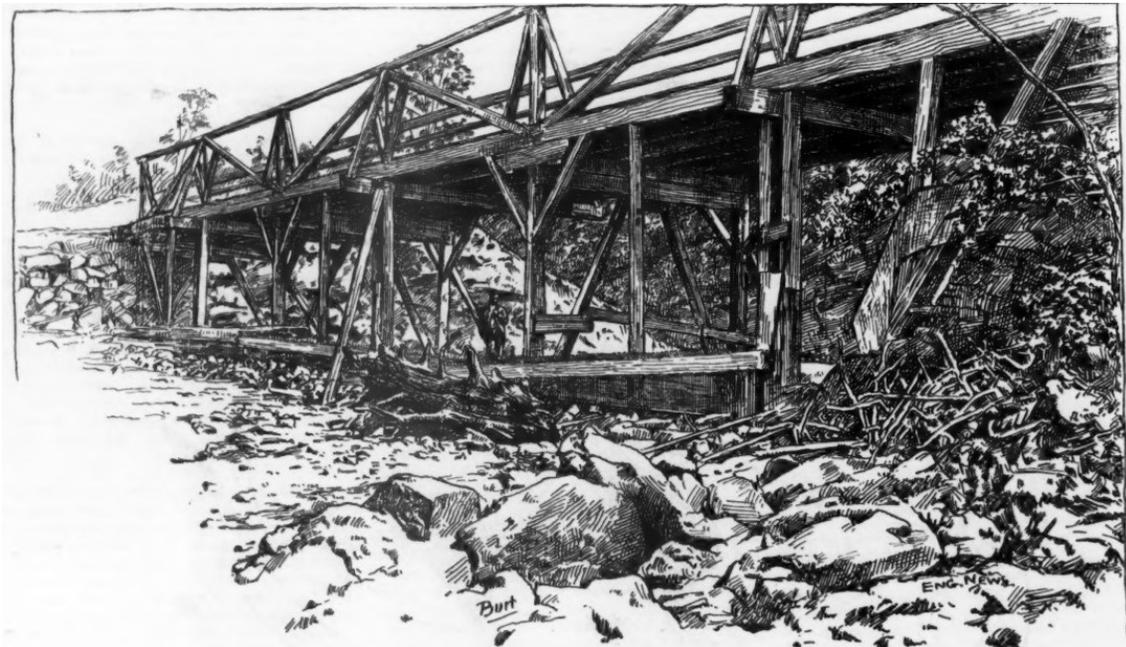
Figure 27: Contemporary illustration of the debris-laden fish screen remnants at Lake Conemaugh's spillway after the South Fork Dam breach. Source: Wellington and Burt (1889 B).

By mid-morning, the rain had largely tapered off. Discharges from local streams hadn't yet peaked, though, and Lake Conemaugh kept rising at around 9 to 10 inches per hour. Unger, Parke, and the laborers toiled valiantly but in vain. Years of carriage traffic had tamped the crest of the South Fork Dam down tightly, albeit not the poorly placed fill deep within it. The plow crew was thus struggling to pile even 1 foot of soil atop the dam, and this loose material would do nothing to halt overtopping. Meanwhile, the laborers in the old southwest spillway had hit bedrock before digging their already overflowing trench even knee-deep. Making matters worse, the timber and debris carried into the lake had overwhelmed the log boom and jammed the fish screens, further lowering the spillway's diminished discharge capacity. Some in the growing

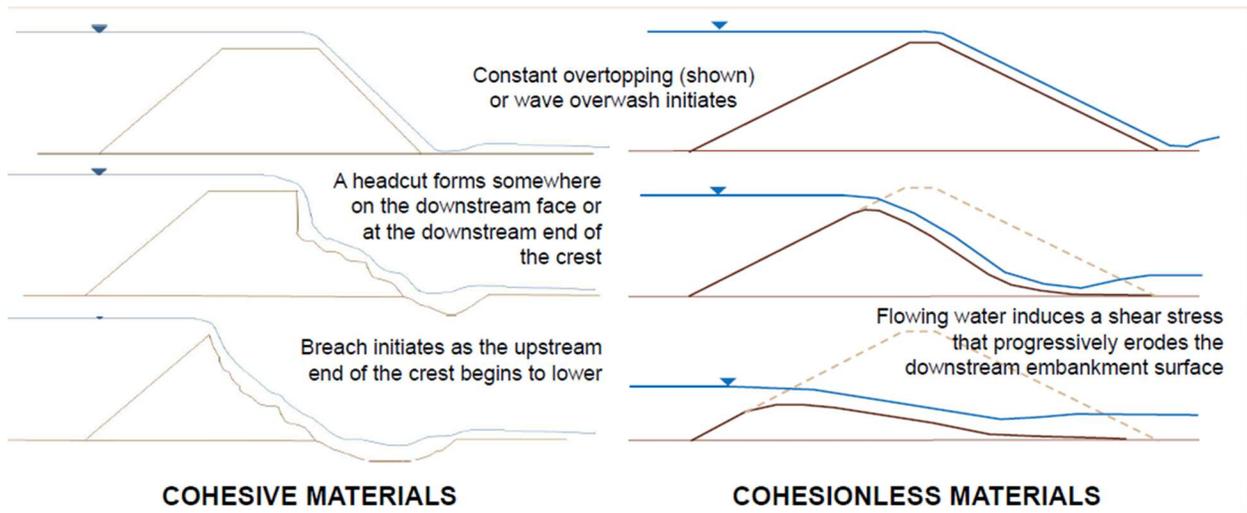
Figure 28: Comparison of overtopping failures in embankments made of cohesive (L) and cohesionless (R) soils. Source: USACE (2017).

The precise mechanisms by which embankments fail in overtopping depend on whether they are built primarily of cohesive soils, which are generally fine-grained, or cohesionless soils, which are usually coarse-grained. Both types of material were used to build and reconstruct the South Fork Dam. However, soils with fine-grained mass fractions of even just 12% will behave like much more cohesive materials. Eyewitness accounts confirm that the stages of the dam’s breach most closely matched those of overtopping breaches of cohesive embankments. Such failures typically begin with surface detachment, whereby overflowing water carves rills and gullies in the structure’s downstream face. John Parke observed this process at play when he returned from South Fork. The undersized riprap on the rebuilt dam’s downstream face had failed in one of its primary roles by not preventing surface detachment (Coleman 2019, Francis et al. 1891, Hanson et al. 2005, McCullough 1968, USACE 2017, Visser 1998).

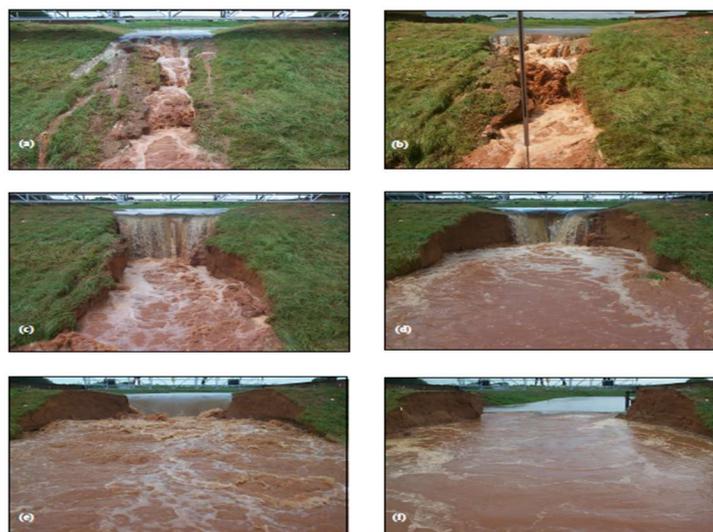
Figure 29: Stages of failure by overtopping of an embankment built of cohesive soil, as seen in a USDA field-scale test. Source: Hanson et al. (2005).

John Parke had done just about everything in his power to protect the South Fork Dam, but his reasonable confidence that it might survive the storm was tragically misplaced. Field studies have since determined that most embankments cannot withstand a sustained overflow 1 foot deep without a high likelihood of an overtopping failure. At the poorly rebuilt dam, even a (likely) shallower depth proved too much. While Parke ate, Lake Conemaugh's overflowing waters etched ever more, ever deeper rills and gullies into the dam's downstream face. Eventually, most of the channels merged into a single step-like gouge in the crest measuring 10 feet wide and 4 feet deep. Such a gouge, now called a headcut, represents the second step in typical overtopping failures of cohesive embankments. When Parke returned from lunch, the unpleasant sight shattered his hopes for the dam's survival. He, Unger, the laborers, and the bystanders watched helplessly as the headcut progressed, or migrated, upstream through the dam (Coleman 2019, Francis et al. 1891, Hanson et al. 2005, McCullough 1968, USACE 2017).

Embankments made of soil compacted near its optimum dry density and moisture content can resist headcut migration during overtopping by several orders of magnitude more than those made of soil compacted less carefully. Thus, Ruff's decision during the South Fork Dam rebuild to let his contractors lackadaisically dump fill material into the 1862 breach almost certainly accelerated the process. Between 2:50 and 2:55 PM, the migrating headcut reached Lake Conemaugh and breached the dam. The embankment failed at that moment, since it could no longer impound the lake. Moments later, though, the dam's myriad issues culminated far more dramatically. Its entire center appeared to give way, and a torrent of water burst forth from the lake. Eyewitnesses remembered this catastrophic final breach much more vividly than the initial, headcut-induced breach (Coleman 2019, Hanson et al. 2005).

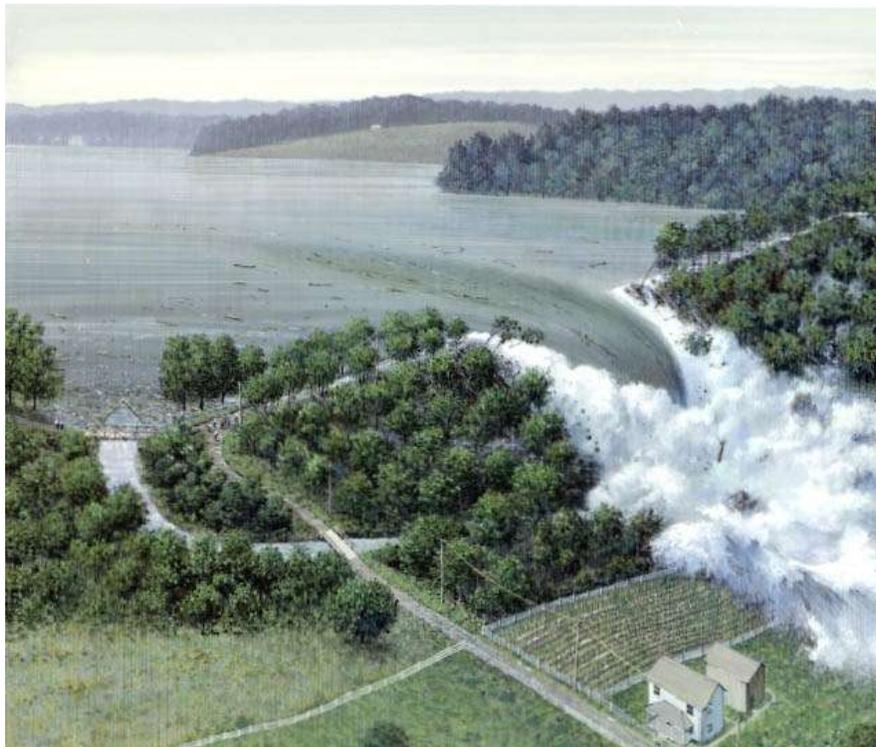
Figure 30: The final breach of the South Fork Dam on May 31st, 1889. Source: NPS (2023 C).

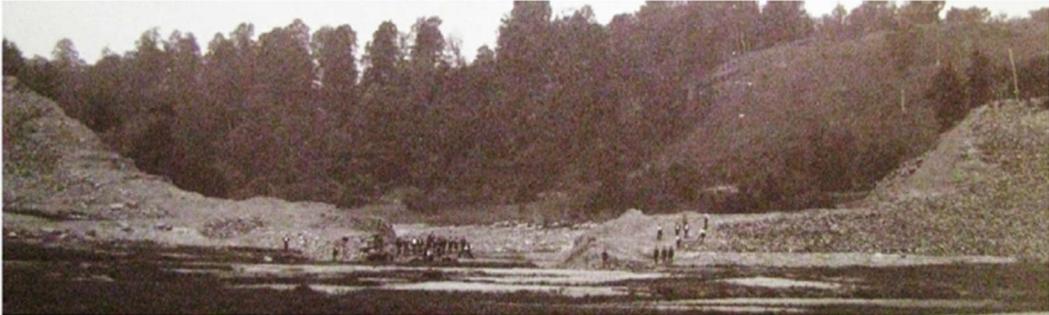
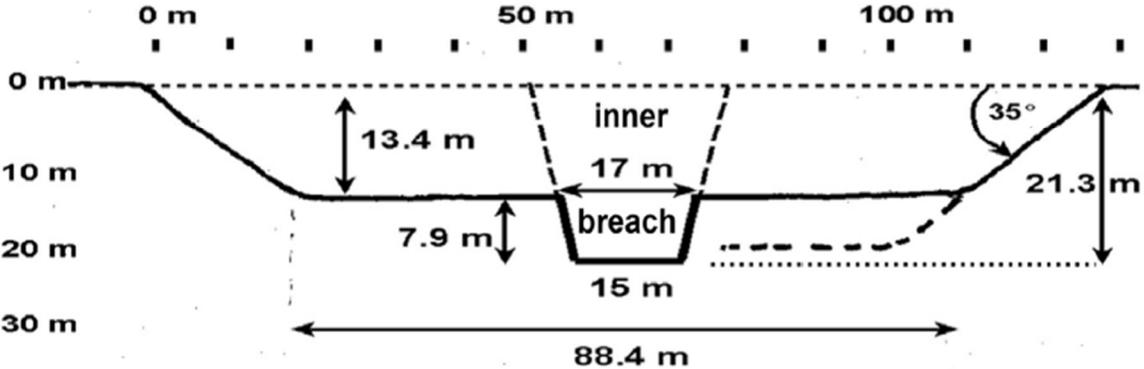
Figure 31: Matching-scale photographic and geometric representations of the South Fork Dam’s final breach. Source: Coleman et al. (2016).

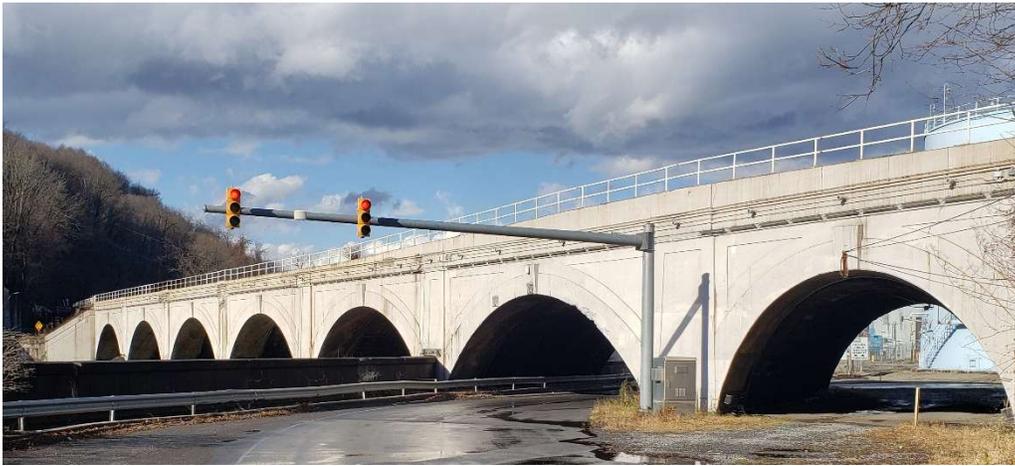
Figure 36: The seven-arched Stone Bridge, Johnstown. The Pennsylvania Railroad later covered its upstream face with concrete during a widening project. Source: Author.

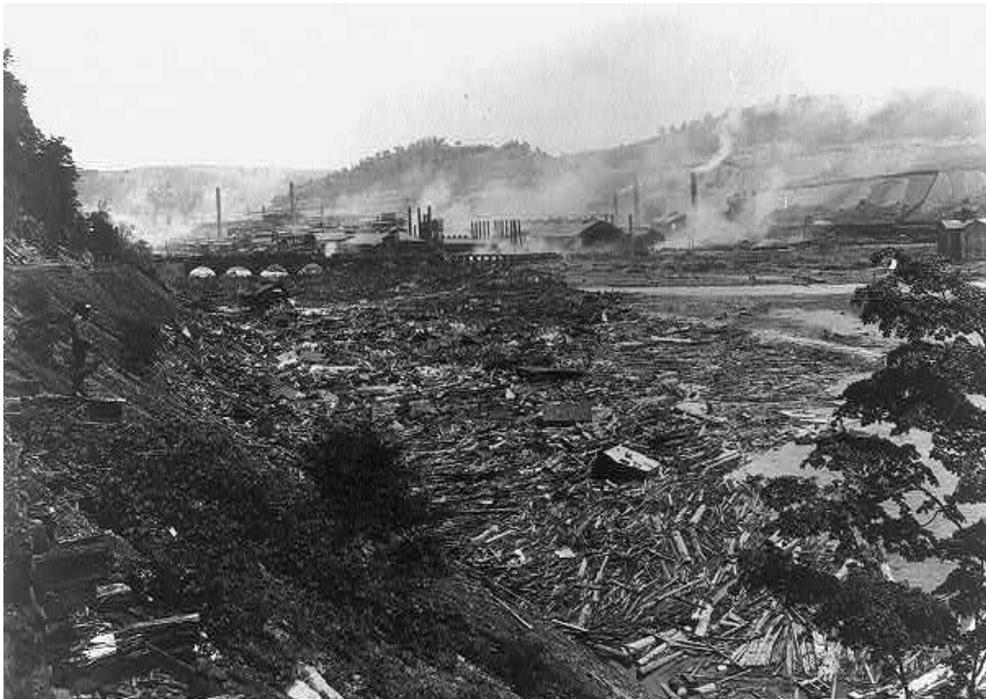
Figure 38: Debris jam at the Stone Bridge after the fire. Source: Lindberg (2024).

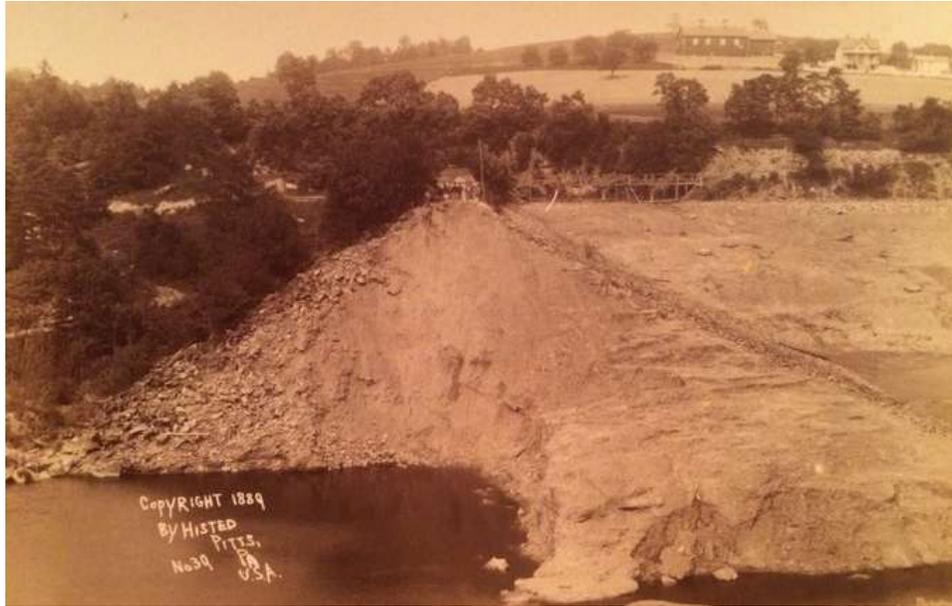
Figure 42: Reporters stand atop and are dwarfed by the former northeast abutment of the South Fork Dam, 1889. Source: Johnstown Flood NPS (2018).

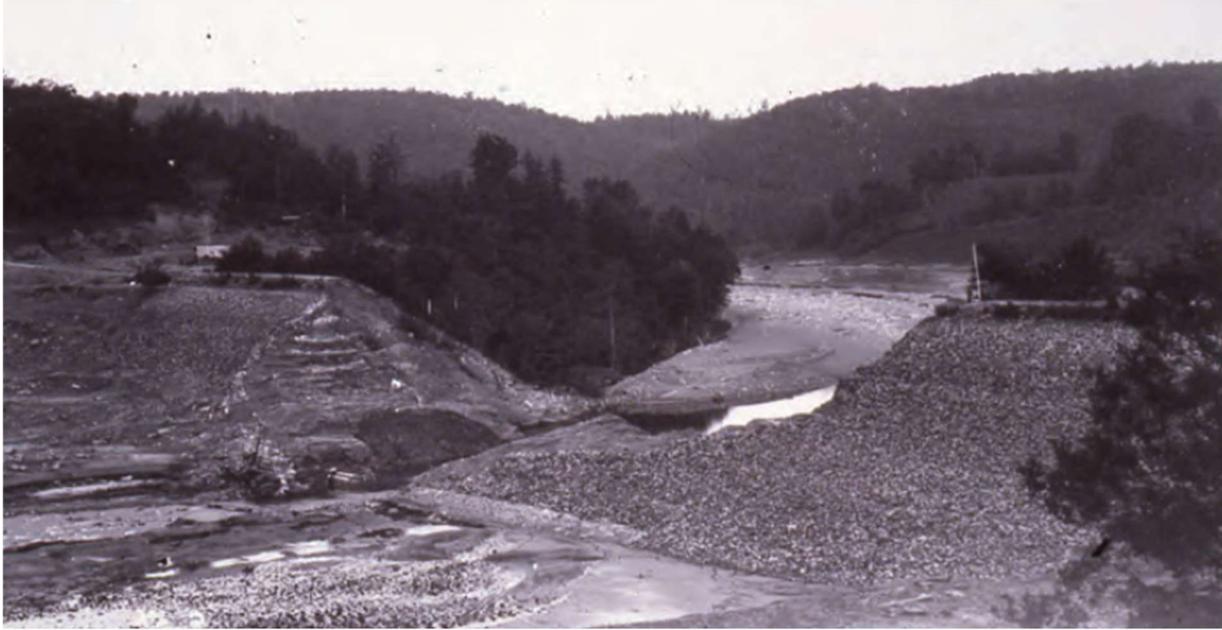
Figure 43: Former bed of Lake Conemaugh and remnants of the South Fork Dam looking downstream, 1889. Source: Hanna (2021).

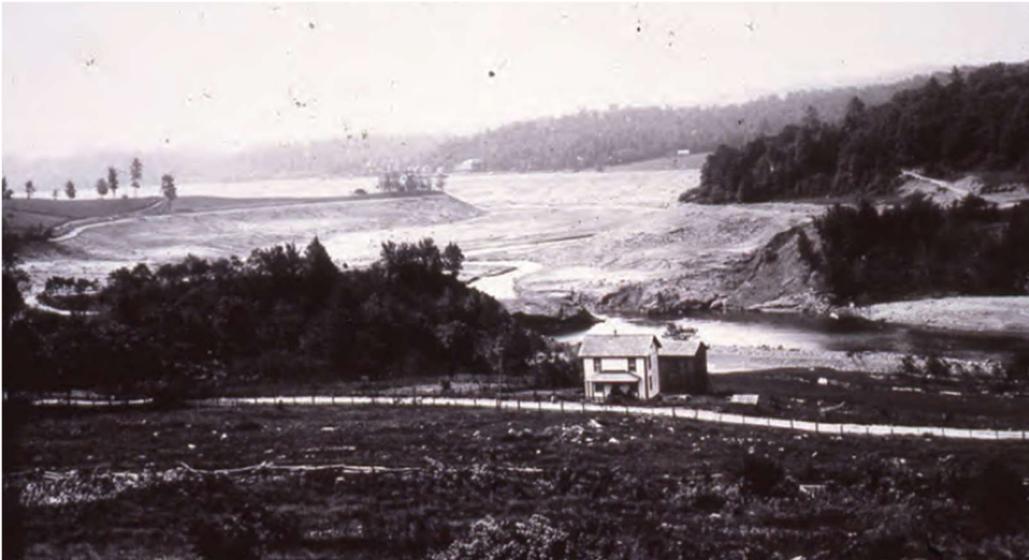
Figure 47: Former bed of Lake Conemaugh and remnants of the South Fork Dam, 1889, looking south. Source: Hanna (2021).
